**Barn at Coppings Farm,
Hemingstone,
Suffolk
HMG 026**

Historic Building Record

October 2010

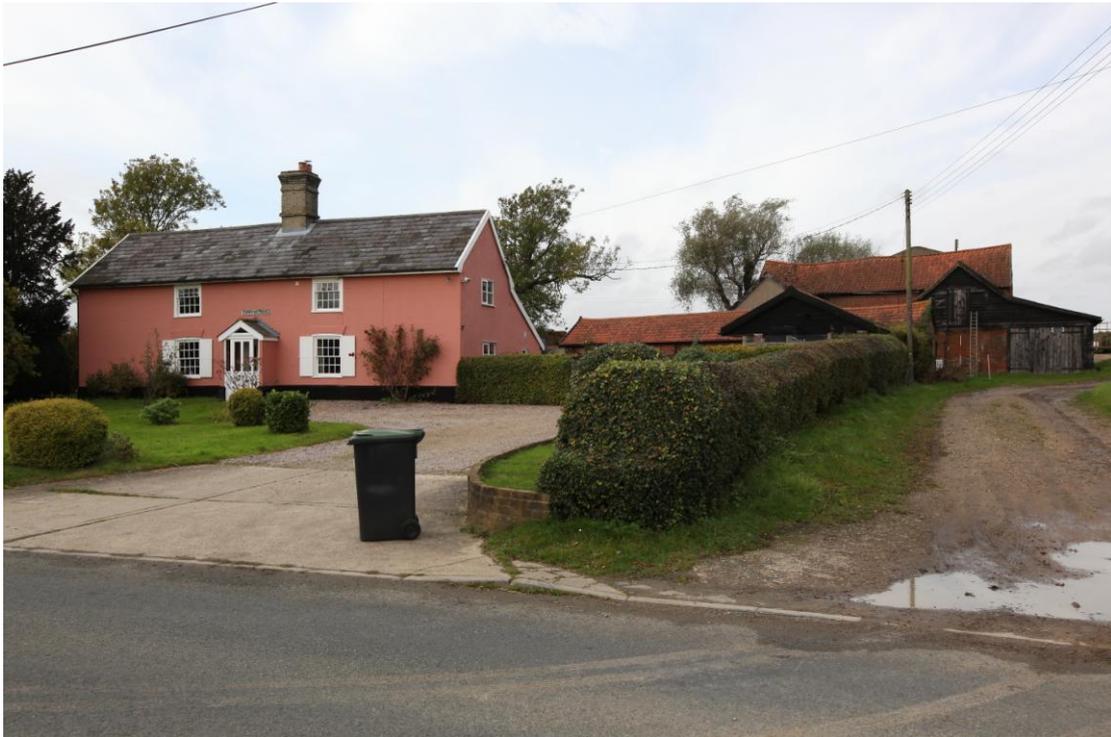
Illus. 1. General view of site from Clay Lane to south showing the grade II-listed farmhouse to left and the barn with its separate access track in the rear to right.

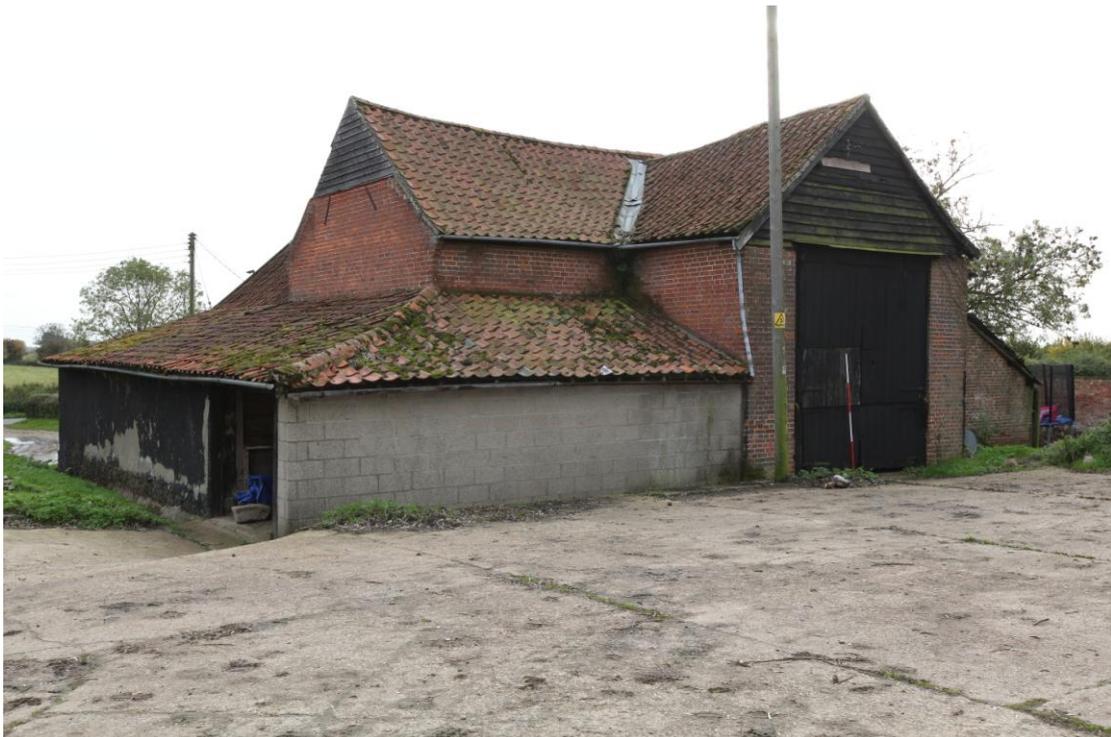
5. A pantiled lean-to shed with open entrance to the east and rebuilt northern wall of cement blocks (probably replacing clay-lump). Adjoining an enclosed yard with a shelter-shed in the 19th century and probably designed as a feed store.

Illus. 2. Exterior of barn from north-east showing the rebuilt cement-block wall of the northern lean-to shed (5) in foreground with the tarred clay-lump wall of the eastern lean-to (4) to the left.

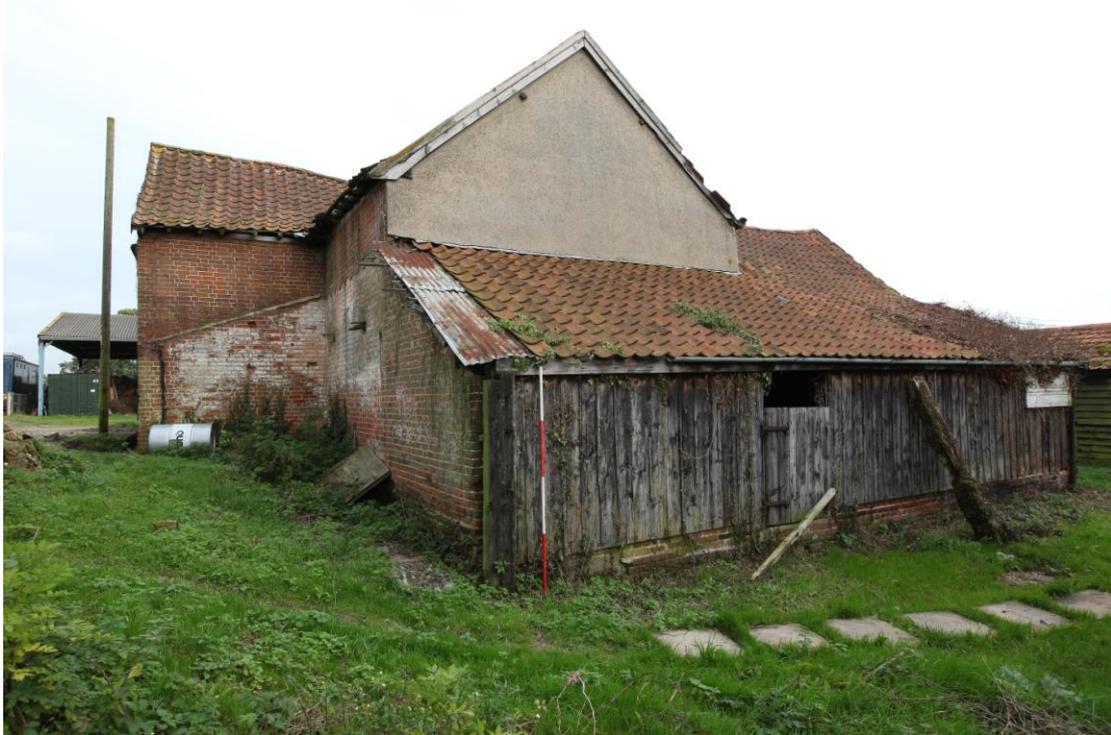
6. Site of demolished lean-to shed as indicated by paint and rafter scars on the brickwork of the barn. The loss of this structure interrupts the building's otherwise uniform symmetry.

Illus. 3. Exterior from west showing the western lean-to sheds (7 & 8) in foreground with the scar of a demolished additional lean-to (6) visible on the porch.

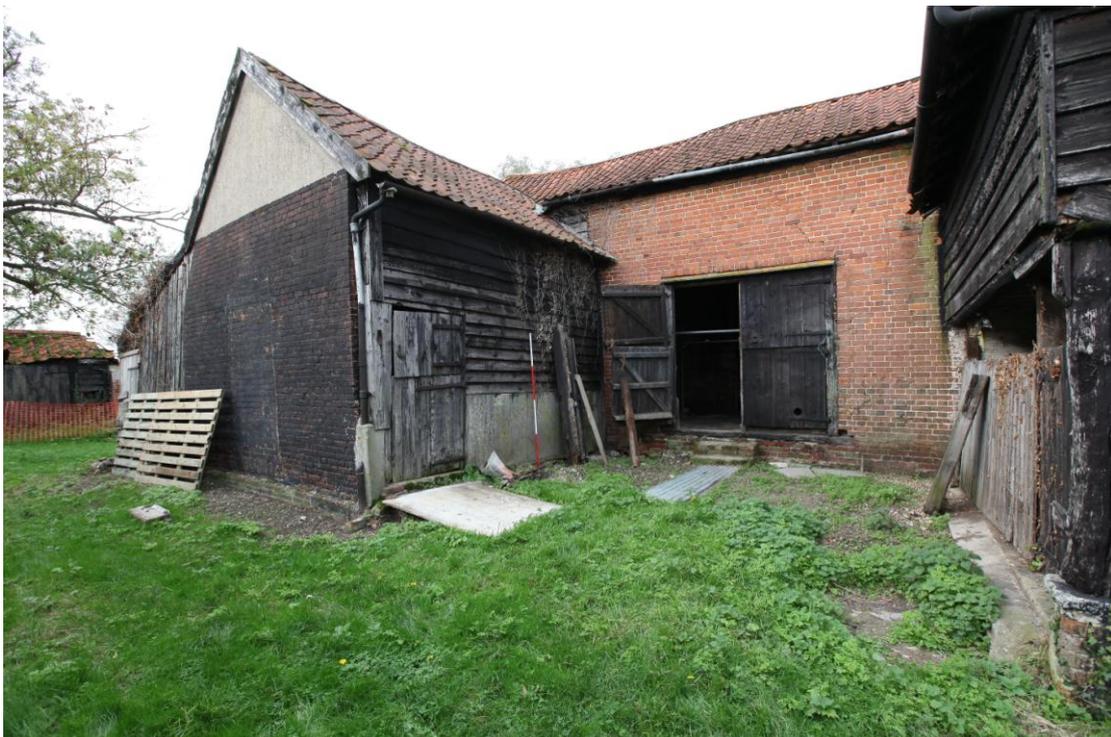
Illus. 4. Exterior from south-east showing the stable wing (2) to the left & the granary wing (3) with its open-sided lower storey to the right. The rear door of the barn lies in the centre and the outline of a blocked stable door can be seen in its brick gable. The detached pig swill shed is visible in the rear to the left.

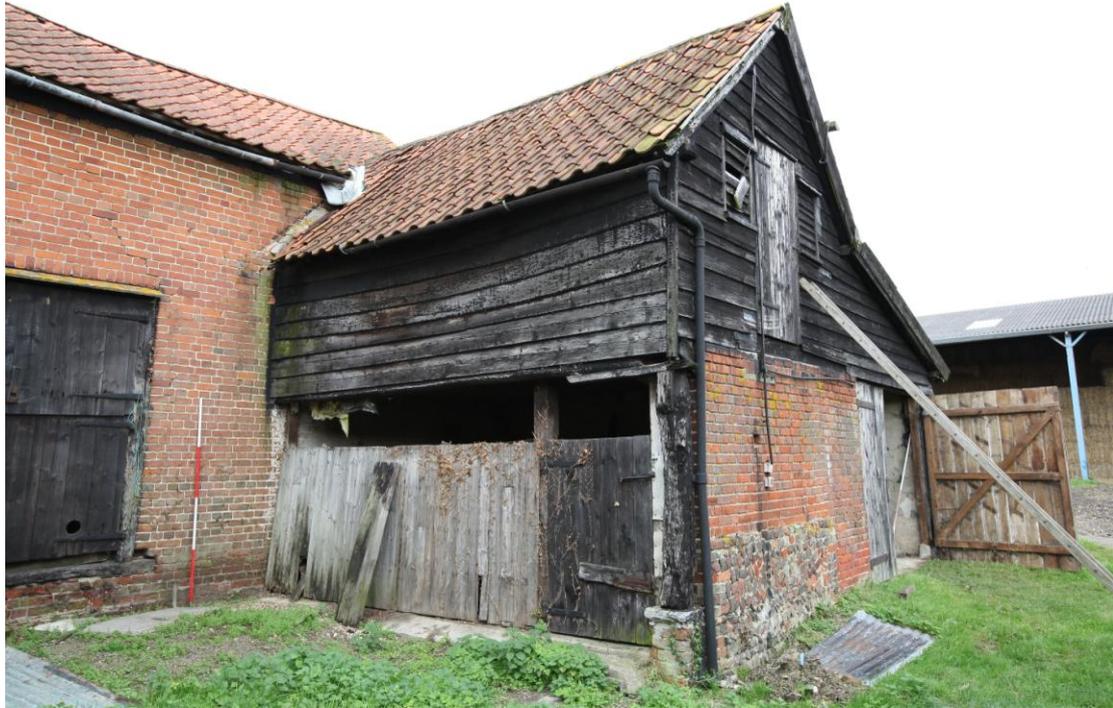
3. Brick wing integral with the brickwork of the main barn but incorporating a section of earlier rubble-bond in its southern gable that may represent a section of an earlier structure or boundary wall. The upper storey forms a granary of 5.2 m in length (17 ft) with an external loading door in its gable and the lower storey contains a shed with an open-elevation to the narrow yard facing the stable (2). This may have been designed as an open-sided shelter-shed but is not shown as such on 19th century Ordnance Surveys and may have been altered.

Illus. 5. Exterior of granary wing (3) from south-west showing the open-sided shelter-shed to the yard on its lower storey with the loading door of the first-floor granary in its southern gable.

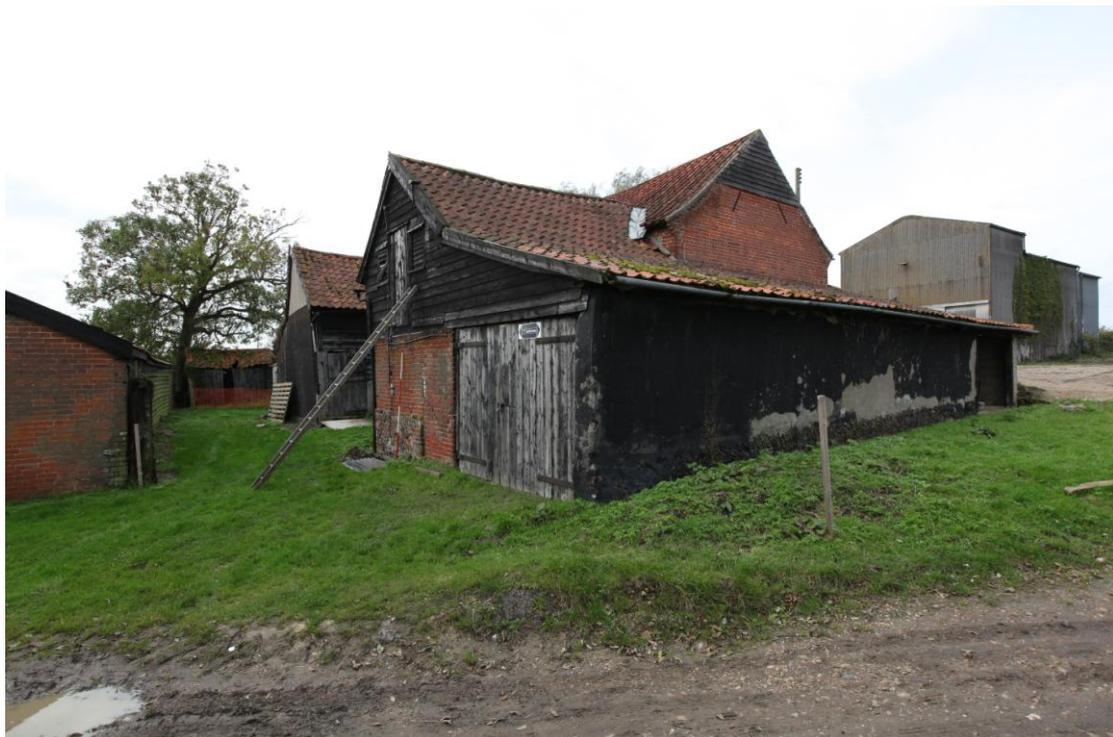
4. A pantiled lean-to shed between the brick wall of the barn and granary to the west and a tarred clay-lump wall on a flint plinth to the east. Entered by 20th century vehicle doors adjoining the site entrance to the south and probably designed as a vehicle shed rather than a feed store. Contemporary with brick barn (like the following sheds 5-8).

Illus. 6. Exterior from south-east showing the clay-lump lean-to vehicle shed (4) in the foreground with a 20th century steel-framed grain store in the rear to right.

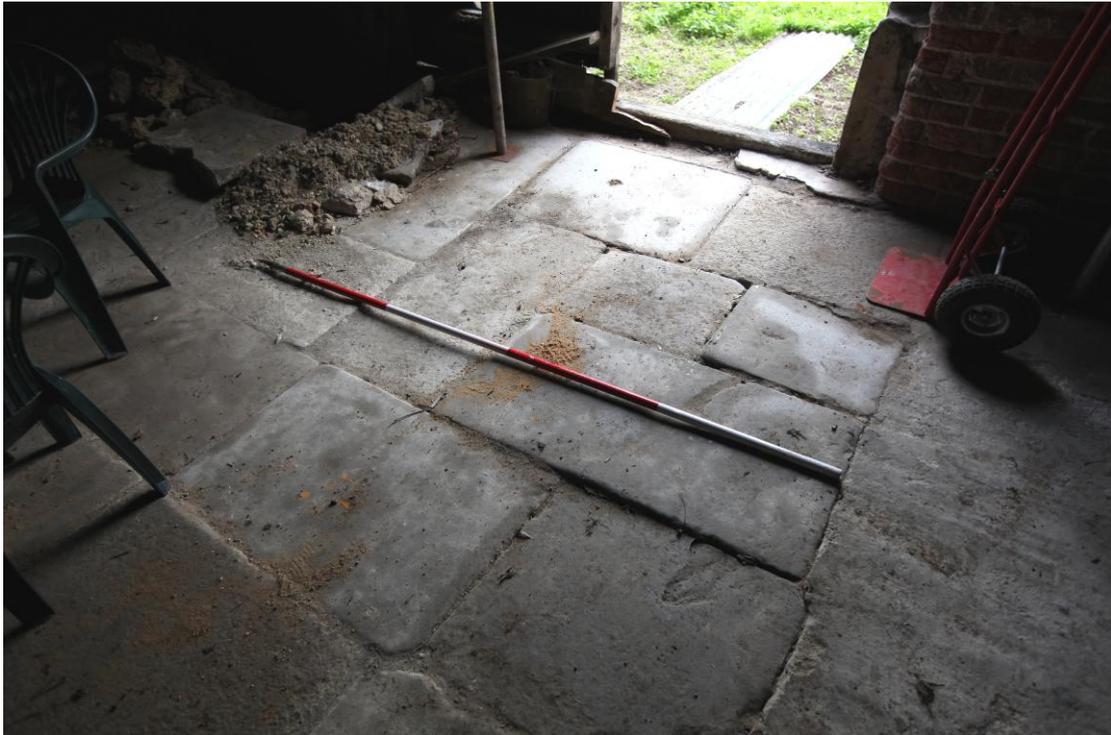
Illus. 7. Detail of the stone flag floor in the entrance bay of the barn (1) showing its southern doors to the yard. These slabs are probably re-using York paving stones and are not uncommon within a narrow radius of Ipswich.

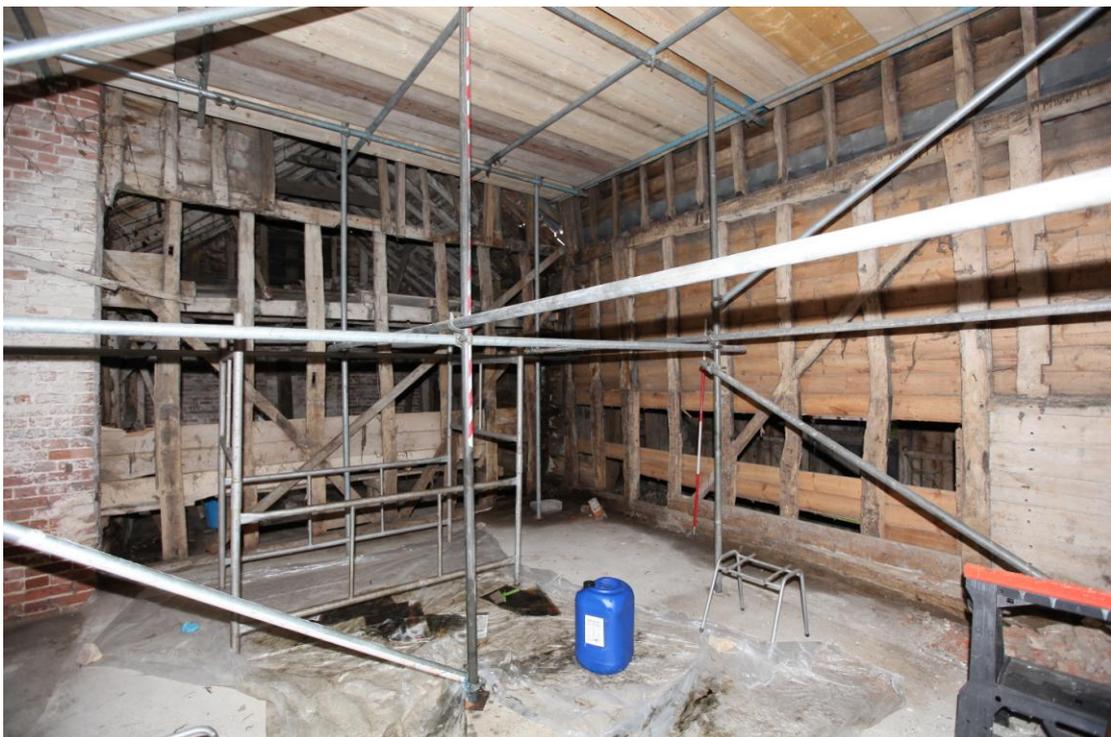
Illus. 8. Internal south-western corner of the barn showing the site of the 17th century structure (1a) with the secondary studwork partition adjoining the stable (2) to the left.

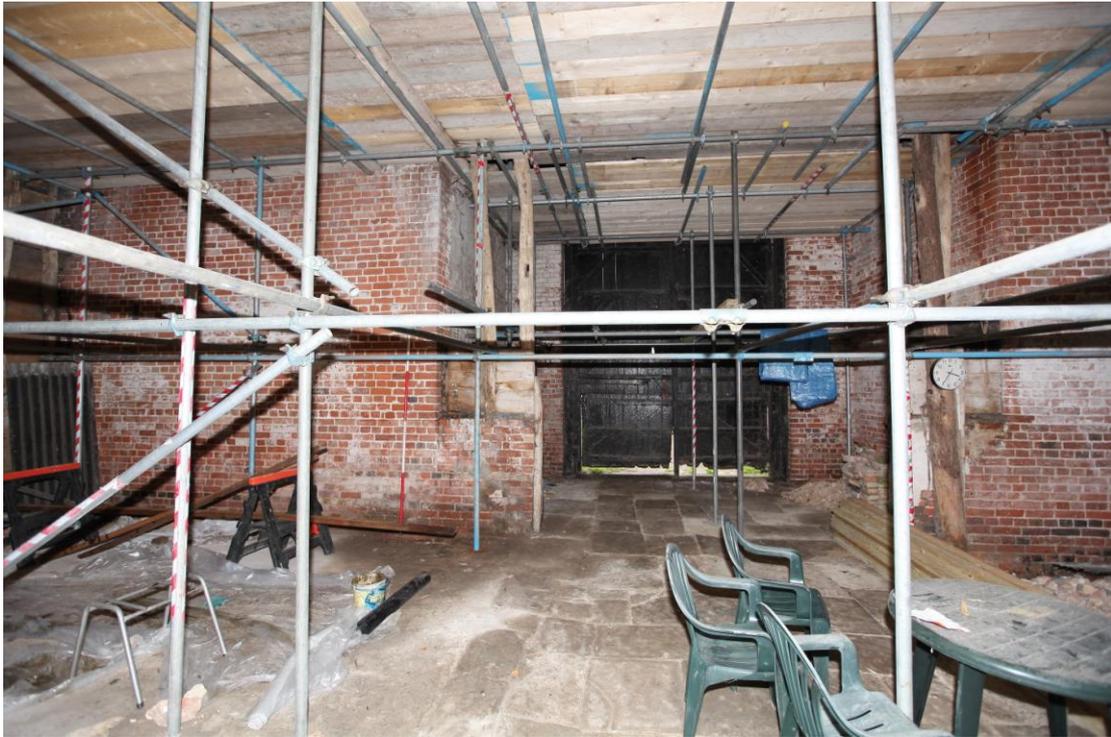
Illus. 9. Northern interior of barn (1) showing its porch with short stub-walls that probably housed grain bins to both sides.

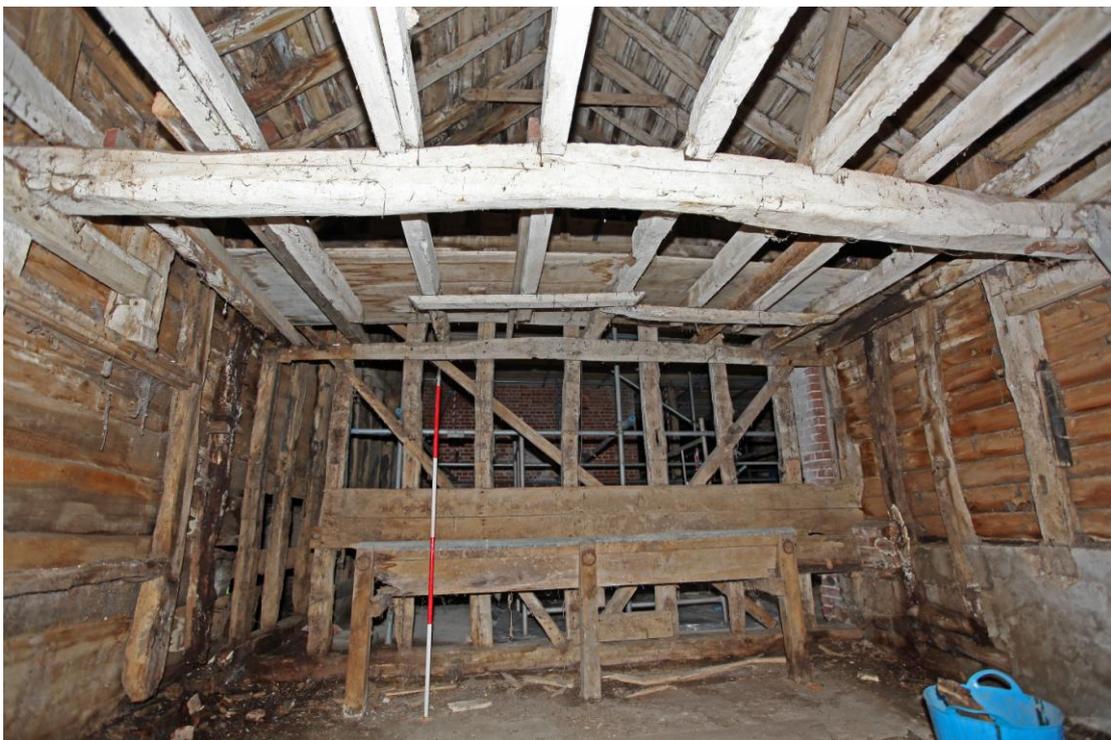
1a-2. The remains of a three-bay timber-framed early-17th century structure of three bays on a north-south axis as shown on the tithe map of 1838. The original building extended to 9 m in length by 4.9 m in overall width (30 ft by 16 ft) with arch-braced tie-beams and externally trenched braces rising to both the roof-plates and gable tie-beams from the corner posts. The building rose to 3 m at its roof-plates (10 ft) with studs of 2.8 m in height (9.5 ft) between its plates and sills: its fully-framed walls have been raised with nailed studwork to the height of the main barn (1) but retain their original proportions to the south where they now form a stable (2) – although the roof was rebuilt at a shallow pitch for pantiles with re-used rafters from a 17th century clasped-purlin structure. The external braces and the north-eastern corner of the building have been removed, but the brace trenches remain in the correct order and there is no evidence to suggest the frame has been reassembled. The building was almost certainly a barn as its central bay is considerably narrower than its outer bays (at 8.5 ft as opposed to 10 ft) and there is no evidence of either floors or windows, although there is no obvious trace of barn doors (the studs of the central bay appear to be pegged and tenoned to the roof-plates, but some may be secondary insertions). The southern half of the structure is now divided from the rest by a studwork partition and contains a secondary lodged ceiling with a 19th century boarded manger of 1 m in height to the north. This appears to represent a stable conversion of the late-18th or early-19th century that pre-dates the addition of the brick barn in the mid-19th century. It is now entered by a door at the southern end of its eastern elevation but there is evidence of a blocked original door in the centre of its southern gable (which consists of secondary brickwork incorporating original framing above the loft floor). The roof gable contains a blocked loft hatch (now rendered externally).

Illus. 10. Northern interior of the stable (2) showing the boarded manger against the barn (1a) and the inserted joists of its hay loft. The framing to right and left is part of a three-bay early-17th century structure with externally trenched wall braces.

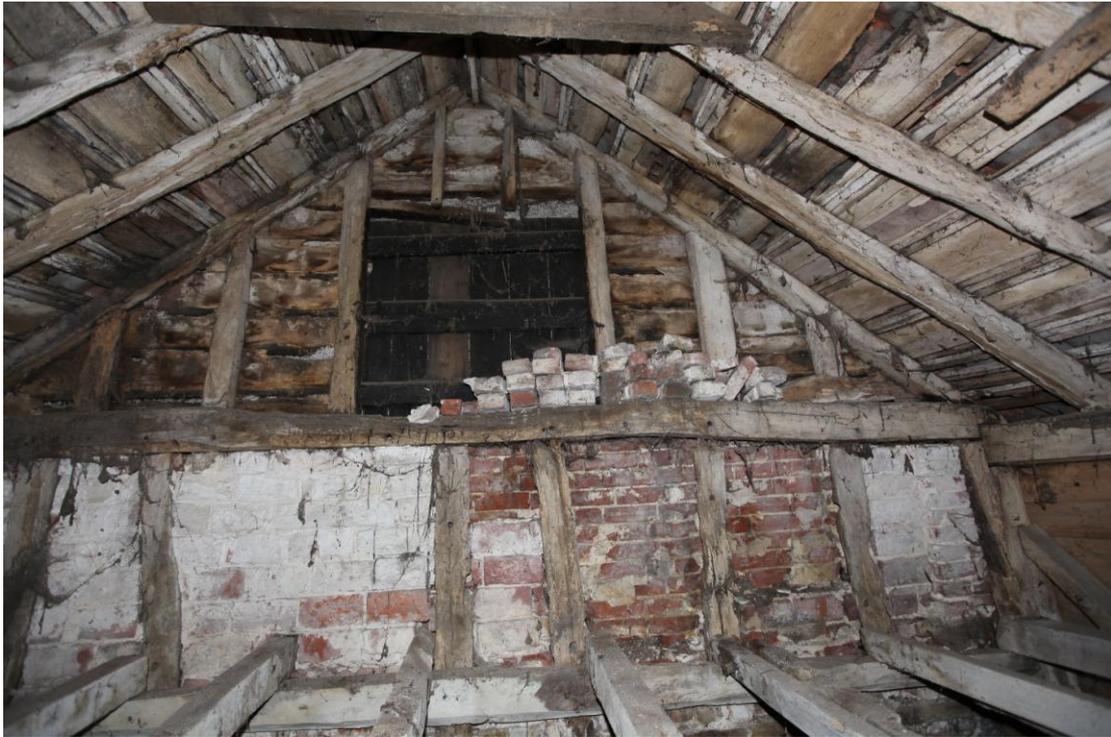
Illus. 11. The southern gable of the hay loft above the stable (2) showing the 17th century tie-beam and studs with later brick infill and hatch.

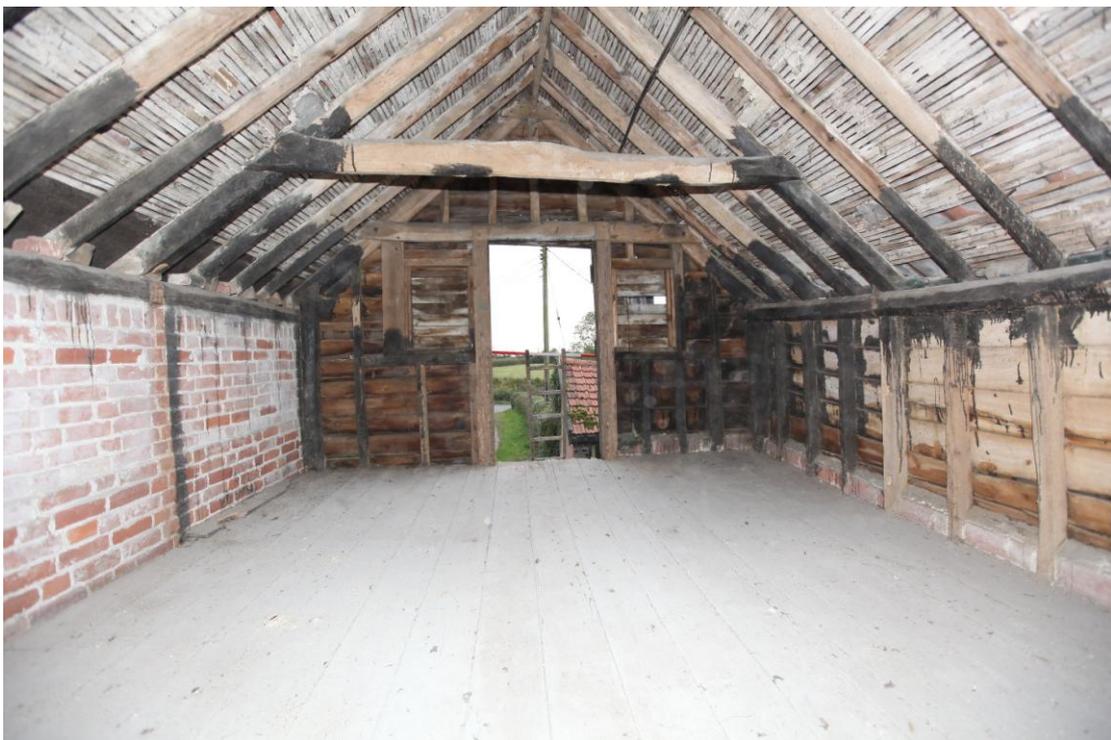
Illus. 12. Interior of the first-floor granary (3) from north showing its entrance door in the southern gable and the original roof structure.
