## **Aviary Wall Monitoring, Abbey Gardens, Bury St Edmunds BSE 334**

**SCCAS REPORT No. 2010/158**

### **Introduction**

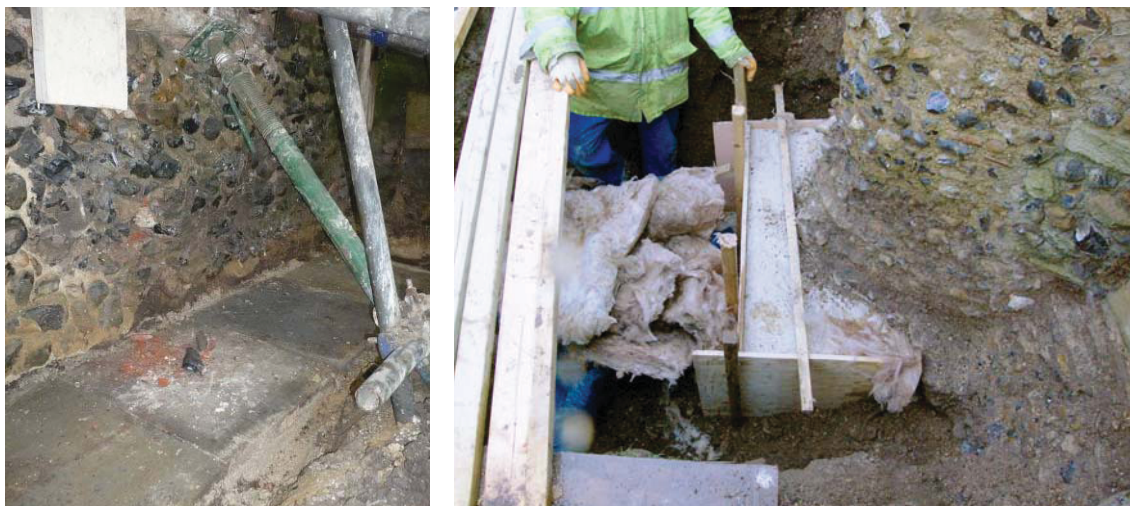
At the base of the south elevation a row of paving slabs were set into the ground 150mm below the existing ground surface. The slabs were laid, in advance of the south wall face repairs, to provide a stable base off which the new work could be built. At this depth the slabs were laid still with the build up of post-medieval soil which has occurred in front of the aviary wall and above the level of the medieval ground surface.

Area 1 Paving slabs at the base of the south side of the wall prior to the breaking out of the face and underpinning of the north face reveal

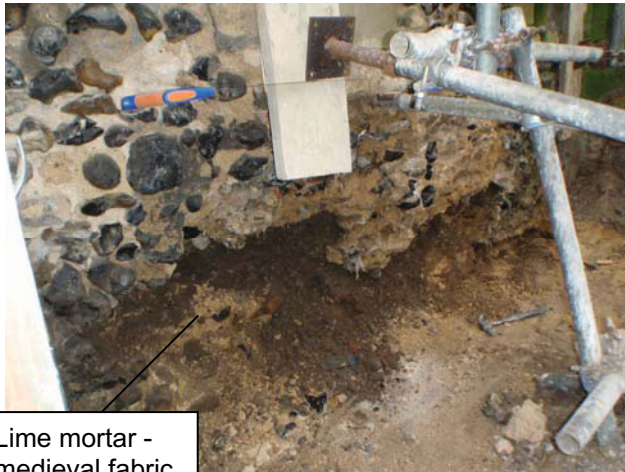
Lime mortar - medieval fabric

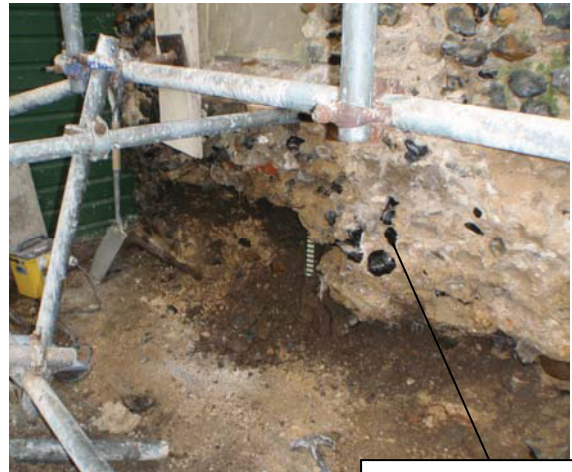
To the west of the lancet the exposed core material was bonded with a modern, very hard concrete-based mortar, the mortar was a close colour match with the medieval material and was difficult to distinguish visually from the original. This is the reverse of the reconstructed west reveal on the north side; the overhanging piece of masonry that was underpinned during the first stage of work, and confirms that the bottom of the window reveal on the north side is a post medieval rebuild. Eroded medieval core was observed behind the face at the very base of the excavation.

Modern repair, core of the north side reveal

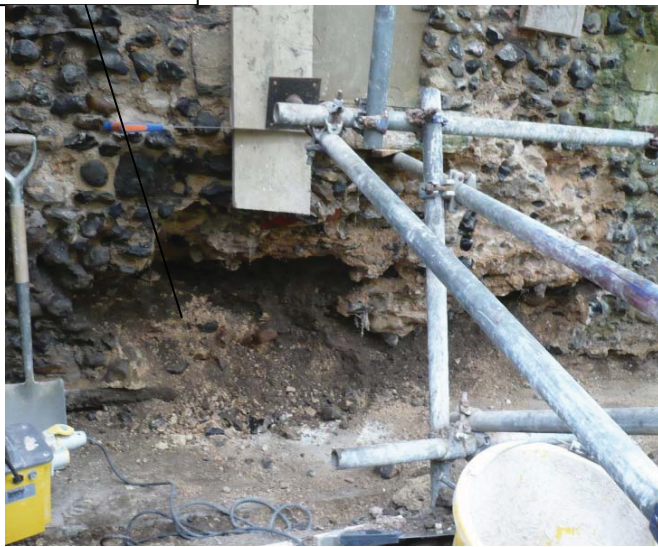
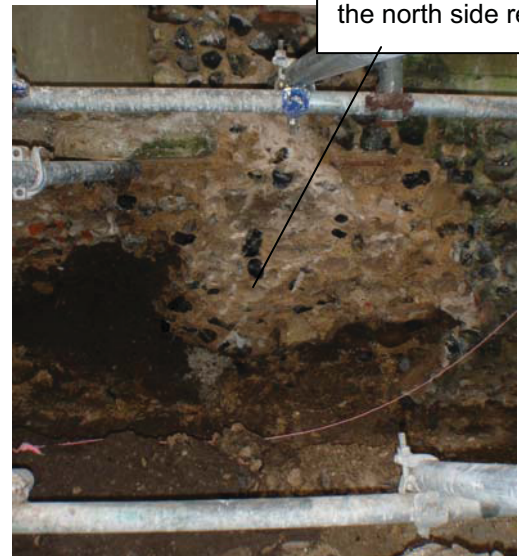
The bulging flint face at the base of the wall was removed directly below the lancet, the stone sills of window had become mis-aligned as a result of the wall failure but these were left in place. The south face of the wall at this point along the wall opposes a deep, full length, reveal on the north side and the wall is only the depth of the stone sill thick. The removal of the face and the resulted in the wall being breached completely exposing the banked soil behind it. This soil was part re-excavated to allow the wall to be reconstructed/underpinned, this was completed in effect in reverse working from the north face back to the south.

Area 1 south face repair below the lancet window

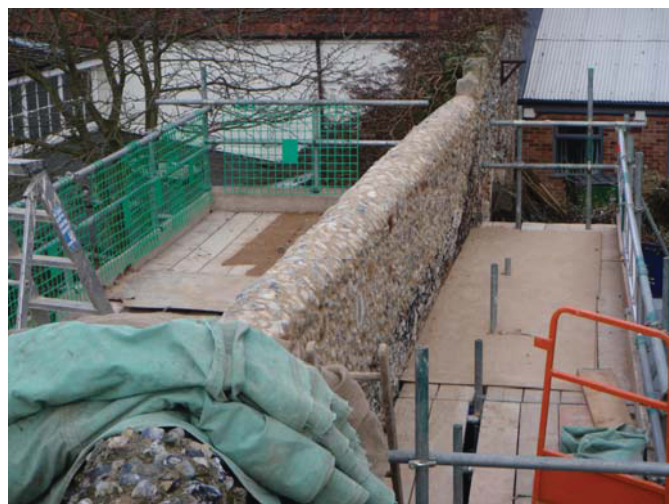
The area of repair at the head of the wall within the gardener's compound was entirely within an area of post medieval infill built during the late 18th or early 19th century when the wall was heightened. The wall was reduced by approximately 800mm removing the existing loose and leaning flintwork before being replaced like for like; no original fabric was impacted upon.

Area 2 Gardener's compound, wall head repaired.

*Remove existing flint fabric at the top of the wall and rebuild*

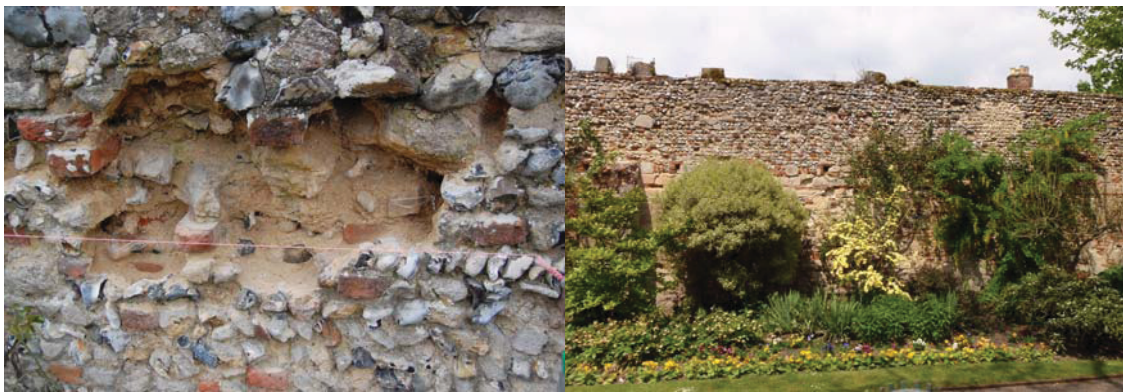
Two areas of localised failure of south wall face were patched to the west of the tea rooms. Here the wall is constructed in two distinct phases the lower half of the wall built in re-used limestone block and soft red brick the upper in flint and brick. The division between the two coincides with the top of the short buttresses which support this section of wall. The bricks, in size and character, are common to both upper and lower parts of the wall, these date to the late 18th/ early 19th century and suggest that the two halves are broadly contemporaneous and a post-medieval reconstruction. The two holes in the wall face were observed prior to repair, the brick header extended into the core and the core mortar indistinguishable from the face work and demonstrate that the wall top, at least, is not based on a medieval core.

Post medieval wall core area 4, area 3 after repair

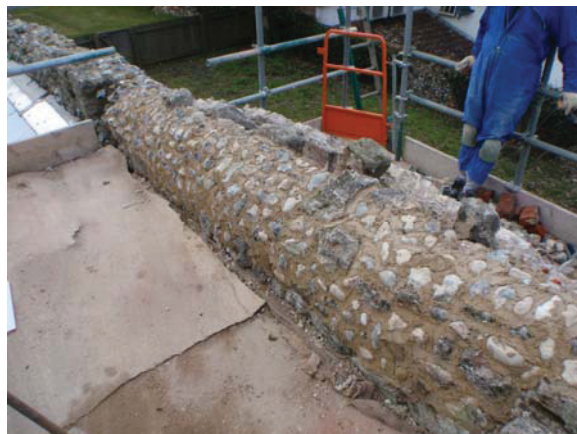
The wall head in area 6 was consolidated and the wall head given a rounded profile to shed the weather. Blocks of masonry which were set in the top of the wall, in the style of battlements, during the previous repair campaign were maintained. The monitoring archaeologist was unable to visit the site during the work and it was only recorded after the work was completed.

Wall head repairs area 6
