**Church Farm Barn,
Cavendish,
Suffolk,
CAV 052**

Historic Building Record
suffolkc1-86631

February 2010

Historic Building Record

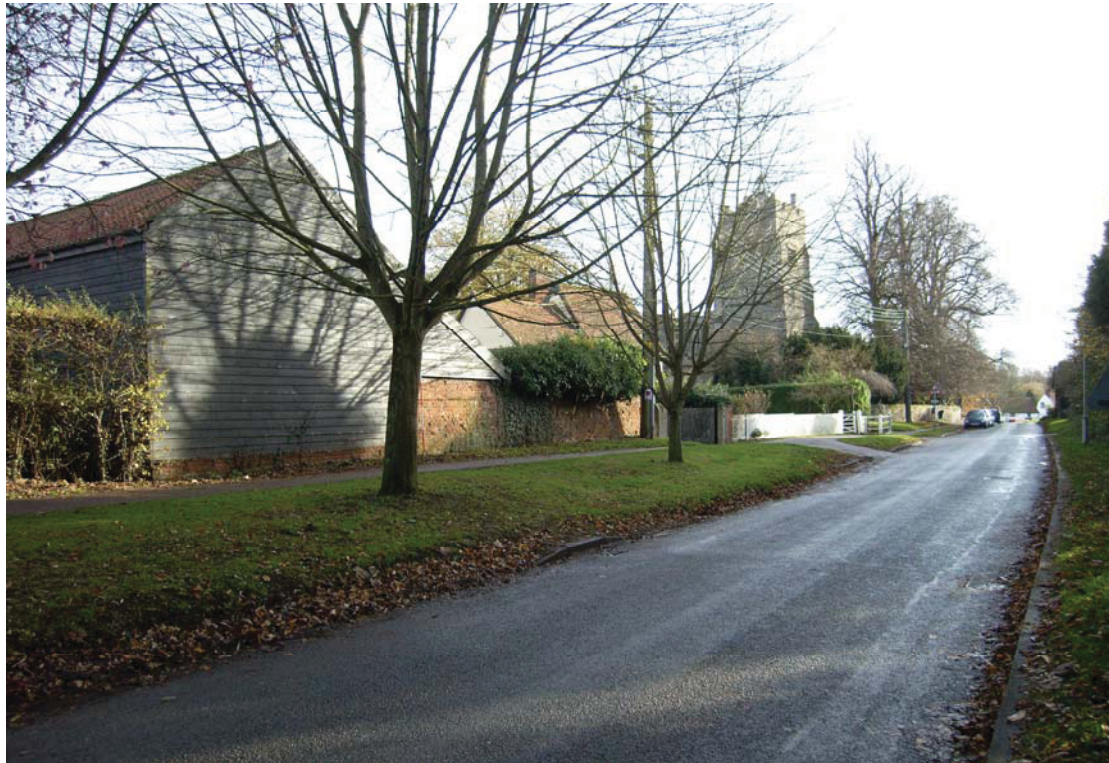
A2.1 General view of site from Peacocks Road to north showing barn to left, former farmhouse in centre & church to right

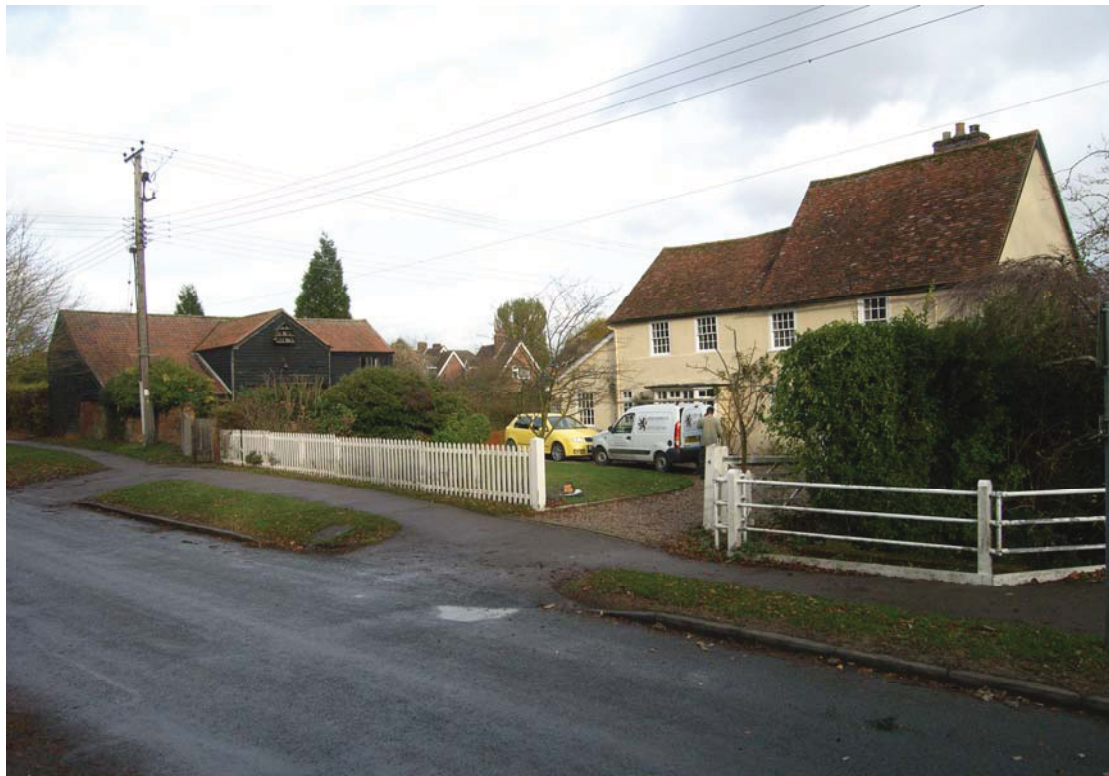
A2.2 General view of site from Peacocks Road to south-west showing barn to left and farmhouse with jettied southern gable to right.

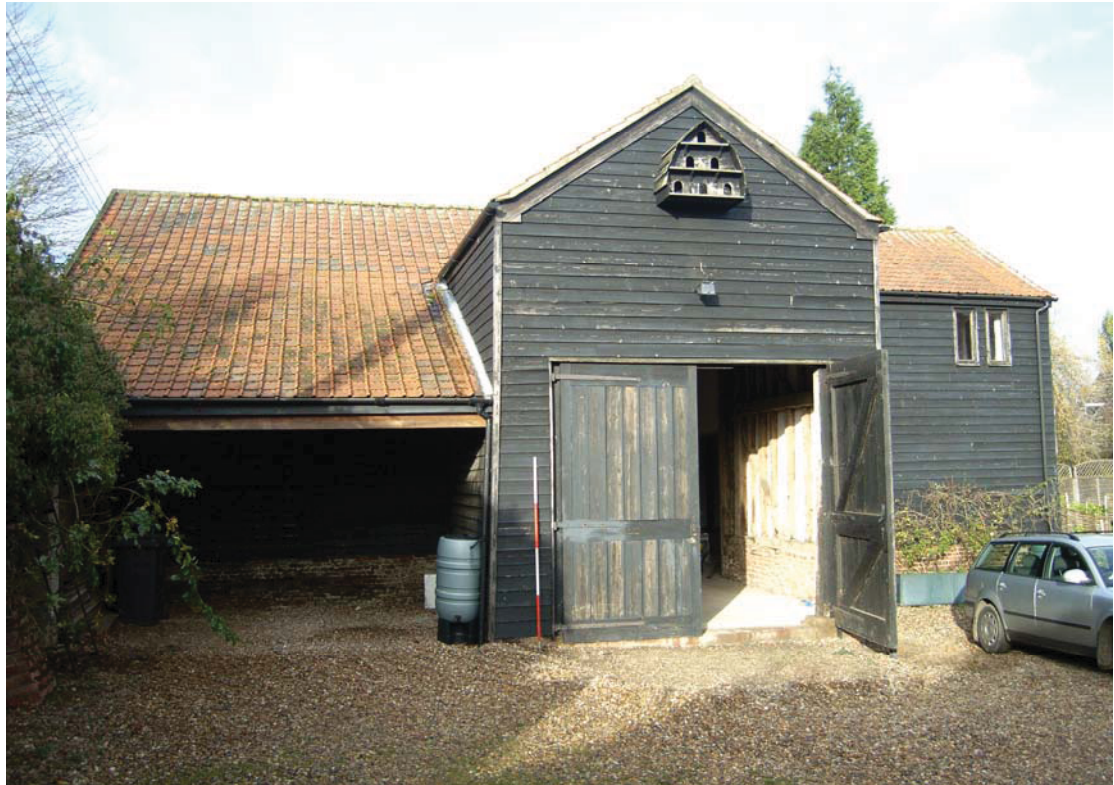
A2.3 External southern elevation showing central porch with lean-to shed to left and windows of converted eastern loft to right

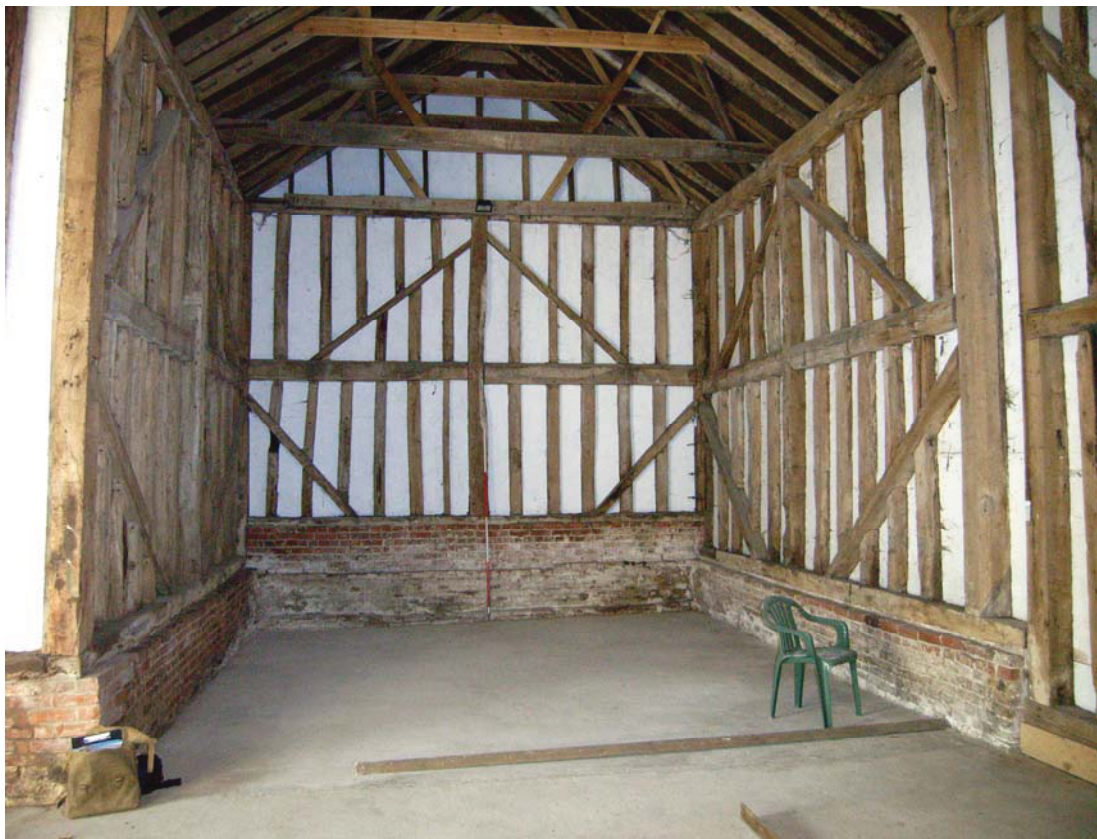
The exposed wall fabric consists of oak studs interrupted by diagonal primary braces with horizontal mid-rails 1.7 m beneath the roof-plates (5.5 ft), as shown in photo A2.4. The various timbers are of substantial section (the studs measuring of 15 cm by 9 cm or 6 ins by 3.5 ins) and are of medieval or 16th century appearance, but contain numerous empty mortises, brace trenches and other features that prove them to have been re-used. The eastern mid-rail of the porch, for example, contains empty diamond-shaped mortises (A2.9) for the mullions of a domestic window. The presence of small holes for glazing bars between each mortise suggests a late-16th or early-17th century origin (before which period glass was rare). The tie-beam to the west of the central bay was clearly re-used from the gable of a late-16th century domestic cross-wing as it contains evidence of a tripartite window with a central oriel (which projected beyond the plane of the wall, hence the absence of mullion mortises) flanked by two smaller, shallow windows with glazing bars and cavetto-moulded mullions with rectangular mortises – the mouldings still visible as scars in the tie-beam's whitewash (A2.6).

A2.4 Interior of barn from east showing primary wall bracing with re-used timbers and the southern porch to left.

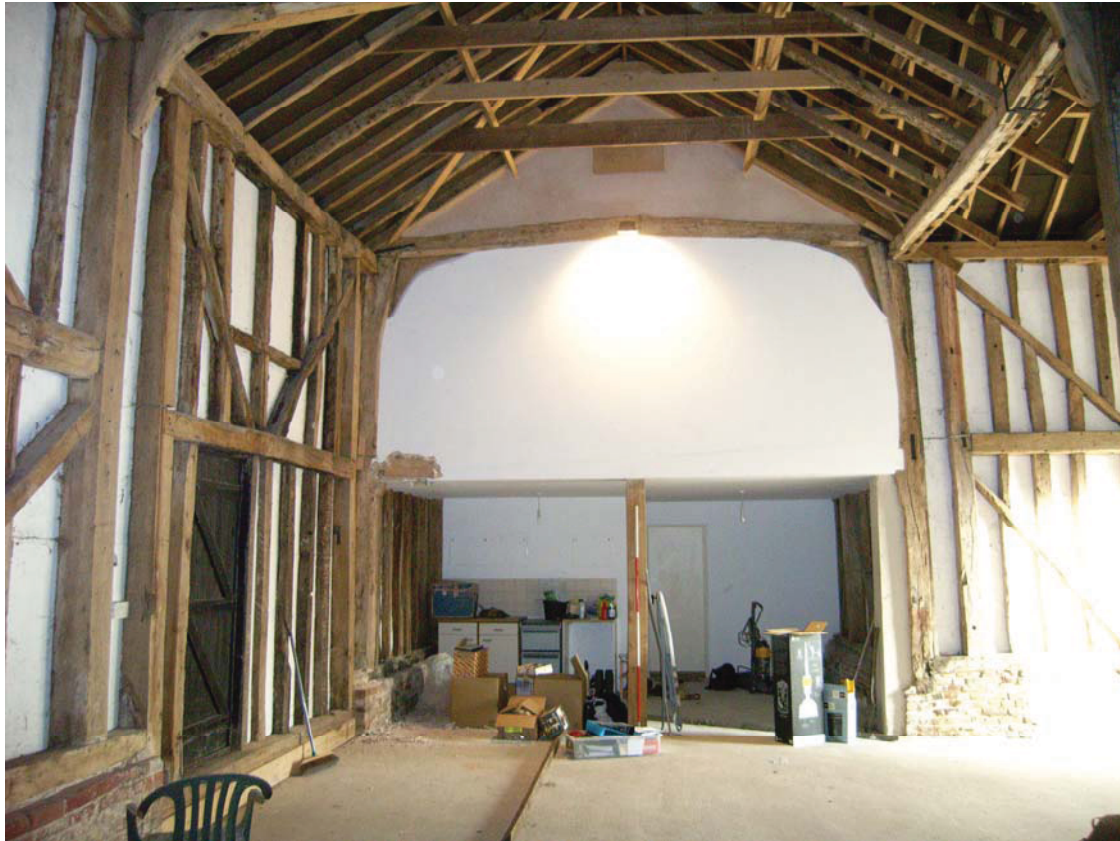
A2.5 Interior from west showing previously converted loft in eastern half of barn with porch to right and blocked northern door to left. The corbel blocks of the storey posts supporting the loft are visible at both sides.

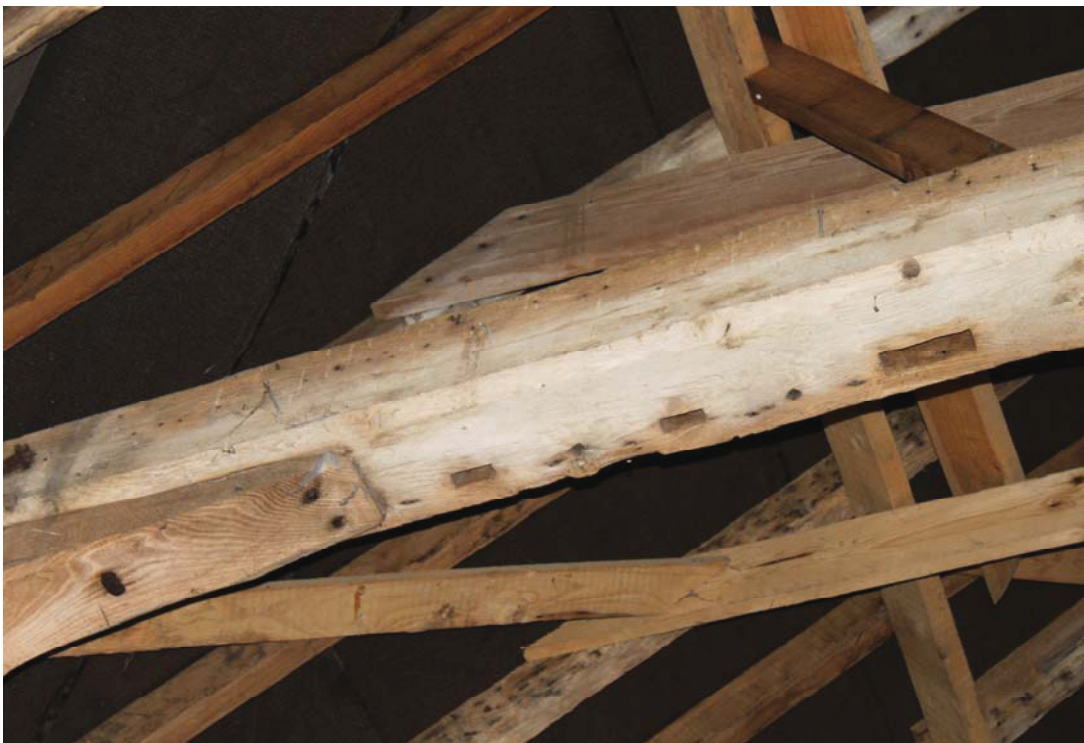
A2.6 Detail of re-used tie-beam to west of porch showing rectangular mullion mortises of clerestorey window with scars of cavetto mouldings in white paint.

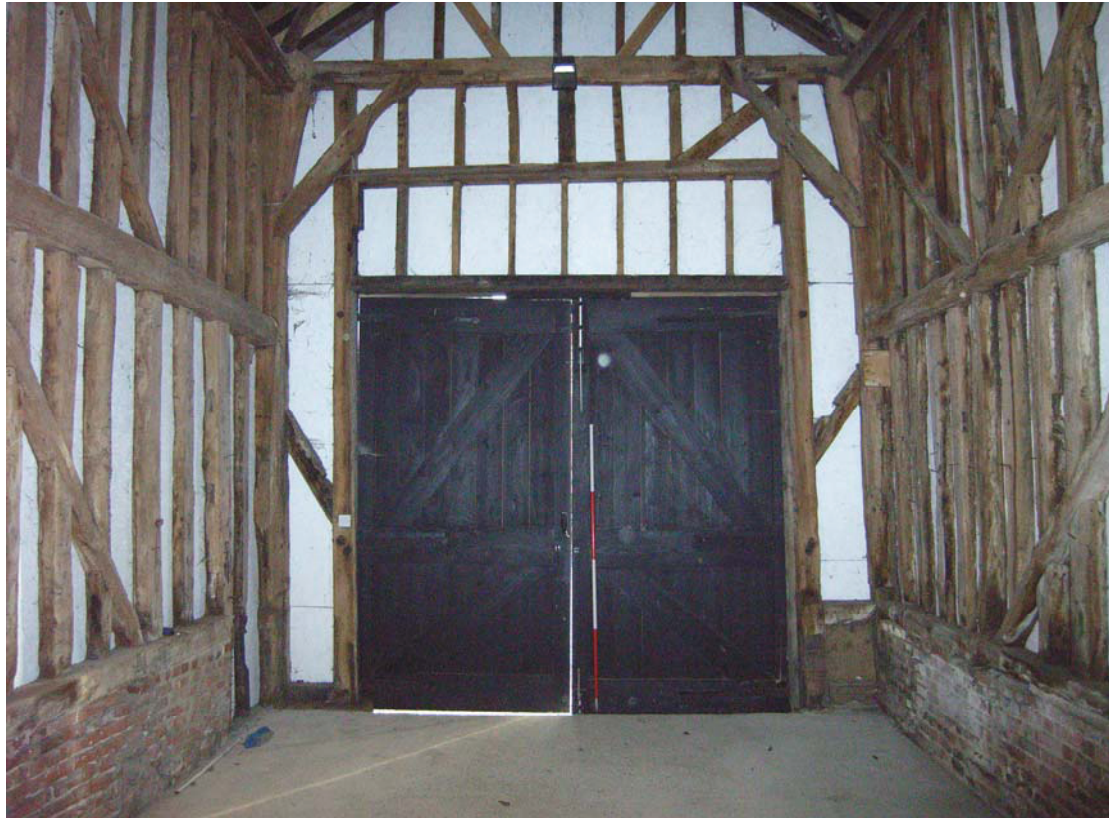
A2.7 Internal southern gable of porch showing corner braces and jambs of original doorway (now reduced in height).

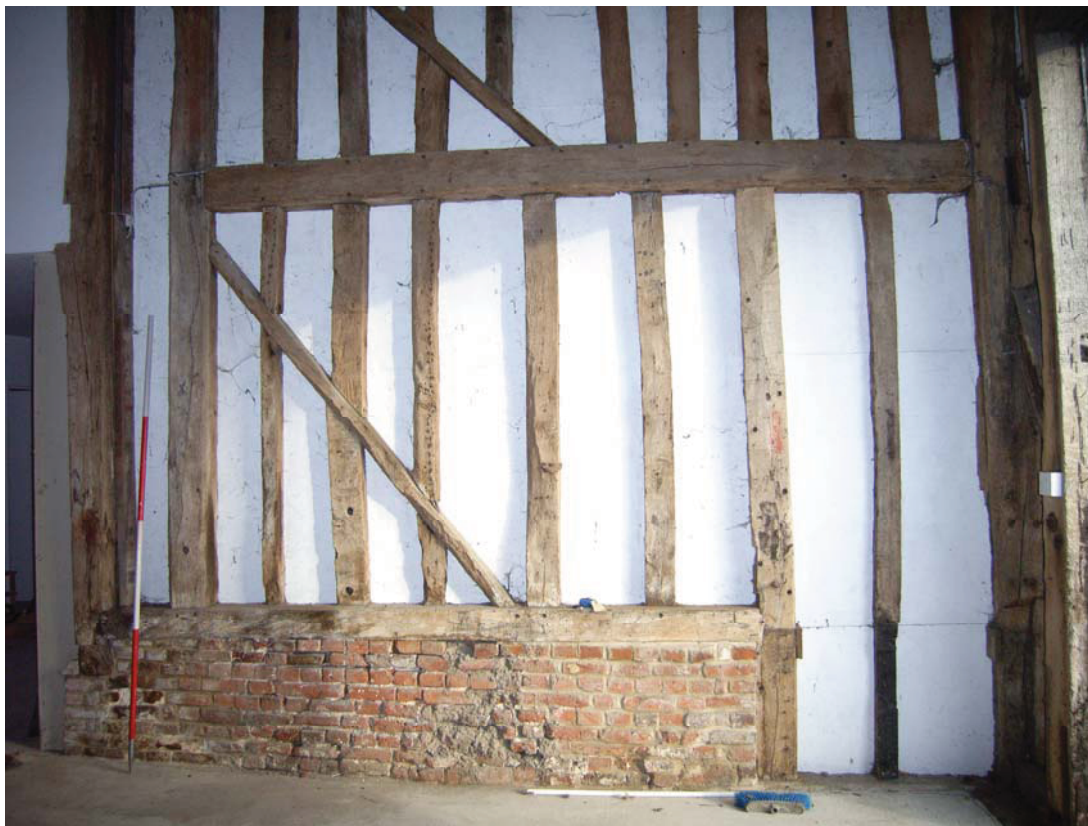
A2.8 Internal eastern elevation of porch showing original side-door to right.

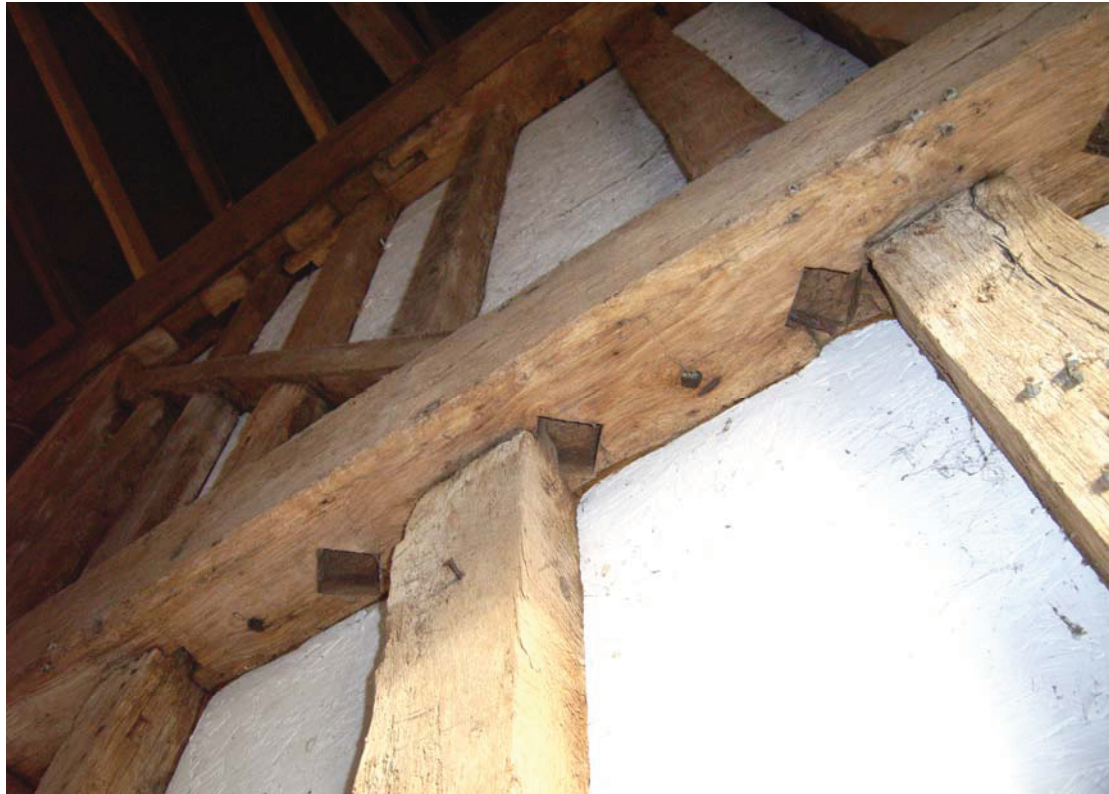
A2.9 Detail of re-used mid-rail in eastern side-elevation of porch showing mortises for diamond window mullions & glazing bars.

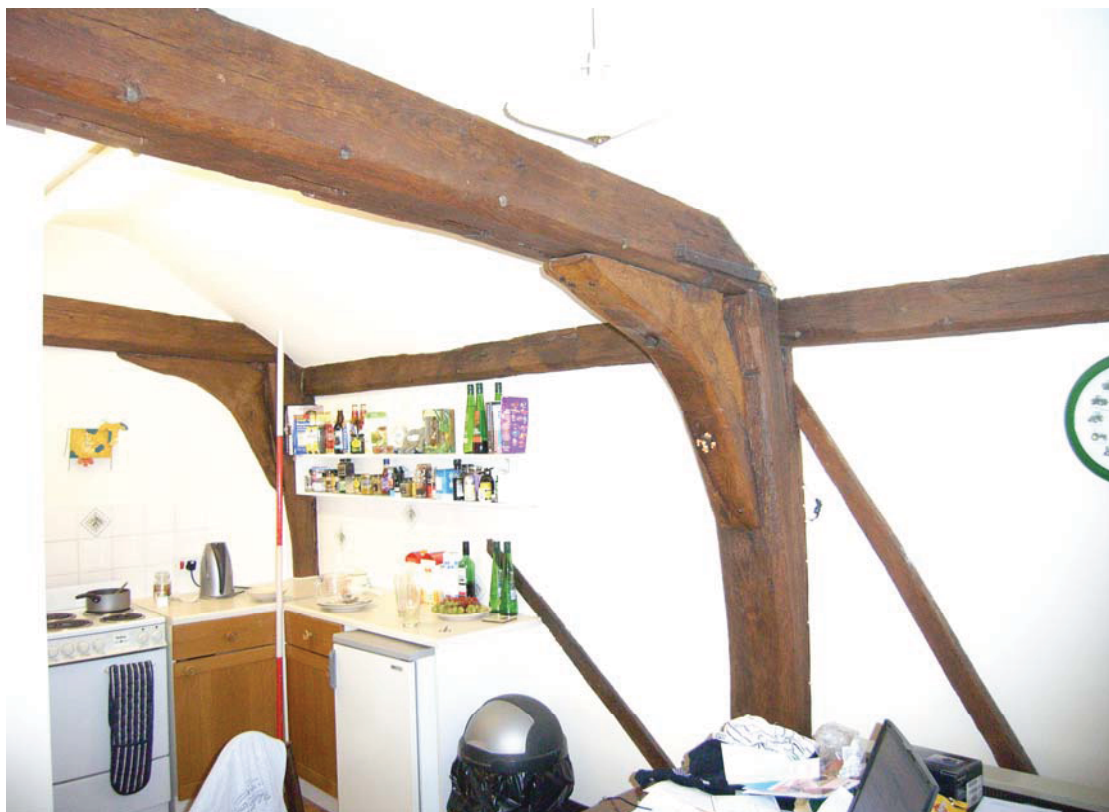
A2.10 Northern internal elevation of converted loft showing apparently *in situ* late-16th century framing with open truss to left and closed truss with empty stud mortises in centre (and position of first-floor door to right). The bolted knee-braces are 19th century insertions.
