**Barn at  
Garden House Farm,  
Drinkstone, Suffolk  
DRK 029**

**Historic Building Record**

**November 2010**

## **Historic Building Record**

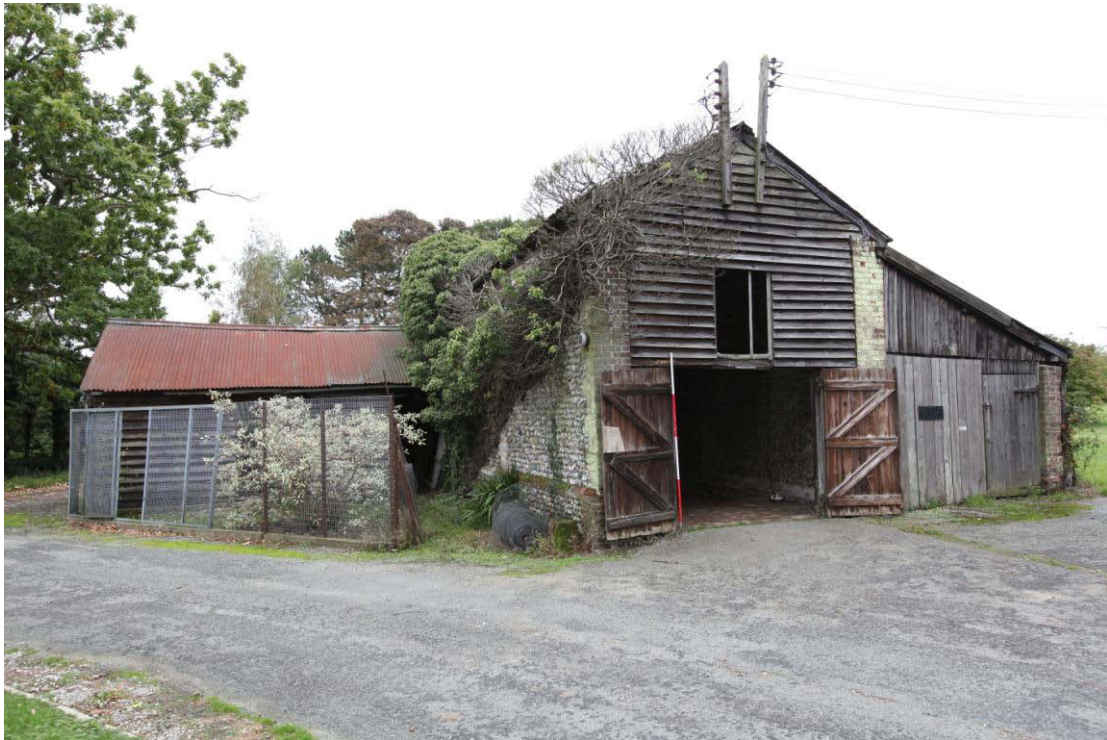
**Illus. 1. Exterior of barn complex from west showing the small timber-framed stable (2) to left, the gabled porch of the flint barn (1) with reduced doors in the centre and the slightly later lean-to shed (3) to the right**

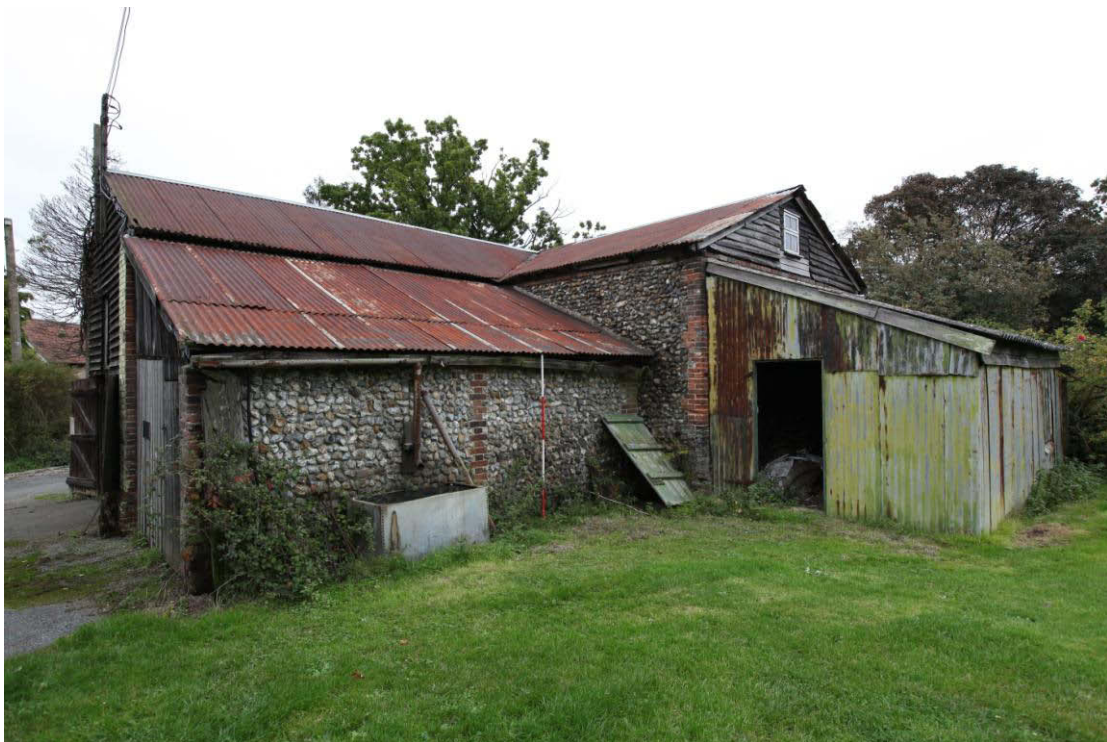
**Illus. 2. Exterior from south-west showing the flint barn (1) with its unusually long porch and lean-to shed (3) to the left and the 20<sup>th</sup> century corrugated iron lean-to (4) adjoining its southern gable to the right.**

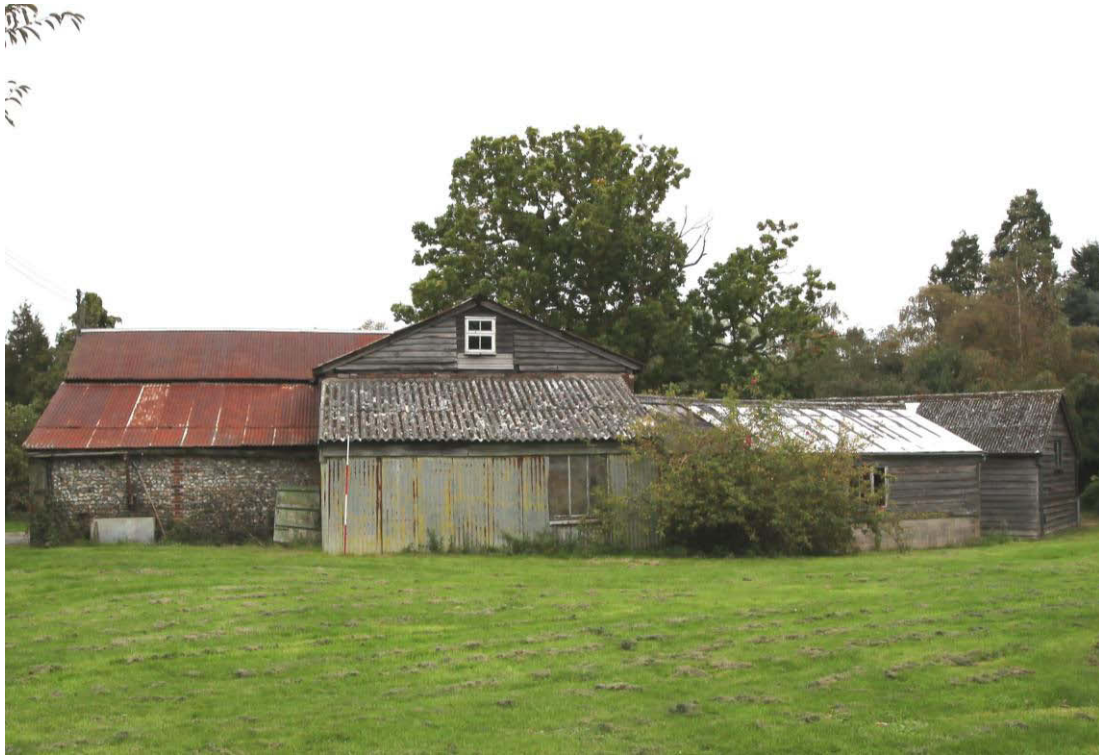
**Illus. 3.** The view from the garden to the south showing the porch and lean-to shed (3) to the left, the southern gable of the flint barn (1) with its lean-to shed (4) in the centre and the two late-20<sup>th</sup> century boarded sheds at irregular angles to the right.

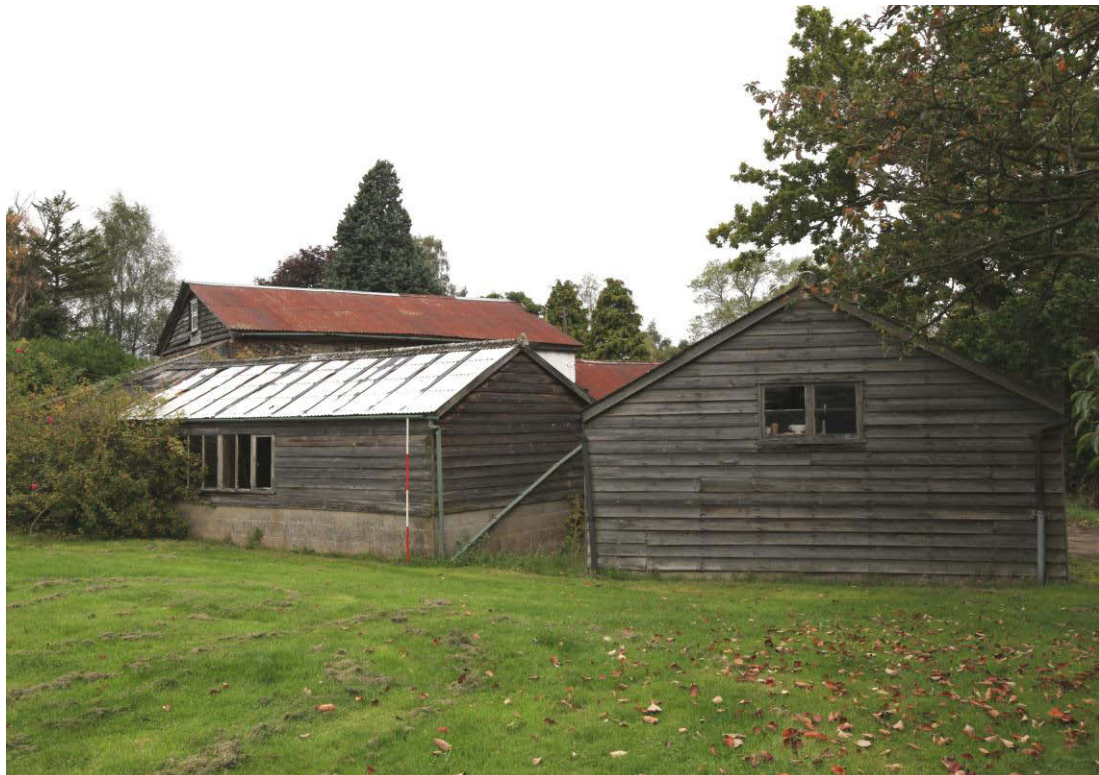
**Illus. 4.** Exterior from south-east showing the two 20th century boarded sheds (5 to left and 6 to right) with the barn (1) and stable (2) in the rear.

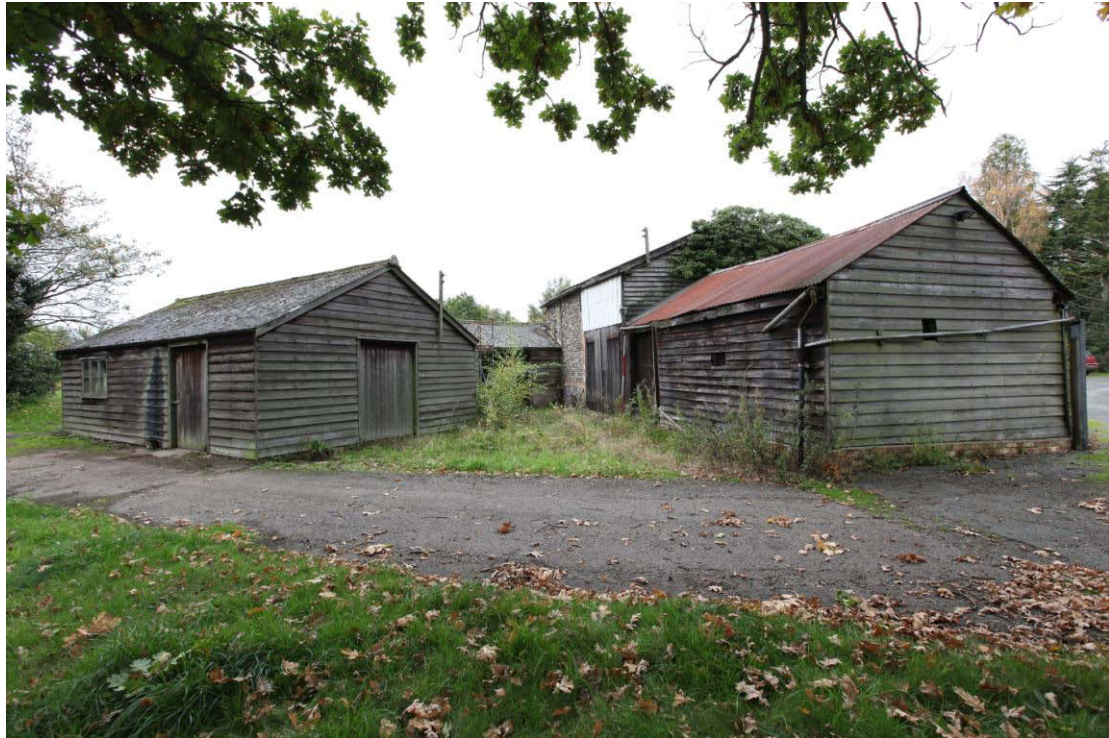
**Illus. 5. Exterior from north-east showing the single-storied timber-framed stable (2) to the right and the 20th century shed (6) to the left with the flint barn (1) in the centre.**

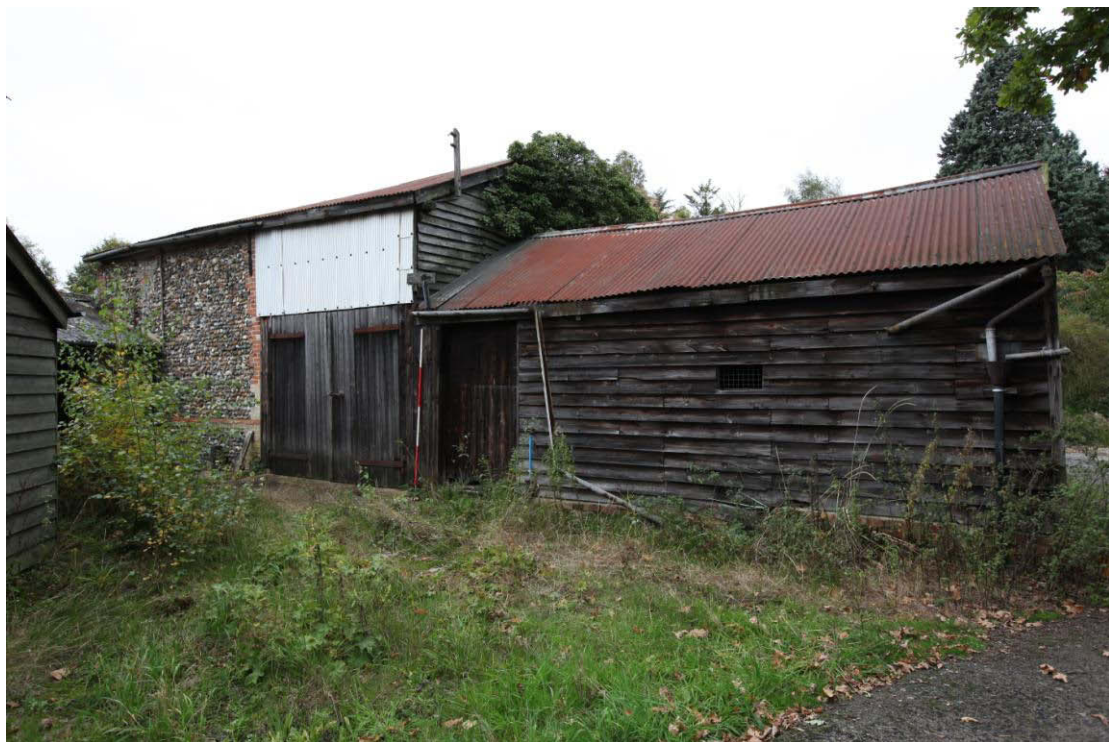
**Illus. 6. The Eastern exteriors of the stable (2) to the right and the flint barn (1) to the left showing their respective doors side-by-side. Both buildings were re-roofed in the 20<sup>th</sup> century and are covered in corrugated iron. The barn doors have been reduced in height.**

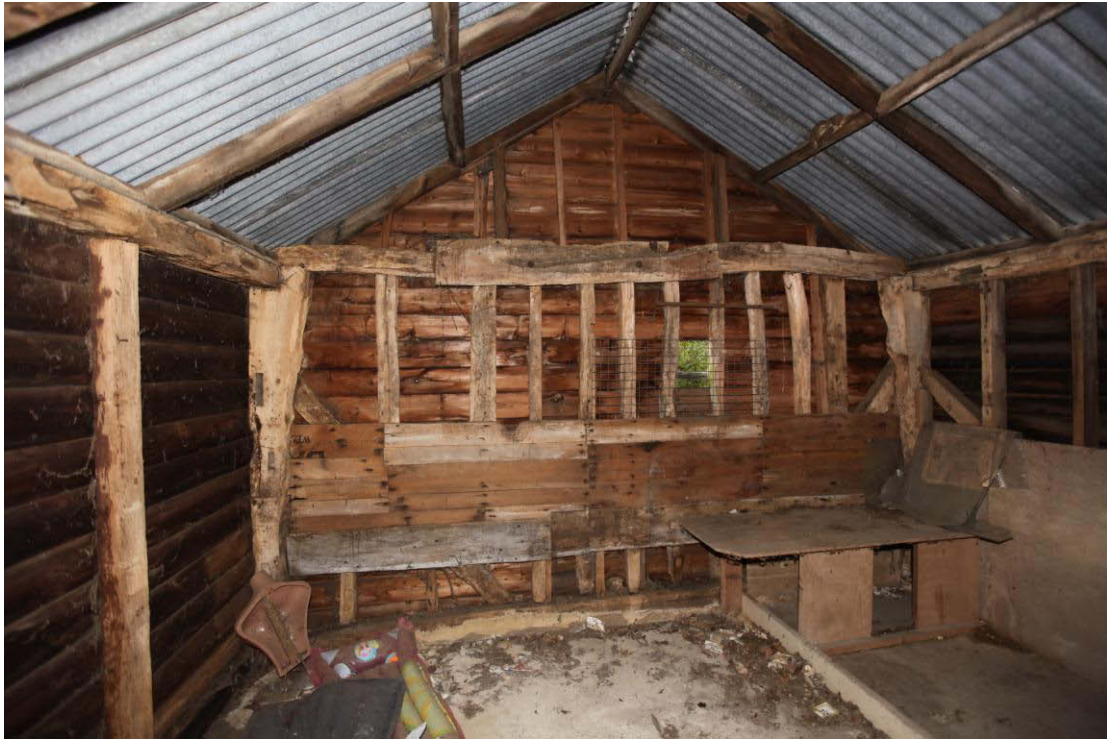
**Illus. 7. The internal northern gable of the stable (2) showing extensive re-used timber with primary bracing and 20<sup>th</sup> century roof.**

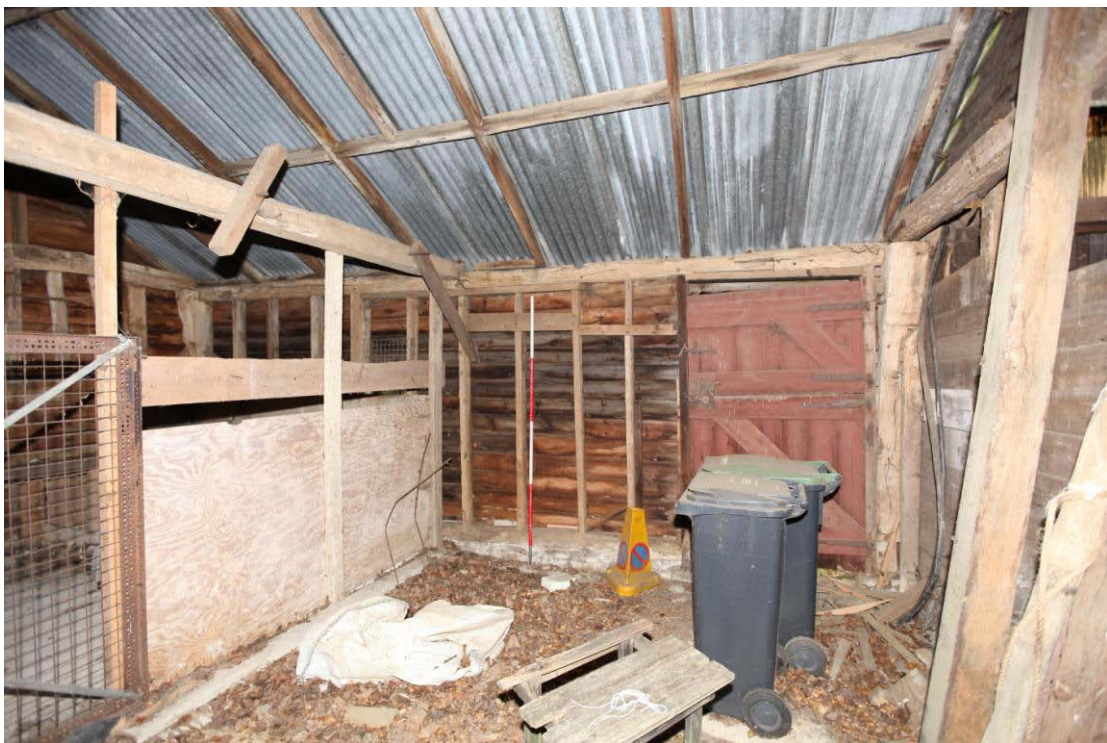
**Illus. 8. The eastern interior of the stable (2) showing the external door adjoining the barn (1) to right and narrow 20<sup>th</sup> century studs. The recent boarded partition to the left forms a dog kennel with a separate entrance in the western elevation.**

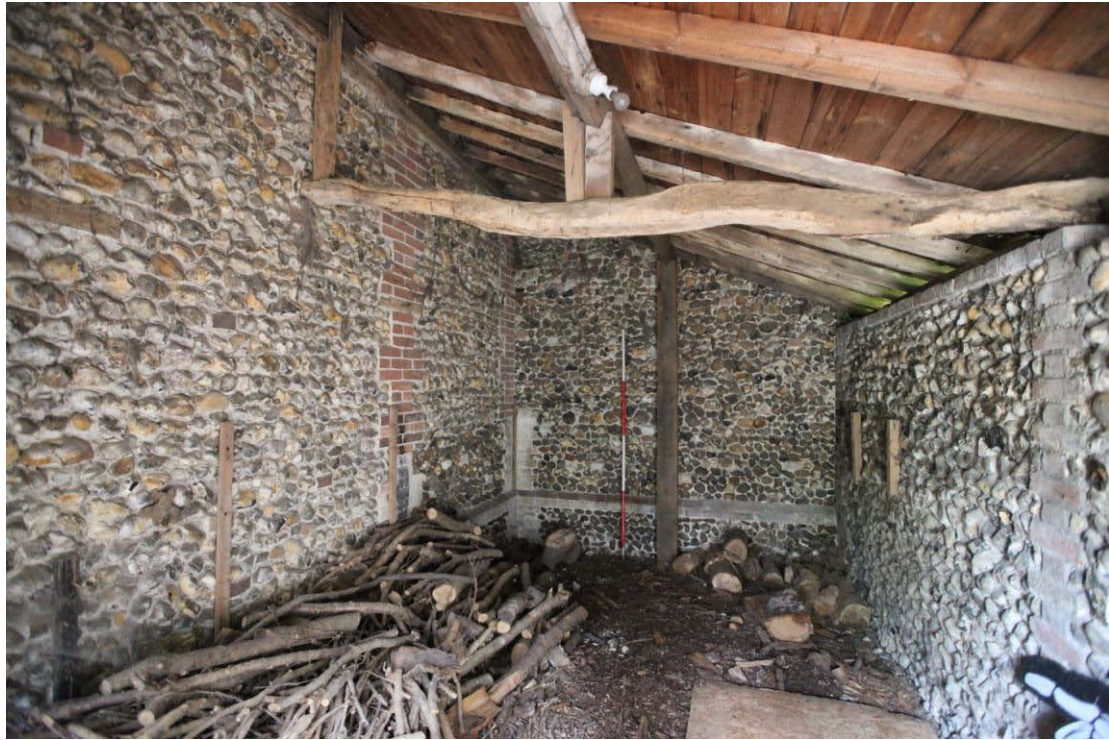
**Illus. 9. The interior from the west of the secondary lean-to flint shed (3) adjoining the flint barn (1) and showing the porch to the left. The wall of the lean-to to the right is not integral to the fabric of the barn.**

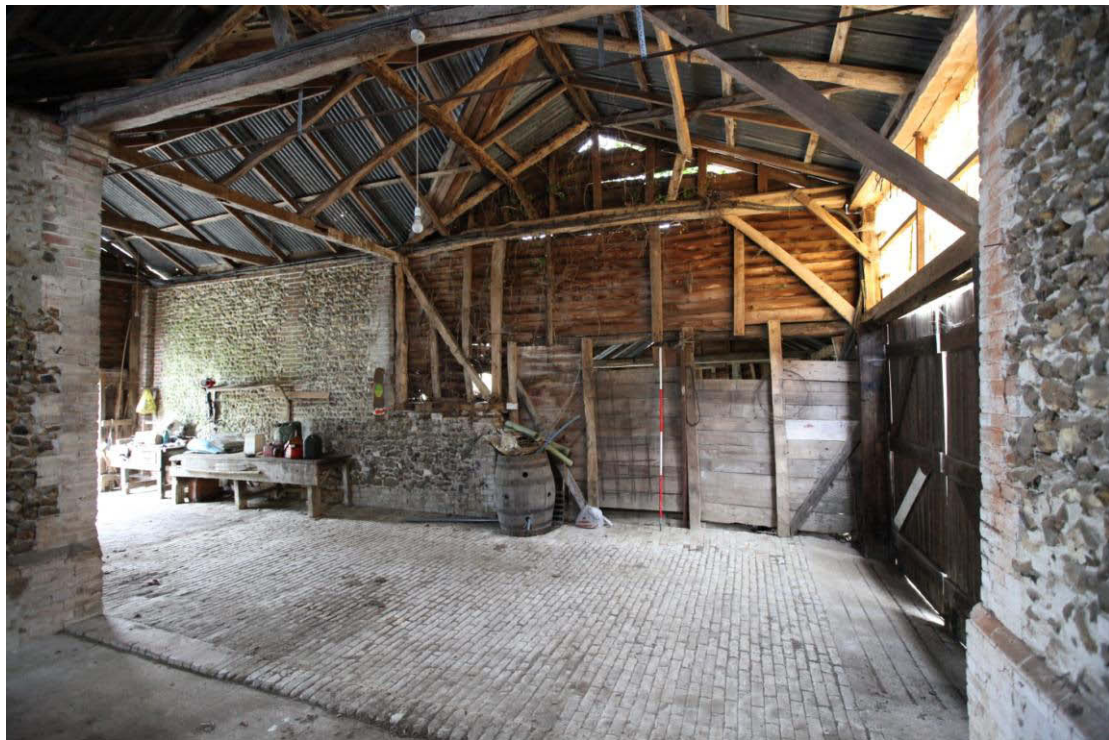
**Illus. 10. Interior of the flint barn (1) from the south showing its long flint porch to the left and the boarded partition against the stable (2) to the right. The flint plinth and stud wall in the centre probably reflects the original appearance of the porch before its timber upper walls were rebuilt.**

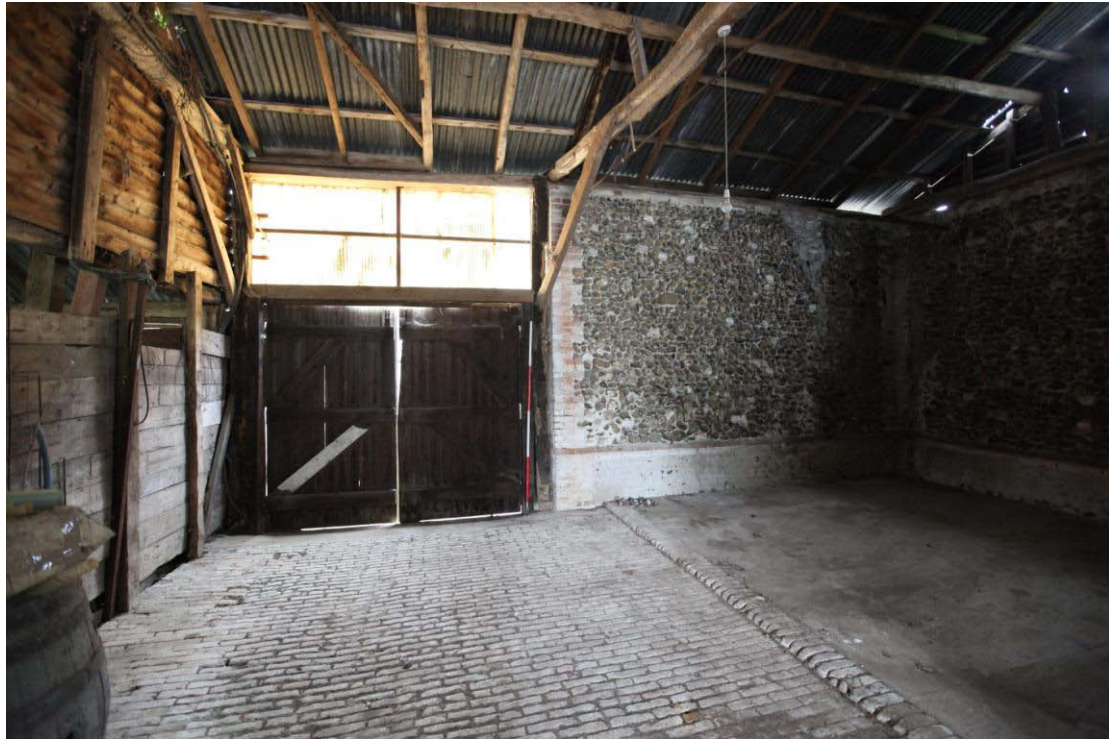
**Illus. 11. Eastern interior of the barn (1) showing its gault brick threshing floor and the original entrance doorway to the left.**

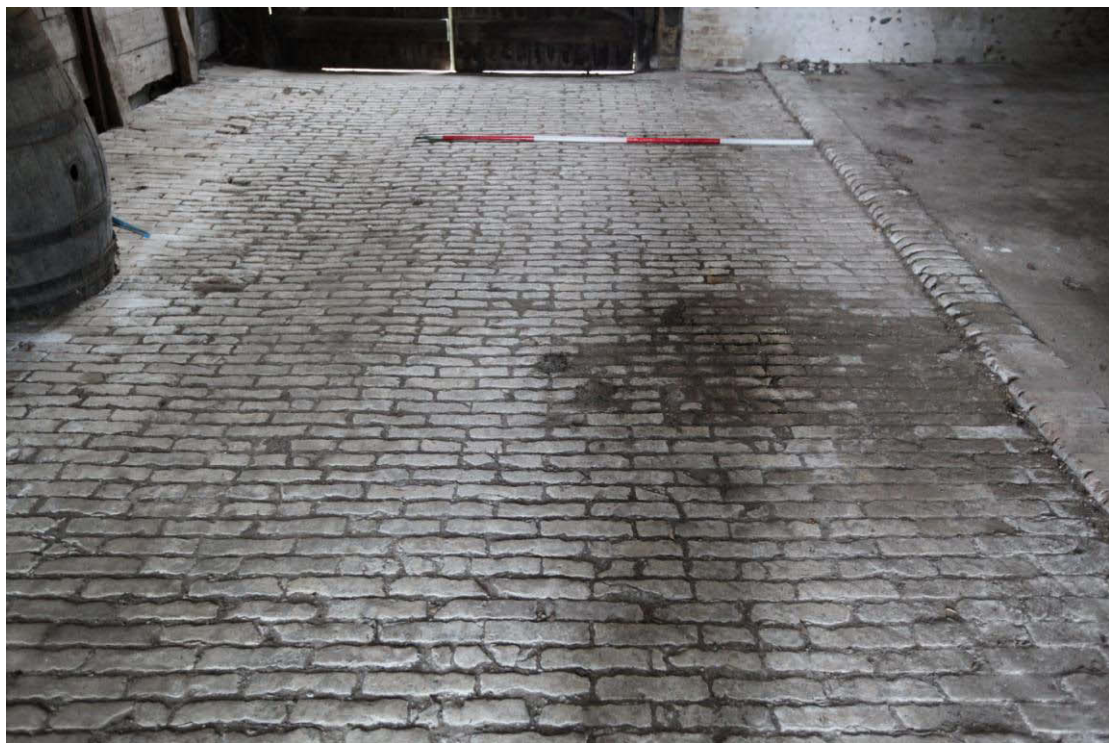
**Illus. 12. The exceptionally well preserved threshing floor of gault brick in the flint barn (1) seen from the west, showing its raised southern edge to the right with modern concrete beyond.**
