**Barn at
Prospect House Farm,
Wilby, Suffolk
WBY 021**

Historic Building Record

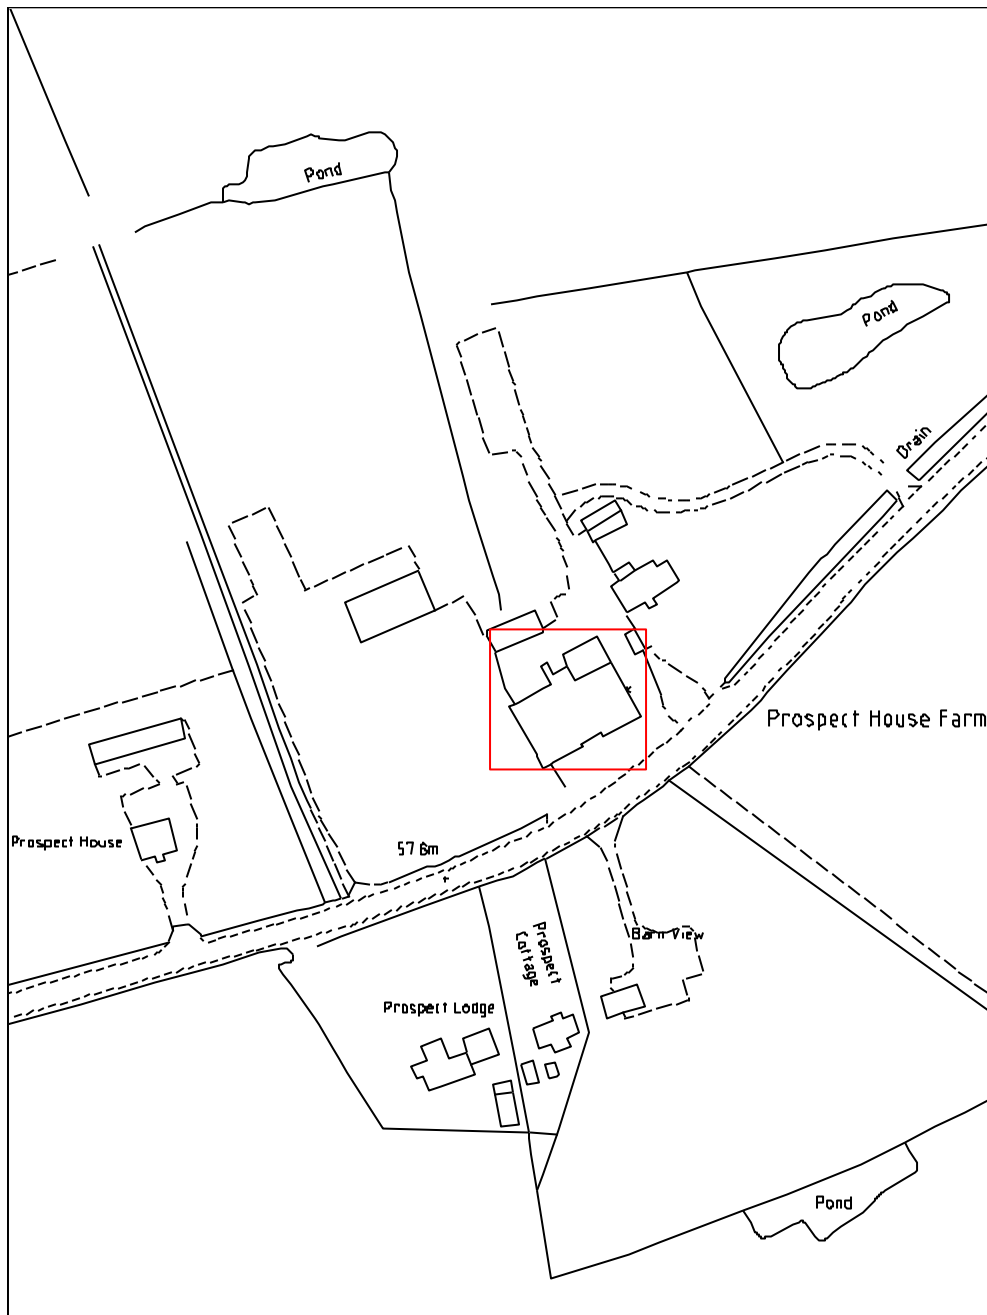
© Crown Copyright. All rights reserved. Suffolk County Council Licence No. 100023395 2008

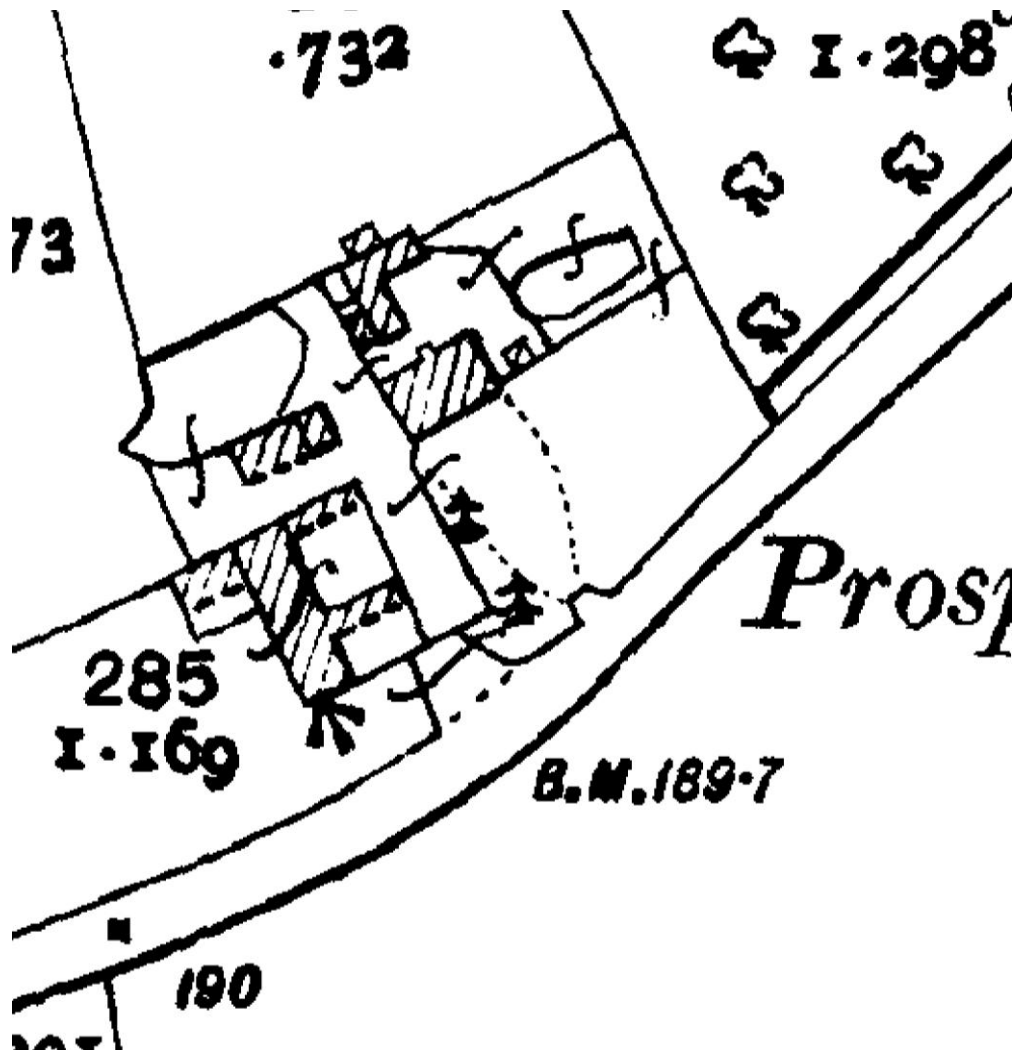
Figure 4. Second Edition 25 inch Ordnance Survey of 1904, showing the two shelter-sheds to the east of the barn more clearly: their open-sided southern elevations are indicated by broken lines. Both were rebuilt later in the 20th century and their replacements (buildings 1 and 3) are visibly wider. Nothing now survives of the western shed and the probable detached cart lodge to the north.

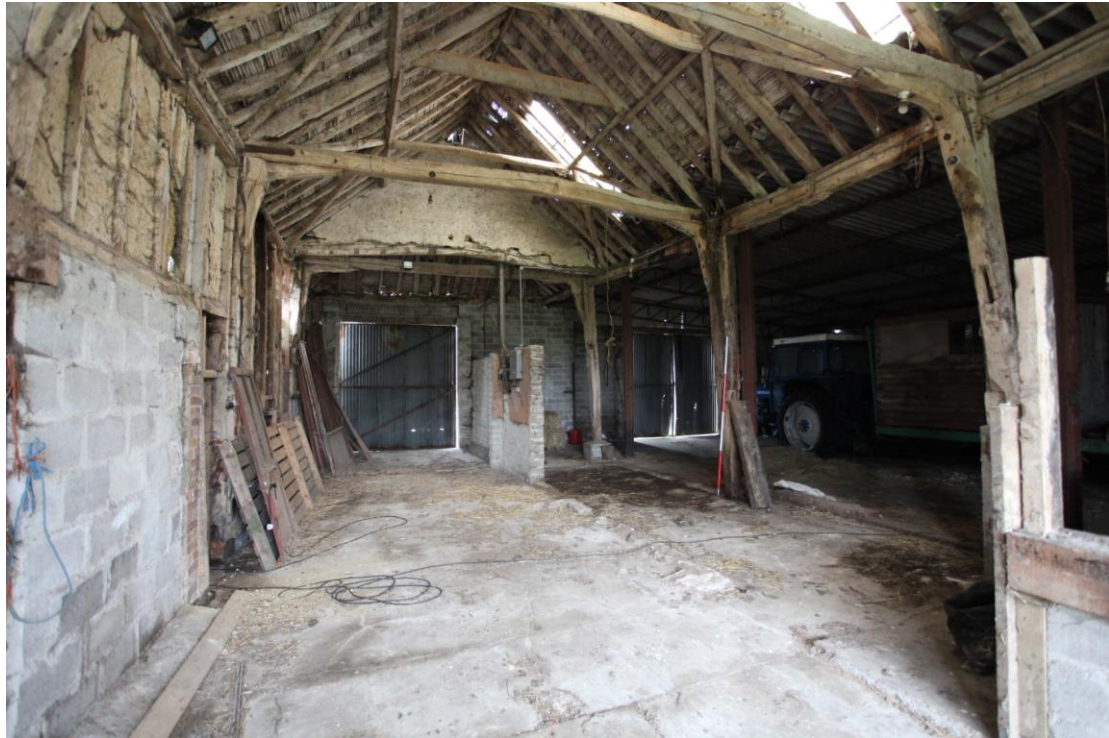
Illus. 5. General internal view of the barn (5) from the north showing the missing studs of the rear (western) elevation to the right and the largely intact studs of the eastern facade to the left. The remaining section of the daub partition against the stable bay (5a) is visible in the rear.

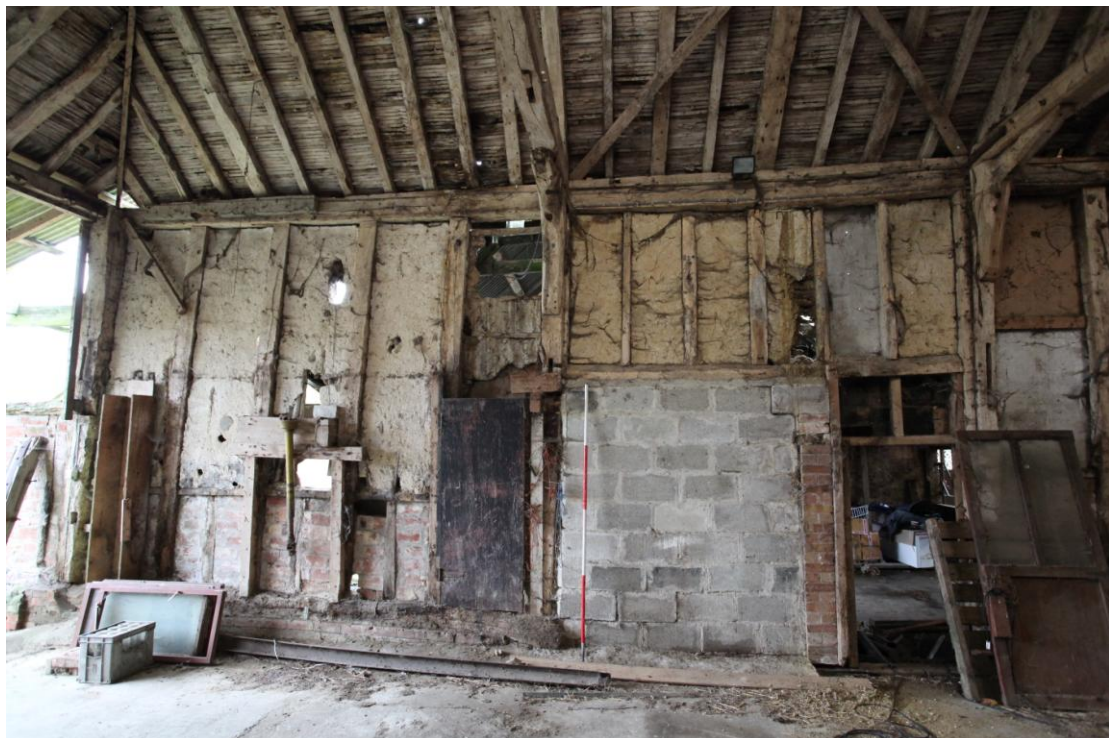
Illus. 6. Eastern interior of barn (5) showing the original framing and secondary wattle-and-daub of the northern bay to the left (with evidence of a removed internally trenched brace) and the blocked original full-height entrance to the right. The storey posts flanking the entrance are rebated for its doors in an unusually sophisticated manner.

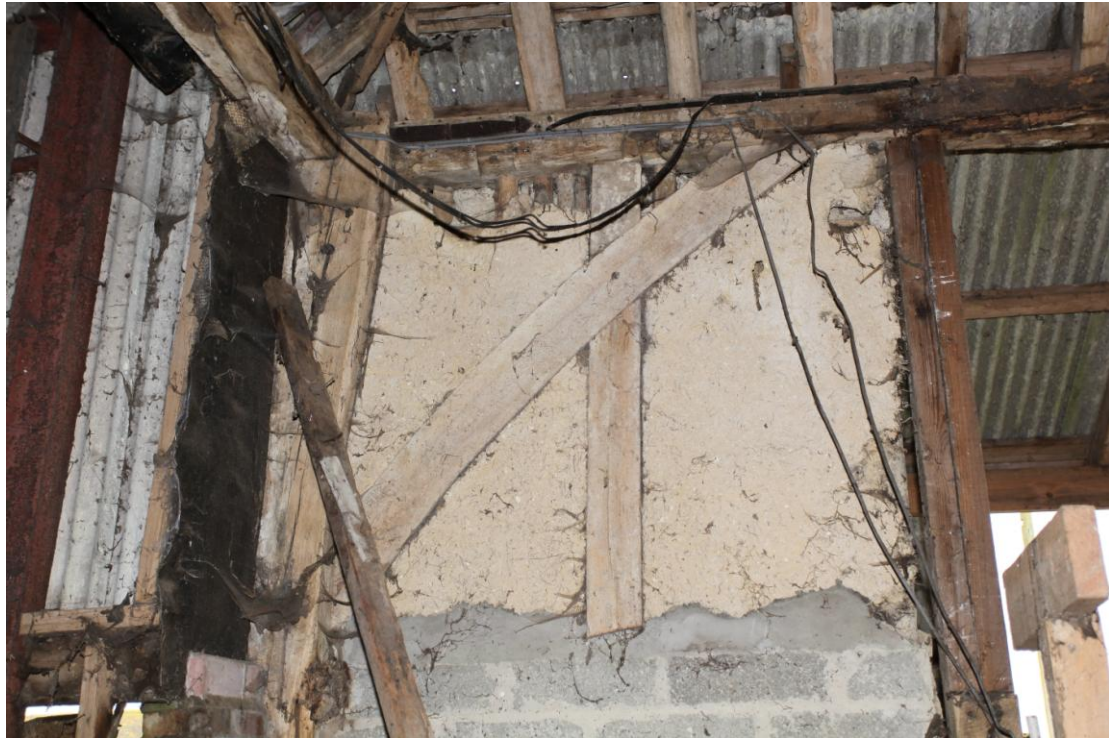
Illus. 7. Detail of the original framing with internally trenched brace in the western section of the northern internal gable of the barn (5). The tie-beam is a re-used replacement of the 19th century which relates to the present hipped roof.

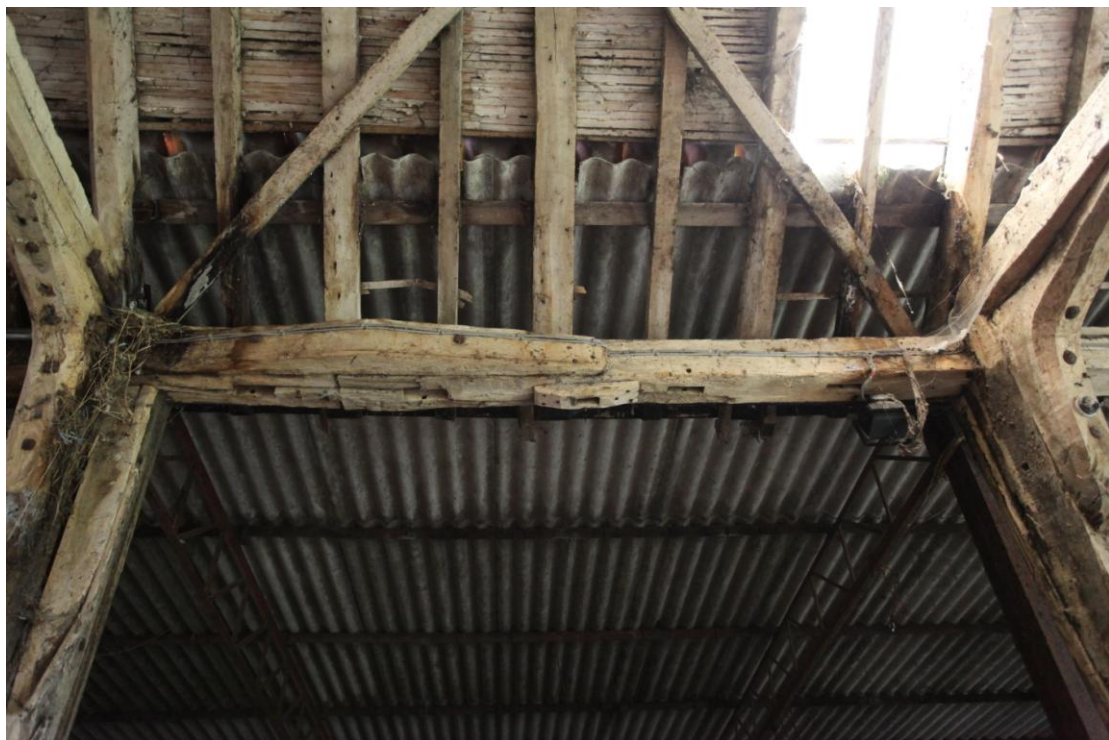
Illus. 8. Western roof-plate of the entrance bay of the barn (5) seen from the east and showing empty stud mortises with a central gap for a narrow rear door. The wooden housing for a door bar is a later addition. An edge-halved and bridled scarf joint is visible to the left (partly hidden by a bolted repair).

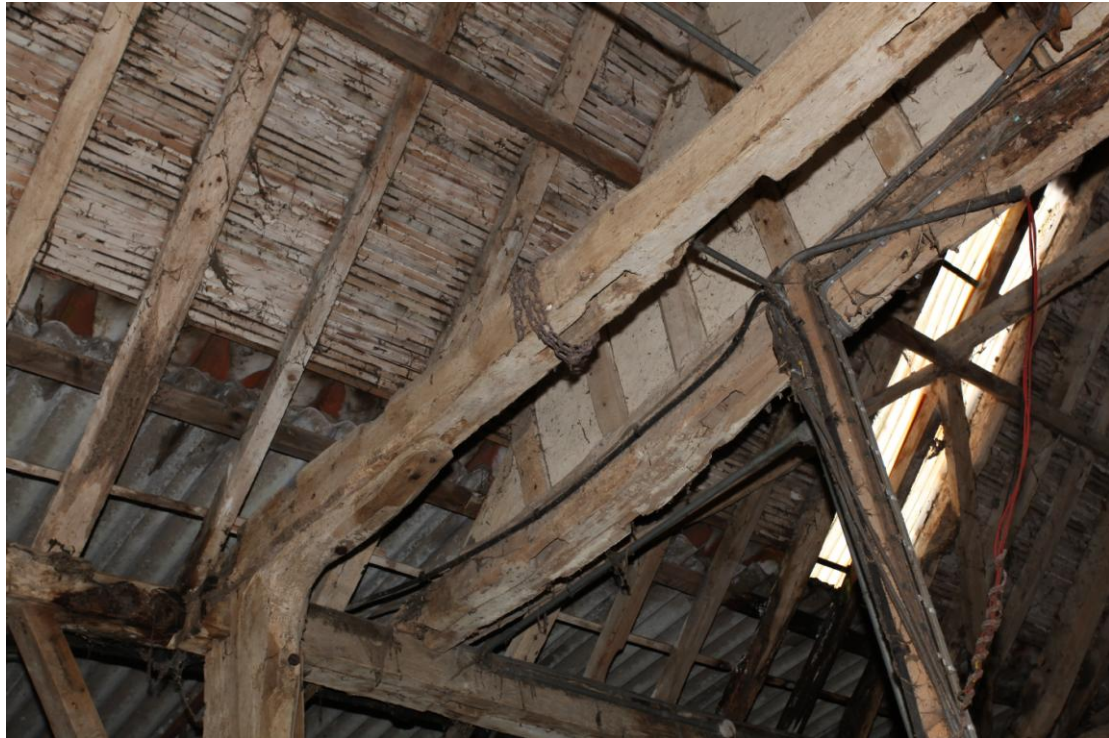
Illus. 9. Detail from the south-east of the original tie-beam of the southern gable of the three-bay barn (5) showing its hip-rafter notches and empty stud mortises. The tie-beam and remaining partition of the stable (which intruded into the barn by 0.5 m) is shown in the rear to the right.

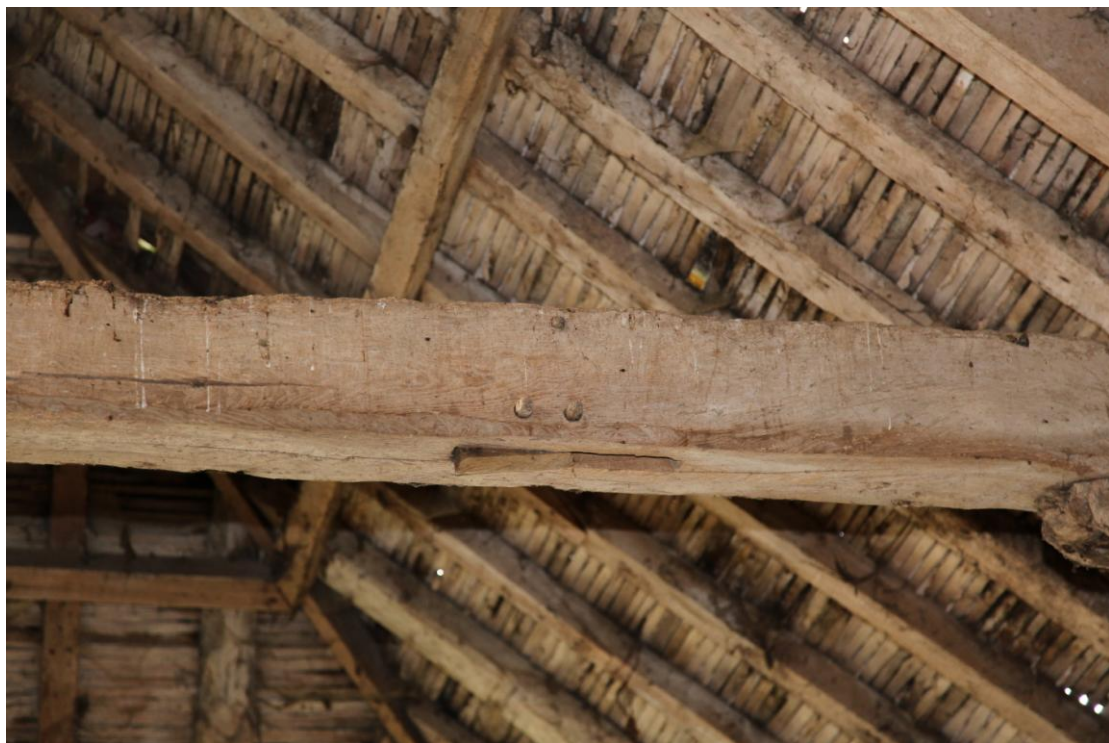
Illus. 12. Detail of the only original open truss tie-beam to survive in the barn (5) – to the north of its entrance bay – showing a pegged mortise for a missing arch-brace in its lower surface and the peg of a queen-post mortise in its upper. Queen post roofs were largely confined to the northern half of central Suffolk in the 16th century.
