**Former Cattle Sheds,  
Dairy & Workshop,  
Abbey Farm,  
Snape, Suffolk  
SNP 098**

**Historic Building Record**

**November 2010**

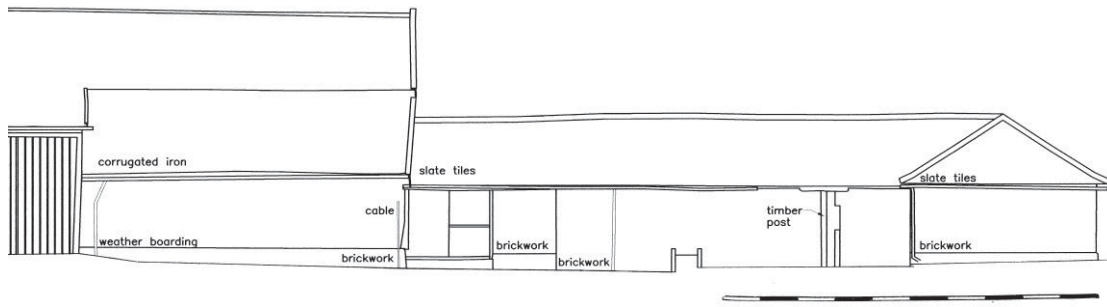
**Figure 8. Southern external elevation of the enclosed shed (1) showing the eastern shelter-shed (3) to the right and part of the barn (6) to the left**

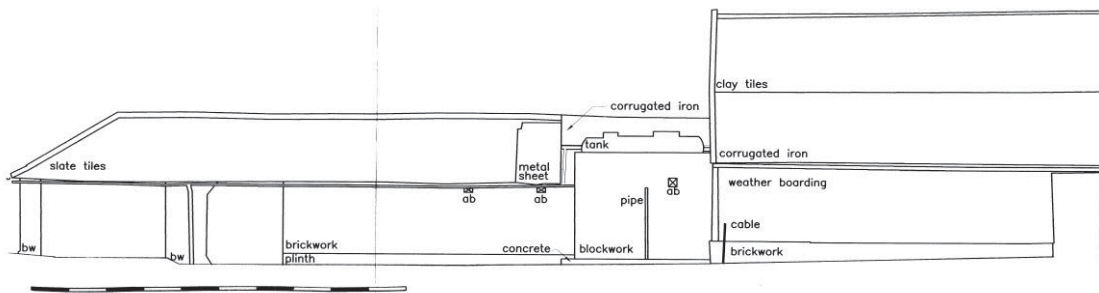
**Figure 9. Northern external elevation of the enclosed shed (1) and the corner shed (2)**

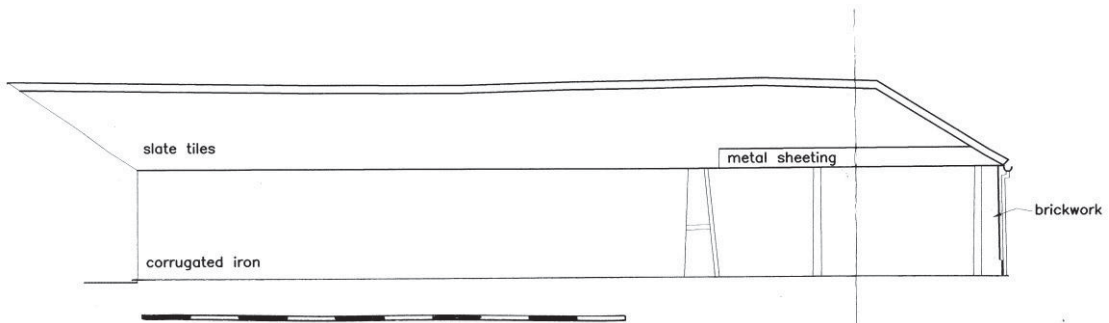
**Figure 10. Western external elevation of the eastern shelter-shed (3)**

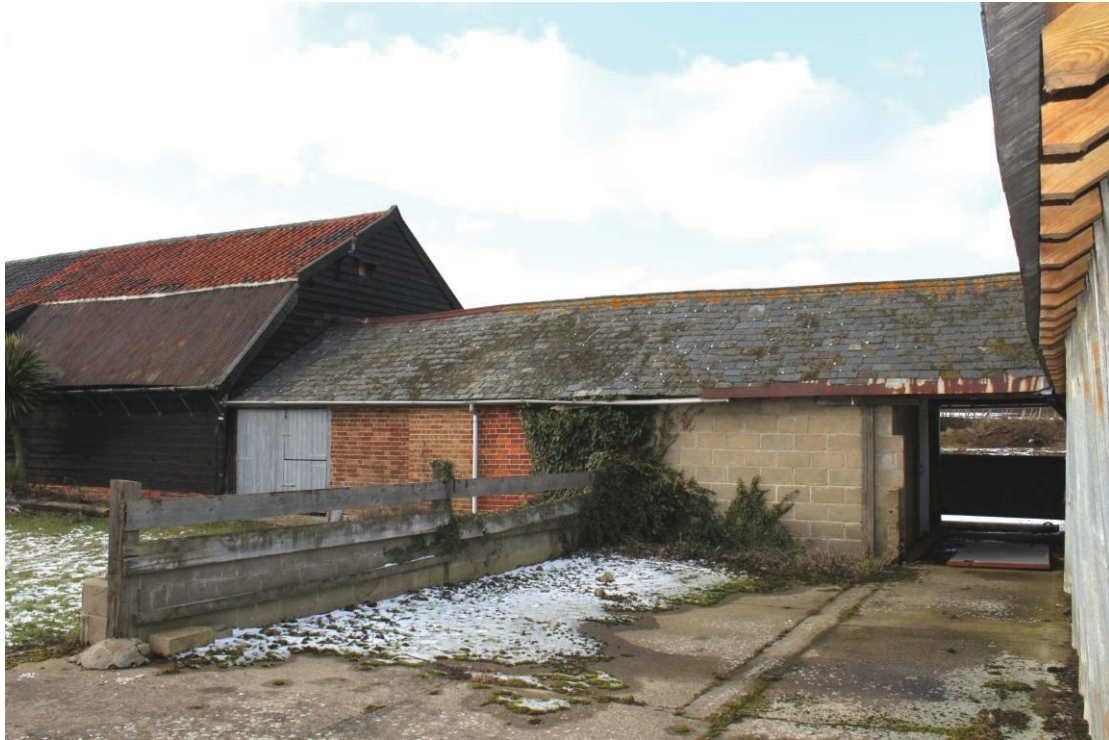
**Illus. 3. The southern exterior of the enclosed shed (1) showing the secondary through-passage adjoining the corner shed (2) to the right and the barn (6) to the left. This elevation was extensively altered in the 20<sup>th</sup> century with new doors to the left and cement-block rebuilding to the right.**

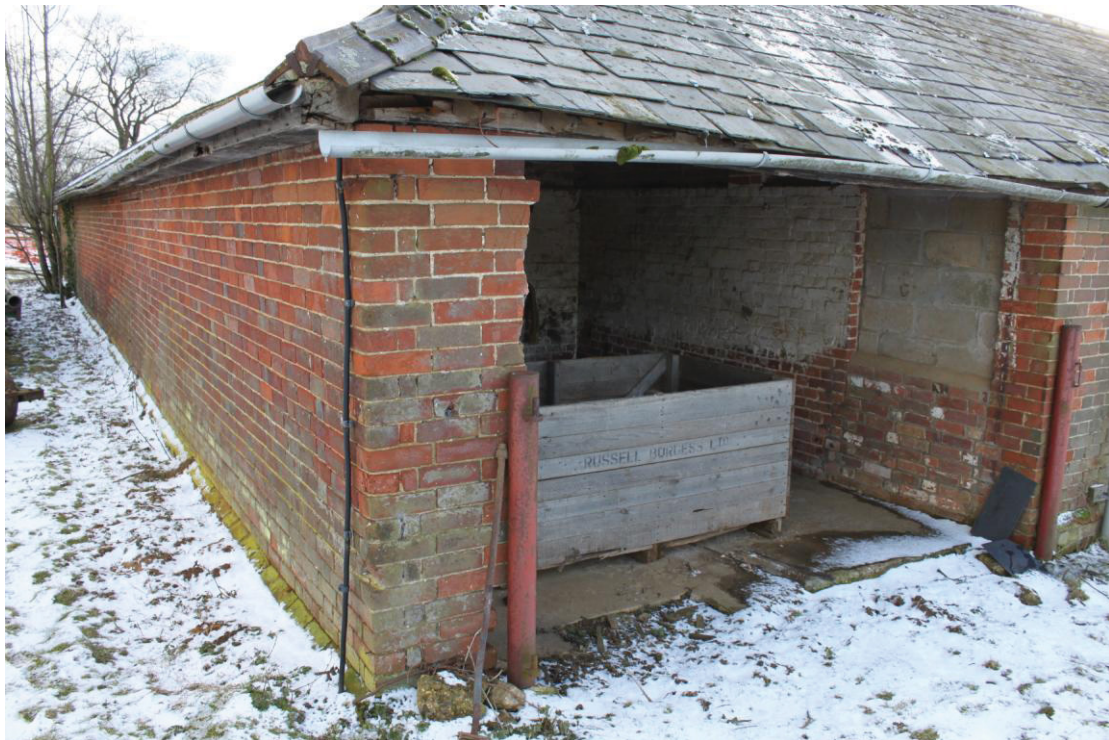
**Illus. 4. Exterior of the corner shed (2) from the north showing its secondary access (breaking the original brickwork) with the eastern elevation of the adjoining shelter-shed (3) to the left. The blocked original internal entrance is visible to the right.**

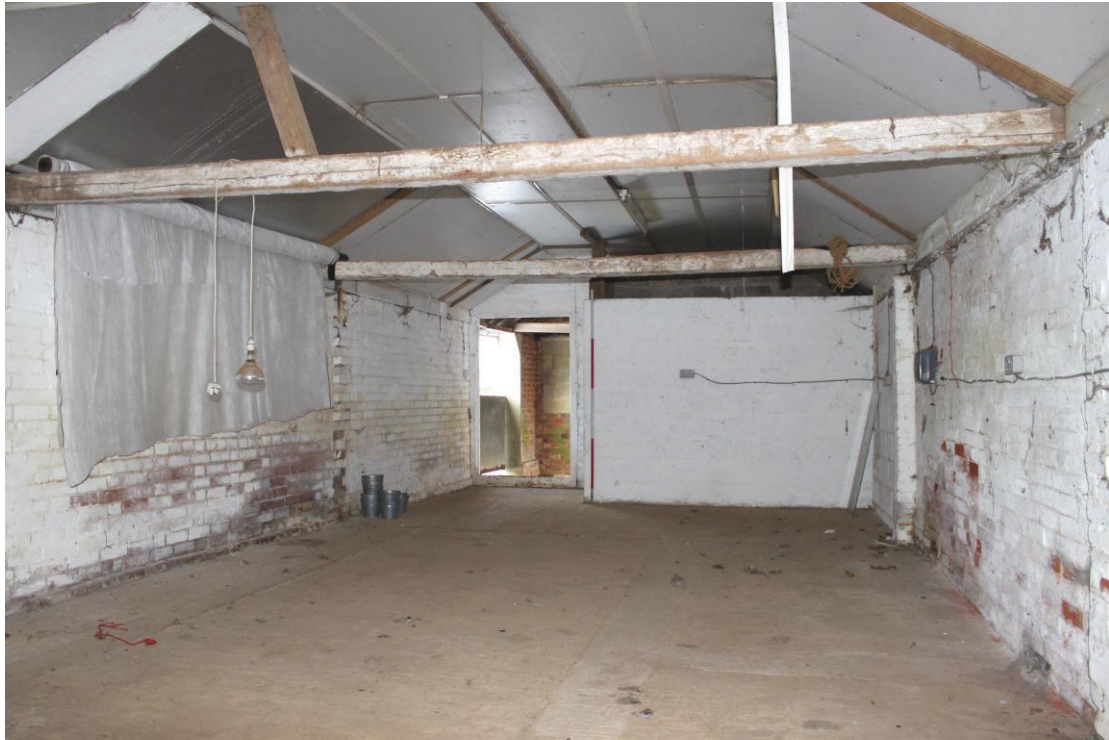
**Illus. 5. The interior of the heavily altered enclosed shed (1) from the west showing the cement-block partition adjoining the secondary through-passage in the rear with the scar of a missing original lateral partition to the left.**

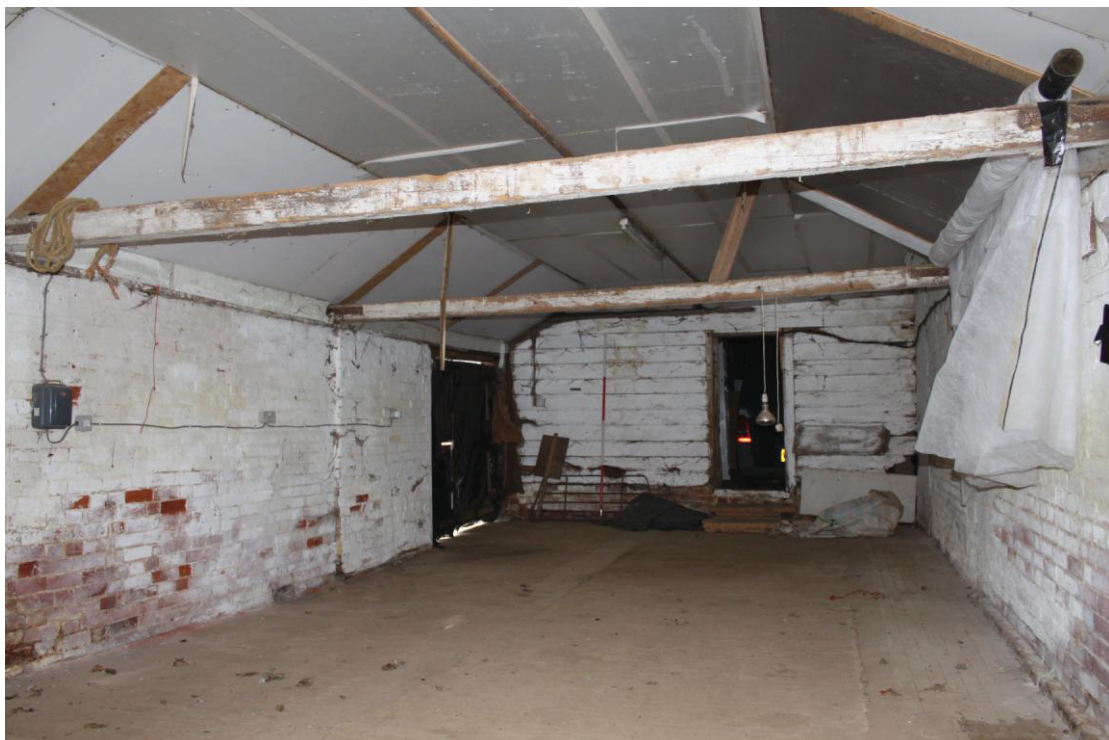
**Illus. 6. The interior of the enclosed shed (1) from the east showing the boarded gable and door of the barn (6) in the rear with a butt-joint in the brickwork of the southern elevation to the left. The ceiling consists of modern plasterboard.**

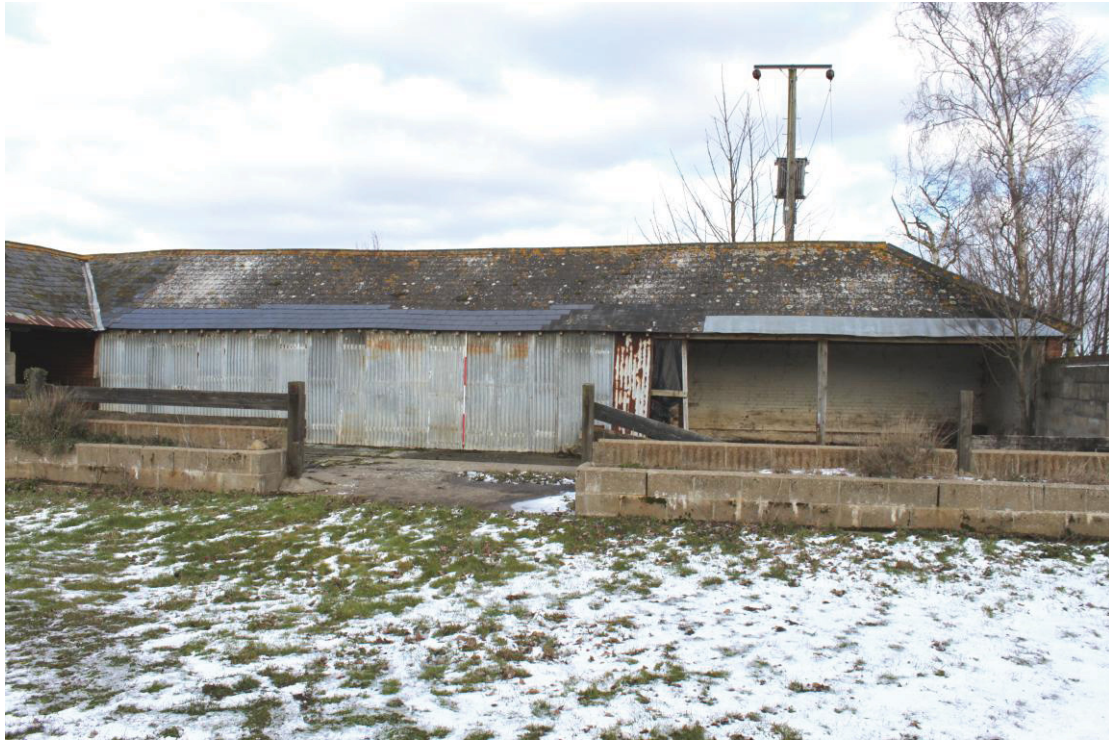
**Illus. 7.** The rebuilt western exterior of the eastern shelter-shed (3) showing its enclosing wall of modern corrugated iron to the left.

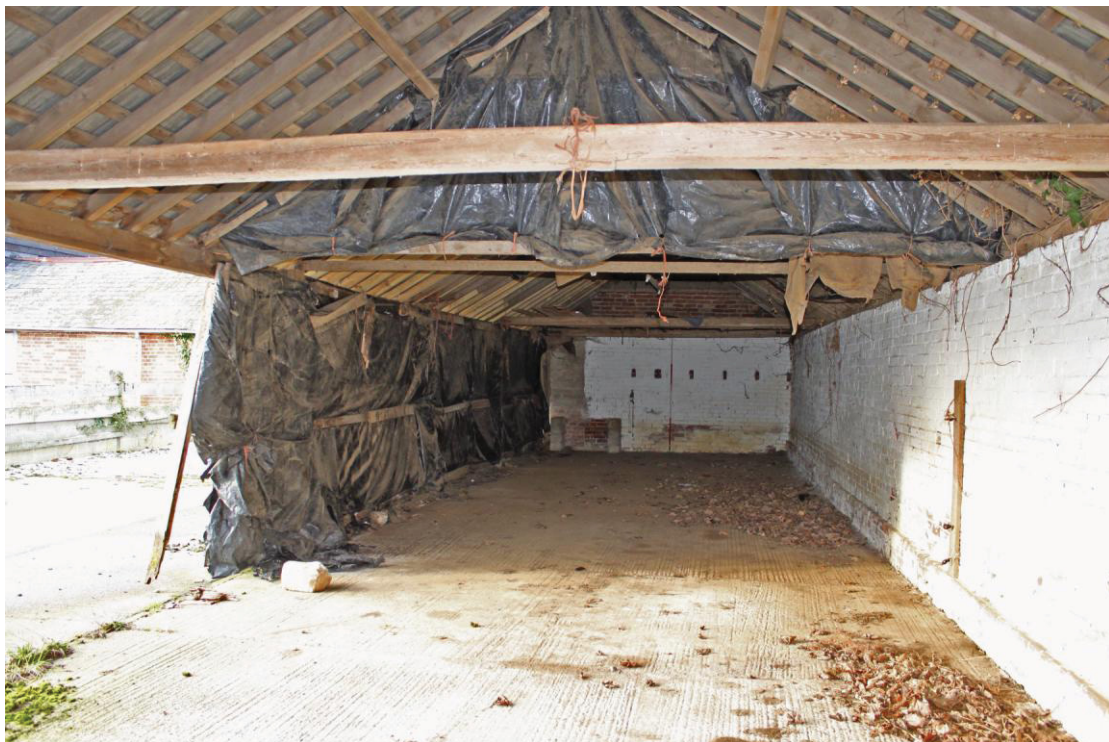
**Illus. 8.** The interior of the eastern shelter-shed (3) from the south showing its rebuilt roof structure of modern softwood with the solid wall adjoining the corner shed (2) in the rear.

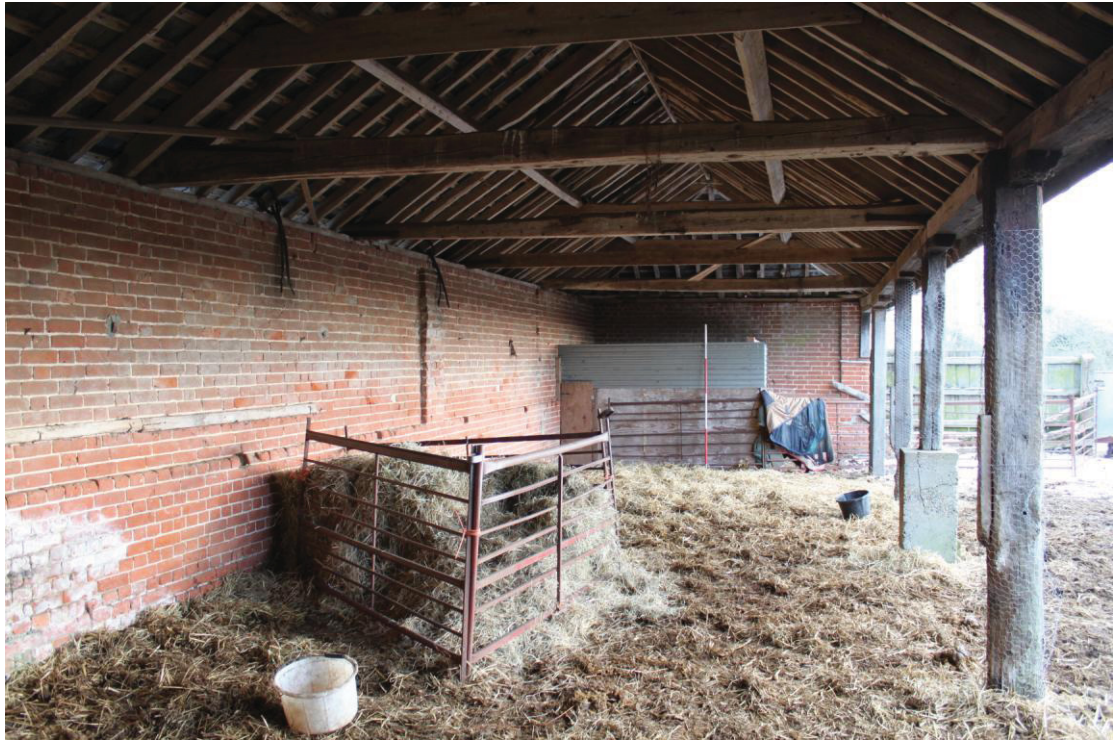
**Illus. 9.** The interior of the western shelter-shed (4) from the north, showing its original softwood roof and replaced arcade posts to the right. The building was in use as a horse shelter at the time of inspection.

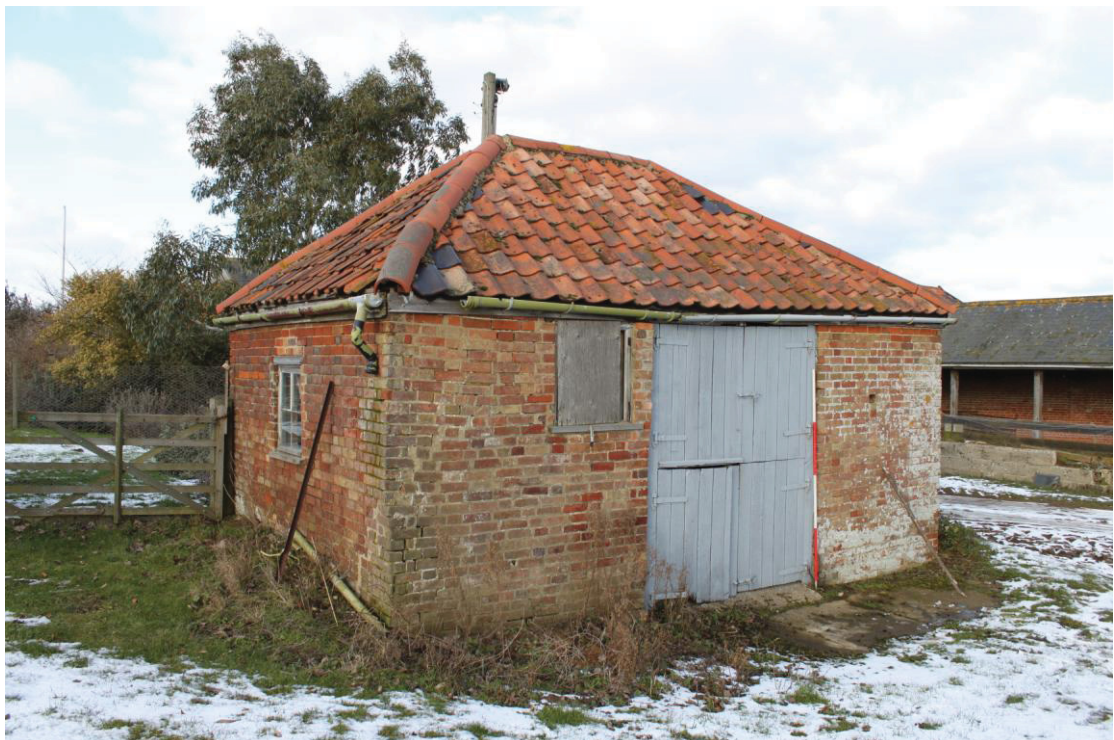
**Illus. 10.** The exterior of the workshop (5), which probably originated as a bull box or possibly a vehicle shed with its present double doors but without windows.
