ARCHAEOLOGICAL BUILDING RECORDING AND MONITORING REPORT

SCCAS REPORT No. 2010/212

Barn at Green Meadows, The Green, Hessett, Suffolk

HTT 019

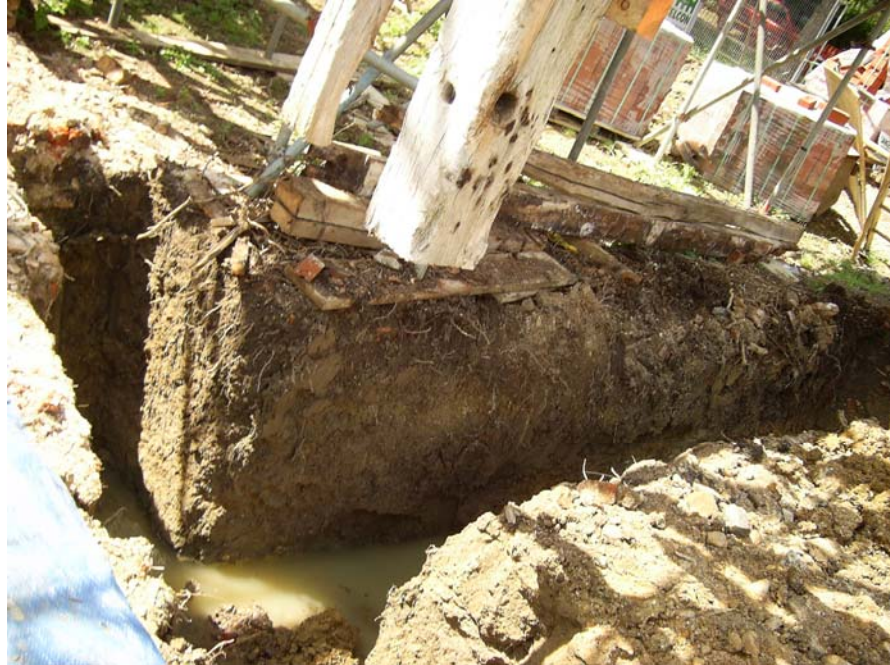
Figure 13. Section of ditch 0001 looking southwest at the footing extension

This feature was c.2m wide and at least 0.7m deep. The visible fills comprised brown silt with a substantial layer of clay within the fill. No finds were recovered from the feature and no fragments of brick were observed in the section.

Ditch 0001 produced no finds and cannot be dated with any certainty. It does however underlie the western expansion of the barn and, at least in part, the main structure; it

must therefore have been earlier. Given the location and alignment it seems reasonable to suggest that it was an early course of the southern green edge ditch (shown on the 1838 tithe map above). Possibly this ditch was re-aligned to the west when the barn was built, thereby increasing the landholding to the east of the ditch.

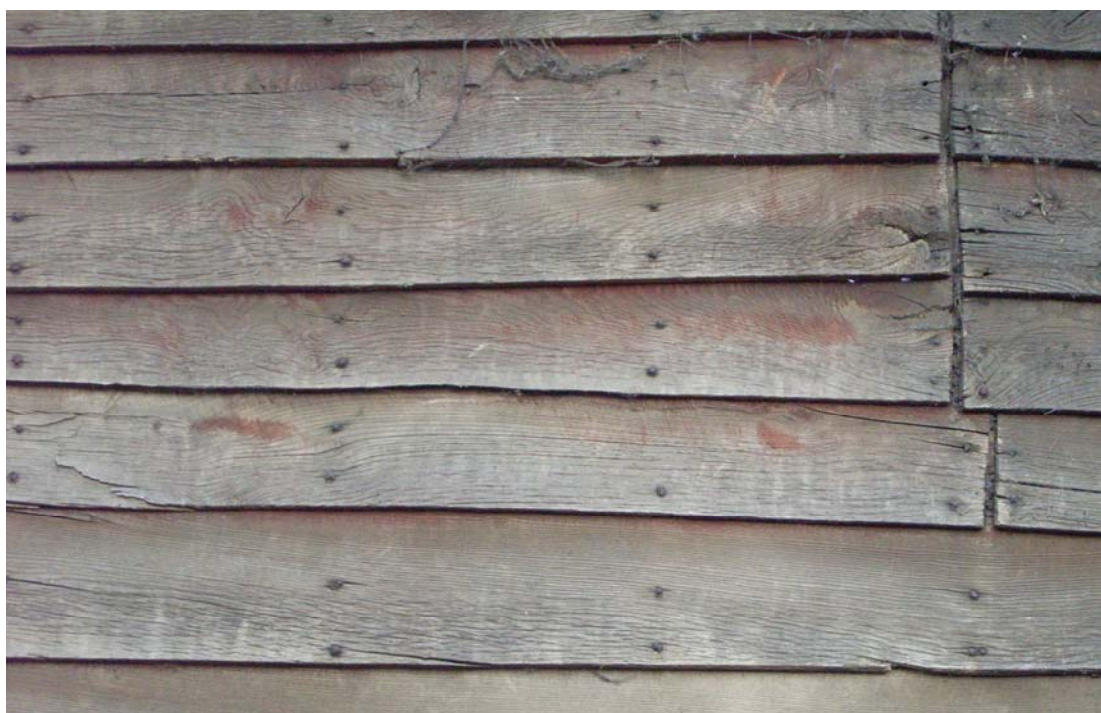
This barn is entirely typical of many late-18th century examples in East Anglia, and its chief historic interest lies in the unusually extensive survival of red ochre pigment (reddle) on the weatherboarding of the front (western) wall where it was protected until recently by a later lean-to (Area 4). This lean-to has lately been demolished. The reddle has also been preserved behind the posts of the porch, which suggests it is original to the building. Many East Anglian barns were decorated and protected from the weather in this manner, but most were coated in tar during the late-19th and 20th centuries (which tar became available as a cheap by-product of the town gas industry). The practise explains the famous Red Barn murder of Maria Marten at nearby Polstead. There is no indication of the lean-to on the 1904 Ordnance Survey above, and both it and the tar which coats the external boarding elsewhere were presumably additions of the early-20th century. Area 5 in Figure 7 marks the site of a demolished structure recorded on recent architects' plans of which there is now no trace. A number of other buildings are shown to form yards to the east of the barn on 19th century maps but these too have now disappeared without trace above ground. A harness hook on the

A2.2 Detail of external cladding to western façade of barn, protected by a recently demolished secondary lean-to and showing unusually extensive evidence of original red ochre pigment (redde).

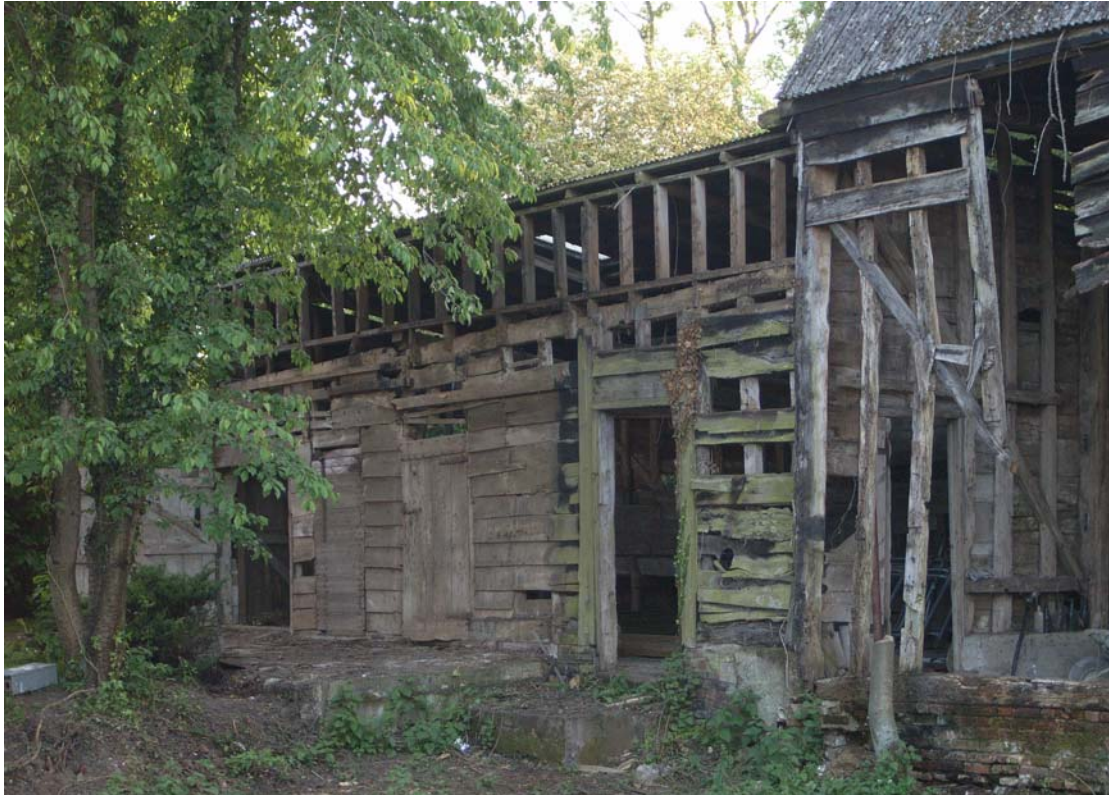
A2.3 The 17th century stable from the east, showing its 20th century single-slope roof and the late-18th century barn to right.

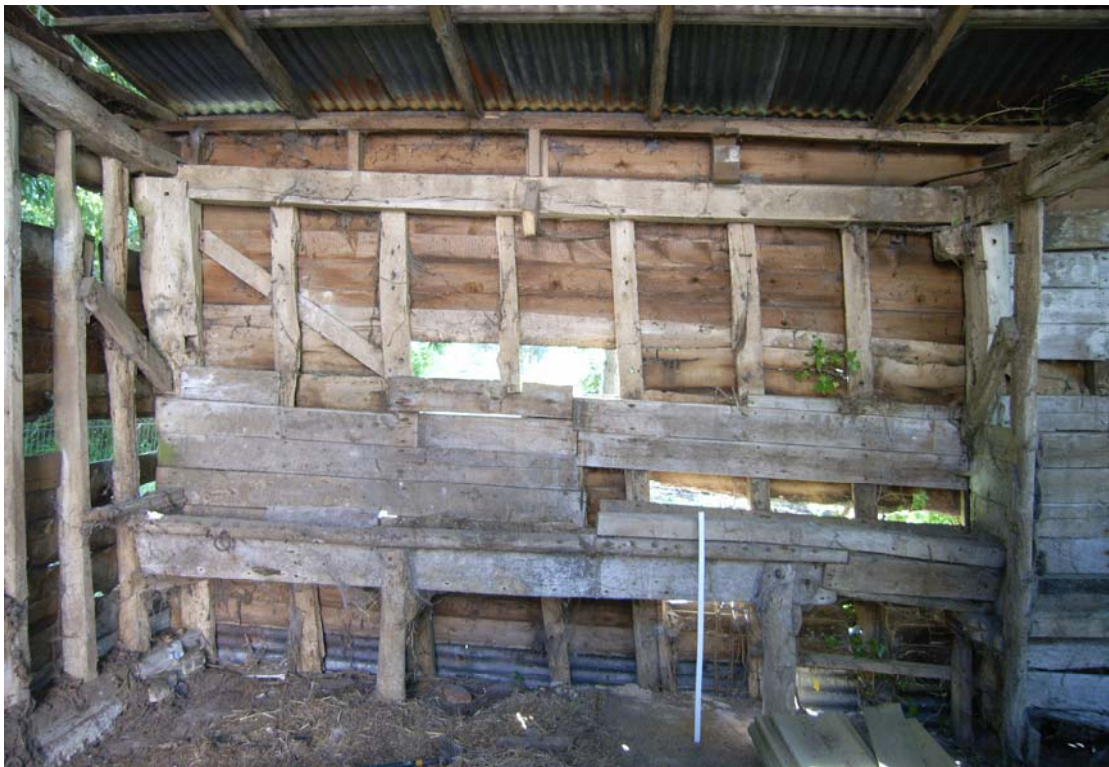
A2.4 The front (western) wall of the stable's southern bay with the remains of the original early-17th century gable to the right. Note the late-18th or 19th century boarded manger and supports for a missing hack rack above. The lintel and sill of an original diamond mullion window lie behind the boarding.

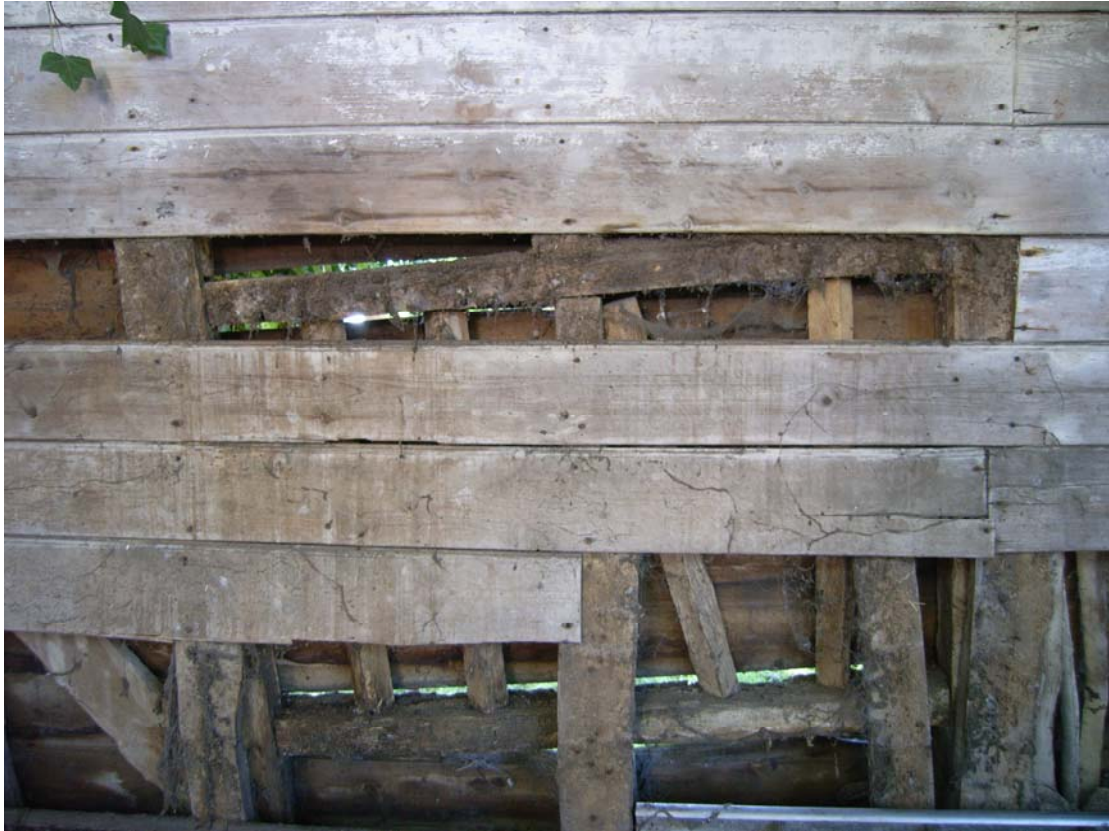
A2.5 An intact early-17th century stable window of five diamond mullions in the western wall behind the 19th century deal internal boarding of the central bay, with an external wall brace visible to the left.

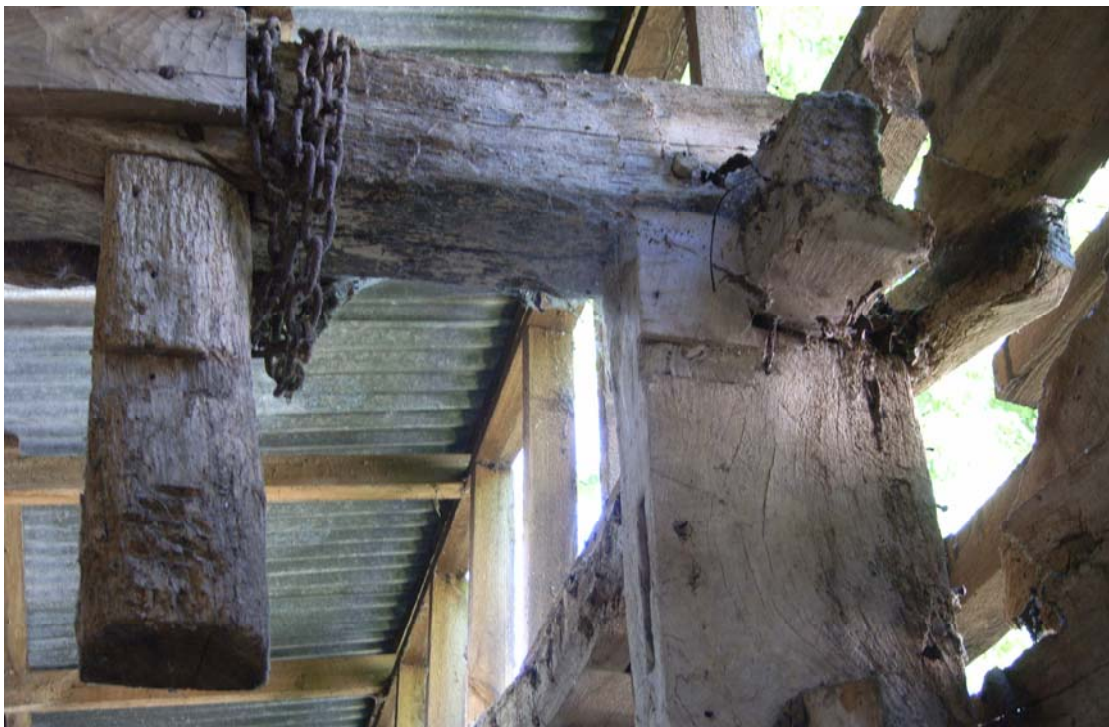
A2.6 The eastern corner of the external gable of the early-17th century stable, showing a lack of weathering and notches that secured original external clay daub. The fragmentary stud to the left is original.
