**Farm Buildings at  
Church Farm,  
Brome, Suffolk  
BRM 015**

**Historic Building Record**

**November 2010**

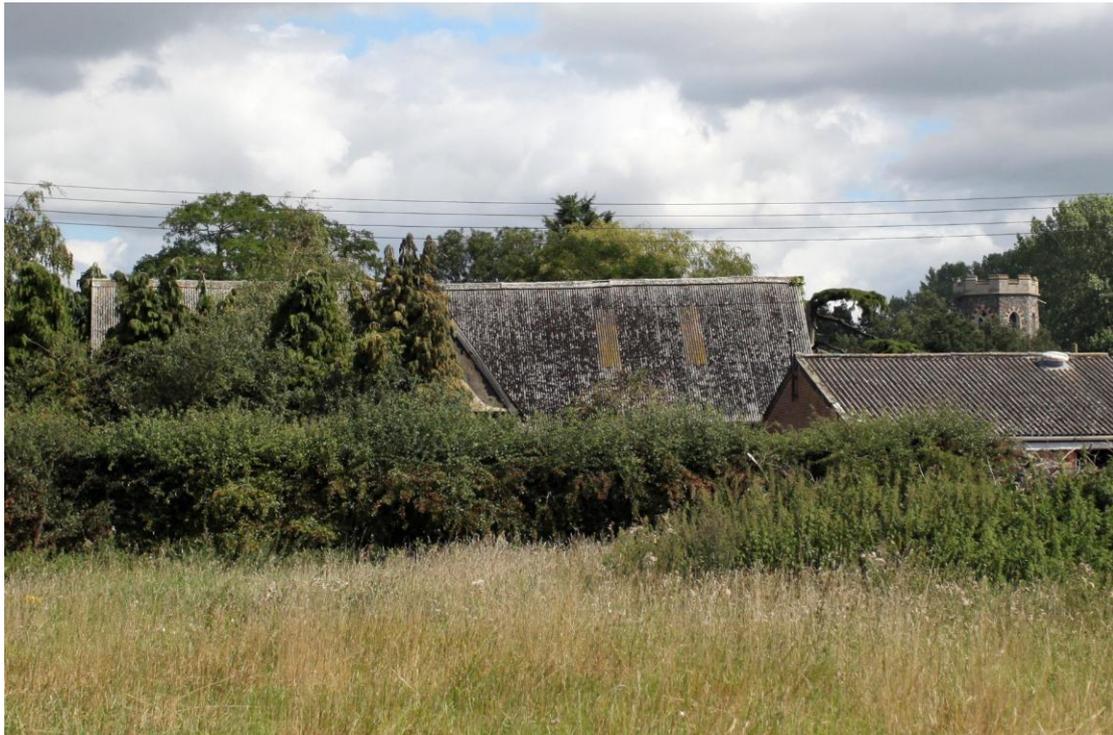
**Illus. 1. Exterior of barn (1) from south-west showing profile of corrugated roof and gabled porch with 20th century brick shed & the 12<sup>th</sup> century round tower with 19<sup>th</sup> century octagonal top of St Mary's parish church to right.**

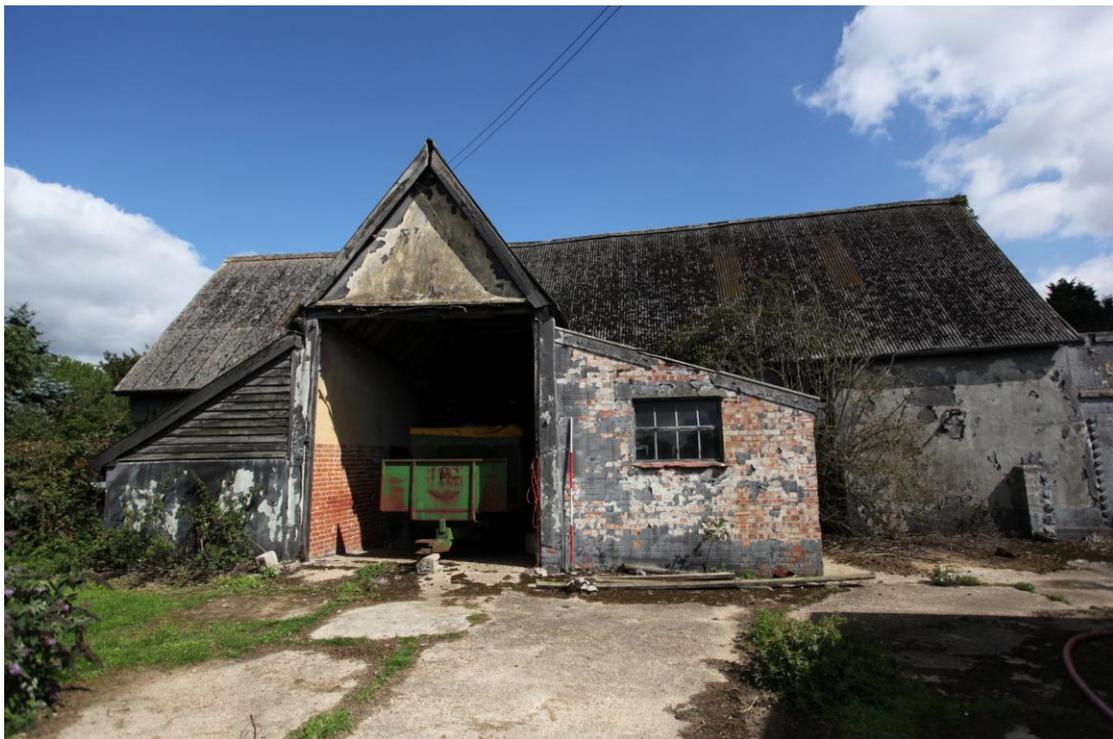
**Illus. 2. South western exterior of barn (1) showing 19<sup>th</sup> century porch (1d) flanked by lean-to sheds.**

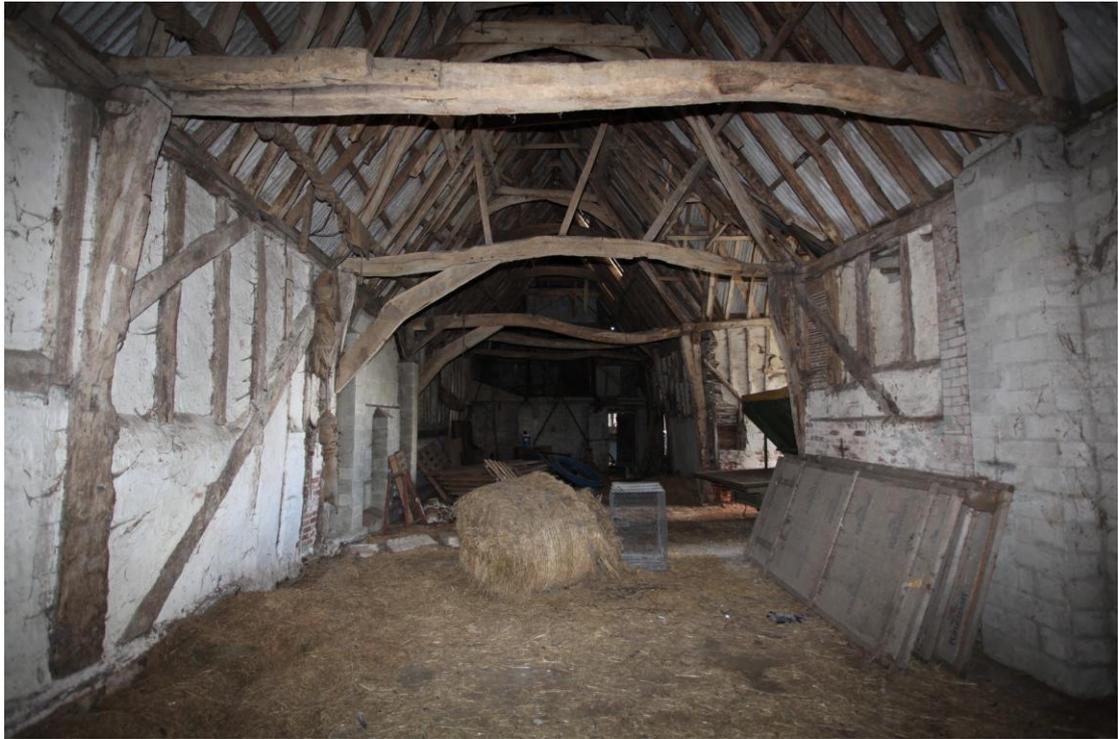
**Illus. 3. Interior of barn (1) from north-west showing the two original arch-braces flanking the blocked north-eastern door to the left. The tie-beam in the foreground was inserted to replace the tie-beam of the original partition between the stable (1b) and three-bay barn (1a), of which a small section survives to the left.**

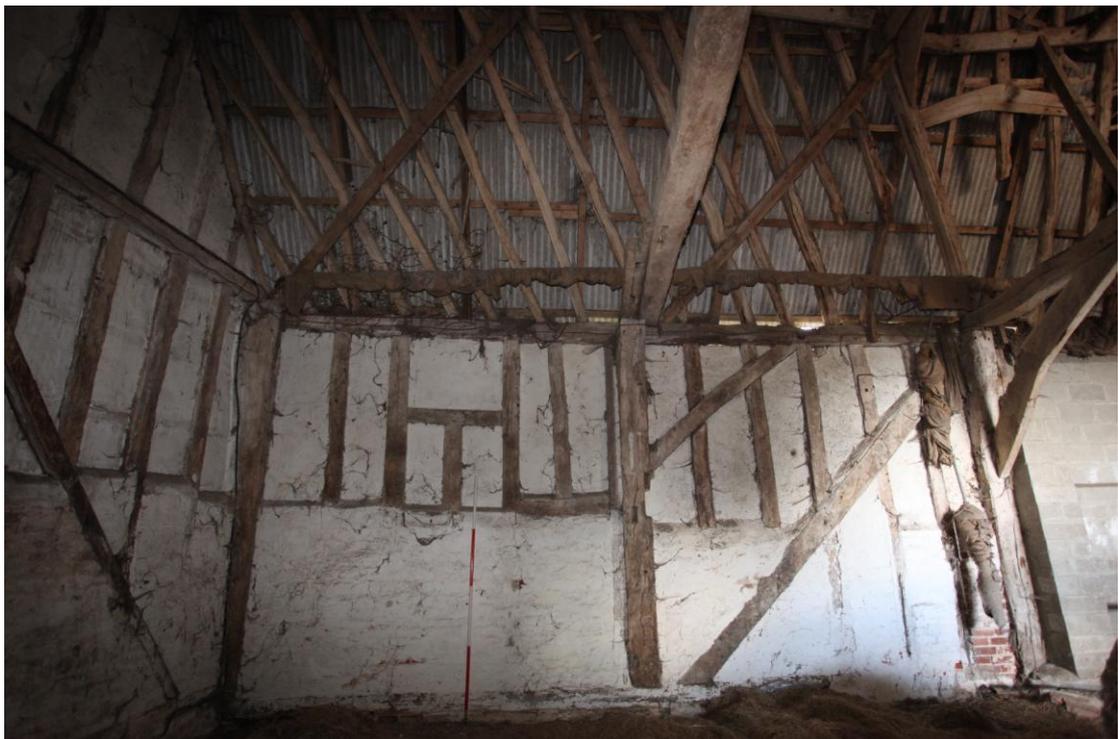
**Illus. 4. The north-eastern interior of the stable bay (1b) at the north-western end of the barn showing the blocked window of its removed hay loft and the lintel of its blocked door adjoining the central storey post. The internally trenched brace to the right rose from the corner of the three-bay threshing barn (1a). The rafters have racked to the left.**

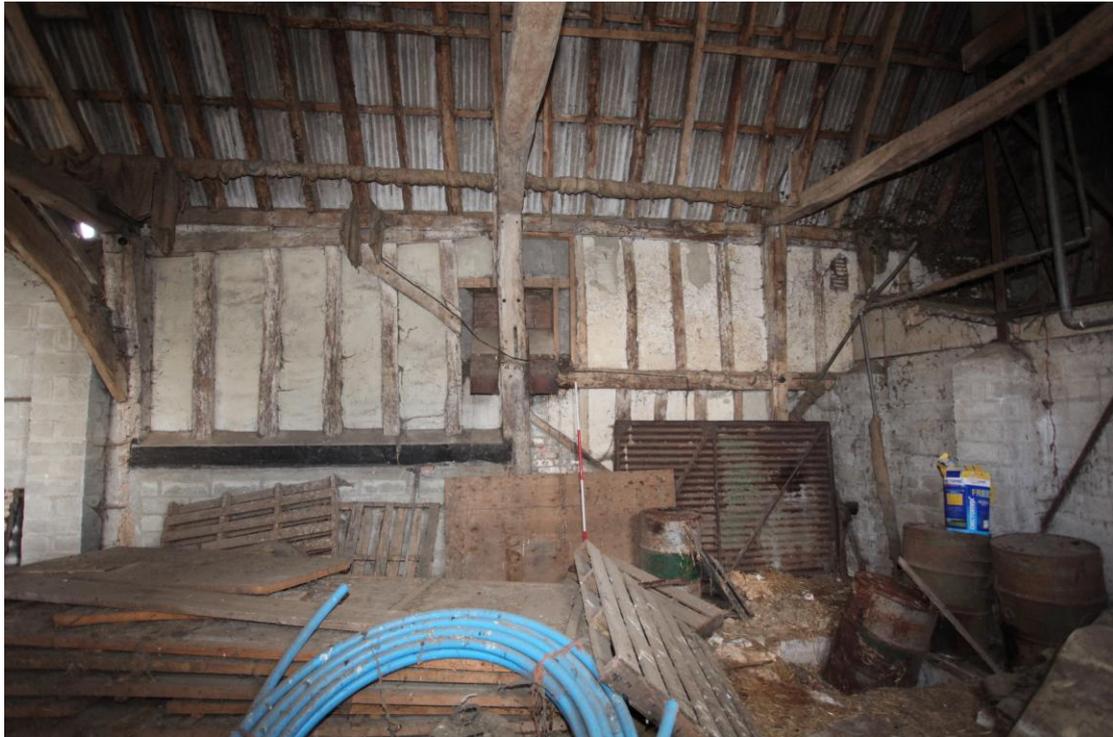
**Illus. 5. The southern end of the barn's north-eastern interior showing the junction between the original 16<sup>th</sup> century structure without mid-rails to the left and the two-bay 17<sup>th</sup> century extension with smaller studs and mid-rails to the right. The ground-floor partition to the right is an intrusion from the adjoining brick milking parlour (2a).**

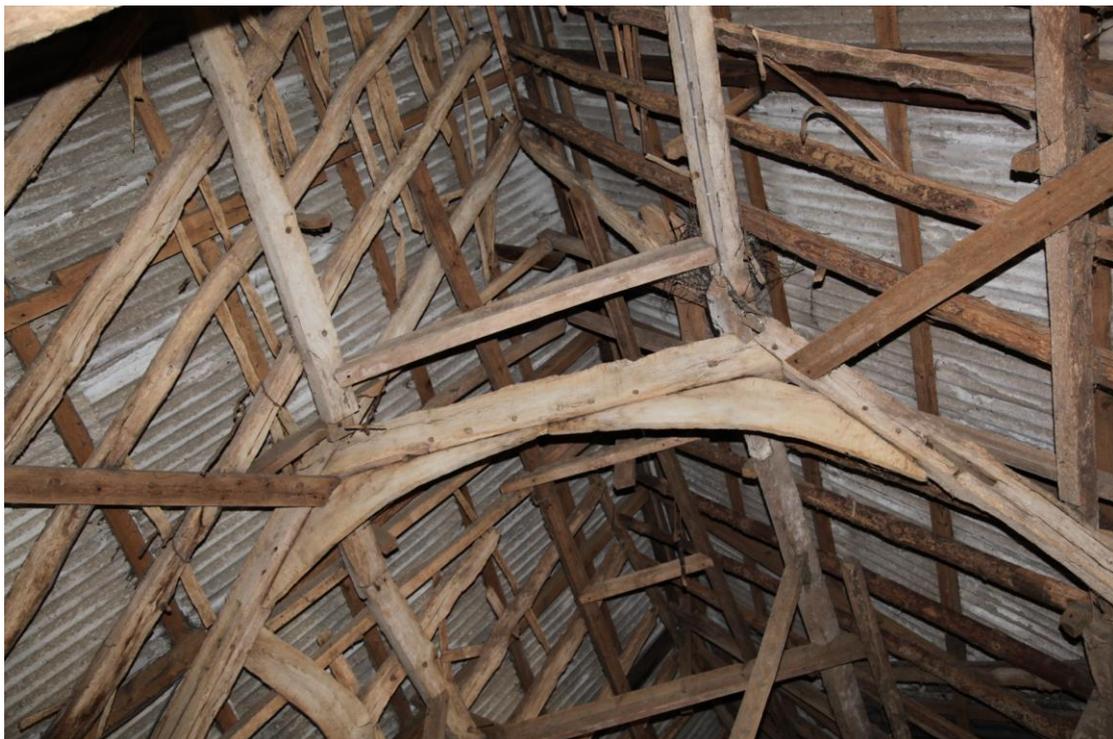
**Illus. 6. Detail of the intact 16<sup>th</sup> century roof truss to the north-west of the threshing bay of the barn (1a), seen from the north-west, showing its tenoned collar braces and empty mortises for missing wind-braces beneath. An original wind brace is visible at bottom-left (now nailed to the rafters).**

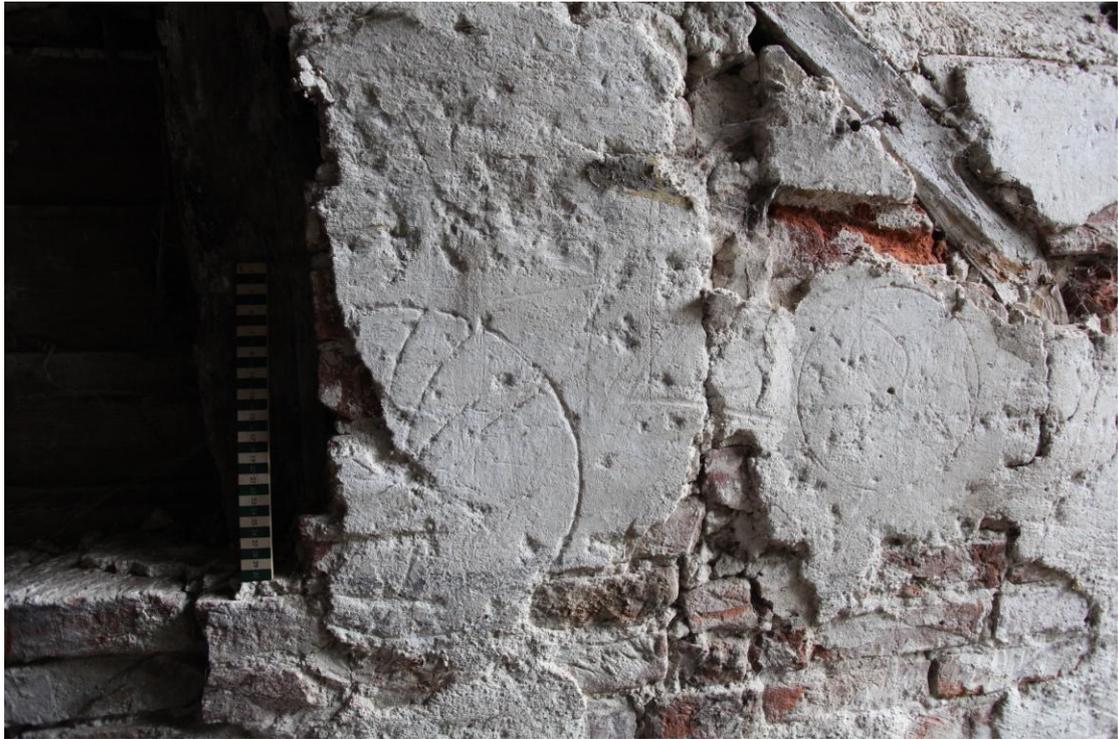
**Illus. 7.** Detail of the apotropaic (evil-averting) circles incised into the plaster of the south-eastern interior of the 19<sup>th</sup> century porch (1d).

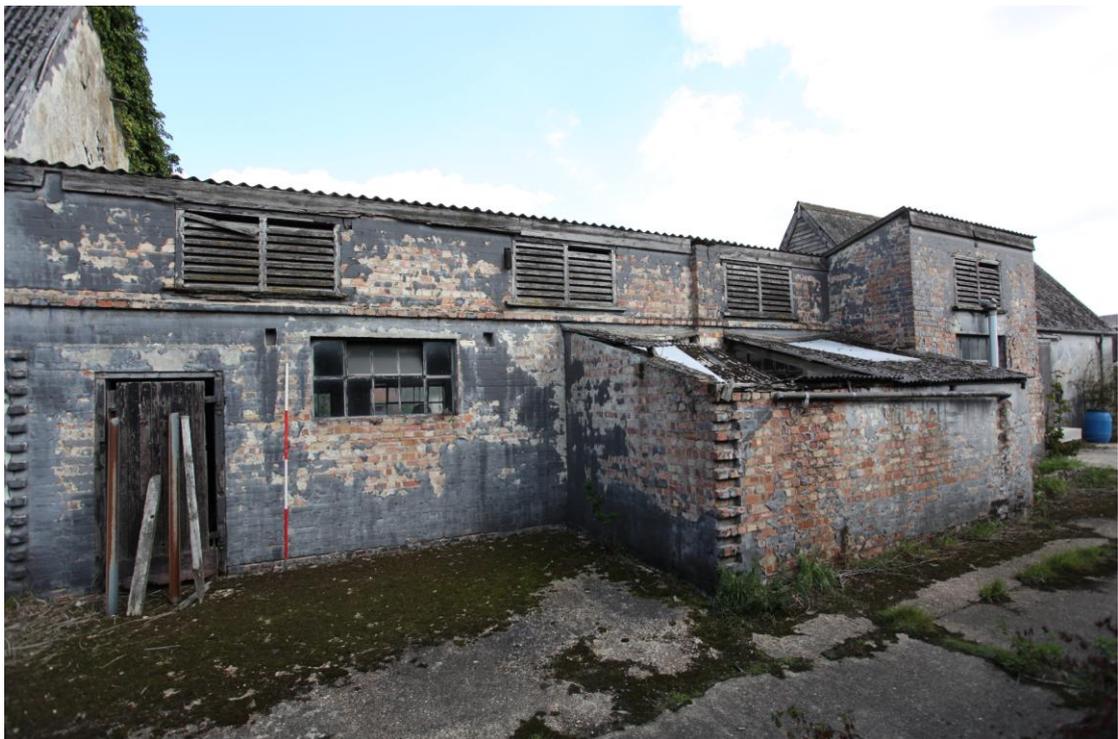
**Illus. 8.** South-western exterior of the brick milking parlour (2) showing the barn (1) to left & the lean-to shed (2c) to the right with the 18<sup>th</sup> century stable (3) to the far right.

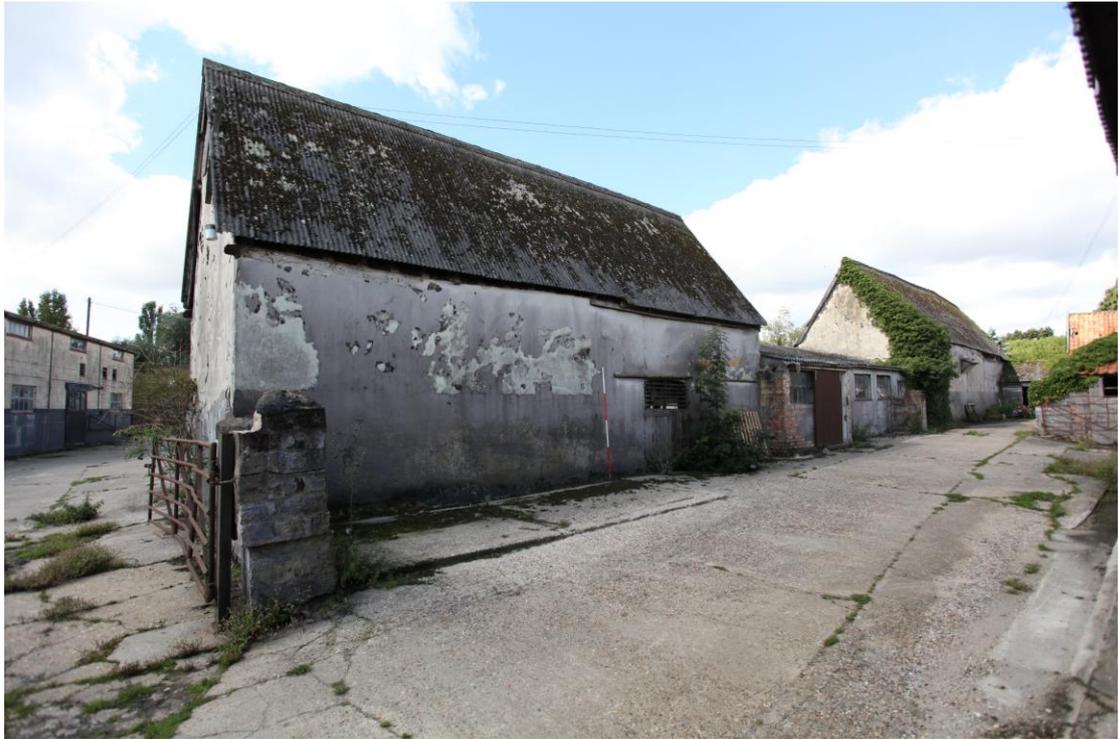
**Illus. 9. North-eastern exterior of the 18<sup>th</sup> century stable (3) showing the barn (1) in the rear to the right.**

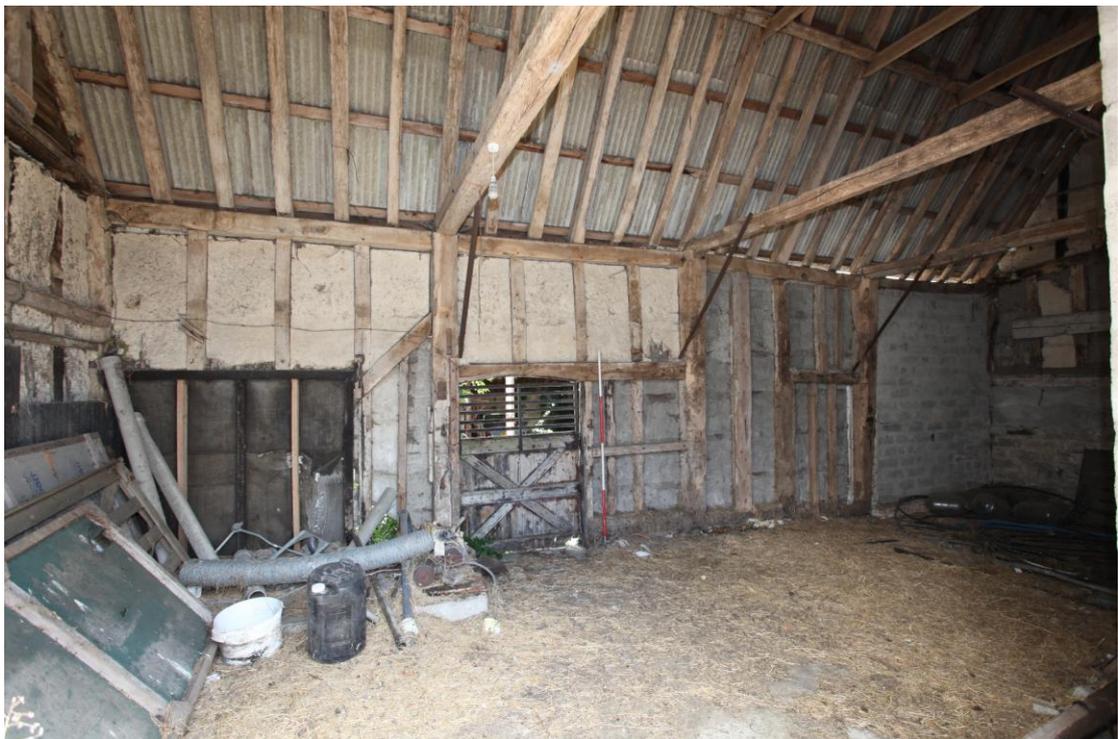
**Illus. 10. The north-eastern interior of the 18<sup>th</sup> century stable (3) showing its two original doors to right and left (the former blocked but retaining its lintel) with the clamp of its missing hay loft joists visible on the north-western gable to the left.**

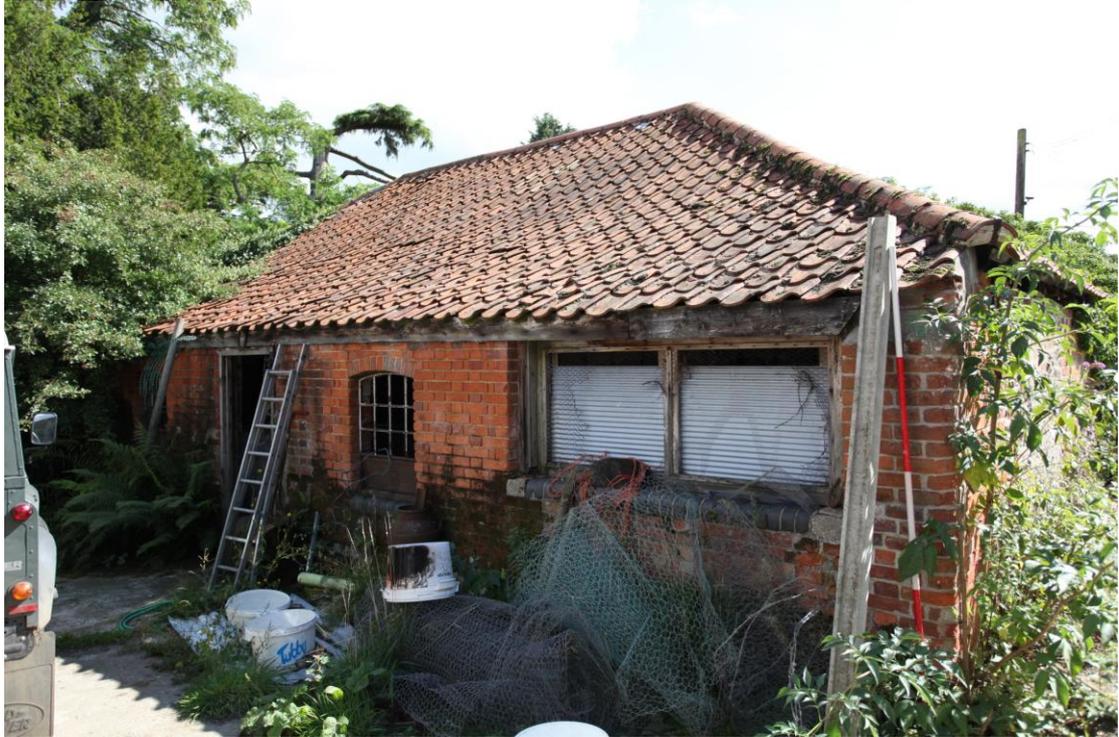
**Illus. 11. The north-western exterior of the western 19<sup>th</sup> century cow-shed shed (5a) showing its original cast iron windows to the left and a secondary hatch to the right.**

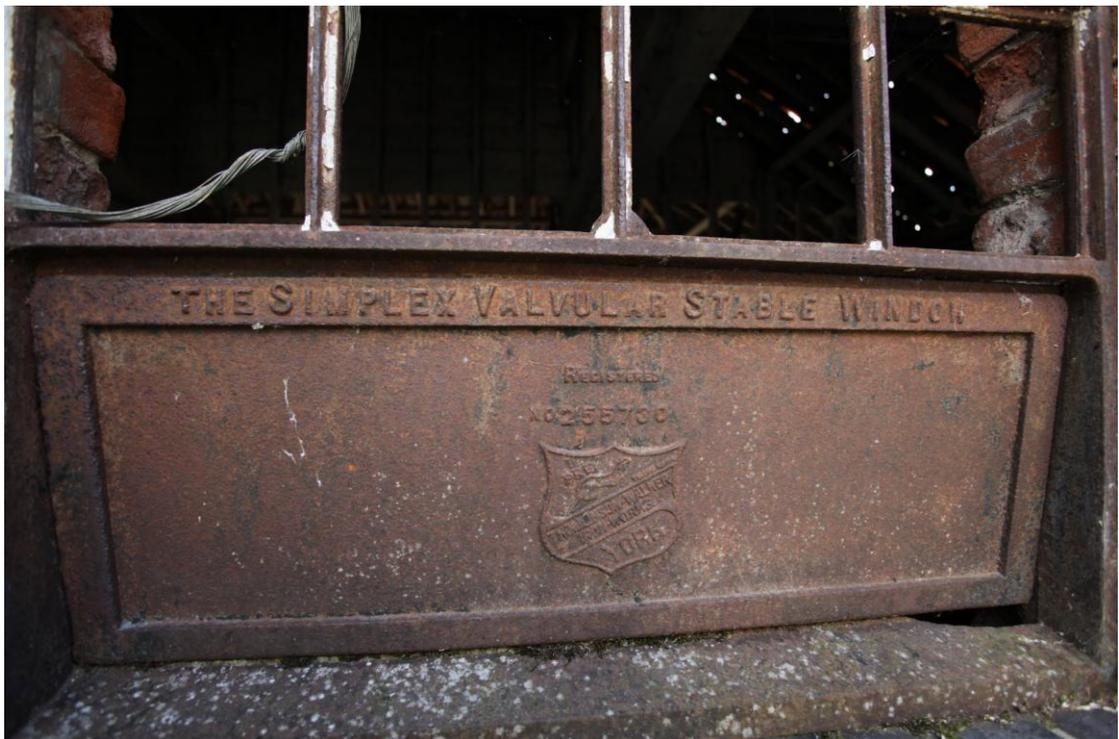
**Illus. 12. Detail of a pivoting lower section of the cast iron windows of the western cowshed (5a) bearing a registration number and founder's badge (Thomlinson and Walker Ironworks, York) with the name 'The Simplex Valvular Stable Window'.**

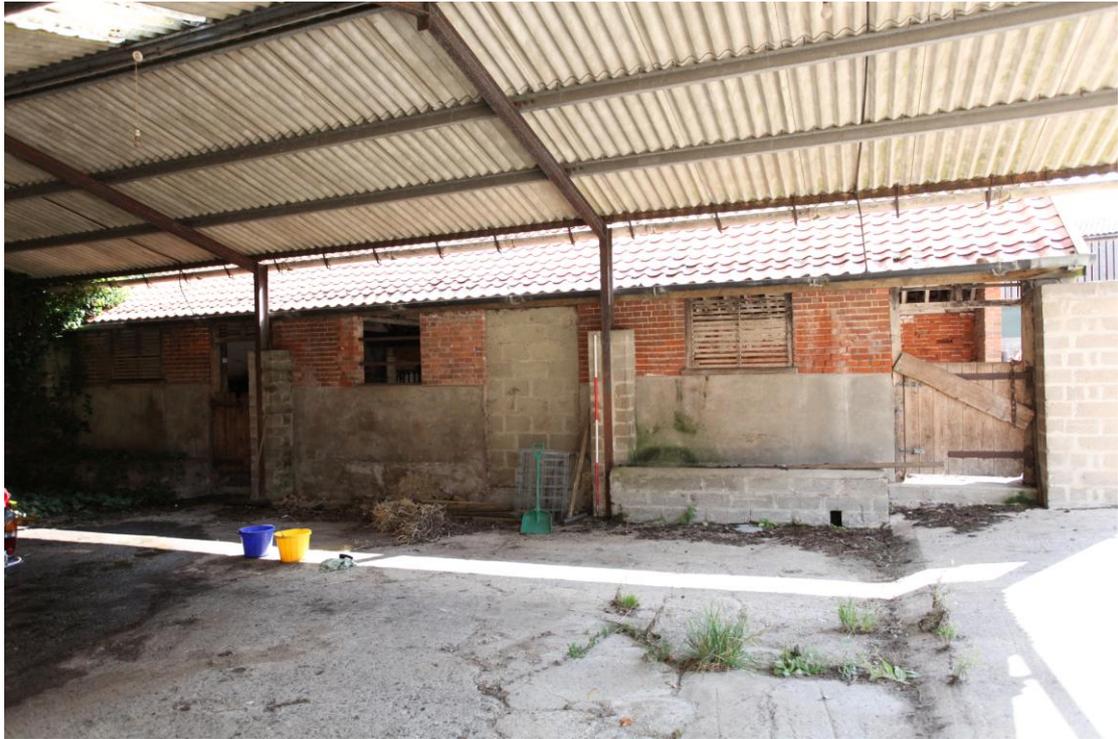
**Illus. 13. The north-western exterior of the eastern cow-shed (6a) seen from the adjoining 20<sup>th</sup> century covered yard showing its original doors and louvered windows (the central door blocked).**

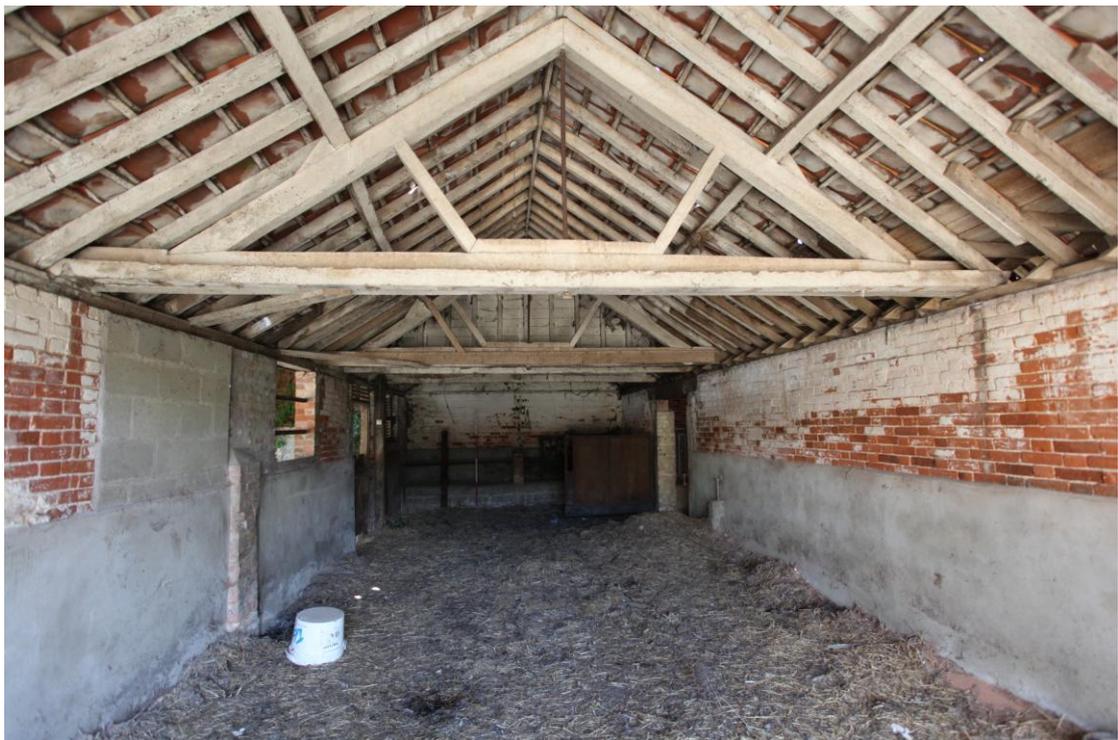
**Illus. 14. The interior of the eastern cow-shed (6a) from the south-west its missing internal partitions and a low, 20th century concrete manger in the rear.**
