**Barn at  
Warren Hill Farm,  
Brome, Suffolk  
BRM 016**

**Historic Building Record**

# **Barn at Warren Hill Farm, Warren Hills, Brome, Suffolk**

## **Historic Building Record**

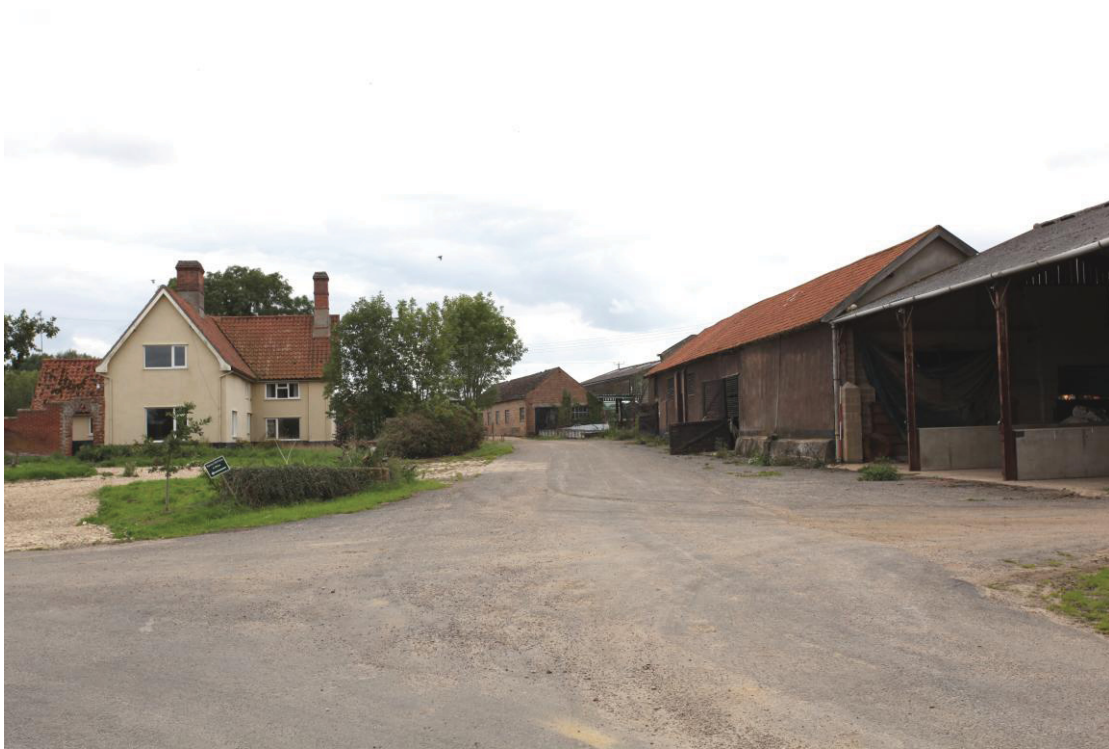
**Illus. 1. General view of site from northern approach showing the unlisted former farmhouse to the left (marked as Warrenhill Farm Cottages in figure 1 but unified and unoccupied at the time of inspection) and the pantiled barn to the right. The right-hand wing of the house was severely truncated to widen the farm track in the early-20<sup>th</sup> century**

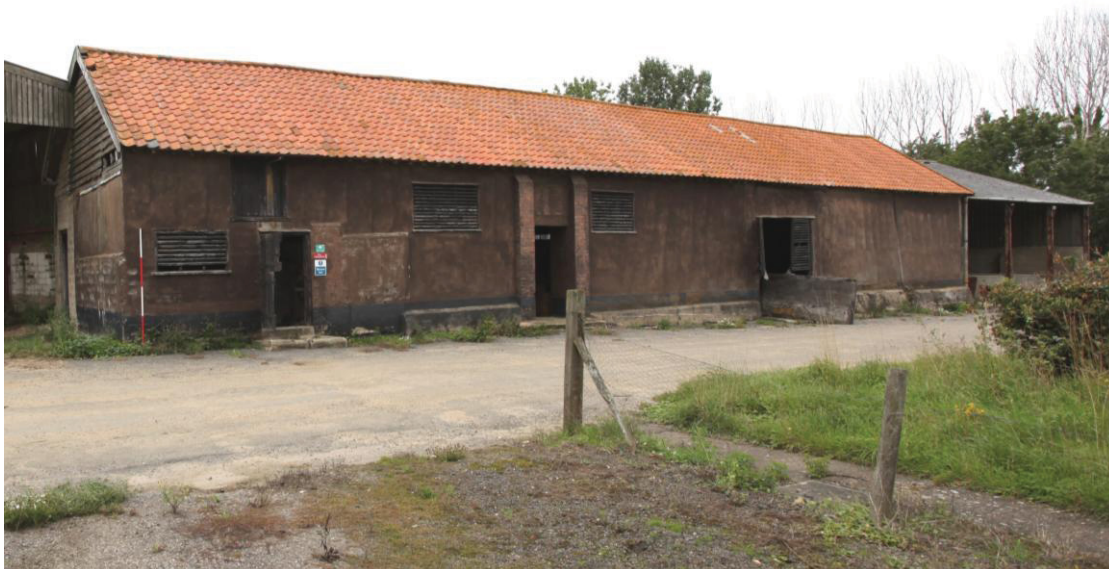
**Illus. 2. The eastern external elevation seen from the former farmhouse, showing the colour-washed cement render and the entrances to the threshing barn (1) to the right and the two stables (2a and 2b) to the left.**

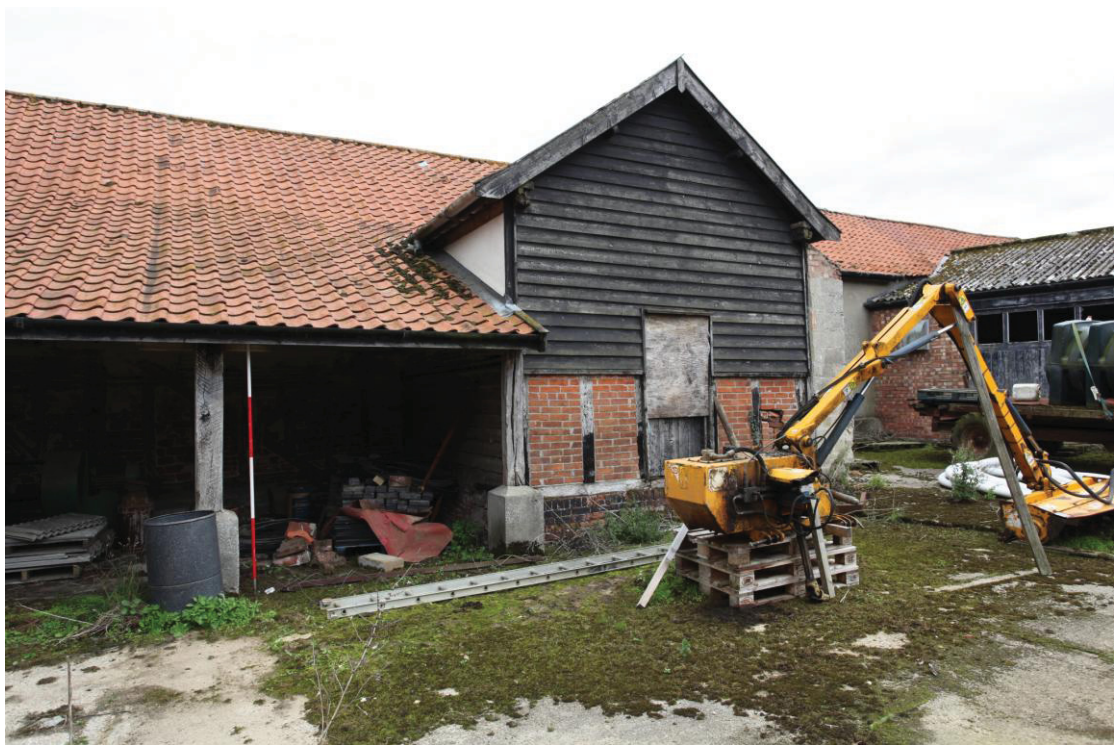
**Illus. 3. The western exterior of the gabled porch of the barn (1a) showing its modern weatherboarding and brickwork with the open-sided shelter-shed (3) to the left.**

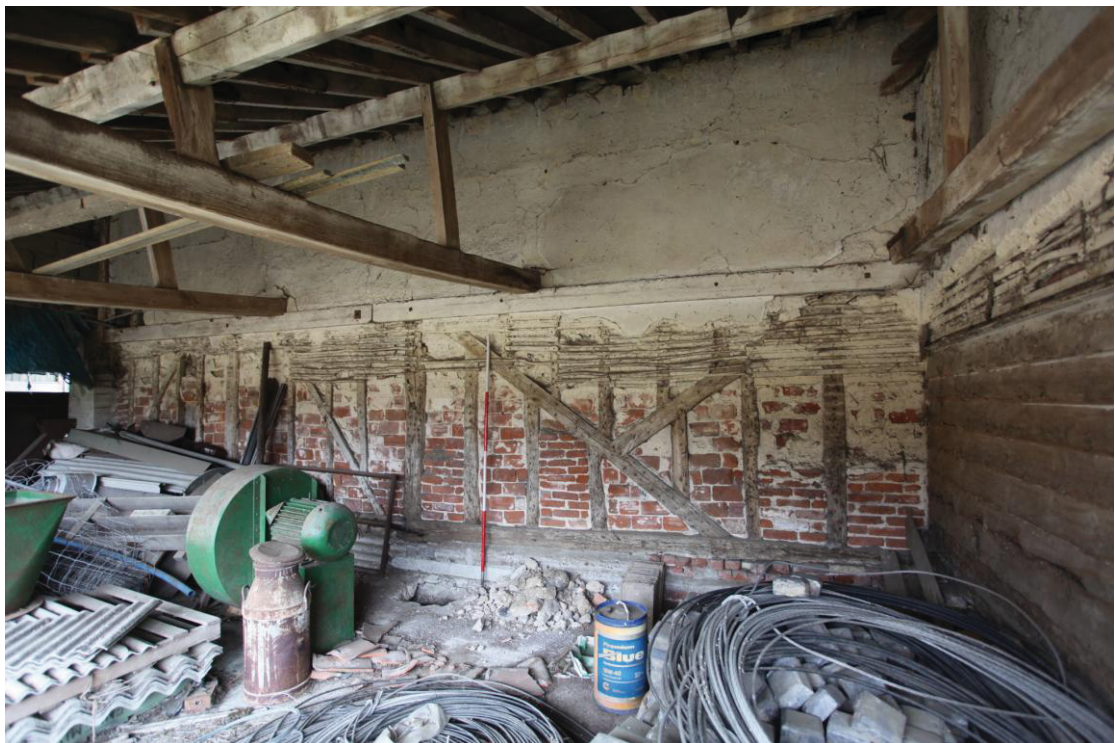
**Illus. 4. The western exterior of the barn (1) protected within the shelter-shed (3) showing its original whitewashed lath-and-plaster with brick infill to the studwork beneath. The porch (1a) to the right is clad in horizontal boarding with render above – a common ‘two-tier’ technique of the early-19<sup>th</sup> century.**

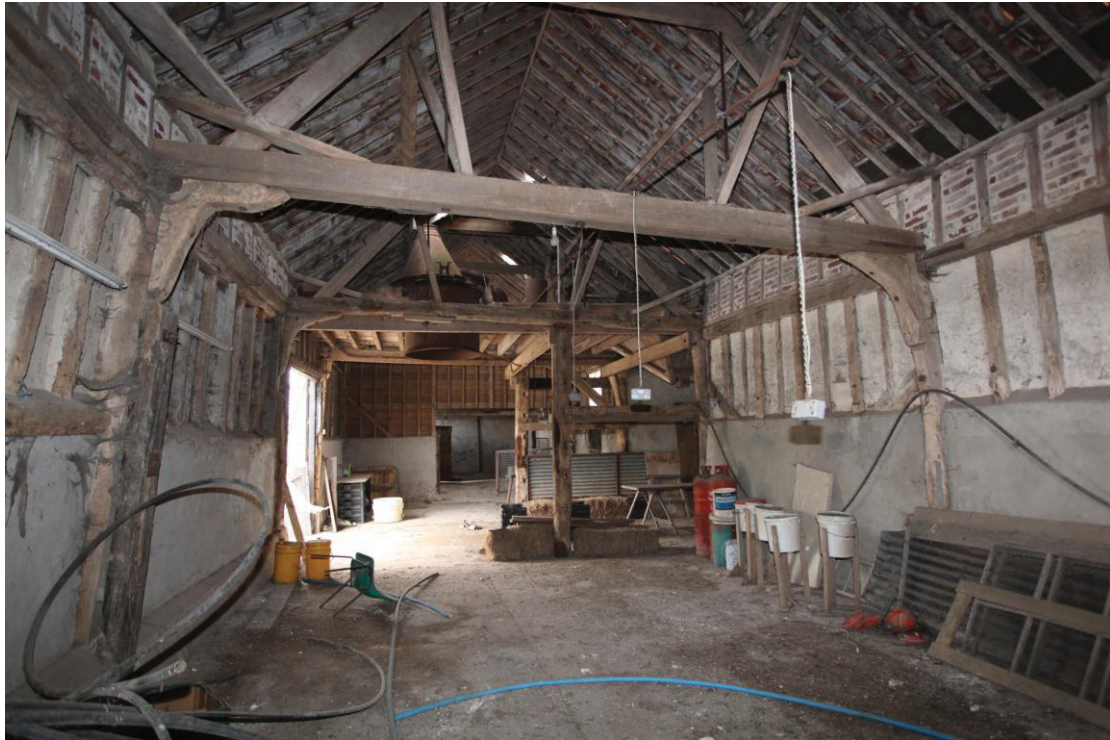
in cement block-work and its eastern exterior cement rendered (with unusual brown colourwash), but sections of original 19<sup>th</sup> century lath-and-plaster are protected within the lean-to shelter shed to the west. A 20<sup>th</sup> century grain milling floor or platform has been inserted into the entrance bay and retained an iron grain chute at the time of inspection.

**Illus. 5.** The interior of the barn (1) from the north showing the 20<sup>th</sup> century grain floor and hopper in the entrance bay and the raised walls to right and left (short studs infilled with brick above the original roof-plates).

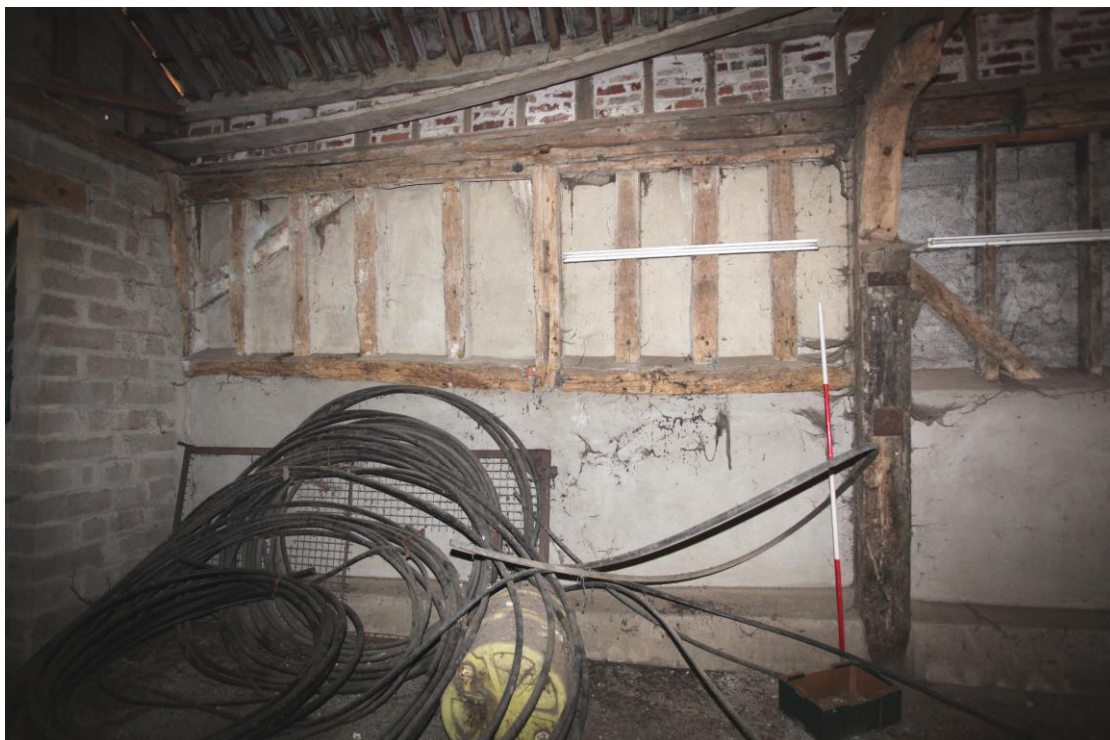
**Illus. 6.** The fragment of 17th century framing at the northern end of the eastern internal elevation of the barn (1), showing the mid-rail with an externally trenched brace to the left and a central storey post with an empty arch-brace mortise. The 19<sup>th</sup> century studwork to the right lacks mid-rails and contains diagonal primary braces that interrupt the studs.

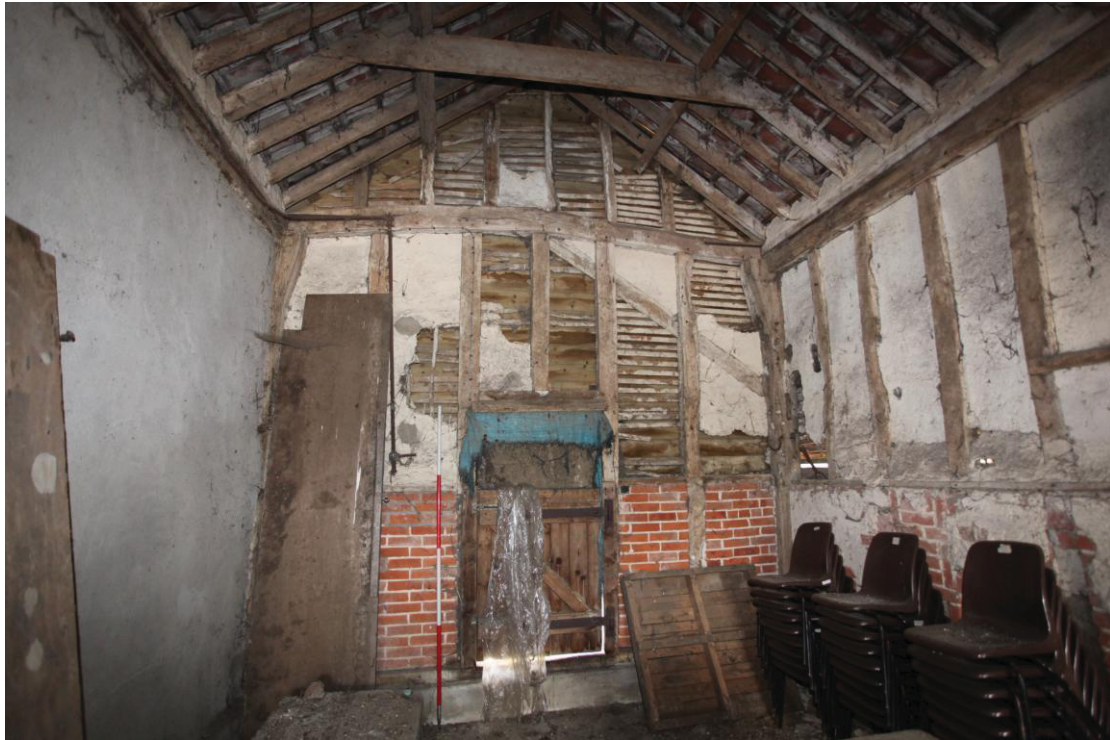
**Illus. 7. The internal western gable of the 17th century porch (1a) showing its asymmetrical externally trenched wall brace with the remains of wattle-and-daub infill.**

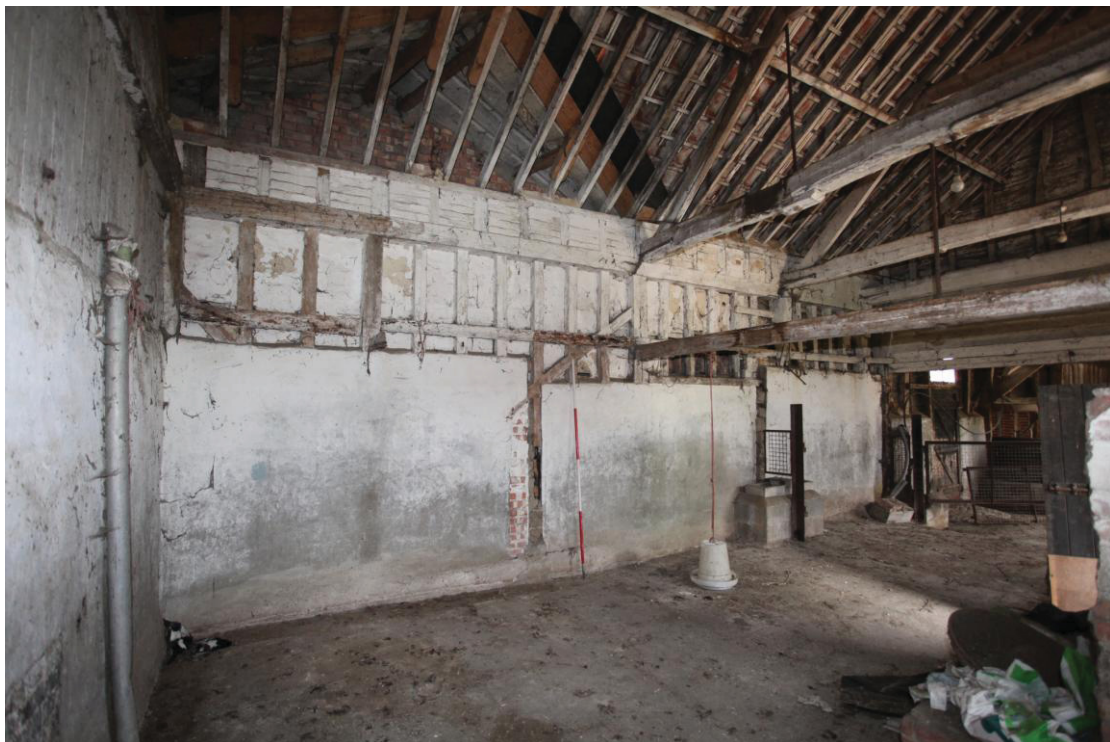
**Illus. 8. The western interior of the northern stable (2a) showing its raised walls and primary bracing with a horizontal rail or clamp which supported the joists of a missing hay loft.**

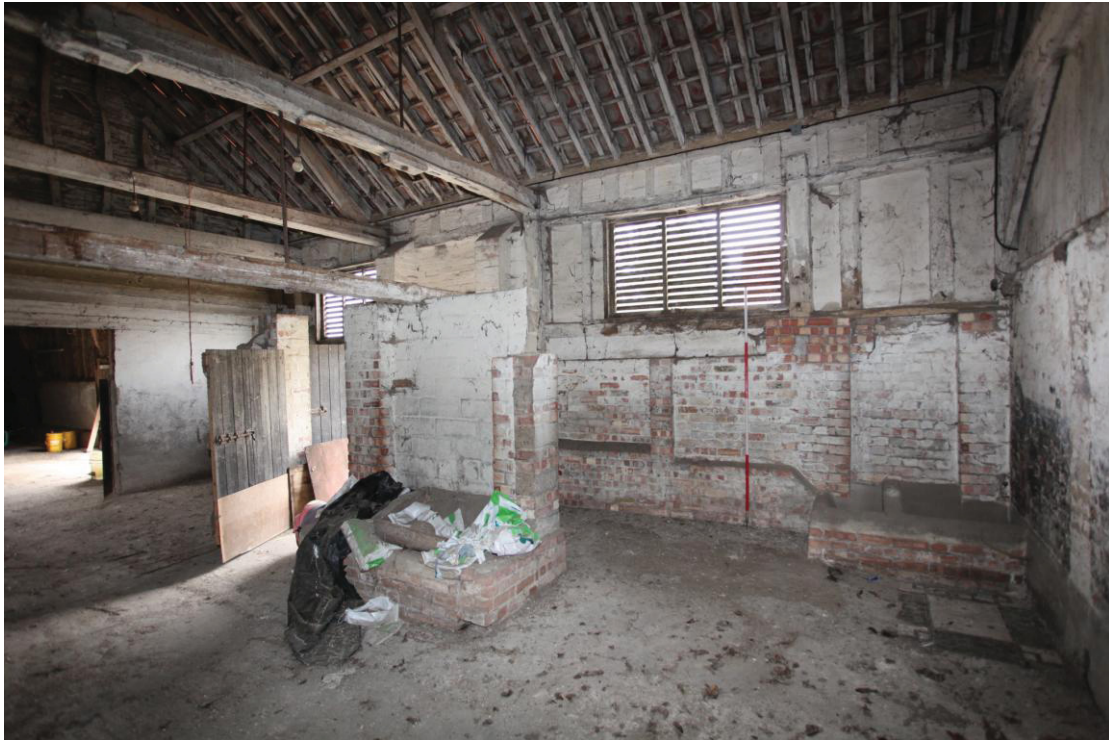
The southern end of the barn was originally a stable with a hay loft extending to 13 m in length (46 ft). Its framing is identical to that of the 19<sup>th</sup> century barn, with nailed primary braces and copious re-used timber, and its walls were also raised when the present roof was built over both structures. With the exception of a small section of original joists lodged on an axial beam in its south-eastern corner the loft has been removed, but its louvered windows remain in the eastern elevation along with two external doors. A secondary partition of vertical boards separates a small compartment of 4.1 m to the south and the interior probably contained a hay rack and manger to the west, but no historic fittings remain and the lower walls have been largely rebuilt in brick (destroying any evidence of its original layout).

**Illus. 9. The eastern interior of the northern stable (2a) showing the raised walls which have been largely rebuilt in 20th century brickwork.**

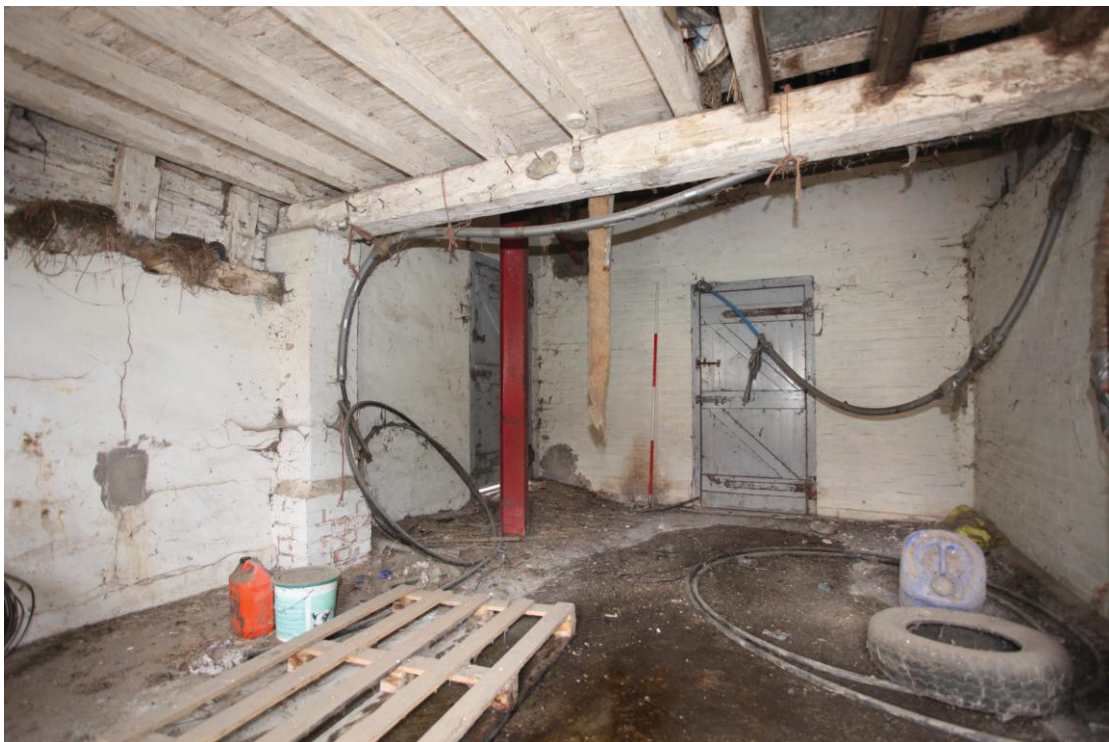
**Illus. 10. The interior of southern stable (2b) from the east showing a surviving section of the original ceiling of lodged joists to the left. The door to the right opens onto the 20<sup>th</sup> century western shed (4).**
