**The Barn,
Yew Tree Farm,
Worlingworth, Suffolk
WGM 027**

Historic Building Record

OASIS Ref: suffolkc1-90873

June 2010

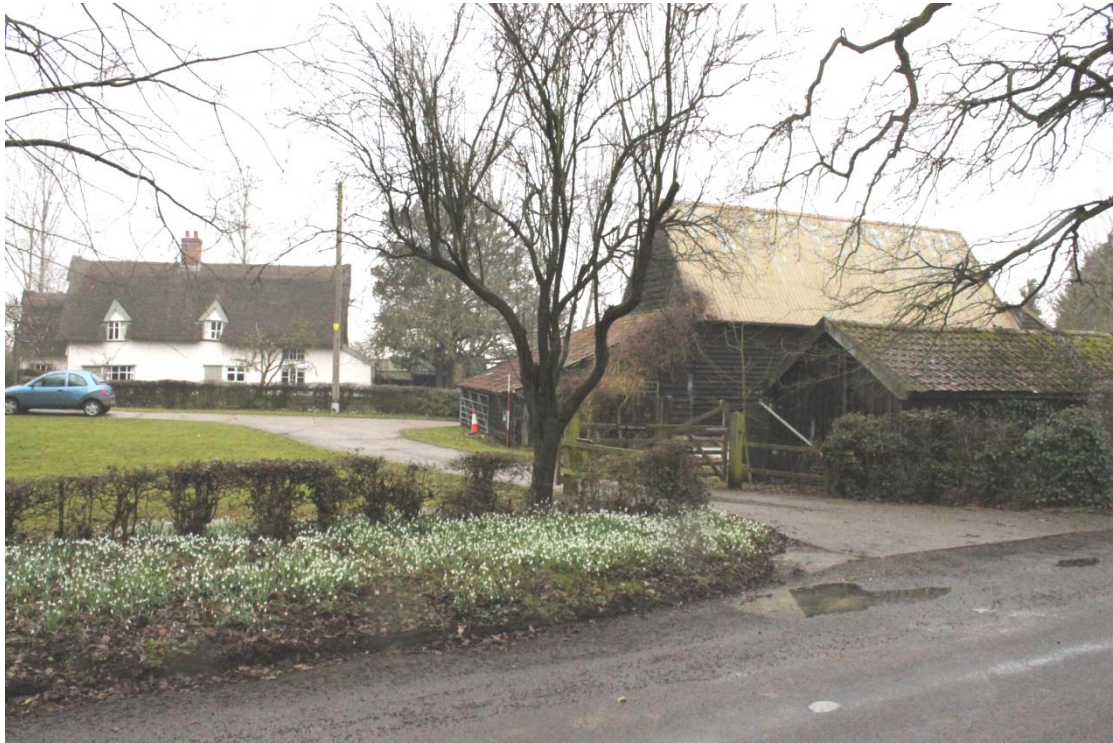
Illus. 1. General view of site from Fingal Street to south-east showing farmhouse to left and barn to right.

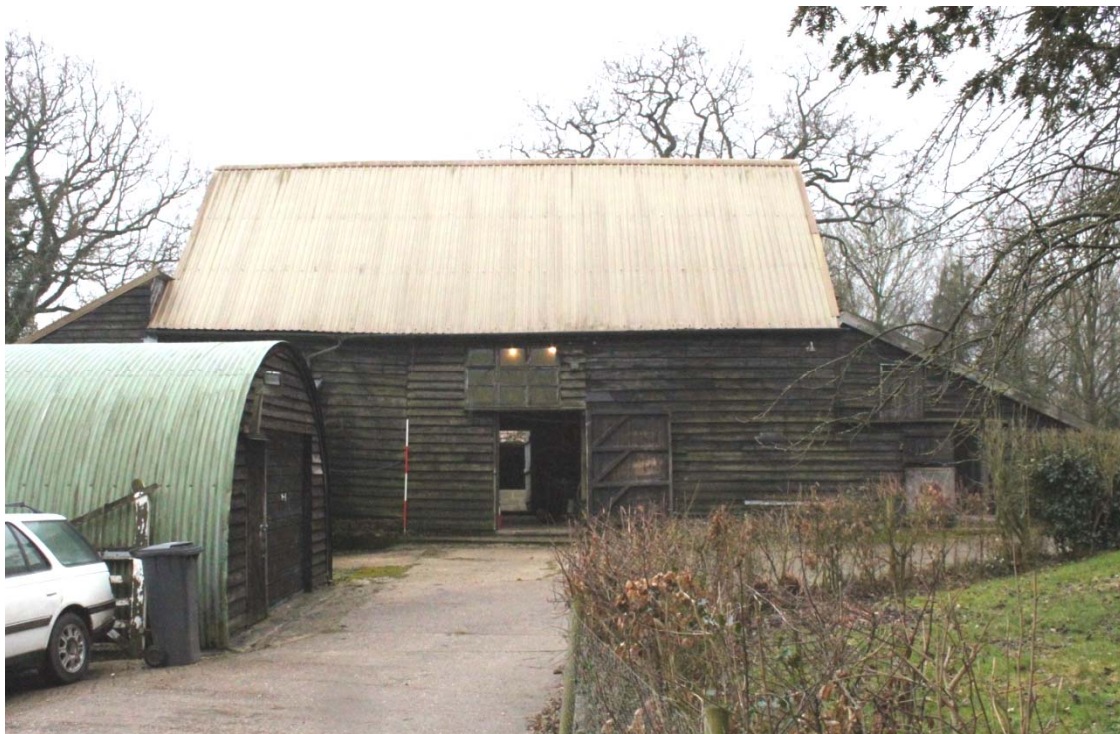
Illus. 2. Exterior of barn from north-west showing sheet-metal roof with lean-to sheds (3 & 4) to right and lean-to stable (2) behind Nissen hut to left. The barn doors in the central bay of this elevation were reduced in size during the 20th century.

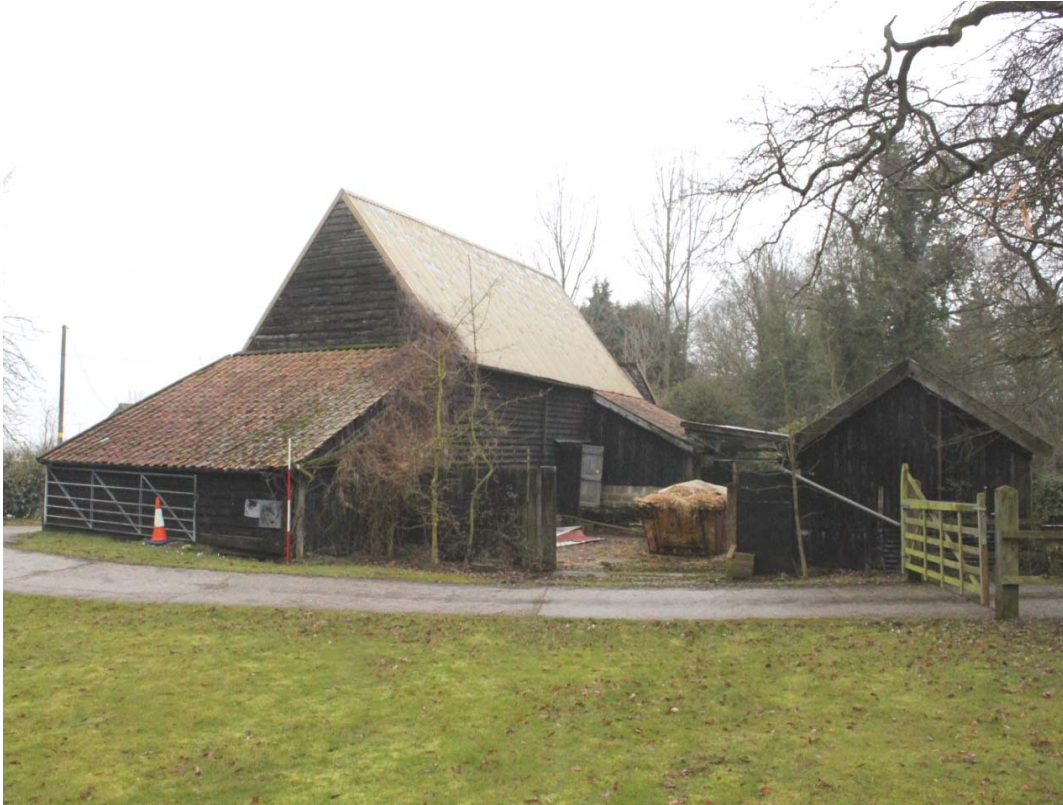
Illus. 3. Exterior of barn complex from south showing barn to left and pantiled shelter shed (8) to right.

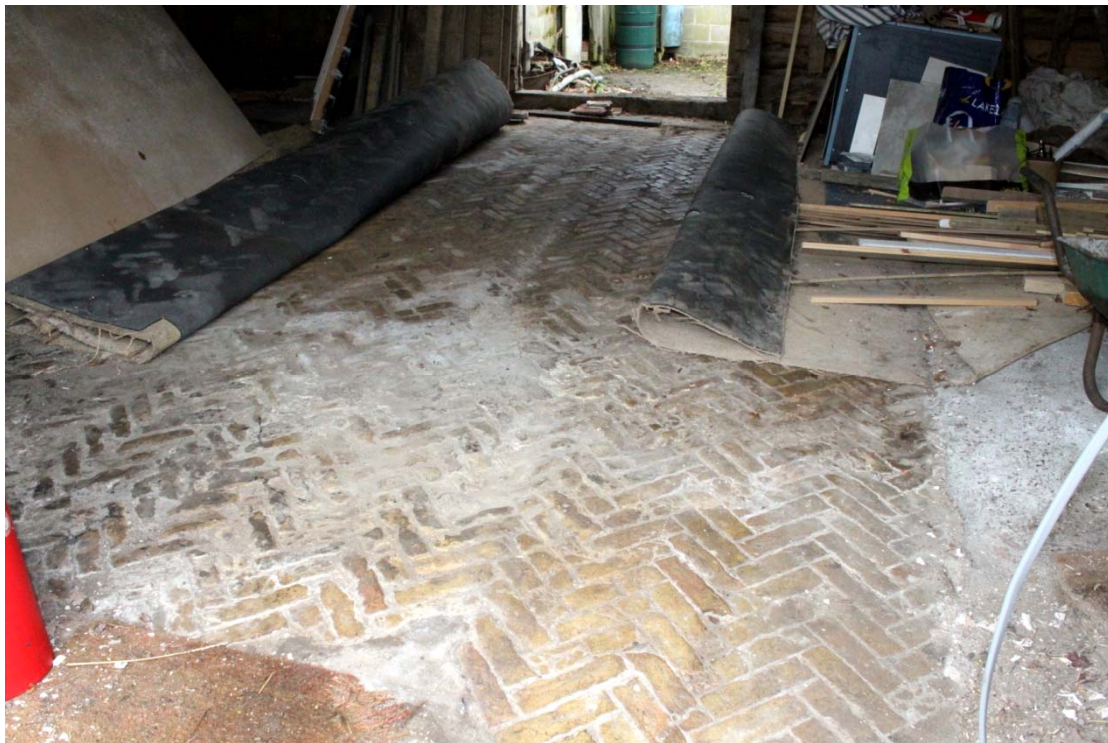
Illus. 4. The unusually well preserved original herringbone threshing floor of gault brick in the barn's central bay, as seen from the north-west.

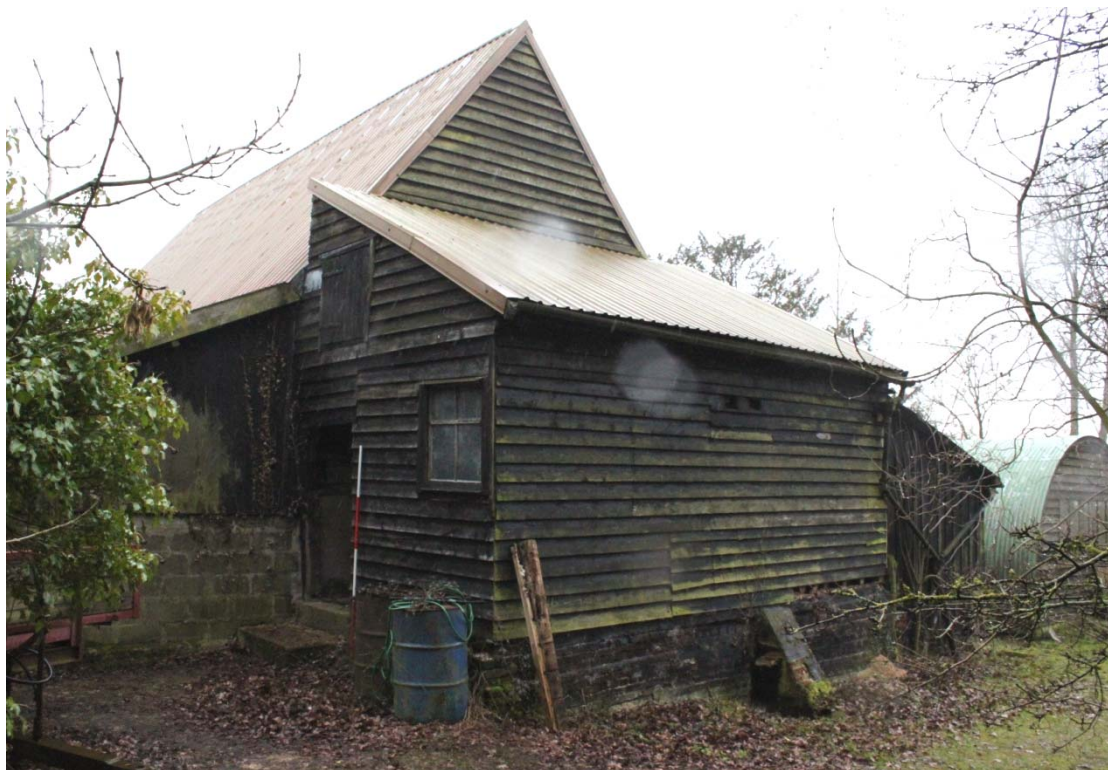
Illus. 5. Exterior of lean-to stable (2) from north-east showing overlap to roof of barn (formerly hidden by thatch).

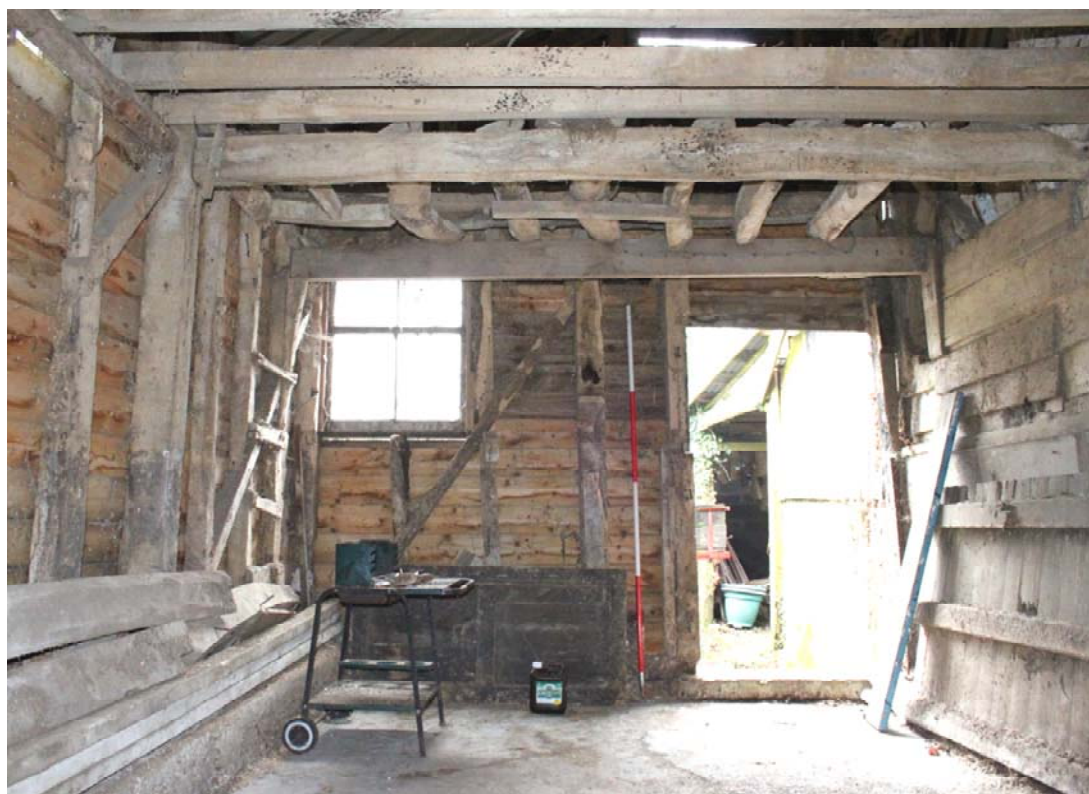
Illus. 6. Interior of lean-to stable (2) from north-west showing the remaining original ceiling joists in the rear with the loft ladder to the left. The joists in the foreground are modern replacements

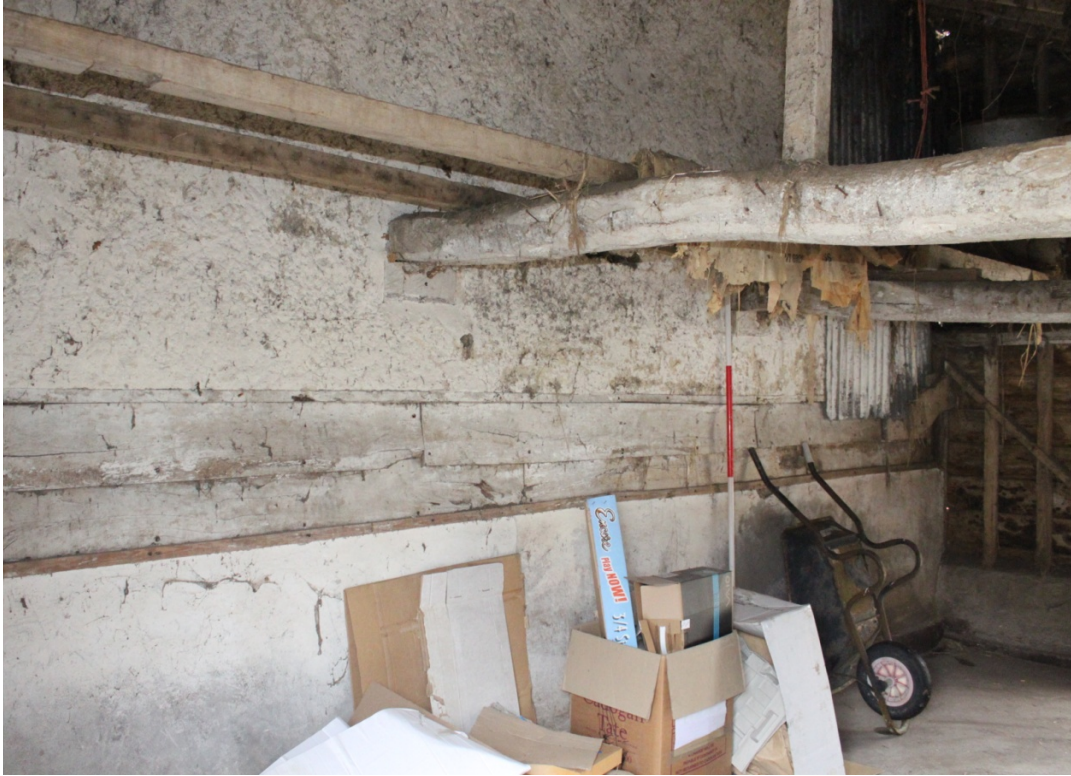
Illus. 7. The original two-tier external cladding of the barn's south-western gable preserved in the adjoining lean-to shed (3). The lower tier of weatherboarding is partly hidden by 20th century render, but the roughcast clay daub remains intact above.

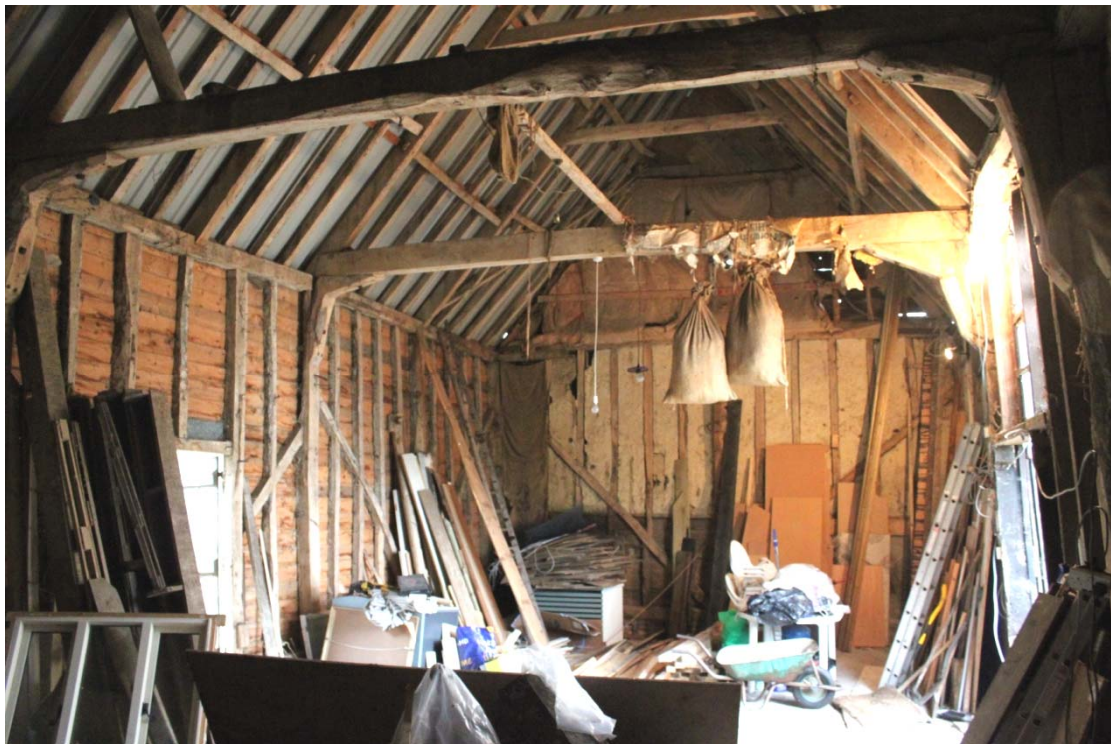
Illus. 8. General view of interior of barn from north-east showing the original bolted knee-braces to the tie-beams which flank the central entrance bay.

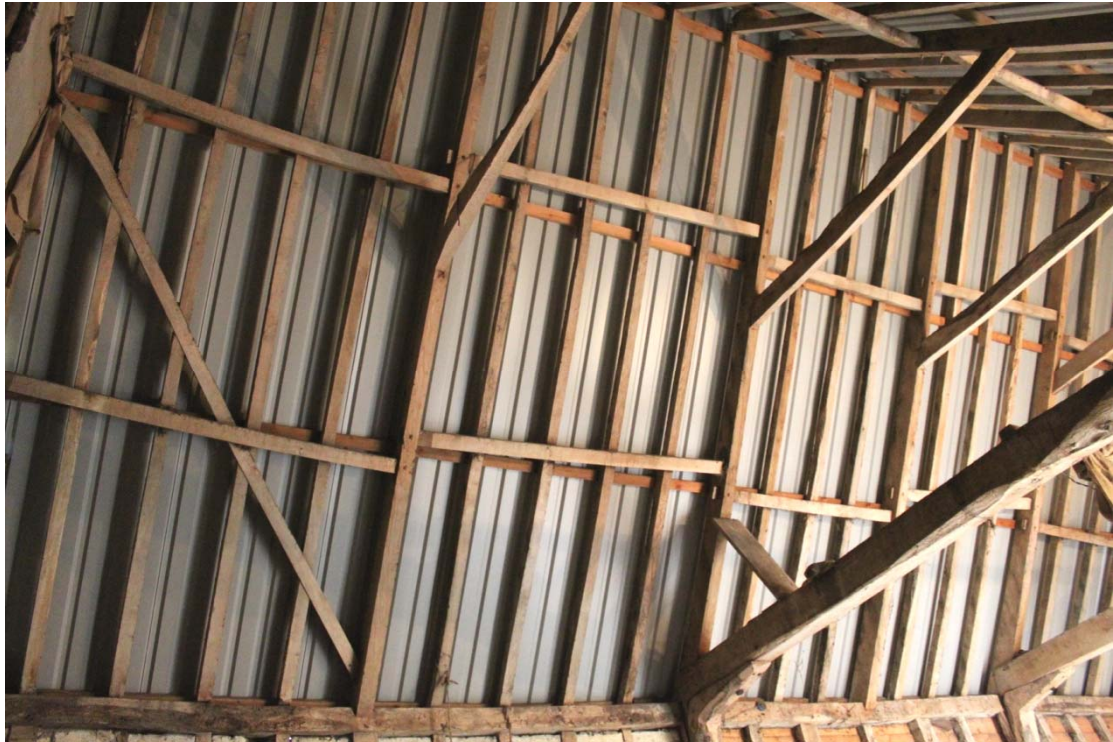
Illus. 9. The intact original roof structure of staggered butt-purlins seen from the north-west. It is steeply pitched at approximately 55 degrees for thatch but is now covered by late-20th century sheet metal.

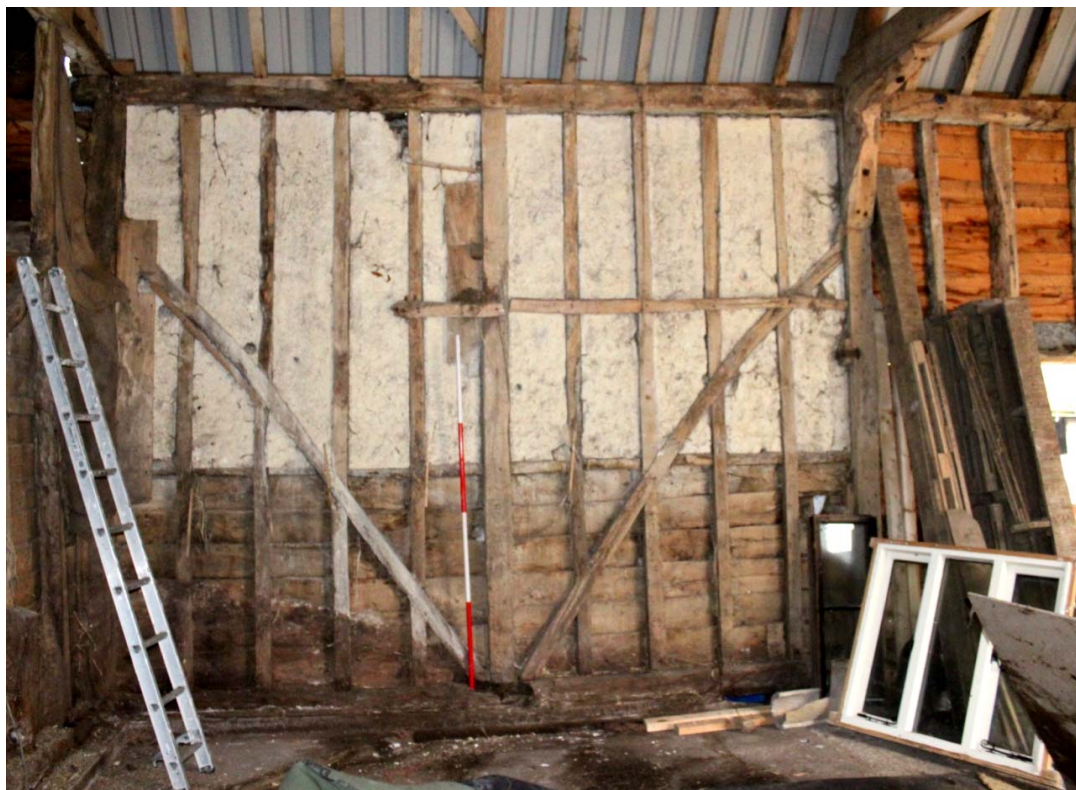
Illus. 10. Interior of northern end of south-eastern elevation showing the intermediate central post with primary diagonal wall braces and the original two-tier cladding of daub above boarding. The horizontal rail is one of many designed to secure the infill panels. The late-20th door and weatherboarding of the central bay is visible to the right.
