**Farm Buildings at  
Blackbarn Farm,  
Monewden, Suffolk  
MWN 012**

**Historic Building Record**

# **Farm Buildings at Blackbarn Farm, Rookery Road, Monewden, Suffolk**

## **Historic Building Record**

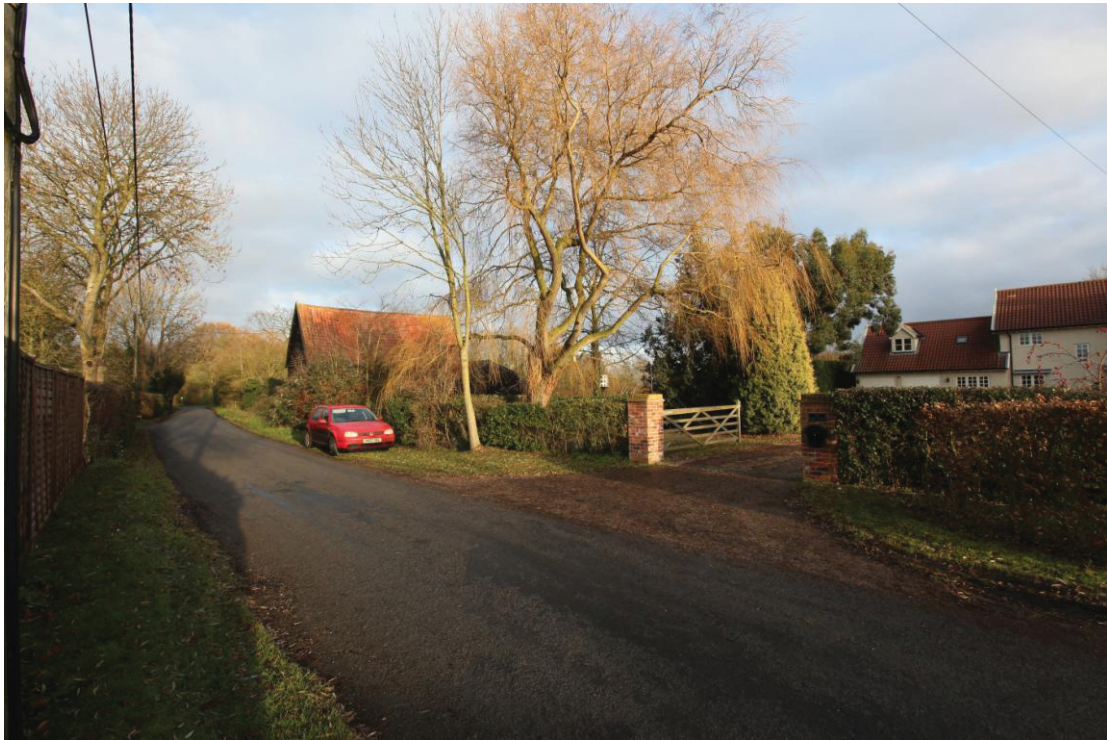
**Illus. 1. General view of the site from Rookery Road to the south-west showing the pantiled roof of the main barn (1) in the rear and the entrance to ‘The Barn House’ to the right.**

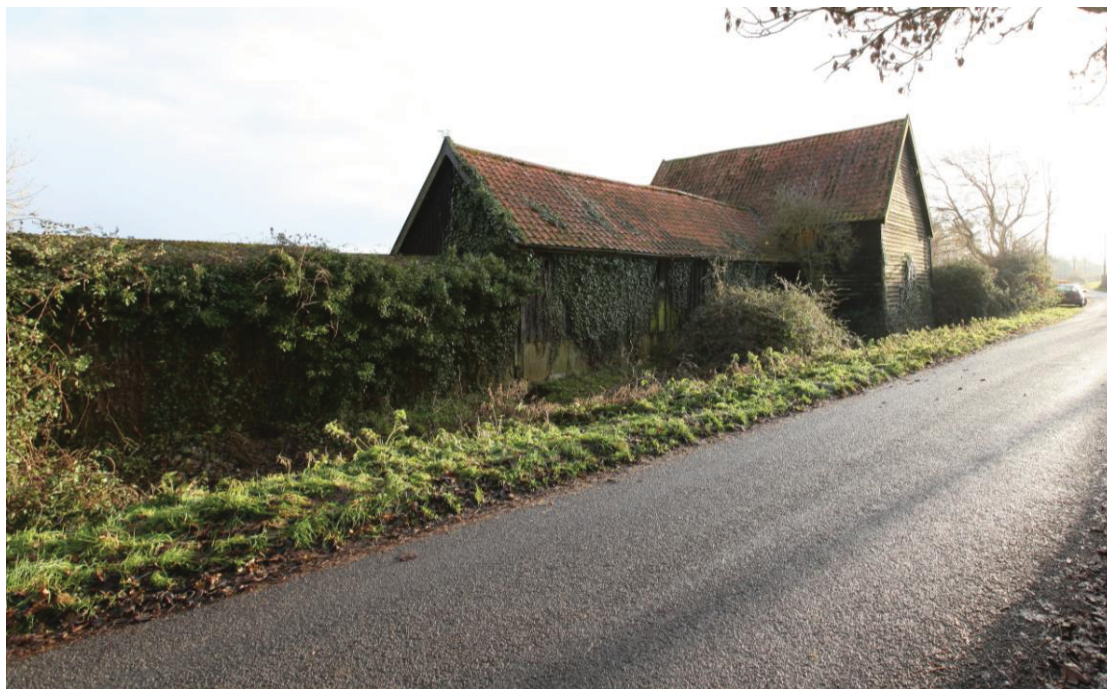
**Illus. 2. General view of the site from Rookery Road to the north showing the main barn (1) at right-angles to the road in the rear with the later roadside shed (3) blocking its original central entrance in the centre and the overgrown wall of the pentice (single-span) 20<sup>th</sup> century sheds (4 and 5) to the left.**

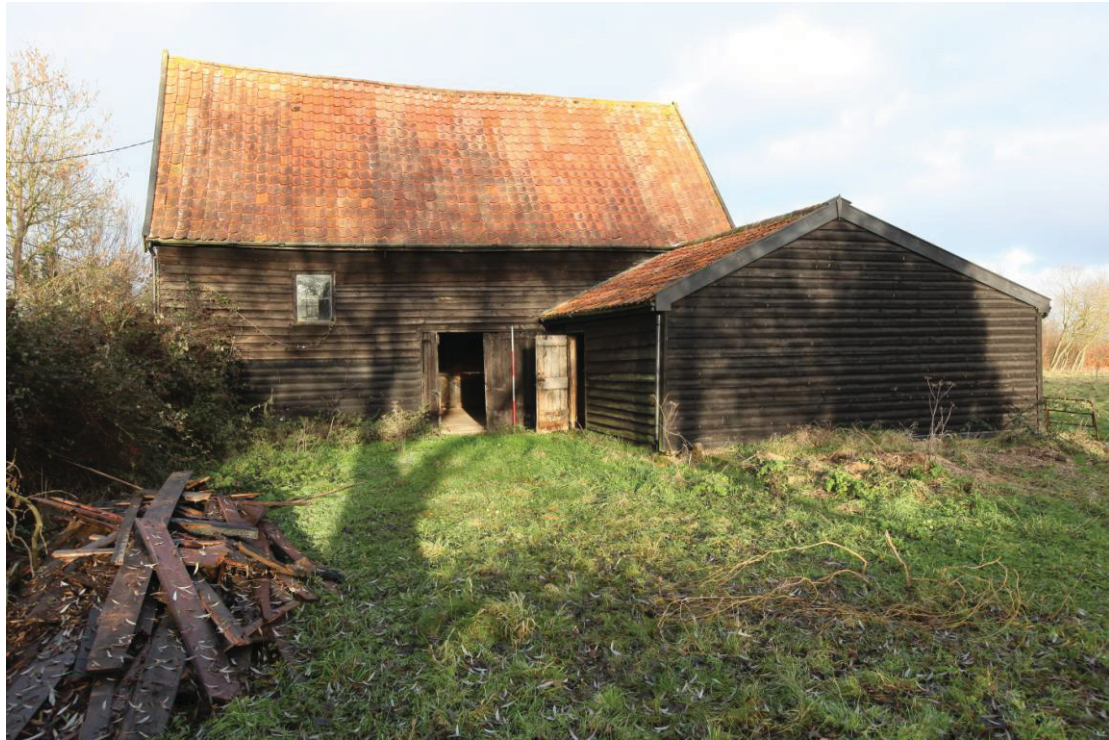
**Illus. 3. The southern exterior of the barn showing the much altered single-storied shed (2) adjoining the original low rear doorway of the main barn (1).**

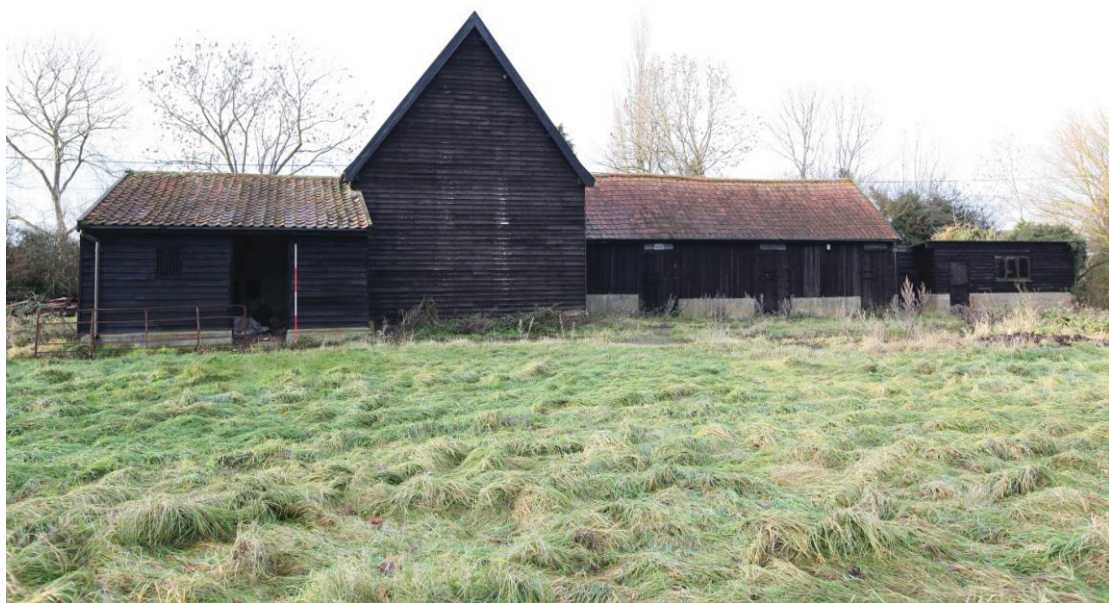
**Illus. 4. The eastern exterior of the complex showing from left to right the southern shed (2), the main barn (1), the roadside shed divided into three loose boxes (3) and the 20<sup>th</sup> century pentice sheds (4 & 5).**

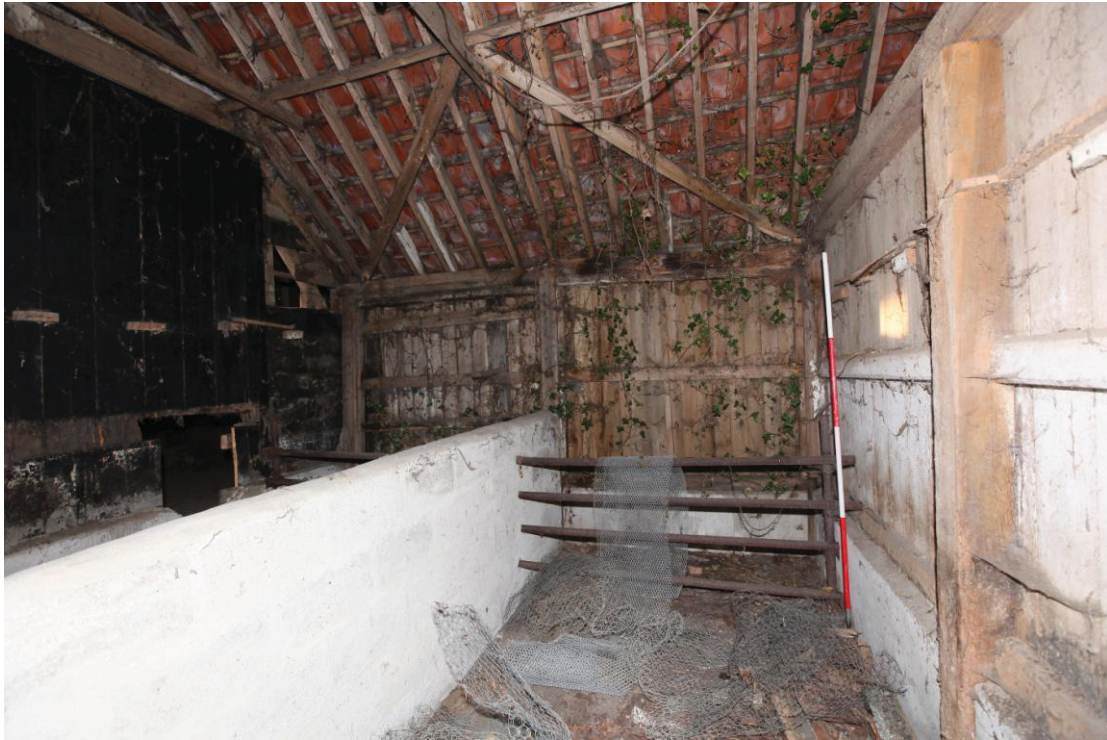
**Illus. 5.** The interior of southern loose box (3c) in the roadside shed of *circa* 1900 seen from the east and showing the iron bars and cement-block wall of the late-20<sup>th</sup> century probable sow crates with the blocked original doors of the main barn (1) to the left.

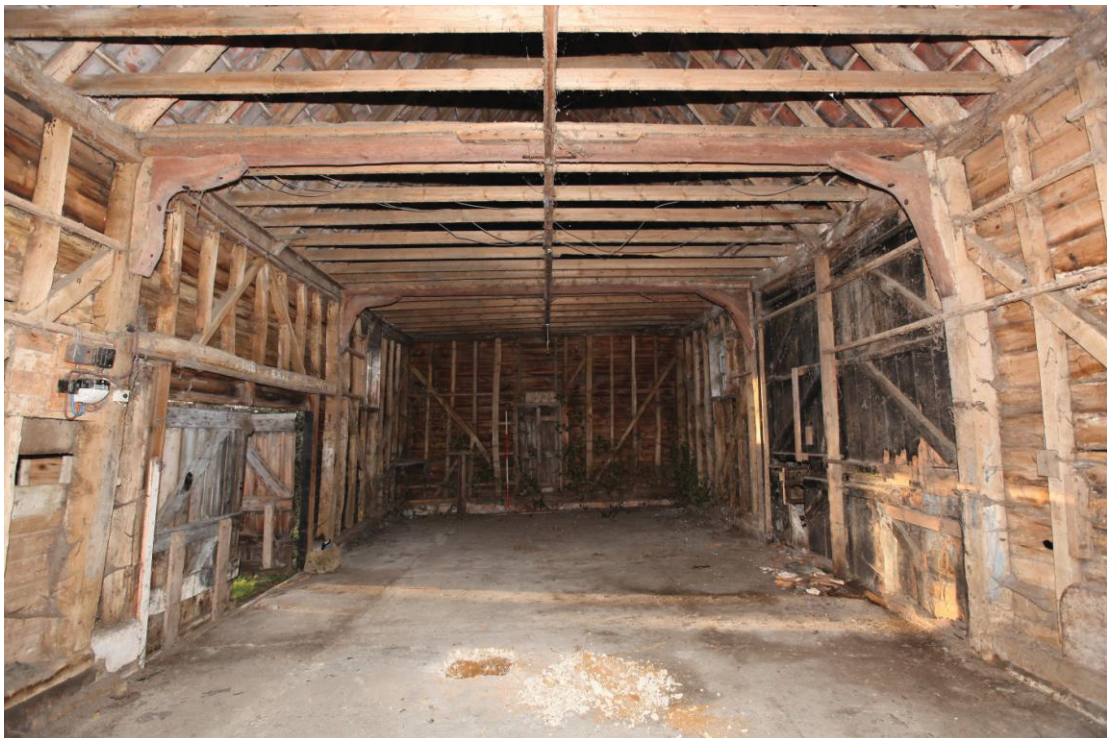
**Illus. 6.** The interior of the main barn (1) from the east showing its secondary ceiling at eaves height with the blocked original northern entrance to the right & the lower rear door to the left. The bolted knee-braces flanking the entrance bay and straight, primary wall braces are typical of the second quarter of the 19<sup>th</sup> century.

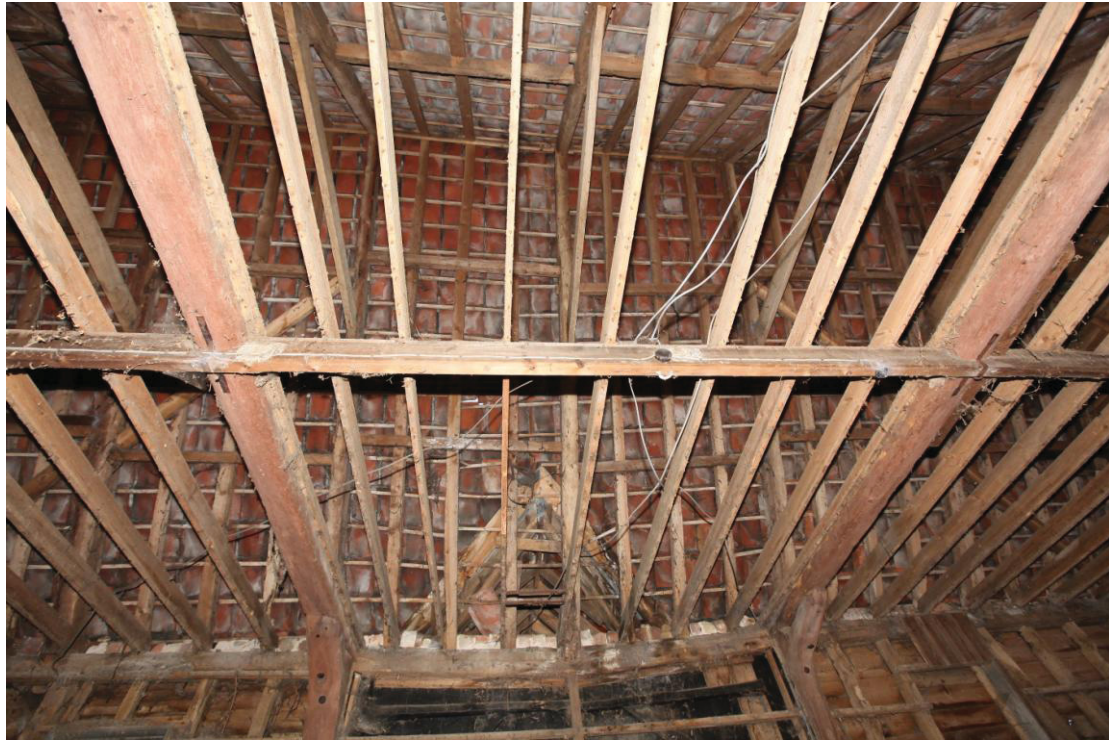
**Illus. 7. The roof structure of the barn (1) viewed from the south showing two tiers of staggered butt-purlins with the joists of the inserted 20<sup>th</sup> century ceiling in the foreground.**

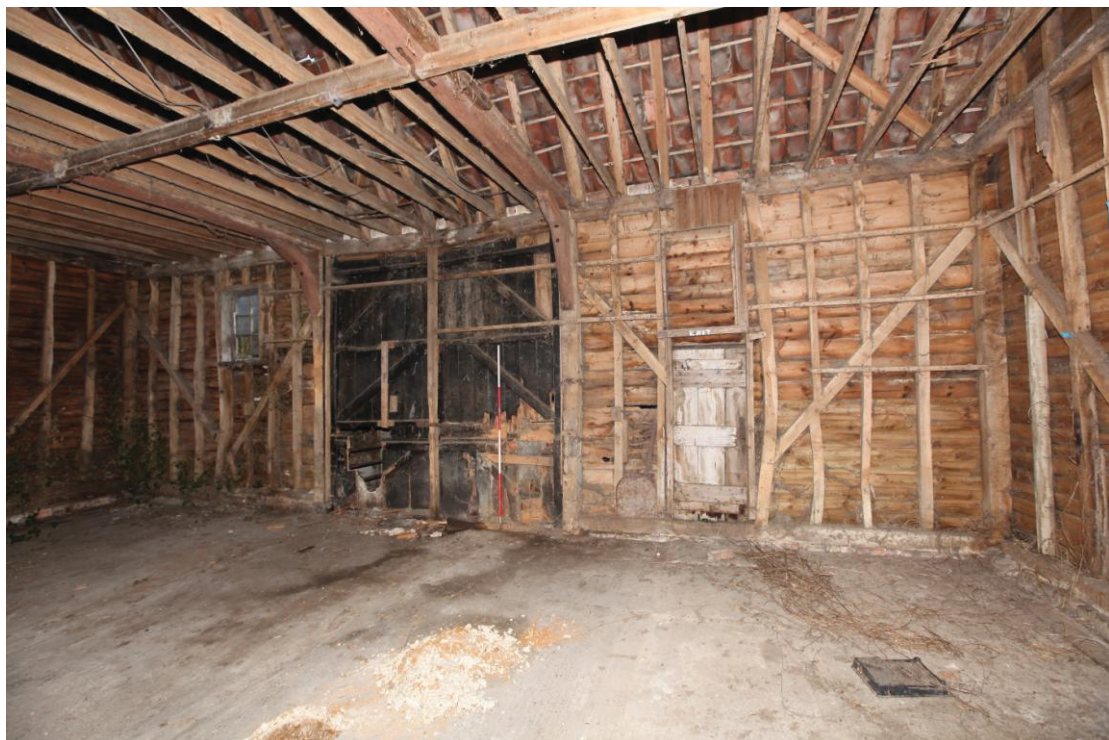
**Illus. 8. The northern interior of the barn (1) showing the bolted knee-braces to the tie-beams flanking the original entrance doors (now blocked by the adjoining shed, 3) and the inserted door & (blocked) upper window of the eastern bay to the right.**

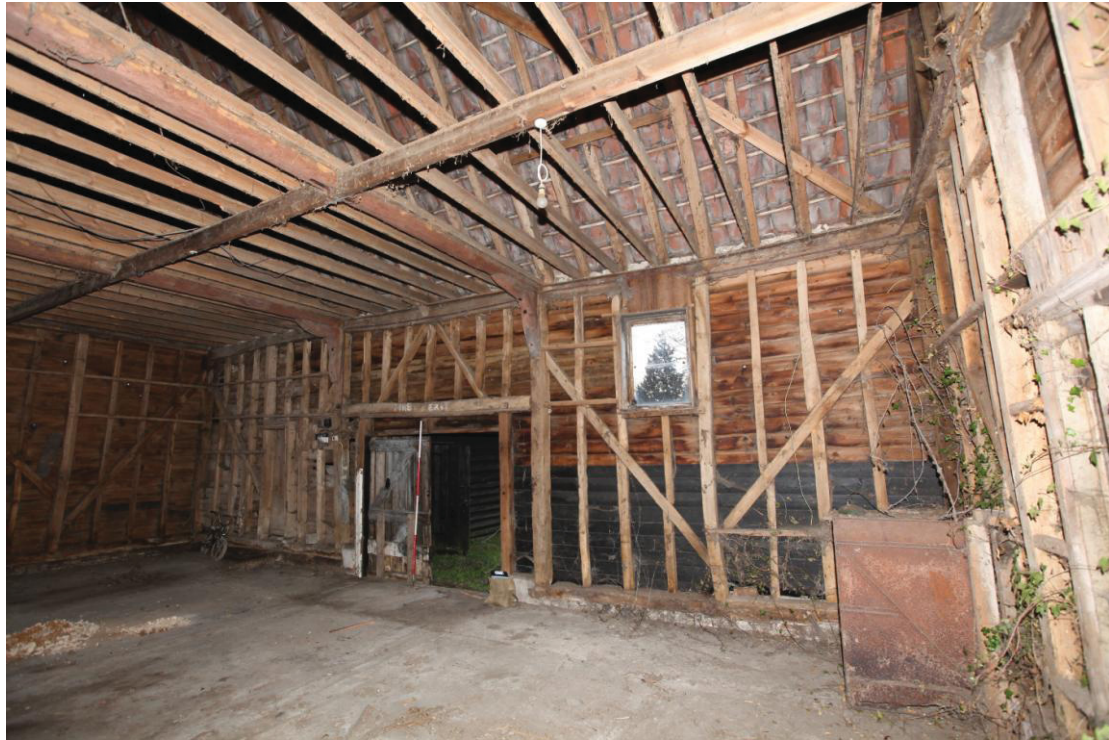
**Illus. 9. The southern interior of the barn (1) from its north-western corner showing the original proportions of the low, wide rear doorway in the central bay and an inserted glazed window to the right.**

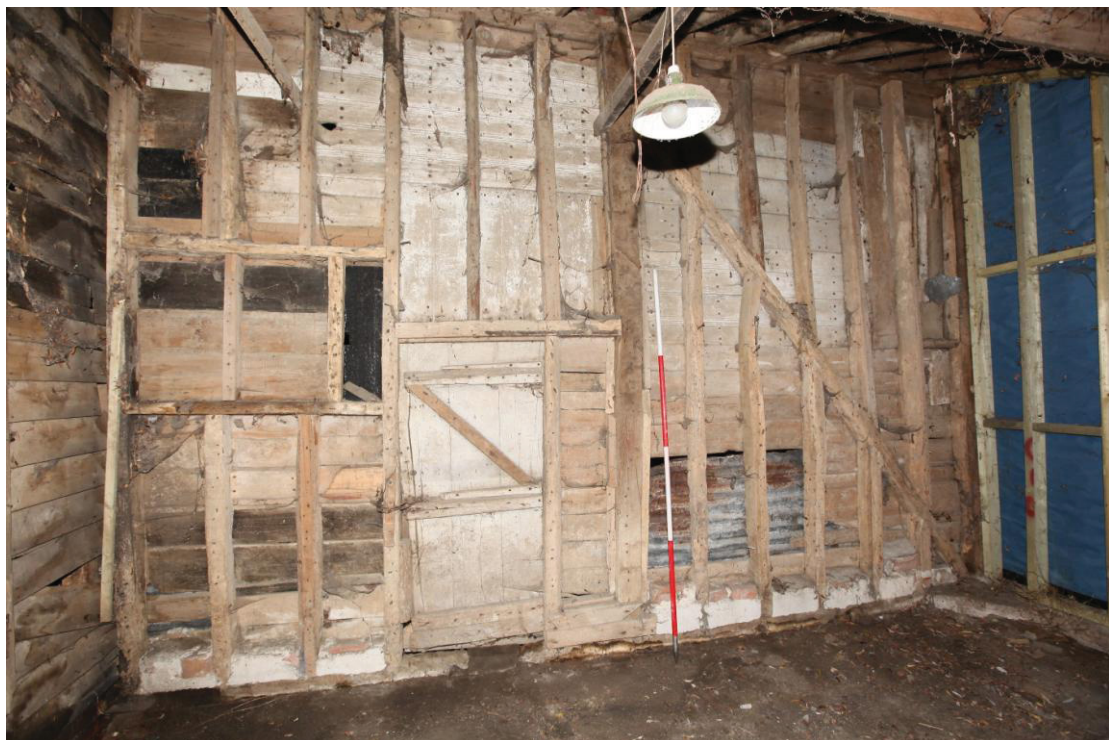
**Illus. 10. The interior of the southern shed (2b) from the west showing the unusual internal partition consisting largely of re-used doors which adjoins the eastern section of the same shed (2a).**

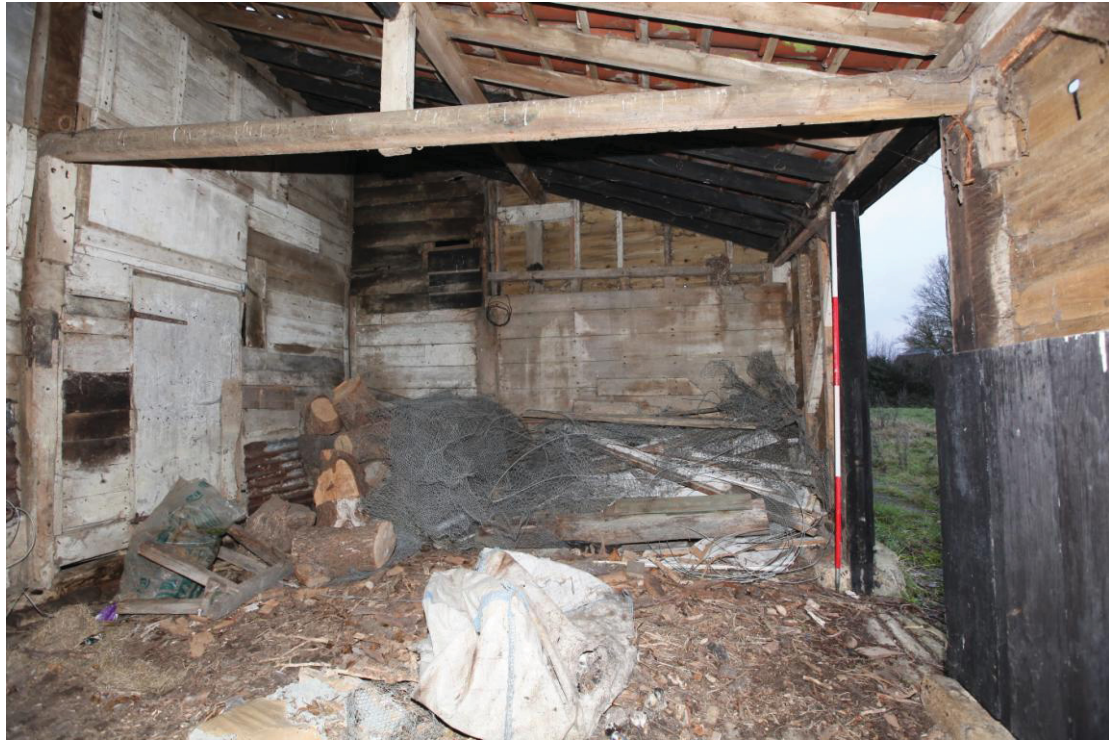
**Illus. 11. The interior of the eastern section of the southern shed (2a) from the south showing the boarded south-eastern corner of the barn (1) to the left and the external door in the rebuilt eastern elevation to the right.**

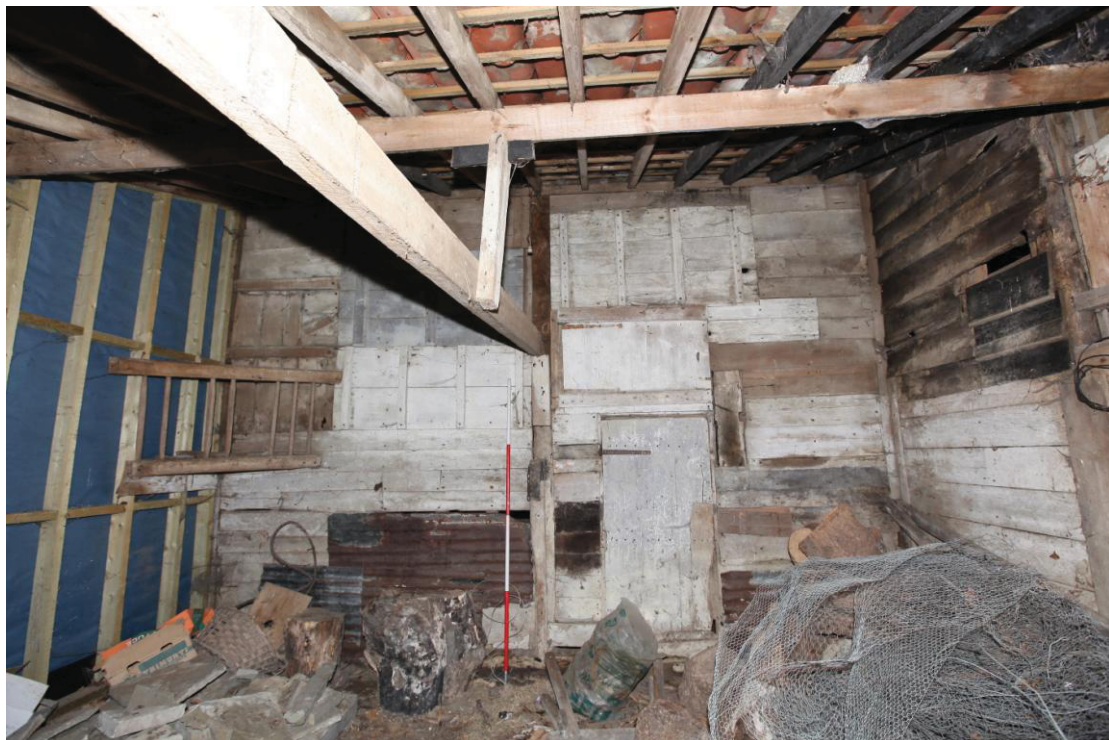
**Illus. 12. The interior of the eastern section of the southern shed (2a) viewed from the east, showing the unusual partition of re-used 17<sup>th</sup> century doors to the western section (2b). The recently rebuilt southern gable is visible to the left and the weatherboarded corner of the earlier barn to the right.**
