**Church of St Botolph, Culpho (CUP 003),  
A Report of Archaeological Recording  
SCCAS Rpt. No. 2005/114; Job No. CULP/CHU/001; Oasis Code suffolkc1-9275**

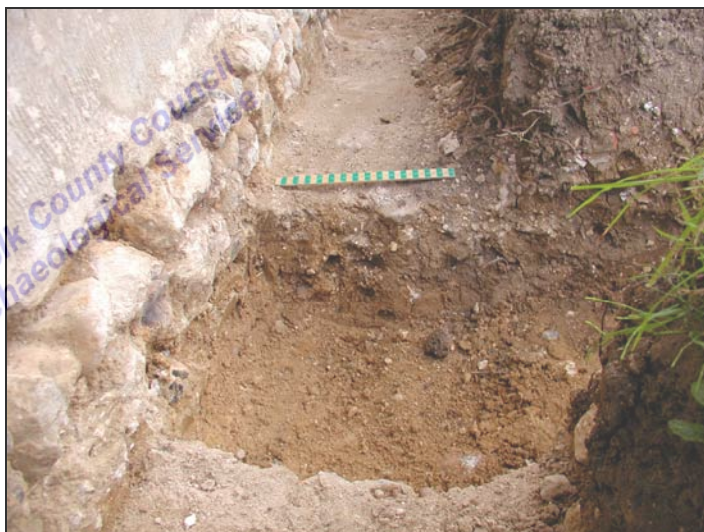
**Plate 1:** nave wall test-pit & stepped footing

The removal of the concrete drainage channel had revealed the rendered face of the wall continuing down to the level where the wall stepped out by 5 centimetres, a point varying between 5 centimetres and 20 centimetres below the existing ground surface. The wall then continued down for approximately three courses of randomly lain flints (0.25 metres). A steep cut visible in the side of the excavated test-pit suggests that the solid, toed, footing then gave way to an excavated trench footing, apparently filled with layers of clay and mortar (Fig. 3 & Plate 1). These layers could be seen to continue down beyond the excavated base of the test-pit.

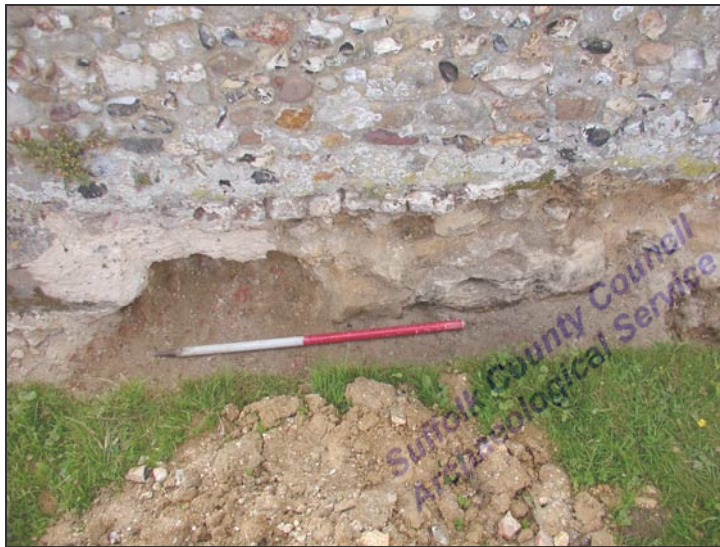
**Plate 2:** chancel, sandstone boulder in stepped footing

Below ground the wall appeared to be broadly similar to that of the nave, although the removal of the concrete channel had also removed at least the top course of the solid toed footing. In this instance the solid footing stepped out c.8 centimetres from the above ground wall face, although this difference from the nave can be explained by the thickness of the render on the latter. The solid footing also included a large piece of sandstone (Plate 2) and a number of larger flint cobbles not seen in that of the nave. However,

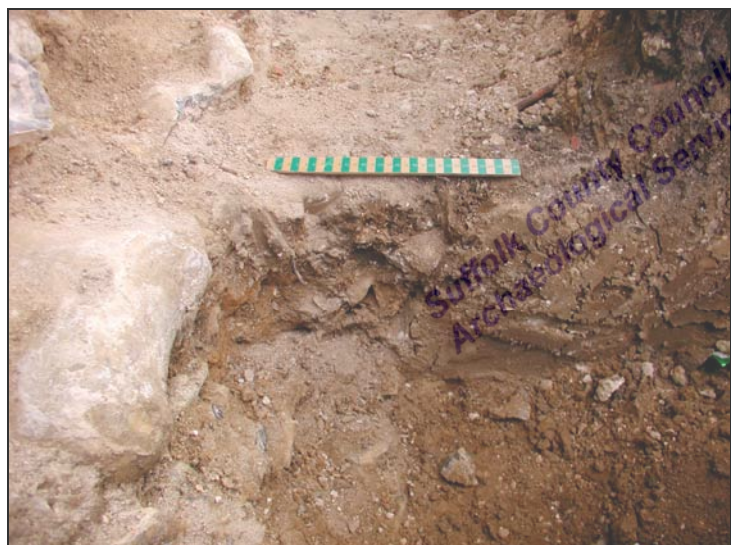
**Plate 3:** chancel wall test-pit

the side of the contractor's test-pit revealed a similar vertical cut suggesting that there was again a trenched footing below the bonded wall (Fig. 3 & Plate 3). In this area the fill was more mixed and included flint cobbles with the unconsolidated mortar, sand and clay.

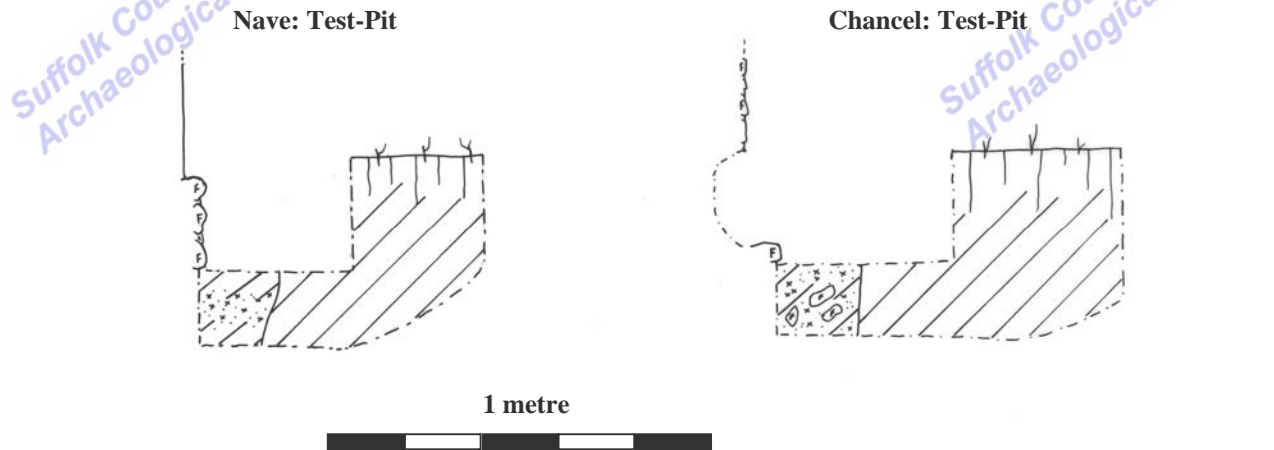
Fig. 3 1:20 scale section drawings

Sketch sections were drawn of the west sides of the contractor's test-pits (Fig. 3).
