**Brook House Farm,
Henley, Suffolk
HEN 013**

Heritage Asset Assessment

Brook House Farm, Ashbocking Road, Henley, Suffolk

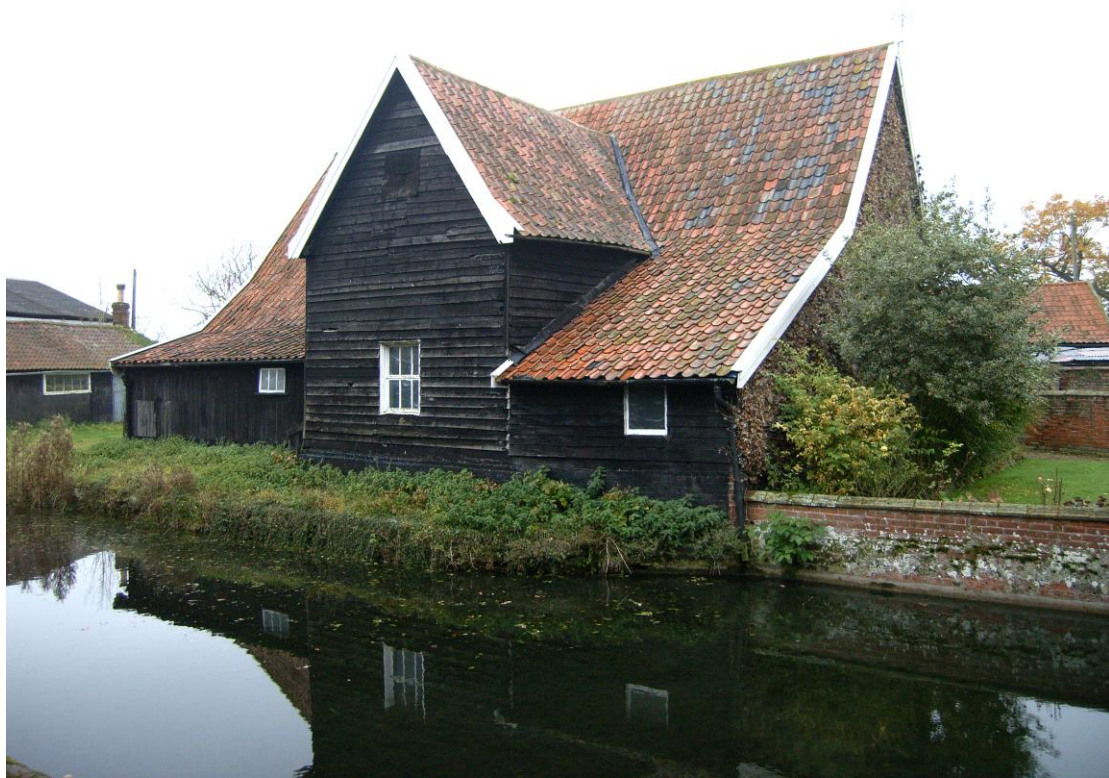
Despite its southern extension and the replacement of its roof structure in the 18th century, the barn retains much of its unusual and impressive 17th century timber frame, and in my view merits listing at grade II.

Illus. 1 The 17th century barn (5) from the south-east, showing the 19th century pantiled roof

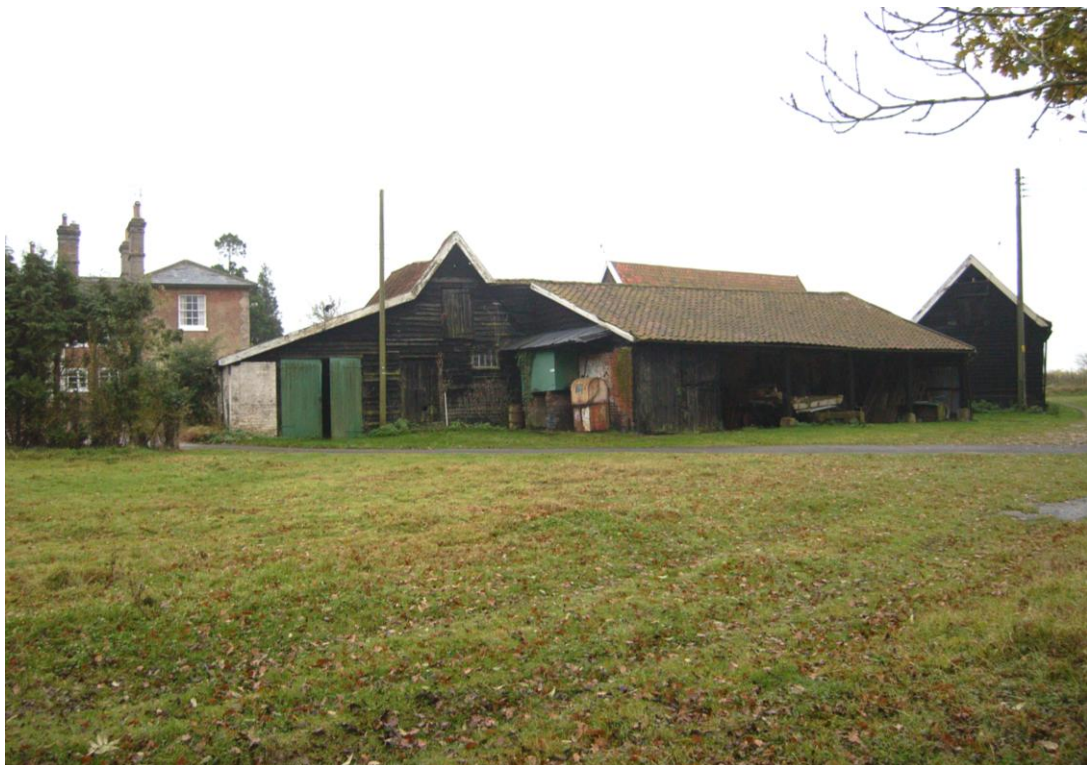
Illus. 2 The farm complex from the north, showing the house (7) to the left and stable (4) to the right, with the granary gable (2) and cartlodge (1) in the centre

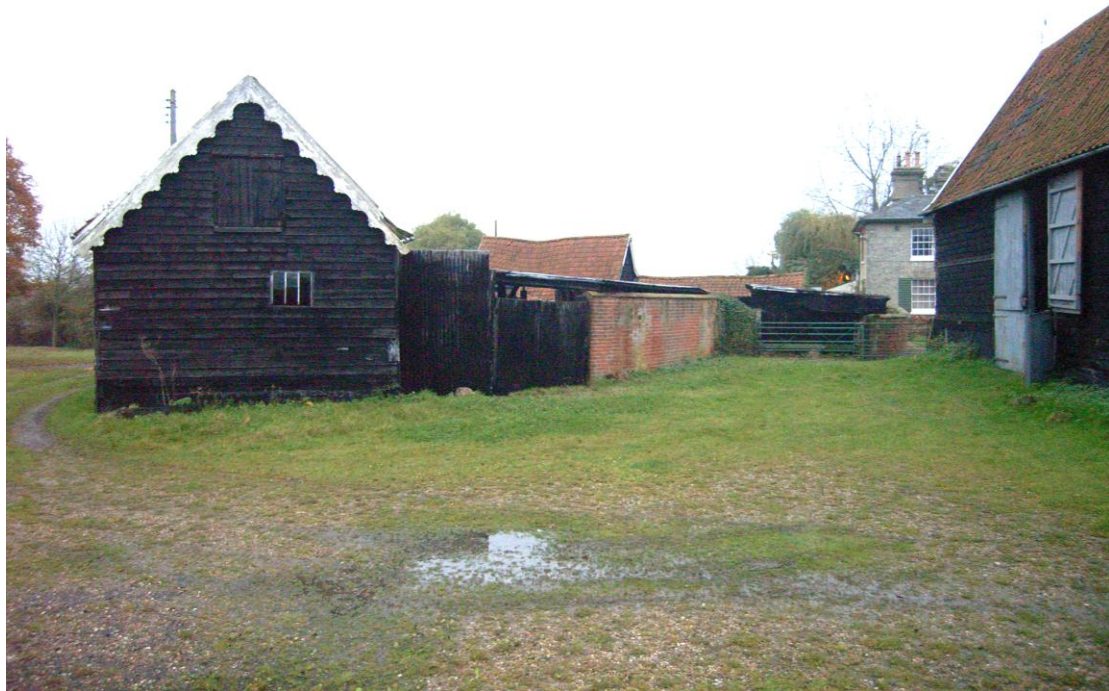
Illus. 3 The site from the south-west, showing the stable (4) to left and the barn (5) right with the granary (2) and house (7) in the rear

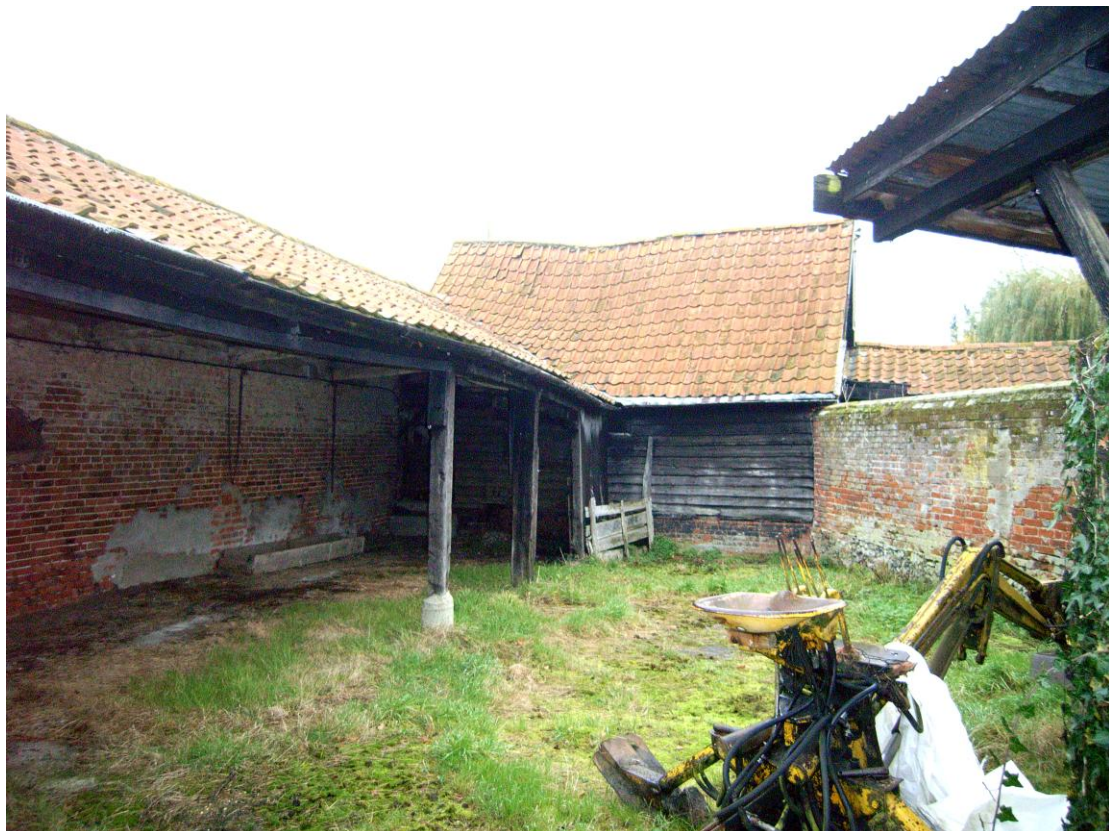
Illus. 4 The eastern end of the original horse yard, showing the shelter shed (1) to the left and the granary (2) in the centre

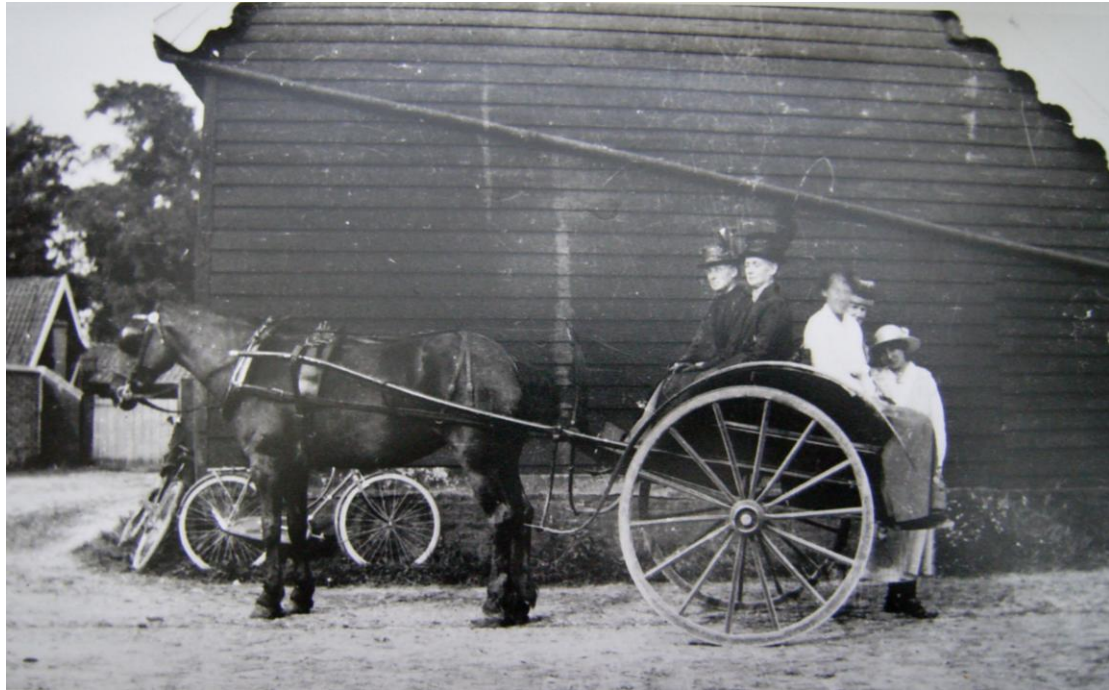
Illus. 5 Southern gable of the barn (5) in an early-20th century photograph, showing its distinctive Victorian Mock-Gothic barge-boards with the granary (2) visible to left

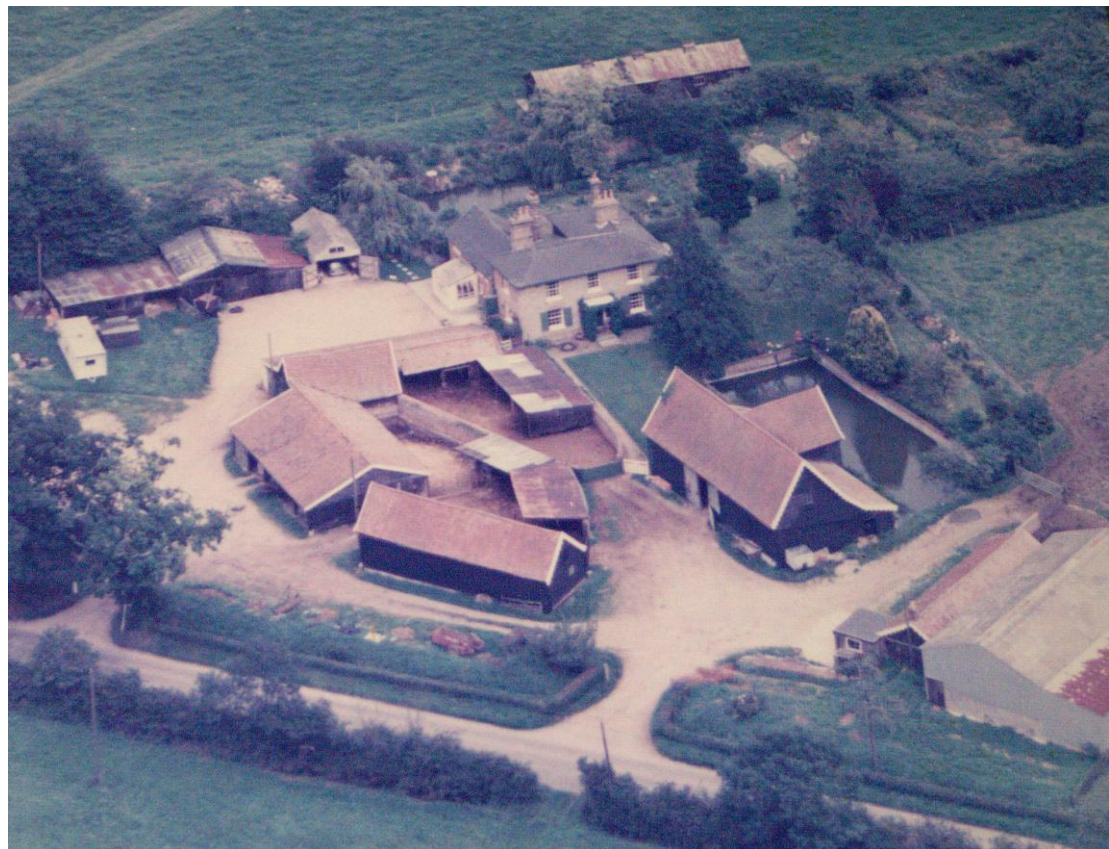
Illus. 6 The site from the west (taken from an aerial photograph of the 1970s, showing the scattered layout much as it was depicted on the tithe map of 1838

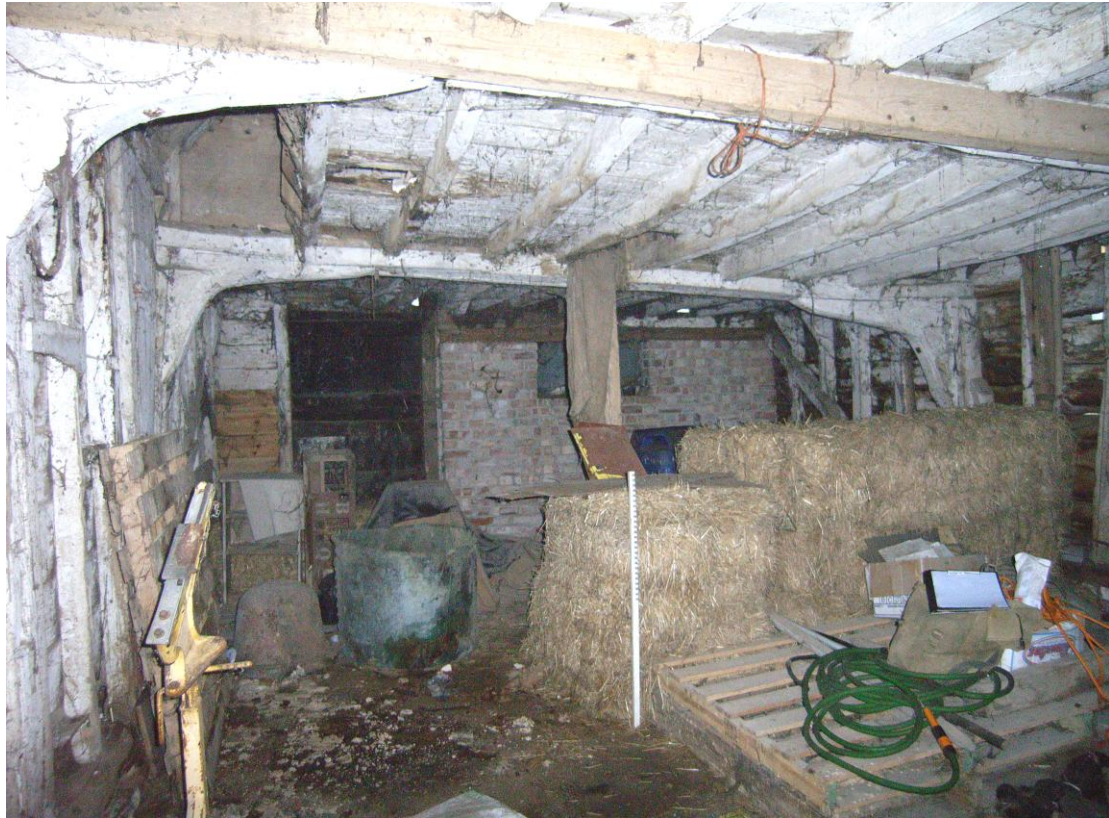
Illus. 7 Interior of the granary (2) from north, showing the loft supported by knee-braces (including a metre scale rod in centre)

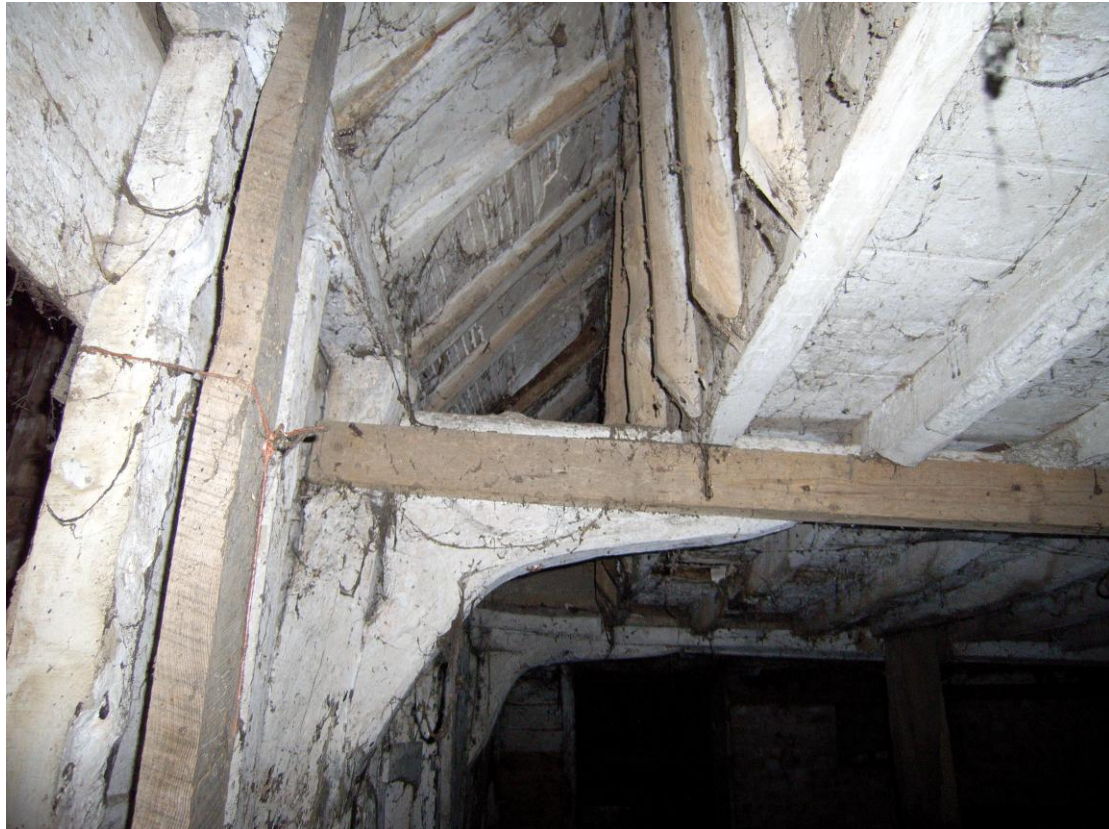
Illus. 8 Detail of granary (2) from north, showing the triangular aperture between the loft wall to right and the eastern elevation to left

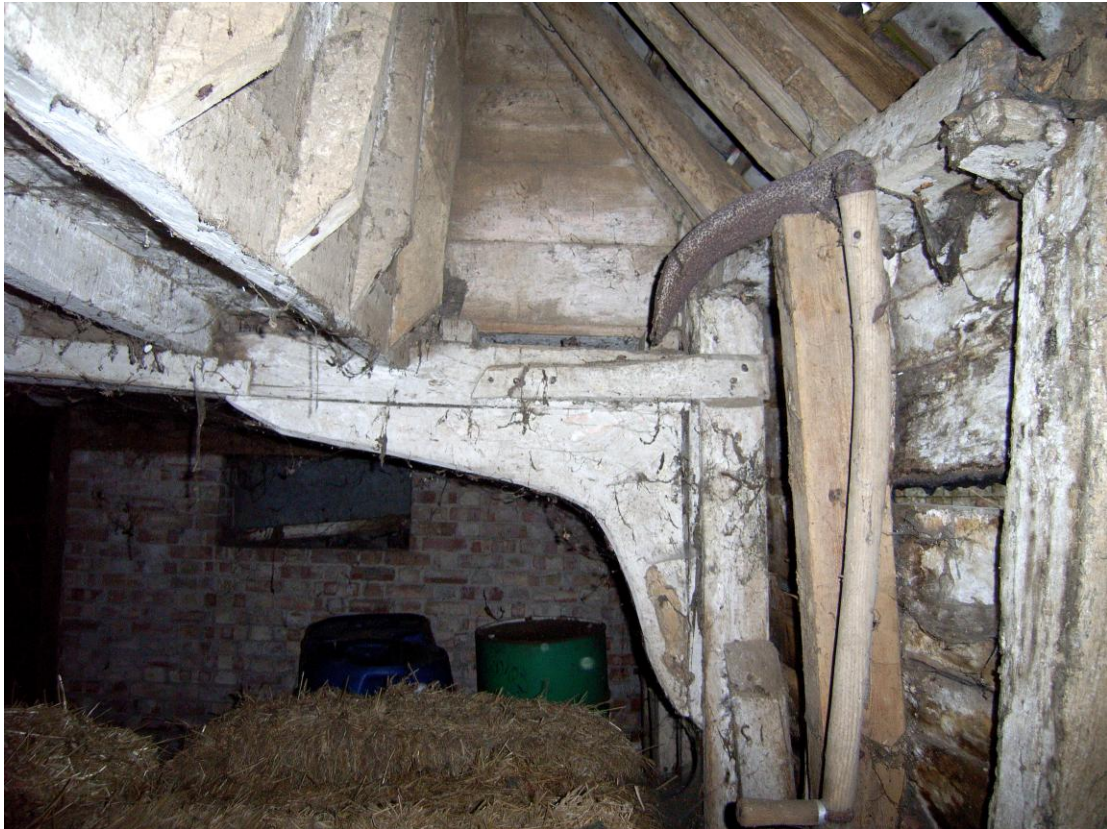
Illus. 9 Detail of granary (2) from north, showing the triangular aperture between the loft wall to left and the western elevation to right

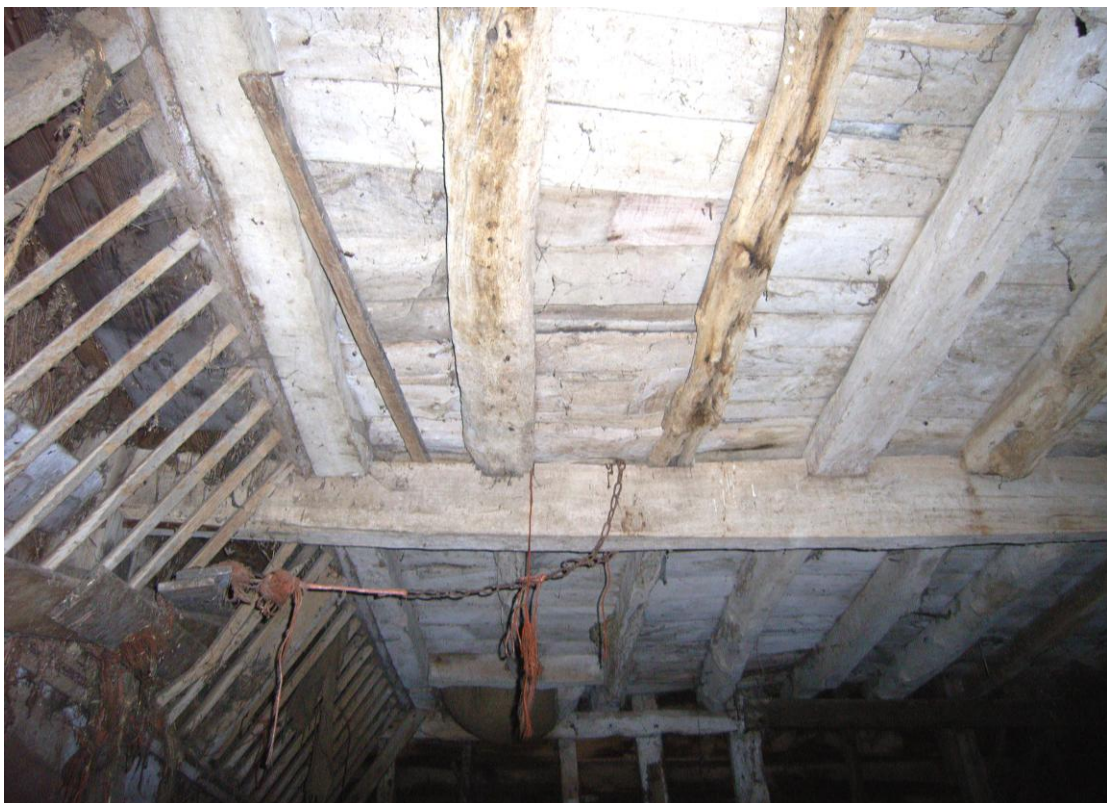
Illus. 10 Detail of stable ceiling (4) from south, showing the hay rack and loft vent against the western elevation to the left

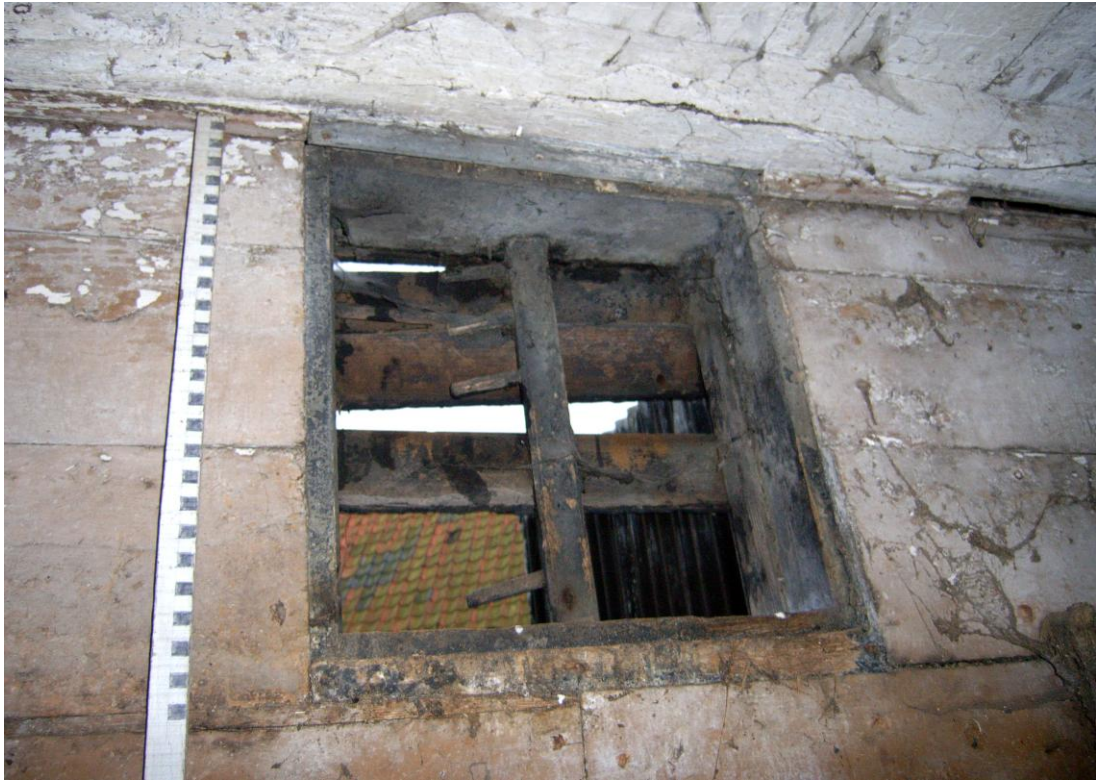
Illus. 11 Detail of the 19th century shuttered window in the stable (4), the shutters of which could be opened or closed by revolving the central mullions (centimetre scale)

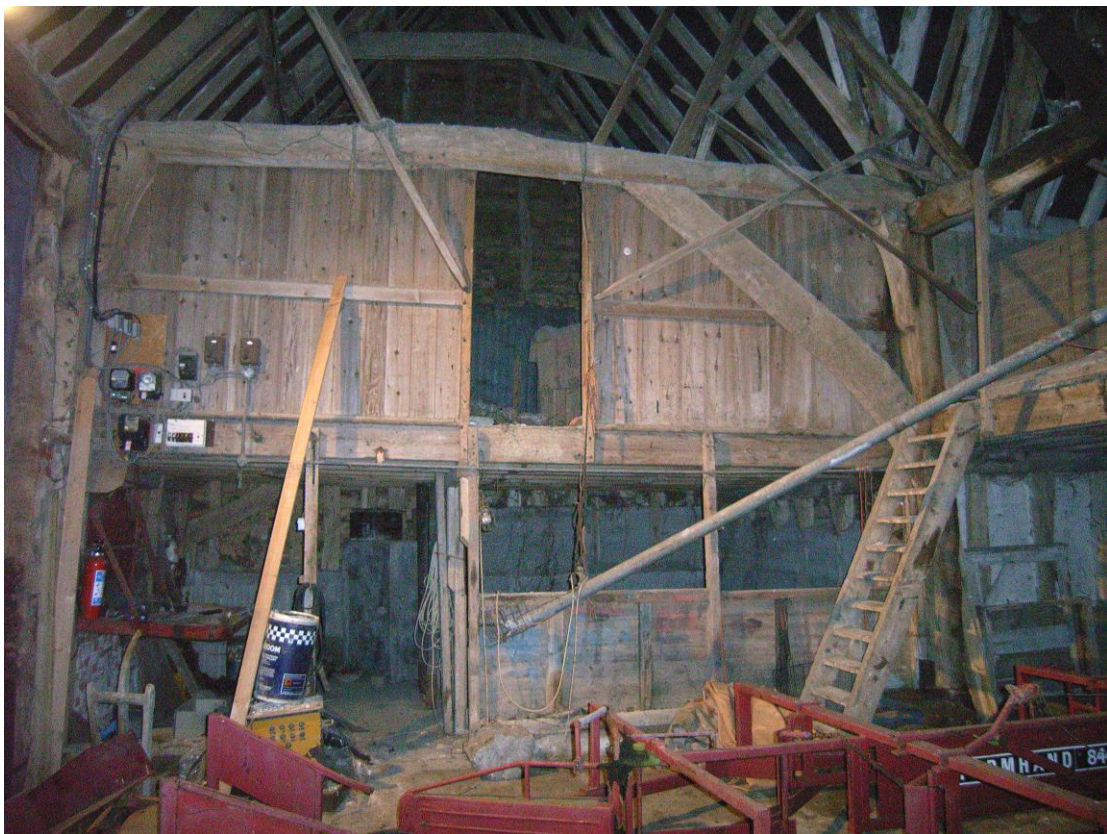
Illus. 12 Interior of barn (5) from south, showing the 20th century granary and milling floor in the northern bay, with an original arch brace to the right

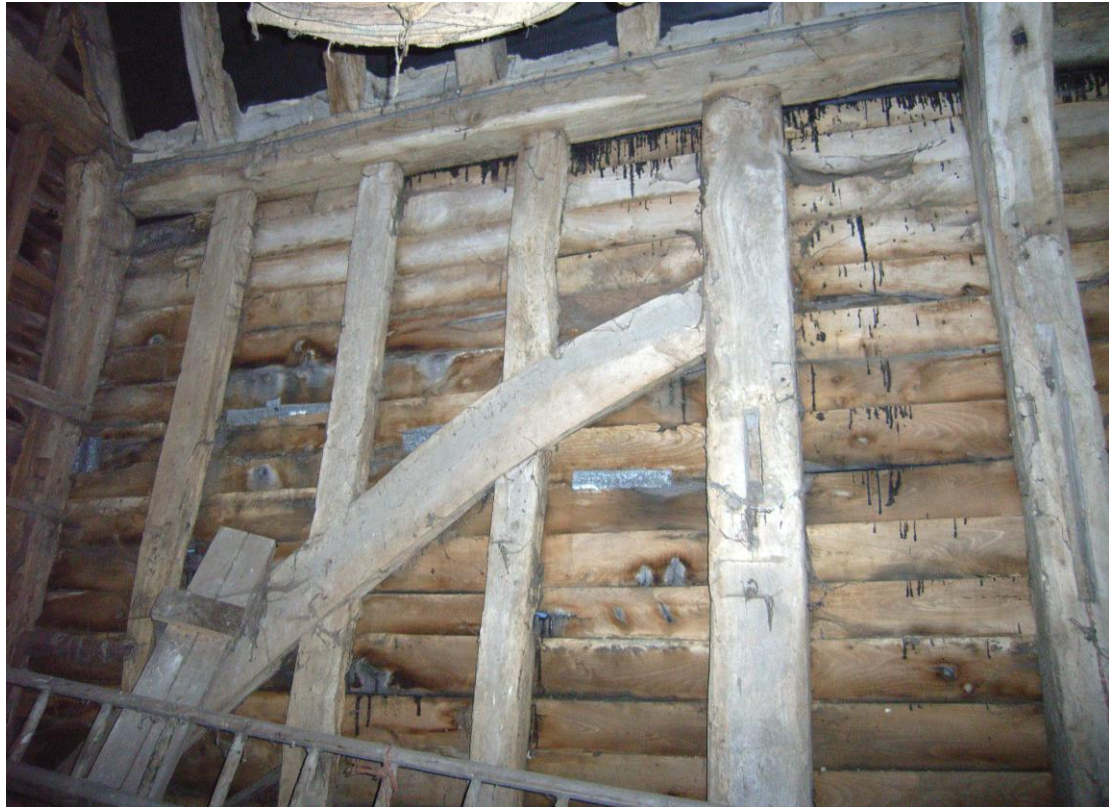
Illus. 13 Detail of barn (5) showing the unusual curved primary brace in the southern bay (re-used in the 18th century extension and possibly taken from a contemporary stable)

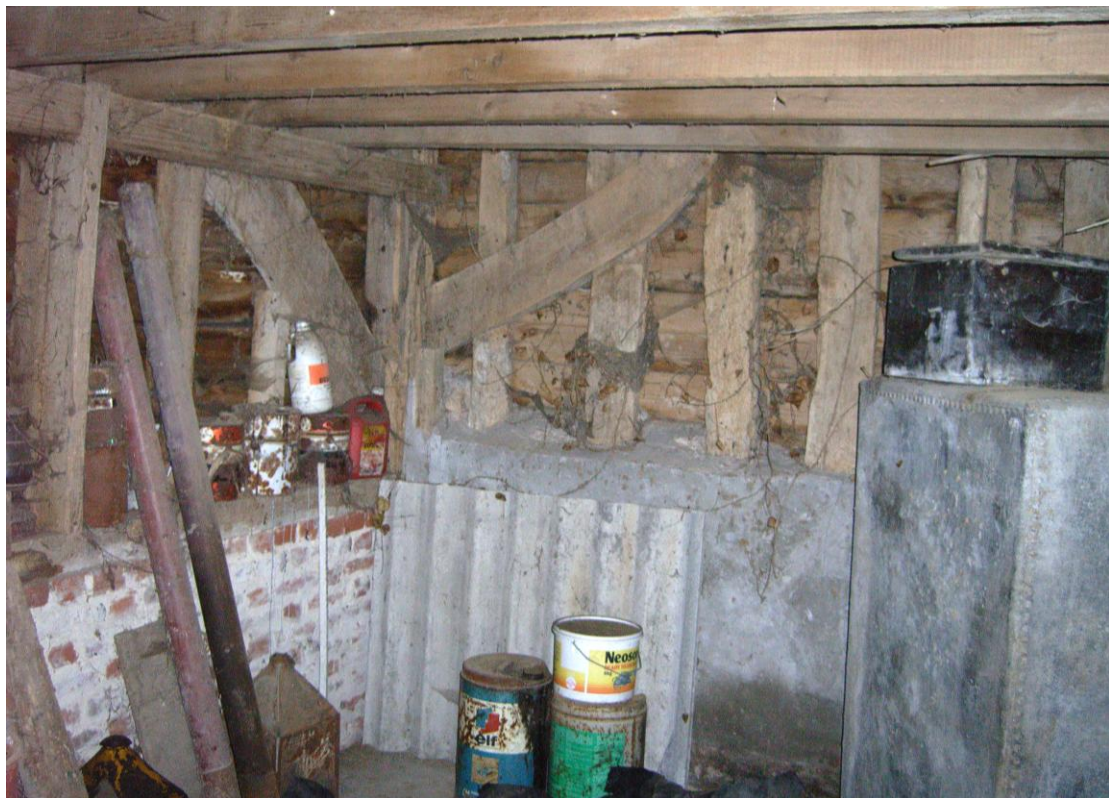
Illus. 14 Detail of the barn (5) showing the curved primary braces in its north-eastern corner – largely hidden by the later granary ceiling and shuttering. Far more of the original structure would be revealed if these later insertions were removed

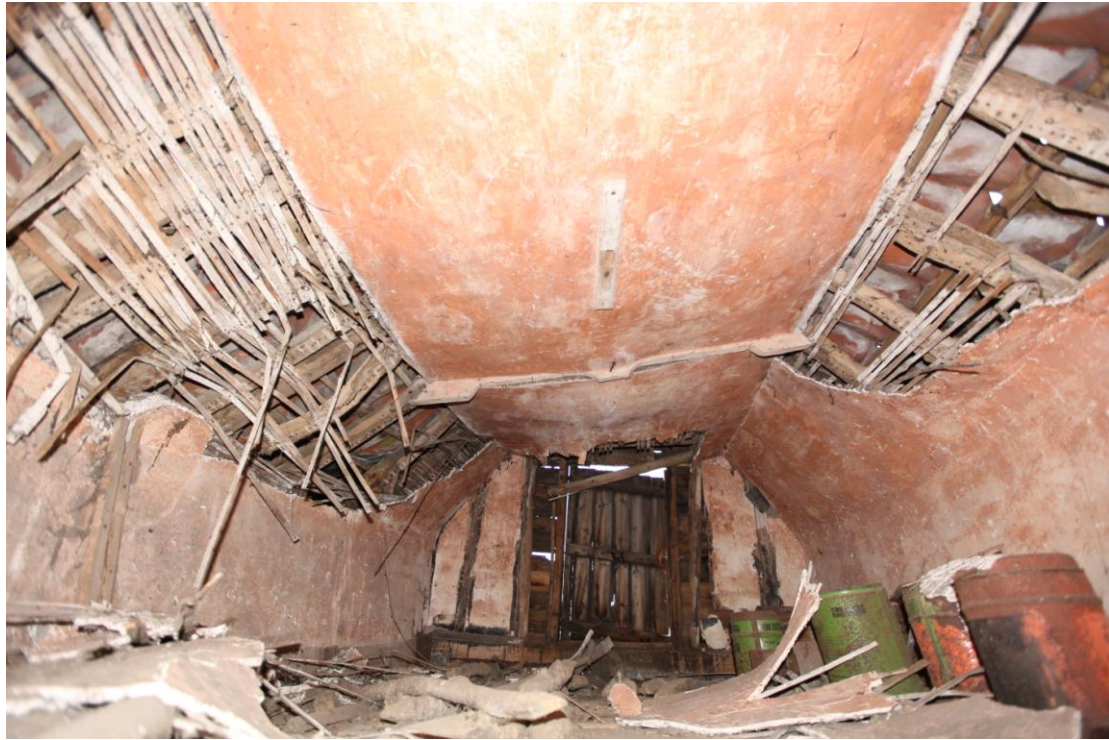
Illus. 15 Interior of the first-floor granary (2) seen from the south, showing the loading door in the northern gable and its 19th century lath-and-plaster with unusual red ochre pigment. Most interiors of this kind were whitewashed.

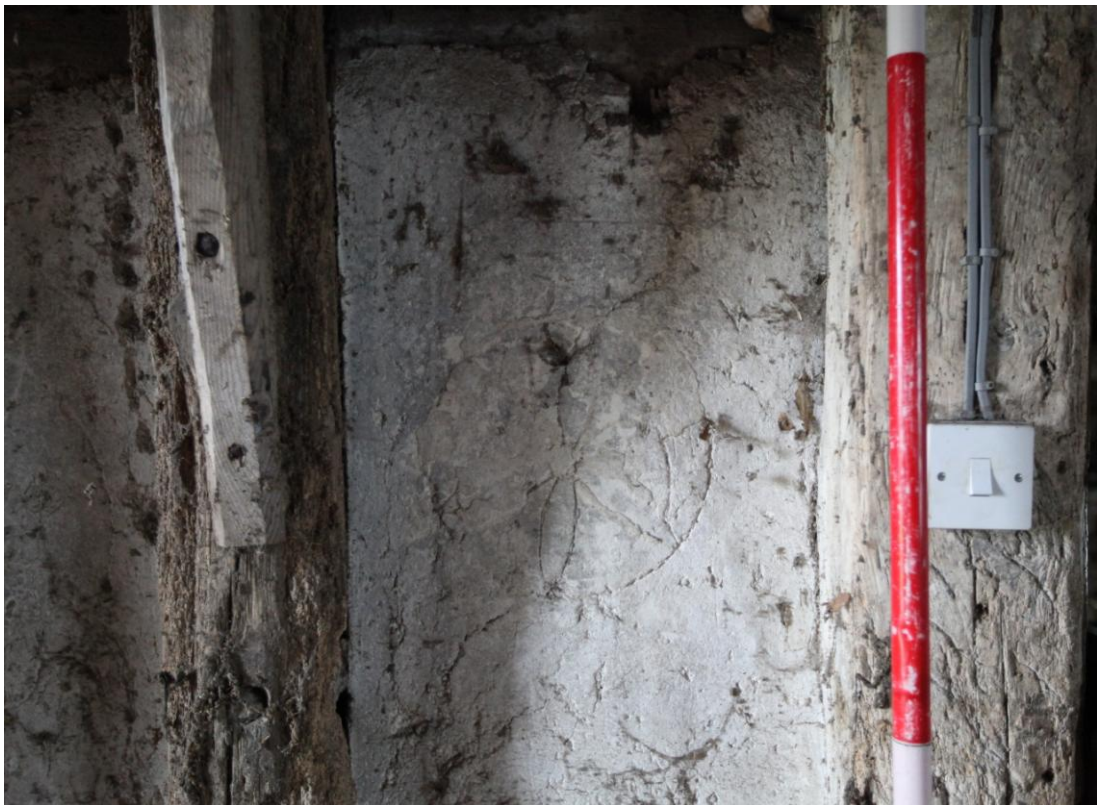
Illus. 16 Detail of the circular 'daisy-wheel' apotropaic mark incised into the clay daub of the northern interior of the porch in the barn (5). Such symbols were believed to avert evil and protect both animals and crops.
