**Clock House Barn,
Stonham Parva, Suffolk
SVA 017**

Historic Building Record

OASIS ID: Suffolkc1-97125

March 2011

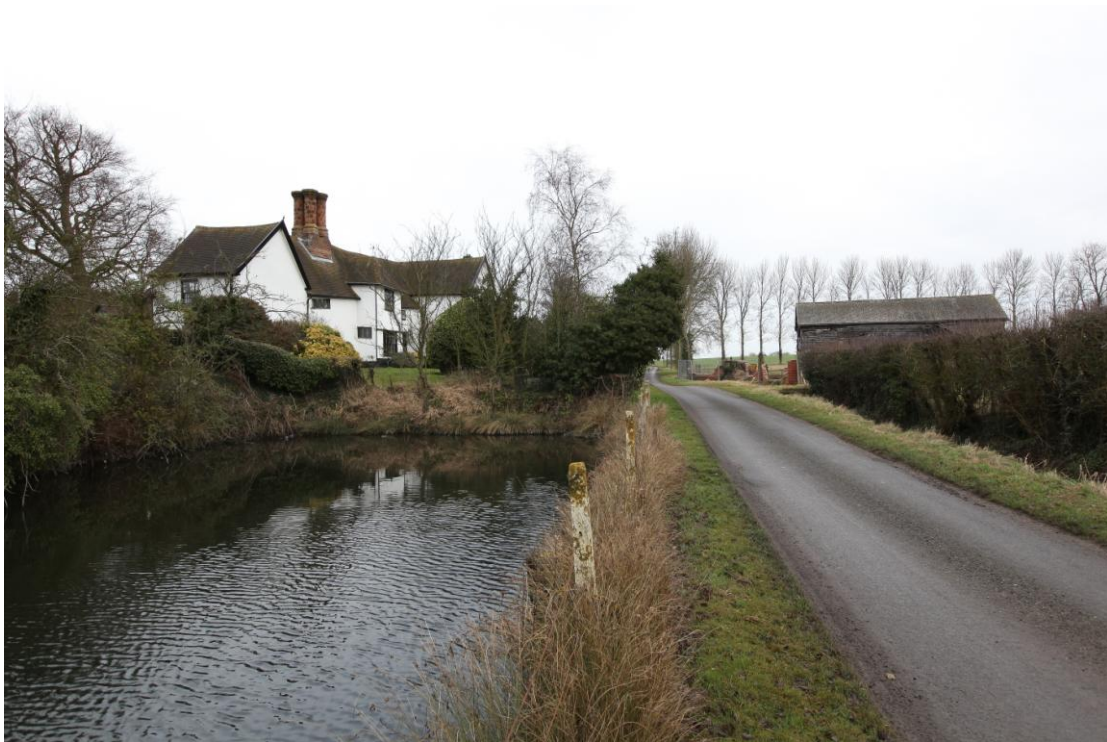
Illus. 1. General view of site from Clockhouse Lane to south showing grade II*-listed Clock House (4) to left and barn (1) to right.

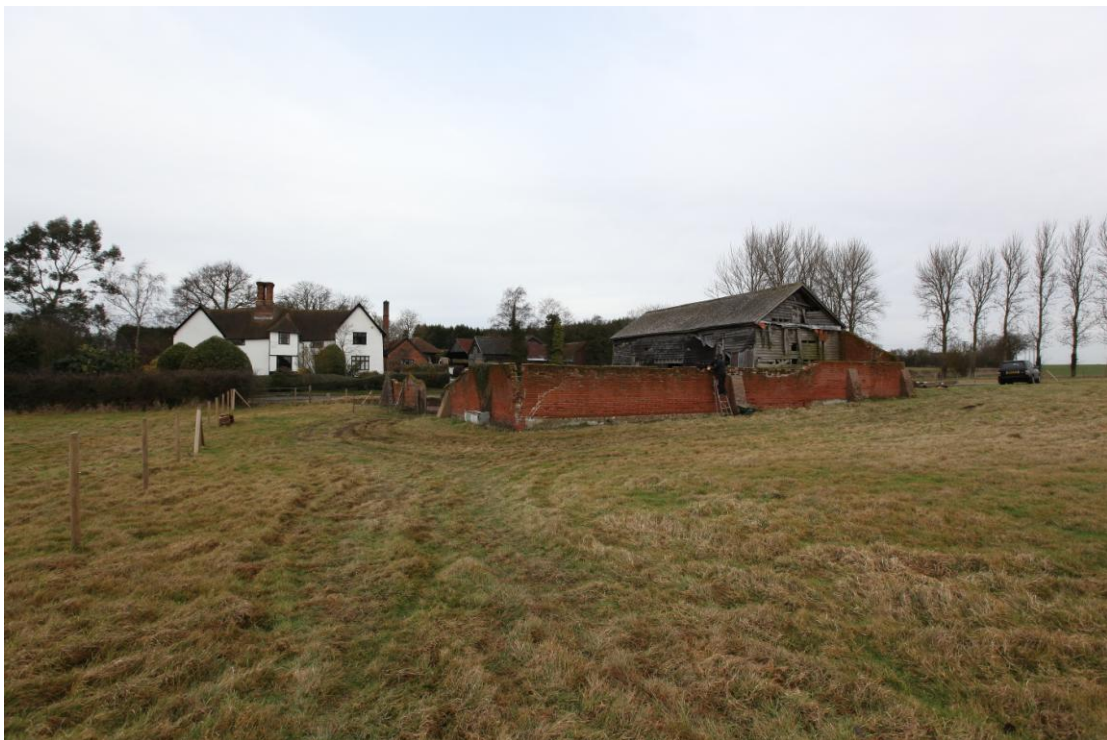
Illus. 2. General view of site from field to east showing the walled yard (3) and barn (1) to the right with Clock house (4) in rear to the left.

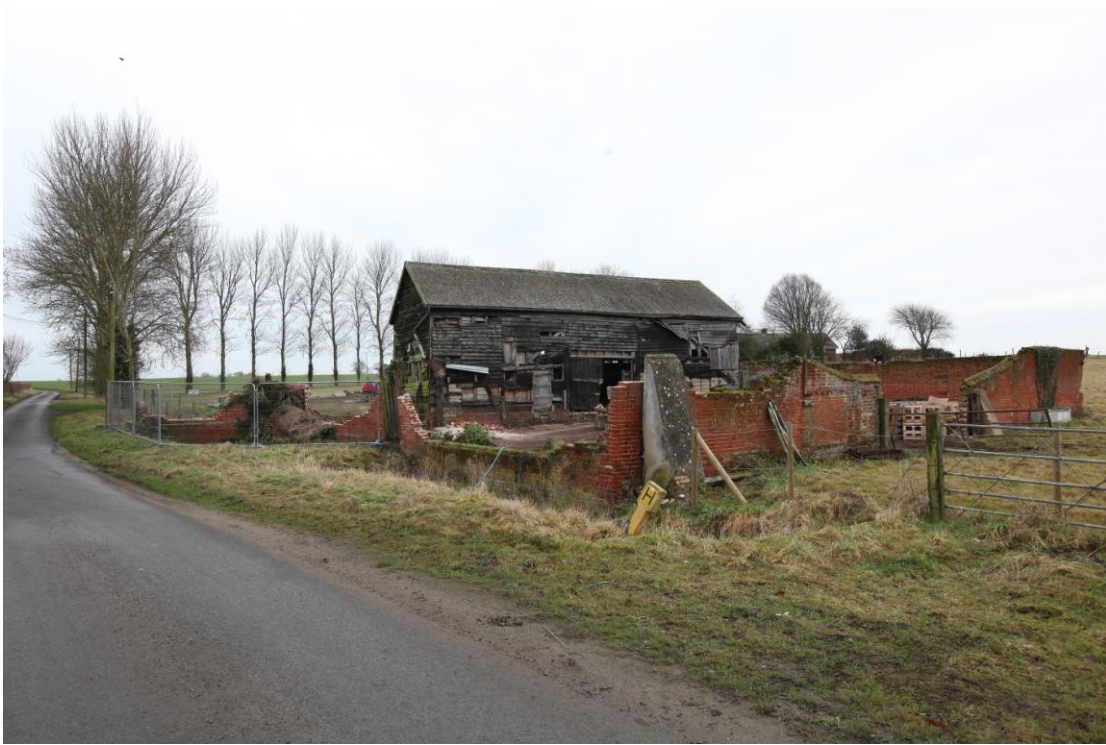
The walls of the enclosed yard to the south of the barn incorporate both early and mid-19th century brickwork of some quality, but had been largely demolished prior to inspection as shown in the accompanying photographs. A small surviving section of the red-brick shed which projected towards the farmhouse from the barn’s western gable retained good examples of circular apotropaic marks intended to protect the contents from harm, but the building’s original layout and purpose is a matter for speculation. Stables often adjoined the gables of barns in this way, but the yard had probably been converted for cattle by the 1880s and the shed may have been similarly adapted. A similar apotropaic ‘daisy-wheel’ is visible on the exterior of the barn’s internal boarding, but this is likely to have been removed from elsewhere. Of the open-sided shelter-sheds shown on the Ordnance Surveys only a series of concrete arcade-post pads remained intact (to the west of the entrance gate in the centre of the yard’s southern boundary). A lean-to shed against the barn’s eastern gable had been similarly demolished, leaving only its rafters and northern elevation intact, and there is evidence of a broad roof which formerly spanned the central yard between the shelter sheds (in the form of a scar on the barn’s southern exterior). Cattle yards were normally roofed in this manner to preserve their manure during the early- and mid-20th century.

Illus. 3. The exterior of the barn and yard complex from Clockhouse Lane to the south-west, showing the extent to which the yard walls had been demolished at the time of inspection.

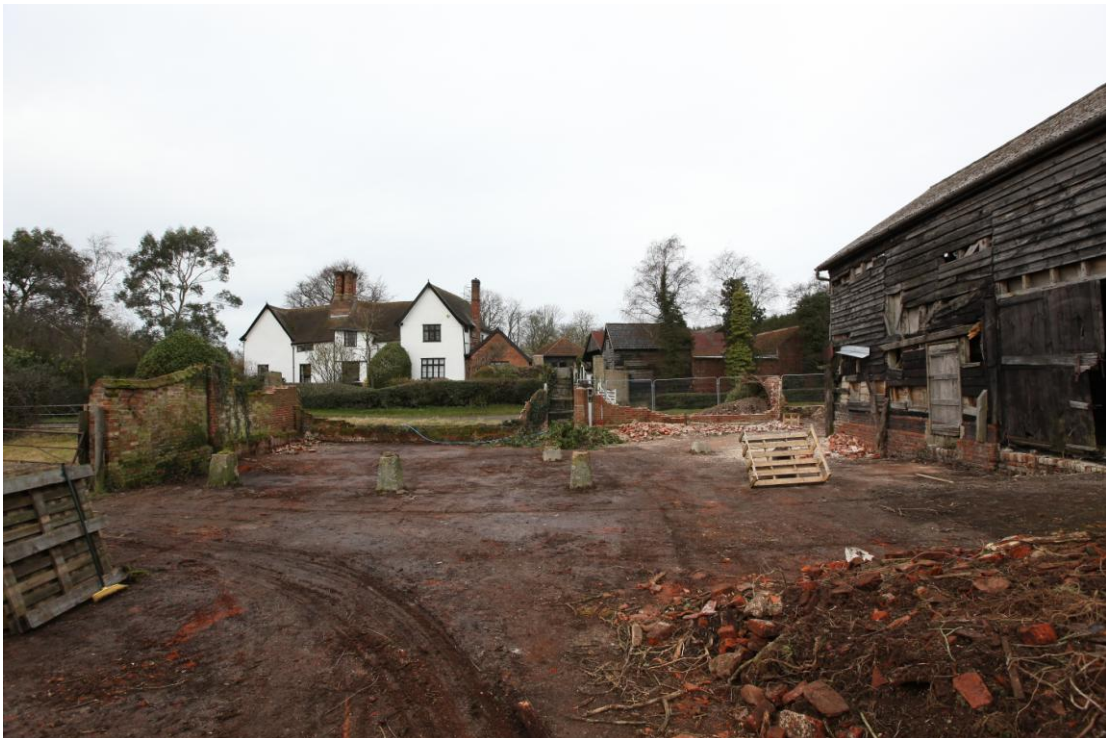
Illus. 4. The interior of the walled yard (3) from the east, showing the concrete pads of a demolished shelter-shed with the barn (1) to the right and the southern gate to the left.

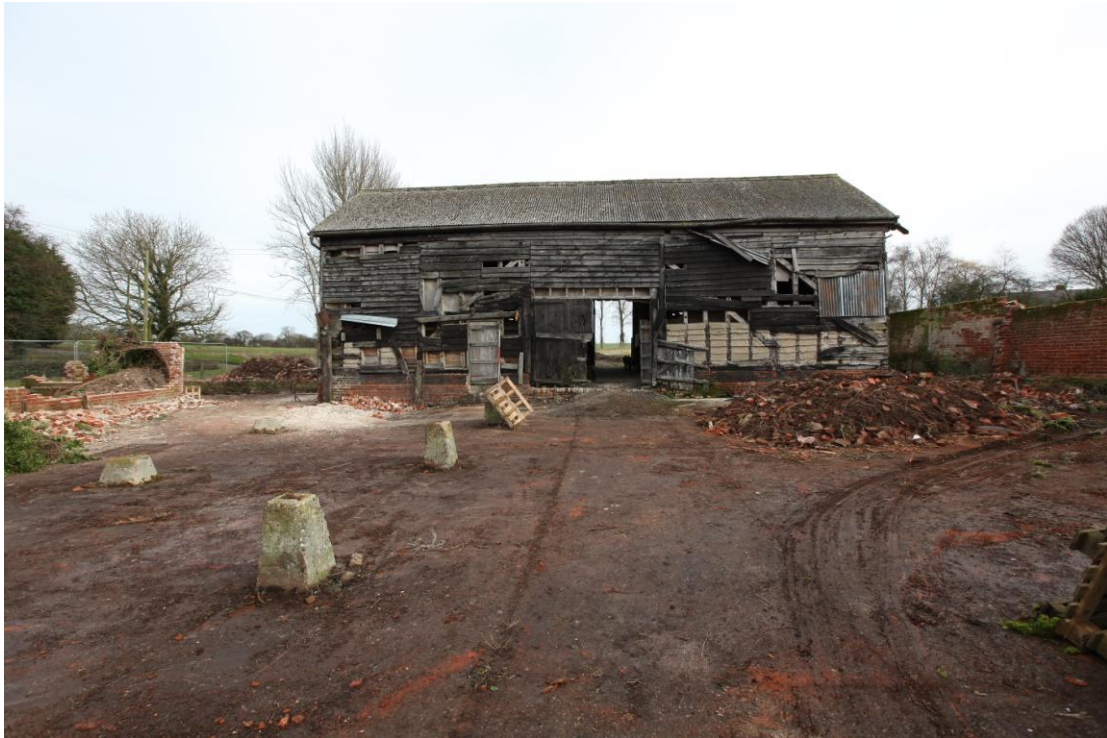
Illus. 5. The interior of the walled yard (3) from its southern entrance, showing the concrete pads of the demolished shelter-shed to the left and the scar of a central yard roof on the barn (1).

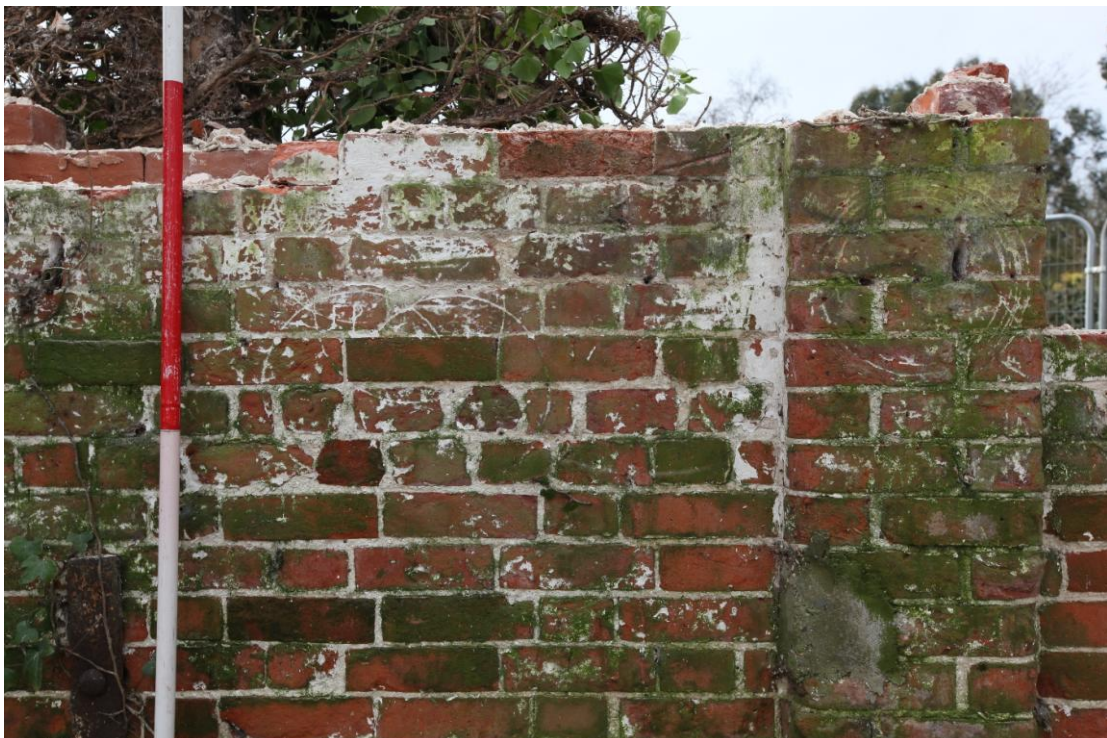
Illus. 6. Detail of the apotropaic circles to the southern interior of the largely demolished shed (2) which adjoined the western gable of the barn.

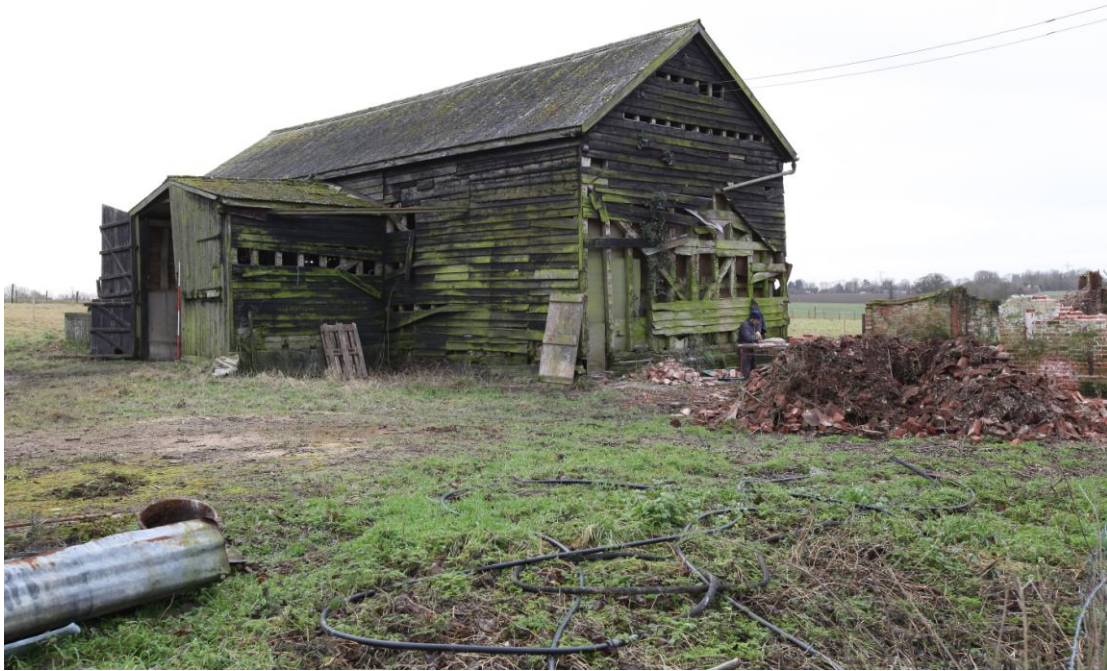
Illus. 7. Exterior of the barn (1) from the north-west showing its 20th century corrugated asbestos roof and northern porch with the scar of the demolished shed (2) adjoining its western gable to the right.

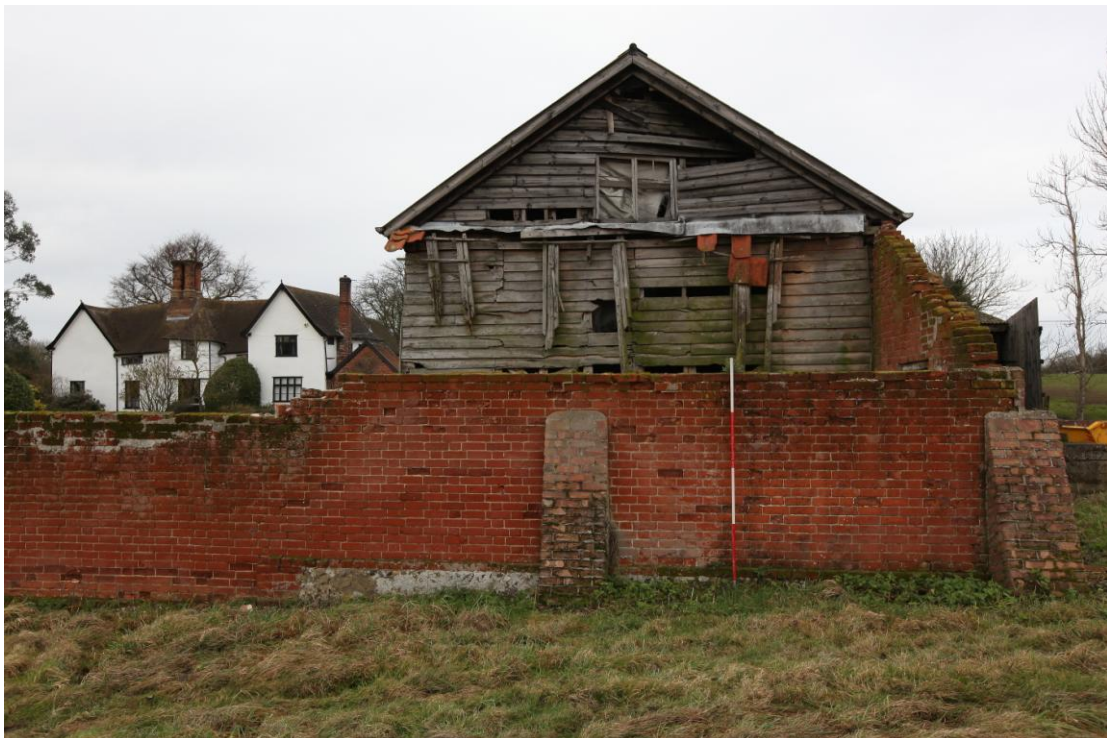
Illus. 8. The eastern external gable of the barn (1) showing the hanging rafters of a demolished lean-to shed with the wall of the yard (3) in the foreground.

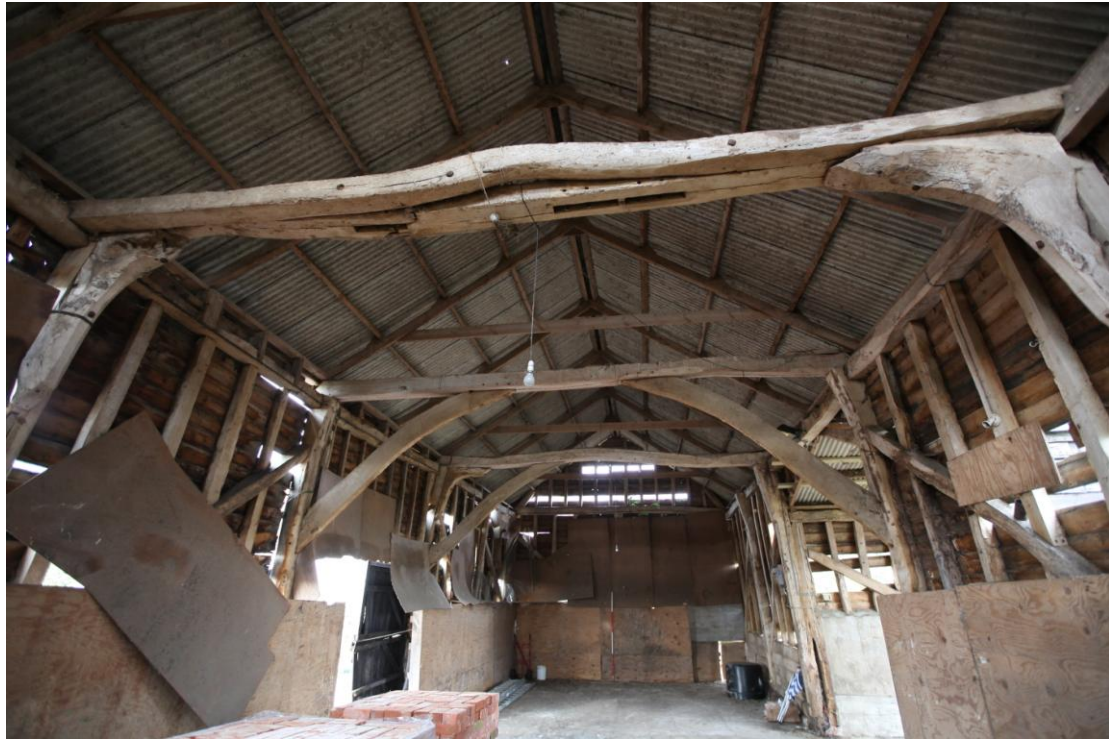
With the exception of its roof the frame survives largely intact, with three of its four original tie-beam braces, but the tie-beam of the westernmost open truss has been removed. The barn was initially entered by full-height doors to the south of the central bay, as indicated by tenoned jambs and a lack of original stud mortises in the roof-plate, but this entrance was subsequently reduced in height and new doors inserted in the northern porch, destroying the original gable (which probably possessed a smaller door). Similar alterations occurred in many local barns and probably took place in the mid-19th century when the yard was enclosed to accommodate cattle (which reappeared in the area as the price of grain fell after the Repeal of the Corn Laws in 1846).

Illus. 9. The interior of the barn (1) from the east showing its 20th century rebuilt roof with the re-used tie-beam and original knee-braces in the foreground.

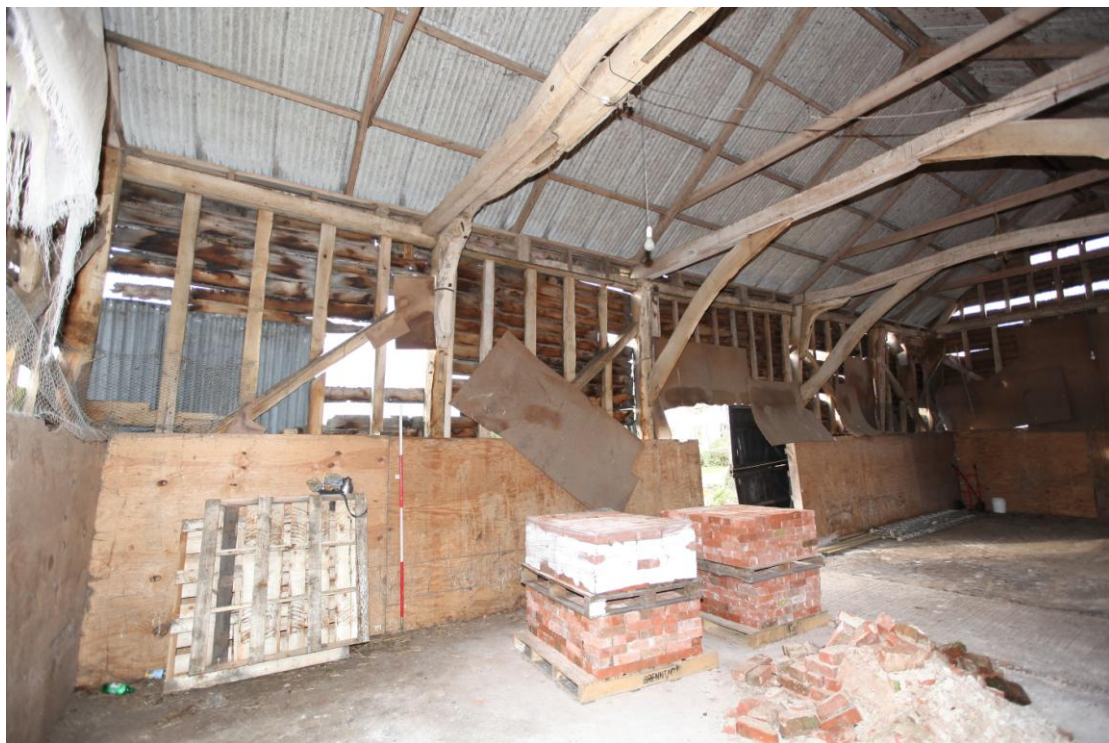
Illus. 10. The southern interior of the barn (1) showing the low doors of the central threshing bay to the right (replacing original full-height entrance doors in the same position).

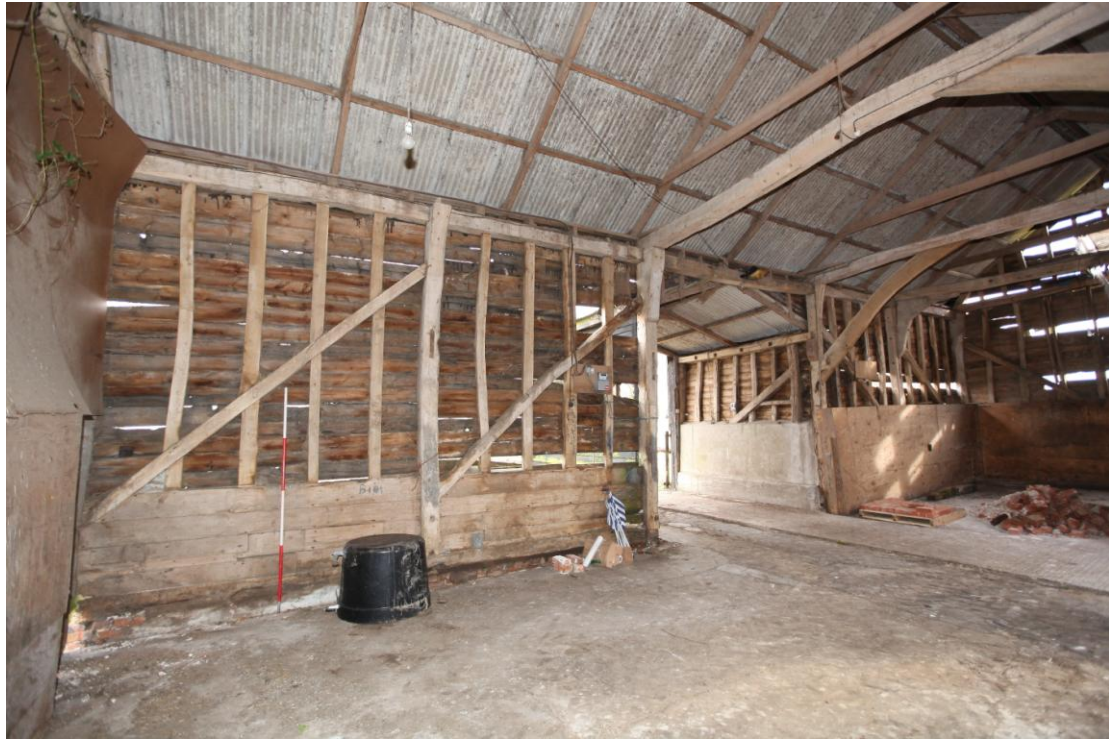
Illus. 11. The northern interior of the barn (1) from its south-western corner showing the original porch of the central bay and the straight, diagonal primary wall braces.

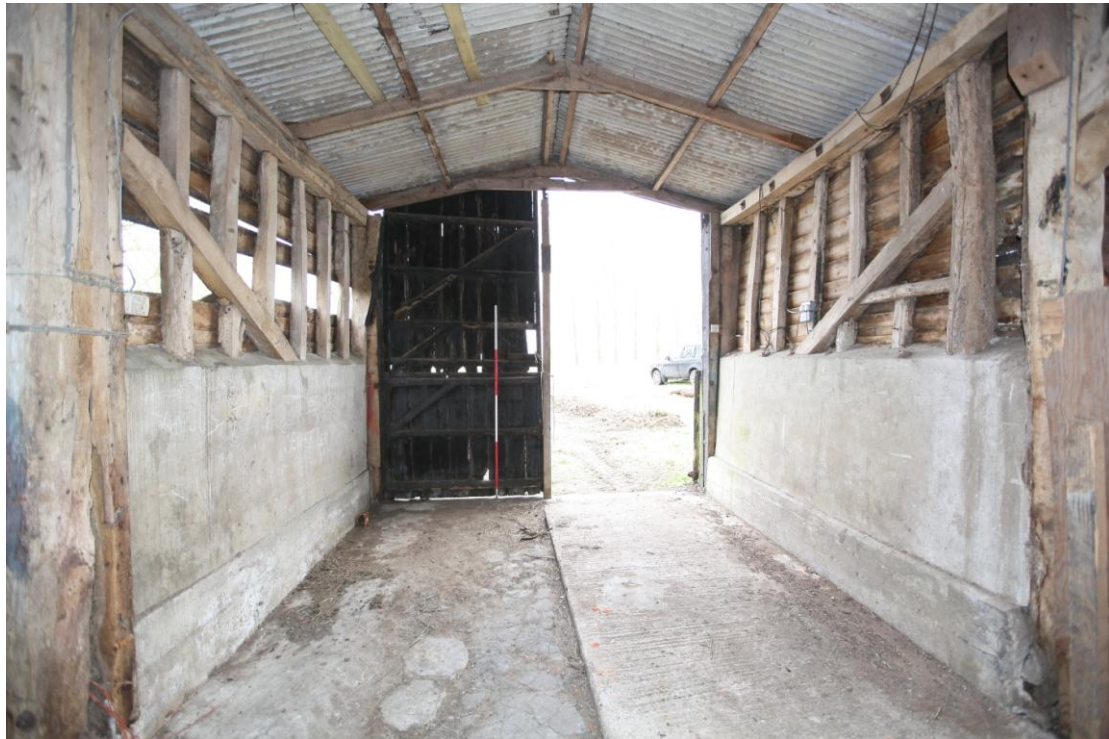
Illus. 12. The interior of the original northern porch of the barn (1) seen from the south and showing its 20th century concrete and bitumen floor. The porch was designed to increase the length of the threshing floor rather than as a principal entrance.
