**Clock House Barn,
Stonham Parva, Suffolk
SVA 017**

Historic Building Record

OASIS ID: Suffolkc1-97125

March 2011

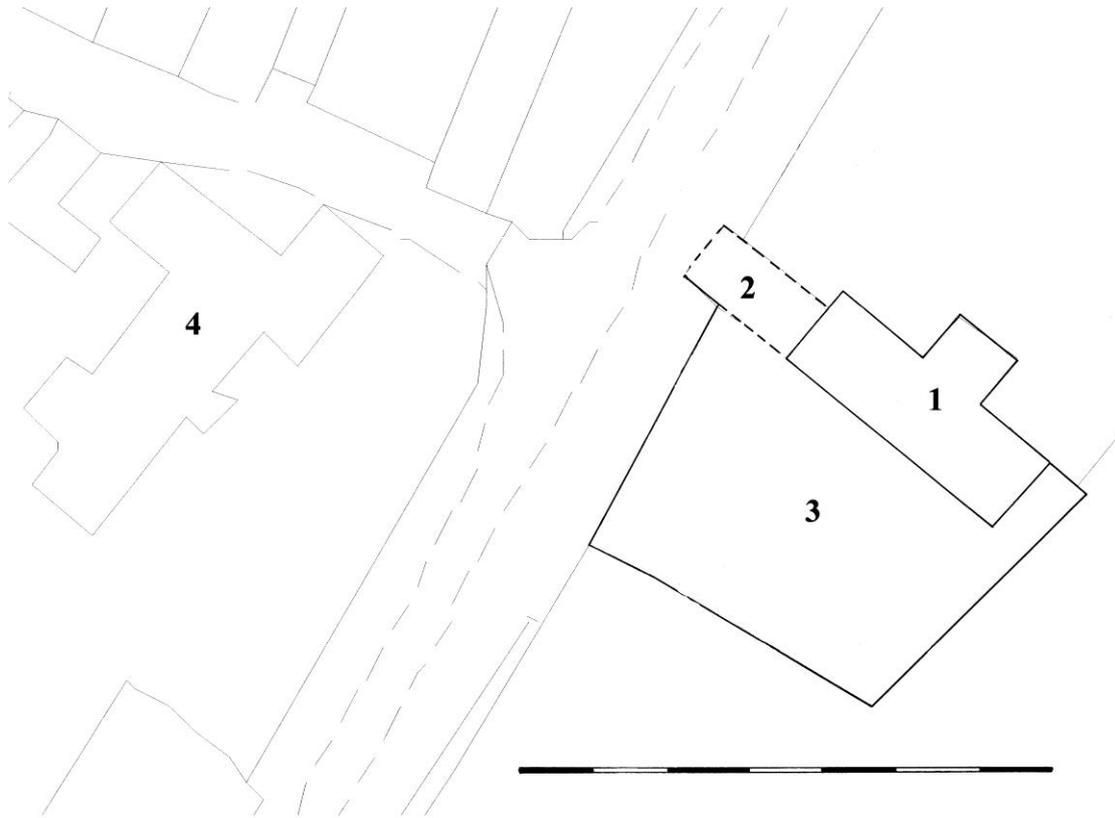
Figure 5

1. A timber-framed and weatherboarded early-19th century threshing barn of five bays, originally entered from the south but with a gabled porch to the north of the central bay. A red-brick lean-to shed formerly adjoined its eastern gable but had been demolished prior to inspection.

2. A red-brick shed adjoining the western gable of the barn. Probably mid-19th century and built as either a stable or a neat-house & feed store. Almost entirely demolished at the time of inspection but retaining good internal apotropaic circles to the surviving fragment of its southern elevation.

3. A walled stable or cattle yard, formerly with open-sided shelter-sheds to east and west and entered from the south. The shelter-sheds and much of the perimeter wall had been demolished at the time of inspection. A scar on the weatherboarding of the barn suggests a 20th century roof once covered the central yard.

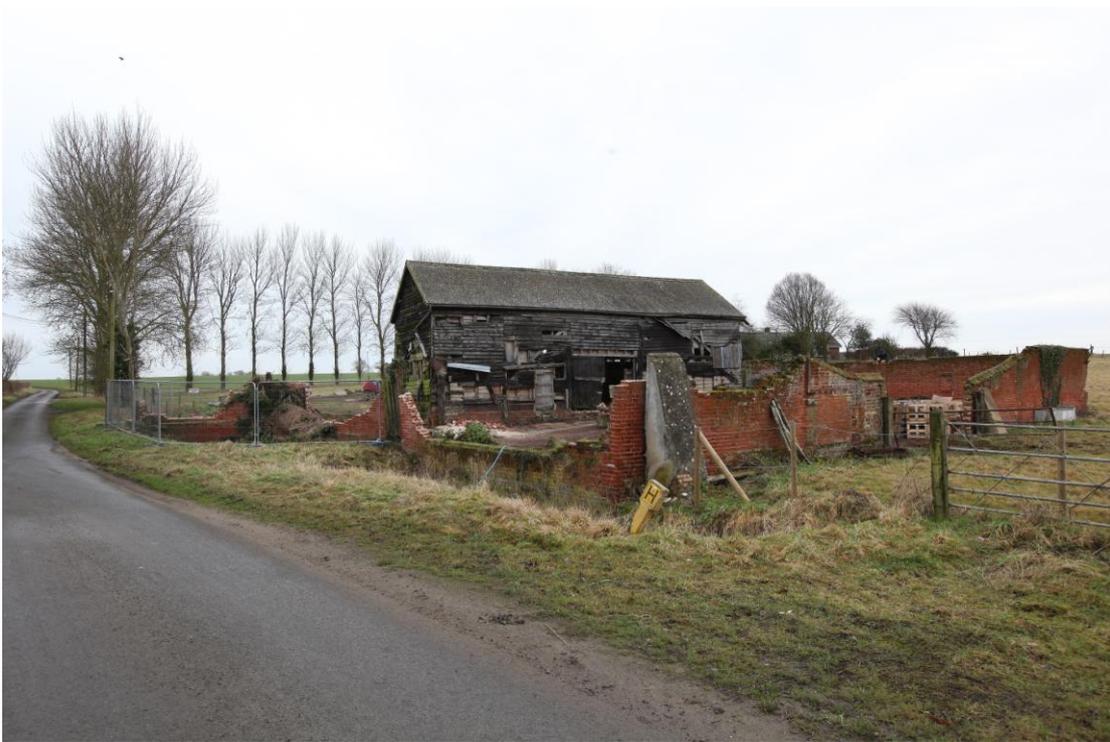
Illus. 3. The exterior of the barn and yard complex from Clockhouse Lane to the south-west, showing the extent to which the yard walls had been demolished at the time of inspection.

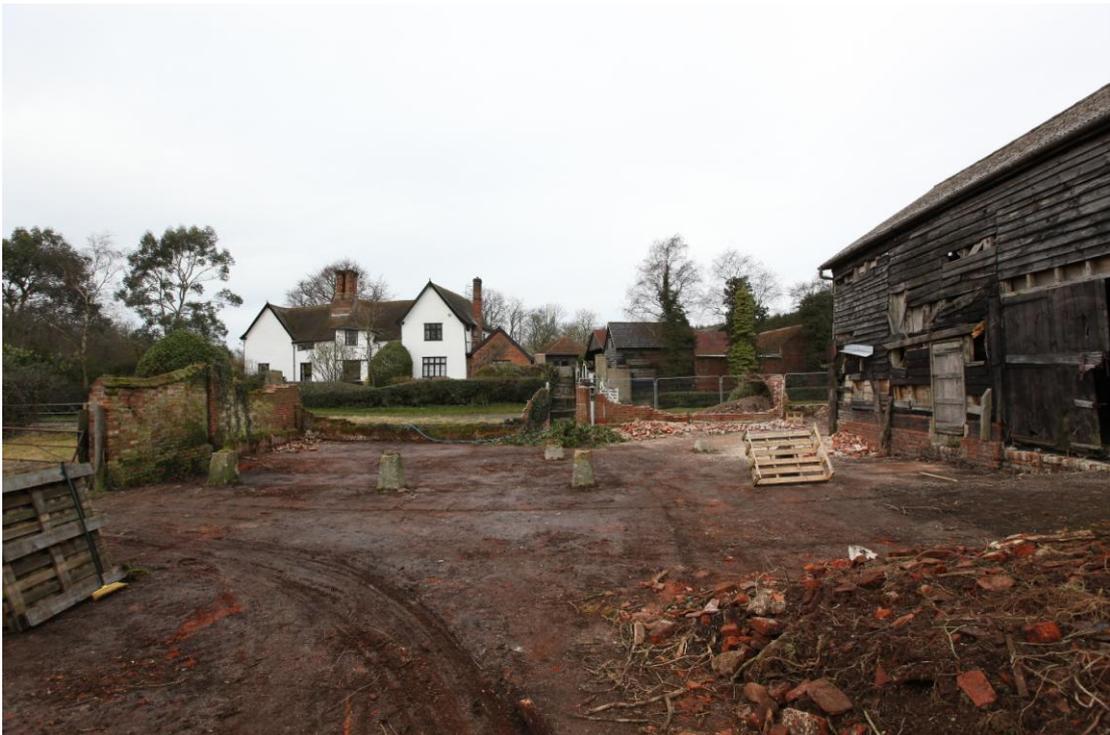
Illus. 4. The interior of the walled yard (3) from the east, showing the concrete pads of a demolished shelter-shed with the barn (1) to the right and the southern gate to the left.

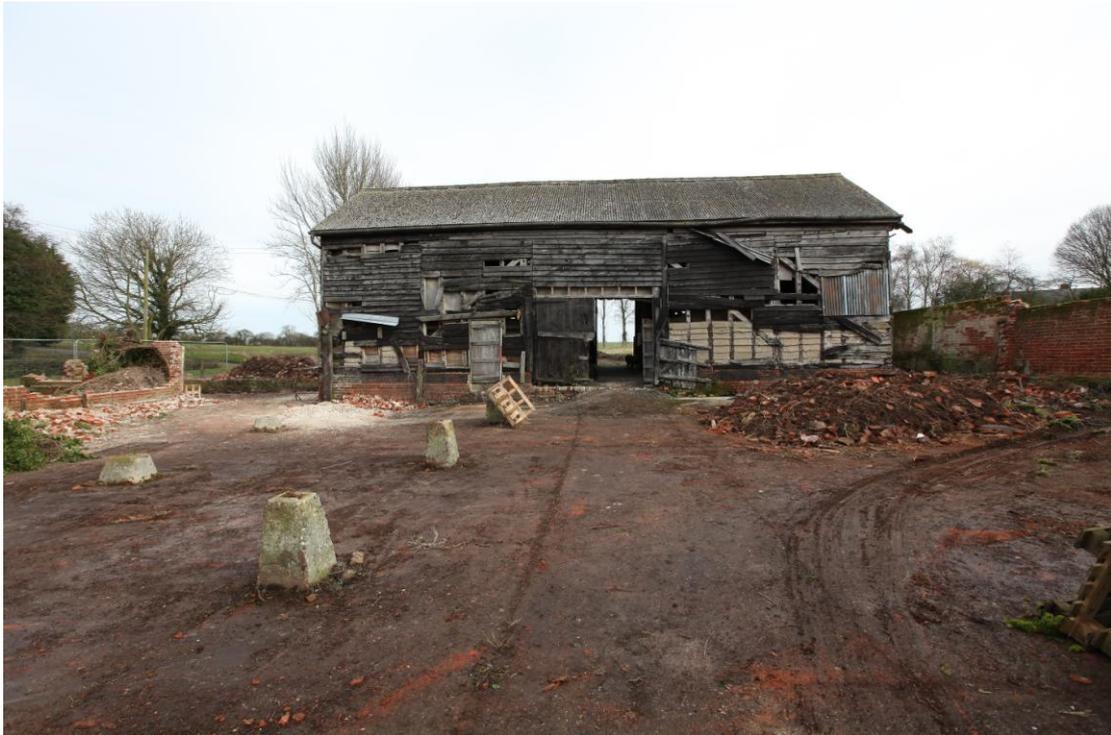
Illus. 5. The interior of the walled yard (3) from its southern entrance, showing the concrete pads of the demolished shelter-shed to the left and the scar of a central yard roof on the barn (1).

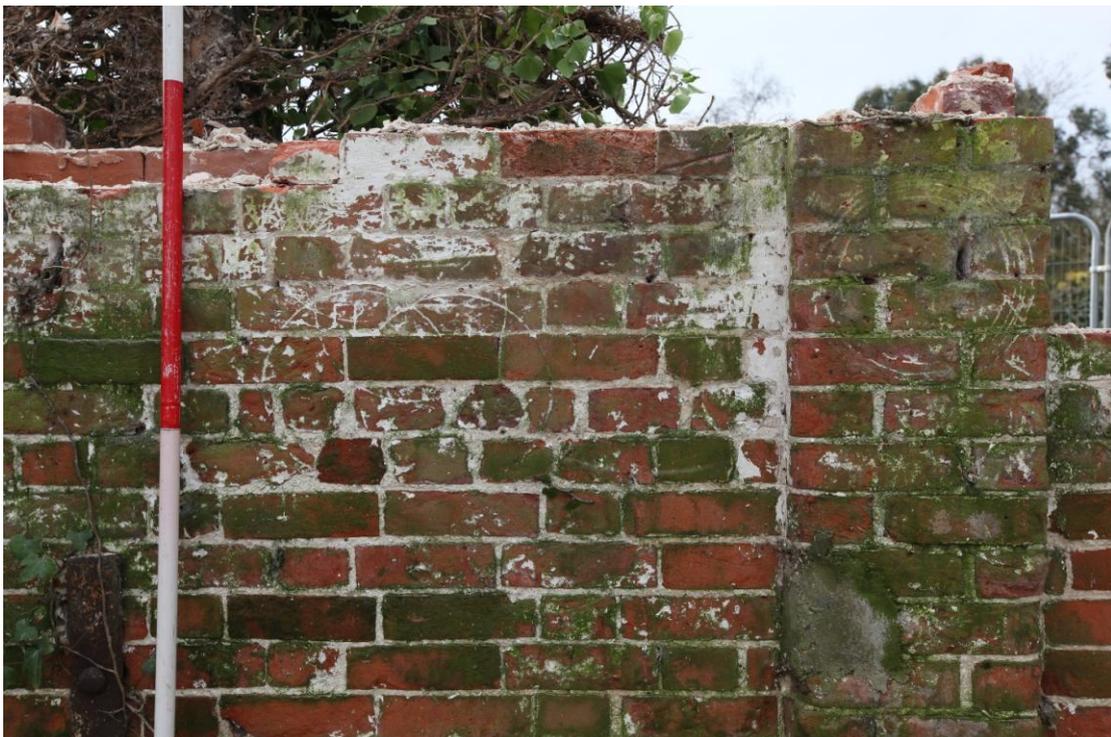
Illus. 6. Detail of the apotropaic circles to the southern interior of the largely demolished shed (2) which adjoined the western gable of the barn.

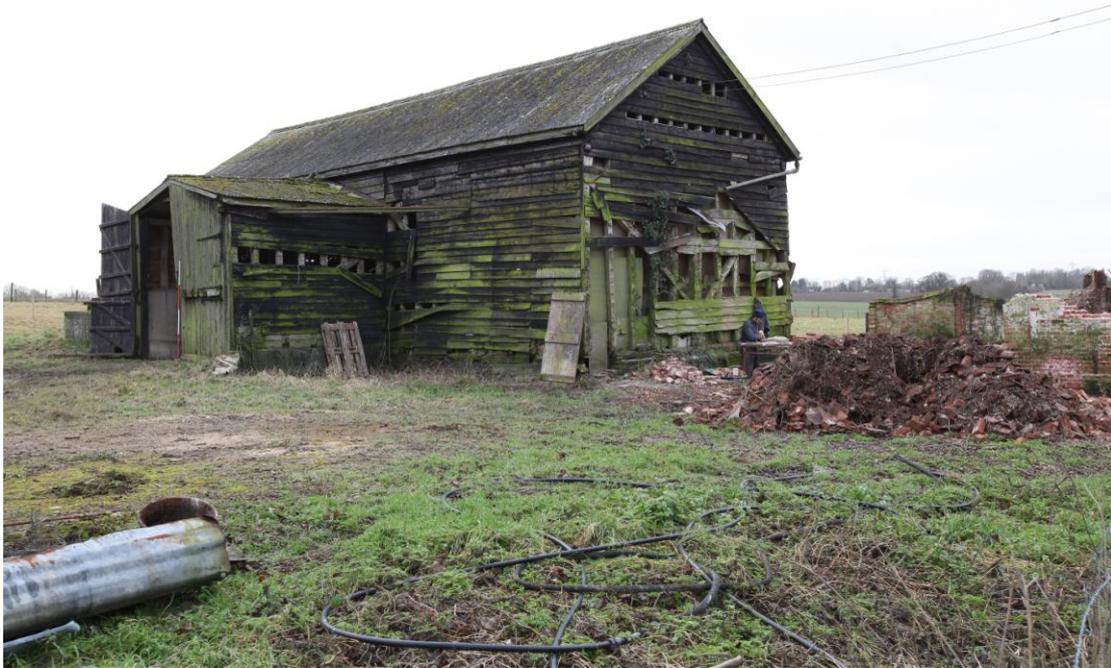
Illus. 7. Exterior of the barn (1) from the north-west showing its 20th century corrugated asbestos roof and northern porch with the scar of the demolished shed (2) adjoining its western gable to the right.

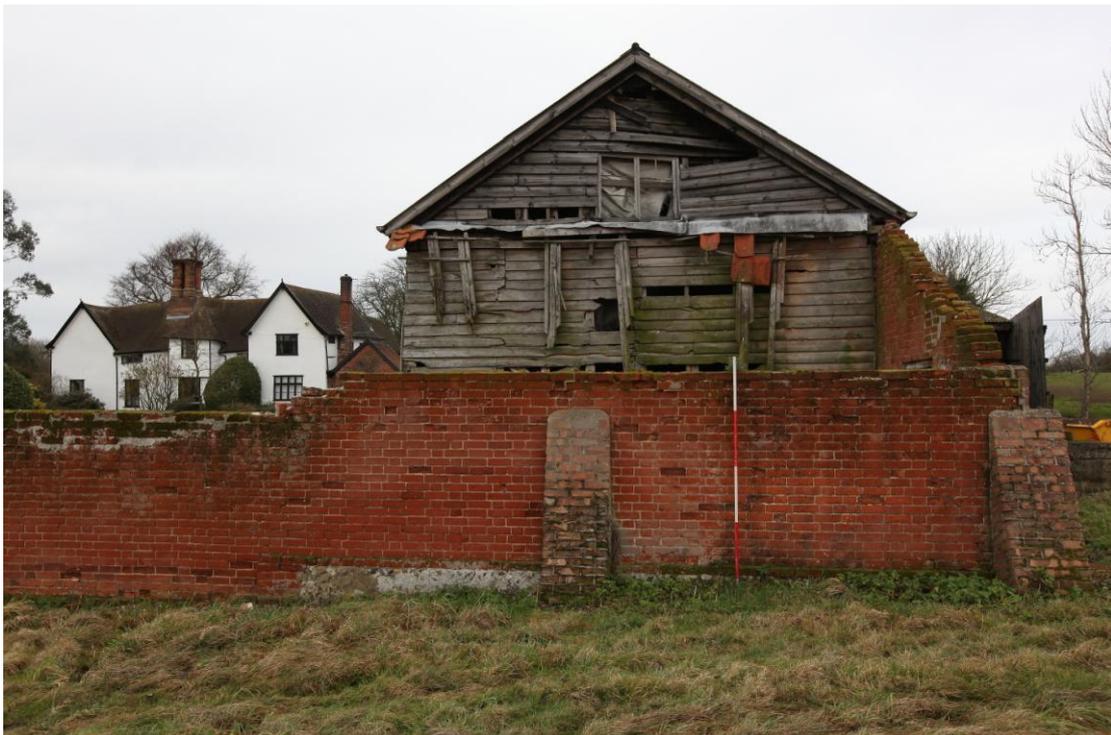
Illus. 8. The eastern external gable of the barn (1) showing the hanging rafters of a demolished lean-to shed with the wall of the yard (3) in the foreground.

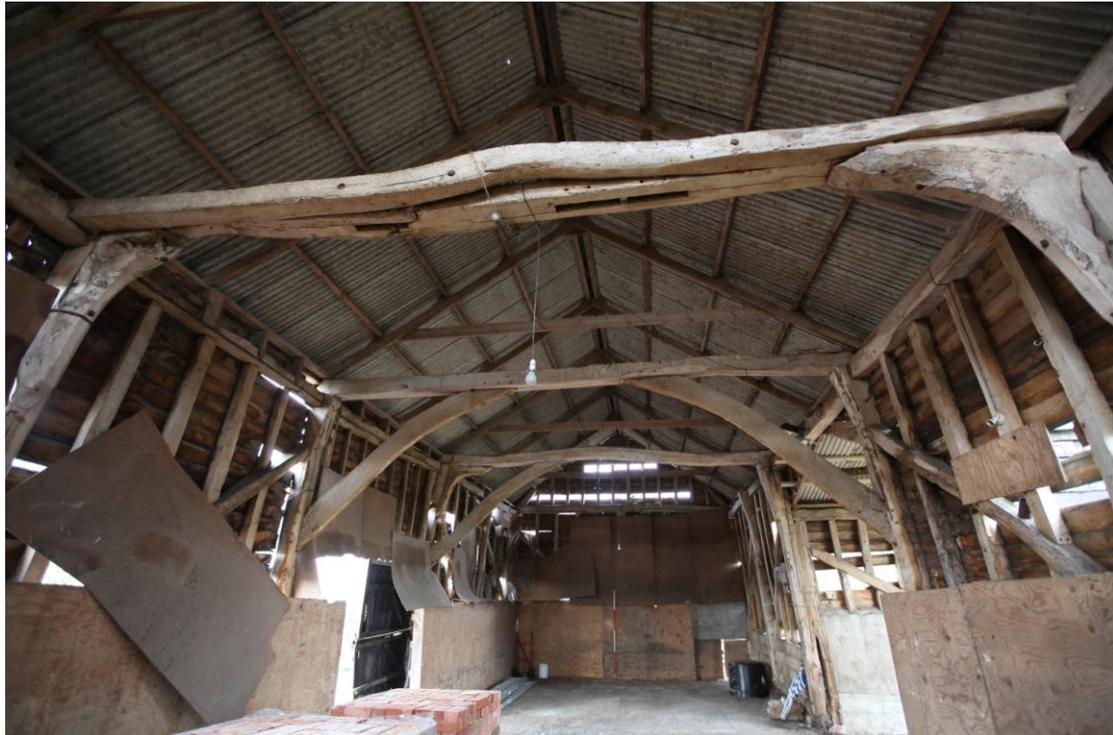
Illus. 9. The interior of the barn (1) from the east showing its 20th century rebuilt roof with the re-used tie-beam and original knee-braces in the foreground.

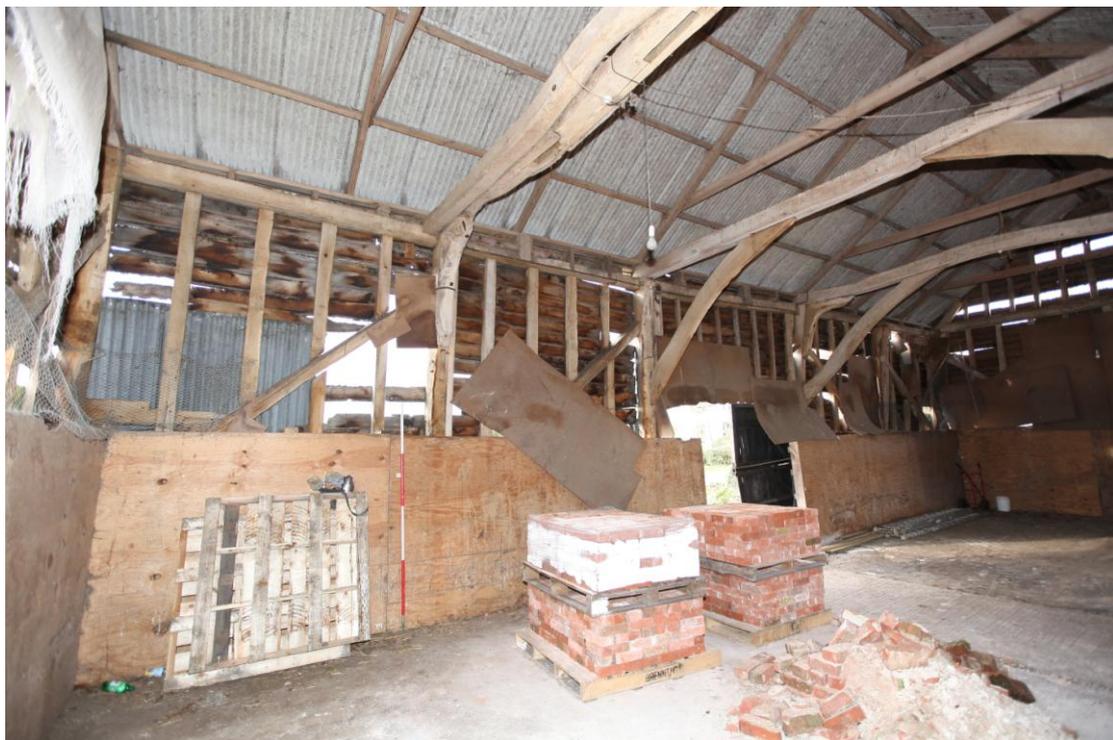
Illus. 10. The southern interior of the barn (1) showing the low doors of the central threshing bay to the right (replacing original full-height entrance doors in the same position).

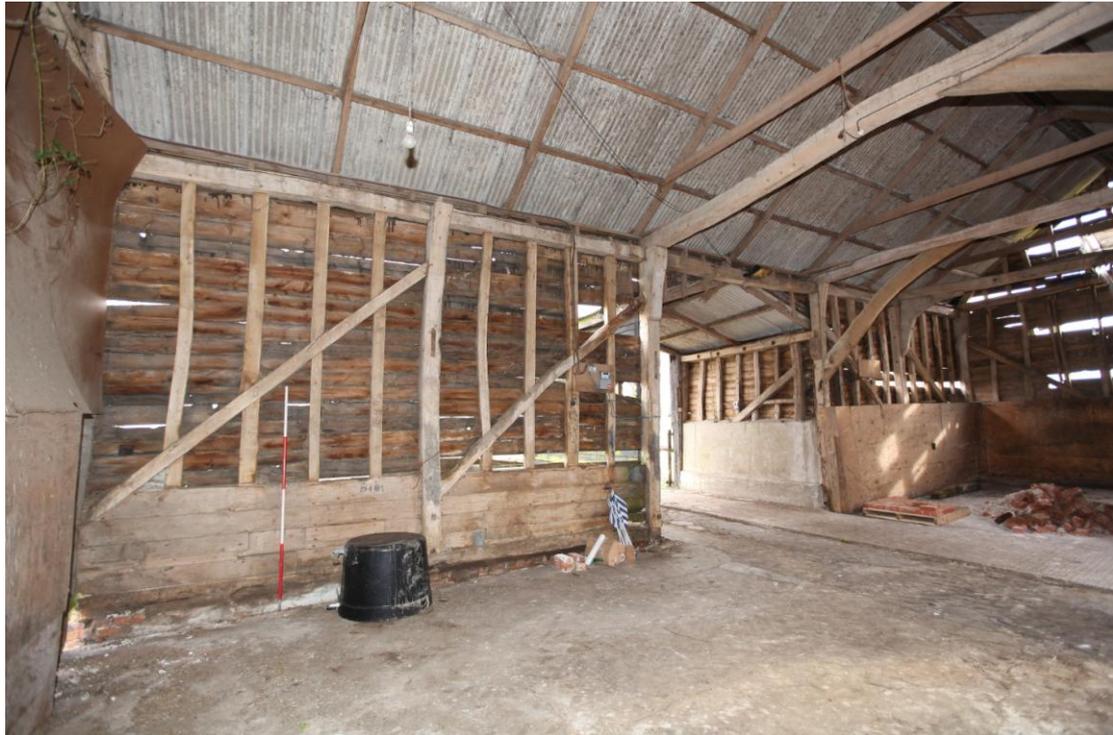
Illus. 11. The northern interior of the barn (1) from its south-western corner showing the original porch of the central bay and the straight, diagonal primary wall braces.

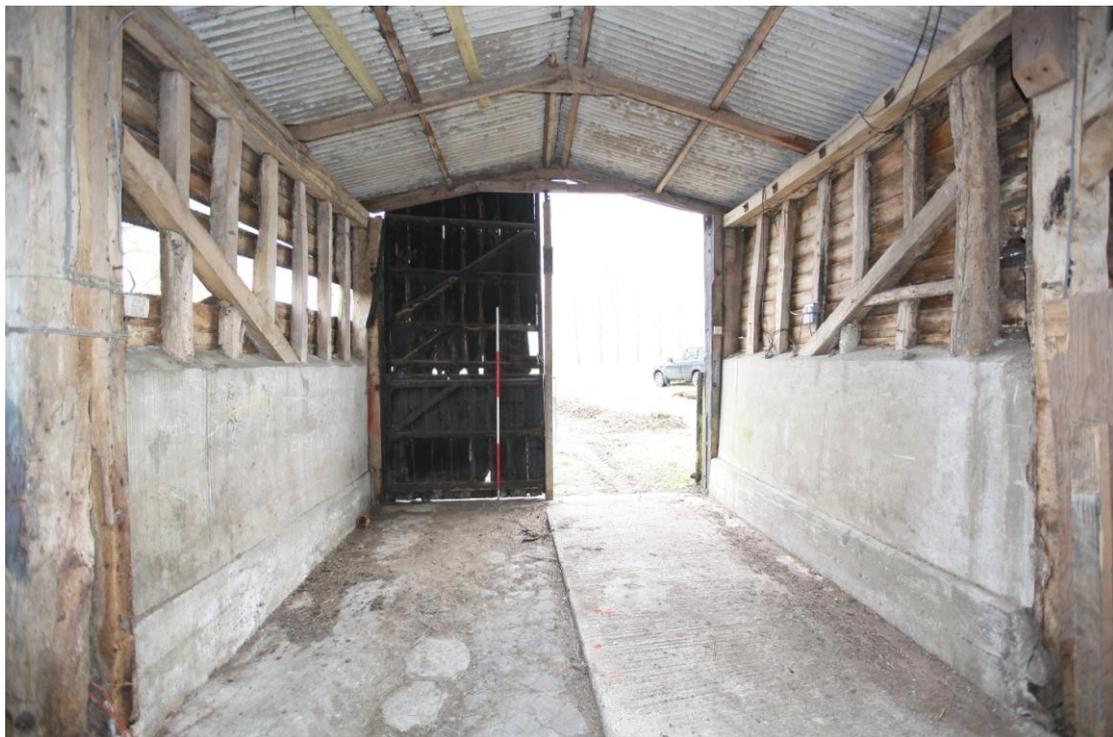
Illus. 12. The interior of the original northern porch of the barn (1) seen from the south and showing its 20th century concrete and bitumen floor. The porch was designed to increase the length of the threshing floor rather than as a principal entrance.
