**Barn at  
Page's Green Farm,  
Wetheringsett, Suffolk  
WCB 066**

**Historic Building Record**

# **Barn at Page's Green Farm, Page's Green, Wetheringsett, Suffolk**

## **Historic Building Record**

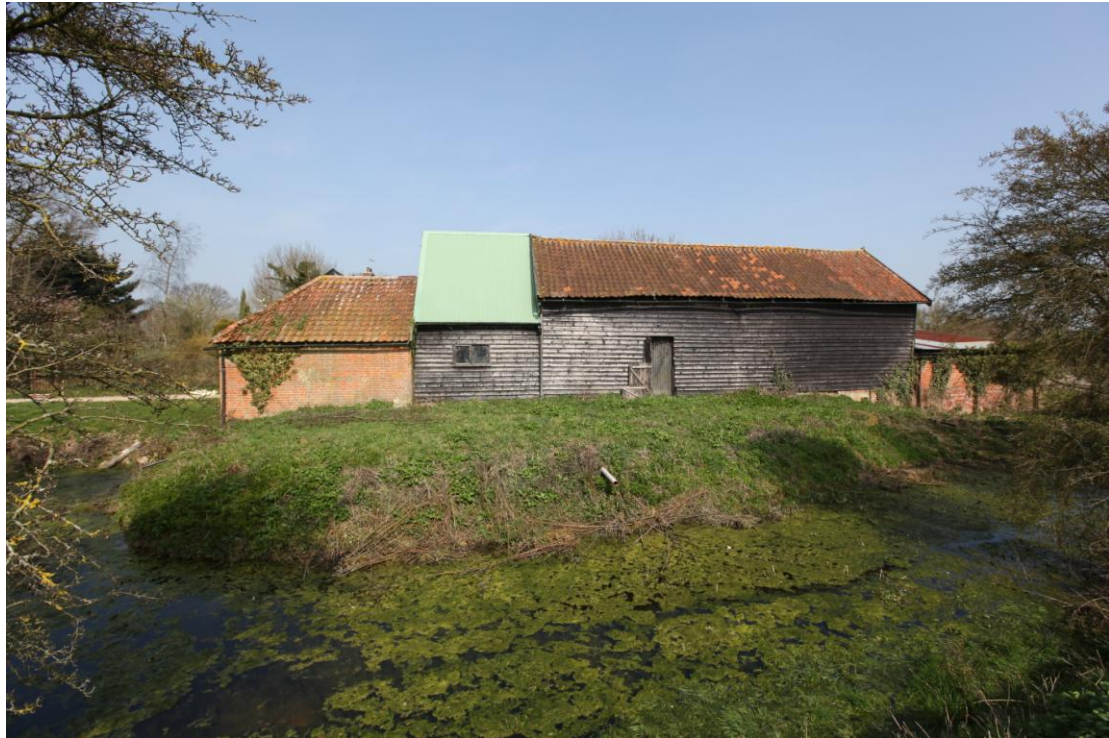
**Illus. 3. Exterior of barn complex from south showing L-shaped pond in foreground with, from left to right, the mid-19<sup>th</sup> century brick shelter-shed (3), the early-19<sup>th</sup> century stable with rebuilt steeply-pitched roof (2), the early-17<sup>th</sup> century timber-framed barn with integral stable (1) and the second mid-19<sup>th</sup> century brick shed (5). The present weatherboarding dates only from the 20<sup>th</sup> century.**

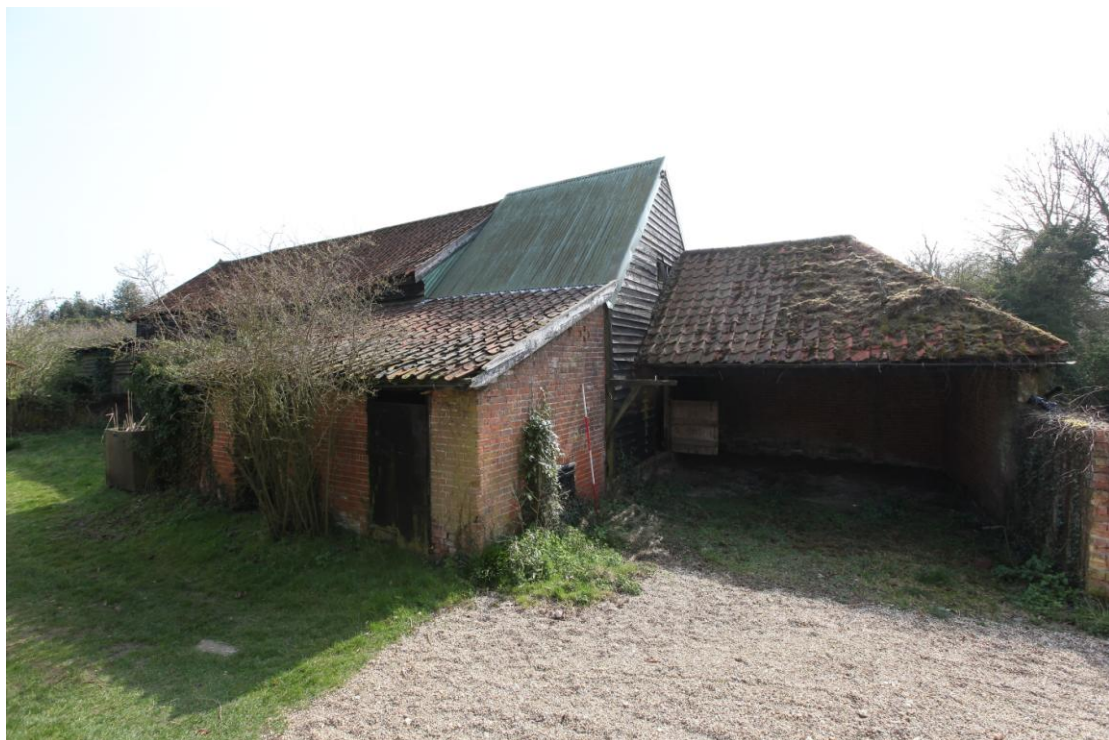
**Illus. 4. Exterior from north-west showing the two lean-to brick stables (4a & 4b) to left) with the open shelter shed (3) to the right and the timber-framed barn (1) and steeply pitched later stable (2) in the rear.**

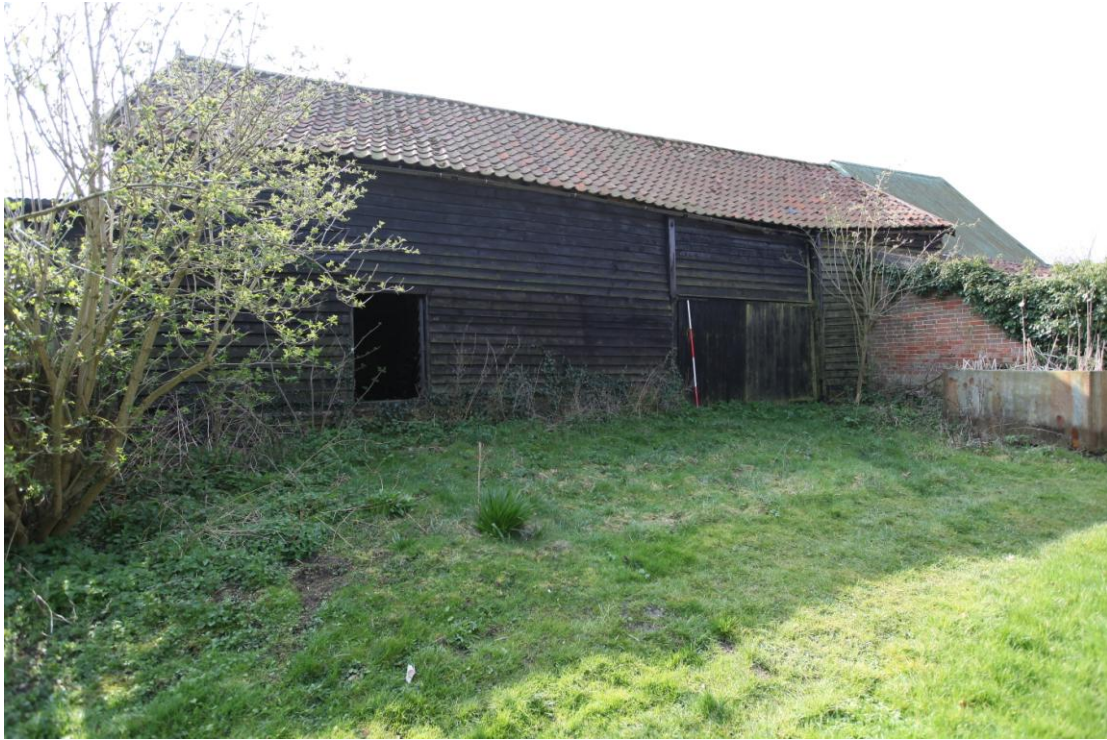
**Illus. 5. Northern exterior of barn (1) showing the position of the original entrance doors to the right (now reduced in height) and the original door to the stable (1a) to the left.**

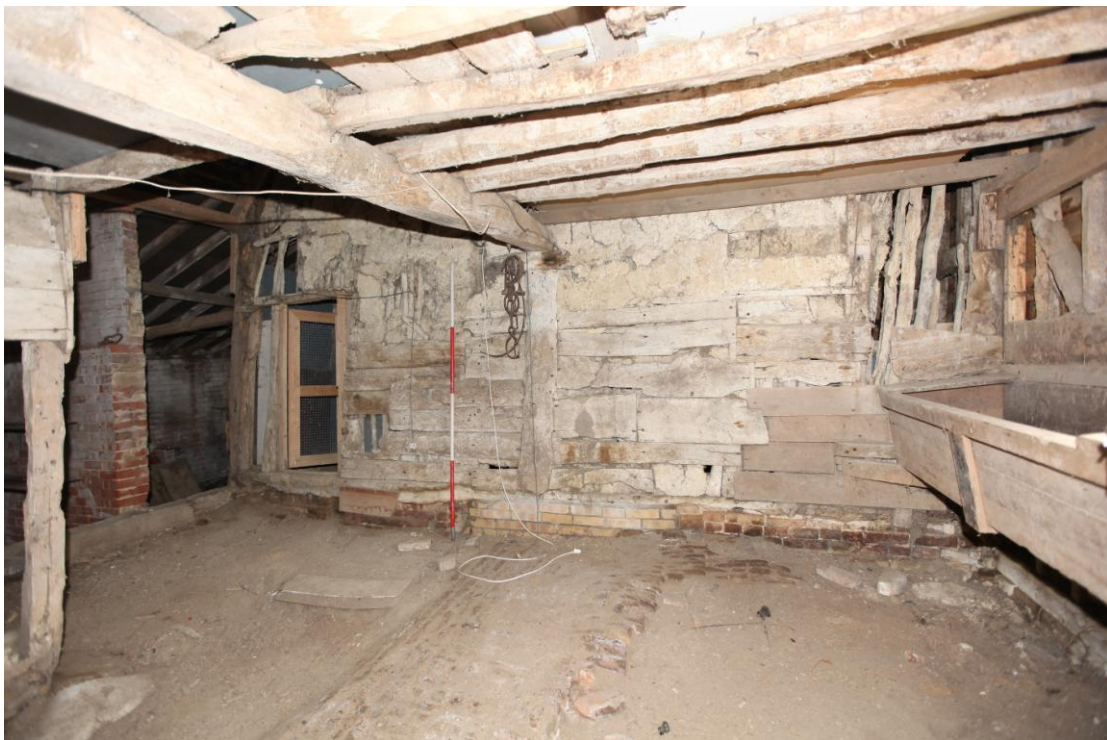
**Illus. 6. The interior of the stable extension (2) from the west showing its hay loft with 20<sup>th</sup> century boarded manger to the right and the secondary horizontal boarding to the external gable of the barn (1).**

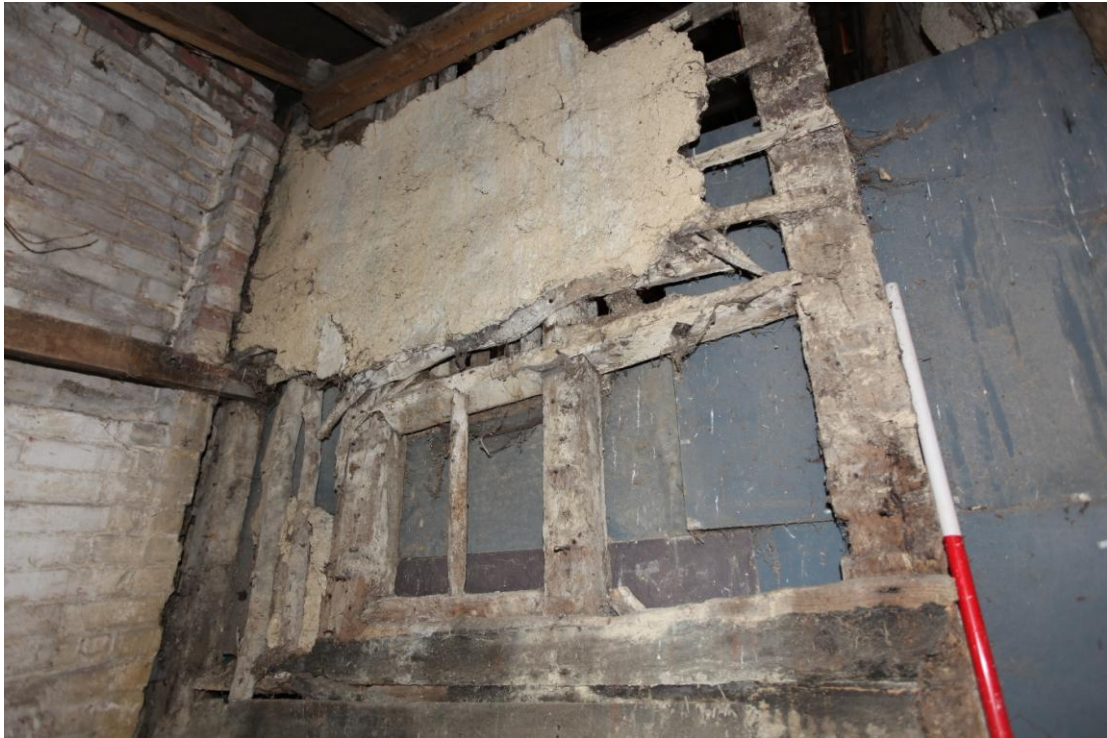
**Illus. 7.** Detail of the original external roughcast plaster and wattle-and daub to the northern exterior of the western bay of the barn (1) seen from the 19<sup>th</sup> century brick lean-to stable (4a) and showing the secondary late-17<sup>th</sup> century window with an original diamond mullion.

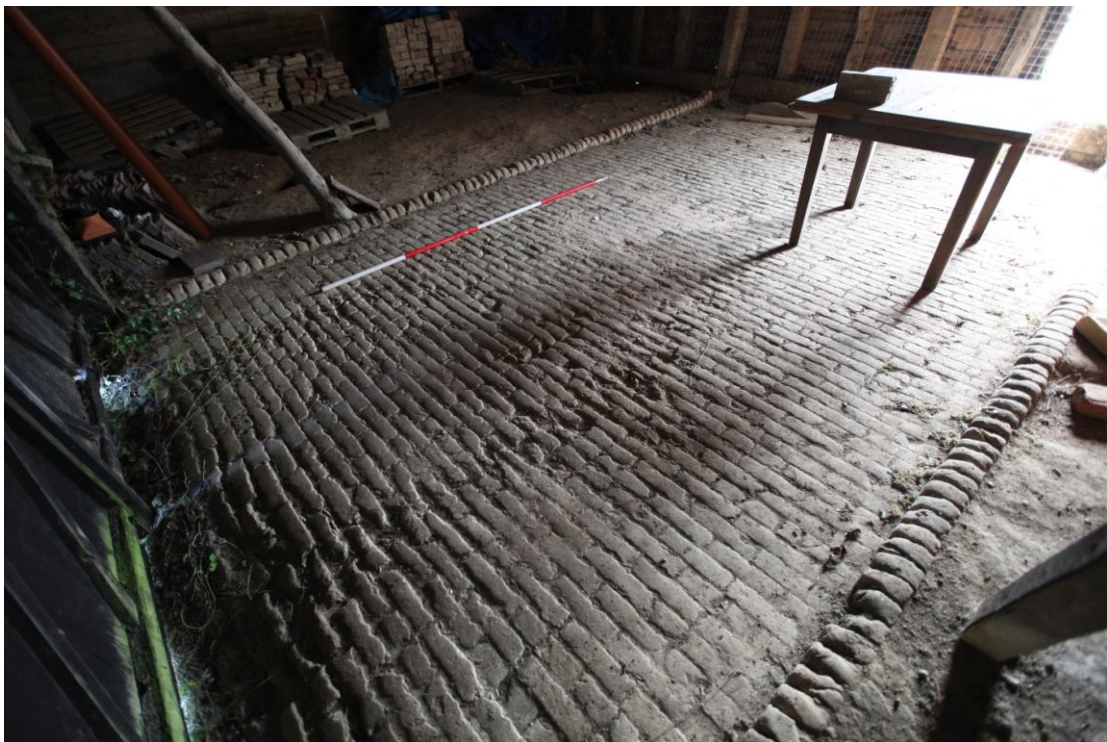
**Illus. 8.** Detail of the unusually well preserved gault-brick threshing floor of the barn (1) seen from north-west.

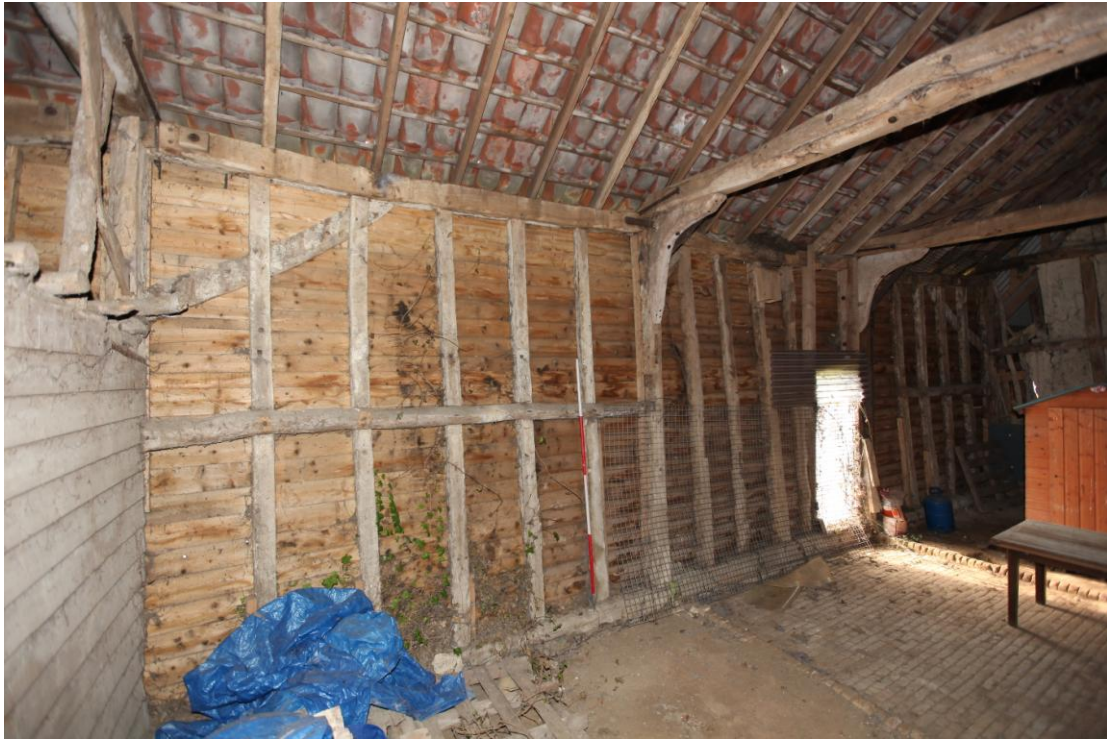
**Illus. 9. The southern interior of the barn (1) showing the position of the rear doorway in the central threshing bay (now blocked with re-used studs). Note the externally trenched wall braces and the partition to the stable (1a) to the left.**

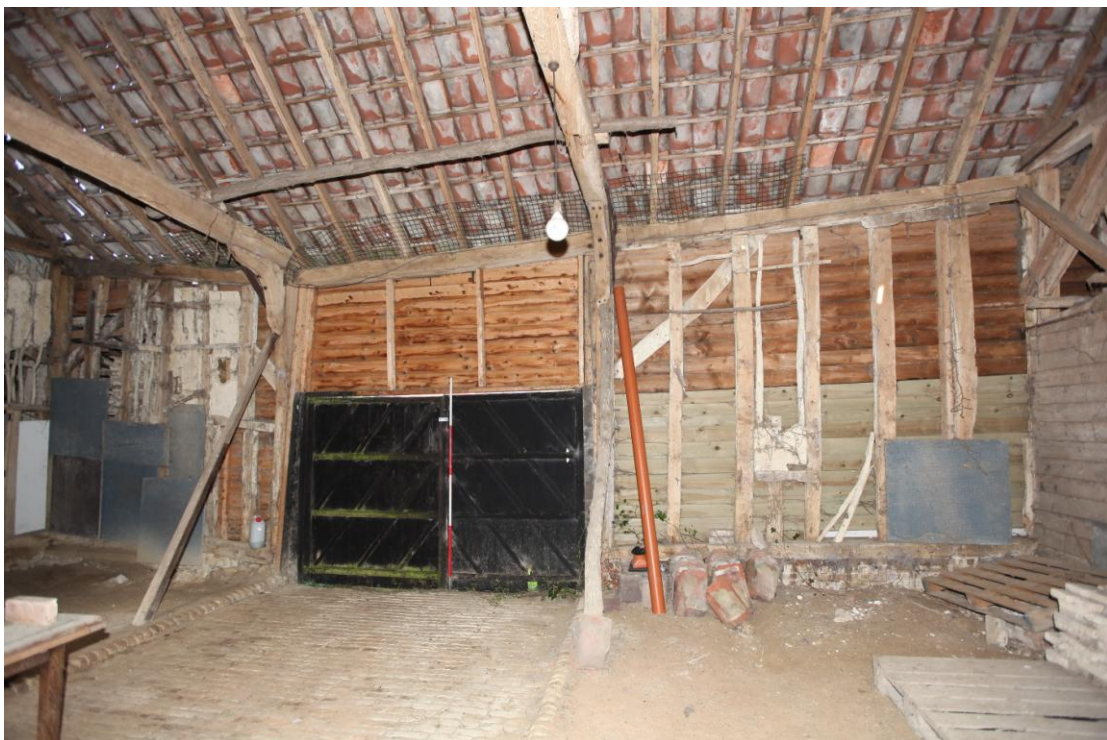
**Illus. 10. The northern interior of the barn (1) showing the position of the original full-height entrance doors in the central threshing bay. The arch-braces to the tie-beams were replaced by bolted knee-braces in the 19<sup>th</sup> century. Note the different pattern of externally trenched wall braces to that of the southern elevation above.**

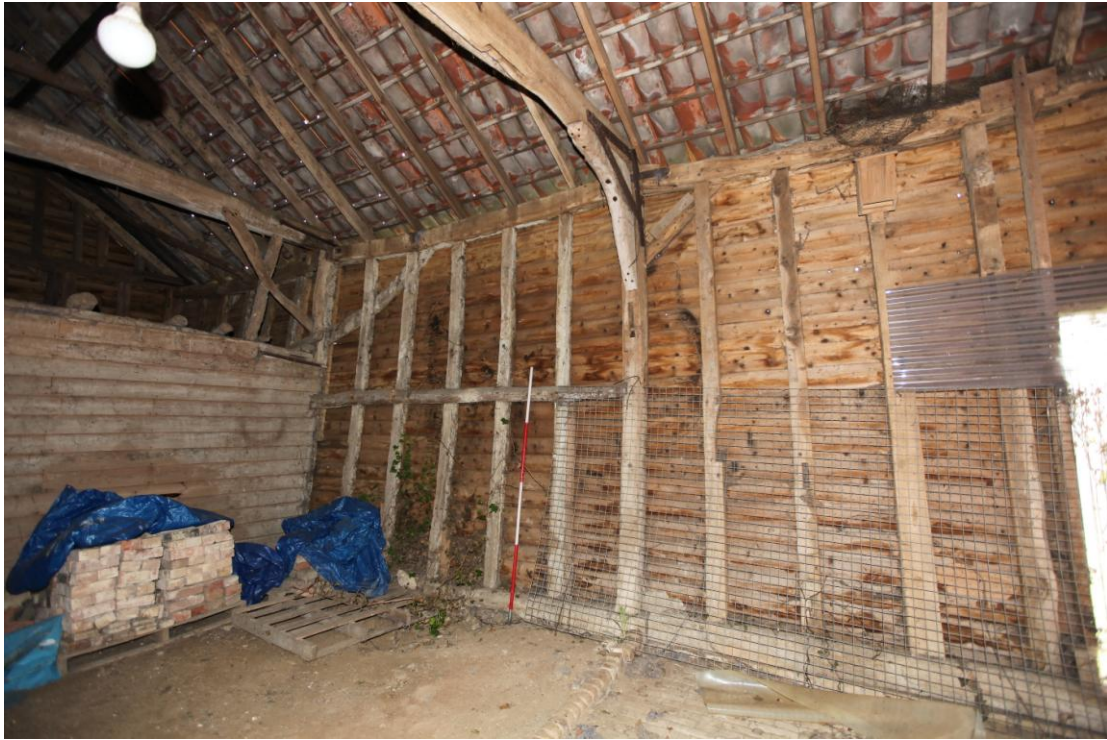
**Illus. 11. The internal south-eastern corner of the barn (1) showing the partition to the original stable bay (1a) to the left. This partition formerly rose to the tie-beam but has been removed above the mid-rail to afford internal access to the hay loft.**

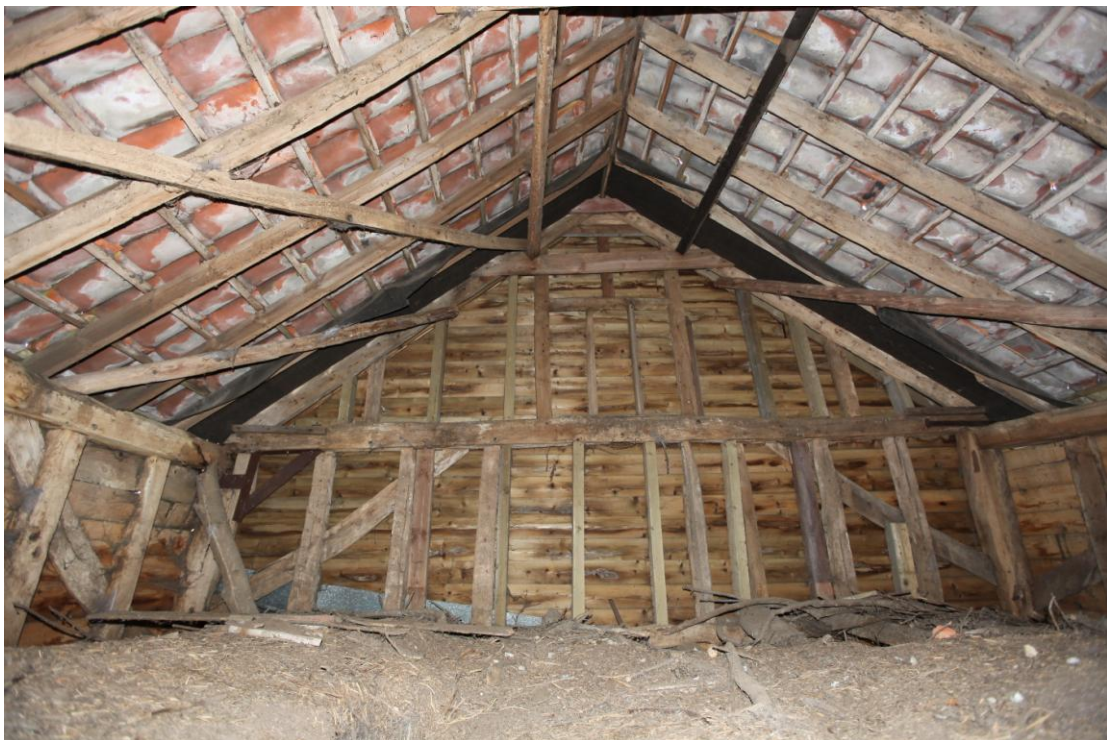
**Illus. 12. The internal eastern gable of the barn from the hay loft above the stable bay (1a) showing externally trenched corner braces and a blocked original window with tenoned and pegged lintel above the tie-beam.**

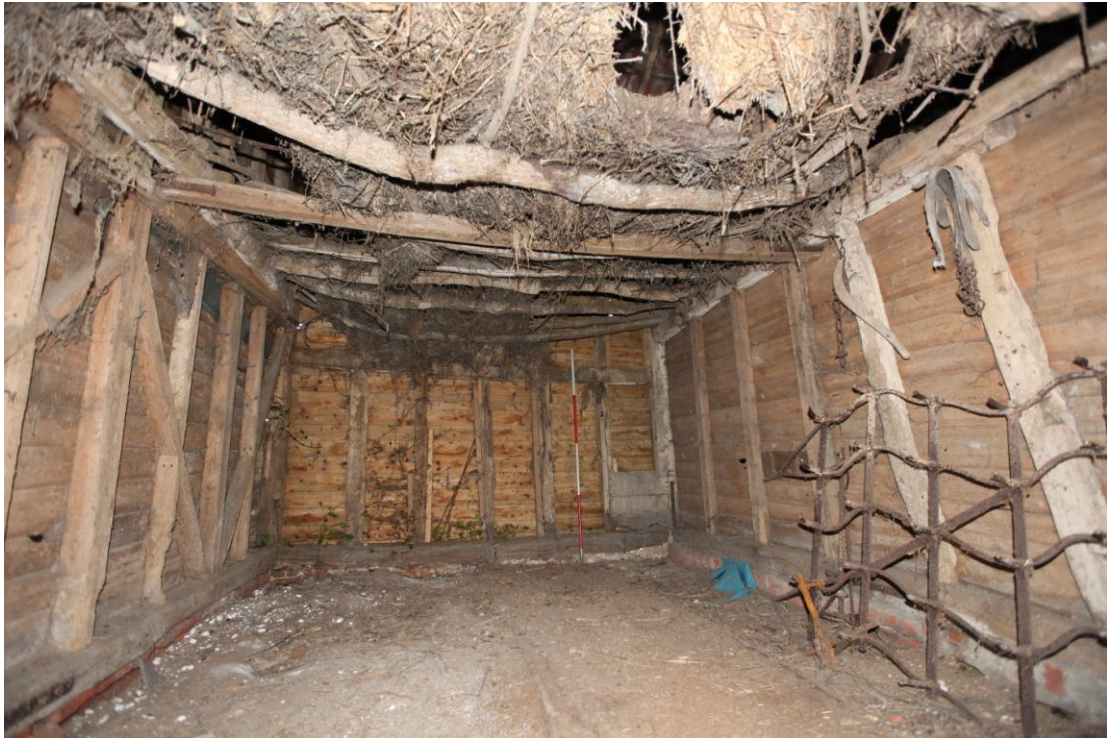
**Illus. 13. The interior of the original stable bay (1a) from the north showing the later lodged round-wood joists of the hay loft with the partly original internal partition to the barn (1) right and rebuilt eastern gable (with original mid-rail) to the left. There is no evidence of an original rear door in the southern elevation, or of any original windows at this level.**

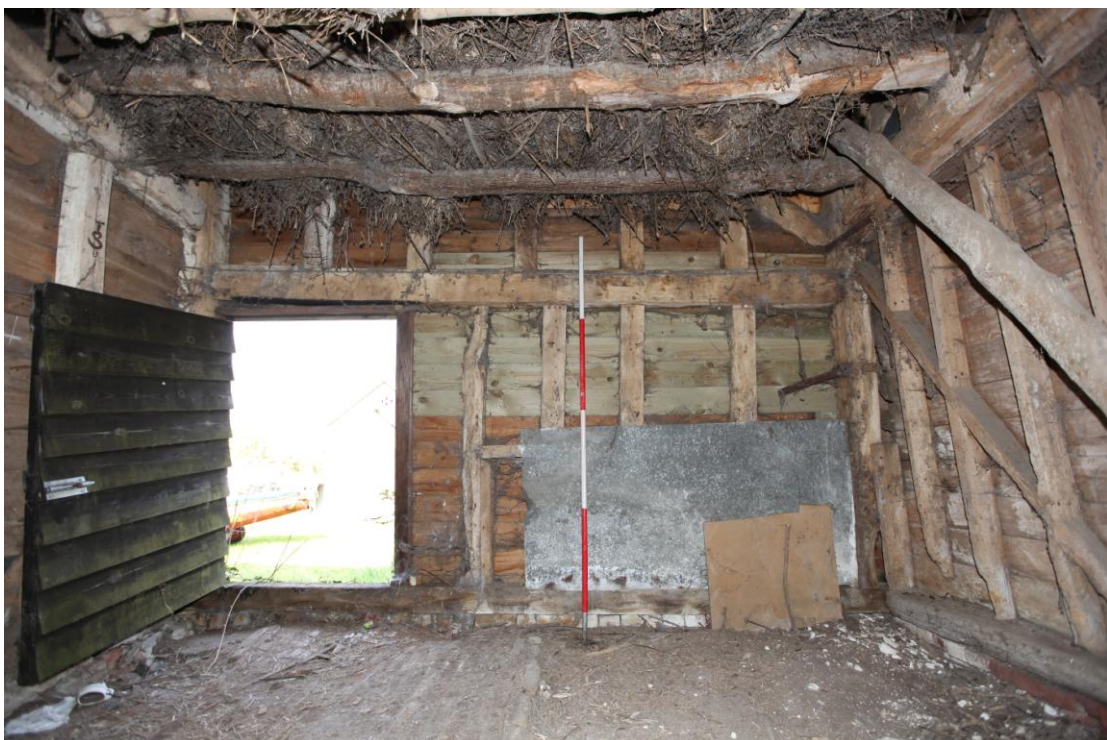
**Illus. 14. The northern interior of the stable bay (1a) showing the original entrance doorway to the left (with a jamb mortise against the storey post) and the slightly rearranged studs to its right.**
