**Agricultural Buildings at
Abbey Farm,
South Elmham All Saints, Suffolk
SEN 063**

Heritage Asset Assessment

April 2011

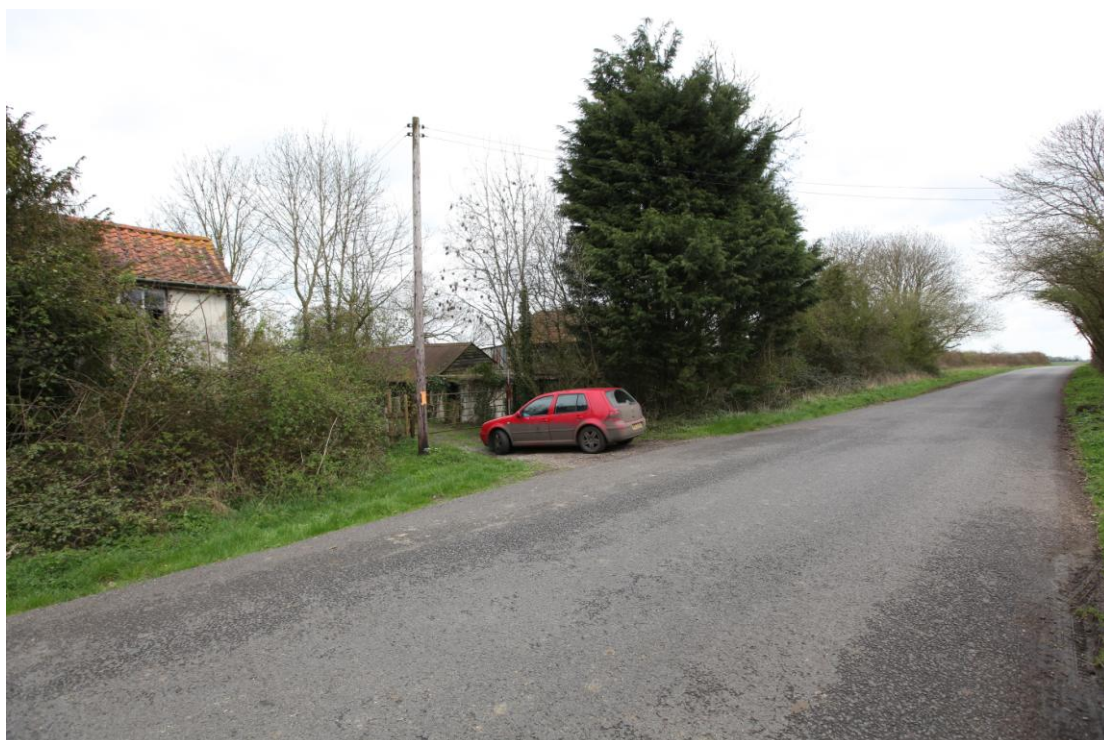
Illus. 1 General view of the site from St Margaret's Road to the west showing the site entrance in the centre with the barn complex to the right and the abandoned former farmhouse to the left.

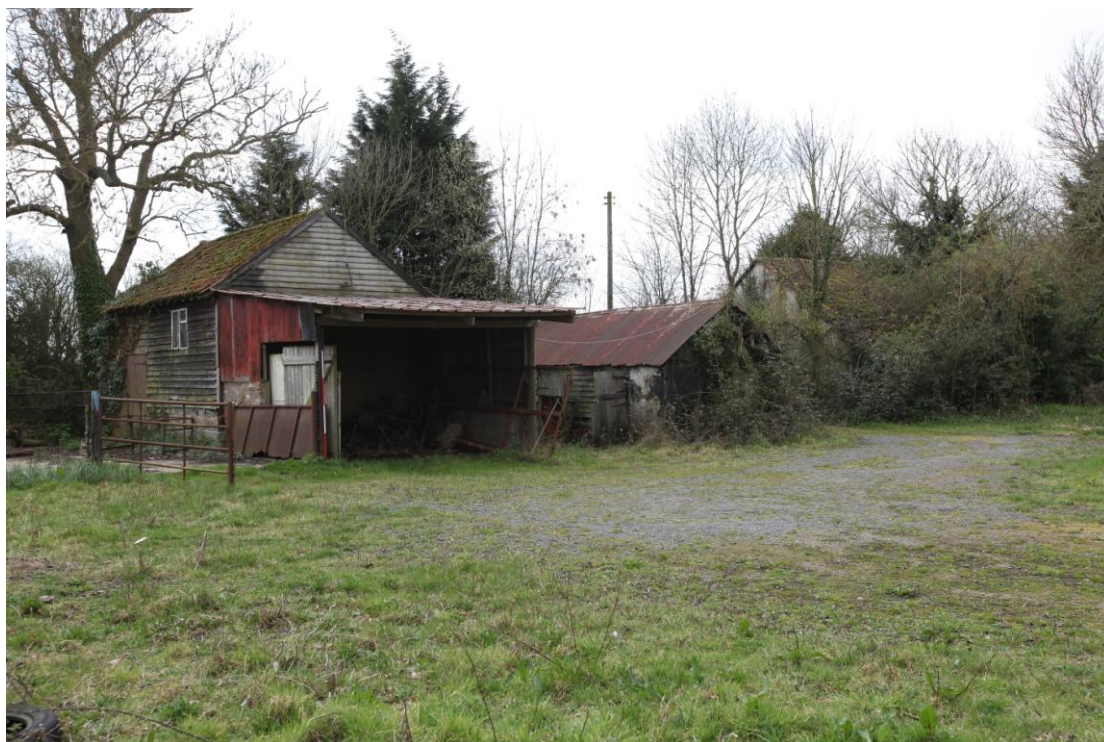
Illus. 2 The exterior of the barn complex from the north-east showing the barn (1) with the open shelter (5) adjoining its northern gable to the left and the clay-lump shed (4) to the right. The former farmhouse is visible in the trees to the rear.

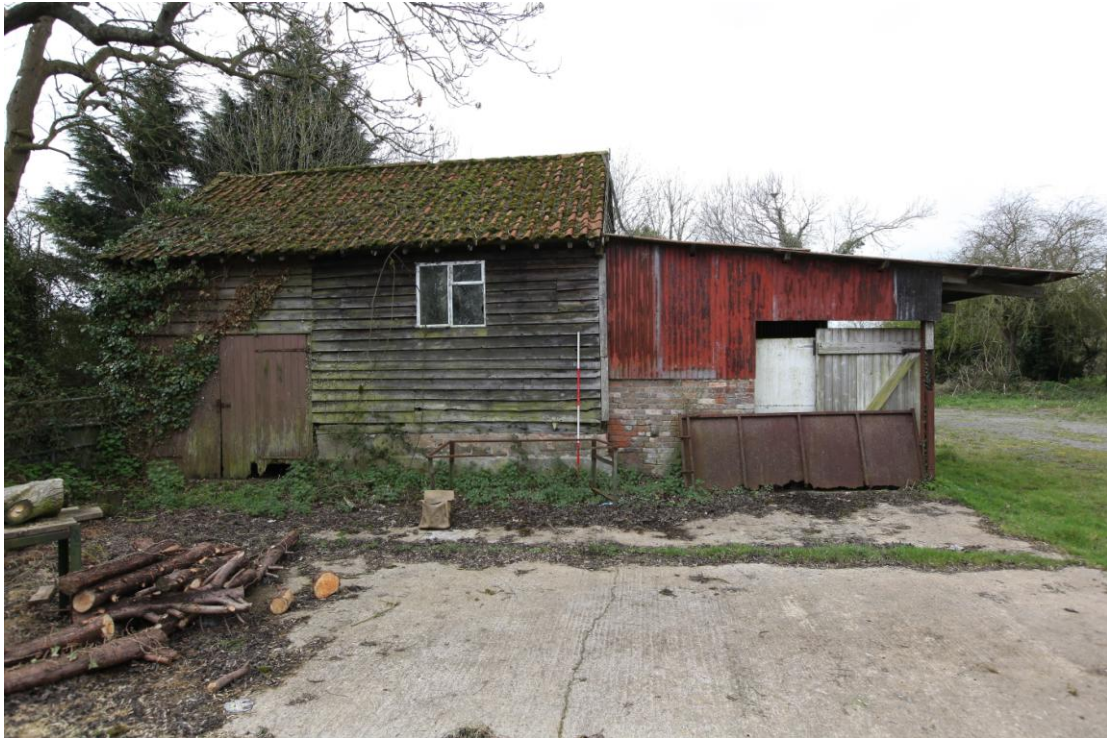
The southern bay contained the threshing floor (of which no trace remains) and was entered by full-height doors from the east. The original door jambs survive *in situ*, as indicated in figure 6 (both tenoned and pegged to the ground-sill which they interrupt), but the opening has been reduced in height and the present double doors date only from the 20th century. The small rear door of 1 m (3.5 ft) in width immediately opposite is an original feature with a (probably late-19th century) half-hung door. Barns typically possessed small rear doors in this manner, sufficient to create a through-draught for threshing and winnowing, until vehicle thoroughfares became fashionable with the advent of mechanical threshing during the mid-19th century. It is uncommon for the principal entrance of a barn to face away from its farmhouse.

Illus. 3 The eastern exterior of the barn (1) showing its principal entrance doors (reduced in height) to the left and the open shed (5) to the right.

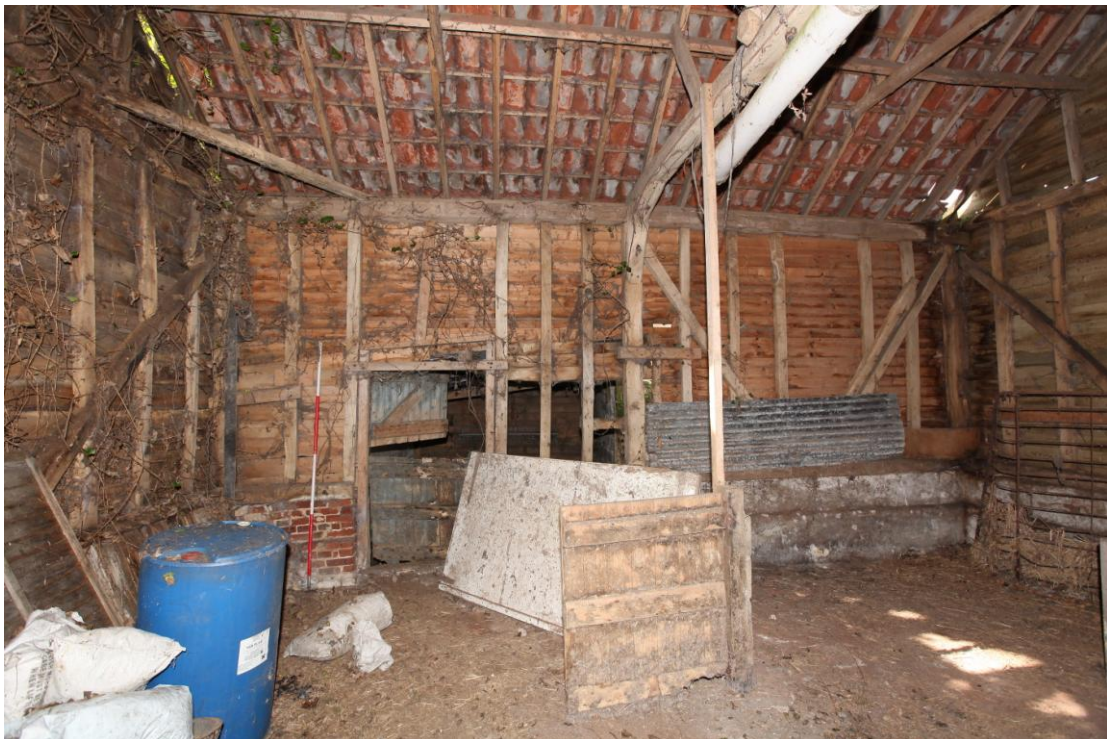
Illus. 4 The western interior of the two-bay barn (1) showing its original small rear doorway to the left with a section of exposed red-brick plinth. The oak studs respect the door, and the ground sill is tenoned and pegged to its jamb.

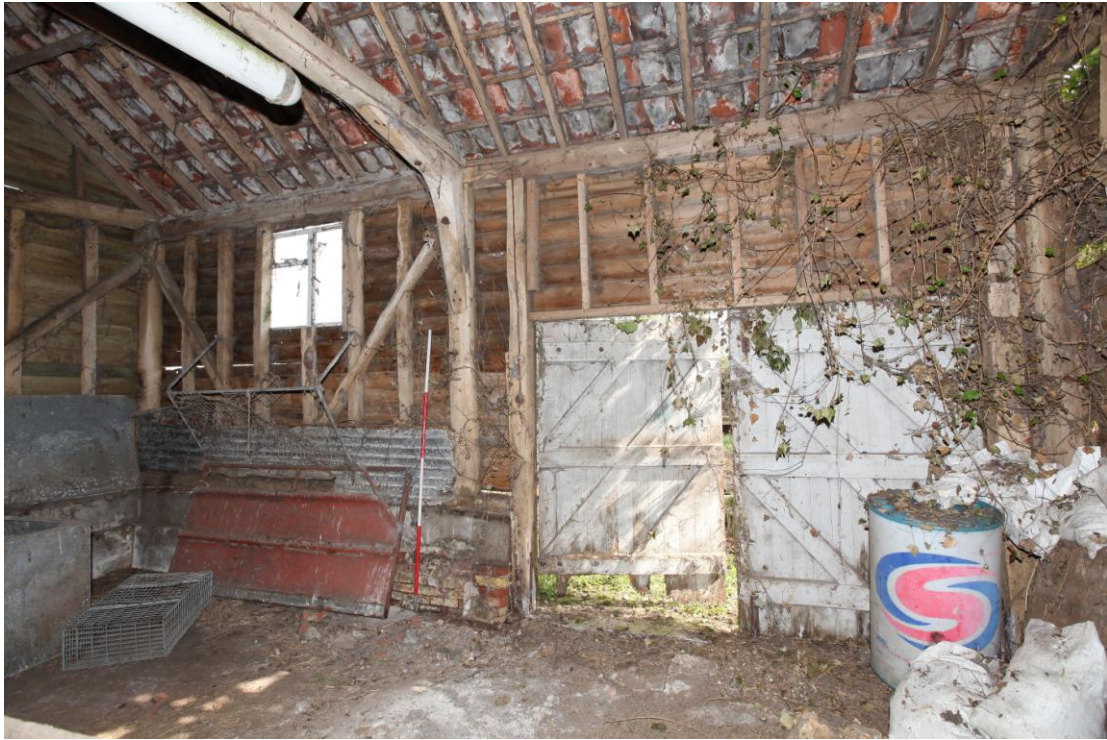
Illus. 5 The eastern interior of the barn (1) showing the position of the original full-height entrance doors to the right. The present doors and the narrow softwood studs above were inserted in the 20th century (along with the roof structure and section of roof-plate immediately above) but the jambs to left and right are original features.

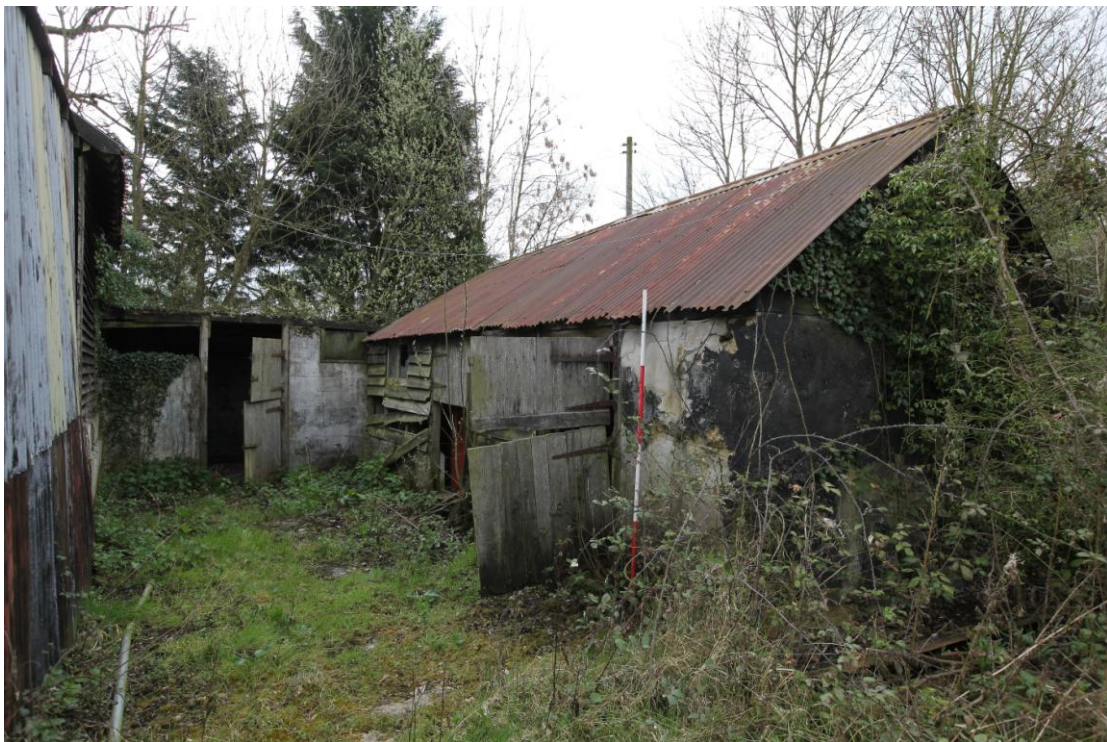
Illus. 6 The narrow central yard from the north showing the barn (1) to the left and the clay-lump shed (4) with its later southern extension (3) to the right. The 20th century cement-block shed (2b) is visible in the rear.

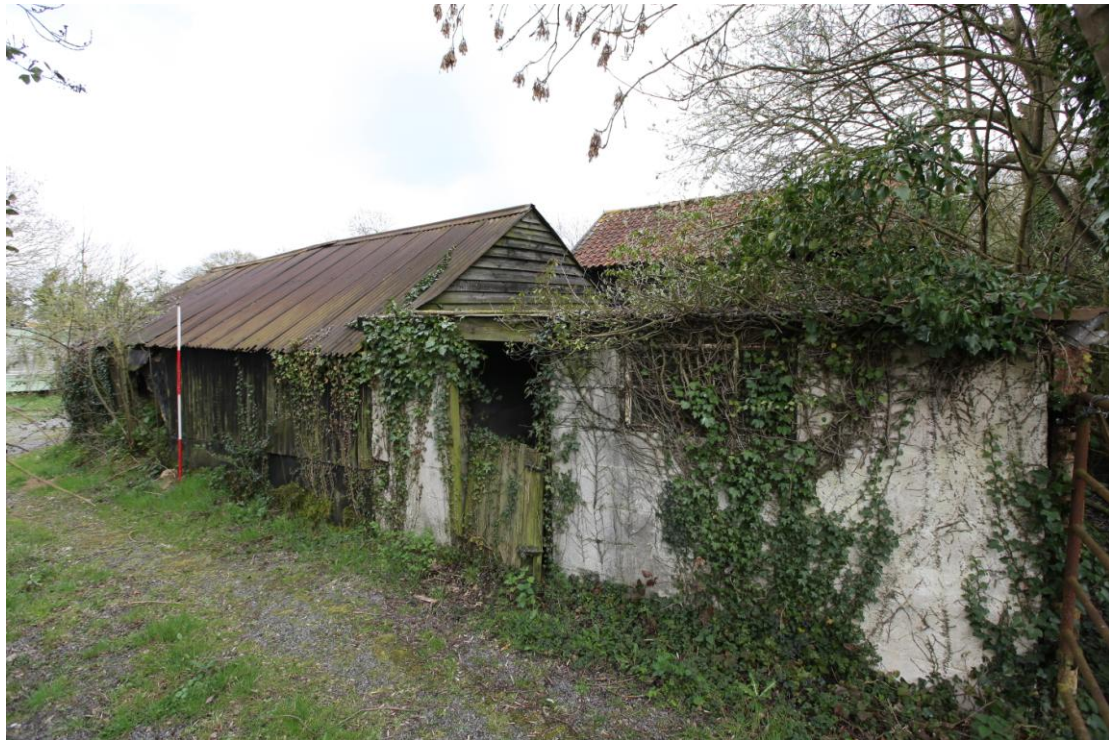
Illus. 7 The western exterior of the clay-lump shed (4) seen from the site entrance to the south-west showing the 20th century block-work shed (2a) to the right and the studwork addition (3) in the centre.

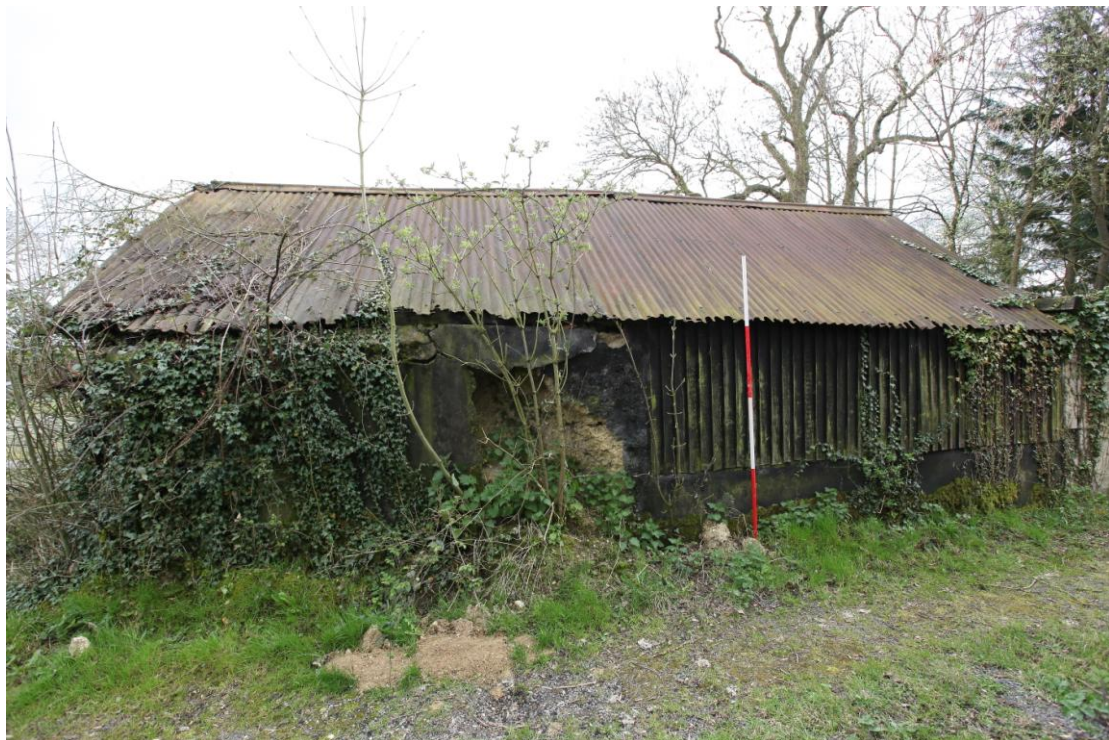
34. Detail of western exterior of clay-lump shed (4) showing decayed clay-lump fabric with cement render and repair & showing the studwork extension (3) to right.

Illus. 8 The western exterior of the clay-lump shed (4) showing its tarred daub with the vertical boarding of the studwork addition (3) to the right. A section of decayed clay-lump fabric is exposed to the left of the scale.

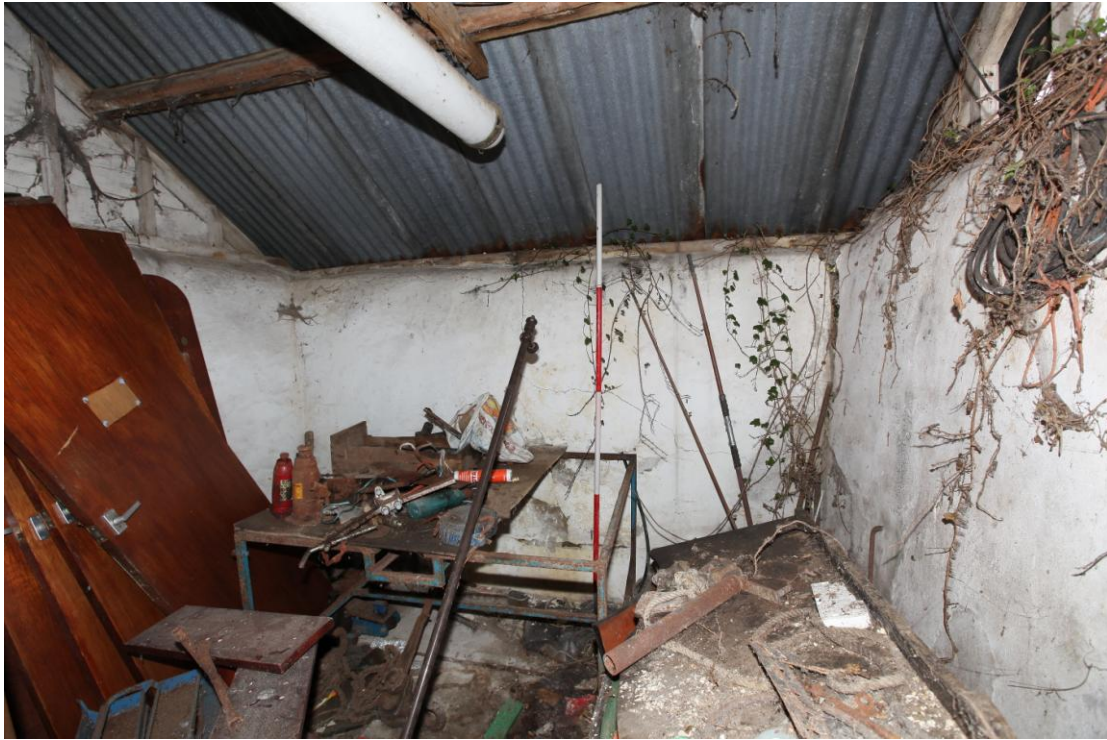
Illus. 9 The western interior of the clay-lump shed (4) showing its cement-rendered walls and 20th century corrugated iron roof.

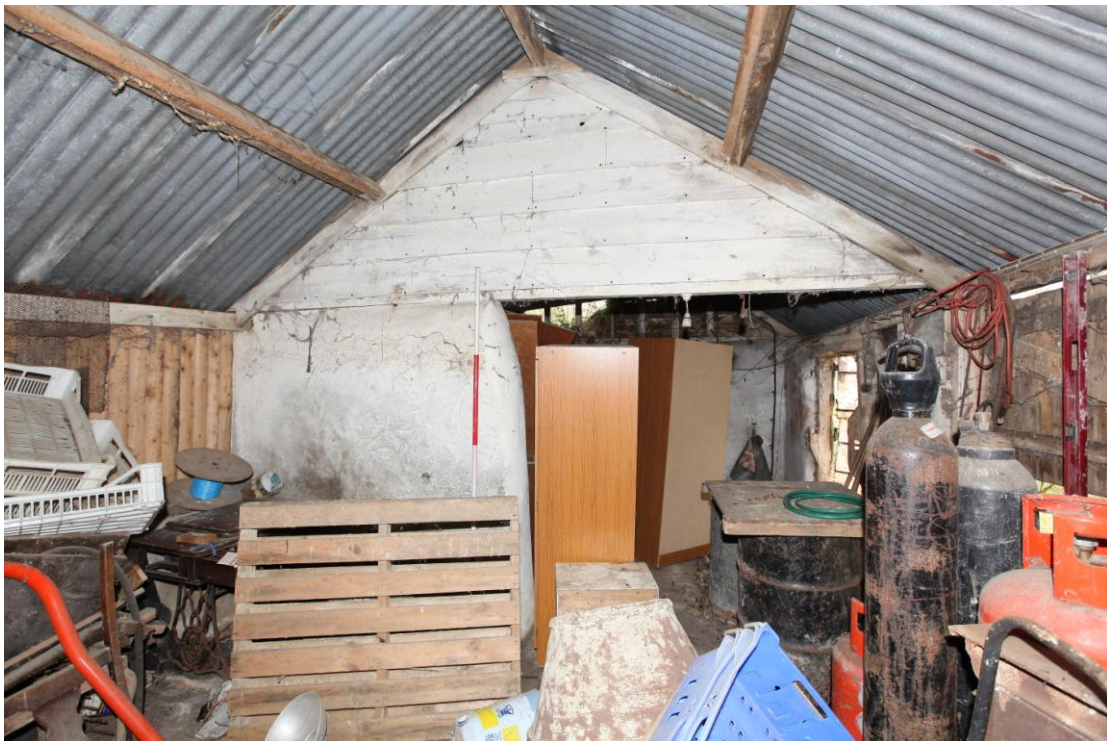
Illus. 10 The southern exterior of the clay-lump shed (4) as seen from the adjoining studwork shed (3) showing its boarded roof-gable and original clay-lump fabric to the left. The right-hand section of the gable has been removed to link the two sheds.
