**Barn at  
Mollett's Farm,  
Farnham, Suffolk  
FNM 019**

**Heritage Asset Assessment**

**Barn at  
Mollett's Farm,  
Main Road,  
Farnham,  
Suffolk  
(TM 366 602)**

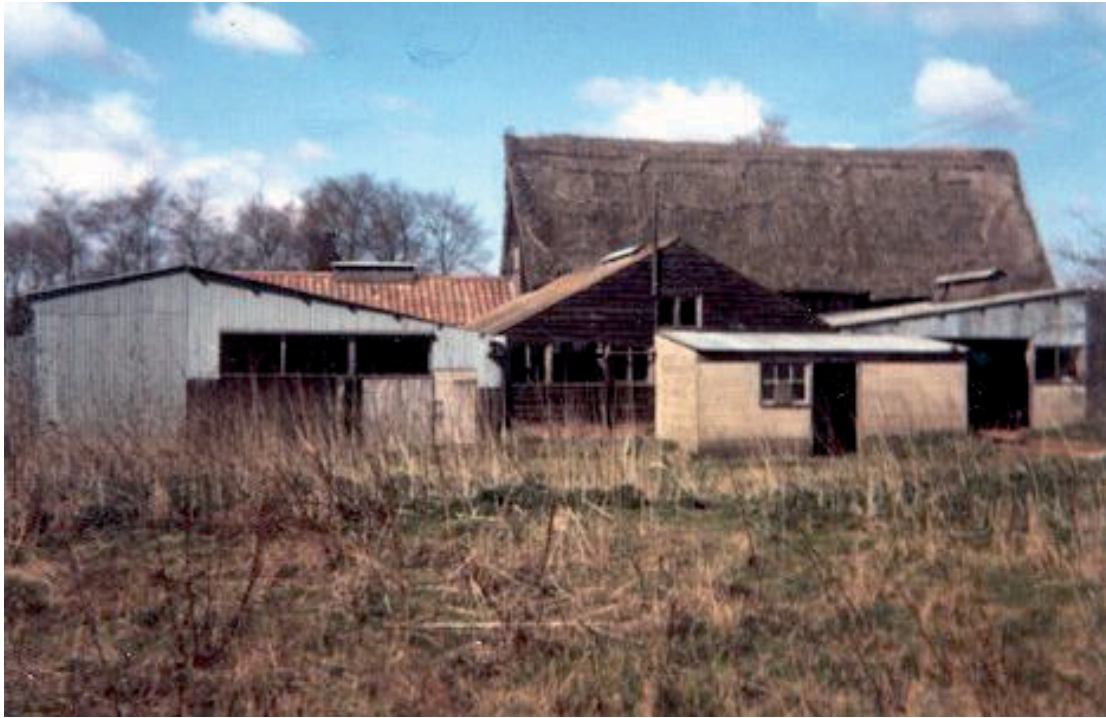
**Illus. 1** *Circa 1974.* The farm buildings from the east showing the original thatched roof of the barn (1) in the rear to the right and the pantiled roof of the southern shed (4) to the left. From an old photograph in the possession of the current owner.

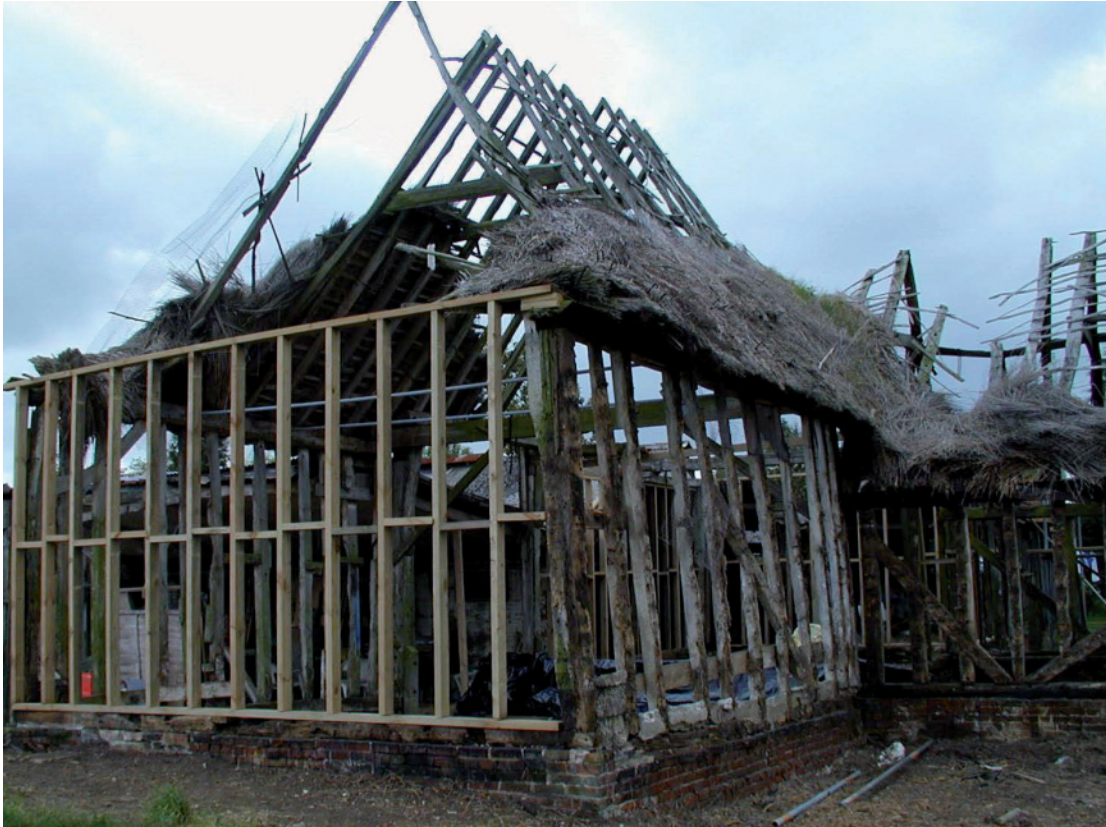
The building extends to 15.25 m in length by 5.8 m in width overall (50 ft by 19 ft), and its walls rise to 3.2 m (10.5 ft) at their roof-plates on low brick plinths above an internal floor of 20<sup>th</sup> century boarding. The roof is a shallow-pitched softwood structure of the 1990s covered in corrugated sheeting which replaced a steeply pitched thatched predecessor with clasped-purlins that was reputedly damaged in the 'hurricane' of 1987 (as shown in illustrations 1 and 2 of Appendix 2 below).

**Illus. 2** *Circa 1990s* old photograph. The exterior of the barn (1) from the north-west during storm repairs showing the remains of its original thatched clasped-purlin roof.

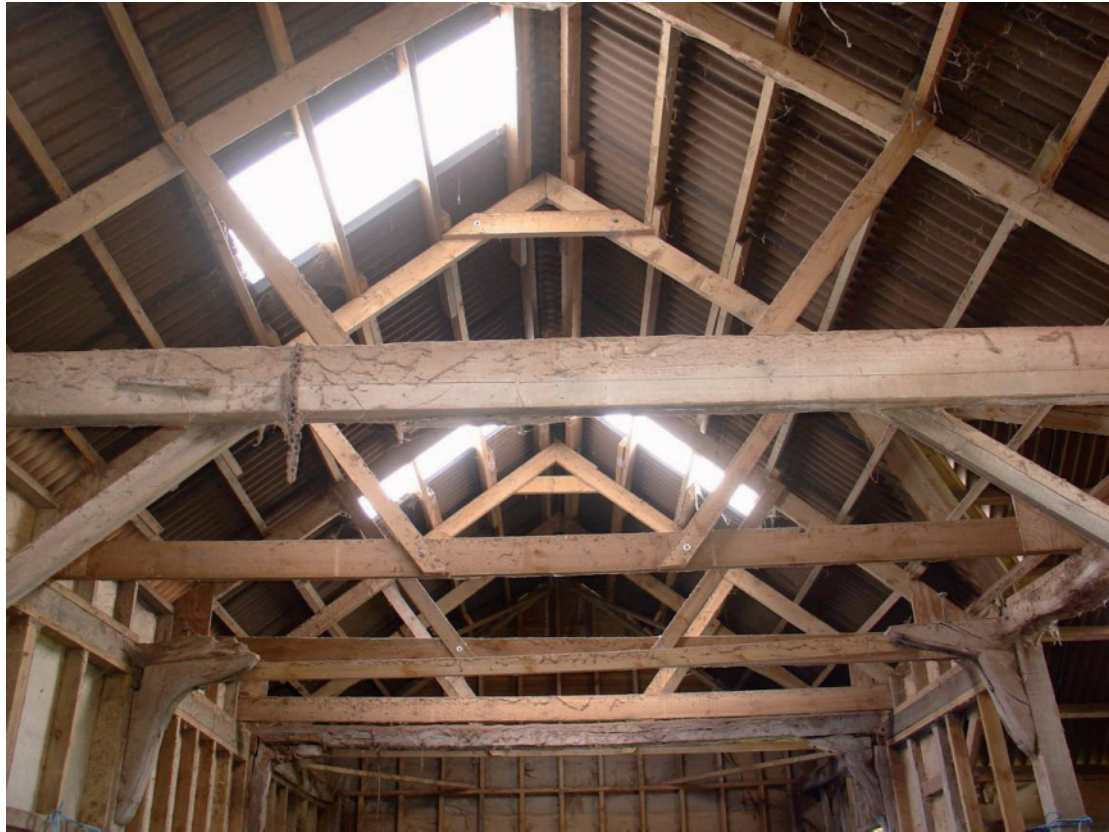
The new roof was hidden above a new boarded ceiling at the time of inspection, and most of the wall fabric was concealed behind wall-boarding inserted as part of a recent conversion. It was therefore impossible to determine the age and layout of the original barn, but photographs supplied by the owner suggest the three southern bays had been largely rebuilt in modern softwood, re-using old roof-plates and tie-beams with 19<sup>th</sup> century bolted knee-braces. A threshing floor or hard-standing of stone flags is understood to lie beneath the boarded floor of the penultimate northern bay, which evidently contained the barn's principal entrance. Parts of this floor are still preserved in the rear porch (which was designed to extend the length of the threshing floor rather than an entrance) and the original full-height doors appear to have faced east towards a farmyard adjoining the house. Flag stones of this kind were often salvaged from the pavements of Ipswich and other local towns in the late-19<sup>th</sup> and 20<sup>th</sup> centuries to serve as hard-standing for vehicles and may not have been used for threshing.

**Illus. 3 2006 old photograph. The interior of the barn (1) from the north showing the largely 20<sup>th</sup> century softwood timber of its walls and roof (all hidden by boarding at the time of inspection)**

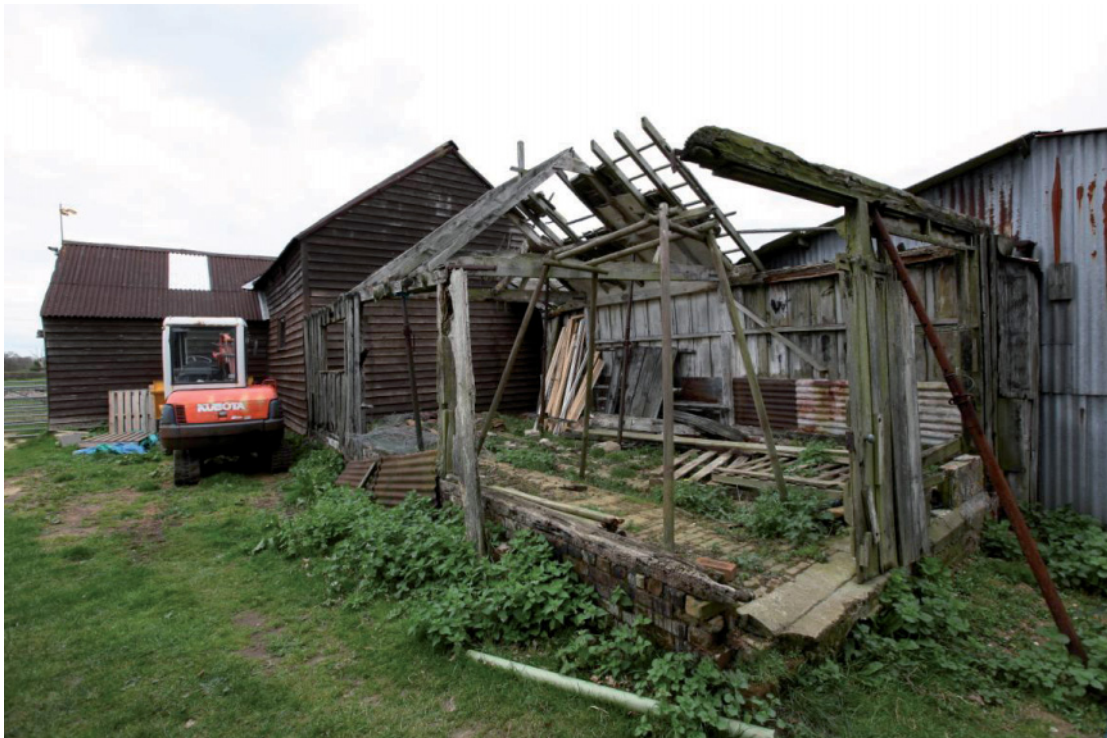
The single-storied shed attached to the barn's southern gable extends to 8 m in length by 4.25 m in width overall and is an addition of the mid-19<sup>th</sup> century. It had been stripped of its original pantiles and largely dismantled at the time of inspection, reputedly after sustaining storm damage in 1987, but retained a gault-brick floor with an axial drain to the west of its centre which suggests it was designed either as a cow-shed or stable. Given its large scale on

**Illus. 6** The exterior of the partly dismantled southern shed (4) from the south-west showing its post-and-rail wall fabric with the barn (1) to the left and the corrugated iron southern yard shed (5) to the right.

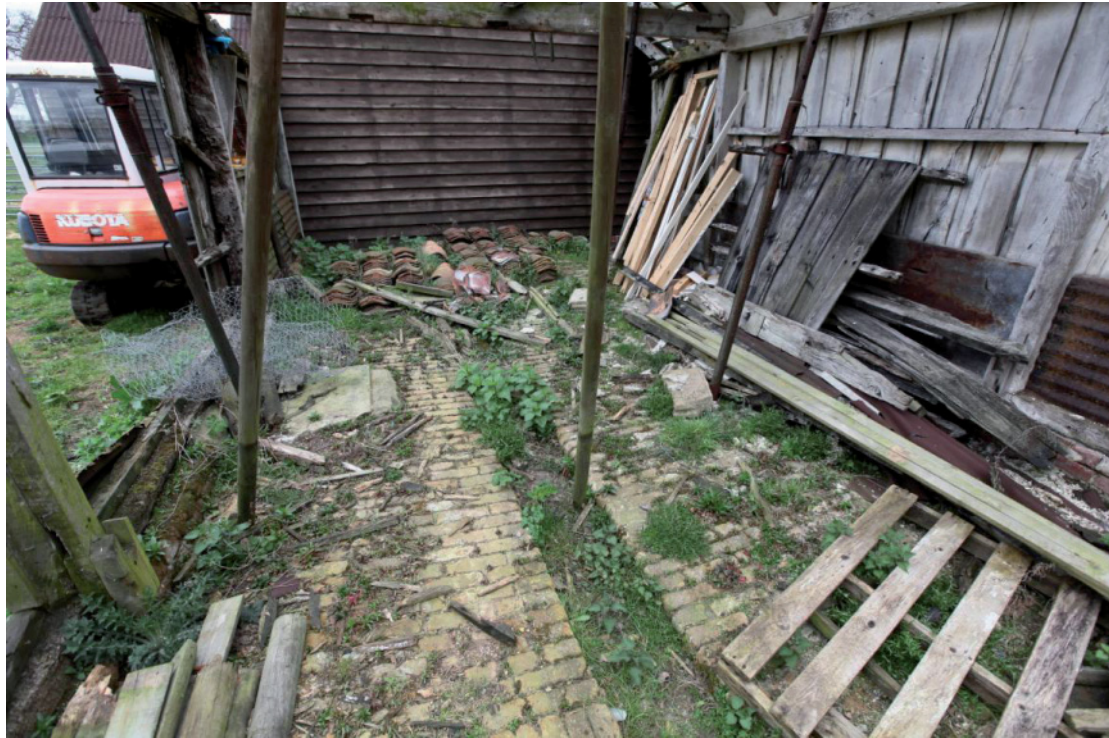
**Illus. 7** The interior of the southern shed (4) from the south showing the axial drain in its original gault-brick floor.

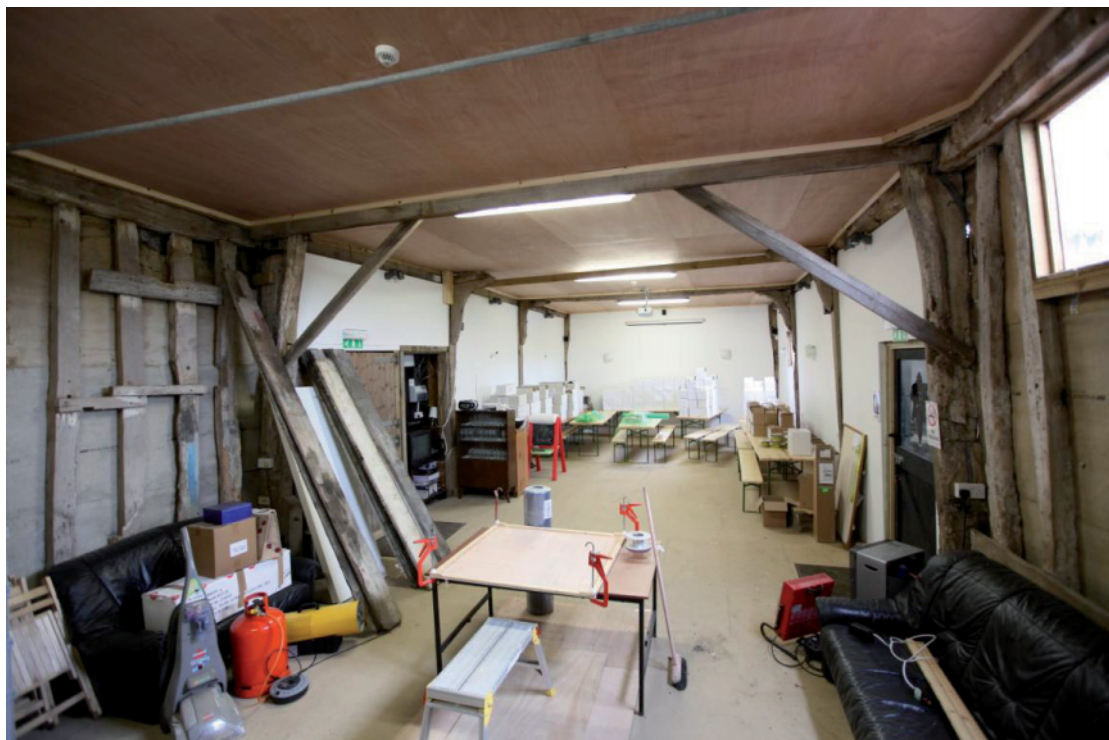
**Illus. 8** The interior of the barn (1) from the north showing the recent wallboard and ceiling board which conceals most of the timber structure.

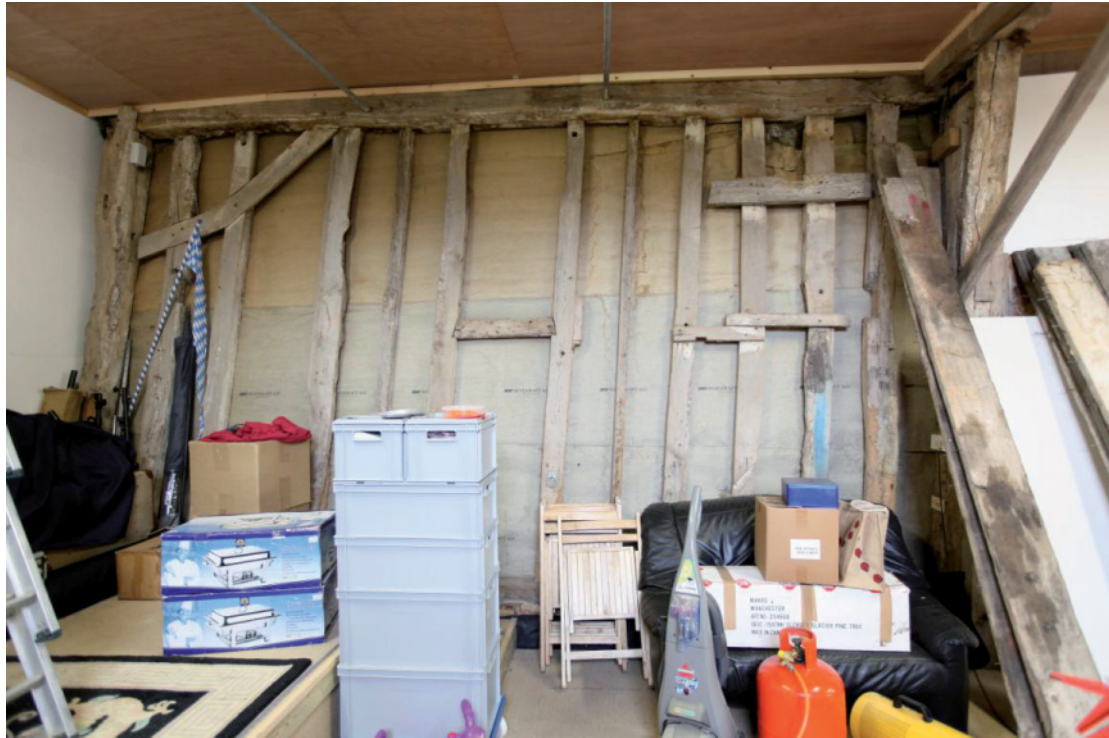
The northern gable also consists only of modern softwood (now hidden but visible in illustration 2) but the side walls of the northern bay (1a) remain intact and are exposed internally. The oak frame is typical of the early-17<sup>th</sup> century, with oak studs of heavy scantling and mortises for internally trenched reverse-cranked corner braces rising to the (missing) gable tie-beam and the roof-plates. A single brace remains *in situ* (to the east) but empty mortises and trenches reveal the positions of the others. A number of additional studs have been nailed between the original timbers (which are tenoned and pegged to the frame), and the southern end of the western elevation has been rebuilt with a diagonal primary brace (interrupting the studs) in the manner of the 18<sup>th</sup> and early-19<sup>th</sup> centuries. The fabric of the porch is identical to this reconstruction, suggesting a major refurbishment at this period. The unusual length of the northern bay, at 5.3 m (17.5 ft), suggests it may have been designed to accommodate the stables and hay lofts often found at the ends of 17<sup>th</sup> century barns in Suffolk, but this is not certain.

**Illus. 9** The eastern interior of the barn's northern bay (1a) showing the intact early-17th century frame with original reverse-cranked trenched brace to left. A number of additional studs have been inserted between the original timbers.

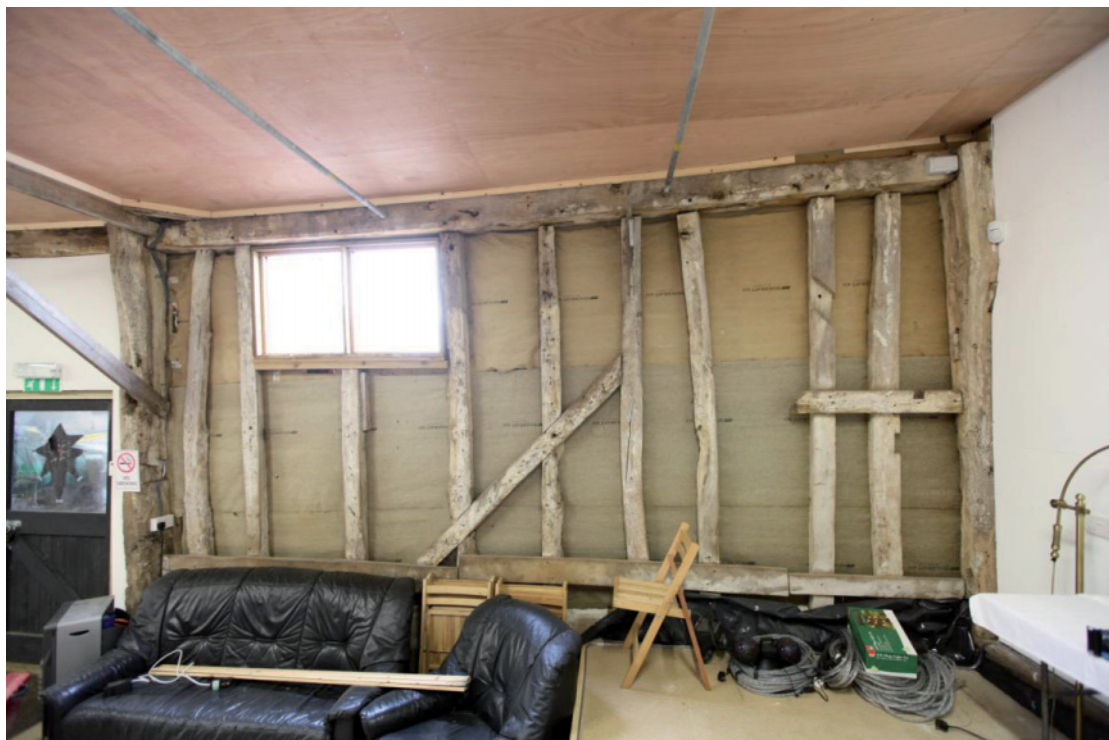
**Illus. 10** The western interior of the barn's northern bay (1a) showing empty trenches for a missing wall brace to the right and later framing with a diagonal primary brace in the style of the 18<sup>th</sup> and 19<sup>th</sup> centuries to the left.
