**An Historic Building Survey at
Town End House, 12 Chapel Lane,
Croxton Kerrial, Leicestershire**

ULAS Report No
2009-093. ©2009

Planning app: 06/01247/FUL

For: The Belvoir Estate

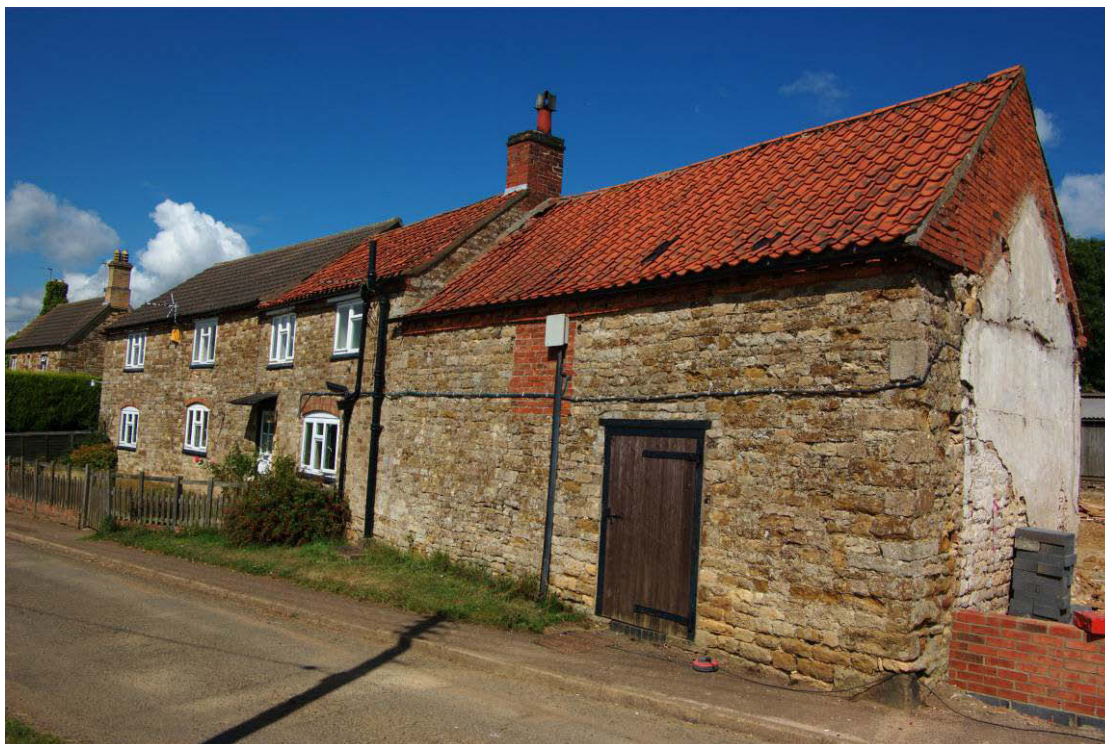
Figure 5 Frontage, barn to foreground. Looking north-west. An outbuilding to the east (RHS) has been demolished since the date of the original assessment.

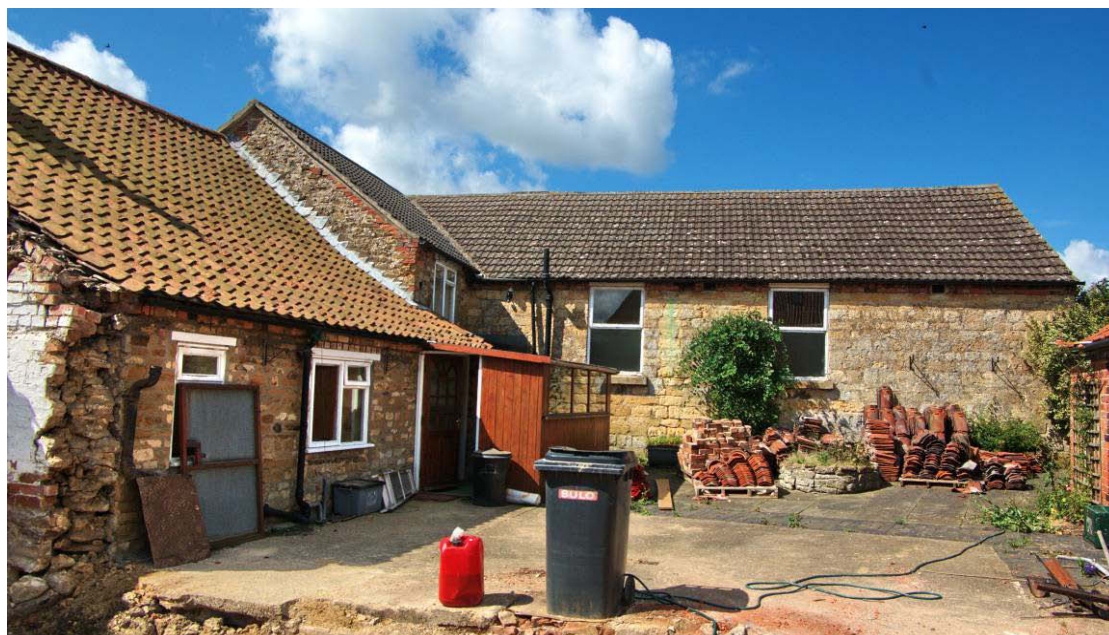
Figure 6 Looking west. Rear of barn, east unit, side of chapel. An outbuilding attached to the wall scar on the extreme left hand side has been demolished since the date of the assessment.

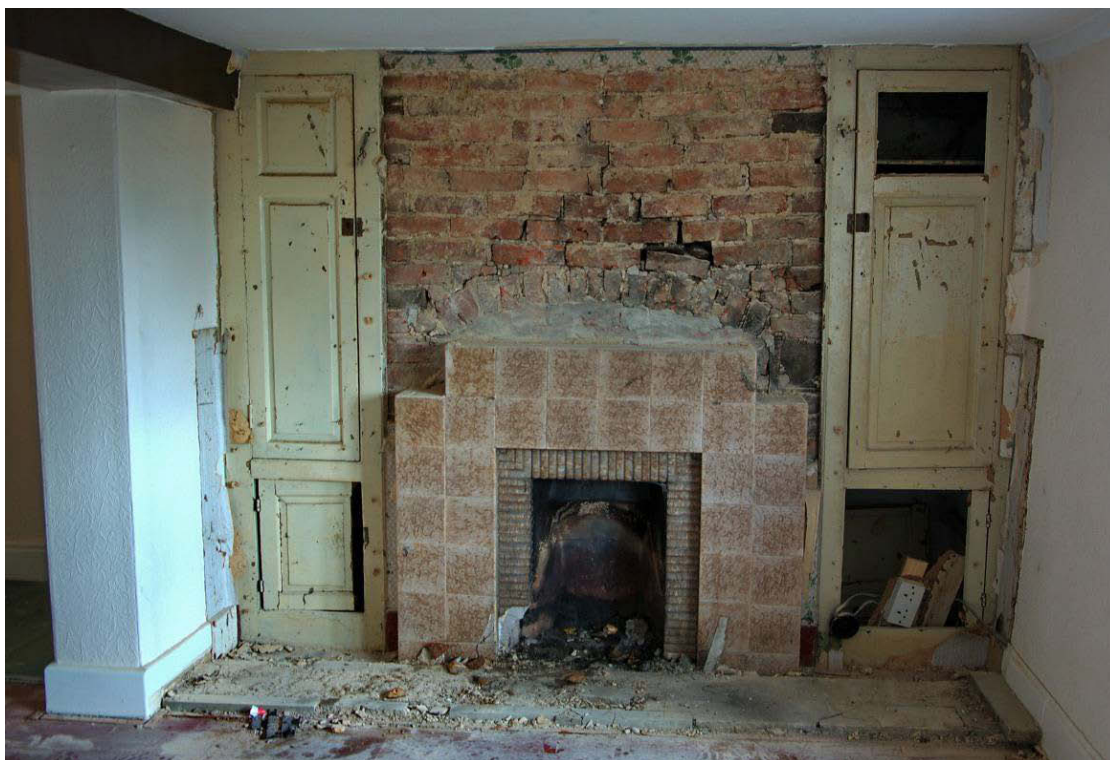
The removal of modern panelling revealed a fireplace and side cupboards. The upper brickwork appeared to be of 19th century date, probably contemporary with the side cupboards. The chimney breast for the fireplace had undergone some structural slippage, perhaps with failure of a lintel spanning the fireplace, and the brick arch seen beneath was probably inserted to address this, with a mid-20th century fireplace inserted. More recently a further fire and full width surround was built in front, the rest being panelled over (compare plate 21 of the assessment report).

Figure 7 Dining Room looking east.

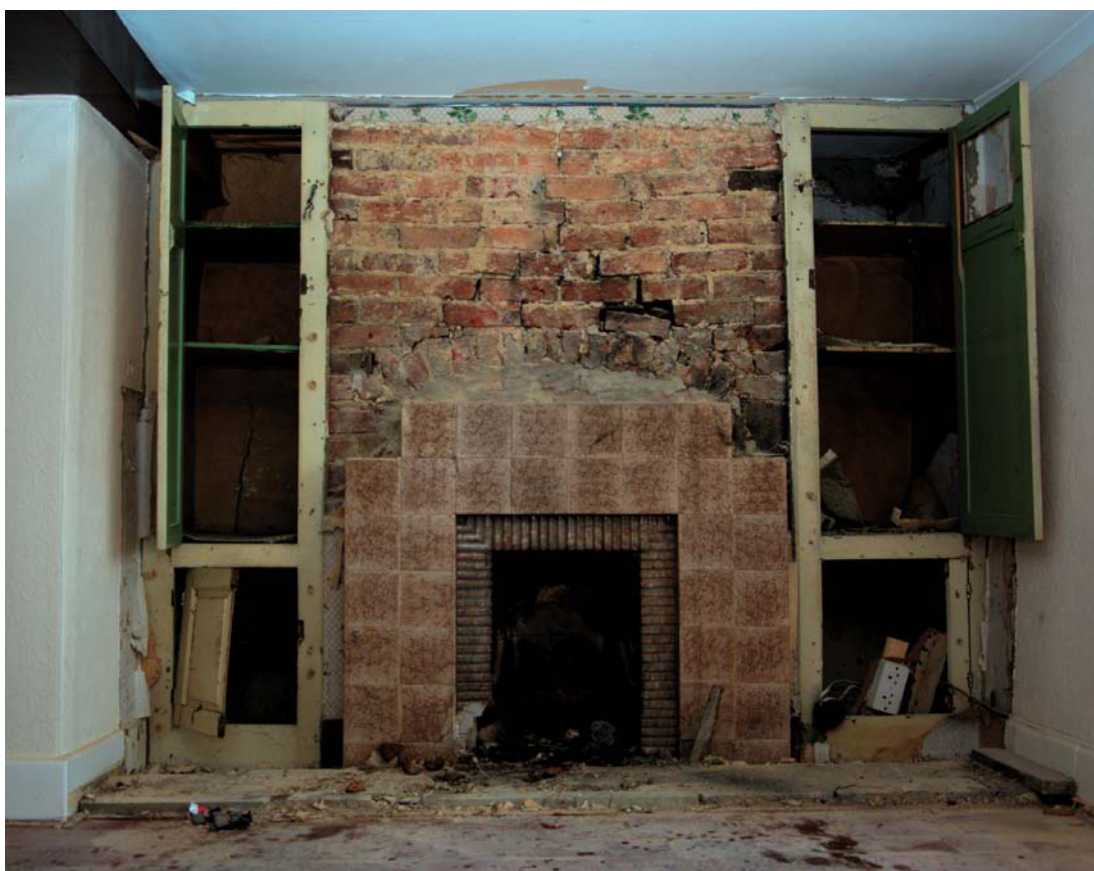
Figure 8 Dining room looking east

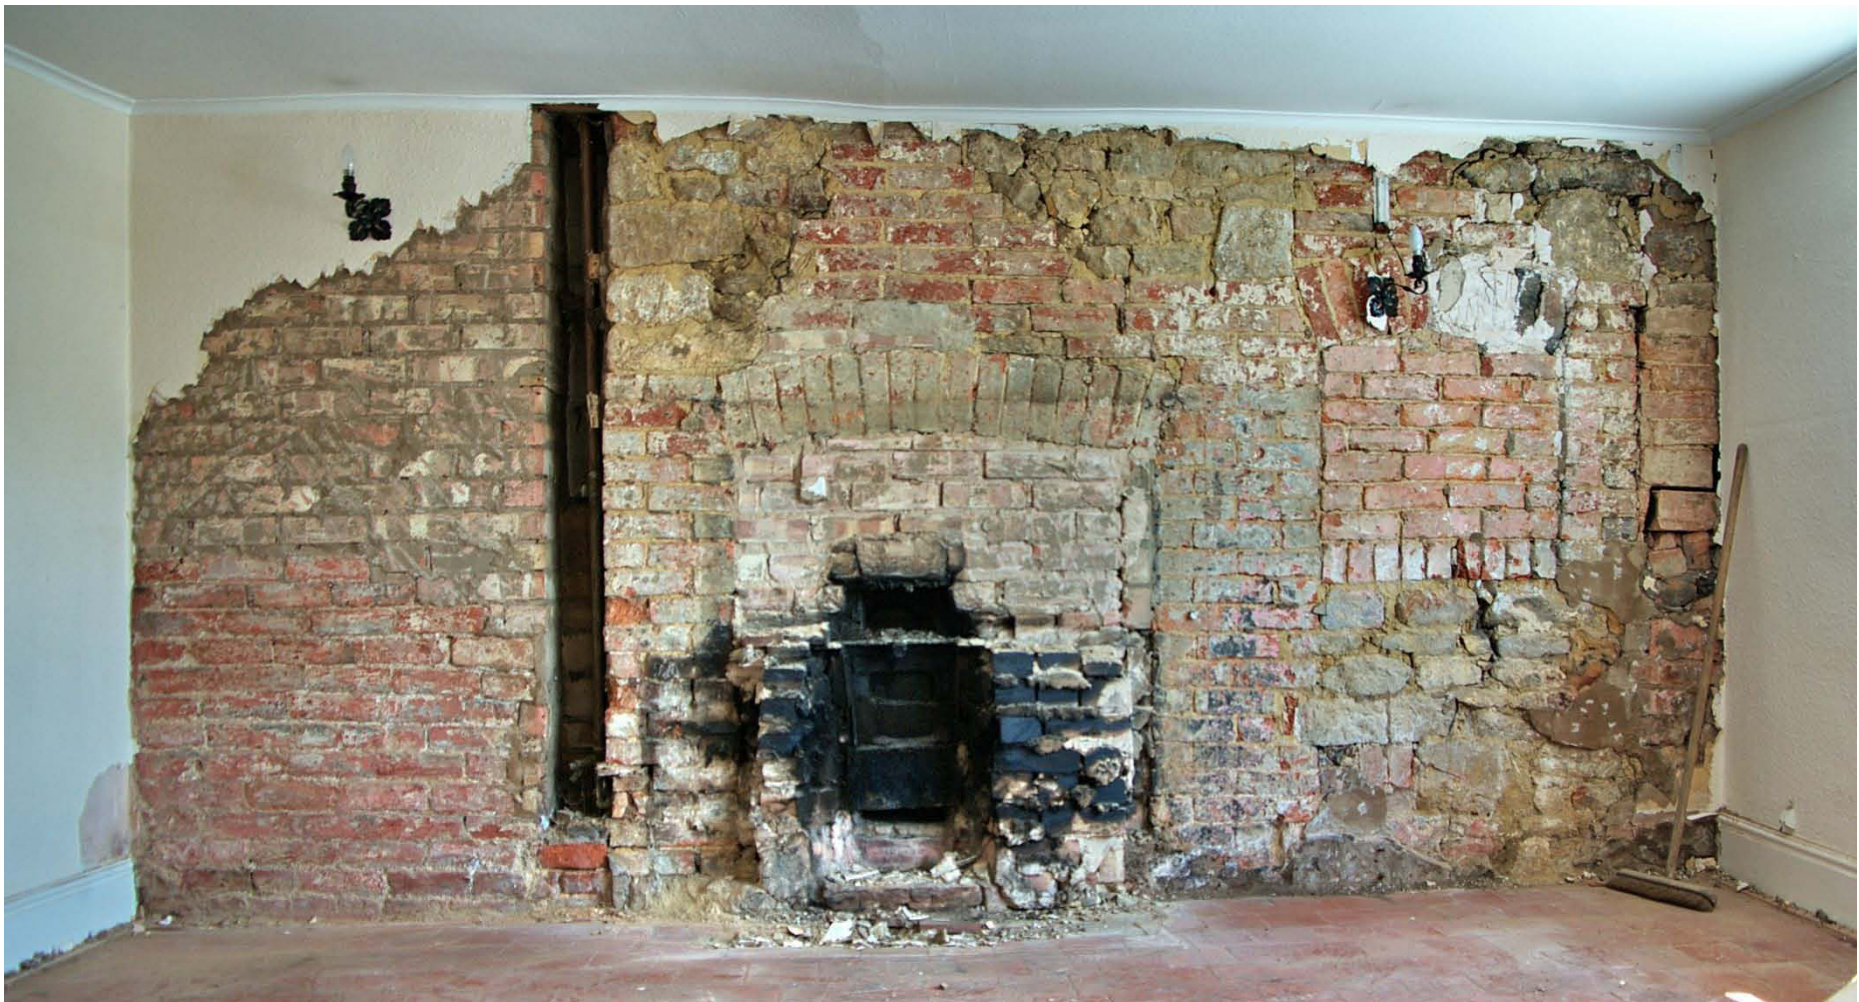
The fabric of the wall separating the living room and the barn shows a complex sequence of multi-phase alteration which is not readily comprehensible. There is a blocked window to the right hand side, which corresponds to the blocking observed in the other side of the wall in the barn; this appears to have originally been a doorway which was first converted to a window. As noted in the assessment report, the eastern building (which this room is now in) may not have been in existence at the stage of the original reduction of door to window. At the far right hand side a single column of brickwork adjacent to the wall return has a small flue behind, the loose brick visible in the photograph to the left of the top of the brush handle exhibits sooting on its inside face. This presumably served a stove set into the corner and this arrangement would presumably be contemporaneous with, or post-date, the blocking of the door.

The vertical channel to the left hand side of the main fireplace is problematic in that it contains water pipes (presumably to a hot tank above) heated by a range or backburner, and thus should be relatively late in the sequence; nevertheless part of the channel is formed by stone quoins on one side with modern brickwork over older brickwork on the other. The lower left hand side of the fireplace must be relatively recent as the pipework runs into and behind it. The central fireplace and chimney breast has been reduced from a tall rectangular opening (defined by the brick arch) to a smaller aperture for a fire/range.

As it seems likely that original stone and brickwork was re-used in the various restructuring episodes, the sequence is ambiguous. The corner stove could have been a copper, and is not likely to have co-existed with the adjacent door, but might have co-existed with the reduced window aperture. The copper could have co-existed with the larger open (wood-burning?) fireplace as they would be performing different functions. Fireplaces were usually reduced in size over time, with a switch to coal and improvements in design, and this appears to have occurred here, ending with a range or stove, with a back burner providing hot water. At this stage the copper would become redundant. Similarities in the brickwork of the window blocking and the fabric above the arch for the larger fireplace aperture hint that the provision of the larger fireplace, the blocking of the window, and the installation of the corner copper and flue may have taken place at the same time.

Figure 9 Living room looking east

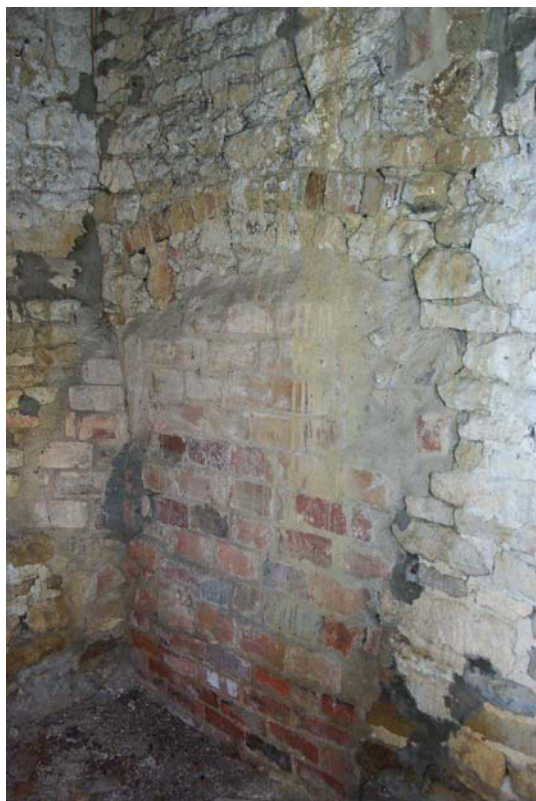
Figure 10 Blocking seen from inside the barn. Looking south-west.

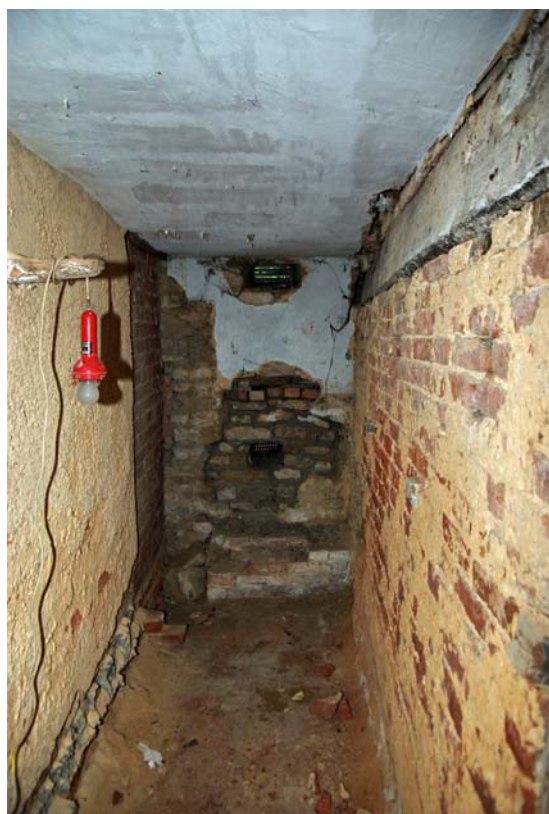
Figure 11 Passage, looking west. Note modern wall blocking opening to rear left hand side; overhead beam and brick panelling to right hand side; stone exterior wall to rear with modern vents.

The north wall of the store was broken through: this revealed a narrow wedge-shaped passage of peculiar and complex form. Reference should be made to the figures and scaled drawing. The majority of the north wall of the store was of stretcher bond brick, and appeared to be 19th century in date albeit with the re-use of some earlier brick. The inner face to the passage was plastered, with the exception of the westernmost one metre (up to the outer side stone wall of the building). This was very recent brickwork, probably constructed within the last 30 yrs, blocking an access into the passage from the storeroom. Along the northern side of the passage, where the south wall of the chapel should be joining, was a large panel of earlier brickwork under a substantial chamfered beam which was set into the exterior stone wall at its west end.

The west exterior wall showed disturbance from the insertion of ventilator grills top and base. The floor of the passage was quarry tiled, and there were several low brick plinths with cut-outs up against the north wall of the passage. The brick panel had incorporated bracket apertures, and a line of extant brackets had been sawn off. The beam ran at head height along most of the length of the passage. Beneath the junction of the west exterior wall and the beam, beneath the brick panel, was a short stretch of dressed stone return wall at ground level. The early brick panel ran east under the beam to an upright post; east of this post was a small rectangular area of dressed stone at the base of the wall. This was on a slightly different alignment than the modern brick over.

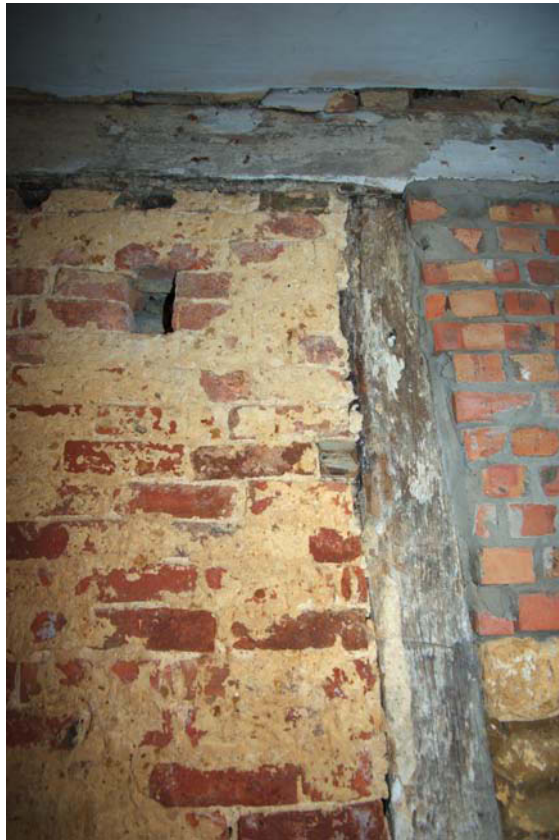
Figure 12 Note chamfered beam running over post, modern brick to the right hand side with stone under; earlier brick panelling to left hand side with aperture, and sawn-off shelf bracket against post.

problems with this in that the chapel is built of good quality dressed blocks. It could be argued that the quality work was for the exterior only. The beam itself appears very large; it shows no sign of pegging or joints along its length, not even at the junction with the post; were there a large vertical tenon from the post into the beam one might expect to see a peg, and moreover the post seems of insufficient size to have acted as much support for the beam independent of the brick wall. The post continues down behind the brick plinth.

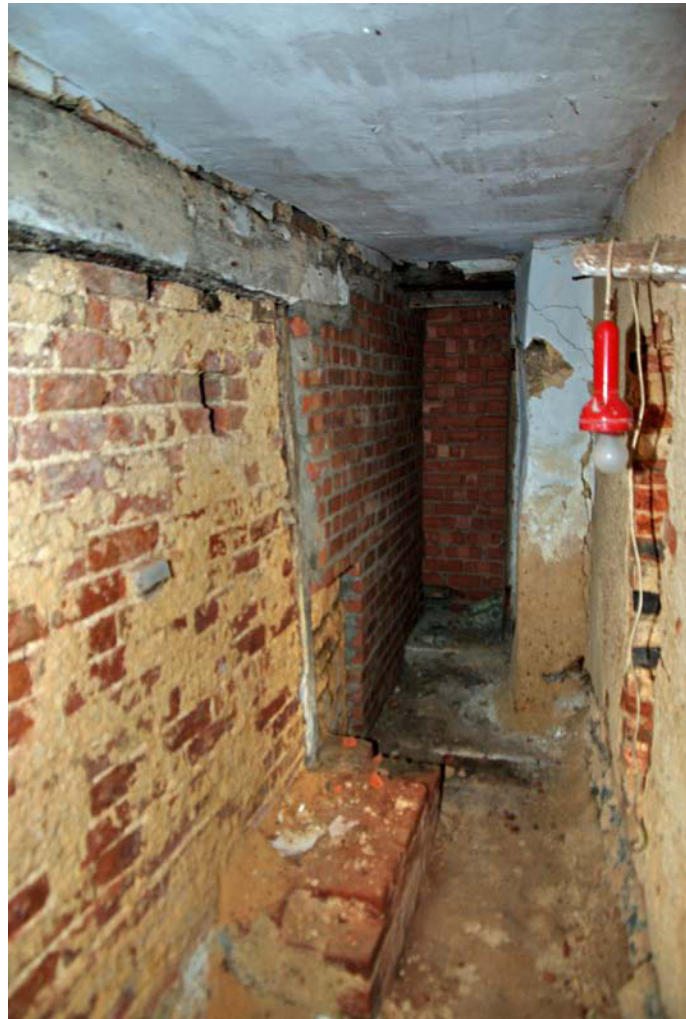
The beam carried on through at head height, but under it, very recent brickwork made up the rest of the wall which ran east up to the end of the passage, returning south. Just before the return, this modern wall had truncated an *in-situ* painted wood doorframe; only the south framepost and southern part of the lintel were visible, the north side either cut off, or lying within/ behind the modern wall fabric. The large chamfered beam, reduced by this point, terminated just before the doorframe. The east wall of the storeroom formed the south side of the door aperture; there are several beams above this spanning across the passage.

Figure 13 Looking east. Note recent brick wall to rear left hand side and rear; doorframe lintel to rear; stone (plastered) east wall forming door opening to rear right hand side. Broken brickwork visible behind inspection lamp is where the wall to the right hand side was broken through for access.

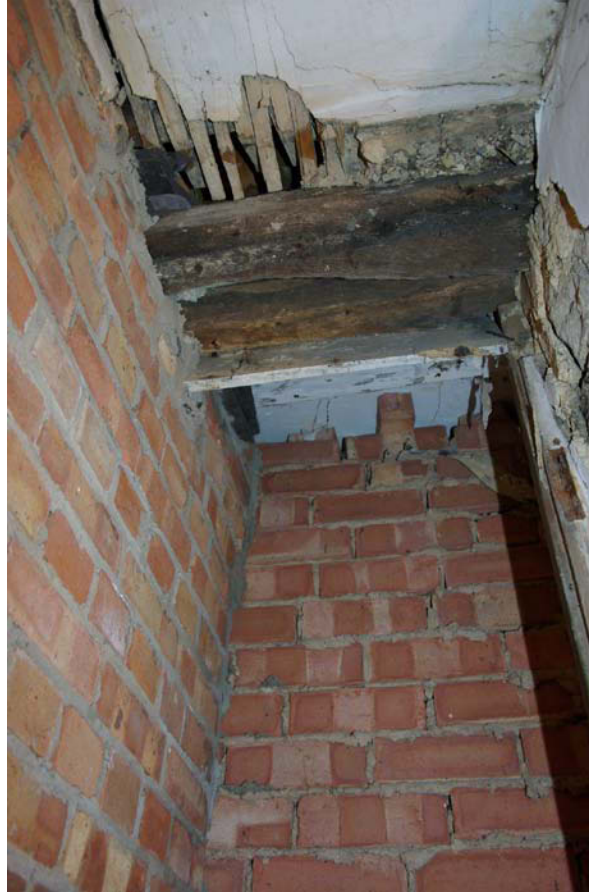
Figure 14 Looking east. Doorframe to right hand side and above; beams over

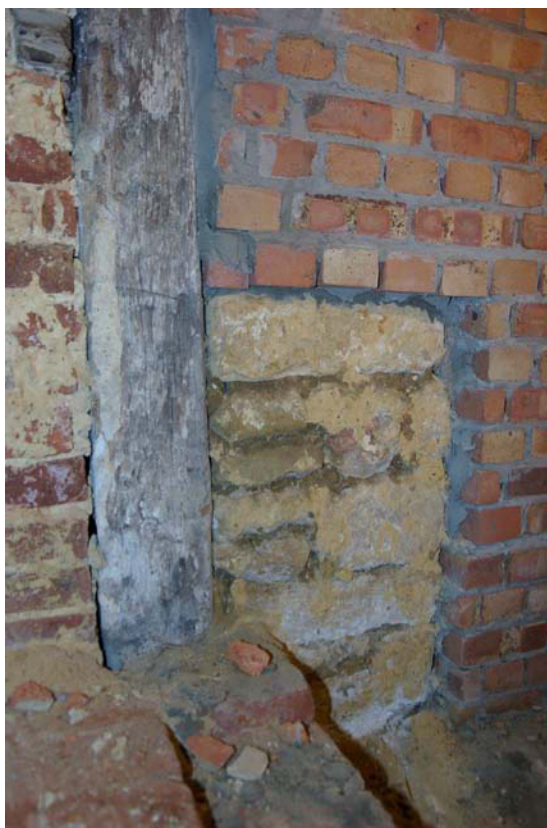
The post could be the same build as the brick, wedged under the beam, functioning as the west side of a door opening, the other side having been lost in the modern work to the east. At first sight the area of stonework east of its base would seem to be a re-appearance of the stone wall in the north-west corner and would have blocked any putative opening, but this may be misleading, as it fits its present position very neatly and may be a subsequent re-use, rather than a survival of the original wall.

Figure 15 Looking north. Post, plinth, stonework and modern brickwork over.

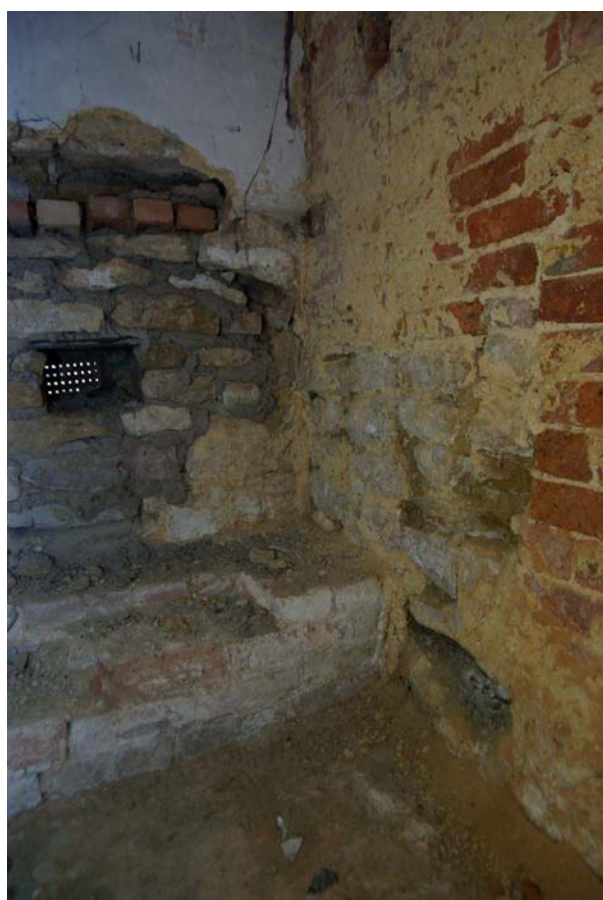
Figure 16 Looking north-west. Stonework at base of wall

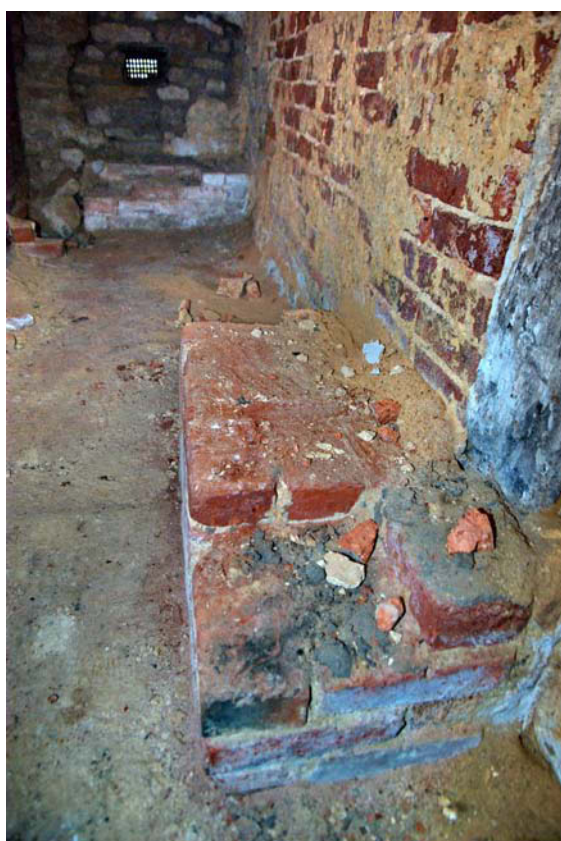
Figure 18 Looking west. Plinths

As to the later function of the 'passage': it was rough plastered, shows evidence for low plinths and shelving, plus it is on the north side of the building; the simplest

explanation is that at some time in the 19th century the opportunity was taken to create a small pantry off the store.

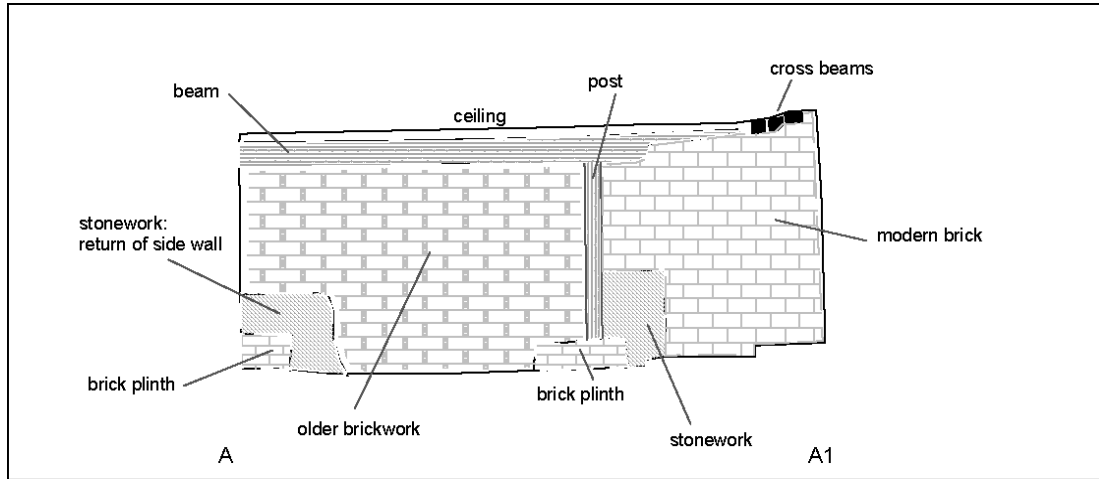
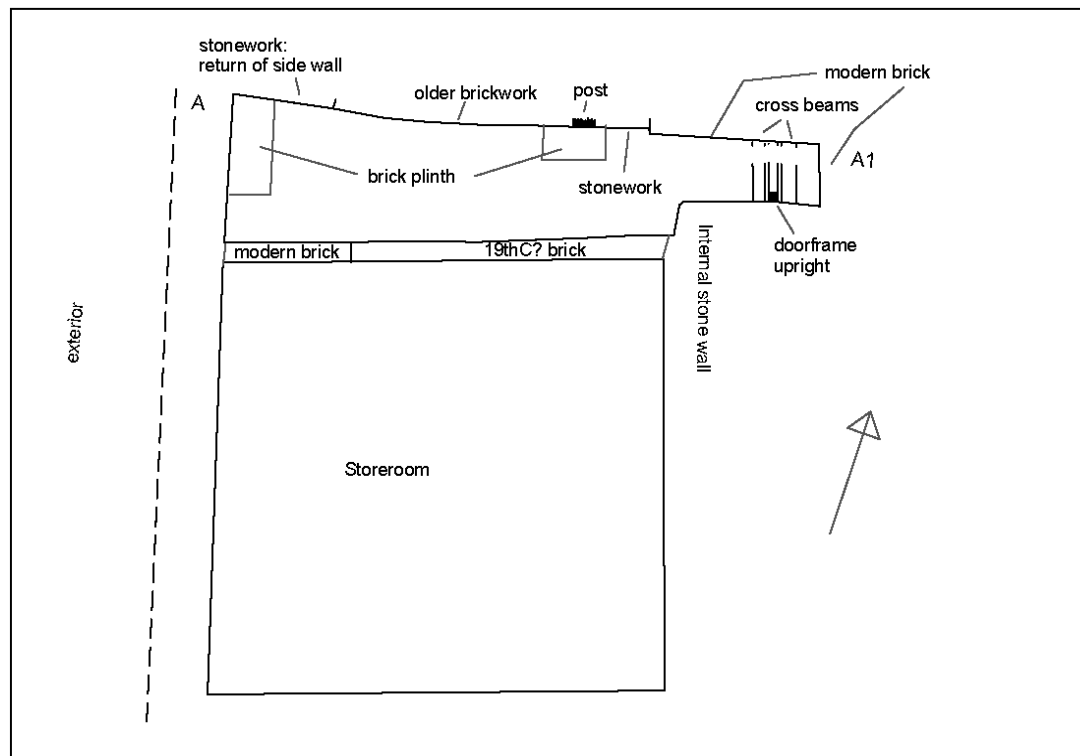
Figure 19 Section, and plan of storeroom/blocked passage room. Fabrics are schematic.

A number of issues arise in the interpretation of the surviving fabric. The west exterior stone wall must be original, and the assumption is that the return of this stone wall seen at low level in the north-west corner of the passage is also original and defines the inside of the north wall of the original build. Taken in conjunction with the position of the outer corner of this return (visible above the exterior chapel porch), it gives a similar width compared to the front wall of the building.

Moreover this would explain the change in floor level between the rooms. The store room unit could have started as a single storey affair, with the beam acting as the rear wall plate (it is at the same height as the front window lintel in the store) and then another storey built on, the stone rear wall replaced with brick. The two units were then combined under a new roof structure (the brick in the rear passage wall is similar to the brick in the west gable apex, so perhaps the replacement occurred at this point). This is speculation, and the extensive alterations since have probably destroyed any supporting evidence.
