Hill Farm, Fenn Lanes, Fenny Drayton, Leicestershire (SP 3585 9775): Historic Building Assessment

ULAS Report No 2011-084 ©2011

Hill Farm, Fenn Lanes, Fenny Drayton, Leicestershire SP 3585 9775: Historic Building Assessment

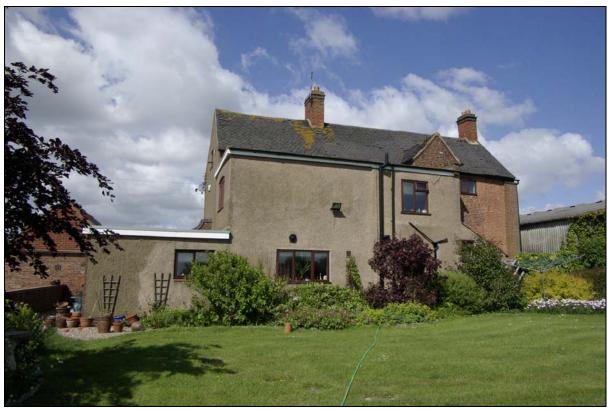
At the rear of the house, is a two-storey range, of two bays with a flat roof. The exterior is coated in render, masking the building sequence. Axial and transverse ceiling beams located in the ground floor kitchen and the bedroom above, which has a segmental arch-headed window opening, indicate that these rooms may represent the remains of the original projecting rear range, with repaired plasterwork in the attic room above indicating repairs to the wall following the demolition of the upper storey.

Plate 4. Rear elevation, looking west.

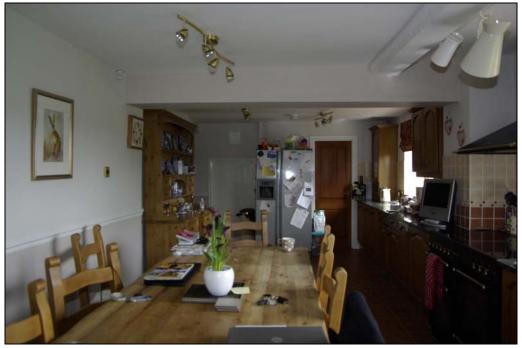
The size of the r.s.j inserted into the ceiling above the kitchen would indicate that an external wall was broken through to create an opening into what appears to be a modern extension. Above the extended kitchen, on the second floor is a bathroom, with an absence of overhead ceiling timbers indicating that this is also a modern addition.

Plate 5. Kitchen, looking north towards modern extension

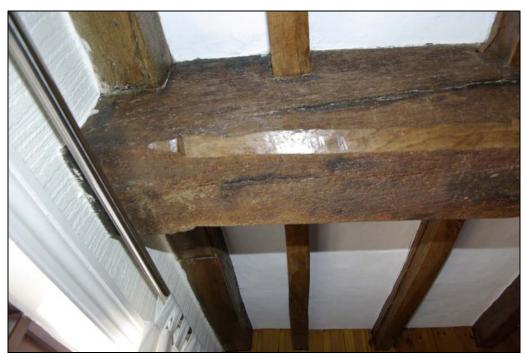
At first floor level, a matching set of internal doors are hung on L- hinges and have four, raised panels, in an unusual arrangement which may date to the late 18th or early 19th century. Exposed transverse and axial ceiling beams over the bedrooms are chamfered with scroll stops.

Plate 10. Chamfered and stopped transverse ceiling beam above northern bedroom. Looking north.

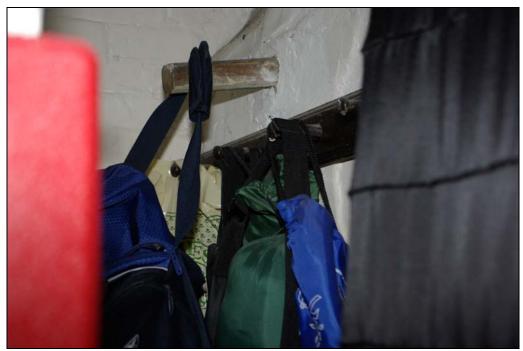
Plate 11. 18th century peg rail in built-in cupboard. Looking south-east.

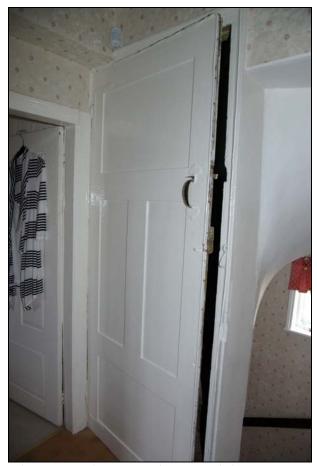
Plate 12. 18th century four-panel door, 1st floor. Looking east.

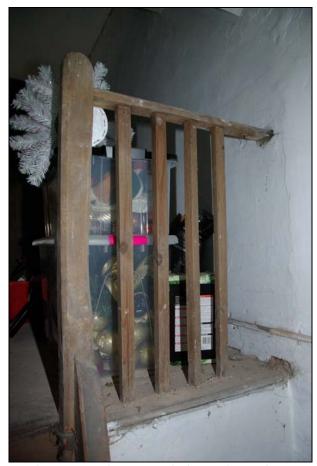
The attic rooms at second floor level are currently used for storage and appear to be largely in their original form. At the top of the timber staircase, which is uncarpeted beyond the first floor, is a plain timber balustrade, with stick balusters, which dates to the 18th century. Flooring throughout is lime ash on reed. Doors housed in openings between the upper floor rooms are 18th century, two of simple plank and batten type, hung on hand wrought iron strap hinges, with early latches and handles. A third door matches doors of the first floor, possibly relocated here from the ground floor. At the northern end of the range, an 18th century doorway opens onto the modern brick skin over the rebuilt gable end. The outer face of the early wall, beyond the doorway, but visible in a void located before the brick skin, is coated with plaster and white-washed to match the surviving rooms. On the external face of the redundant door, is an applied decorative timber fascia panel.

Plate 13. 18th century balustrade, 2nd floor. Looking west.

The planning proposals are generally thought to be sympathetic and in keeping with the character of the listed building, and will present a minimal impact on historic building fabric. The plans show that all existing 18th century fixtures and fittings to the second floor, including staircase, doors, frames and iron-work are to be retained, *in situ* wherever this is possible. The 18th century wooden door, with the unusual decorative fascia board will become redundant in its present position: this is to be re-used elsewhere within the conversion, to form the doorway opening to the new en-suite bathroom.

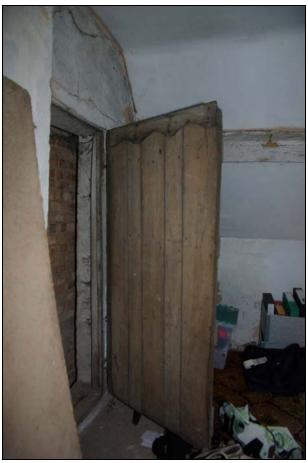
through a doorway on the second floor of the existing building, which would have provided access through to the demolished bay. The brick-work skin appears late and it would seem likely that the demolition occurred in the second half of the 20th century, but prior to the listing of the building in 1989.

Plate 15. 18th century plank and batten door with decorative fascia board. 20th century brickwork skin to exterior of northern gable end visible through doorway. Looking east.

The planning proposals submitted by the applicant will involve the conversion of two of the attic rooms to provide more bedroom and living accommodation, incorporating an en-suite bathroom within the northern-most room. This will involve the insertion of stud partition walls to create an enclosed space, encompassing the existing window opening. In order to light the smaller bedroom space, the architects propose to create a window opening in the position of the former doorway, which will involve breaking through the modern brick skin over the northern gable end wall.
