**A Photographic Survey of a Workshop  
to the Rear of 58 Wigston Road,  
Countesthorpe, Leicestershire  
(NGR SP 58660 95647)**

Planning Application No's: 11/0060/1/LX

**ULAS Report Number 2011-118**

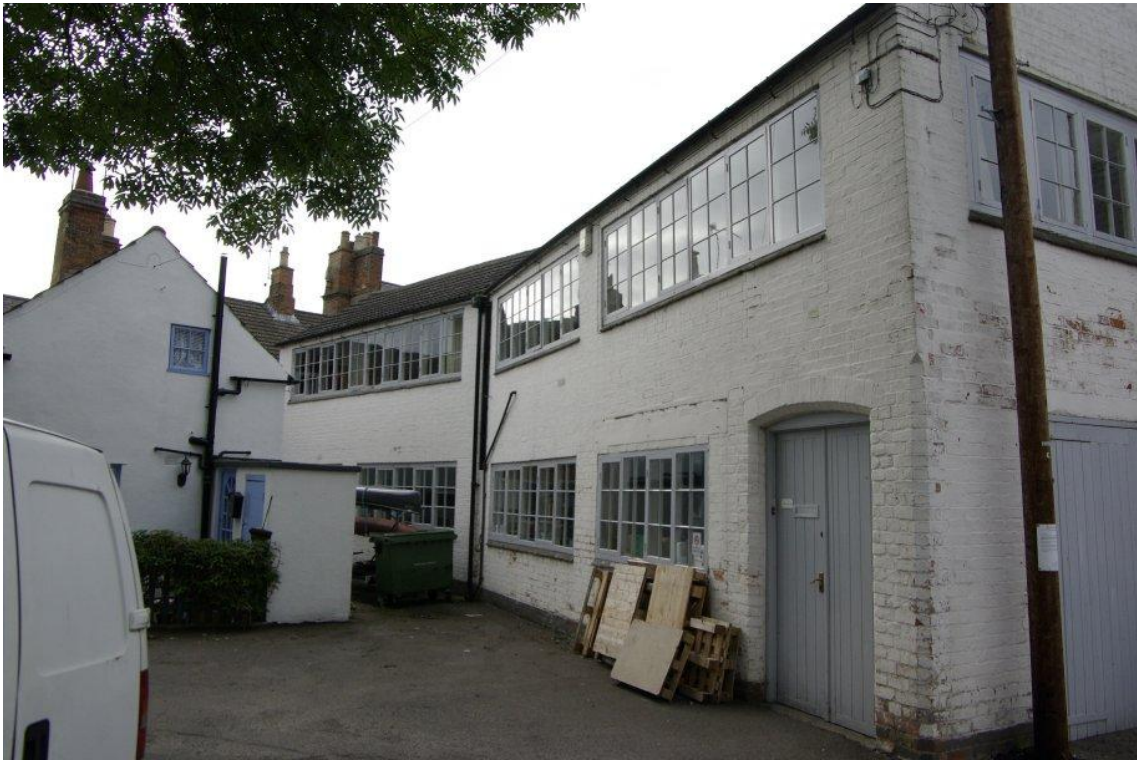
The workshop is linear in plan, aligned east-west, of two bays, bay A to the west and bay B to the east (*Figures 4 & 6*). There is a later single storey lean-to extension to the south, C. The building is constructed of local red bricks (brick dimensions 9 x 3 x 4 ½ inch) laid largely in a Flemish Garden Wall bond (three stretcher bricks and one header brick). The lower courses of the southern elevation are in a simple stretcher bond. The long ‘weaver windows’ are all on the north-facing elevation and are as described in the listing description (above). The windows have red cant brick sills and flat brick heads, the westernmost window on the ground floor has a blue cant brick sill, and the straight joint in the brick work below indicates the window is a later insertion into what was

**Figure 6** Principal elevation, looking south east (003-004).

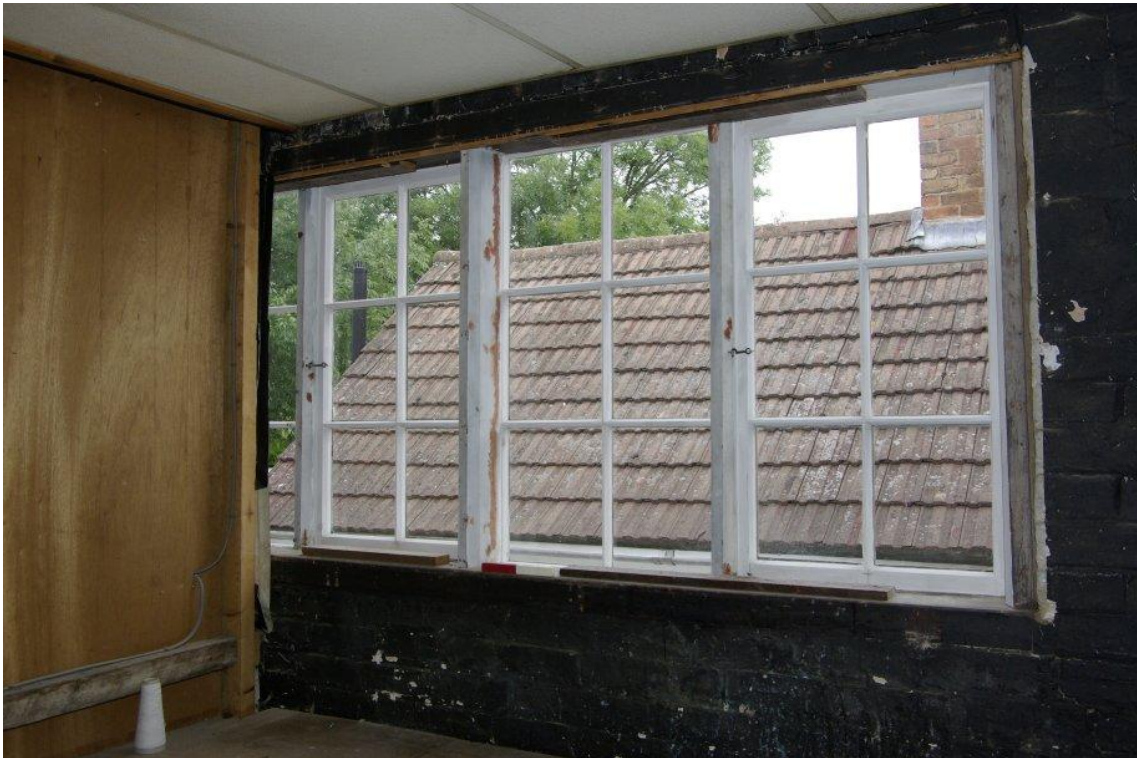
originally a double door. The windows themselves are unlikely to be original (*Figures 7-11*). The roof is modern concrete tiles, probably early 1980s in date.

**Figure 7** Easternmost window, first floor (011-012).

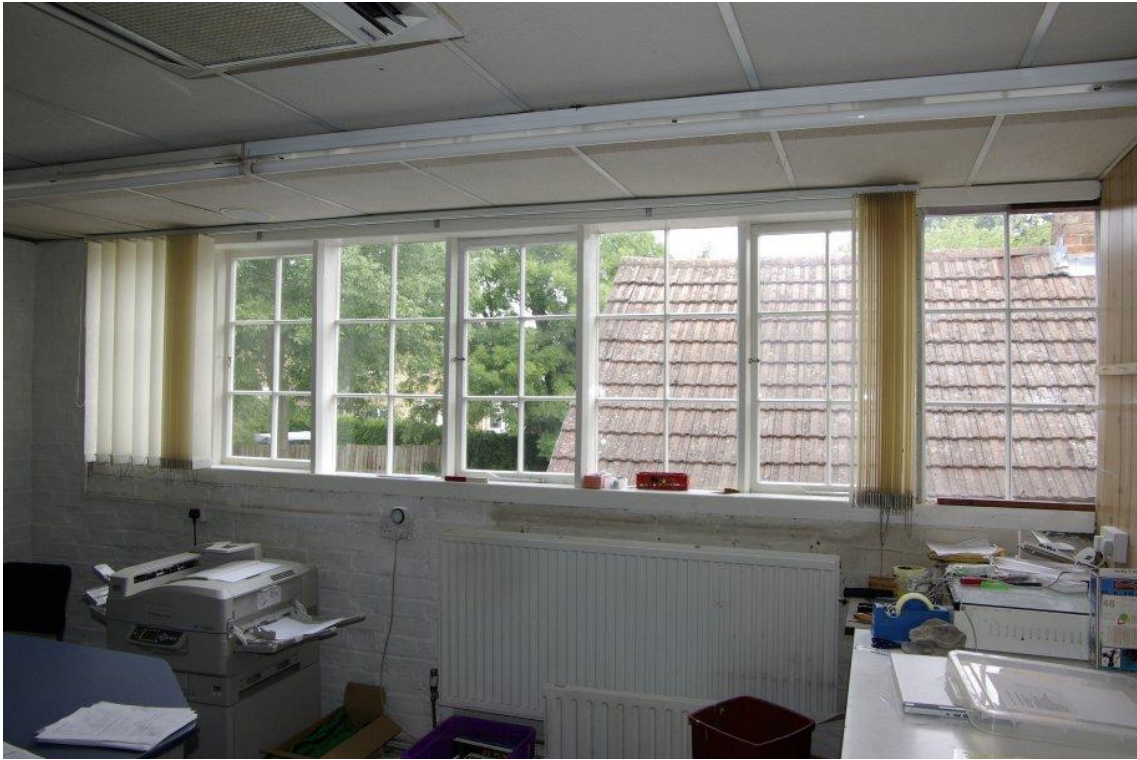
**Figure 8** Easternmost window, first floor (015-016).

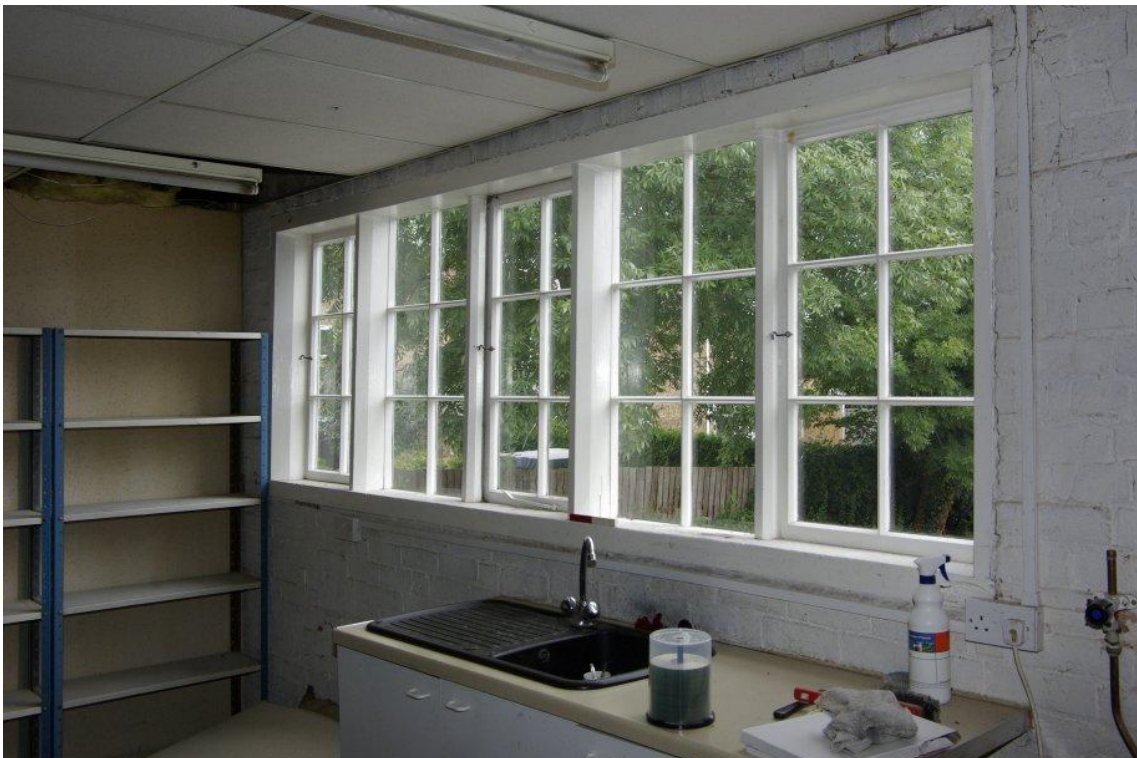
**Figure 9** Middle window, first floor (023-024).

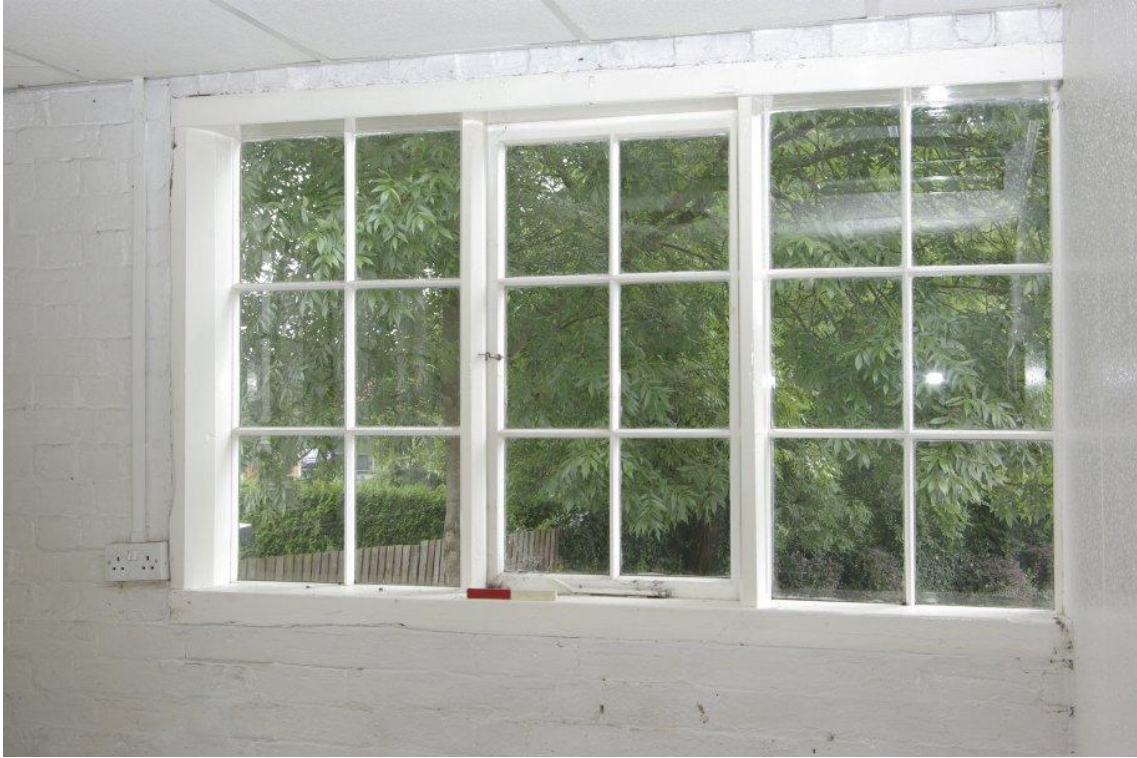
**Figure 10** Westernmost window, first floor (037-038).

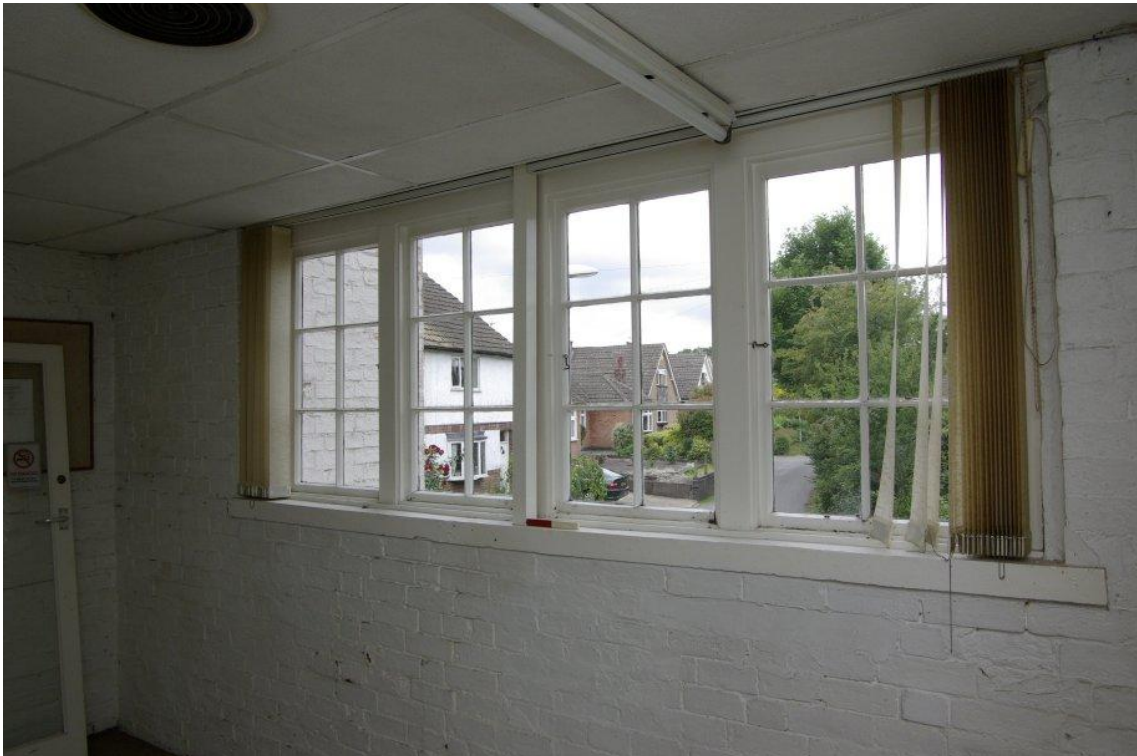
**Figure 11** Window in west gable, first floor (039-040).

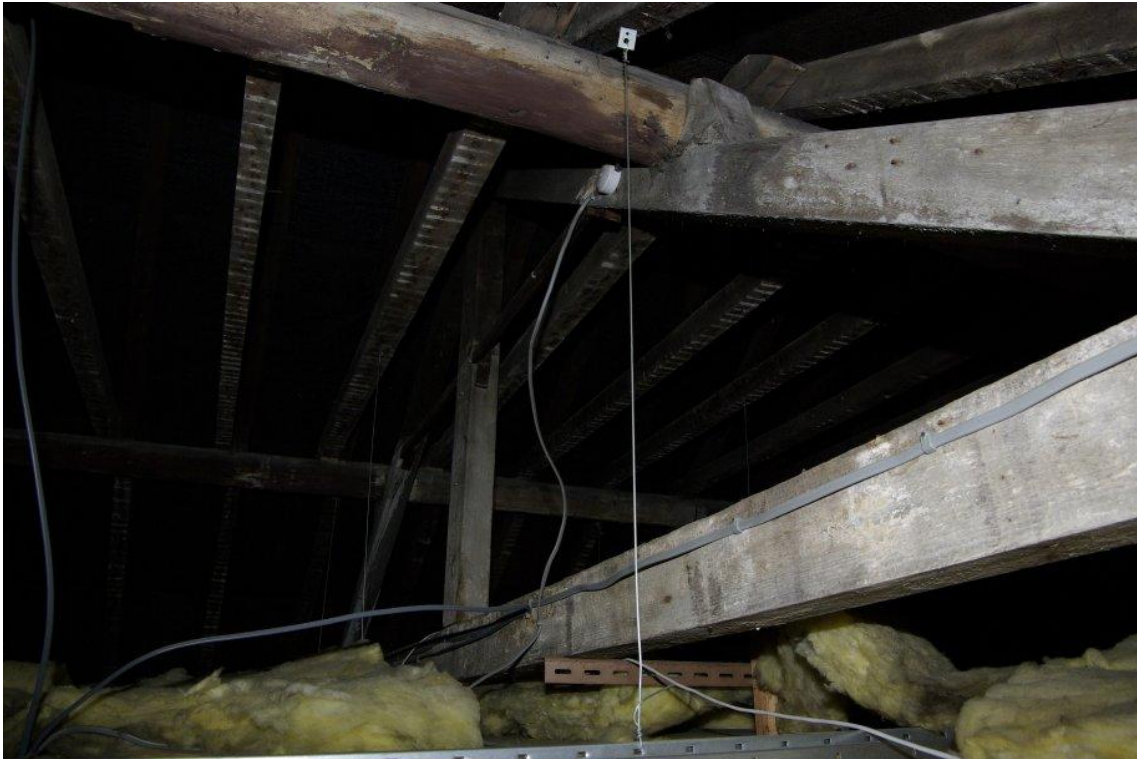
There is a modern suspended ceiling, and where tiles are missing a king post truss can be seen carrying the roof (Peters 1988). There are likely to be six trusses. The purlins are only roughly finished, and the roof structure appears to be softwood and possibly original (*Figure 12*).

**Figure 12** Limited view of roof structure (027-028).

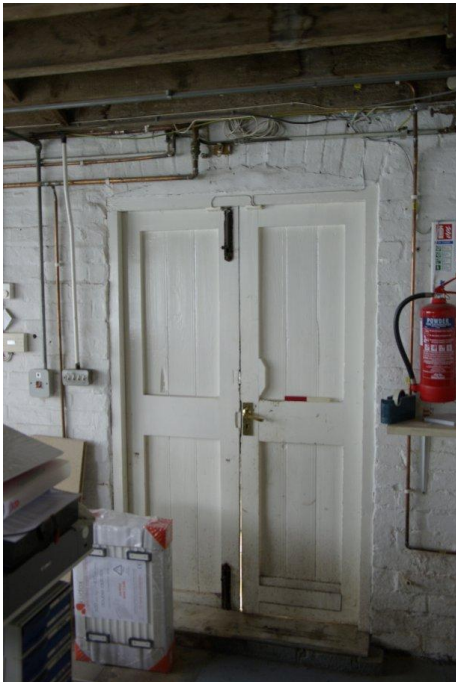
There is a straight joint between bays A and B, the bricks, however are identical, suggesting that if not contemporary, the two bays were built in close succession. There is an iron tie plate adjacent to the straight joint. There is an inserted double door on the western gable. Pedestrian access is via an original looking door on the western side of the northern elevation; it has cant brick reveals and a flat arched head, also in cant bricks. There is a second, identical pedestrian door on the easternmost gable, which is to be blocked as part of refurbishment work (*Figure 13*).

**Figure 13** Door to be blocked during proposed works (047-048).

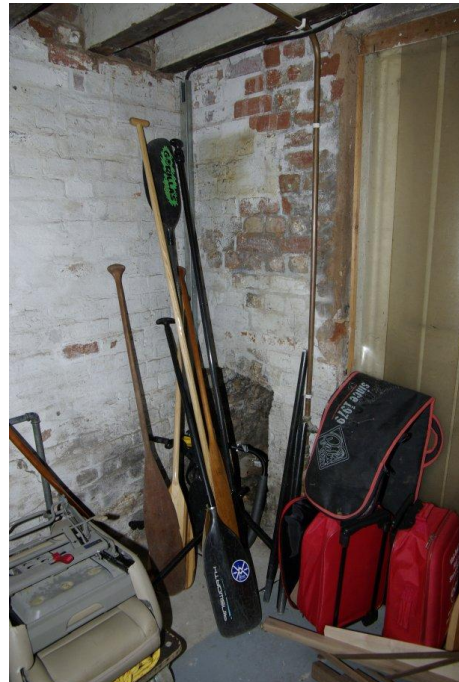
Internally, there is little of historic or architectural interest remaining. On the ground floor there is a fireplace with an external square stack in the south-westernmost corner of the building (*Figure 14*). There are two wall stubs indicating the original north-south wall. The floor is modern poured concrete.

There is no evidence of a blocked fireplace in the chimney, suggesting that it was only the ground floor which was originally heated. There is the outline of a blocked arched window on the eastern gable.

**Figure 14** Fireplace/flue opening in western gable (059-060).
