A Photographic Survey of the Former Swonews

Newsagents, 53-55 Castle Street,

Hinckley, Leicestershire

ULAS Report Number 2010-202 ©2010

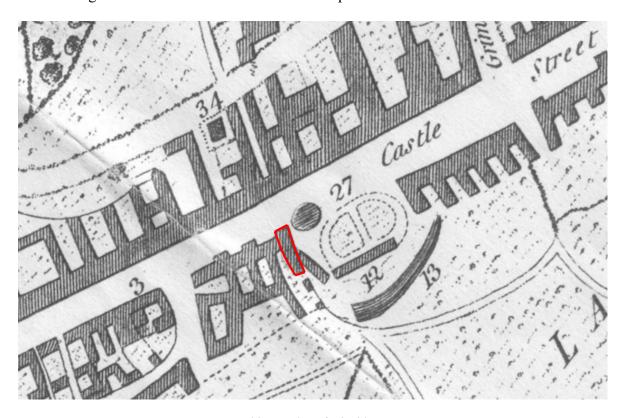
Figure 3 Robinson Plan of Hinckley, 1782. (Proposed development area highlighted in red)

Further stripping out of the ground floor revealed two blocked windows on the western wall. The wall is not straight, this twisting to the south east is clearly visible on the Robinson Plan of 1782 (*Figure 3*), it is almost certain, therefore, that this part of the building is retained from the 18th century building.

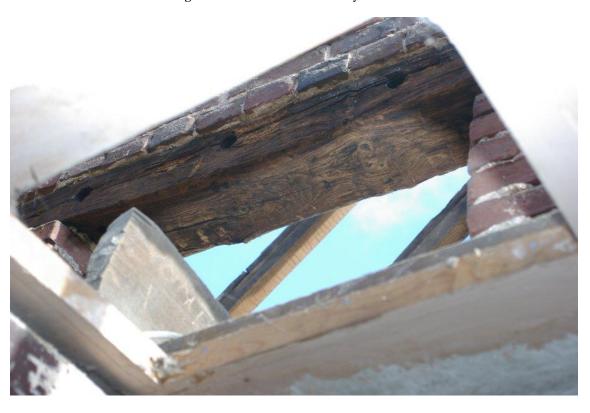
The two rooms on the second floor have remained largely unaltered, but again lack any significant historical or architectural features; this is mainly as a result of these rooms originally being rather plain. The only significant feature is the retained clothes rails suspended from the ceiling within S2, suggesting the room may have had a non-domestic use. There was also what appeared to be an early, and possibly original, fire surround on the westernmost gable. An original purlin is partially exposed on the rear roof. Within the attic space there is a limited view of a re-used timber with overly large peg holes being used as a lintel within the firewall (*Figure 5*).

Figure 5 Limited view of re-used timber in attic space.

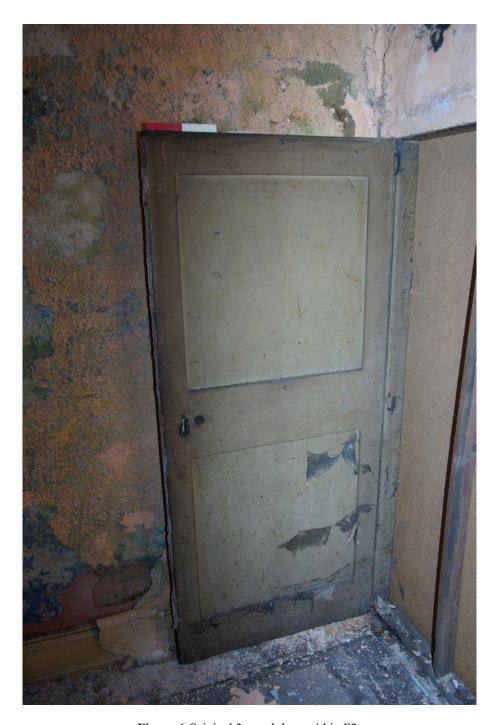
Figure 6 Original 2 panel door within F2.

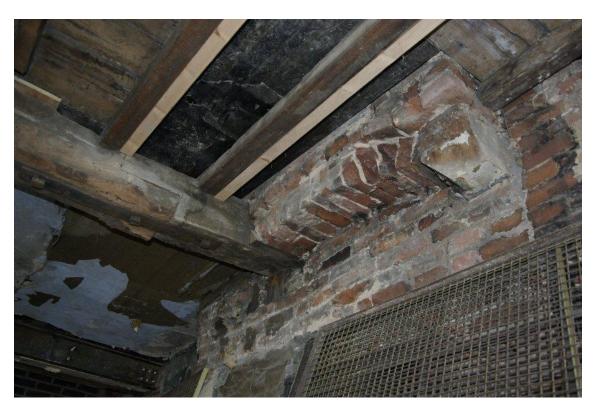
Figure 7 Inserted chamfered beam within G2.

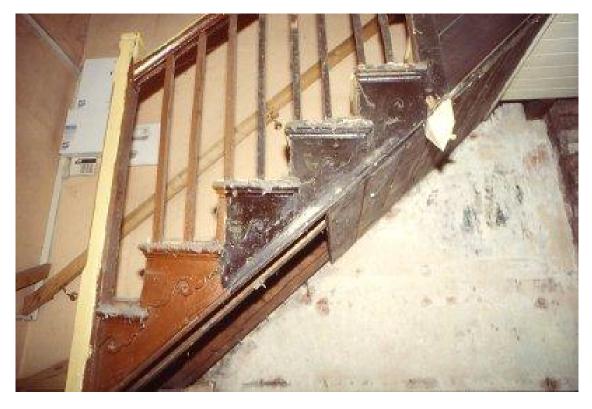
Figure 8 Decorative brackets on string.
