**A Photographic Survey of Outbuildings
On Land Adjacent to Hall Close
Formerly Part of Cottesmore Hall, Mill Lane,
Cottesmore, Rutland
(NGR SK 9042 1375)**

ULAS Report No 2011-024v2
©2012

Planning Application No's: LBA/2010/0706

For: Hazelton Homes

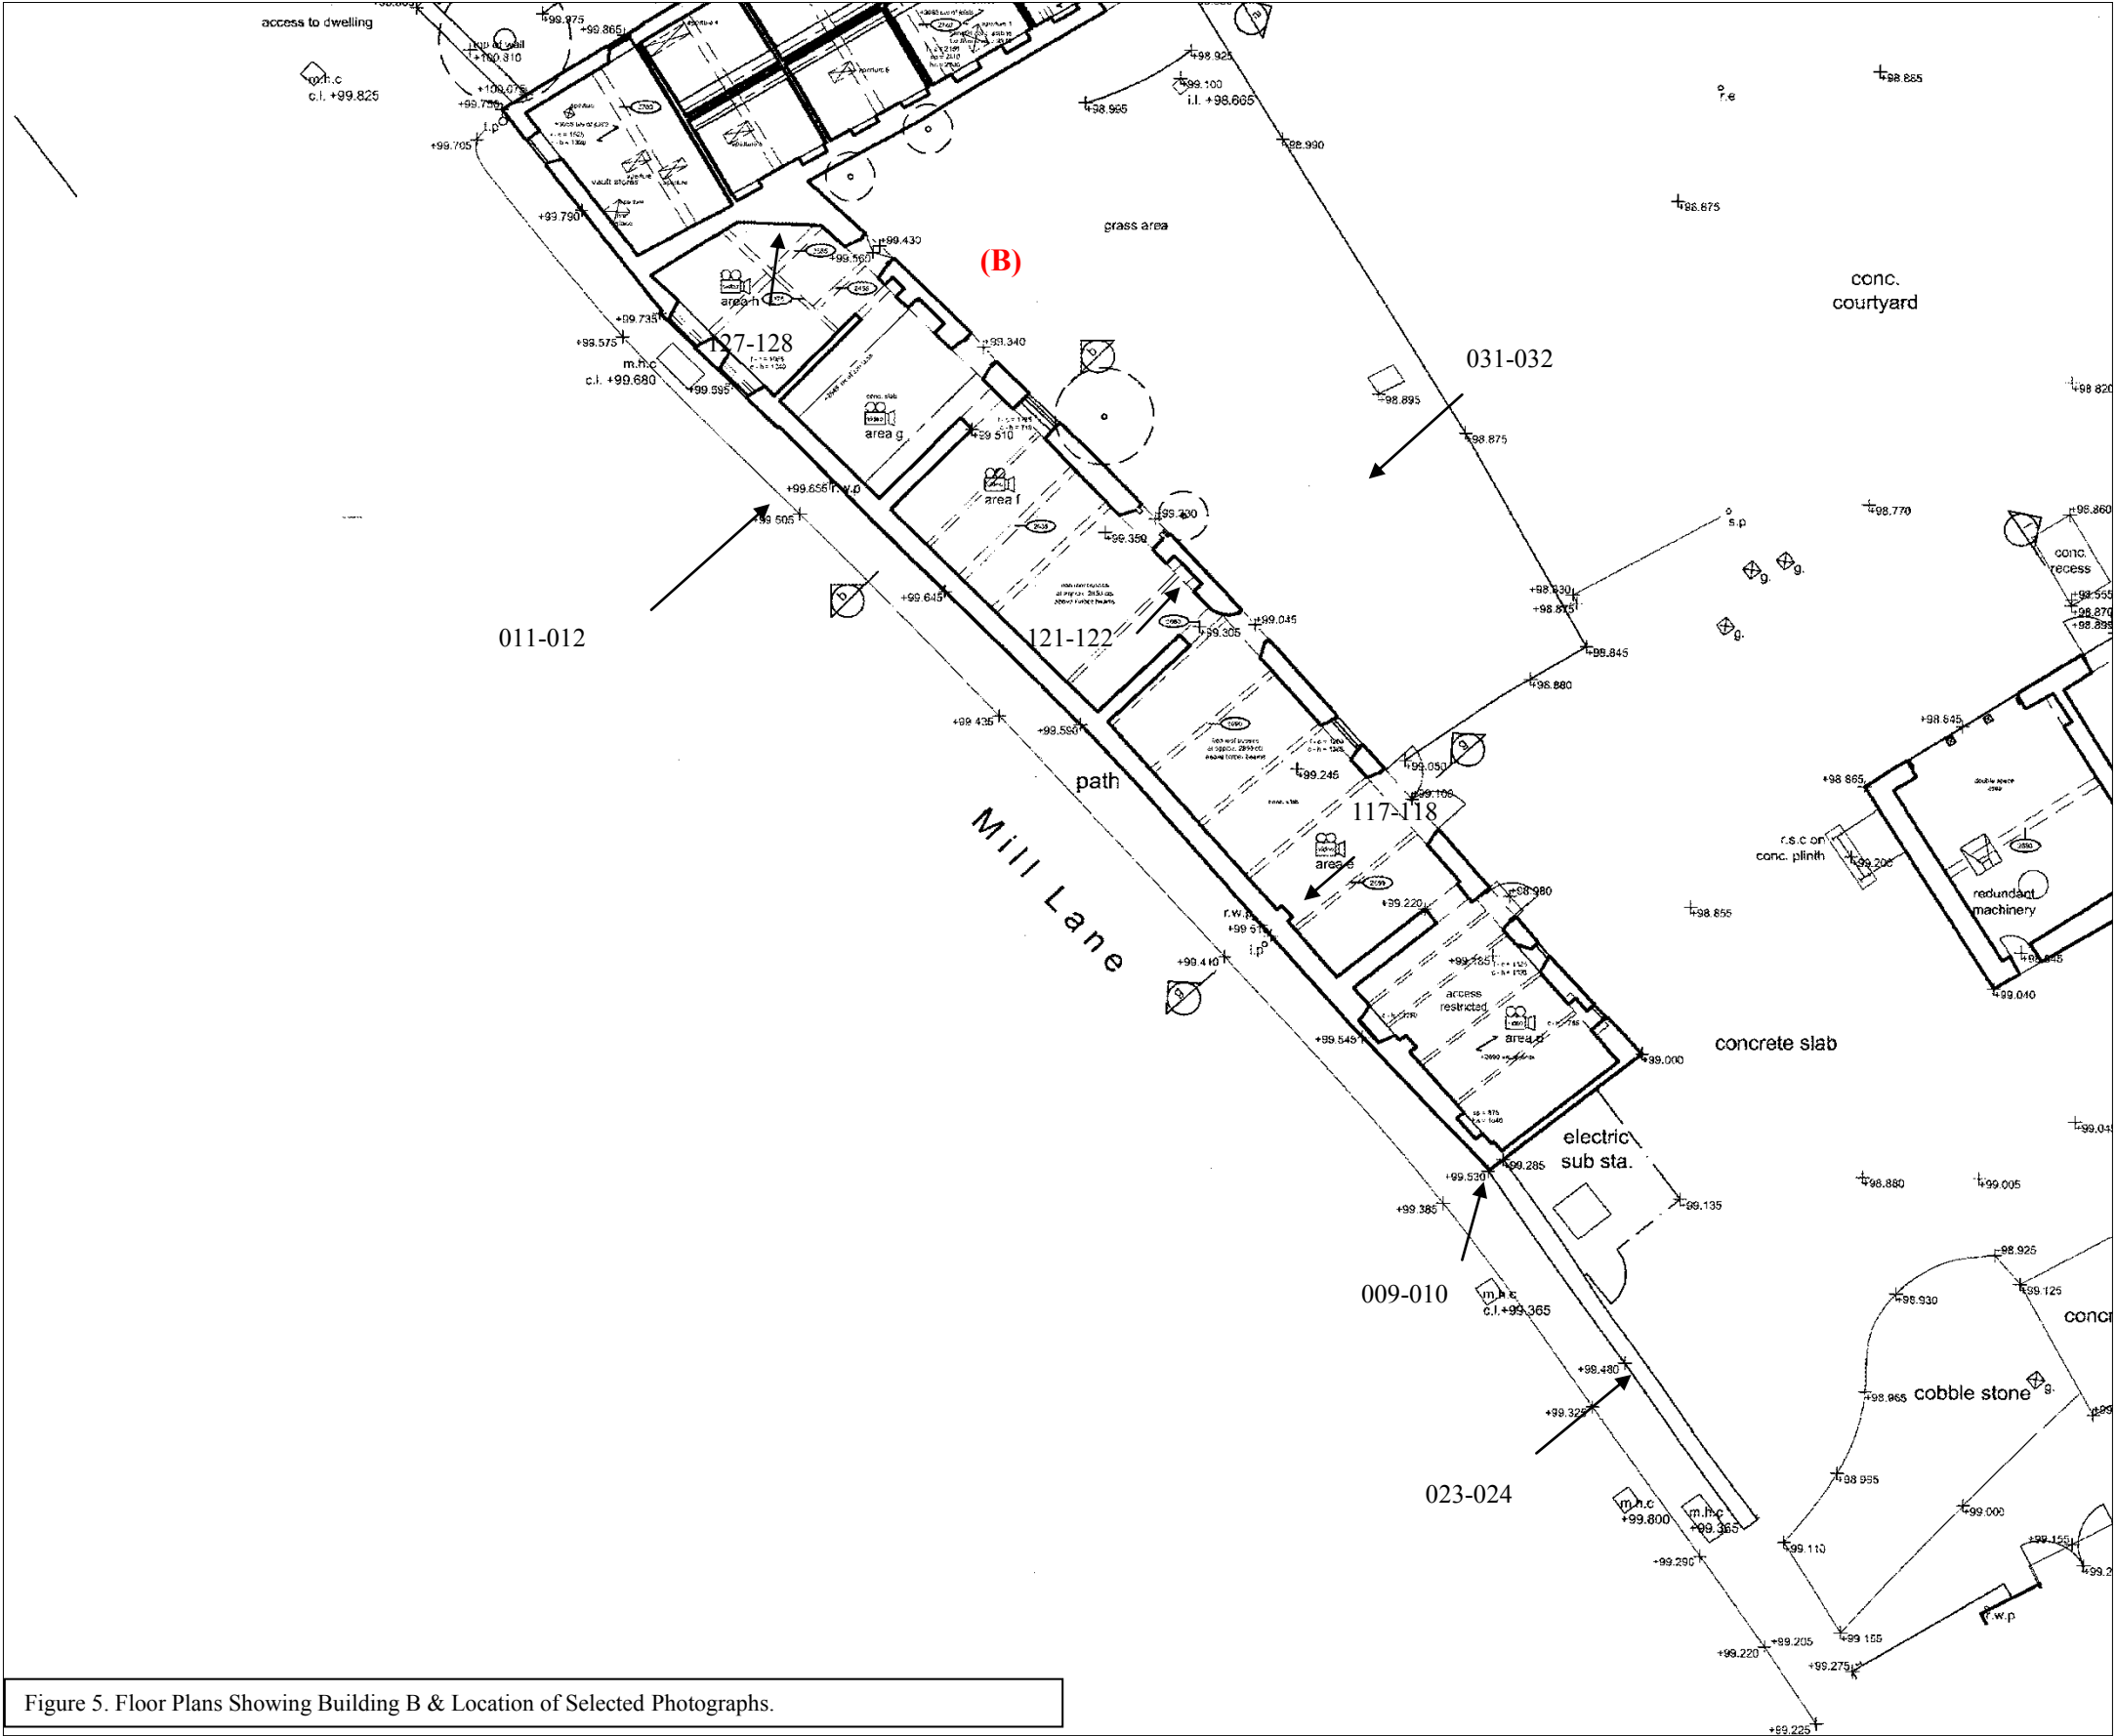
Figure 5. Floor Plans Showing Building B & Location of Selected Photographs.

Building B abuts the western end of building A and is aligned north-south (*Figures 3 & 5*). Again the building is coursed ironstone; the roof has been stripped and is currently

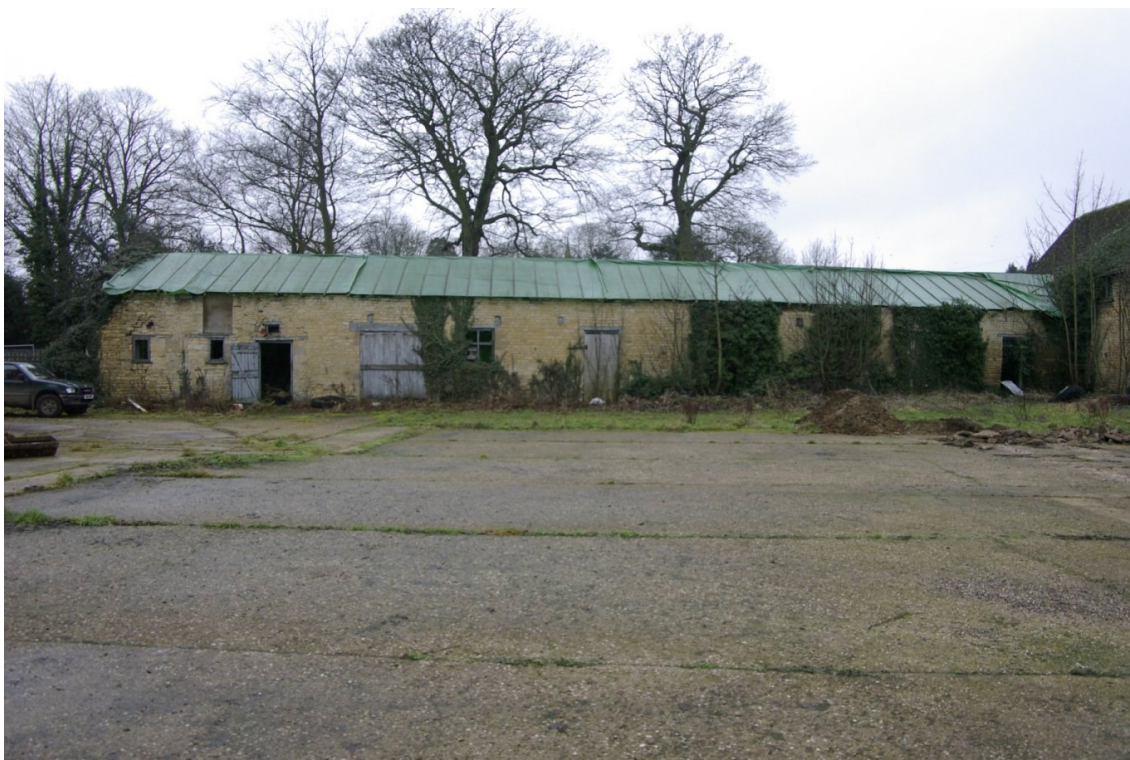
tarpaulin covered (*Figure 6*). The building is single storey, the tie beams, run completely through the east facing wall and the beams themselves are visible; the reason for this is unclear. The distance between the tie beams and the eaves indicate the range was originally two stories. Again the building is multi-phase with stone quoins indicating junctions, most clearly visible on the Mill Lane frontage. Also on the Mill Lane frontage, there are numerous blocked openings, including two arrow slit openings, suggesting part of the building may originally have been a barn. The other openings are a mix of styles, including a 19th century iron framed window with a flat cambered brick arch. Others have stone lintels and there is also a timber lintel above a blocked doorway towards the centre of the range. Interestingly, the stone work at the southern end of the range is very similar in appearance to that of the house within building A, suggesting this southern part of the range may be the earliest part. There is also straight joint visible between the two types of stonework.

Figure 6. Building 01B, principal elevation, looking west (031-032).

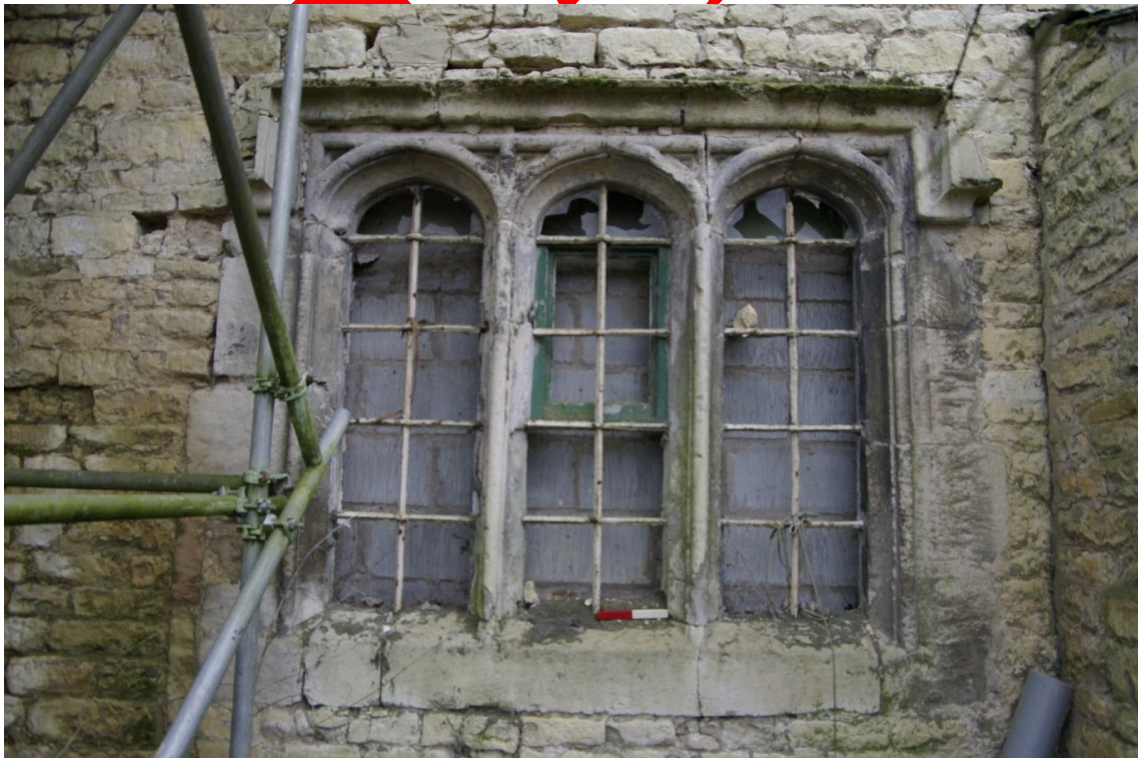
Externally, the rear wing contains two original 15th or 16th century moulded windows. On the groundfloor there is a three light stone mullioned window with hood mould with Tudor arches above each light (*Figure 11*). There are also iron glazing bars. The first floor window is largely obscured by the scaffolding and is likely to be of the same design, but with two lights. To the south of the ground floor window there appears to be a straight joint in the stonework, suggesting different phase of building. To the north there is a modern-built lean-to.

Figure 11. Building 01C window detail east facing elevation (055-056).

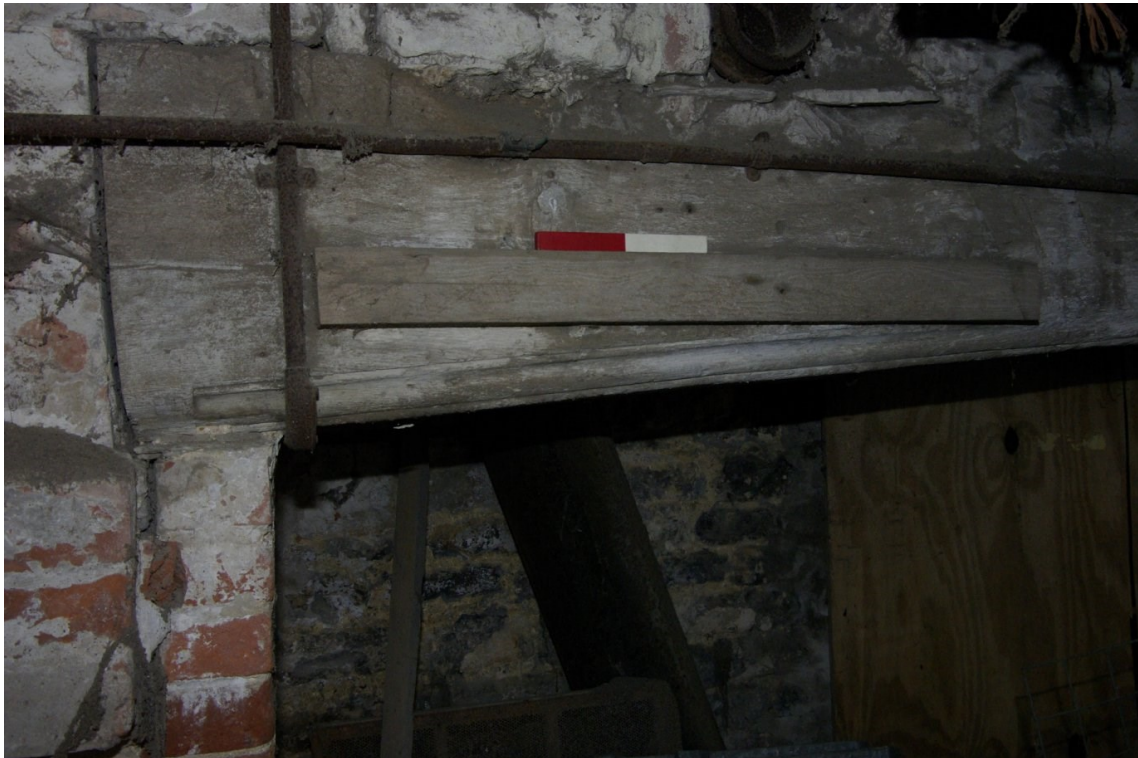
Internally, the building has been virtually gutted and contains extensive remains of the grain drying machinery, for which this part of the building was used during the late 20th century. There are, however, still a number of significant architectural and historical features remaining, most significant is the large 15th or 16th century fireplace on the

west wall. It has a moulded flat cambered arched timber lintel with straight stops (*Figure 12*). Most of the back wall of the hearth has been removed to accommodate machinery and pipe work running from Building A. To the south of the fireplace there is extensive brickwork, possibly the remains of a bread oven. On the south wall there is a blocked arched opening, near ground level, the exact purpose of which is unclear.

Figure 12. Building 01C/5 fireplace lintel (081-082).

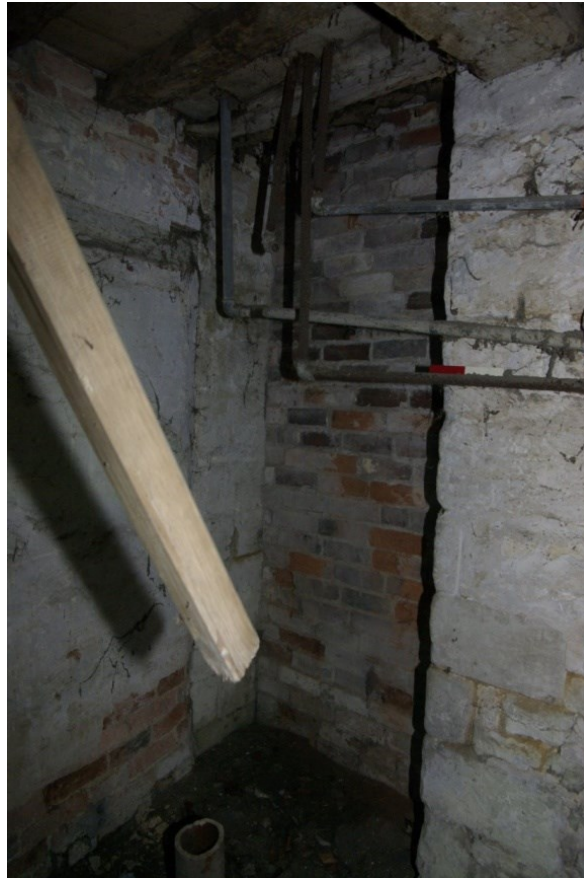
To the north of the fireplace there are two bricked up doorways, one on the west wall and the second on the northern wall, possibly a blocked cross passage. The east wall, between the two blocked doorways is ashlar block work (*Figure 13*). There is no ashlar within the rest of the building, suggesting this part may again be a separate phase of building. Also on the northern wall, towards the east end there is an arched recess, approximately 1m tall with a brick arched head, apparently a fireplace, although there is neither a chimney nor an external flue, so the exact purpose of this feature is unclear (as with the blocked arch on the southern wall). There are limited remains of probably original Colleyweston flag stones on the floor.

Figure 13. Building 01C/5 blocked cross passage (135-136).

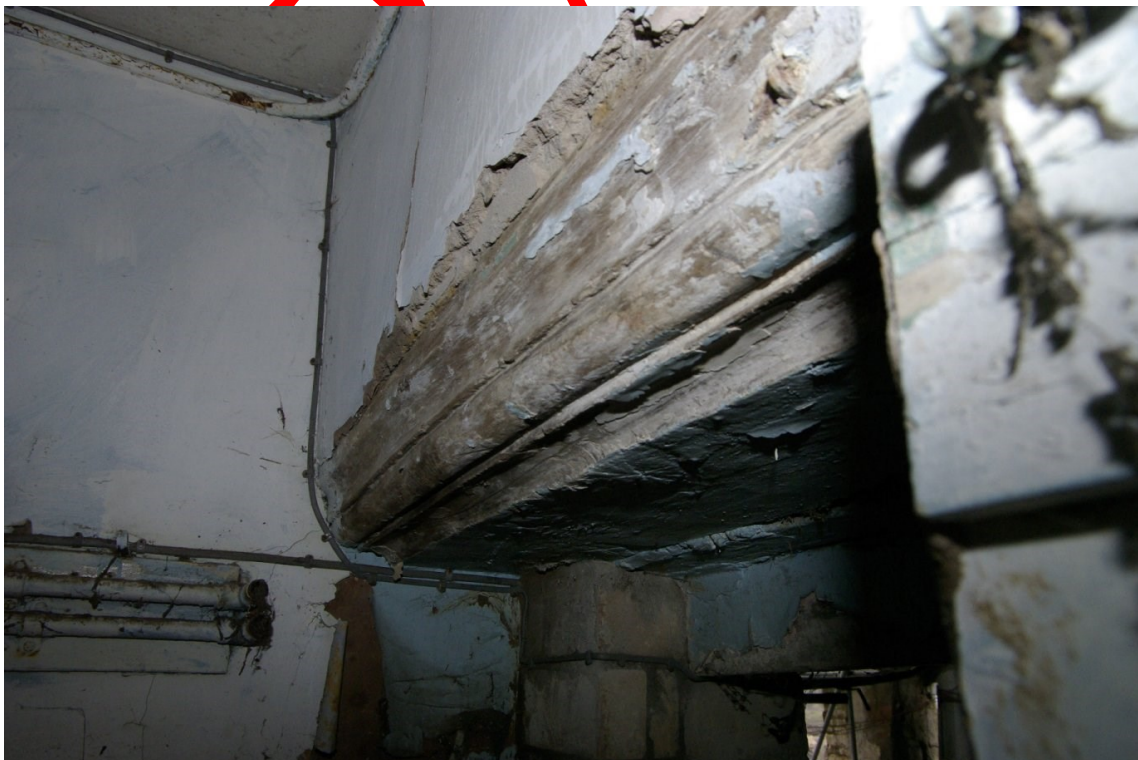
Access to the rear, north-south wing is via an original-looking opening on the north wall, with quoins, or ashlar blocks on the east reveal. Above the opening is a moulded, 15th- or 16th-century beam (*Figure 14*).

Figure 14. Building 01C/5 moulded timber lintel (145-146).

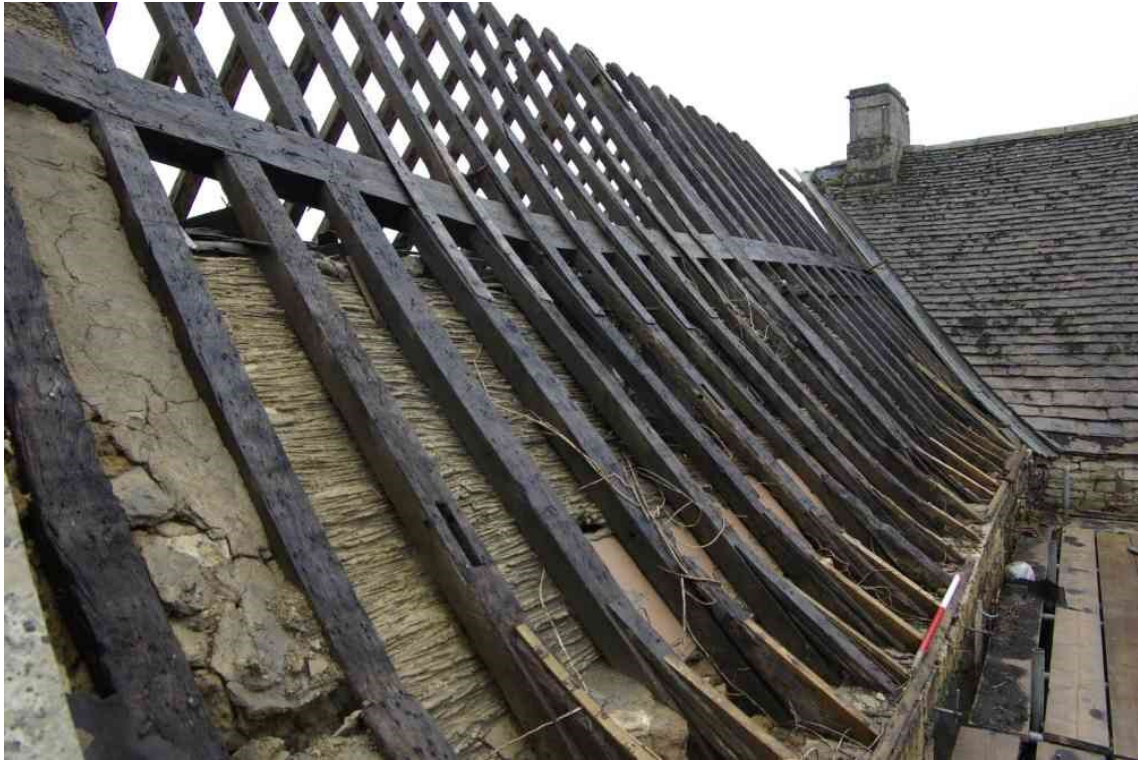
At the time of the initial survey the roof structure of this wing was partially obscured by debris filling the attic space, so a return visit was made after the removal of the Collyweston slates (*Figure 15*). At this stage it could be seen that the roof structure

consisted of oak rafter couples which were bridled at the apex using a mortice and tenon joint. Many, if not all, of the rafters have been reused from elsewhere as they have a number of mortice holes at various points along their lengths. Each rafter is tenoned and pegged into a substantial purlin and has a Roman numeral carved into each timber at every joint from north to south (*Figure 16*). The only rafter to extend from wall plate to ridge is a central pair of very thick (up to 300mm). The purlins are tenoned into these rafters. On the inner face of the purlins are a series of empty sockets which appear to have been cut for floor joists. The whole roof structure warps and dips quite significantly possibly due to the warped nature of the reused timbers or perhaps from the weight of the Collyweston roof. To overcome this uneven shape a number of thin wedged shaped pieces of timber have been nailed to the outer faces of some of the coupled rafters. It is not clear if this was part of the original build or carried out during a later re-roofing stage. A thin tie-beam or collar has been nailed to the south side of each rafter in an attempt to prevent the roof from spreading (*Figure 17*). The quality of this work suggests it is a later modification.

Figure 15. Building 01C. Roof structure.
1m scale. Looking south-east

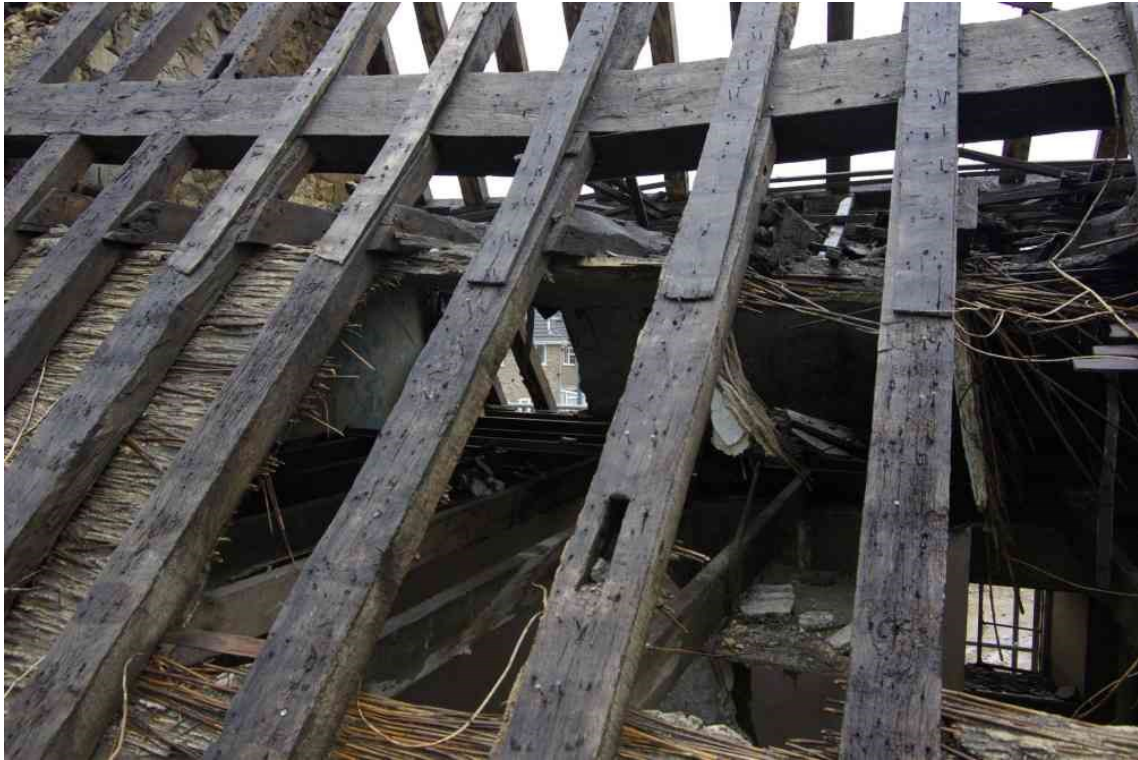
Figure 17. Building 01C. Tie-beam detail

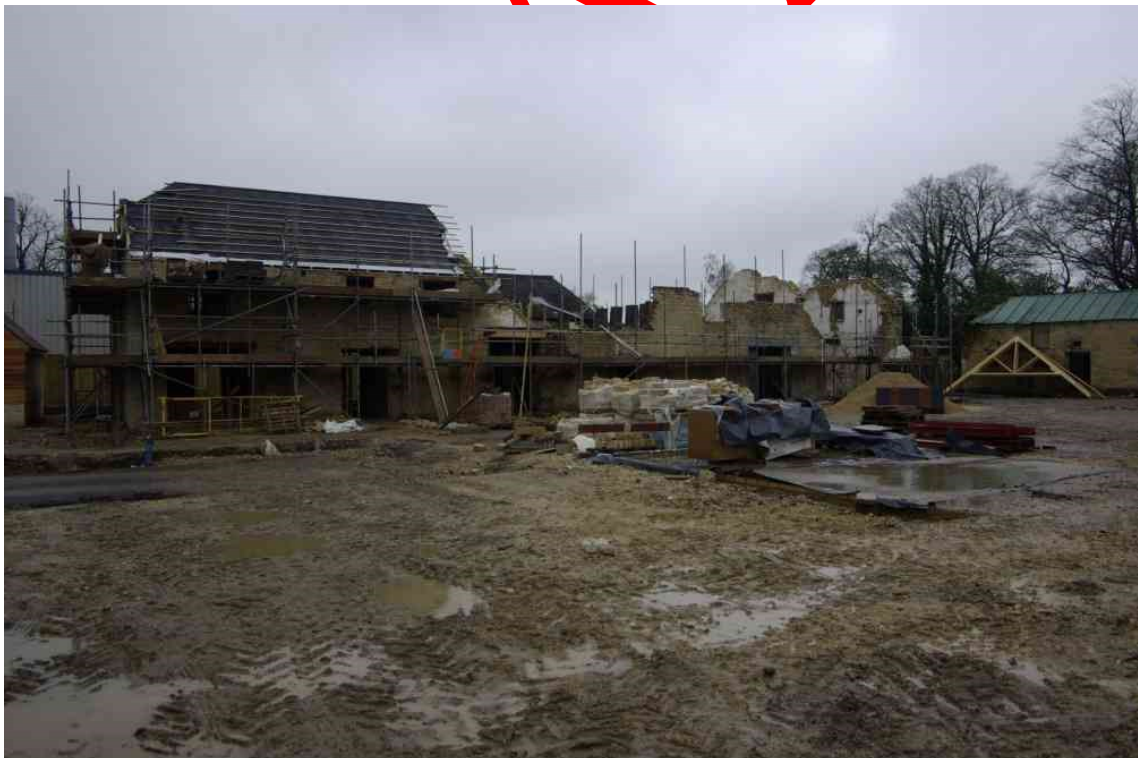
Building D is a large free-standing barn on the south-eastern side of the courtyard formed by the other buildings (*Figure 18*). At the time of the survey the original roof had been removed, any remaining fixtures and fitting had been removed and the whole building was well into the process of conversion and rebuilding. The building is constructed from coursed ironstone rubble as with the other buildings on site. The plan supplied by Hazelton Homes (shown here as *Figure 3*) indicates that Building D consisted of a two storey barn with a large central room flanked by a smaller room on each side. The remaining wall fabric evidence of surviving window sills and empty joist sockets suggest that the room plan on the ground floor was matched on the first floor.

Figure 18. Building D north facing elevation as surveyed on 19.04.2012

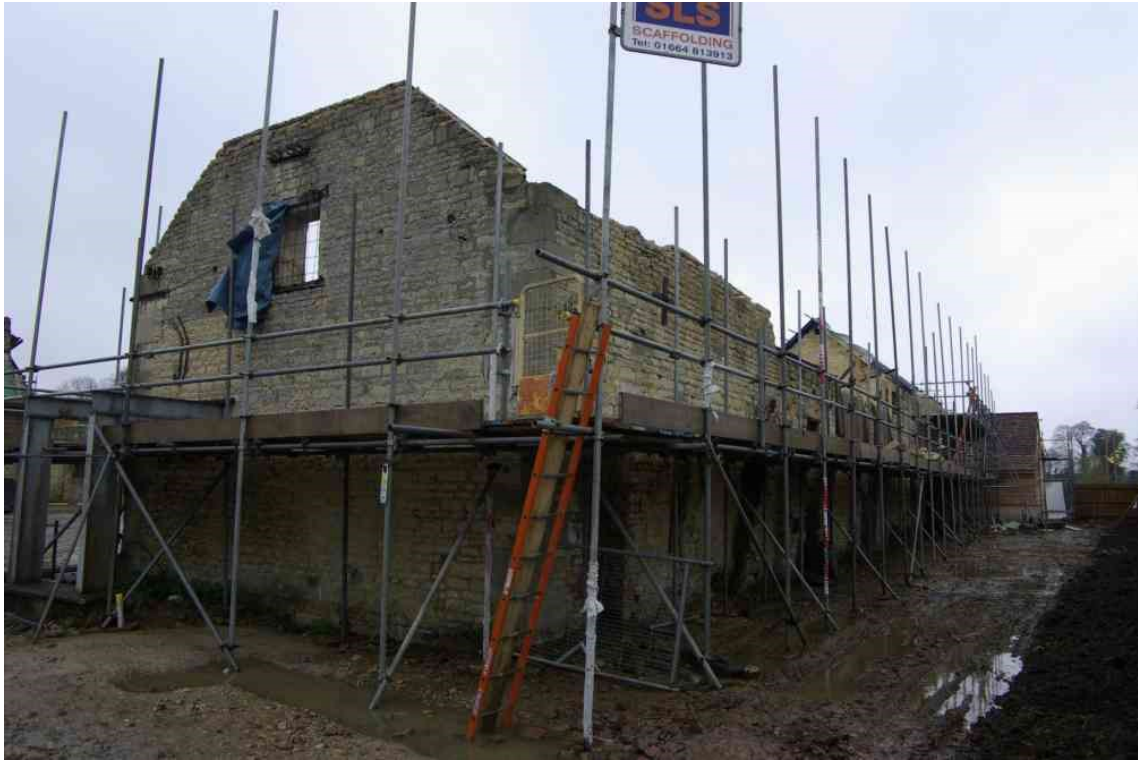
Ashlar quoins have been used at each corner and similar detailing surrounds some of the doorways (*Figure 19*). The internal dividing walls do not appear to be bonded to the outer walls and could be a later addition. A large stop chamfered beam survives in the south-western room running from north-east to south-west. Otherwise, the rest of the building had been so heavily converted and rebuilt that little else remained to be recorded.

Figure 19. Building D south and west facing elevations
Looking north-east
