**An Archaeological Watching Brief
at the Church of St Peter and St Paul,
Great Bowden, Leicestershire**

NGR: SP7462 8887

ULAS Report No 2012-186

**For
Great Bowden PCC**

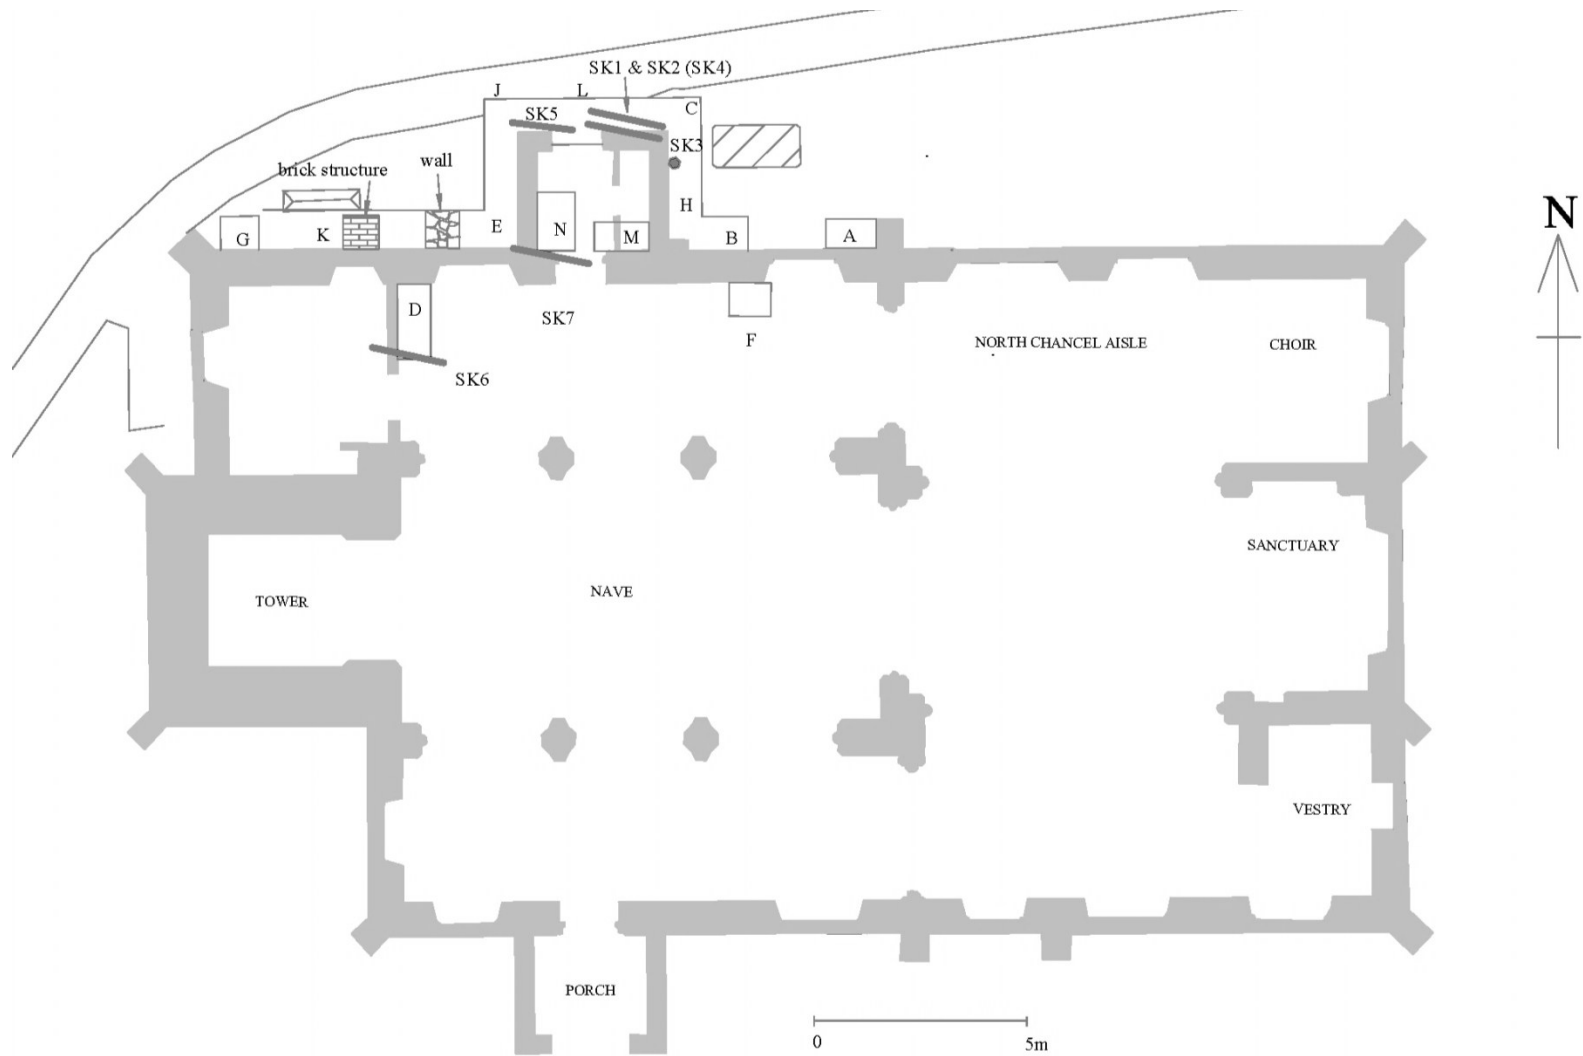
Figure 2: Plan of church showing location of trenches and archaeological features (NTS)

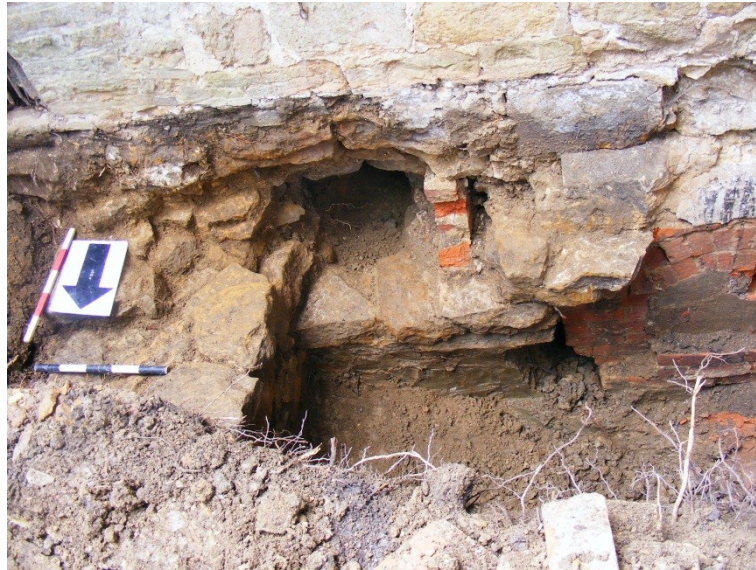
Trench K was located between Trench G and Trench O. A fragment of masonry was identified. This consisted of a linear wall foundation, measuring 0.95m in length by 0.8m wide. It was constructed predominantly from ironstone blocks measuring approximately 0.4 x 0.25 x 0.15m in dimension. The stones were roughly faced on the outside but not wholly regular in shape. The footing was roughly faced on the outside with smaller, more irregular stones on the inside and small flat stones filling the gaps. No mortar was observed and the wall was therefore either dry-stone or clay-bonded, with the latter seeming to be the most likely explanation. Only a short stretch of wall was present and no return was observed, therefore a possible interpretation was that the masonry represented an early buttress (Figs 3-4).

Figure 3: The possible buttress seen from above

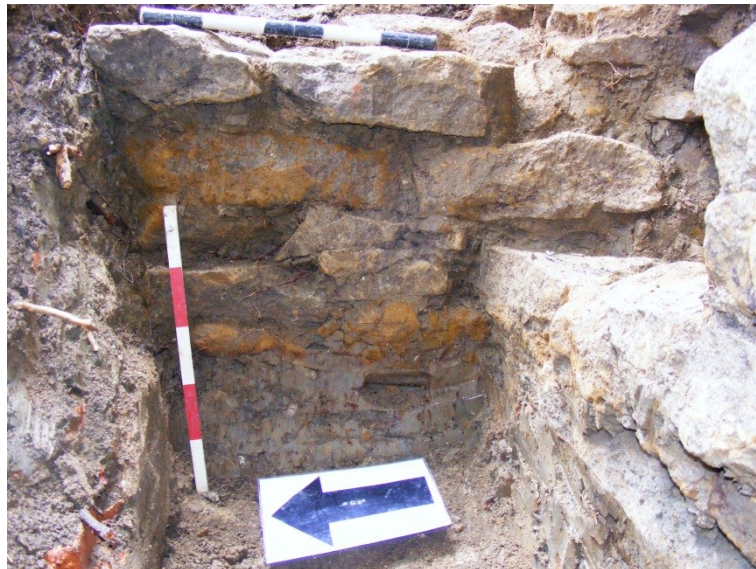
Figure 4: The possible buttress seen in elevation

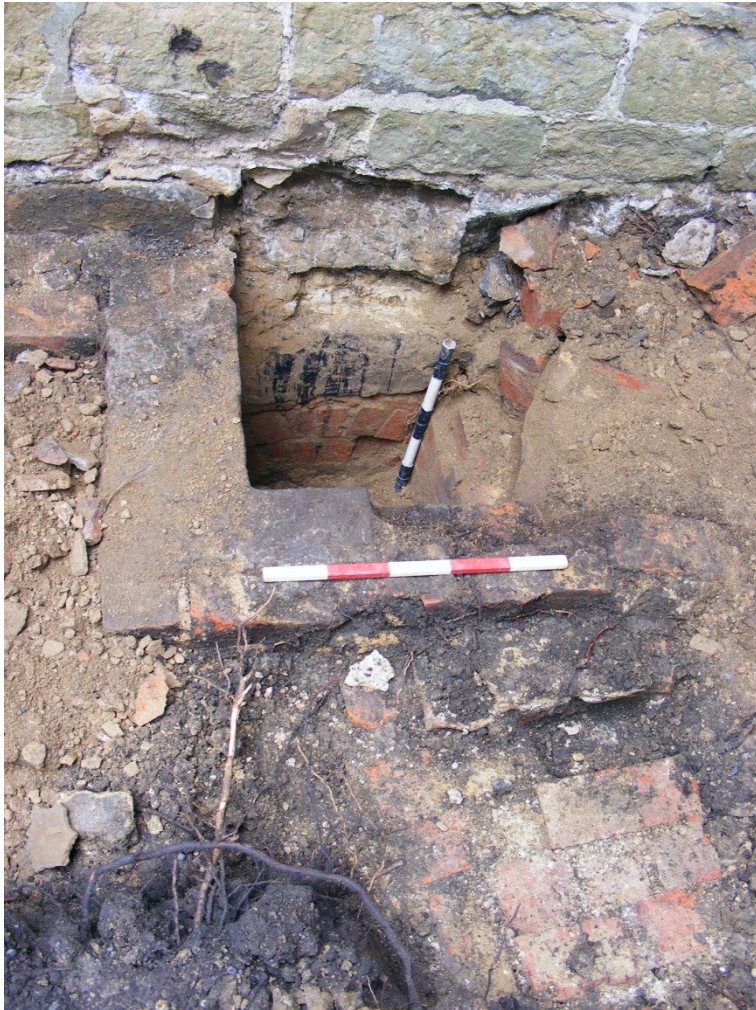
West of this feature, there was a rubble-filled brick shaft approximately 0.5m wide. This was filled with loose sandy material with frequent brick and tile rubble. Excavation eventually revealed a brick arch and a former aperture to the interior of the church which had been filled with concrete (Figs 5-6). This was thought to represent a vent from the probable hot-air heating system seen in trench D and could even be the site of the exterior furnace.

Figure 5: The brick shaft prior to removal

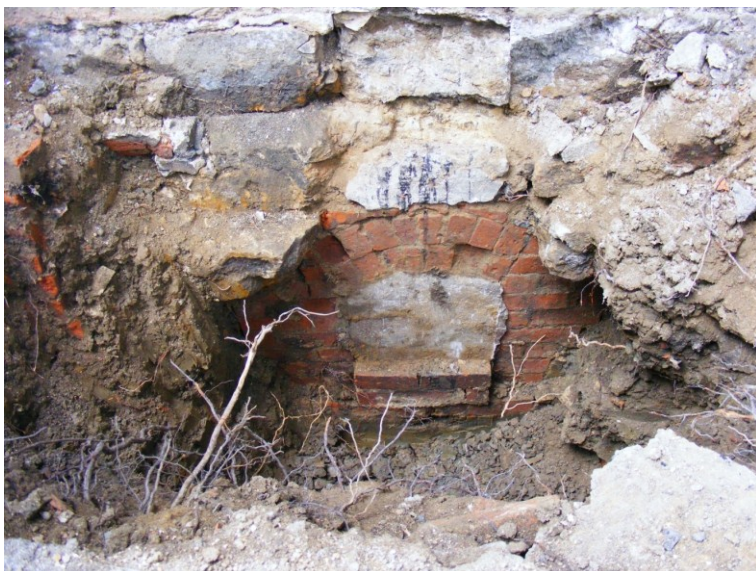
Figure 6: A possible vent for the heating system, as seen from the exterior following removal of the brick shaft

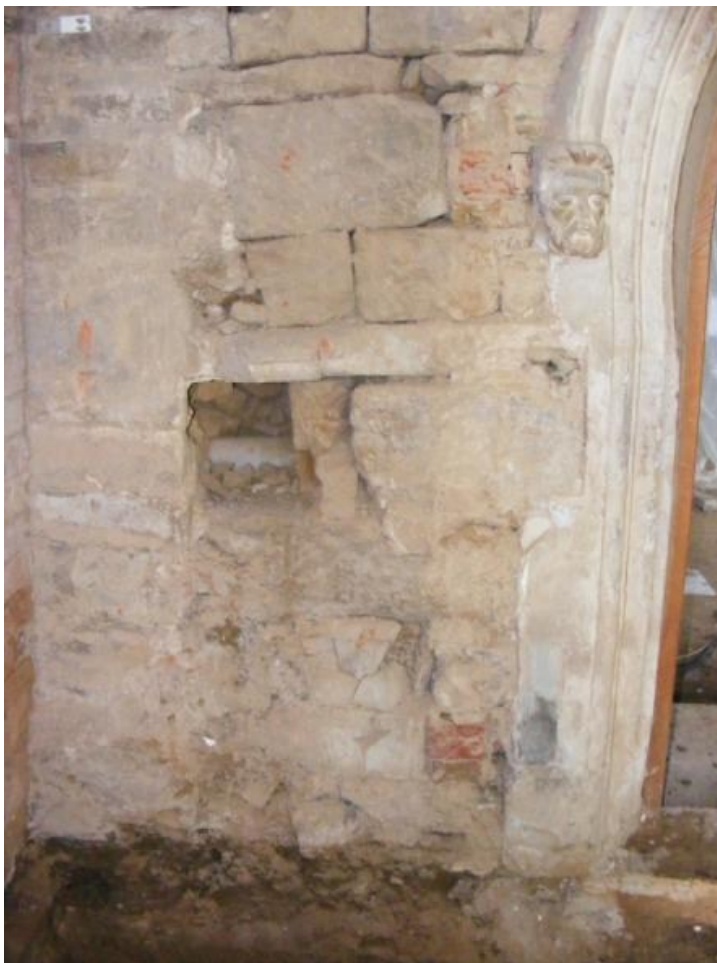
Trench M was excavated on the inside of the north porch against the east and south walls. The trench measured 0.7m (north-south) and 1.3m (east-west). Natural subsoil was present at approximately 0.7m deep below mid grey brown silty clay with frequent chalky stones, cobbles, ironstone fragments and flecks of brick and tile. The trench revealed the foundation of the aisle wall, showing that the foundation was 0.85m deep below threshold level and stepped out twice, extending 0.5m north of the aisle wall. The wall of the aisle itself showed signs that of alteration and rebuilding in the Victorian period (Fig. 7).

Figure 7: The exterior of the north aisle wall, as seen from inside the north porch (trench M below)
