**Historic Building Record:
59 & 59a Highcross Street, Leicester
NGR SK 5835 0464**

For Hammerson Plc

Historic Building Record: 59 & 59a Highcross Street, Leicester

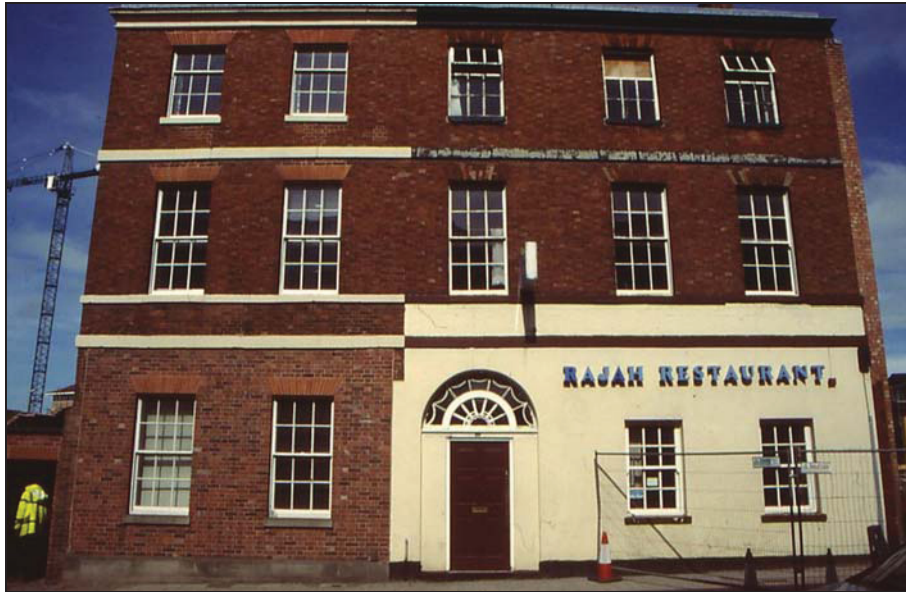
The Highcross Street elevation (Plate 1) is five sash window bays wide, of red brick with gauged arches, with painted stone bands at first and second floor level and at first floor sill level. It has a slightly projecting crowning cornice and frieze band, somewhat small-scaled and a low parapet above, now clad in lead. The central front door, possibly originally flanked by sidelights, has a semi-circular fanlight. The south (right-hand) half of the ground floor façade is rendered with two recent sash windows that are much smaller than those of the rest of the façade. North of the main entrance the ground storey façade (59a) has been reinstated in domestic form within the last decade or so, using reclaimed brickwork and good replica sash windows, replacing a much altered early 19th century shop front which is seen in early photographs (Appendix 1, Figures 3-4). The roof is covered in non-local slate, probably Welsh slate.

Plate 1. 59-59a Highcross Street. Looking east

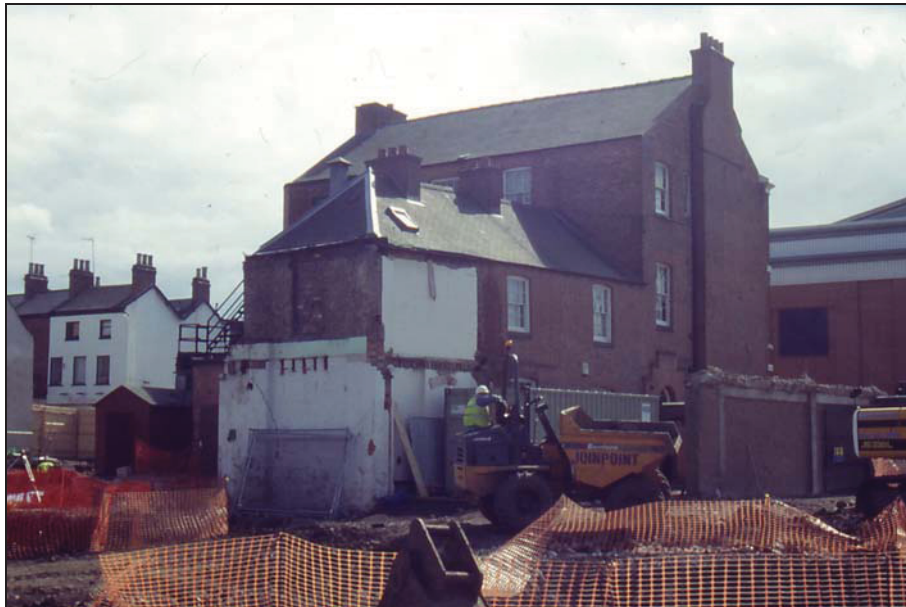
The alignment of the two-storey rear wing behind 59a is offset from the parent building (Plate 2). There are at least two distinct phases of build in the north wall of this rear block, using two different types and sizes of brick. The earliest phase of brickwork is attributable to the early 18th century. The later phase of brickwork appears to have been added to mask alterations to window and/or door openings in this elevation.

Plate 2. Rear of 59a Highcross Street. Looking south-west.

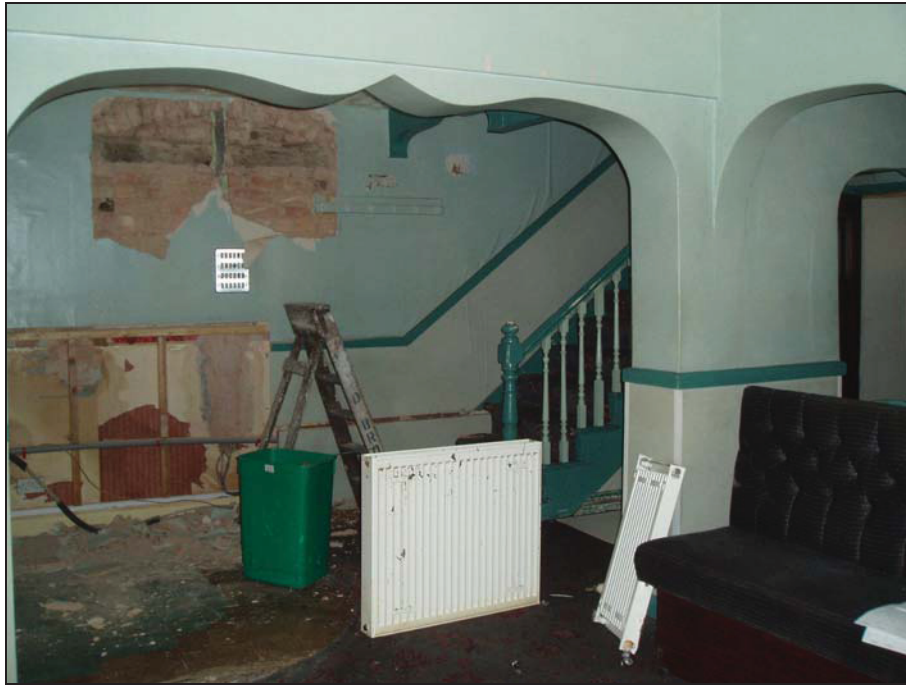
At the foot of the stairs, on the north side, is evidence of a blocked doorway with a segmental relieving arch over a timber lintel (Plate 3). This blocked opening was the principal access through from the entrance hall into the largest of the ground floor rooms of the 18th century house, now Flat 1 of number 59a (Room 9 on Figure 6). Under the stairs, a flight of 20th century concrete steps, occupying the position of an earlier staircase, leads down to the cellar. At the top of this flight of steps, in the north wall, is a blocked opening which formerly gave access to the service entrance, service staircase and rear wing.

Room 1 is open onto the entrance hall, its north wall having been largely removed (Plate 3). There is a blocked fireplace in the south wall. The only surviving early feature in this room is a ceiling cornice which is mostly hidden by a modern suspended ceiling incorporating a large *cupola*- part of the restaurant décor. There is damage to the cornice on the west side of the room, its condition elsewhere is uncertain. The early ceiling has been truncated over the centre of the room to accommodate the *cupola*.

Plate 3. Room 1, showing staircase and blocked doorway through to Room 9.
Looking north.

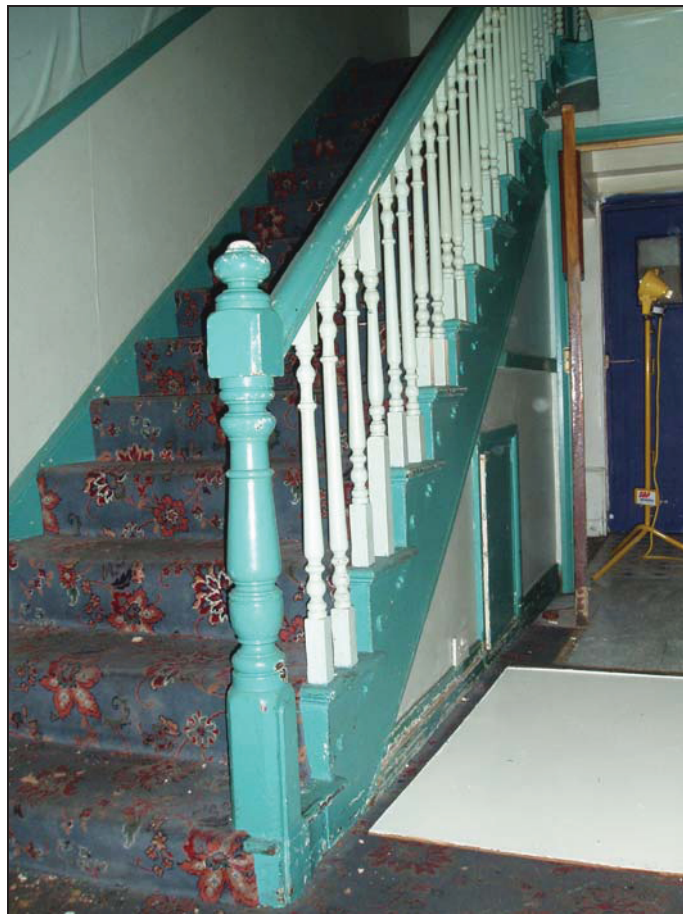
The ground floor of number 59 lately formed the dining area of the Rajah Restaurant and a partially open plan arrangement has been contrived with the removal of one wall and partial removal of another (Plate 3). The existing entrance vestibule is a recent creation and formerly this area would have been open onto the entrance hall and main staircase. Directly opposite the principal entrance is the fine, open string main staircase with turned newels, two turned balusters to each tread, carved tread ends and a wide, mahogany, ramped handrail (Plate 4).

Plate 4. 59 Highcross Street, ground floor staircase detail.
Looking east.

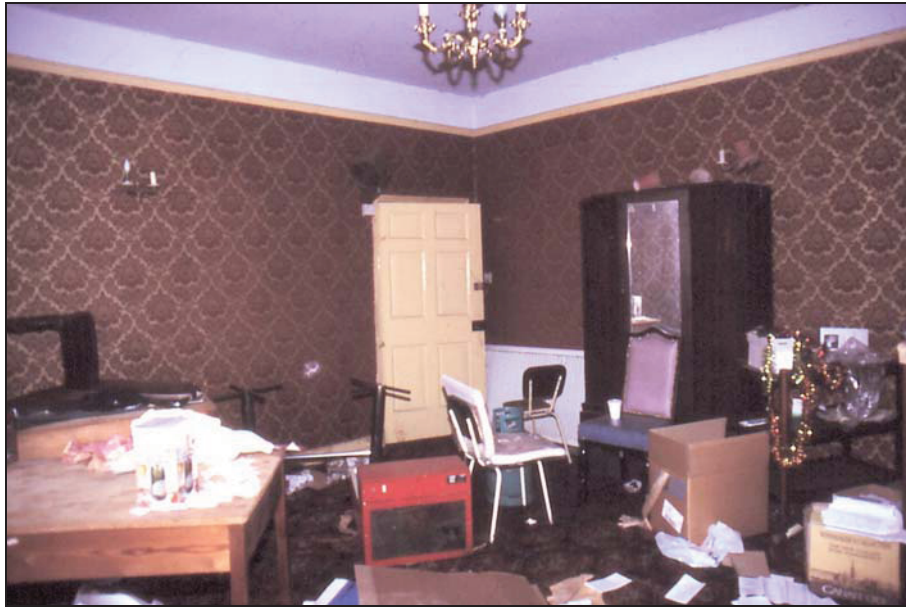
Room 3 overlooks Highcross Street (Plate 5). It has an early 6-panel door with L-hinges and the surround has moulded architrave on both faces. Early skirting survives throughout, interrupted only on the south wall where the fireplace would have been. The fireplace was blocked and the surround was removed some time in the past. A (broken) slate hearth remains. A moulded picture rail, probably 19th century, is intact around the room. This room is lit by two sash windows in the west wall. In both of these the upper sash is early but the lower is a later replacement.

Plate 5. 59 Highcross Street, Room 3. Looking north-east.

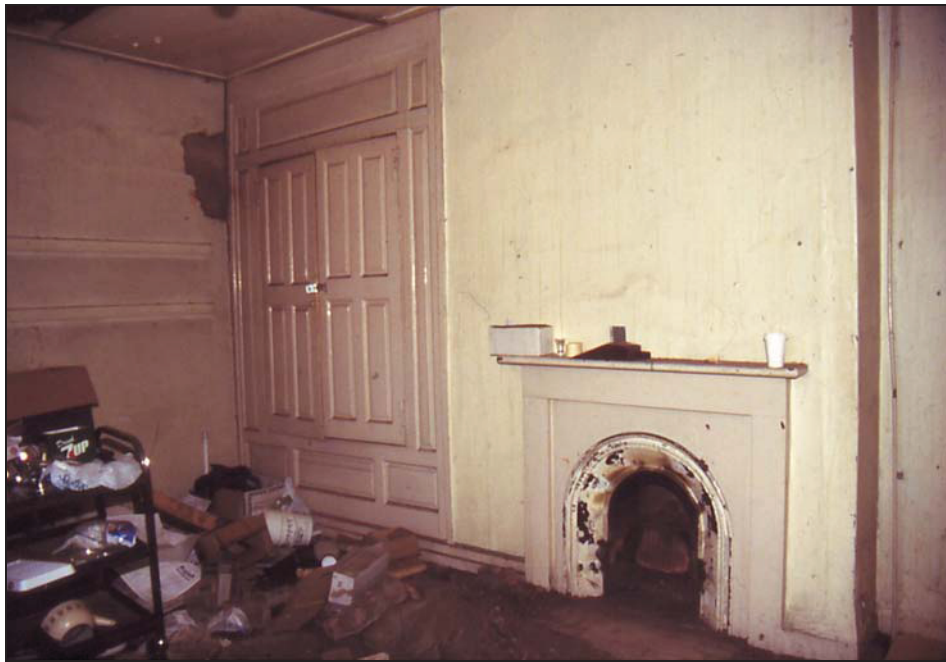
This room was latterly used as a storage area for the restaurant (Plate 6). The doorway has an early moulded architrave to both faces, but houses a modern, plywood door. There is early skirting throughout the room, matching that of Room 3. The fireplace has a cast-iron arch plate register grate of a type which became popular in the 1850s (Eveleigh 1983, 8-9). The fire surround is plain, of painted stone or marble and may be 18th century. To the left-hand side of the fireplace is an 18th century, panelled, fitted cupboard, with H-hinges. A large, modern window in the east wall lights this room. The ceiling is modern fibreboard. The floor structure in this room is similar to that of Room 3 except that there are two angled transverse beams into which the joists are joined. At the south end of the room the ends of the floor joists are supported on a further transverse beam set against the inside face of the south gable wall. The floor covering is 4½ inch (114mm) wide tongue and groove boards, except beneath the early fitted cupboard where there are earlier butted boards 6 - 6 ½ inches (152-165mm) wide. These evidently extended into the room originally, but have been crudely sawn through in line with the front of the cupboard.

Plate 6. Room 4, Looking south-west.

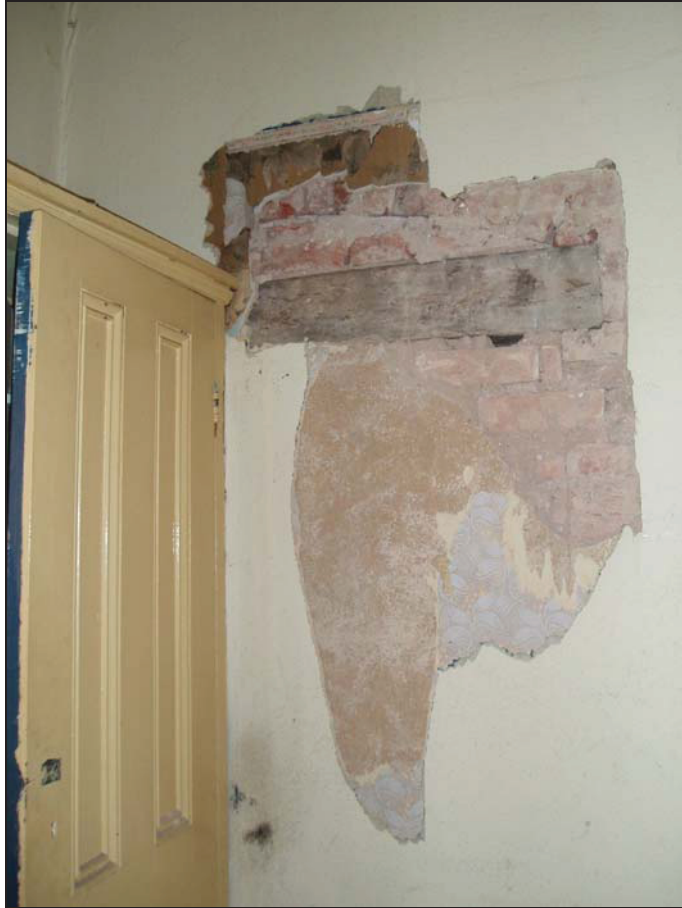
This cupboard partially masks a blocked doorway which originally gave access to the third principal first floor room, now Flat 4 of number 59a (Room 13). The blocked doorway was partially exposed revealing a timber lintel with brick relieving arch over (Plate 7). The floor of the landing is of gypsum plaster on reed type.

Plate 7. First floor landing, showing C19th cupboard and blocked doorway through to 59a Highcross Street. Looking north.

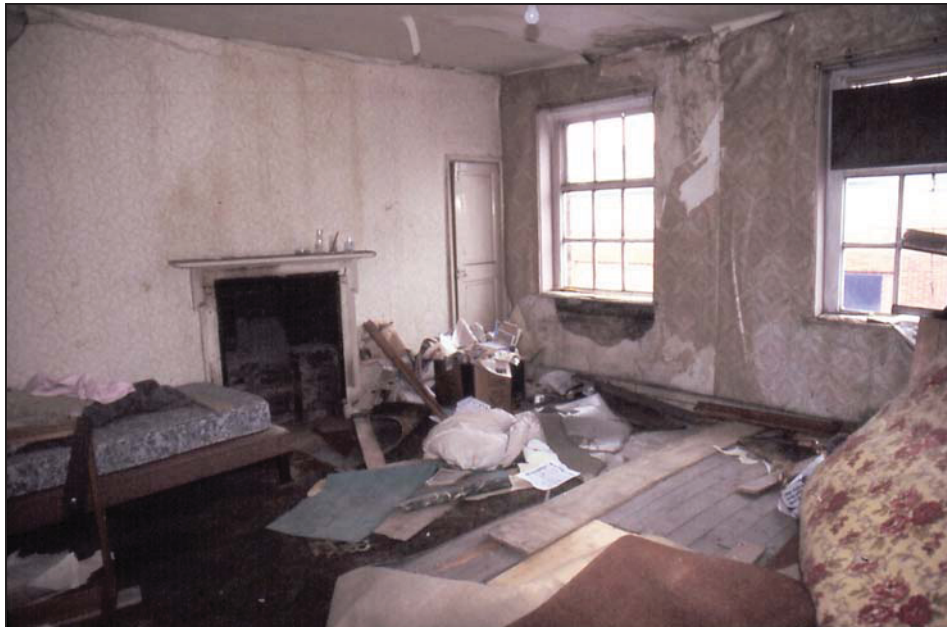
Room 6 is a large room located at the front of the building and recently served as sleeping quarters (presumably for staff working at the restaurant) (Plate 8). This room has an 18th century 4-panelled door with L-hinges. Architraves on both sides of the surround are early, with a more elaborate moulding displayed on the 'public', external face. There is an 18th century timber, eared fire surround although the hob grate has been removed. Skirting in this room and in Room 7 matches that seen in Rooms 3 and 4 on the floor below, and is present throughout with the exception of the wall dividing this from Room 8, which has plain skirting. There is a recessed cupboard in the south-west corner of the room which has an 18th century 2-panel door, complete with early latch handle and H-hinges (Plate 9). Evidence from the brickwork within the cupboard reveals a similar arrangement to that found on the first floor at this point. It is also evident that the south gable wall is not tied into the chimney stack serving this room, or to the internal wall dividing this room from Room 7. The floor structure is comparable with that of Room 3 below.

Plate 8. Second floor, Room 6, looking south-west.

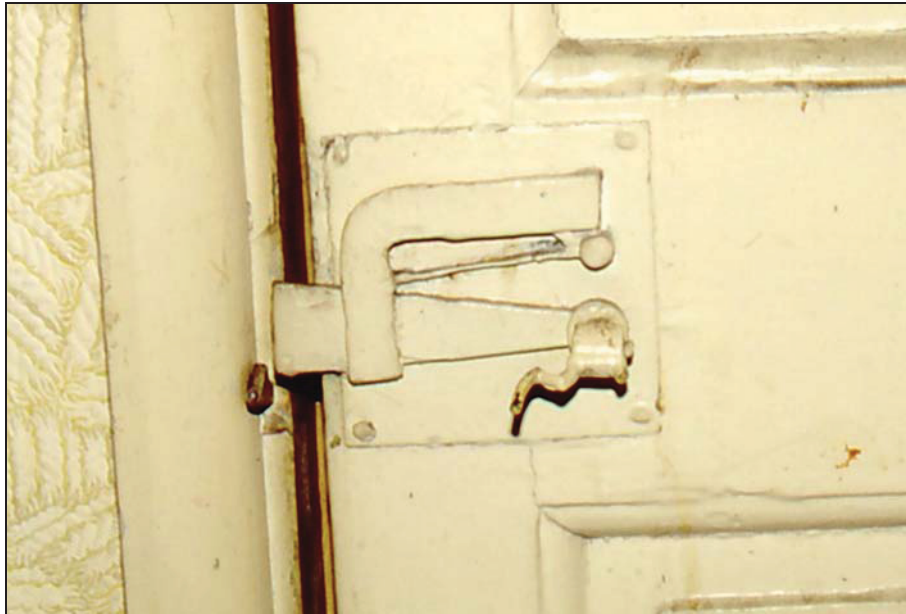
Plate 9. Detail of latch-handle to fitted cupboard, Room 6. Looking south.

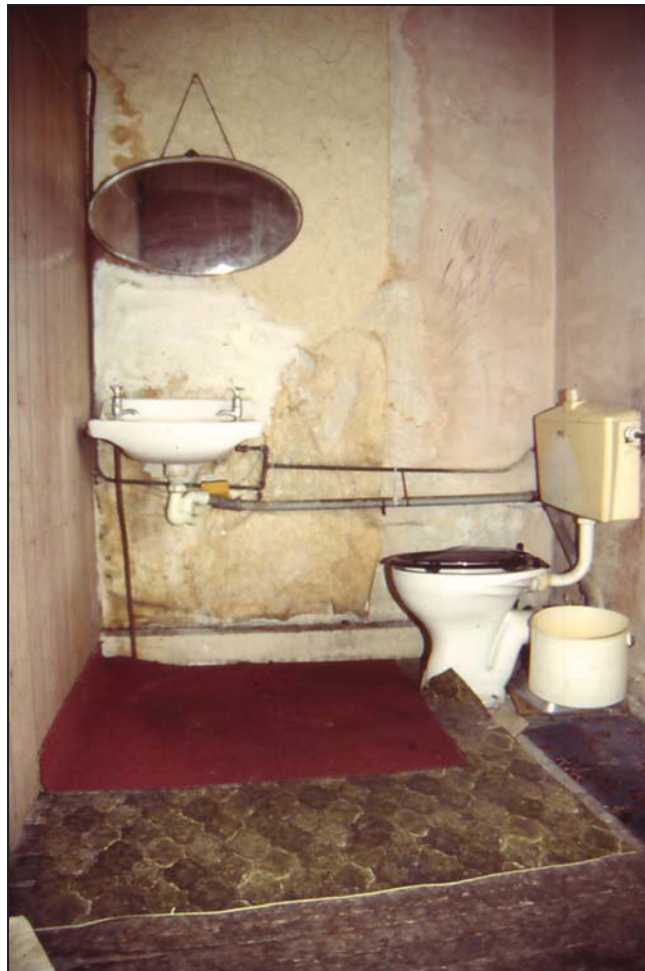
Room 7, towards the rear of the building, is presently sub-divided by plywood partitions to form an office space and washroom with toilet and hand-basin (Plate 10). Enclosed within the office space, on the west wall, is the original fireplace. This has a plain, painted slate surround, similar in style to that of Room 4 below, and a Forest pattern hob grate (Plate 11). The fireplace was intact at the time of the initial survey, but was subsequently partially dismantled by persons unknown, resulting in damage to some of the slate pieces, although all the component parts are present and reconstruction should be straightforward. Adjacent to the fireplace is an 18th century panelled, fitted cupboard with H-hinges (Plate 12). The door and surrounding architrave to this room, in addition to the skirting are also early and match those of Room 6. The south gable end wall does not appear to be properly tied into the rear (east) wall of the building: there is evidence of broken brickwork that may again indicate that the south wall is retained from an earlier structural phase. The floor structure in this room appears to be the same as that in Room 4 directly below.

Plate 10. Room 7 Bathroom. Looking north.

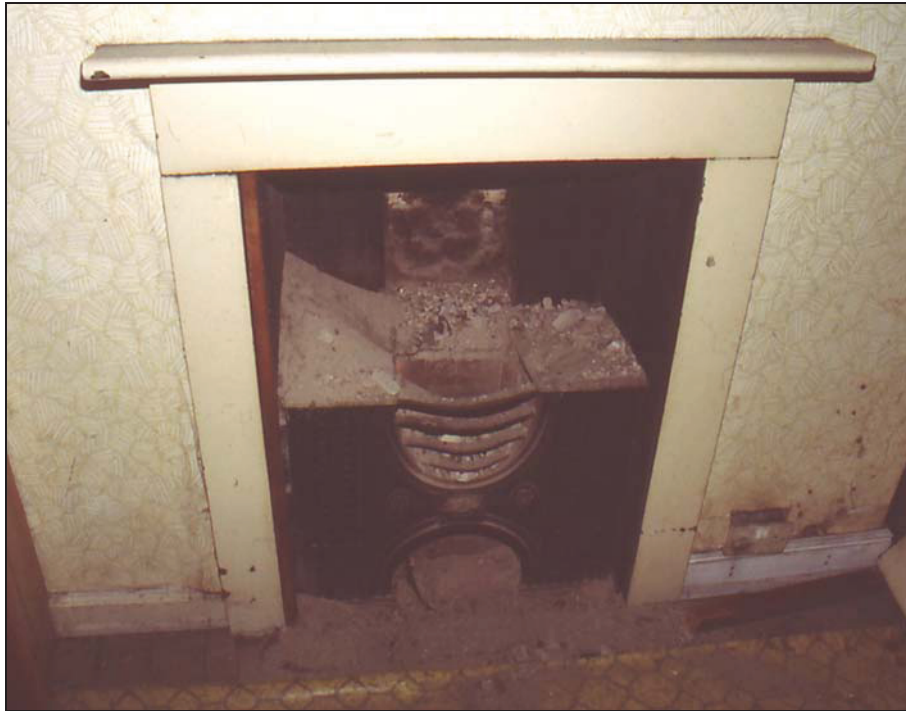
Plate 11. Room 7 fireplace. Looking west.

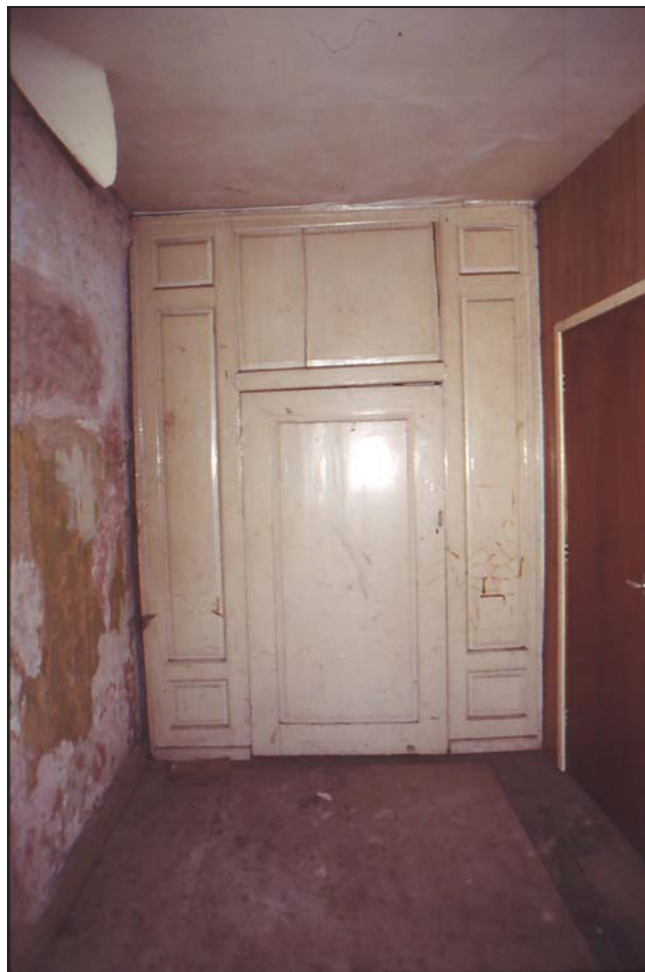
Plate 12. Room 7, fitted cupboard. Looking west.

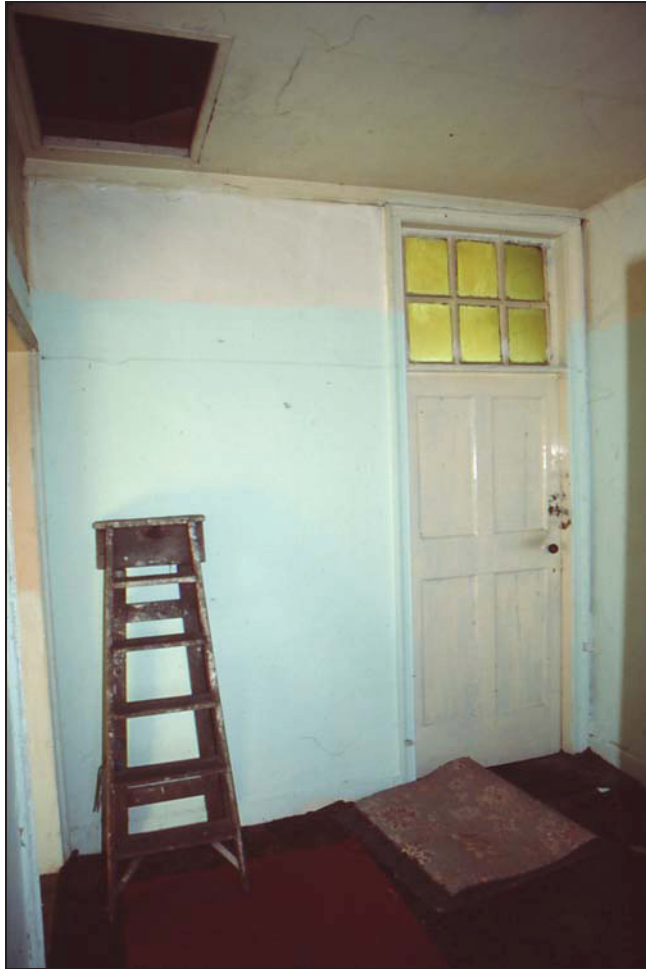
Plate 13. Second floor landing, four-panel door to Room 8, with overlight.
Looking north-west

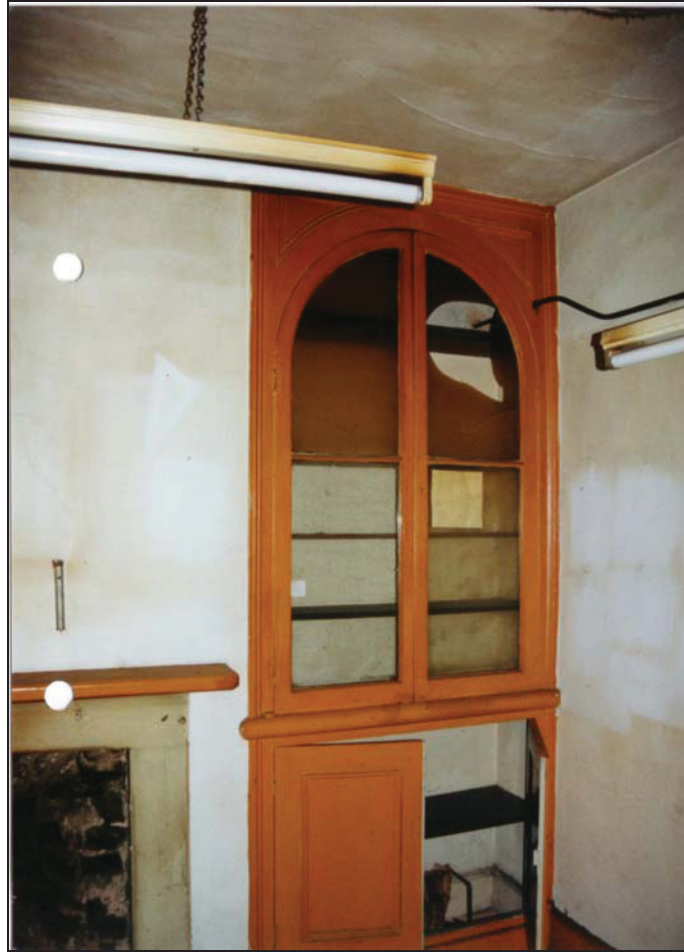
Room 10 probably functioned as a service room in the 18th century. Surviving early fixtures and fittings however, including a rising shutter to the window in the north wall and a fitted cupboard adjacent to the fireplace, appear to date to the mid-19th century, and may relate therefore to a scheme of upgrading and refurbishment following the sub-division of the property. An exposed ceiling beam, part of the 18th century structure, is chamfered with run-out stops. A photograph of this room prior to the residential conversion

shows that the fitted cupboard had previously had glazed doors: the glazing has now been replaced by wooden panels (Plate 14).

Plate 14. 59a Highcross Street, Room 10. Showing fitted cupboard and part of fireplace. Photograph taken prior to 1990s flat conversion and supplied by N. Weafer.

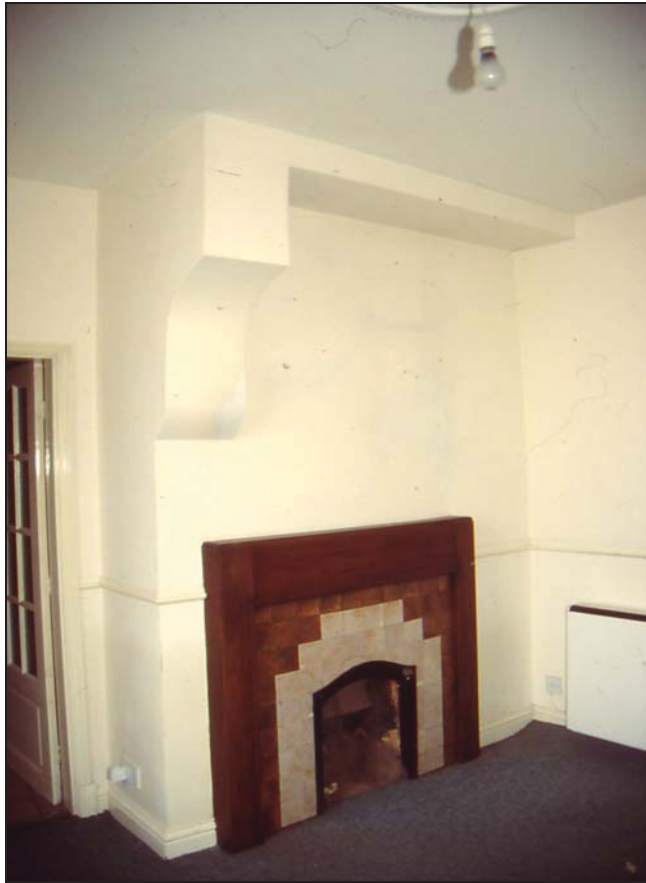
The massive chimney stack located between Rooms 11 and 12 may indicate that this area was originally the kitchen. The present timber fire-surround with tiled insert can be dated c.1910-1920 (Plate 15). The sash window is the same as that within Room 10 and a rising shutter may survive here also.

Plate 15. Room 11. c. 1910/20 fireplace within chimney stack.
Looking east.

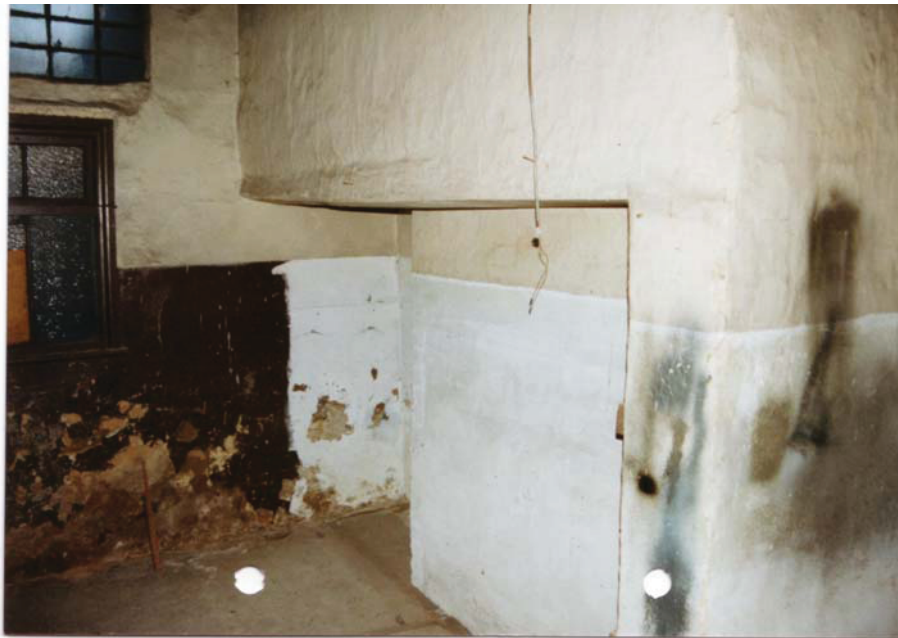
Plate 16. Room 12. Rear of large chimney stack, taken prior to 1990s redevelopment.
Looking south-east. Photograph supplied by N. Weafer.

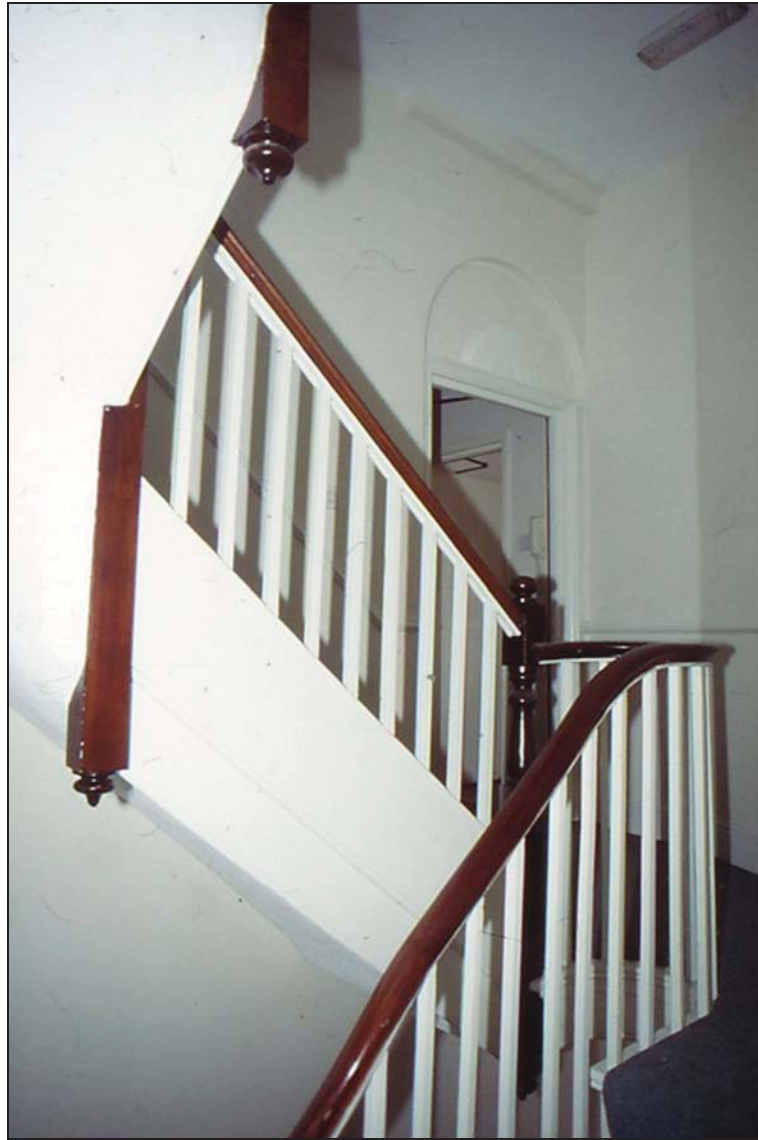
Plate 17. 59a service staircase, showing position of former 1st floor passage into Room 13. Looking north-west.

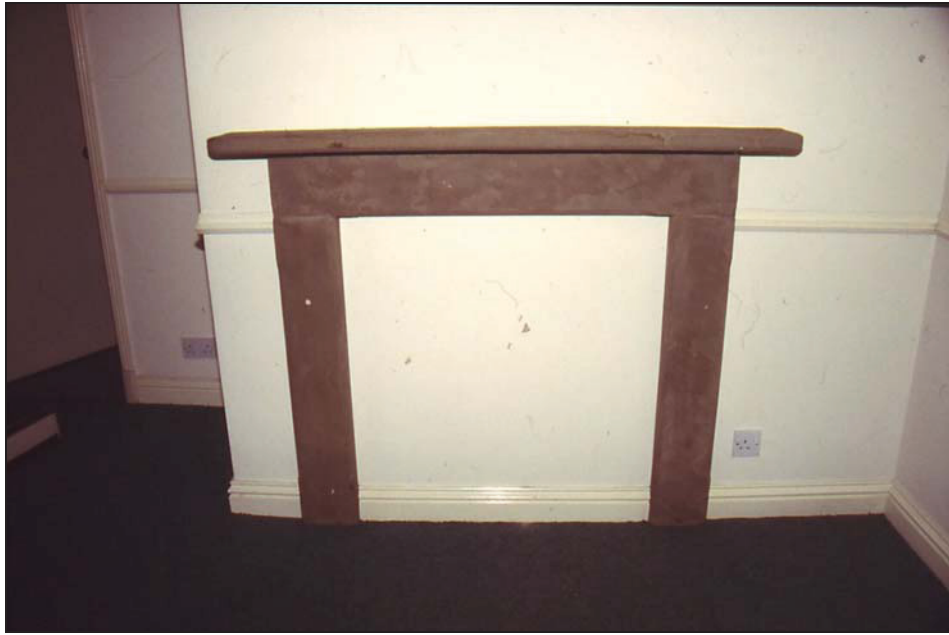
Plate 18. 59a Highcross Street. Room 15 fire surround. Possibly relocated here from Room 10 as part of 1990s redevelopment. See Plate 14 above.

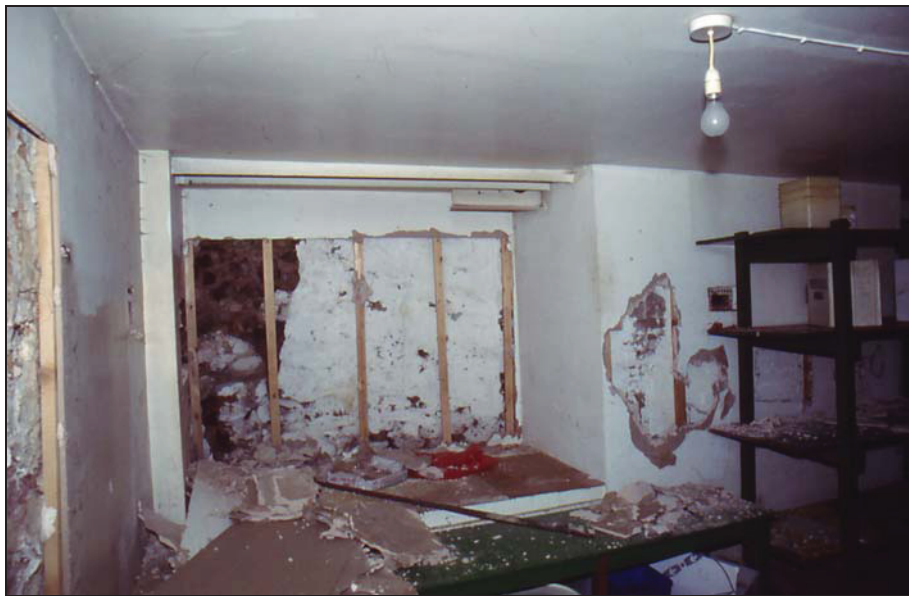
Plate 19. Cellar 1, showing stone wall behind plaster-board. Looking west.

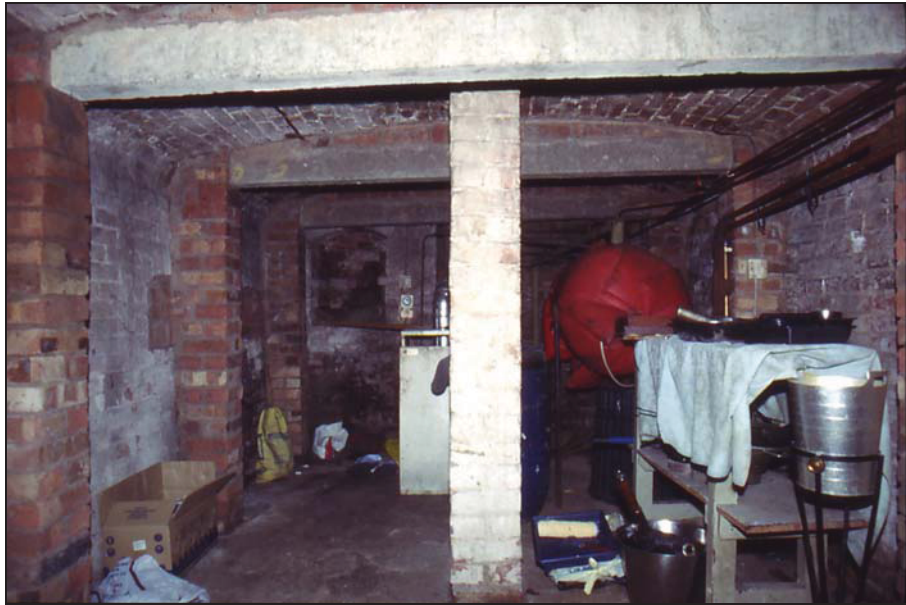
Plate 20. Cellar 2. Looking east.

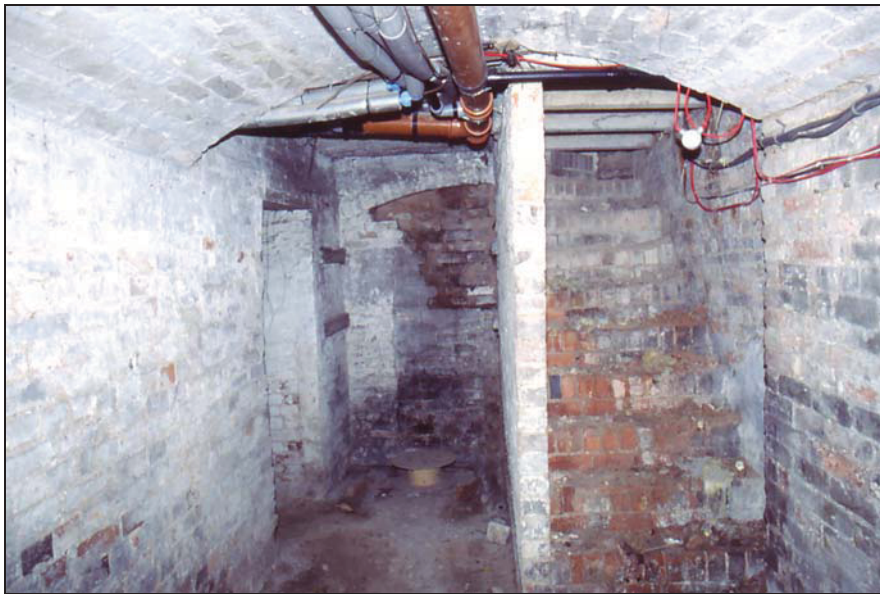
Plate 21. Cellar 3, showing blocked staircase leading up to 59a Highcross Street and blocked doorway through to cellars of number 59 to the left. Looking south.

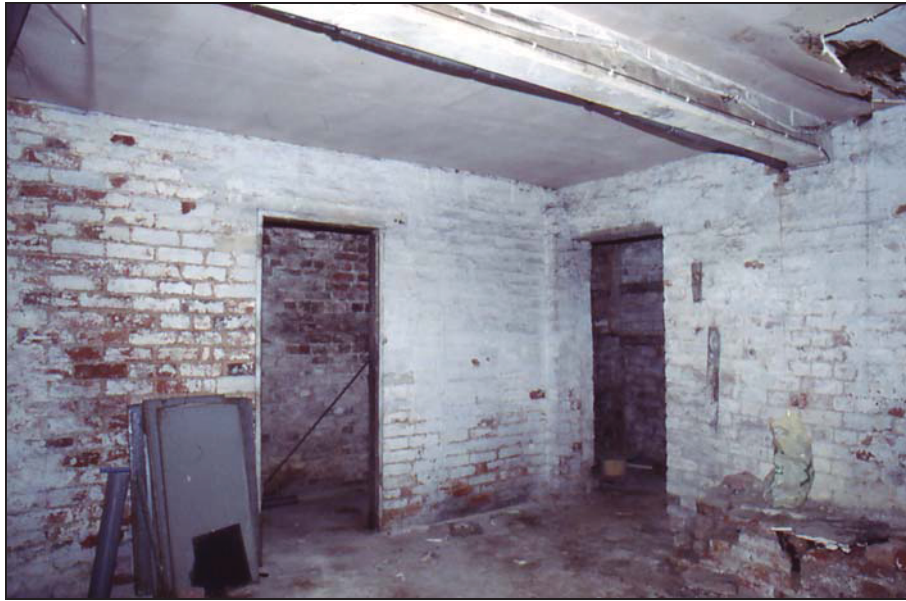
Plate 22. Cellar 4. Looking south.

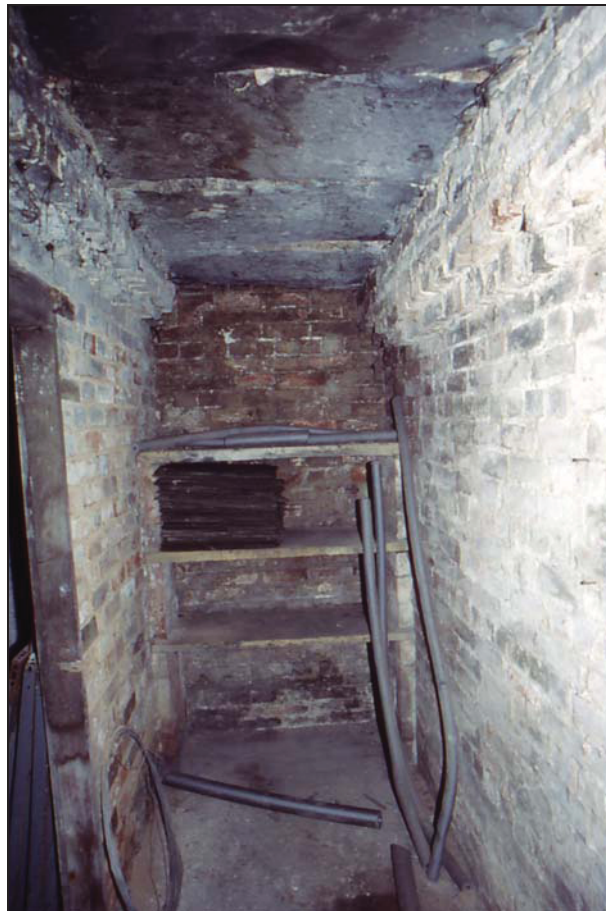
Plate 23. Cellar 5. Looking east.

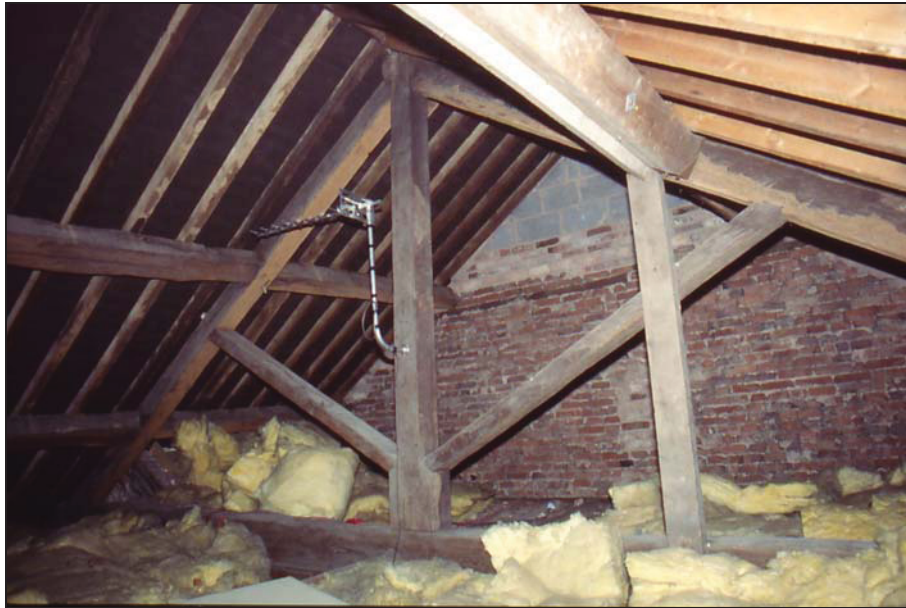
Plate 24: King-post roof structure above Rooms 17 and 18, frontage range. Looking north.

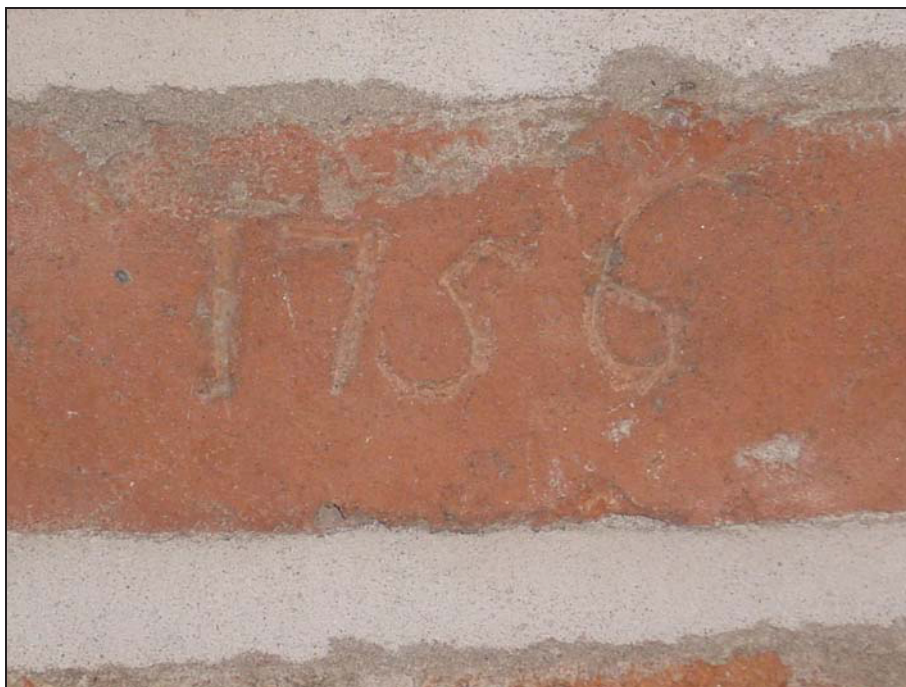
Plate 25: Date inscribed brick '1756', located within north gable-end wall.

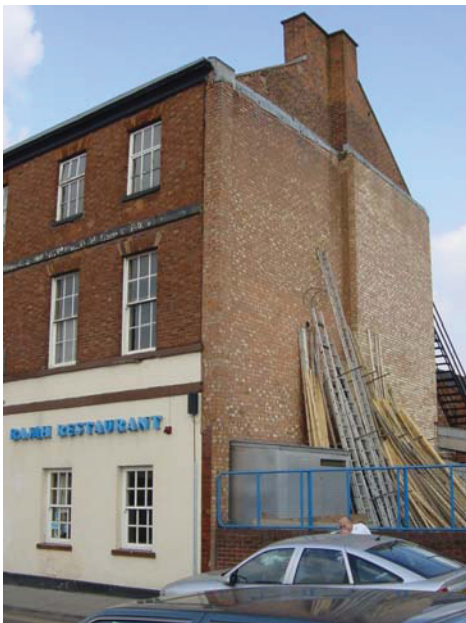
Figure 1: Grade II listed No.59 Highcross Street. Note the 'skin' wall against the southern gable end.

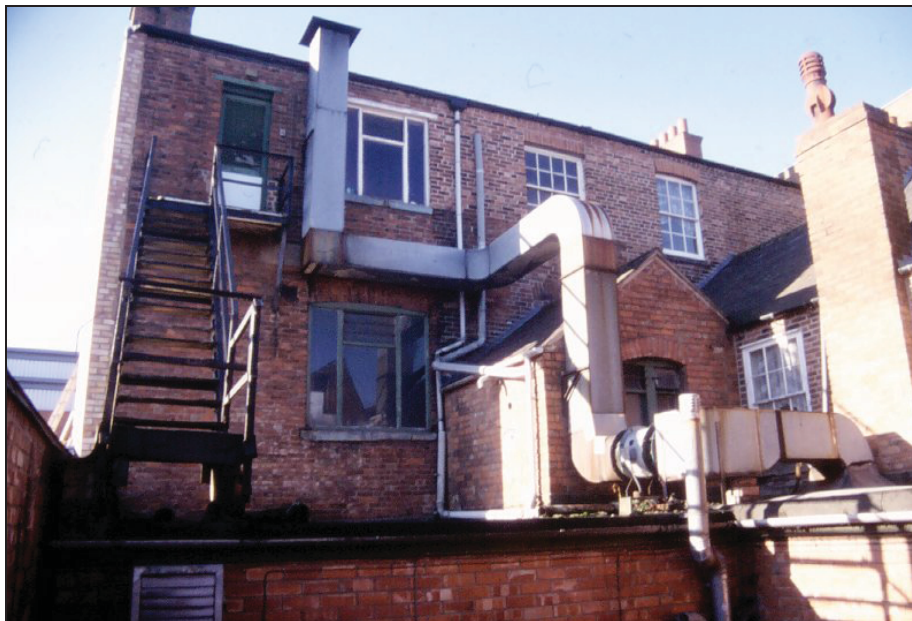
Figure 1. Rear of 59 Highcross Street showing the first floor section of the 19th century two-storey range (behind extractor ducting).

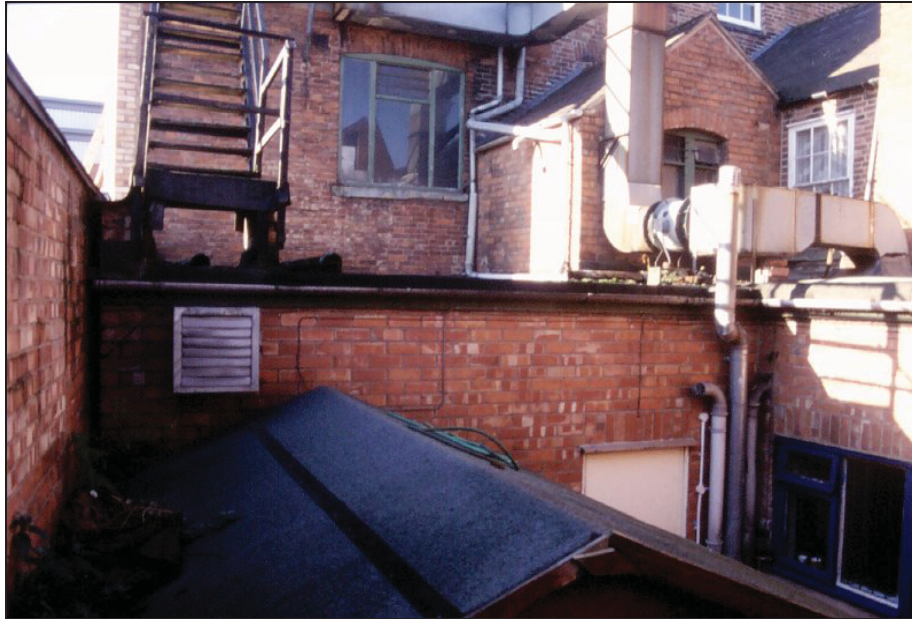
Figure 2. Rear of 59 Highcross Street showing the late 20th century single storey flat roofed range (centre of frame).

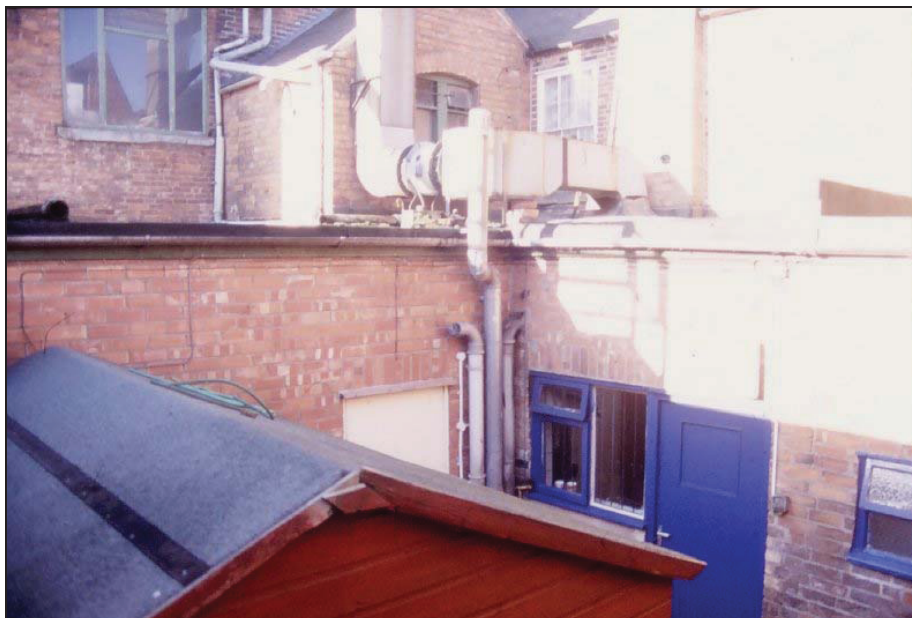
Figure 3. Rear of 59 Highcross Street showing (on right) single storey flat roofed range on north side of plot. In the lower right corner of the frame is the 19th century toilet block.
