**An Historic Building Photographic
Survey at 49 Main Street,
Great Bowden, Leicestershire
NGR: SP74150 88835**

ULAS Report No. 2012-068
©2012

For: Mr and Mrs B Organ

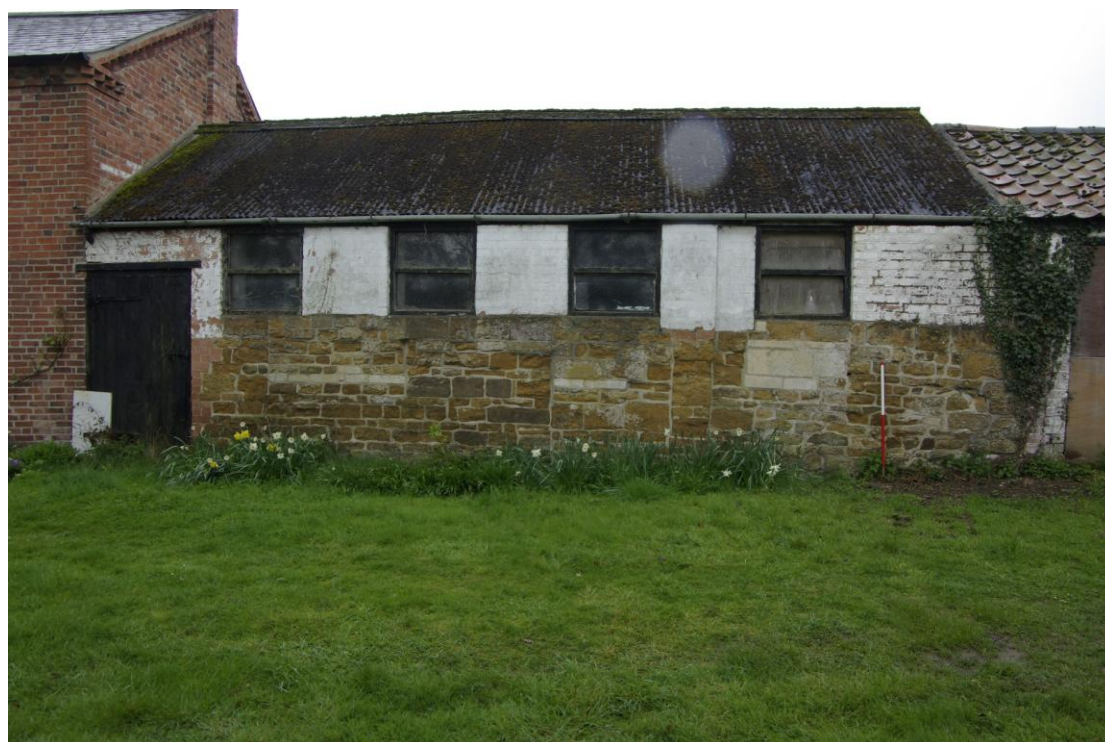
The north facing elevation is the principal elevation and is constructed of coursed ironstone rubble from ground level to window sill height and red brick from window sill to eaves (Fig. 6). On the eastern end is a single wooden doorway surrounded by brickwork filling in what appears to be a later crudely knocked through opening. Four equally spaced wooden framed windows rest on top of the ironstone wall and are surrounded by brickwork laid in a mix of English and Flemish bond. There is evidence of a blocked window in the stonework to the west of the doorway and a blocked doorway can be seen in the centre of the elevation. At the western end the stonework has had an opening partially filled with ashlar limestone blocks and also appears to have collapsed and patched with smaller pieces of ironstone. This wall is leaning outwards and appears to be somewhat unstable. There is little evidence of the possible gap between the buildings shown in the 1886 Ordnance Survey map although the patched stonework may be a remnant of this. The roof is of modern corrugated asbestos sheeting.

Figure 6. East building, north facing elevation
Looking south. 1m scale

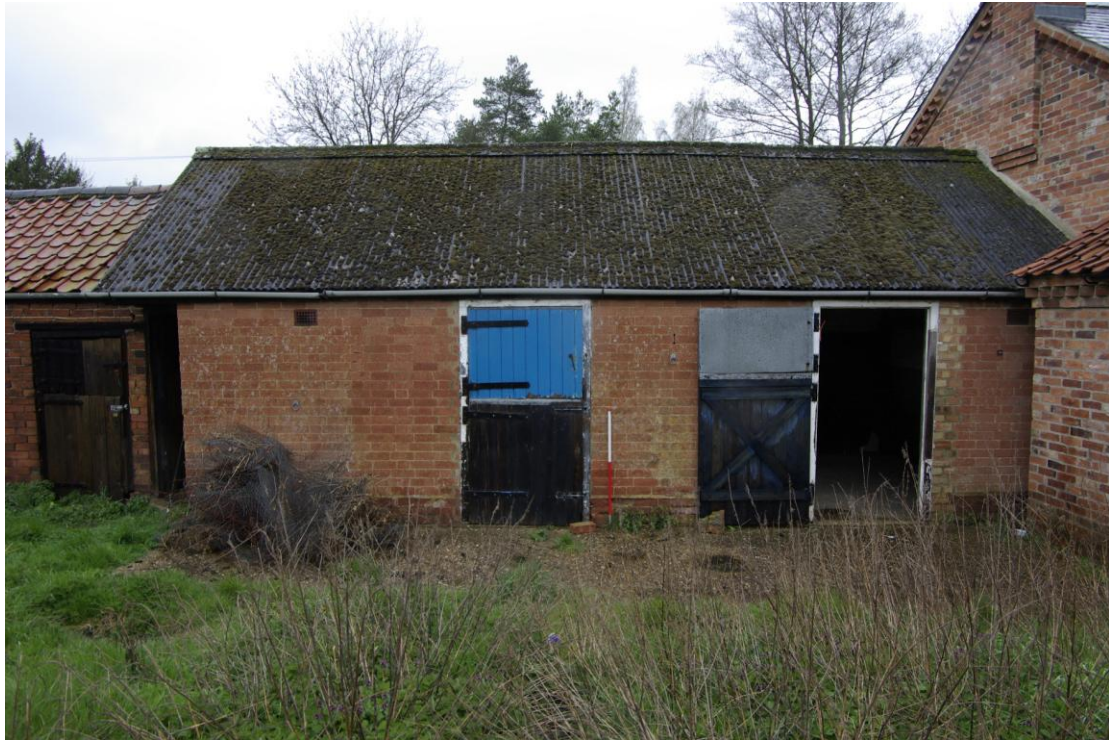
The south facing elevation of the eastern building has been extensively altered in the later half of the 20th century by the addition of a skin of modern brick covering the entire elevation (Fig. 7). The reason for this is not clear although it does now support the south side of the modern roof and may mask any possible scars left by the demolished southern range seen on the 1886 and 1926 OS maps. Two stable doors lead into the east and central rooms whilst a door on the south-west angle of the building leads into the west room. The angle of the door accommodates the change in

width of the east and west buildings. At roof height the increased width of the eastern building roof is covered over with timber planks.

Figure 7. East building, south facing elevation
Looking north. 1m scale

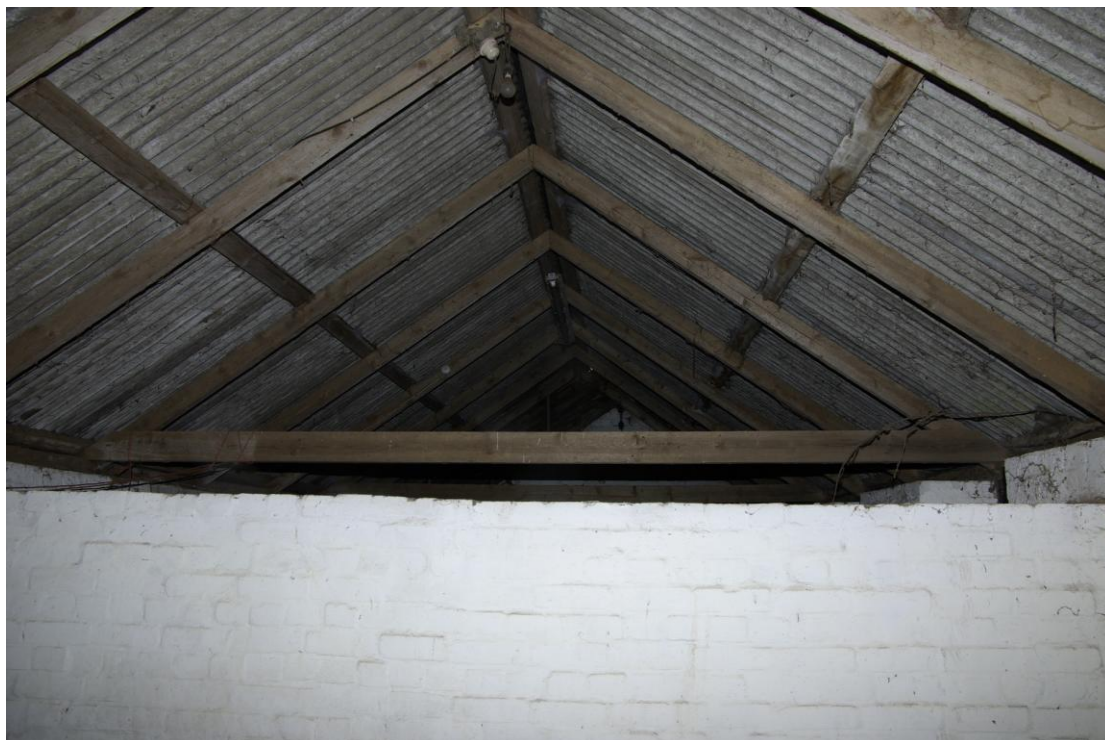
Figure 8. East building, roof and partition detail
Looking west from eastern room

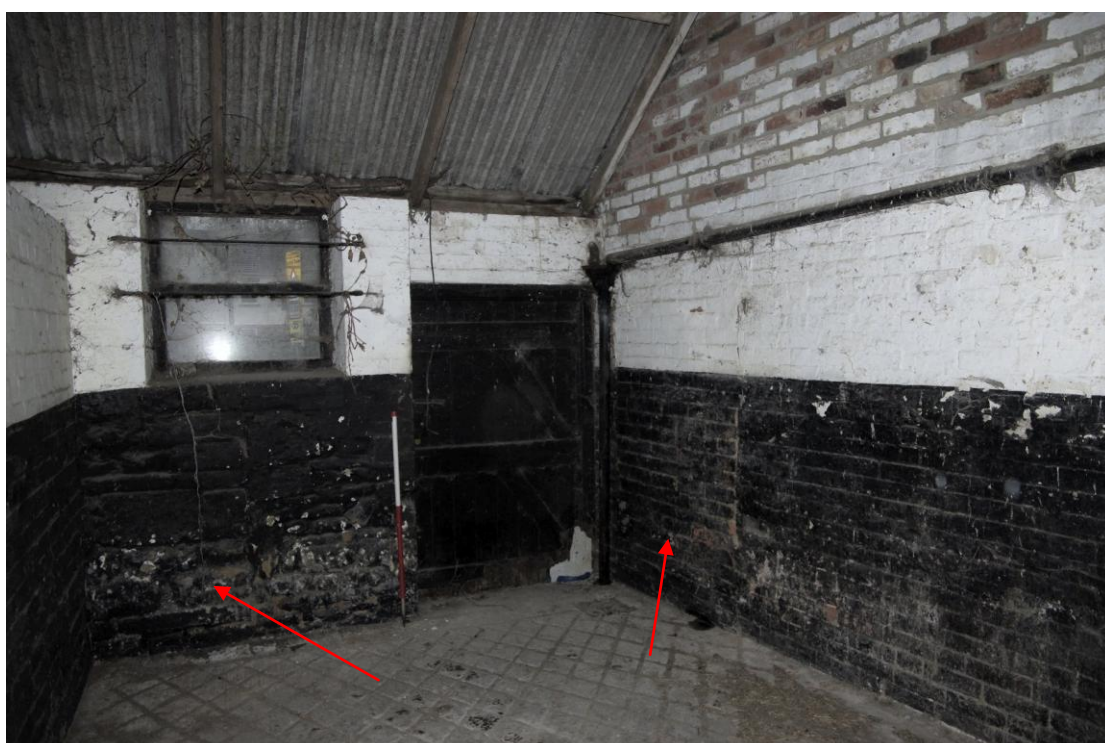
Internally, the eastern building is divided into three similarly sized rooms with a brick-built partition rising to eaves height between each room. The bricks are laid in an attempt at English bond and the sizes match those used on the north elevation and on the internal skin of the south elevation. Apart from the existing doorway the brickwork on the southern wall has no other sign of any doorways or openings that may have led into the demolished south range. The roof timbers are modern and lightweight (Fig. 8). All of the floors are concrete. A wooden door in the north-east corner leads out to Main Street and a blocked doorway with a wooden lintel is on the eastern gable end suggesting that it may pre-date the adjacent house or that the two buildings were connected. Another blocked doorway is visible in the stonework on the north wall in the north-west corner but does not extend to the brickwork (Fig. 9).

Figure 9. East building, eastern room
Looking north-east. 1m scale.
Note blocked doorways in north-eastern and north-western corners marked with arrows

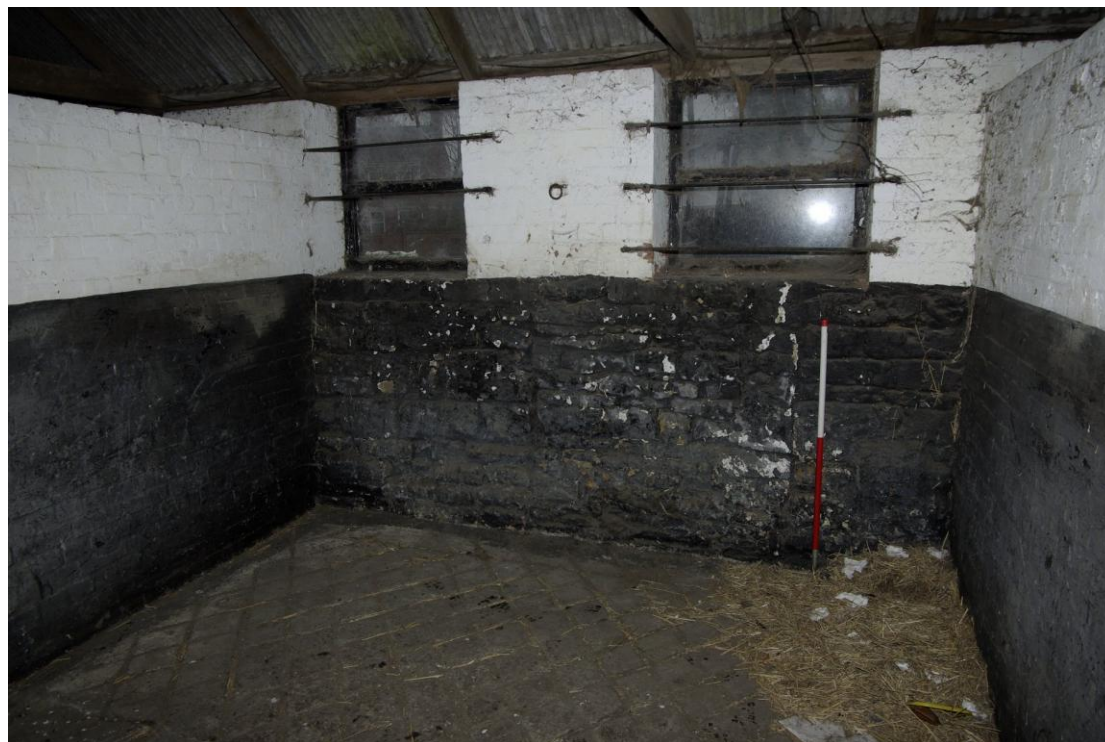
The centre room is quite plain with only two windows and a blocked doorway on the north wall (Fig. 10). As in the eastern room the blocking of earlier features is only visible in the stonework up to sill height indicating that the modification pre-dates the brick modification.

Figure 10. East building, centre room
Looking north-west. 1m scale

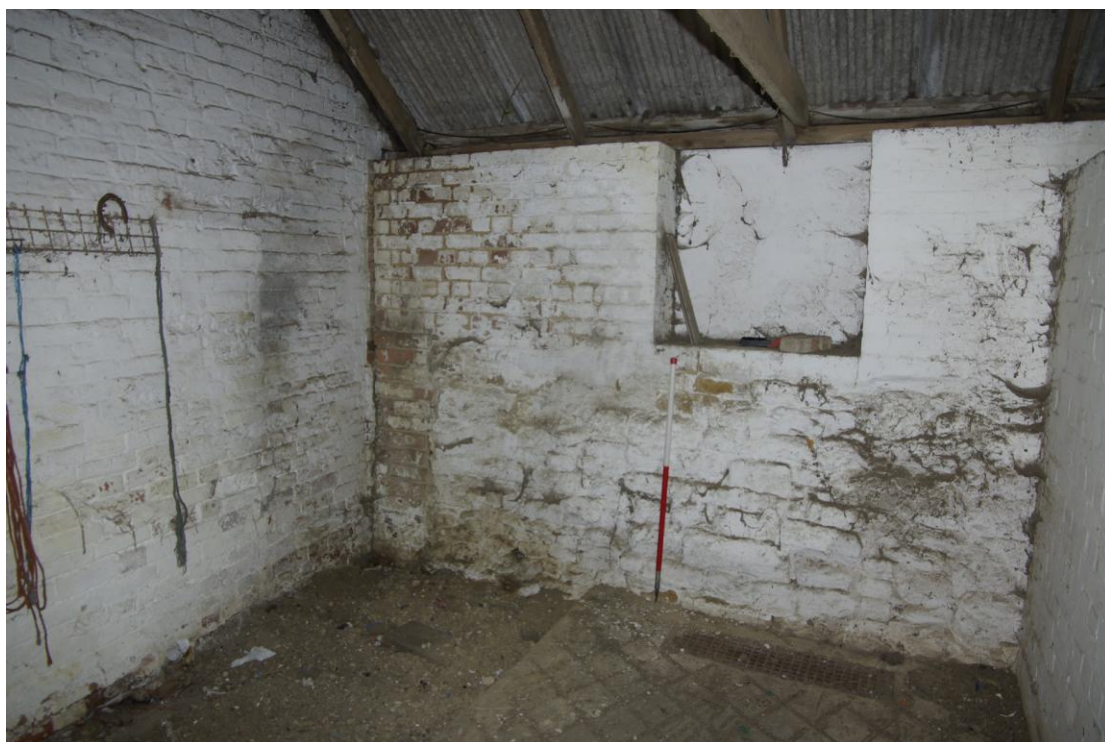
As noted earlier the doorway is set on an angle between the two buildings. The window has been boarded over and the repaired stonework can be seen to the west. Bricks have also been used in the patching process (Fig. 11). This wall has separated from the west gable end and is moving outwards.

Figure 11. East building, western room
Looking north-west. 1m scale. Note patched stonework

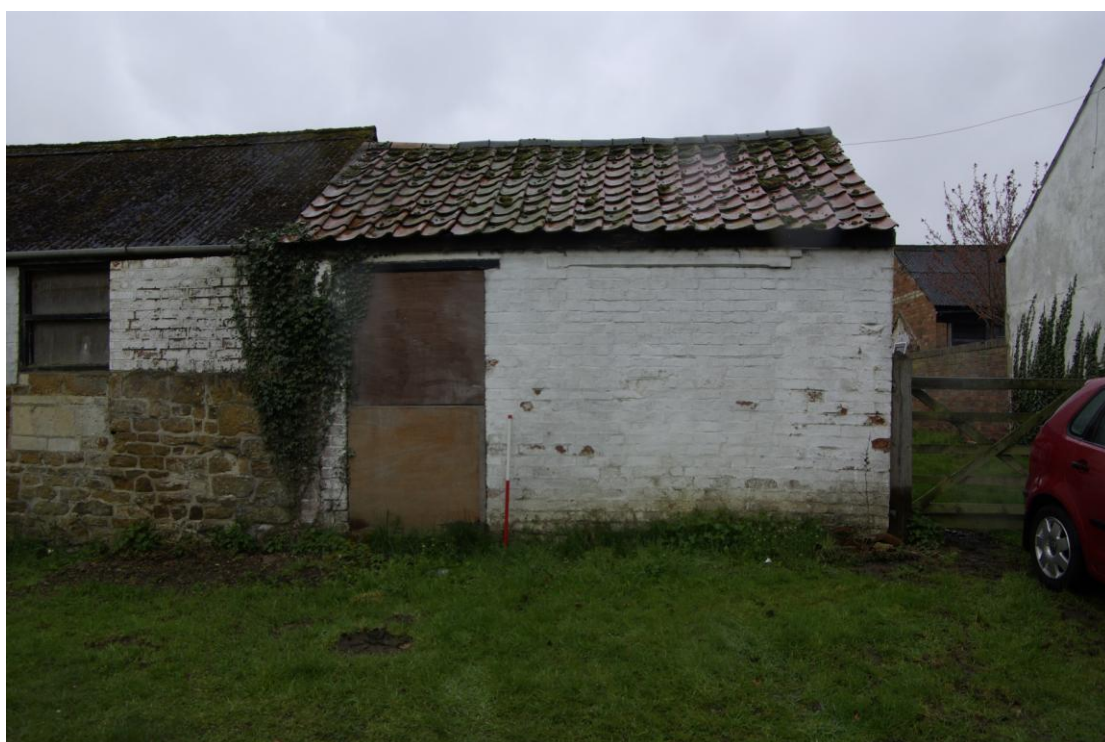
The north elevation is built entirely of red-bricks laid in a Flemish garden wall bond. It has a wooden doorway on the east side and a bricked-in window on the west (fig.12). The wooden framed window has a substantial wooden lintel with stop chamfers. The roof appears to be the original one and is covered with pan tiles. This elevation is on the same alignment as the eastern building.

Figure 12. West building, north facing elevation
Looking south. 1m scale

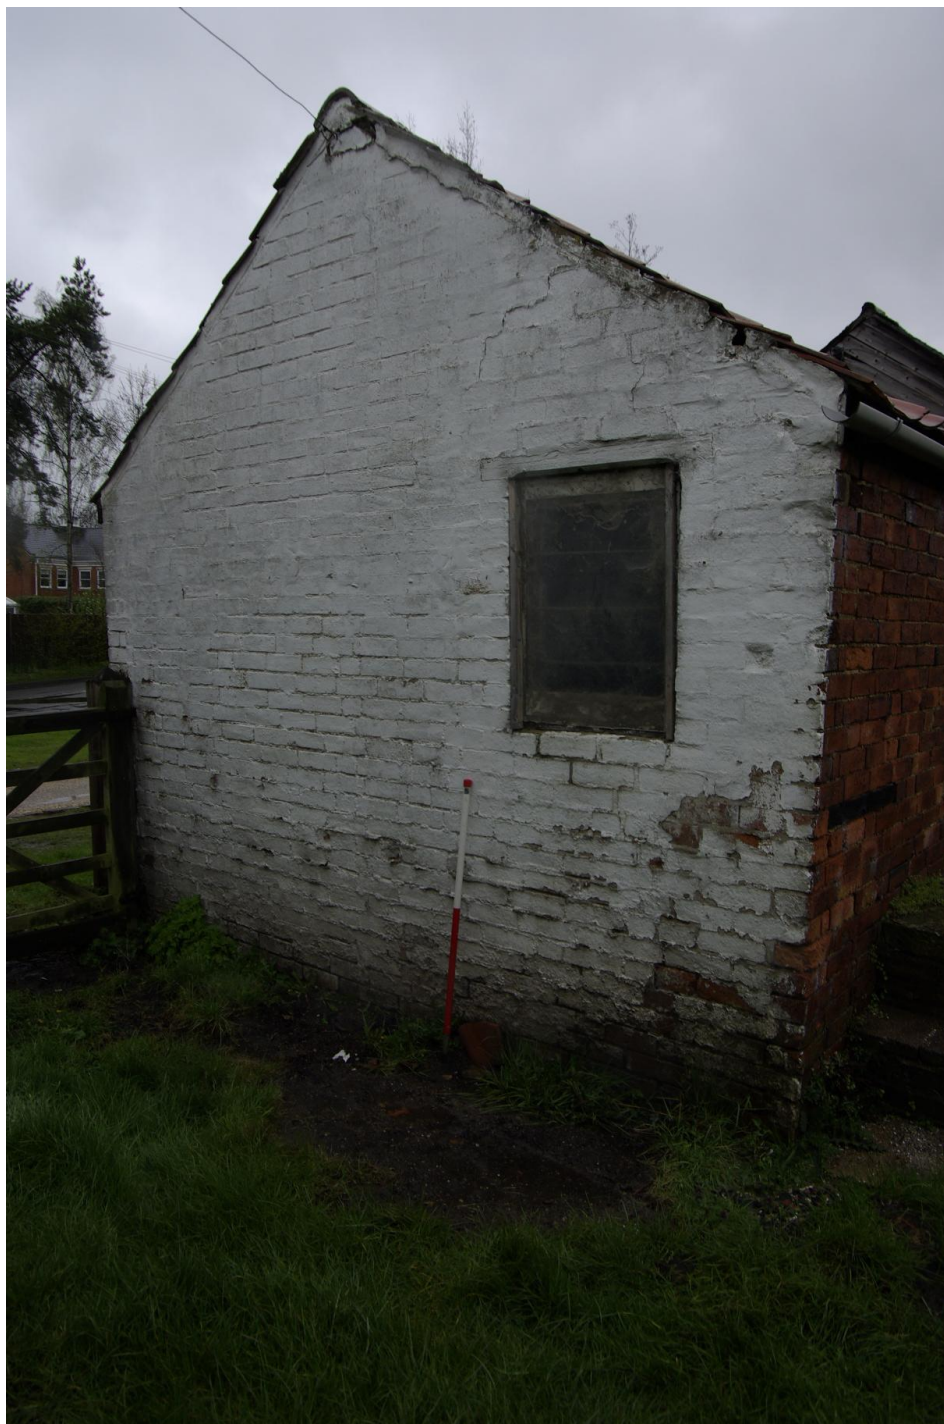
The western gable end brickwork matches that of the north and south elevations. It is pierced by a single wooden framed window on the southern side of the gable. There is no evidence of any other blocked openings.

Figure 13. West gable end
Looking north-east. 1m scale

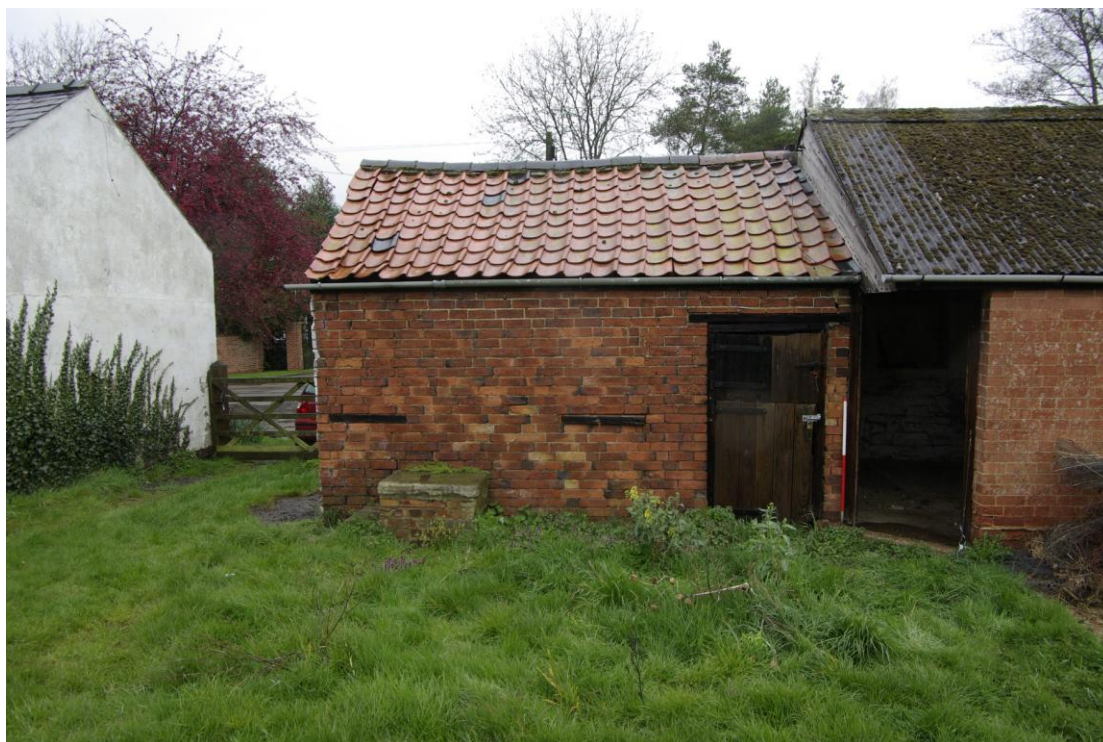
The south facing elevation has a single doorway on the east side. Two lengths of timber have been let into the wall approximately 0.75m above present ground level (Fig. 14). These have evidence of metal hooks being attached to them and could be to hold riding tack or equipment. They do not penetrate through the wall to the inside. A low brick and stone mounting block has been built against the wall.

Figure 14. West building, south facing elevation
Looking south. 1m scale

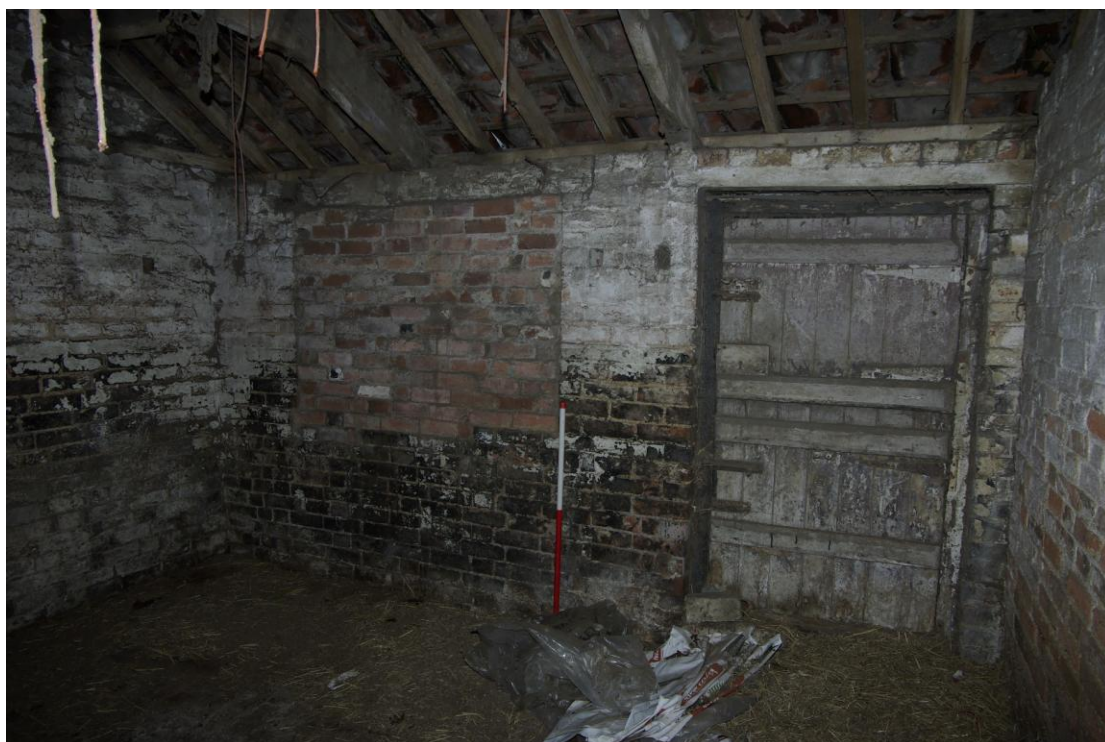
Inside the single room of this building the floor is made from red bricks over rammed earth. The doorway on the north wall has its original hinges and other ironwork (Fig. 15). The bricks blocking the window appear to be modern. An assortment of thick Victorian bricks and thinner hand-made bricks has been used to make the east gable wall (Fig. 16). The different bricks make up random courses at all heights in the wall suggesting re-use from elsewhere rather than building on an earlier wall.

Figure 15. West building, north wall
Looking north-west. 1m scale

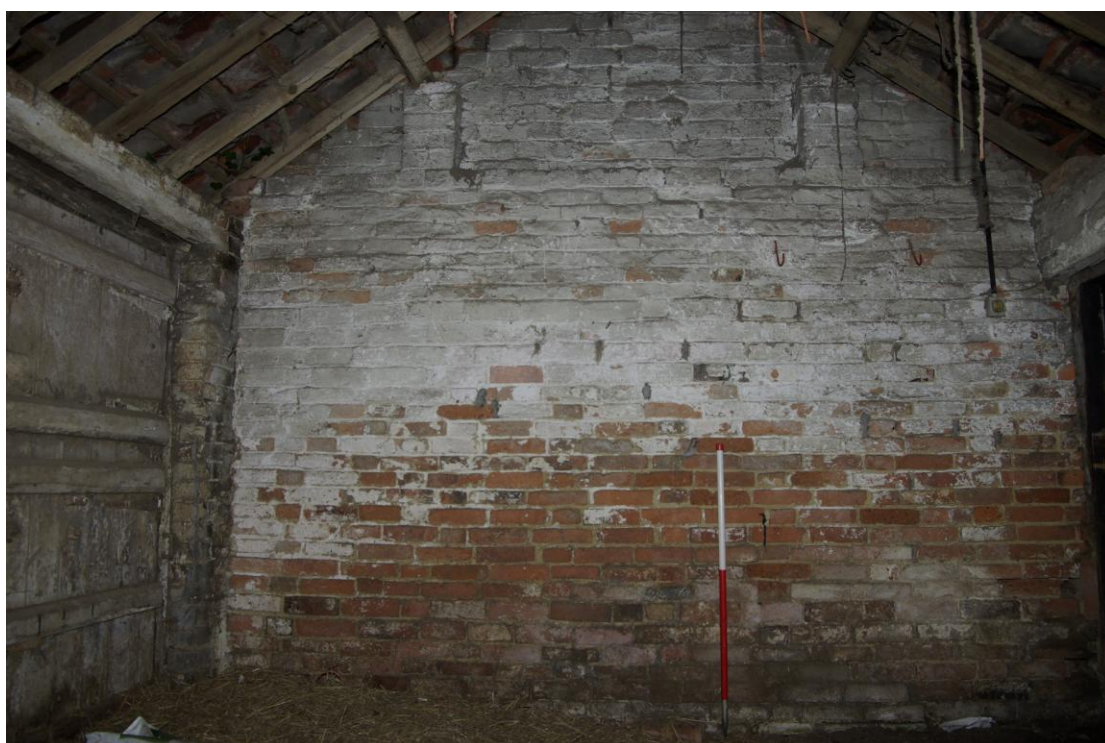
Figure 16. West building, east gable wall
Looking east at the different sizes of bricks used. 1m scale

The western building has only one apparent phase and, with the materials used and style of roofing timbers, would seem to date from the mid to late 19th century. The use of earlier bricks within the east gable wall is probably an example of careful recycling.

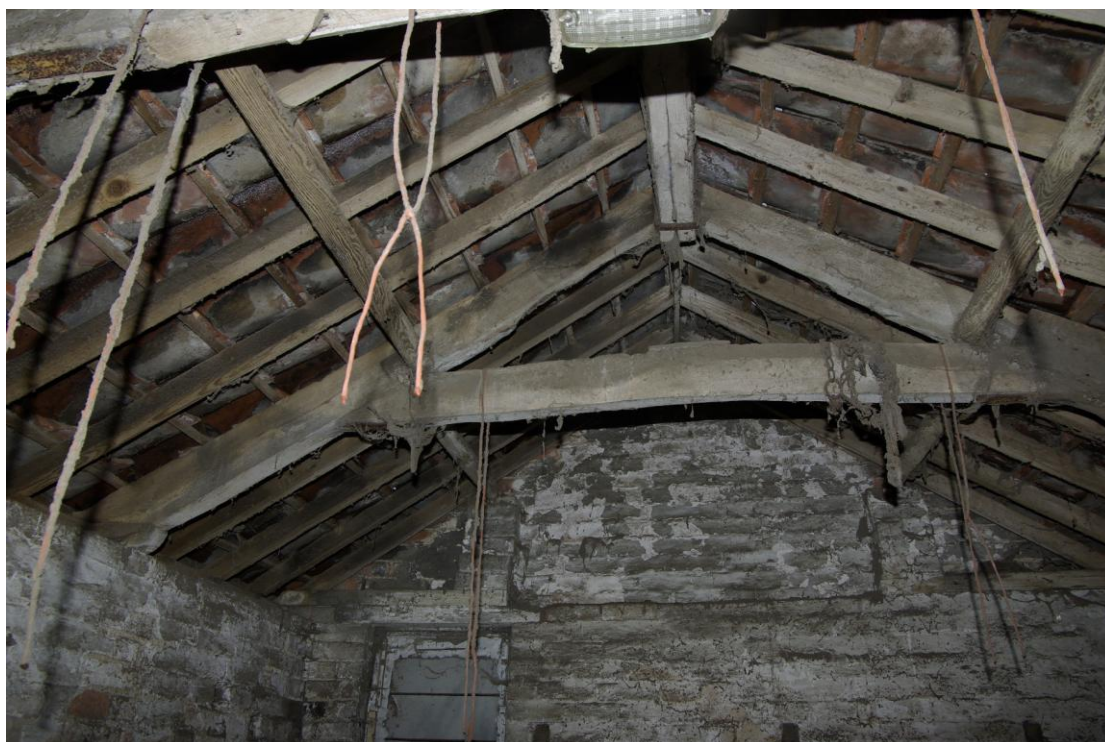
The roof has the purlins tenoned into the principal rafters with a narrow board serving as the ridge (Fig. 17). The rafters are carried on the backs of the purlins whilst the tie bars are attached to the principals by an iron strap on their underside. The principals sit on a chamfered block of wood projecting out from the wall plate.

Figure 17. West building roof detail
Looking west
