**A Level 3 Historic Building Record:  
The Woodlands, The Pastures,  
Forest Road, Narborough,  
Leicestershire.**

ULAS Report No. 2013-145  
©2013

**For: Taylor Wimpey East Midlands Ltd**

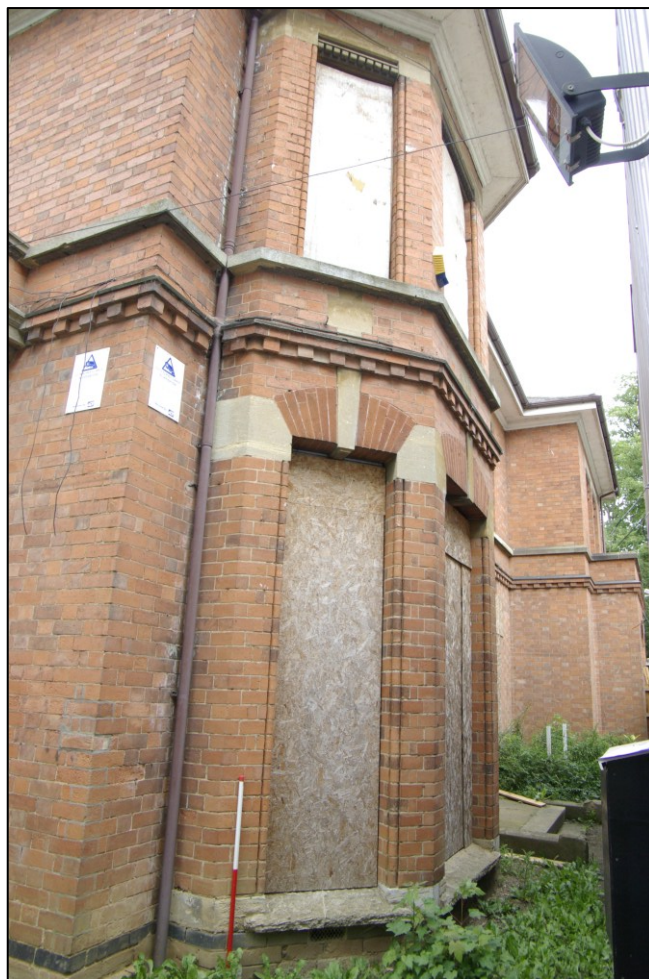
The northern element consists of a separate block which stands out from the main house and has a separate roofline (see Fig. 7). The ground floor windows project out further than the rest of this segment and open out onto the former garden but maintain the same style and decoration seen on the rest of this elevation, with the exception that they do not have the vertical cylindrical details but instead have chamfered edges. The first floor windows match those above the doorway but the sandstone band continues between the two. Although the bricks match, the brick courses between the centre segment and the northern element do not align nor do the courses appear to be bonded which may suggest a slightly different phase of building. The different roofline of this element to the rest of the house might also point towards a slightly different phase.

Figure 7. East-facing elevation bay window  
Looking north-west. Note northern element of façade on right of picture. 1m scale

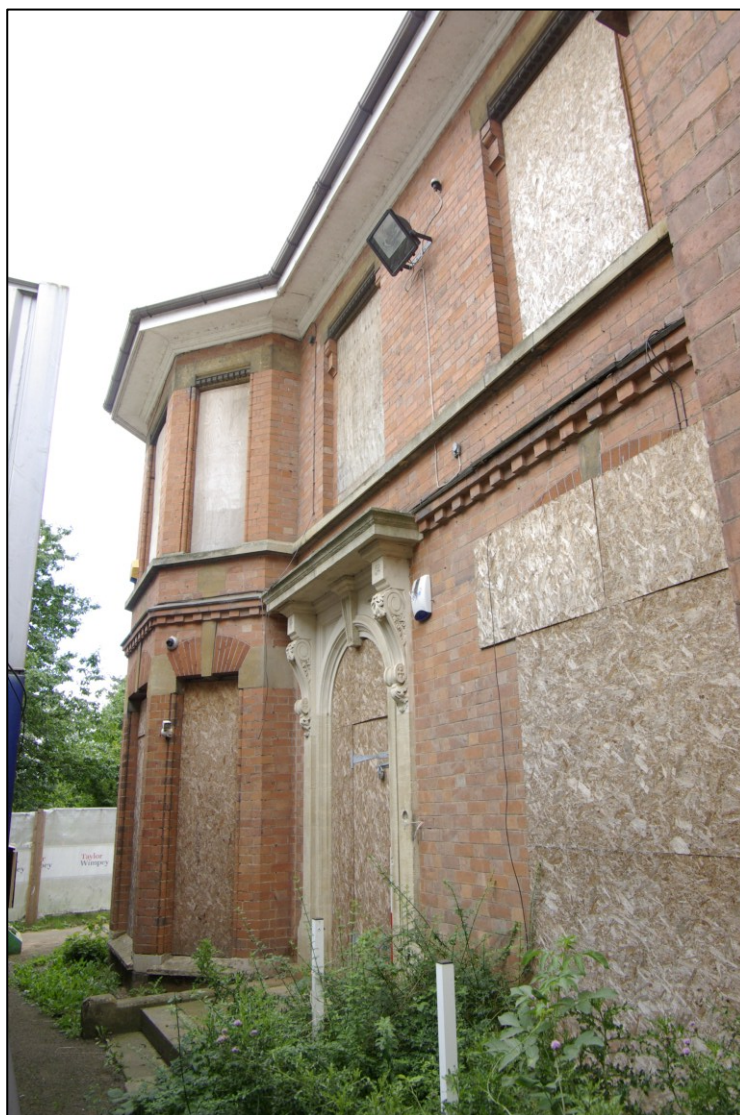
The centre element of the east elevation is dominated by the front door which is reached via a low stone step (Fig. 8). The doorway consists of a relatively simply carved limestone door surround with a Romanesque arch and pediment. The 1.2m wide door appears to be original and has four panels, the upper two being glazed. A rectangular ground floor window, to the north of the doorway, has a brick arched lintel and detailing matching the bay windows to the south. The brick dentil course and limestone string course continues across the elevation from the bay. At first floor height are two more rectangular windows which match the details of the first floor bays but with the addition of two small brick shoulders.

Figure 8. East-facing elevation front door.  
Looking south-west

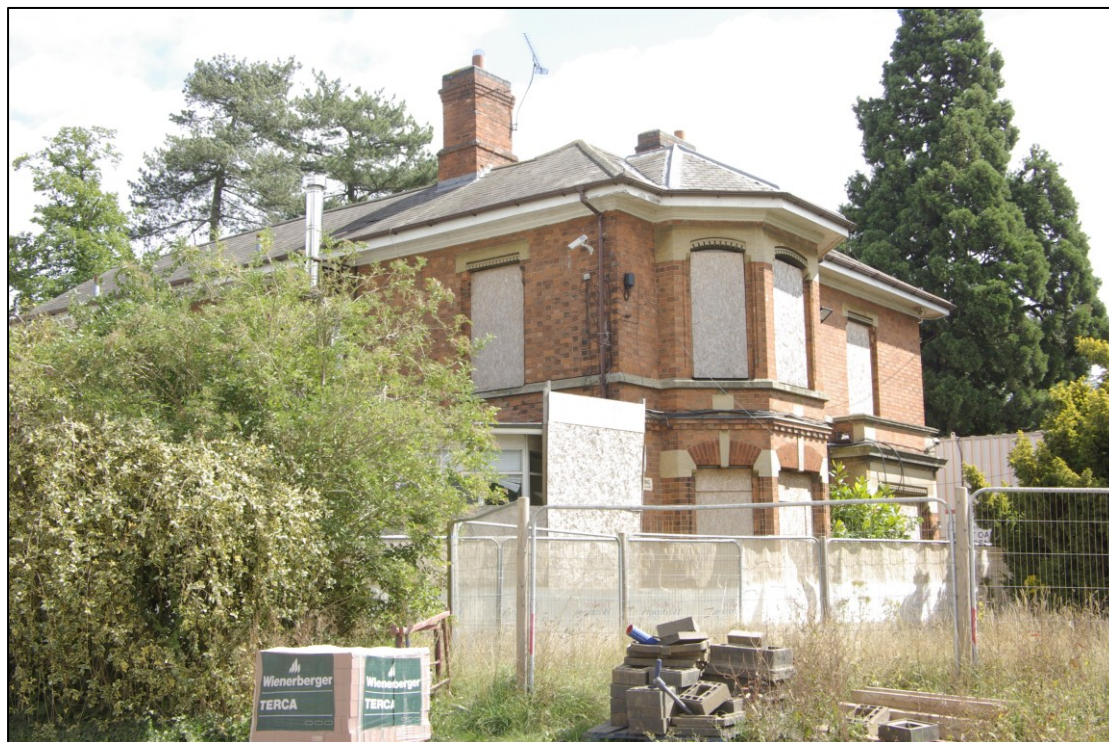
When first built the south elevation faced down a small slope and over the ha-ha into the main garden (Fig. 10). This elevation consists of two elements; a two storey, three sided bay window on the western side, and a single storey rectangular bay. The two

Figure 10. South facing elevation  
Looking north-east

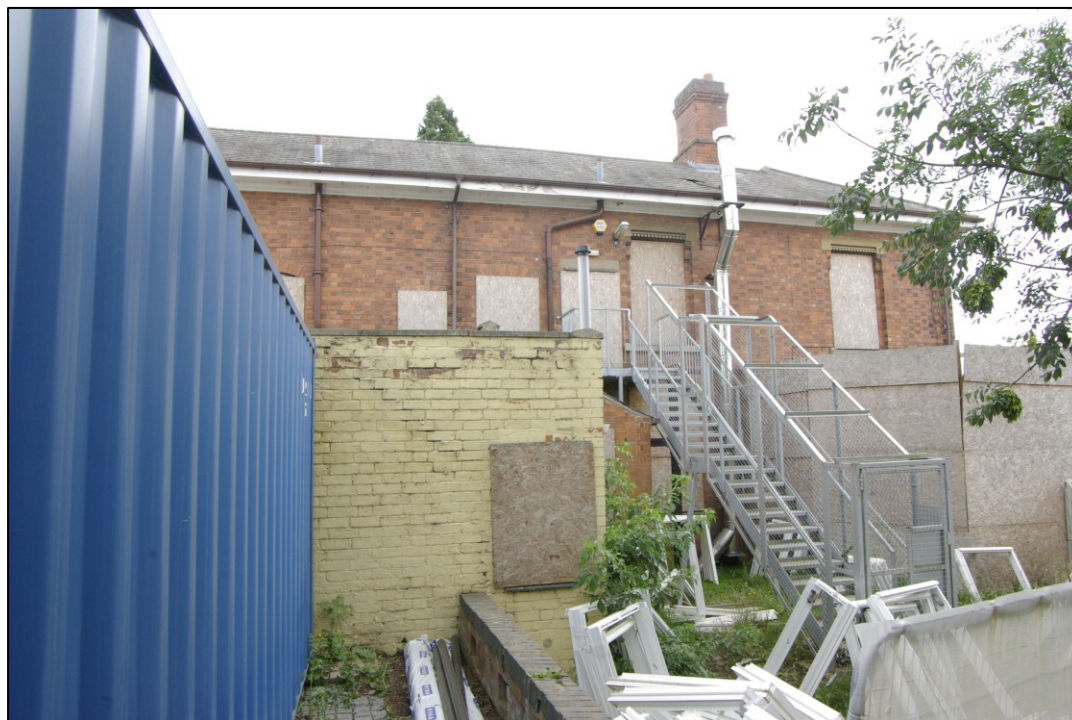
Figure 11. West facing elevation  
Looking south-east. Blue container on site of glasshouse.

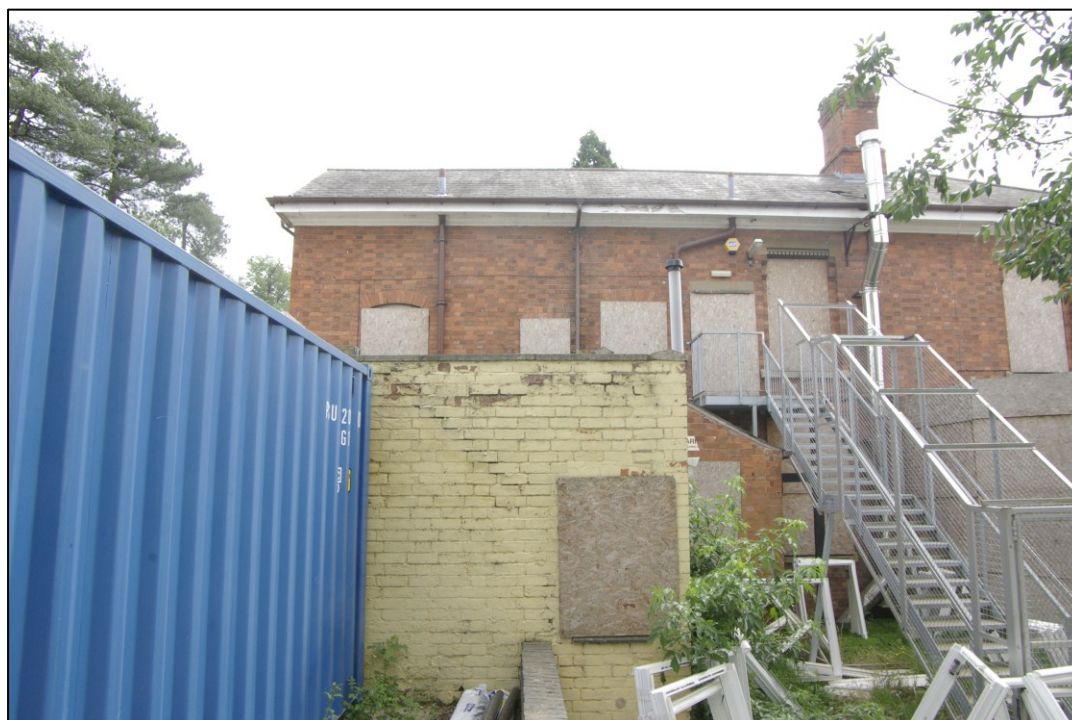
Figure 12. West facing elevation, service wing  
Looking east. Yellow wall is the rear of the privies

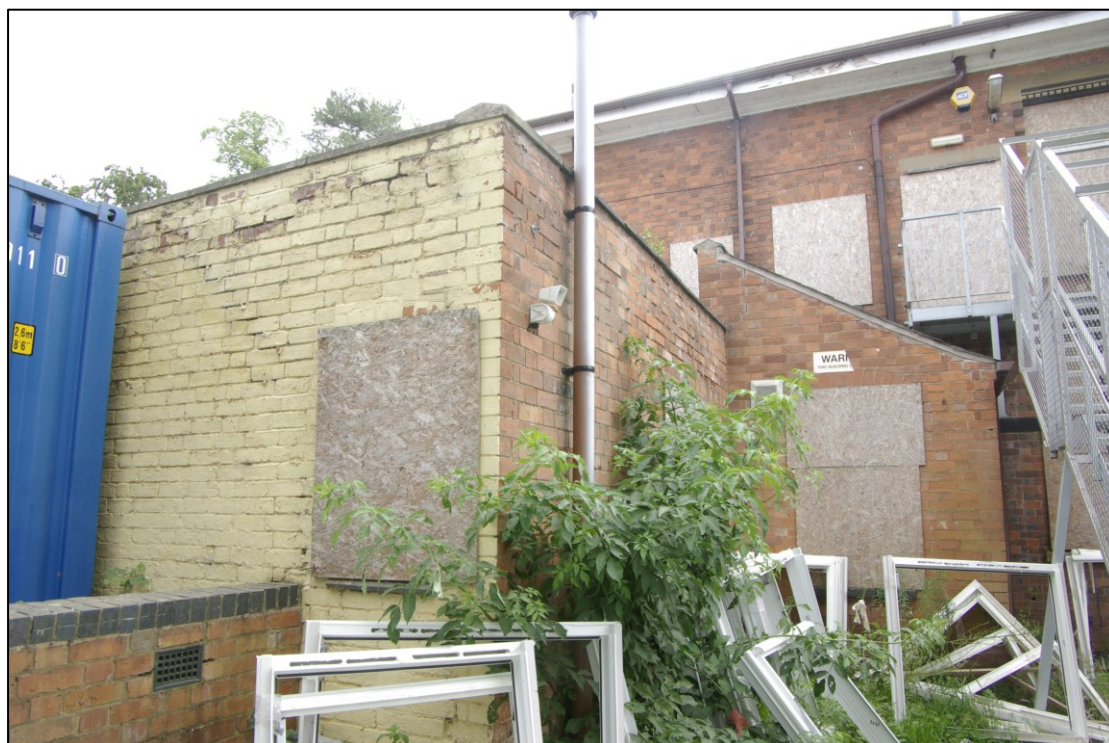
an L-shape and extending further west (Fig. 13). The low brick walls of the glasshouse shown on the Ordnance Survey maps extend further to the west from the end of the toilet block. This has a partially paved floor with granite sets and evidence of a doorway at the western end. No trace of the glass superstructure remains (Fig. 14).

Figure 13. West facing elevation outbuildings  
Looking north-east

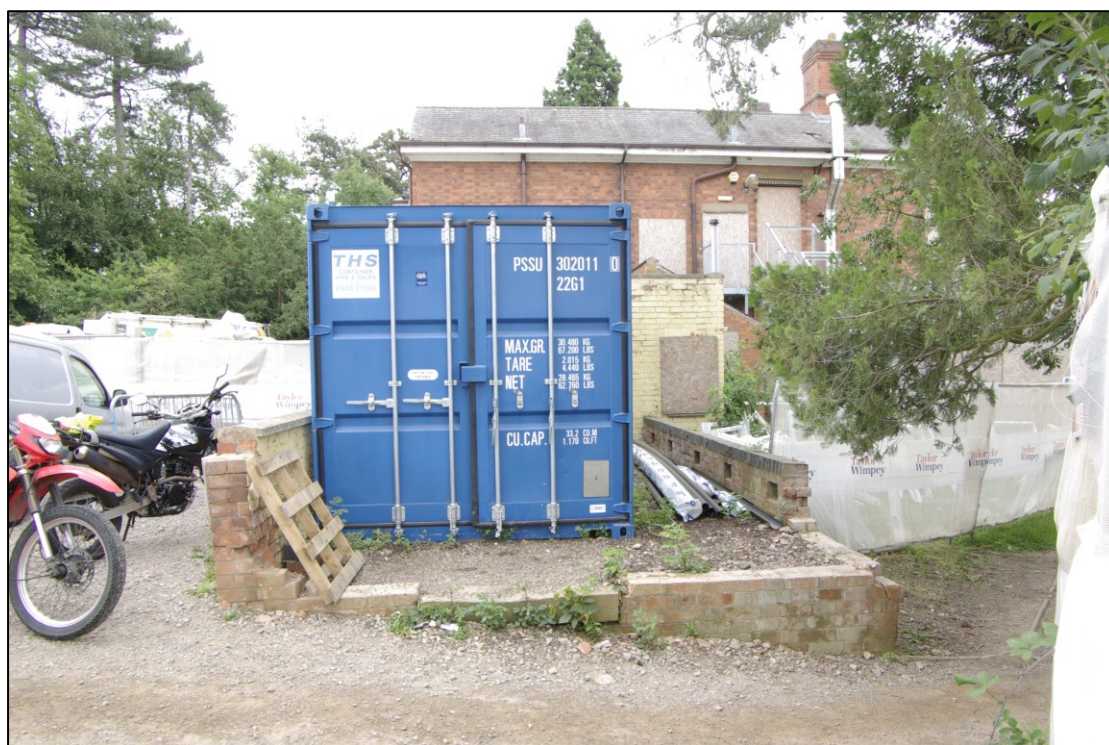
Figure 14. Remains of glasshouse  
Looking east

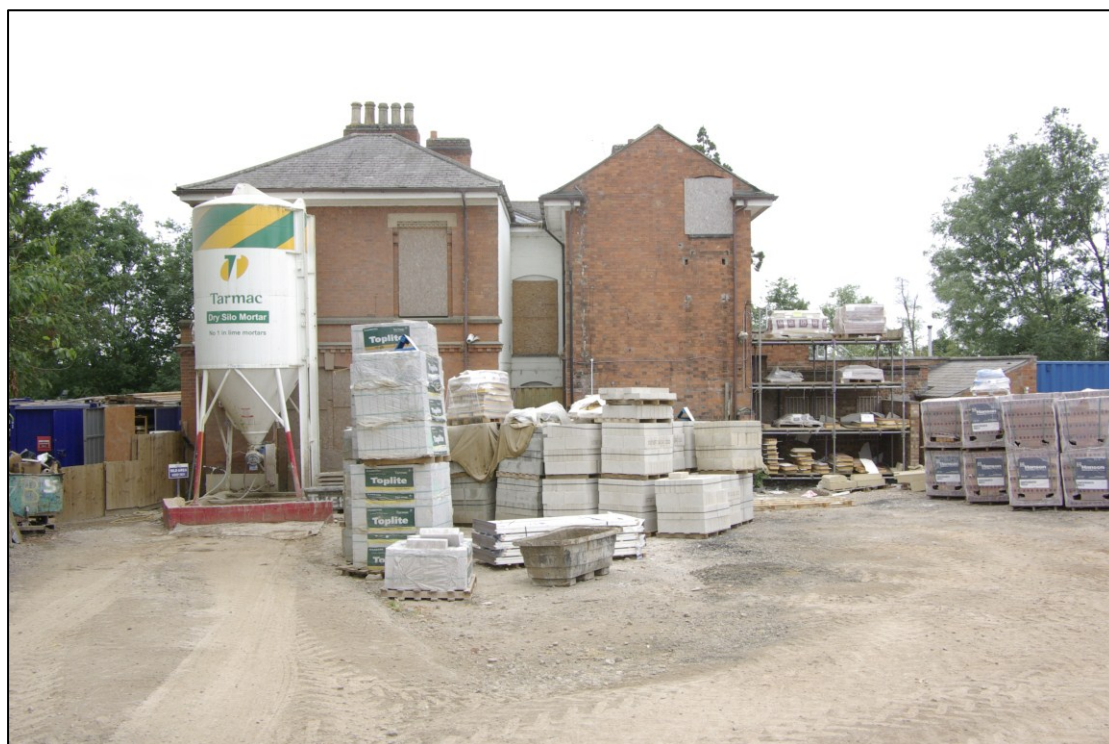
As with the other elevations the north facing elevation consists of a number of elements (Figs. 15 and 16). On the eastern side is the residential wing which has the brick dentil and limestone string course continuing round from the east elevation. The ground floor window is set under a wide low brick arch whilst the first floor window, with its stone lintel, matches those on the other elevations. This wing is a separate block from the service wing which creates a narrow alley between the two wings leading to a rear door. The service wing has a flat gable end at roof height and is plain brickwork with a small window at second storey height lighting a small room set partially in the attic (Room S2). There is a trace of bitumen at first floor level suggesting the removal of a pitched roofed structure but no evidence exists to show what this was or when it was removed.

Figure 16. North facing elevation  
Looking south

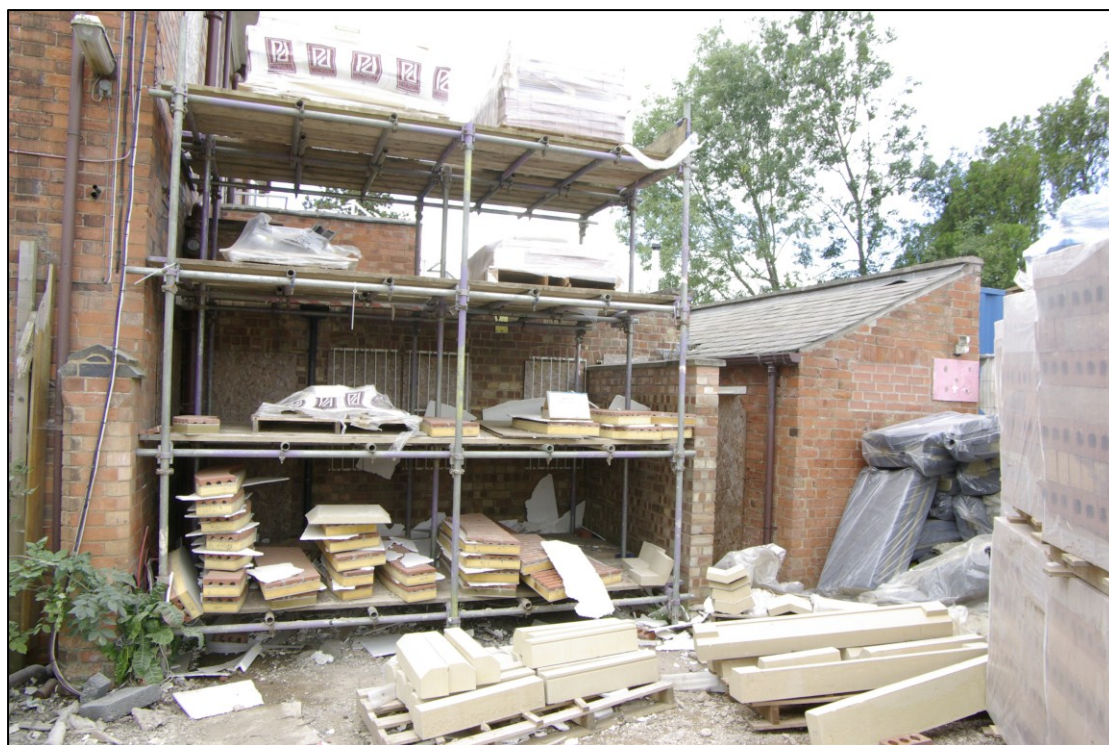
The single storey outbuilding/toilet block extends out from the western side of the service wing (Fig. 17). The north face of the toilets is built of what seem to be of mid to late 20th century bricks with a door at the east end and four small windows. This appears to be a later addition and may be a blocking in of a covered walkway leading out to the privies set at right angles to this block and which back up against the removed glasshouse.

Figure 17. North facing elevation of toilet block.  
Looking south-west. Note mid-20th century brickwork behind scaffold shelving.

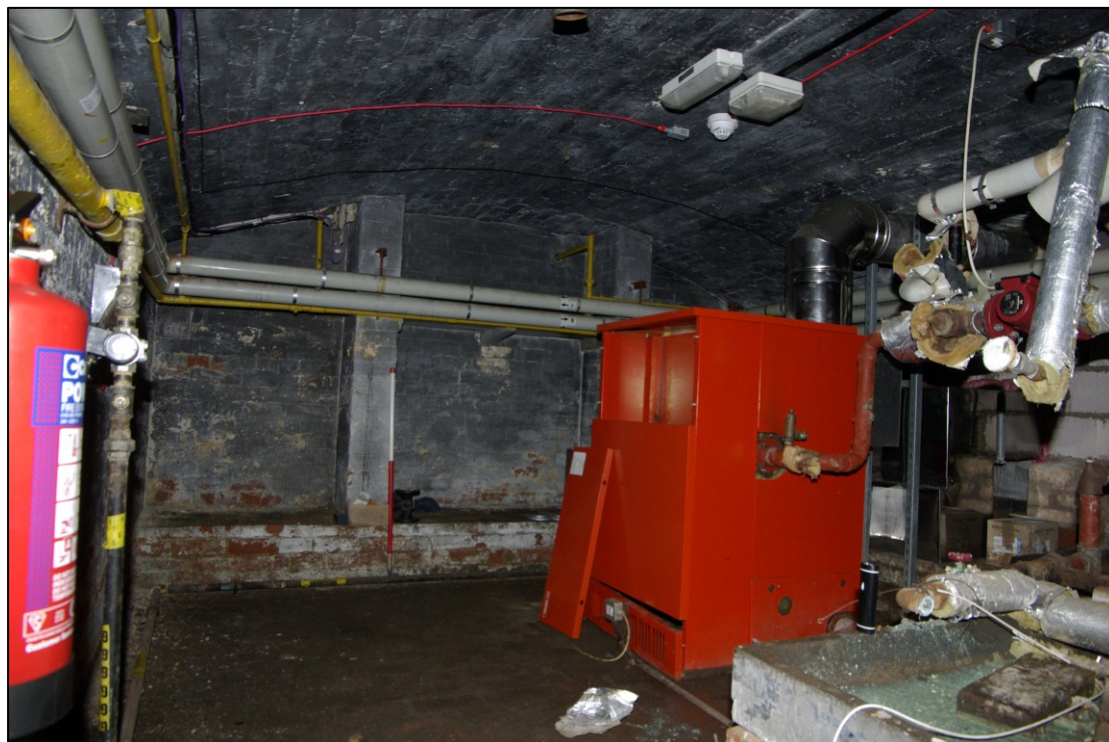
The cellar is reached via a set of brick-built stairs adjacent to the servant's stairs in the service wing. It has vaulted brick ceiling and brick floor (Fig. 18). The main room, C1, has a low brick and stone plinth running around the south and west walls. A shallow stone trough on raised bricks lies against the north wall. Leading out of room C1 is a smaller pantry/larder type room, C2, which has a lockable slatted wooden door and brick and stone shelves built on its east wall (Fig. 19). A fire resistant metal safe made by Milners of London, Manchester and Liverpool rests in the corner of this room. A rectangular room, C3, fills a gap between the stairs and C1.

Figure 18. Cellar, main room  
Looking south-west. 1m scale

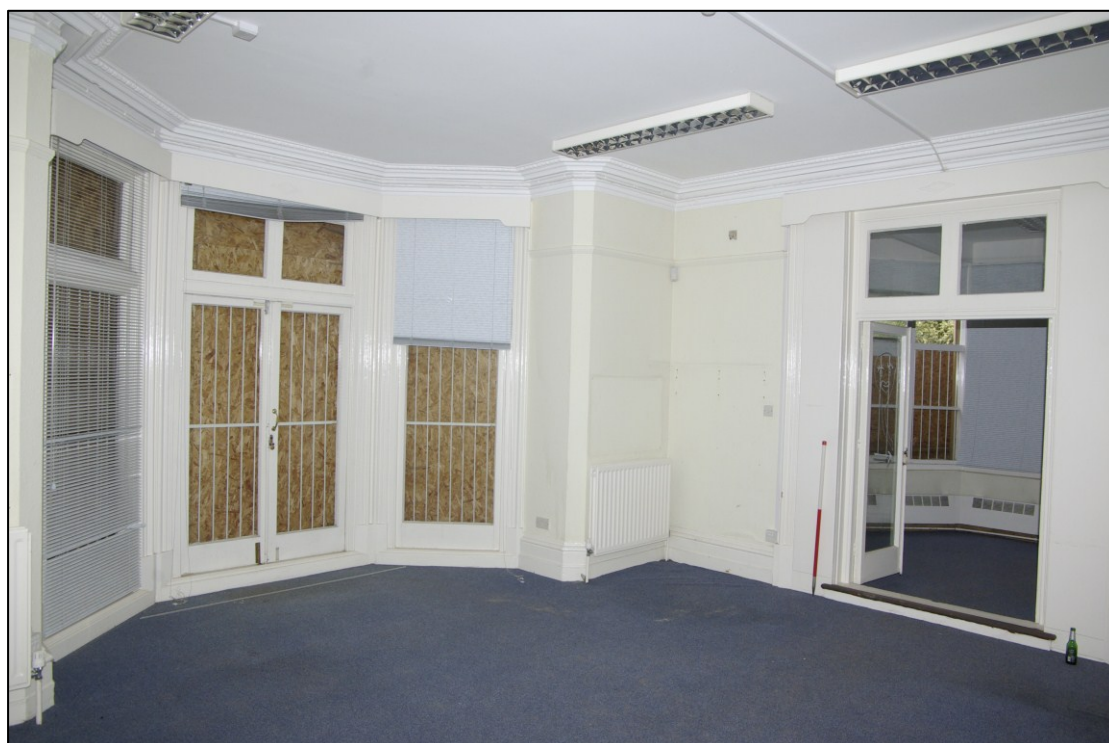
The only access into Room G2 is from a small door in the hall near to the base of the stairs. This room is similar to G1 but has a greater level of decoration in the moulded cornice and a higher skirting board (Fig. 25). The fireplace has also been taken out of commission and blocked. A small conservatory is reached through a wide doorway on the west wall. The conservatory has a masonry base and a glazed upper half. The window fittings are modern but the door latch from G2 into the conservatory is brass and matches that used on the patio doors in Room G3. It is not clear if this is part of the original design or a later addition. It is however clearly visible on the 1886 First Edition Ordnance Survey map.

Figure 25. Room G2  
Looking south-west. Conservatory on right of picture.

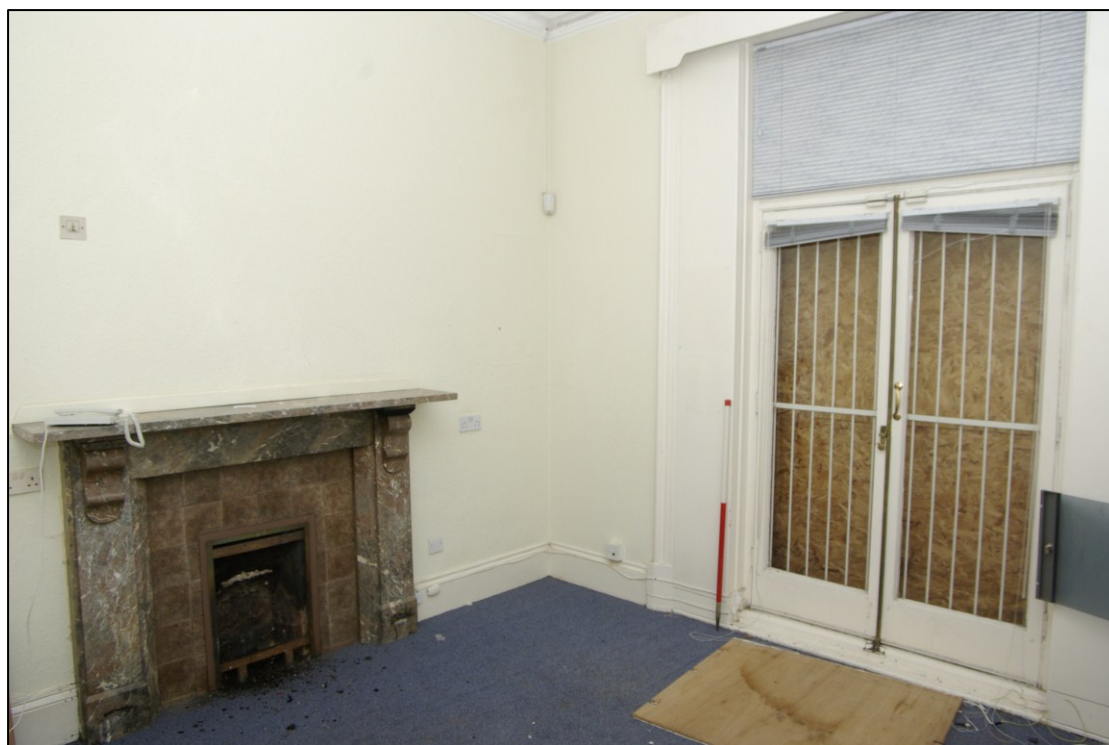
Room G3, on the opposite side of the hall to G1, is a smallish square room with full-height patio doors set into the rectangular window (fig. 26). The fittings on the door appear to be original but have also been supplemented by more modern fittings. The only surviving fireplace in the house is found in this room and is built from a brownish marble. As with all rooms, the floor has a fitted carpets preventing inspection of the floor structure.

Figure 26. Room G3  
Looking north-east. 1m scale

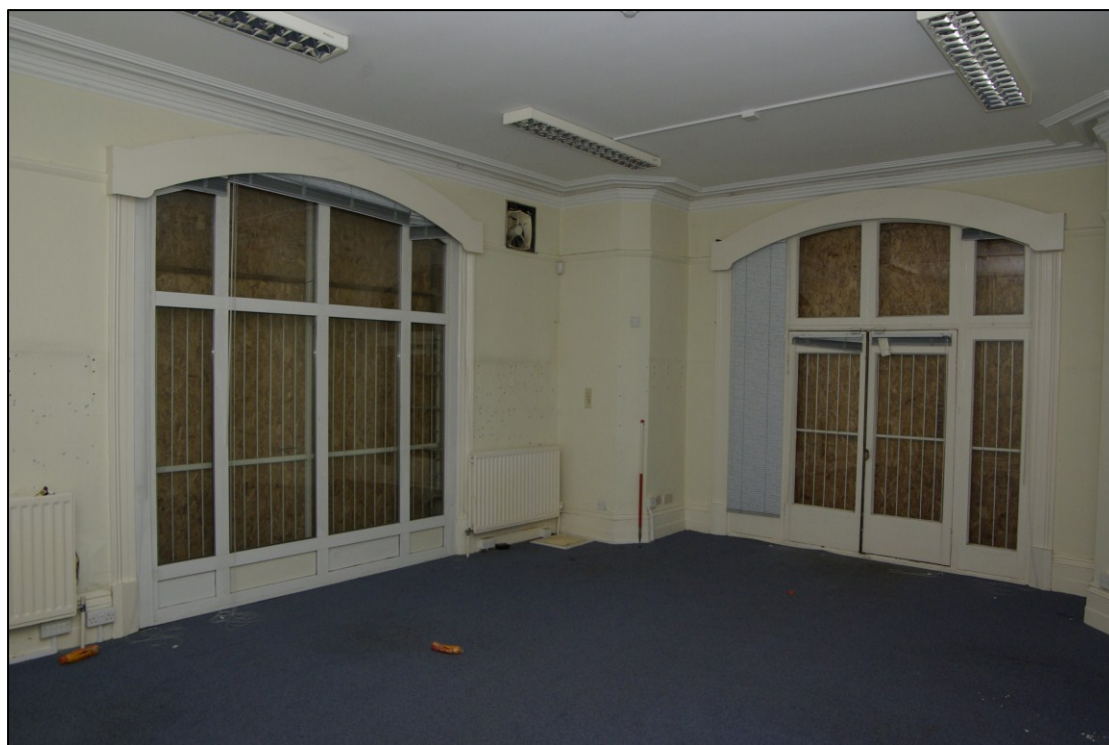
Room G5 is located in the north-east wing of the house and forms a large, square room with windows on the north and east walls and a blocked fireplace (Fig. 27). Because the service wing corridor runs behind the west wall there is no window on this side which has a tendency to make the room quite dark, even without the boarded over windows. The patio doors set into the rectangular bay on the east wall have fittings which match those seen in Rooms G2 and G3 suggesting a contemporary date.

Figure 27. Room G5  
Looking north-east. 1m scale

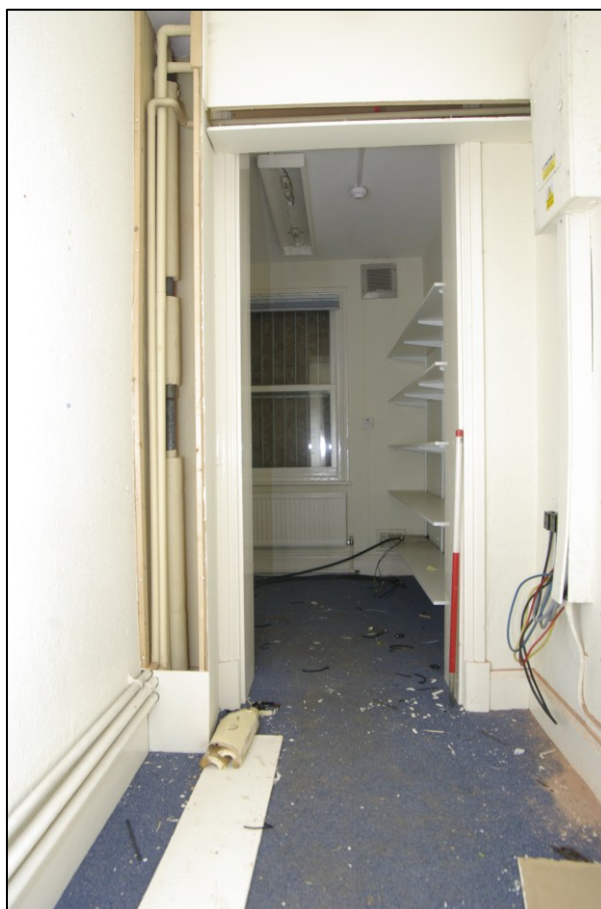
Room G7 consists of two small rooms which may have been used as offices, possibly for a butler or housekeeper (Fig. 29). They are both quite small and narrow with the eastern one fitting in between G6 and the servant's stairs. The western room is built into the pitched roof single storey outbuilding seen on the west facing elevation. This appears to be a rather awkward addition although there is no structural evidence to show if this is a later build.

Figure 29. Room G7  
Looking west. 1m scale

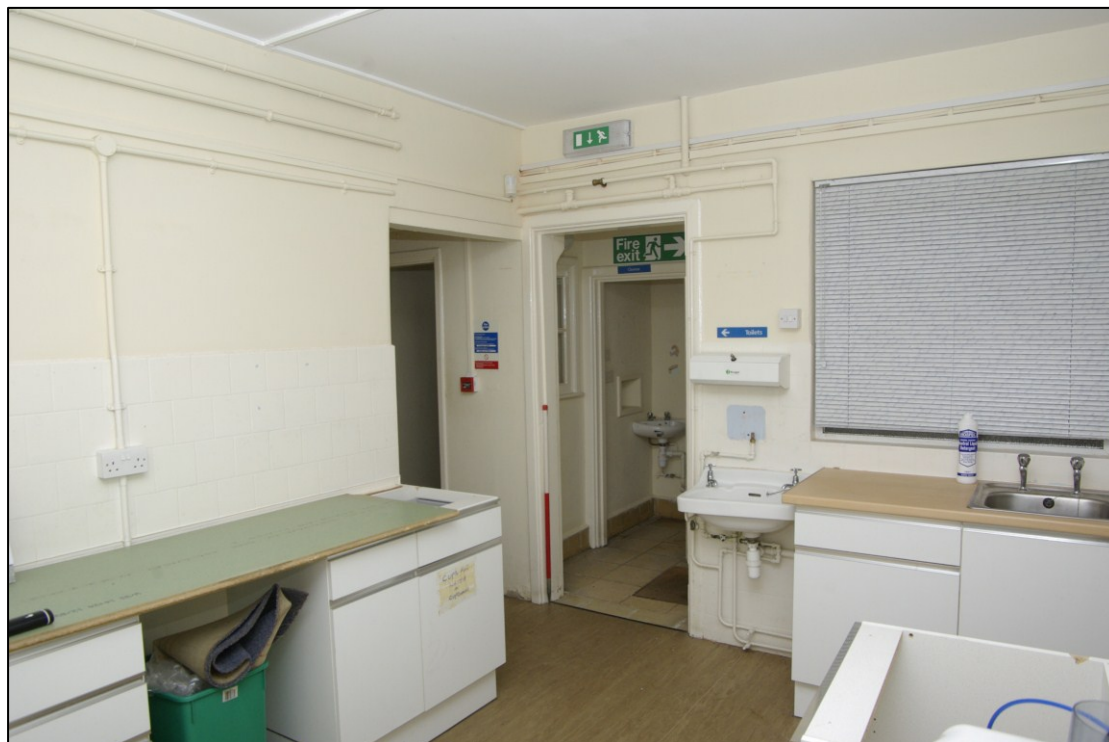
Figure 31. Room G8  
Looking south-west. 1m scale. Original back door to left of sink. Door to privy  
corridor to left of fire alarm.

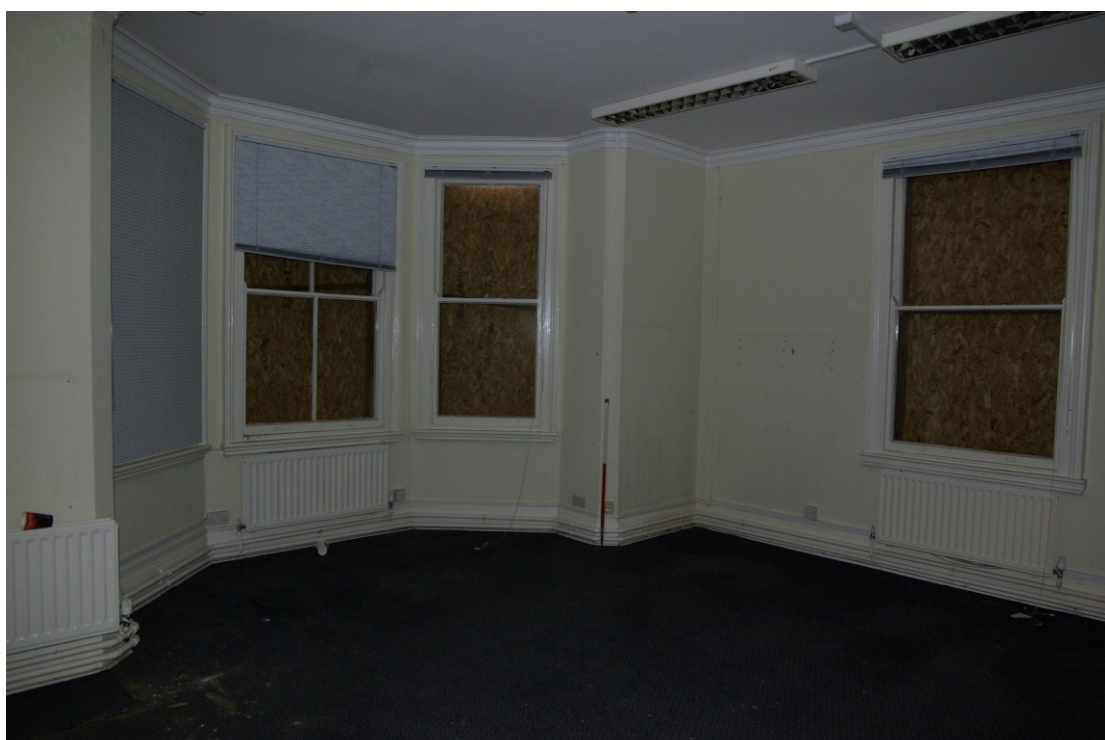
Room F1 is located in the south-west corner of the house. It has a large wooden framed bay window with original sashes on the south wall (Fig. 33). The fireplace has been blocked and plastered over and there are no other original fittings that survive. This room, along with Room F2, seems likely to have been one of the master bedrooms.

Figure 33. Room F1  
Looking south-west. 1m scale

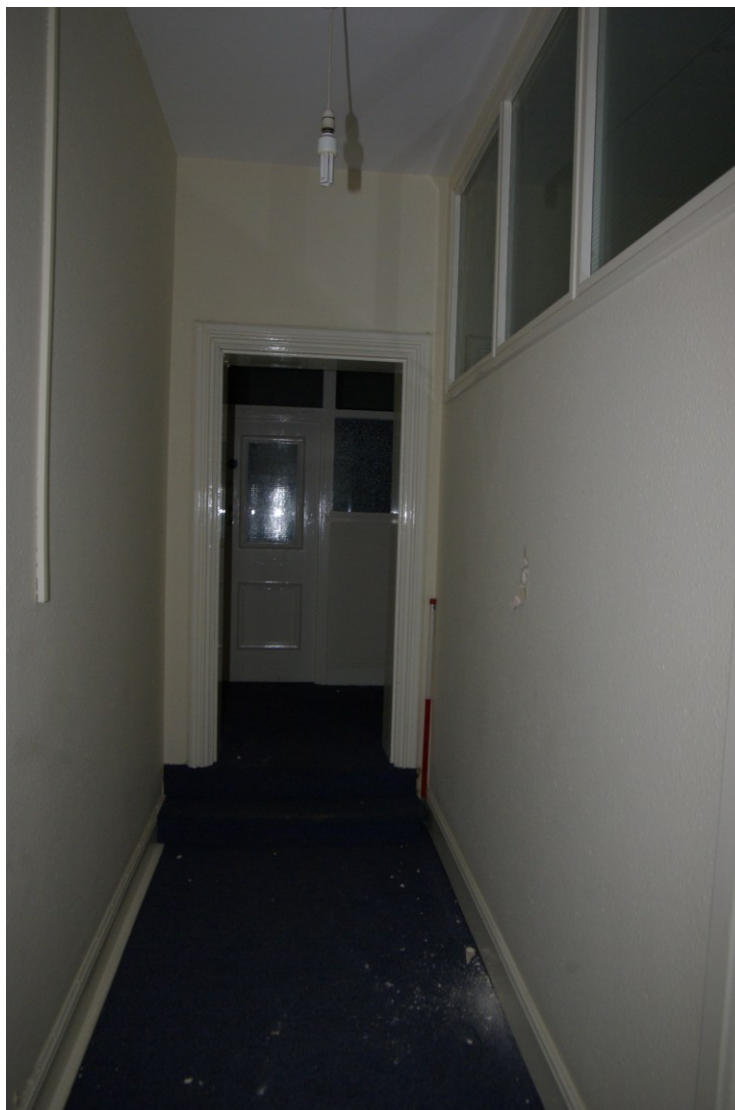
A plasterboard partition runs along the west side of room F4 to create a corridor leading to Room F5 (Fig. 35). This appears to be quite an awkward way in which to reach F5. The fireplace has been removed as have all other fittings. The sash window is original.

Figure 35. Corridor to Room F5  
Looking north. 1m scale. Partition wall of Room F4 on right of picture.

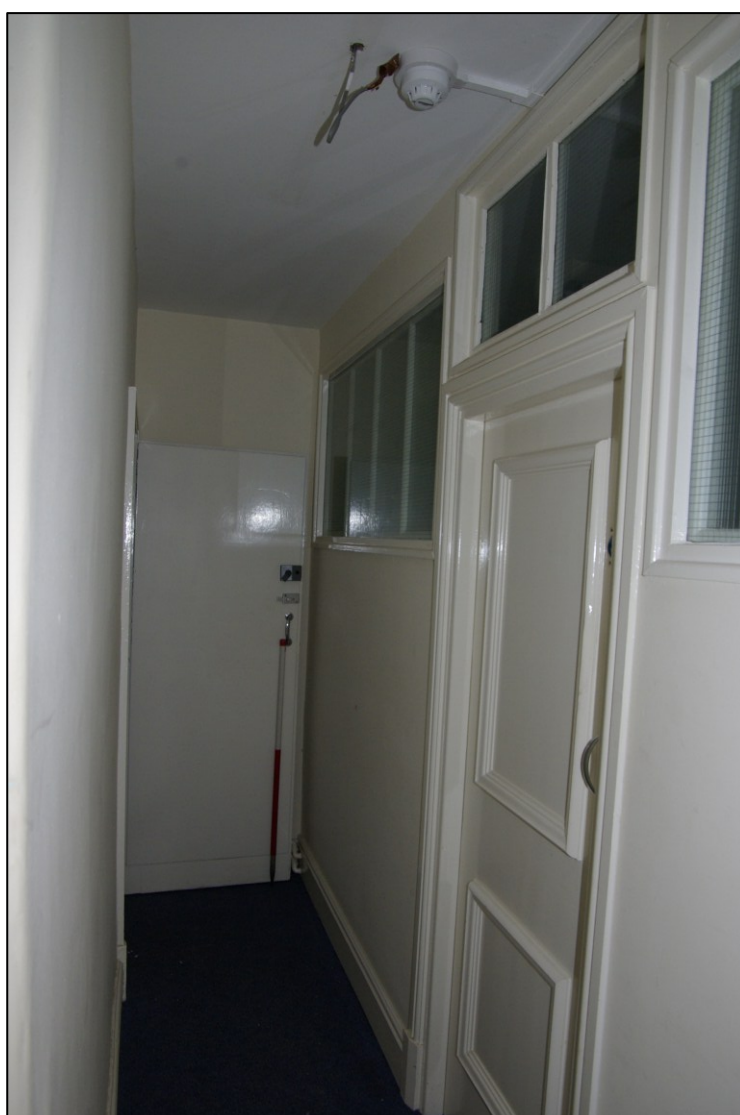
Room F9 has had a modern partition added to create a small corridor leading to a toilet built under the stairs (Fig. 39). The resulting room, with blocked fireplace, is quite small and, in common with most other rooms, has only the sash window as an original fitting.

Figure 39. Room F9  
Looking north-west. 1m scale

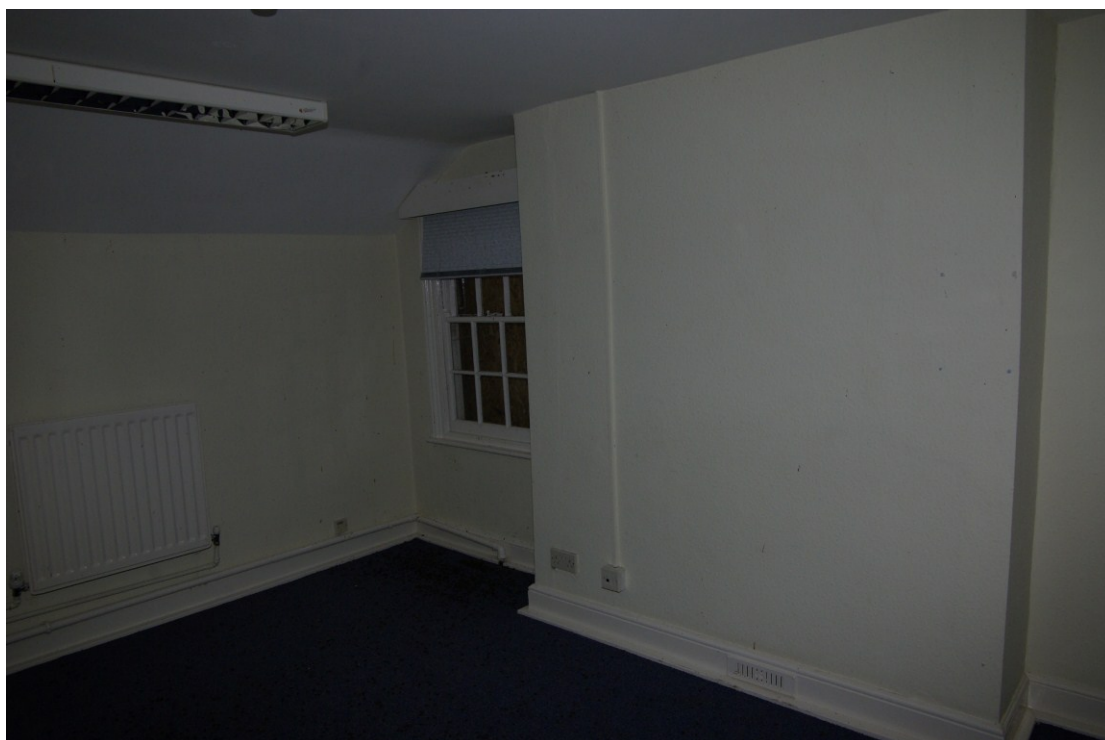
To the north of the stairs is Room S2 which was also full of bees (Fig. 42). cursory inspections showed this room to have a small window adjacent to the chimney breast on the north wall and a small cupboard behind the stairs (Fig. 42).

Figure 42. Room S2  
Looking north-west
