**A Historic Building Photographic  
Survey at the former Ritz Cinema,  
Northampton Road,  
Market Harborough,  
Leicestershire.**

**NGR: SP 7348 8706**

ULAS Report No. 2012-156  
©2012

**For: CgMs Consulting**

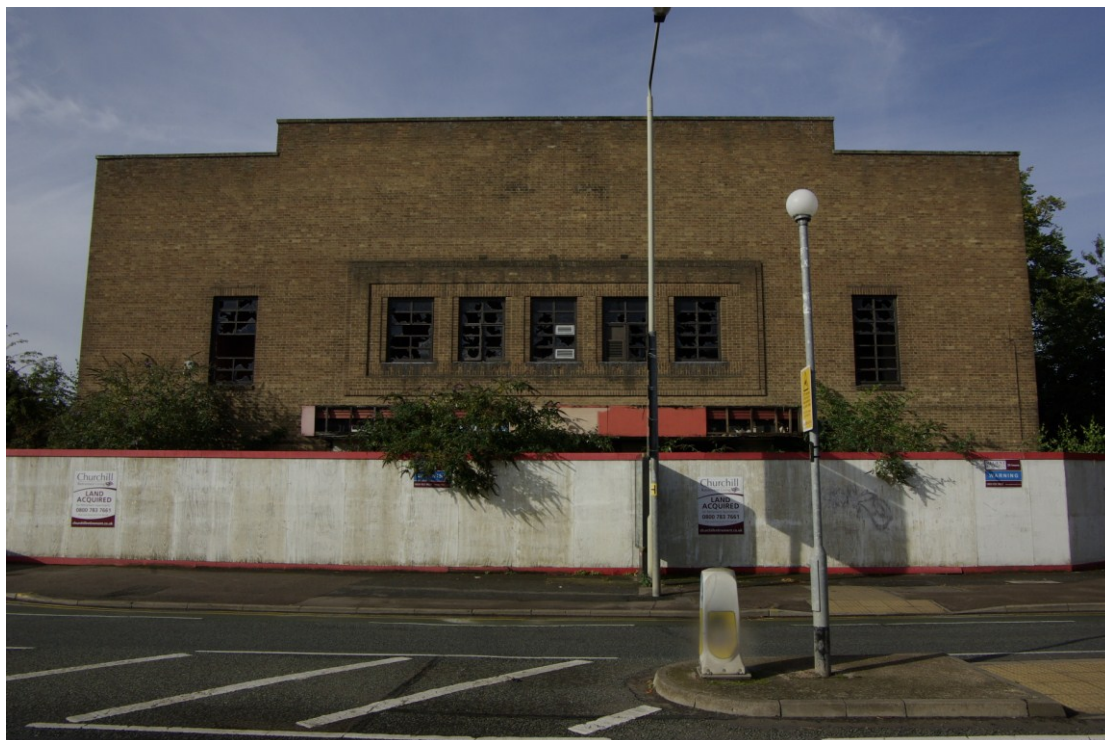
The east facing elevation is the main face of the building and is brick-built using a better quality brick from that employed on the other faces of the auditorium building (Fig. 8). A fairly basic version of Art Deco decoration has been used to create a flat fronted façade with a ground floor entrance to the main foyer flanked by double doors which, when first constructed, led to two sets of internal stairs. One set of stairs has since been removed (see below). The entrance steps seen in Figure 3 have been modified to provide wheelchair access (Fig 9). The second floor has a central row of five wooden-framed windows lighting an upstairs landing. Around these windows is a raised rectangle of brickwork which relieves the otherwise plain frontage (Fig. 9). Either side of the landing windows are a matching pair of larger windows of identical style which light internal staircases. A narrow coping runs along the parapet screening the flat roofed block built against the hipped roof.

Figure 8. East facing elevation  
Looking west

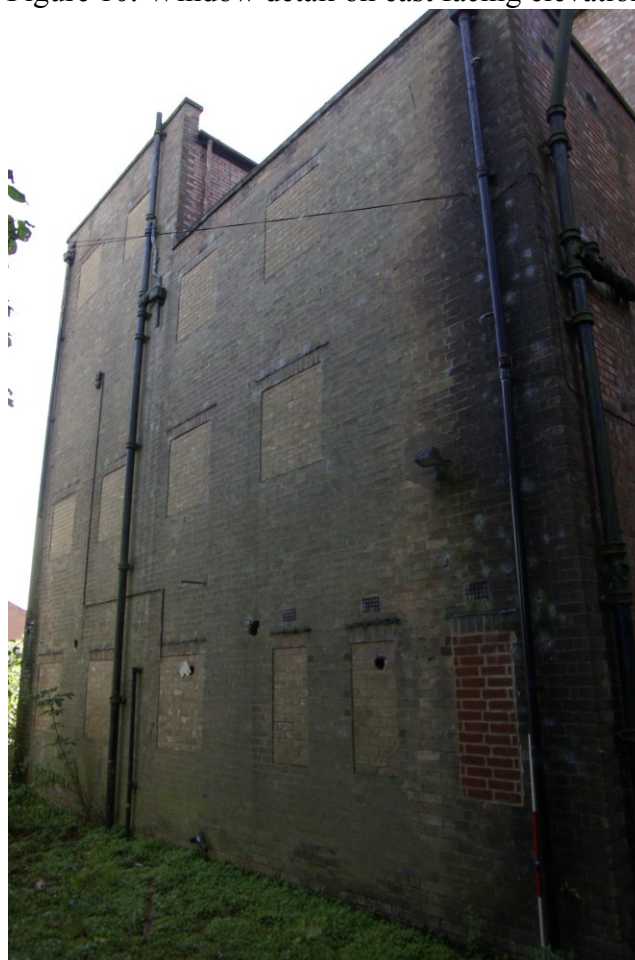
The higher quality brickwork wraps around the east facing elevation to form two wings extending beyond the sides of the main auditorium. All of the windows on the two wings facing to the north and south have been blocked using modern bricks (Figs 11 and 12).

Figure 11. North wing blocked windows  
Facing south-east. 1.5m scale

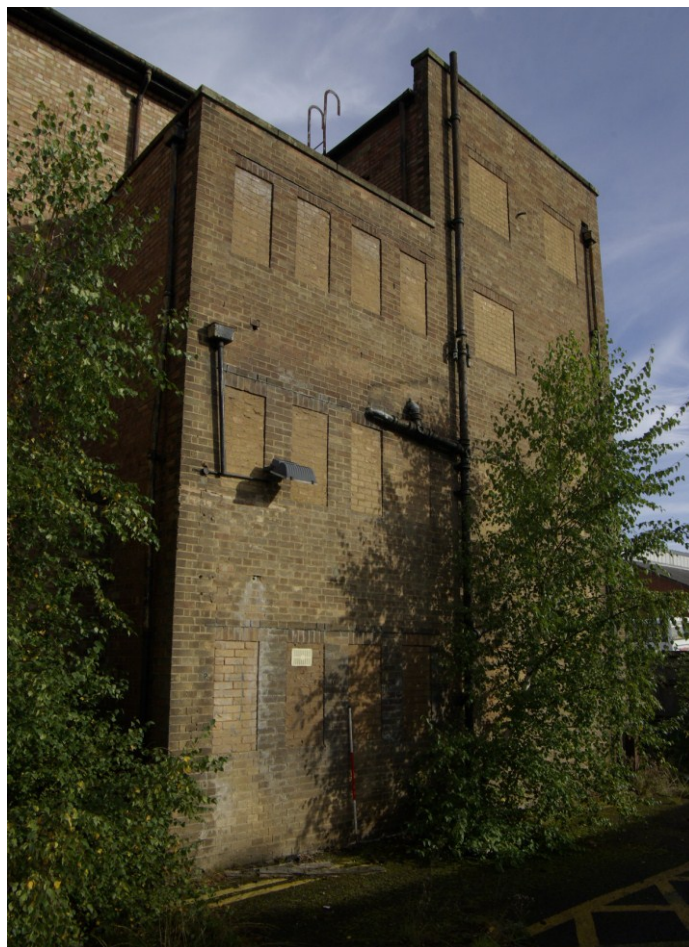
Figure 12. South wing blocked windows  
Facing north-east. 1.5m scale

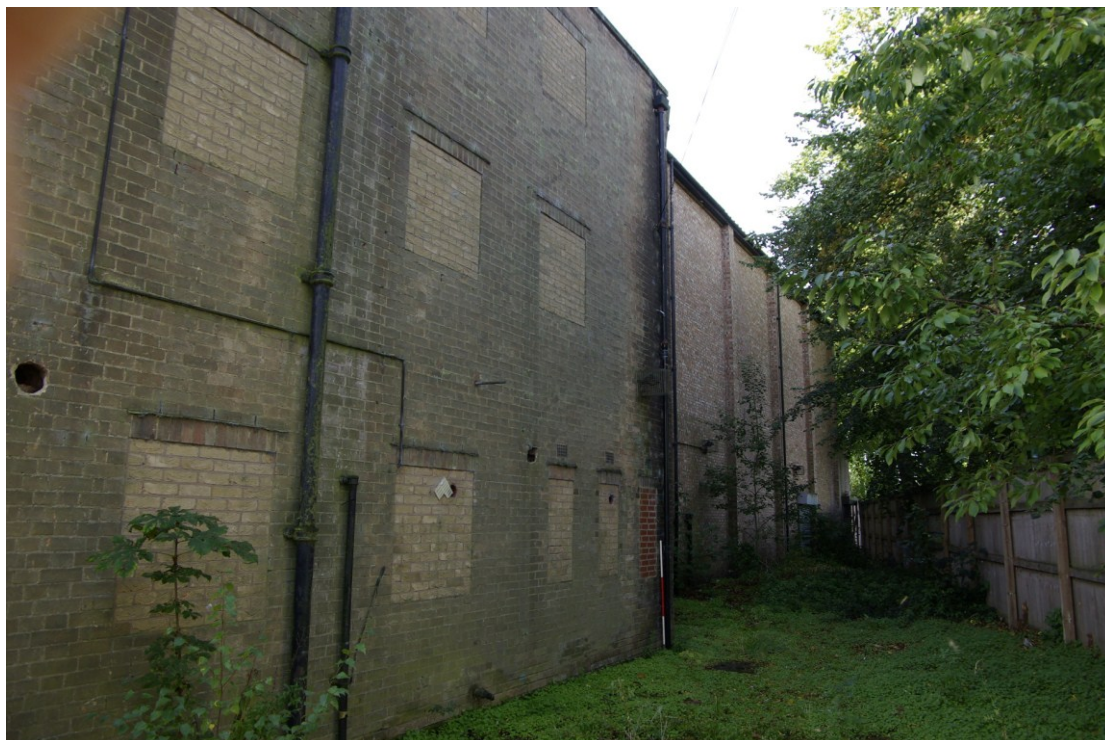
As noted, the main auditorium is built from a lower quality and much less attractive brick giving the impression of a large monolithic box-like structure (Figs. 13 and 14). A series of brick pilasters support this large wall. Only two small doors, which may have acted as fire-escape doors, pierce these faces.

Figure 13. North facing elevation  
Facing south-west. 1.5m scale. Note different types of brick used in main façade (on left of picture) and those used on the main auditorium

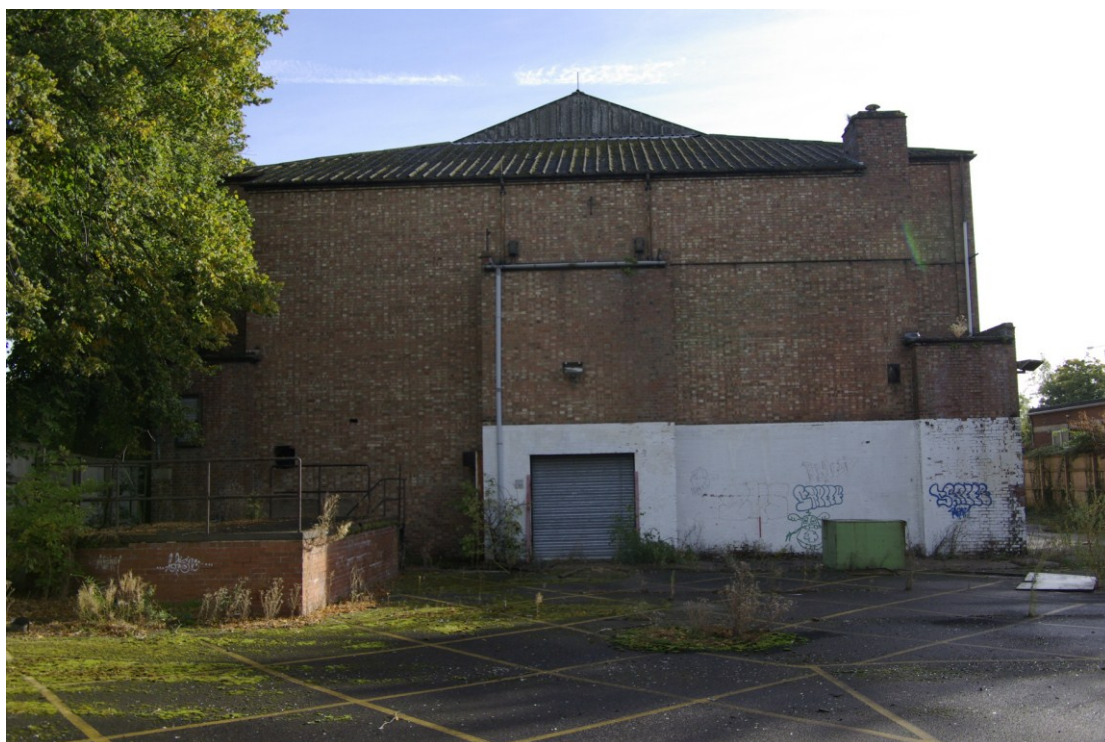
The rear face of the main auditorium is constructed from the same functional bricks that are used on the north and south elevations (Fig. 15). At ground floor level on each corner are small projections as well as a central extension the purpose of which is not clear. A chimney also rises above eaves height near to the southern corner.

Figure 15. West facing elevation  
Facing east. 1.5m scale

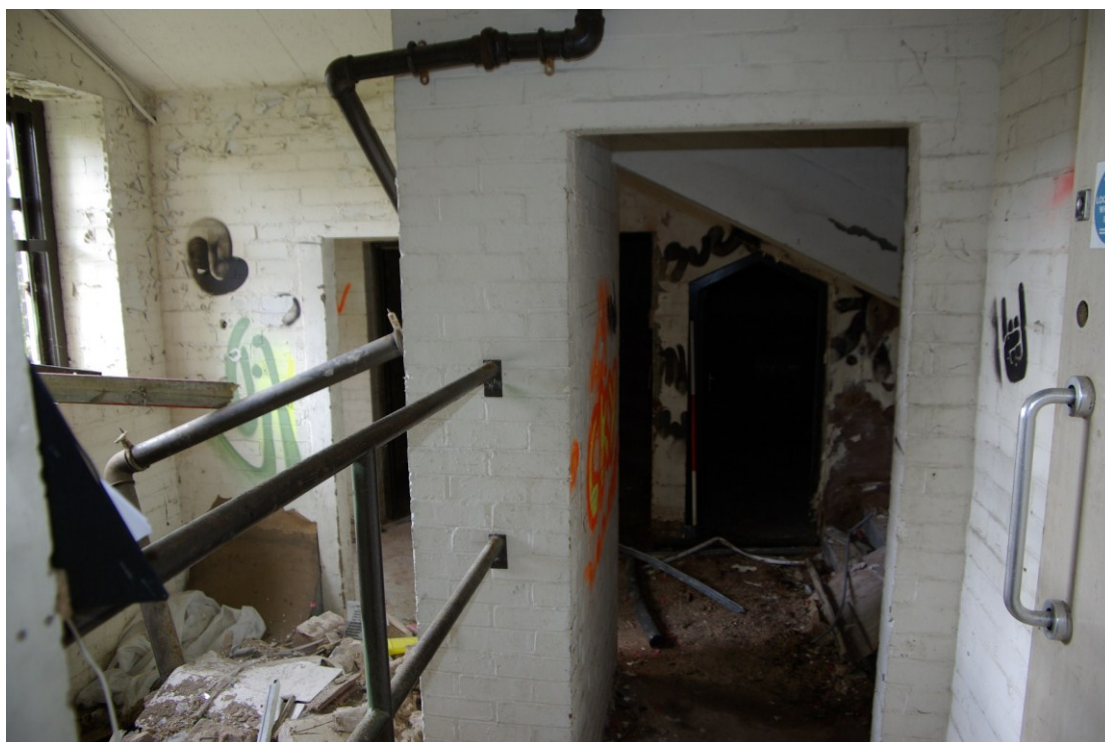
Figure 16. Removed public staircase to south of entrance foyer  
Looking south. 1.5m scale

Since its construction in 1939 the building has seen little alteration to its main external fabric. The most noticeable modifications to the fabric of the building are the removal of the main stairs to the south of the entrance foyer, removal of all foyer walls and the blocking of all side windows. Internally, with the exception of the top floor Projection Suite, there is little to show for its life as a cinema or even as a supermarket.

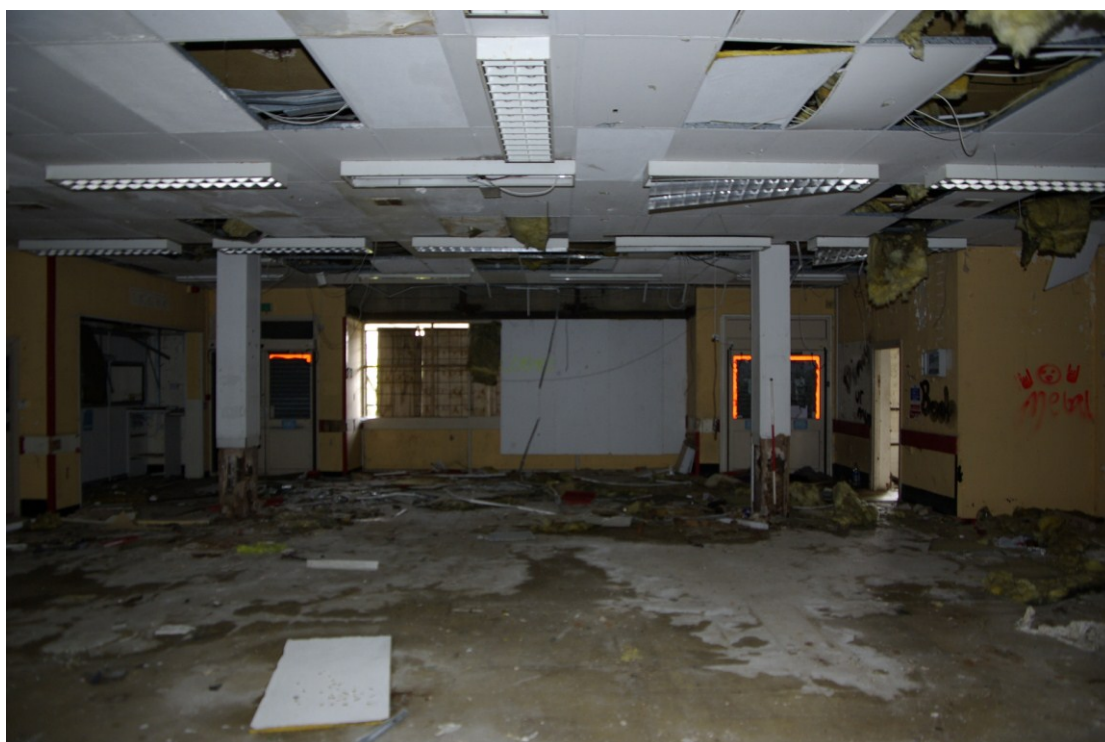
The entrance foyer has had the dividing wall between the foyer and the auditorium removed to create a large open space with a low false ceiling (Figs. 17 and 18). There is also no trace of any ticket office or booth. Where the false ceiling has collapsed the front of the first floor curving balcony can be seen extending out approximately 15m into the auditorium (Fig. 19).

Figure 17. Ground floor entrance  
Looking east. 1.5m scale

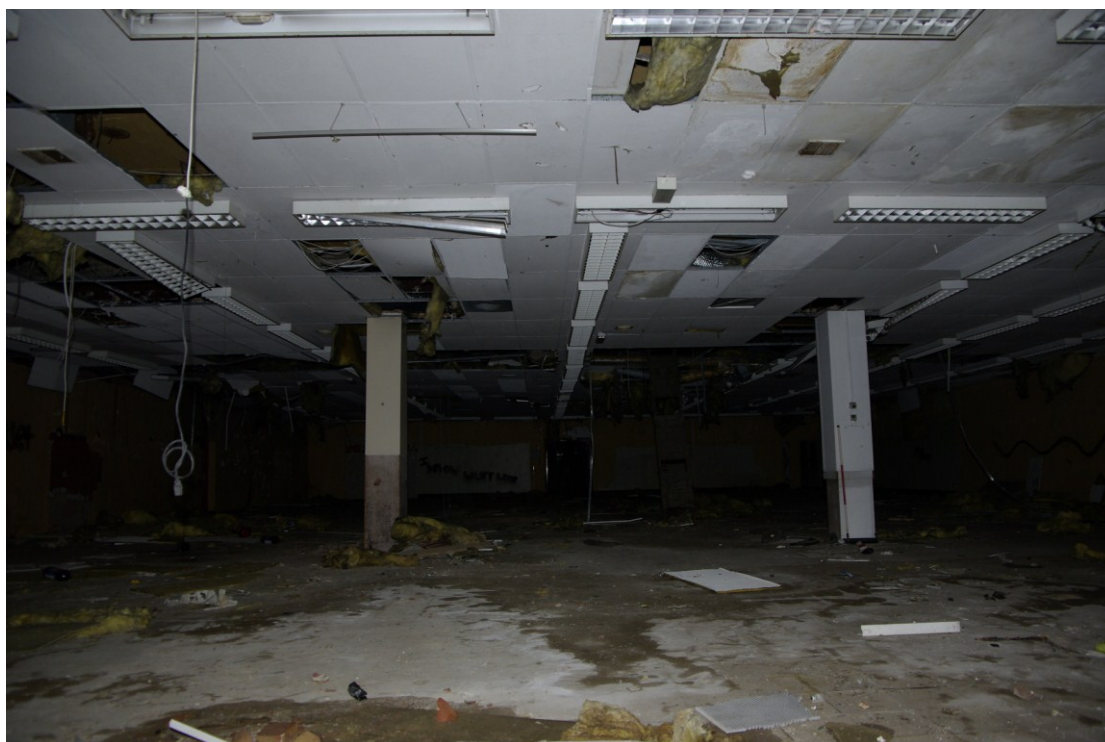
Figure 18. Main auditorium, ground floor  
Looking west. 1.5m scale

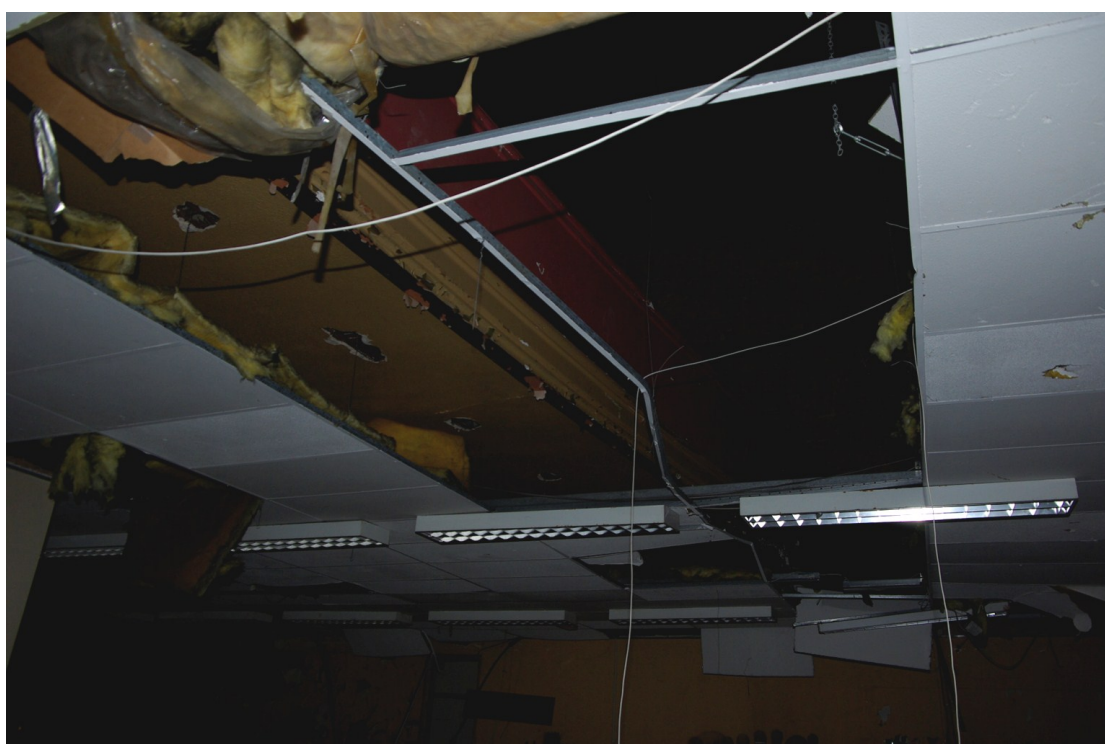
Figure 19. Front and underside of balcony seen through modern false ceiling  
Looking south-east

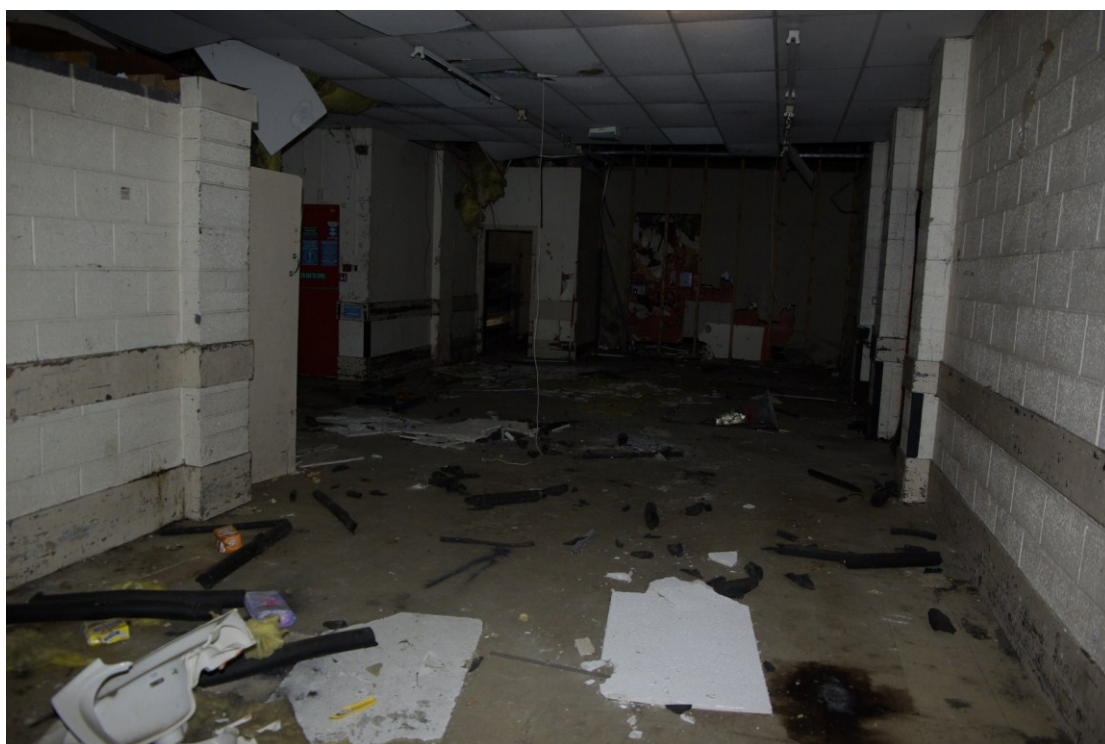
Approximately 30m west from the entrance a 2m high breeze block wall has been built from north to south across the auditorium to create a warehousing space for the

supermarket (Fig. 20). Glimpses of ironwork, ladders and gantries which could be part of the original screen support can be seen through the false ceiling in this space.

Figure 20. Rear portion of main auditorium  
Looking north-west.

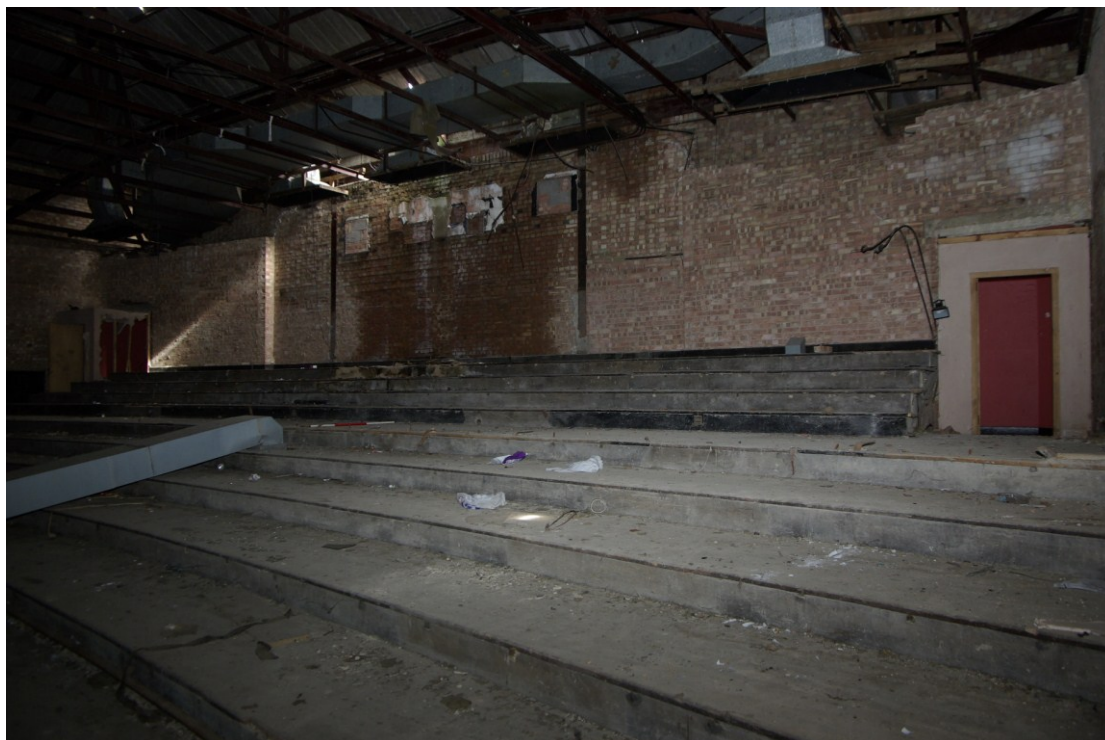
The balcony in the auditorium has had all of its seats removed leaving only the wooden boarded curved, stepped base (Fig. 24). The windows on the rear (east) projection wall have been blocked but the original ventilation/extraction ducting is still present. What looks like a fire screen has been built half way across the auditorium and this may be contemporary with the insertion of the false ceiling. Above the balcony the L-section roof supports can be seen (Fig. 25). These supports also appear to have held the original ceiling which is now missing.

Figure 24. First floor balcony  
Looking north-east. 1.5m scale

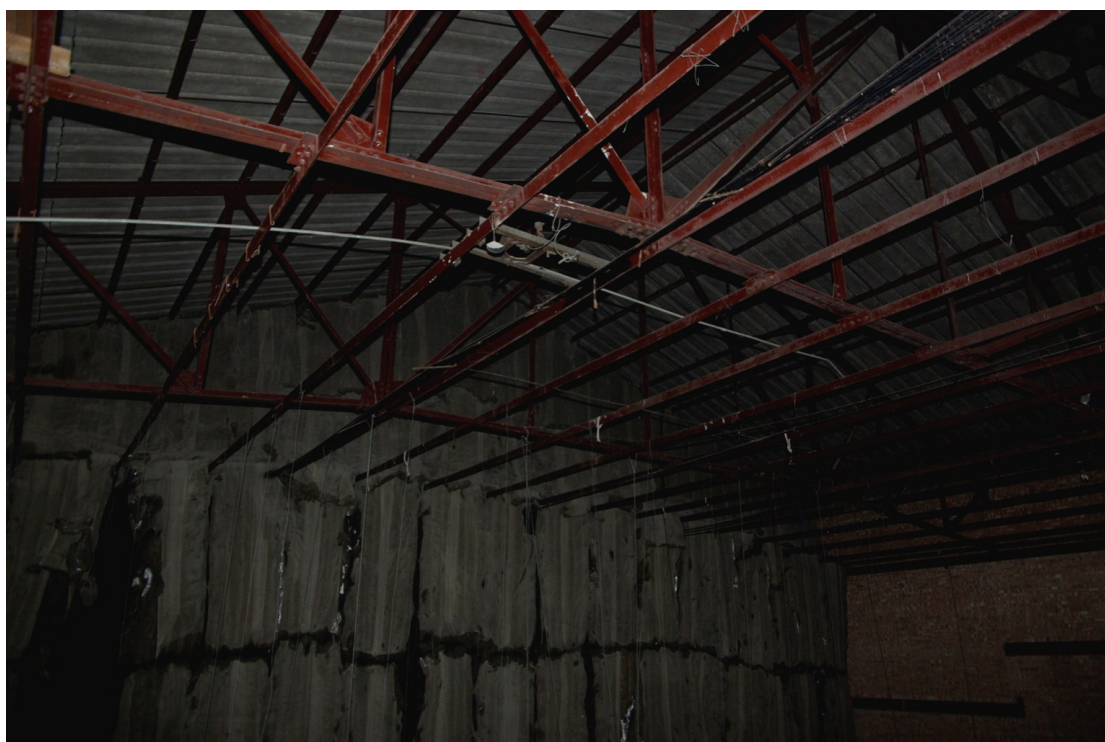
Figure 25. Roof structure as seen from balcony  
Looking north-west. Note inserted fire screen.

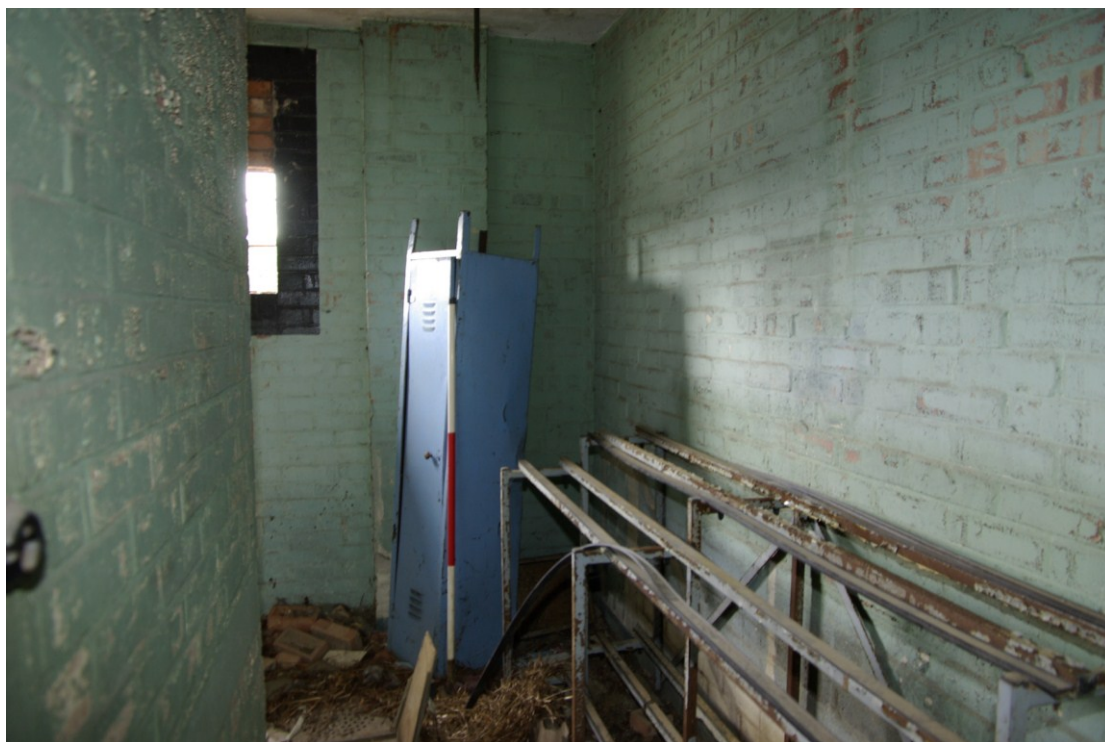
The most southerly room of the projection suite is the Battery Room (Fig. 28). Only a few broken remnants of battery plates remain in this room along with some metal racking which may or may not be related to the batteries.

Figure 28. Battery Room  
Looking west. 1.5m scale

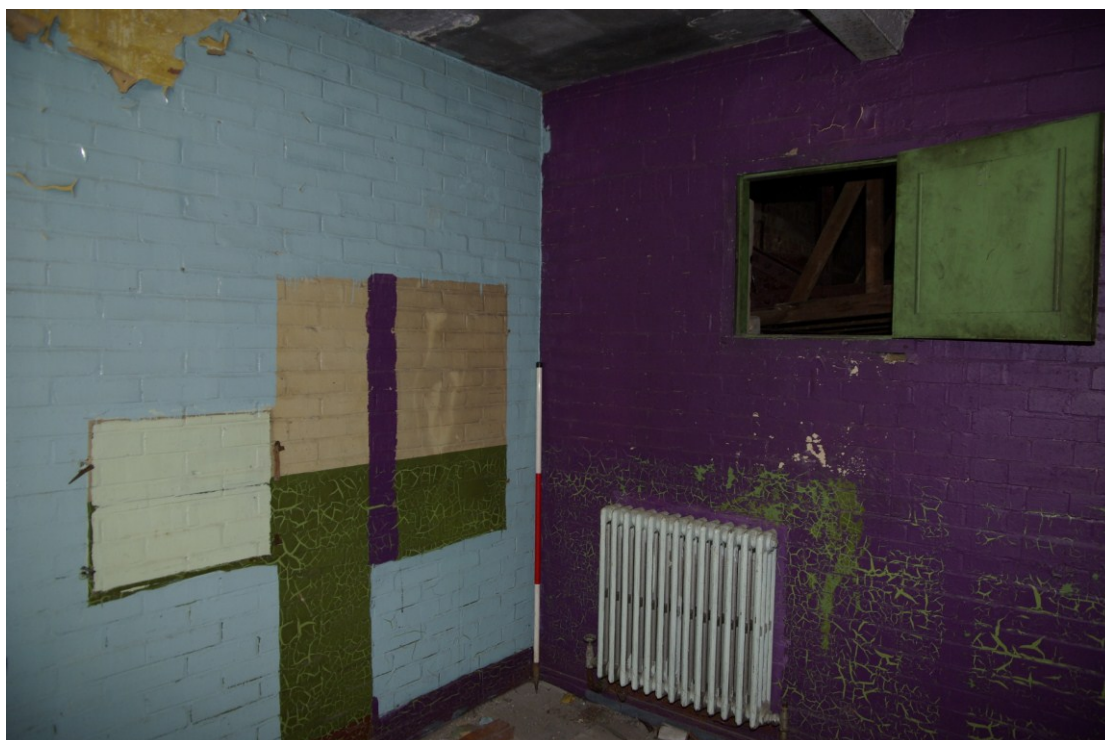
The next room to the north of the Battery Room is the Rest Room (Fig. 29). Traces of the original painted green and cream wall colour scheme remain as does a viewing hatch used by staff to check the progress of the film (Fig. 30).

Figure 30. Rest Room

Looking south-west. Note hatch into auditorium and original green and cream paint scheme. 1.5m scale

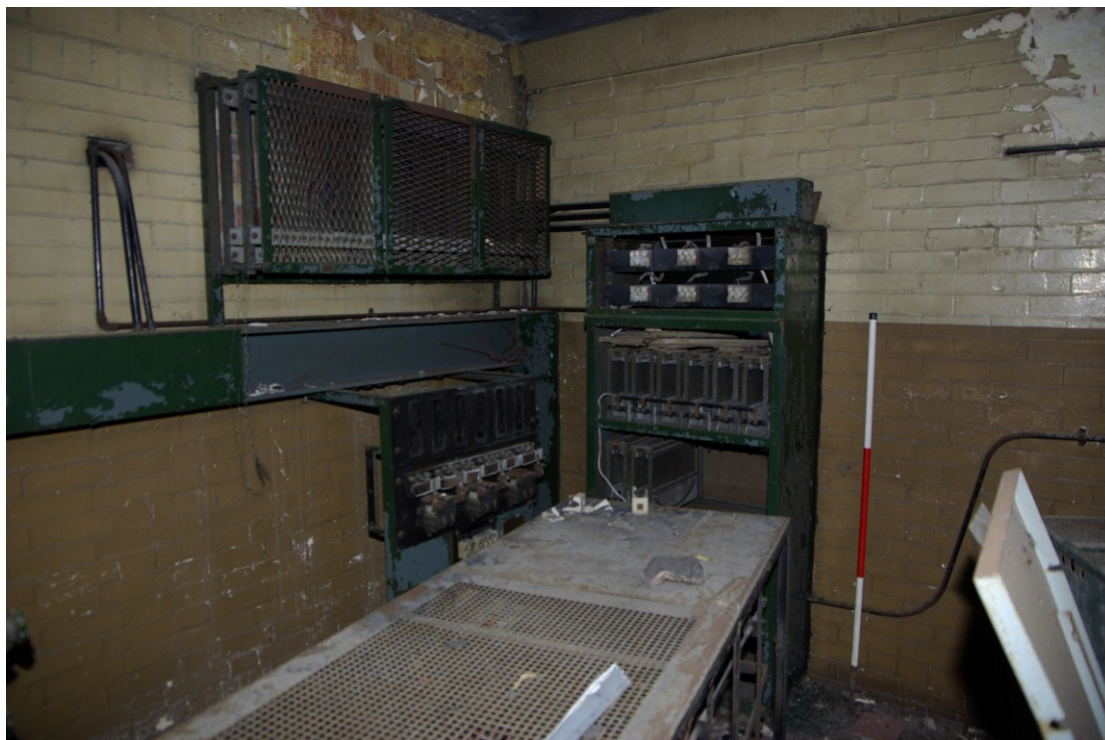
Beyond the Rest Room is the Rectifier Room (Figs. 30 and 31). A considerable amount of electrical switchgear and related equipment survives in this room. A door sized hatch on the north wall is filled with electrical equipment leading into the adjacent projection room. Small circular holes in the flat concrete roof allow some natural light into this room.

Figure 31. Rectifier Room  
Looking north-west. 1.5m scale

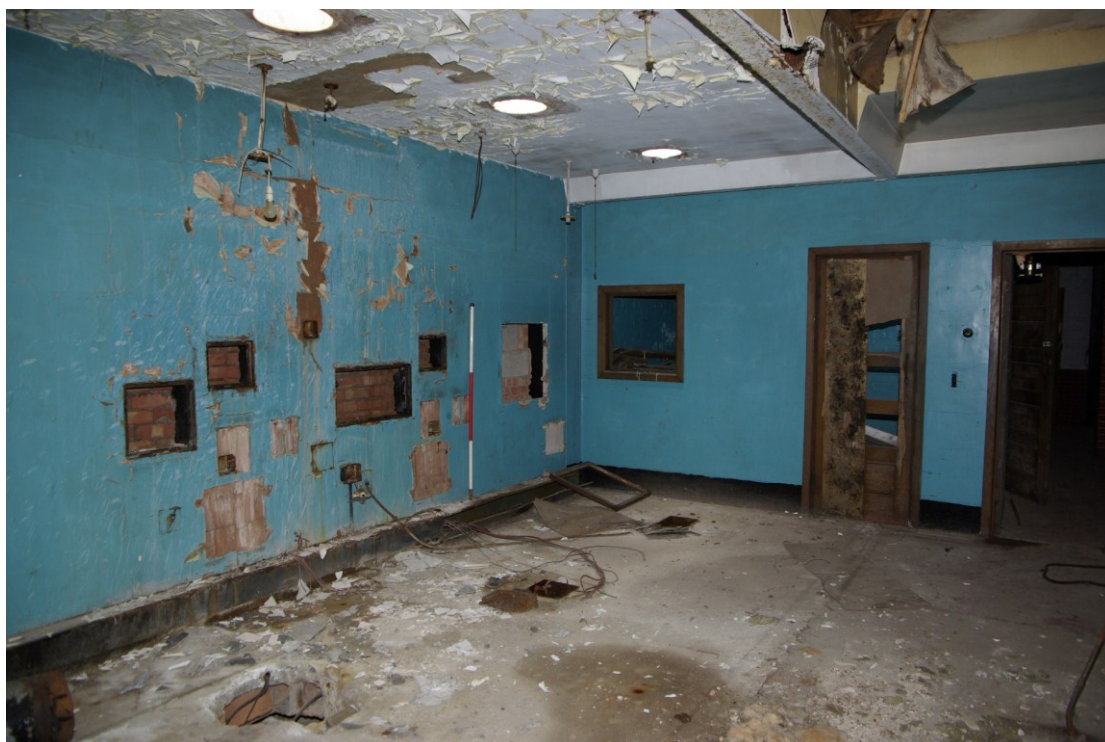
In the centre of the Projection Suite, to the north of the Rectifier Room, is the Projection Room which fills the whole width of this floor (Fig. 33). Nothing remains of the projection equipment except for the fixings set into the concrete floor (Figs. 34 and 35).

Figure 34. Projection Room  
Looking north-west. 1.5m scale

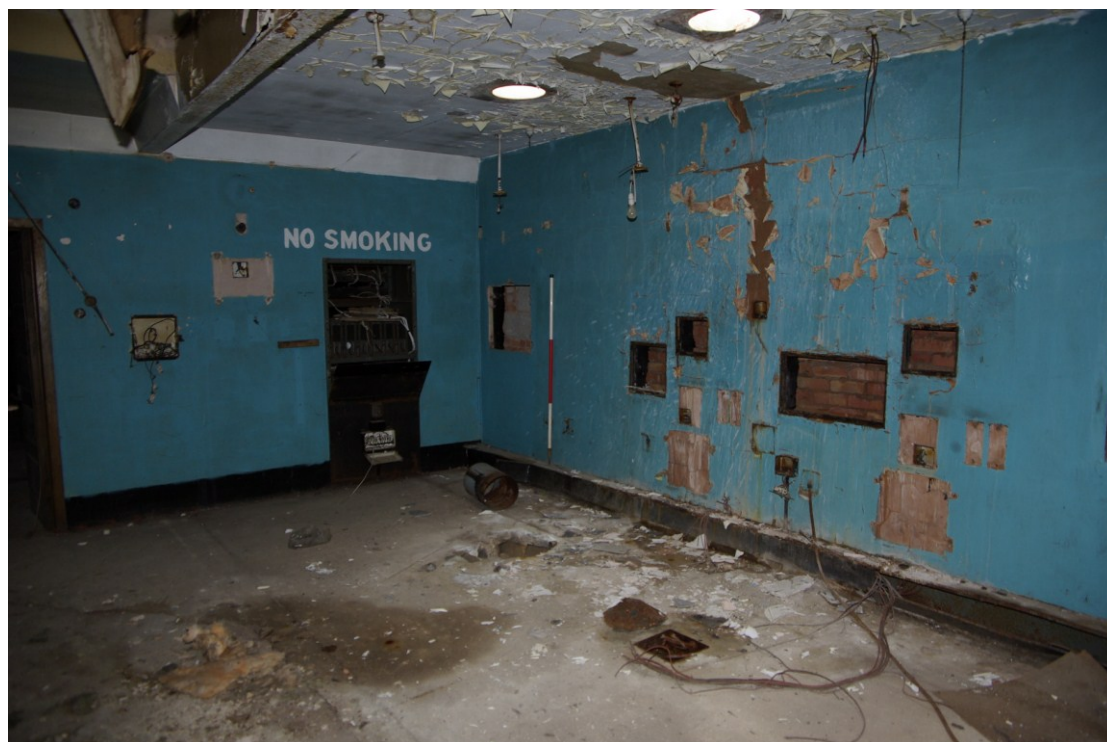
Figure 35. Projection Room  
Looking south-west

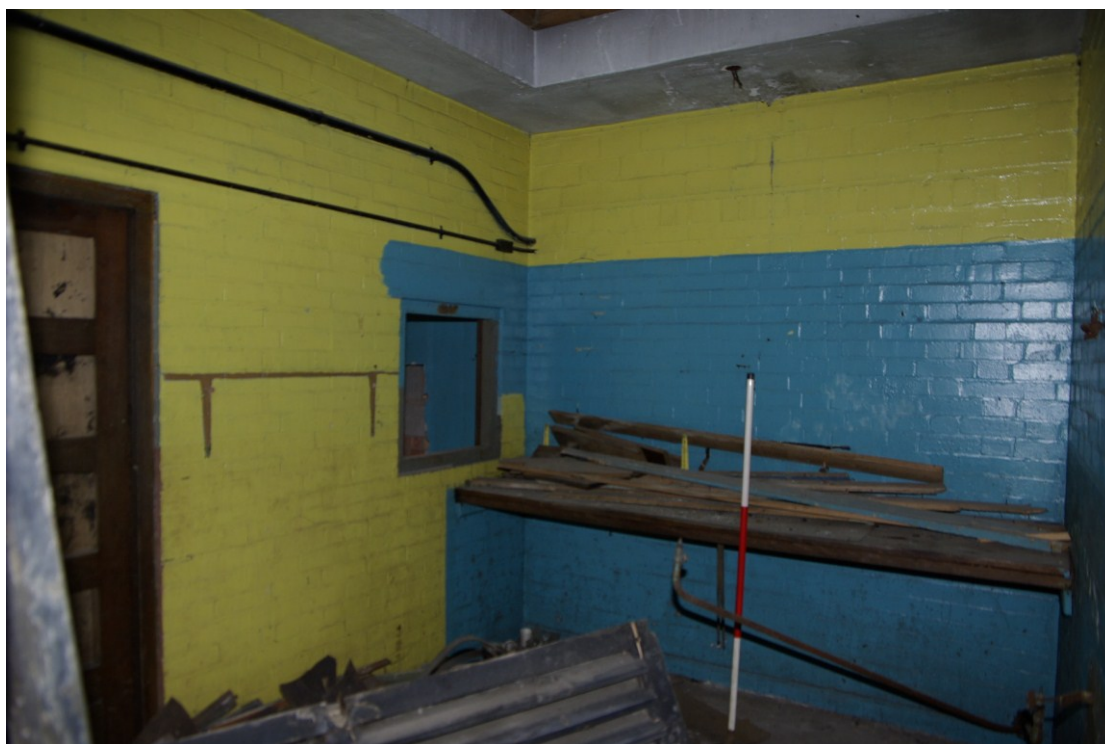
To the north of the Projection Room none of the three rooms have any names stencilled on them. The southernmost of these rooms has a door and window leading into the Projection Room as well as a door to the corridor (Fig. 36). A large amount of wooden debris has been deposited in this room although it is not clear where this came from.

Figure 36. Room to the north of the Projection Room  
Looking south-west. 1.5m scale

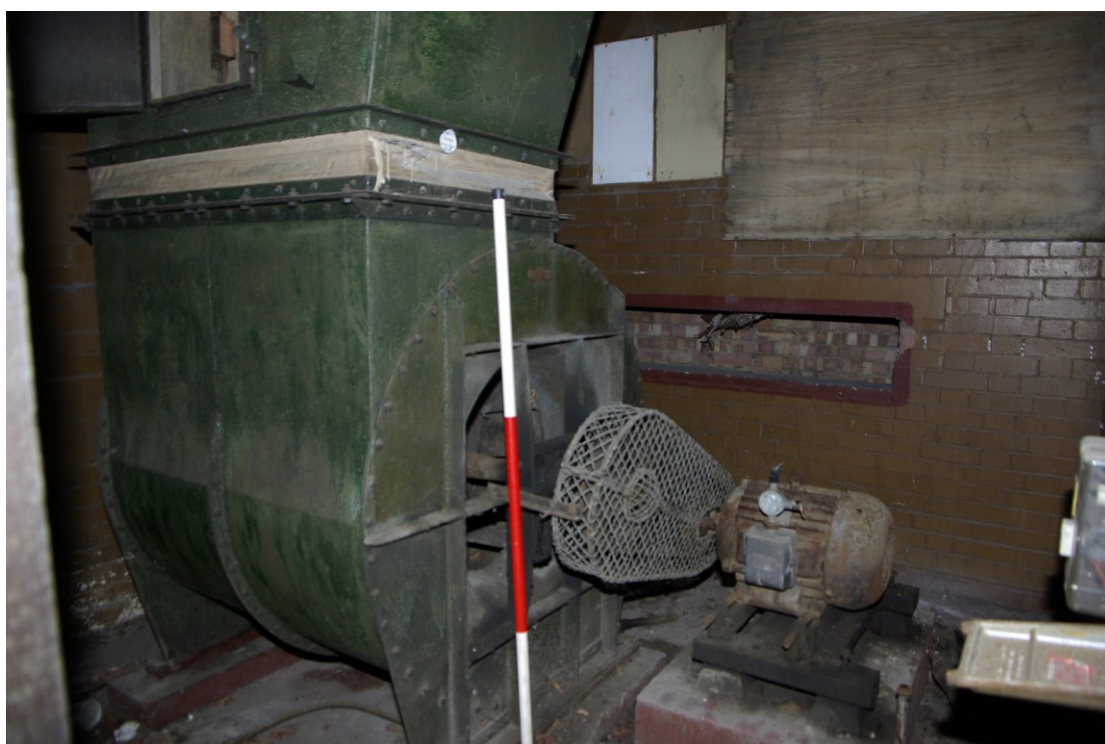
Beyond this room is a smaller room housing the original ventilation/extraction equipment which is connected to the ducting seen above the balcony (Fig. 37). The motor appears to be a later replacement but an unmounted one in the corner could be the original.

Figure 37. Ventilation/extraction room  
Looking south-west. 1.5m scale

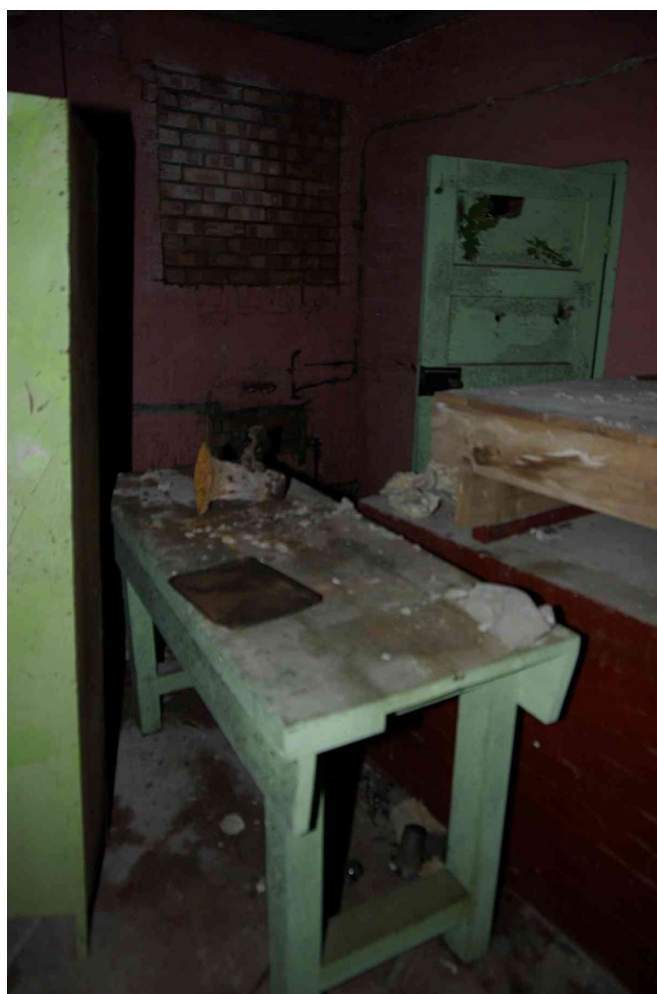
The final and northernmost room along the corridor is filled with wooden benches and other equipment, there is also a toilet in the north-west corner (Fig. 38). The purpose of this room is not clear but there are a number of lengths of film scattered around the floor suggesting film storage or repair.

Figure 38. Northern room of Projection Suite  
Looking north-west. 1.5m scale
