Temple Mill, Gibbet Lane,
Bilstone, Leicestershire
(SK 35660 03483):
Historic Building Record

ULAS Report No 2014-062
©2014

**Temple Mill, Gibbet Lane, Bilstone, Leicestershire SK 35660 03483:
Historic Building Record**

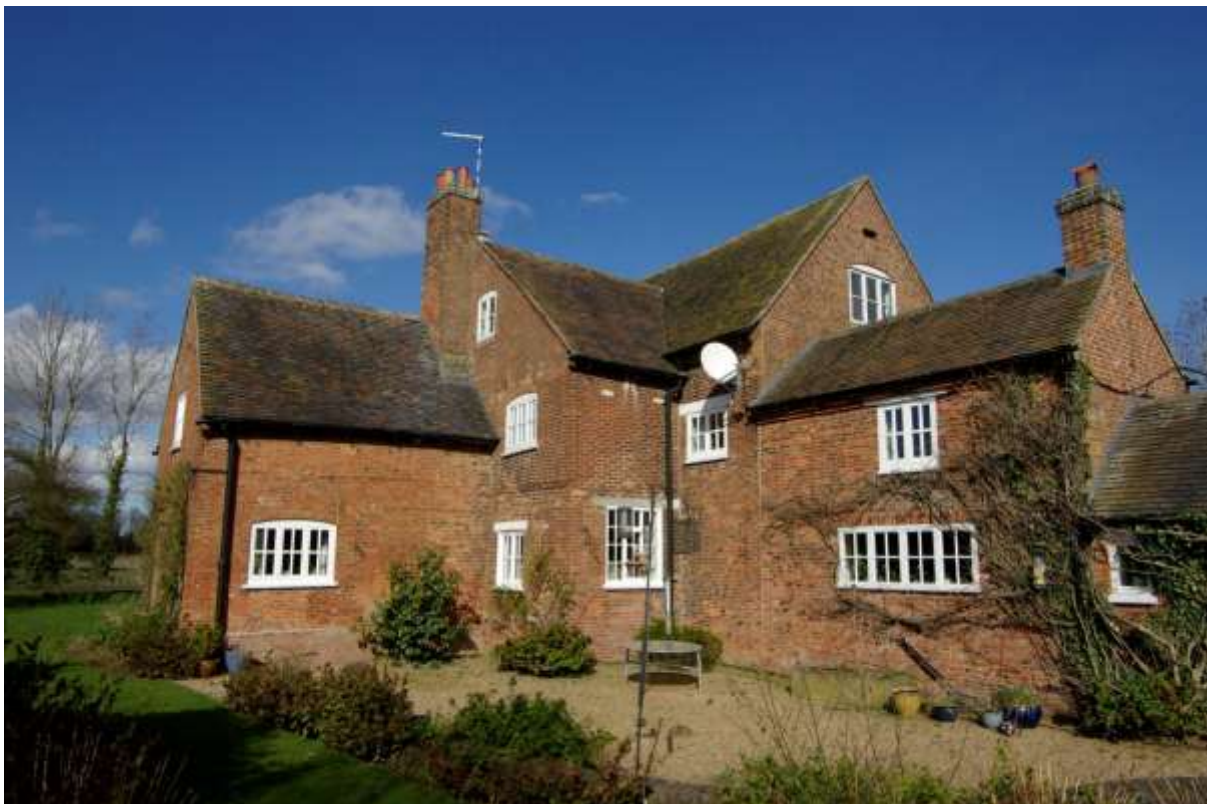
Figure 1. Temple Mill, rear elevation, looking south-west.

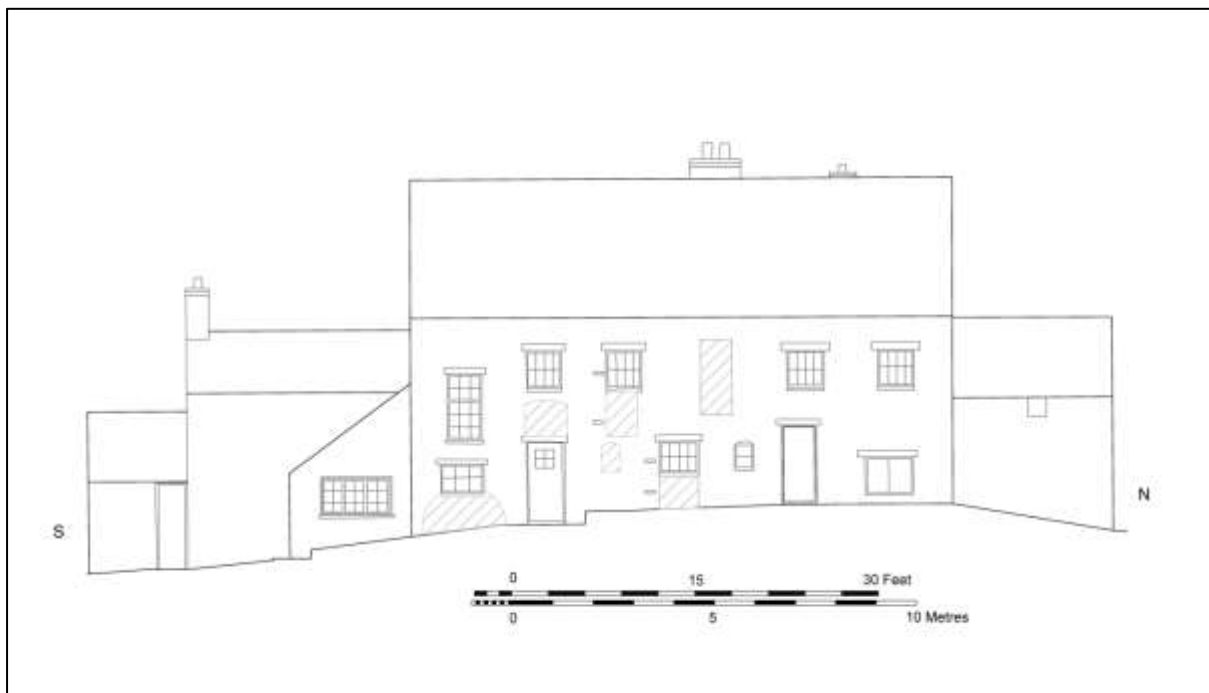
The east-facing, principal elevation of Temple Mill has a number of blocked window and doorway openings within the brickwork, which reflect how the use of the building and

internal layout has changed over time. The central doorway depicted in the sketch of 1786 is now partially blocked to form a window; the smaller window lights on either side of this are still visible, although one is now blocked. A pair of sandstone blocks on the left hand side of the blocked doorway opening indicate where the pintles for the door hinges would have been fixed and there is a second pair located at first floor level, to the left of centre, associated with another blocked doorway in this position. The present doorway entrance is located to the south of the range; this is a late insertion, and may date to a 20th-century arrangement. To the left of this, a blocked archway at ground floor level may be evidence of the ‘cellar’ referred to in the sales particulars of 1927 (see above), although this is not likely to have been fully subterranean, due to the high level of the water table in this area.

Figure 9. East-facing elevation (derived from Bosworth Design survey)

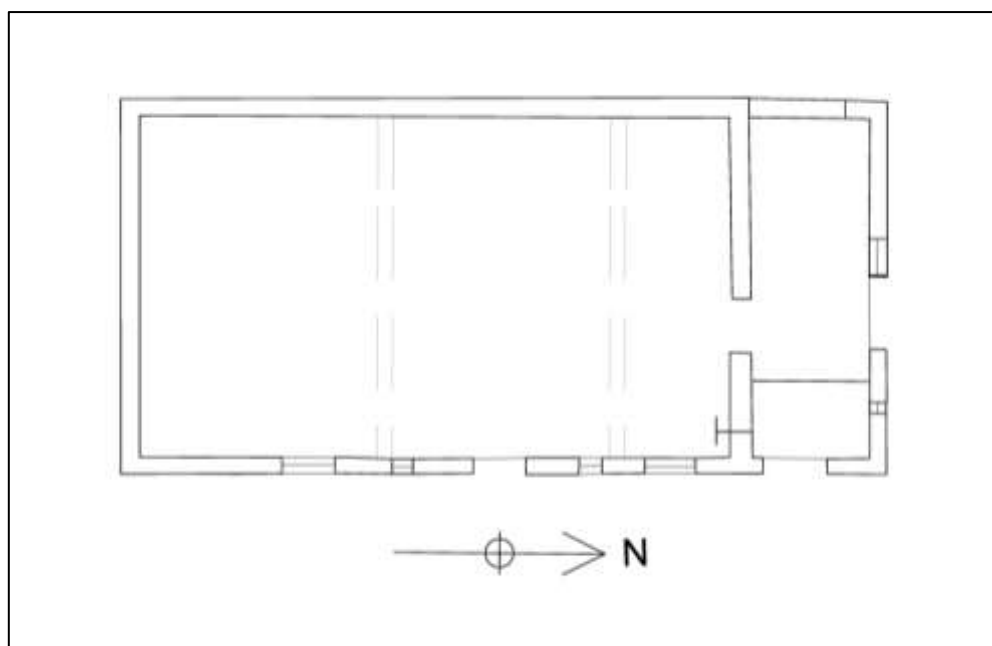
Originally, the building is likely to have been constructed on a simple linear plan, which can be deduced from the current plans below (figure 13). The position of the bay divisions corresponds with the line of the roof trusses on the second floor plan; the wall-posts of the original timber-framed structure are no longer present, but there are brick piers in this position which were constructed to support the substantial transverse axial beams of the first and second floor structures.

Figure 13. Block plan to show basic three-bay plan of early house.

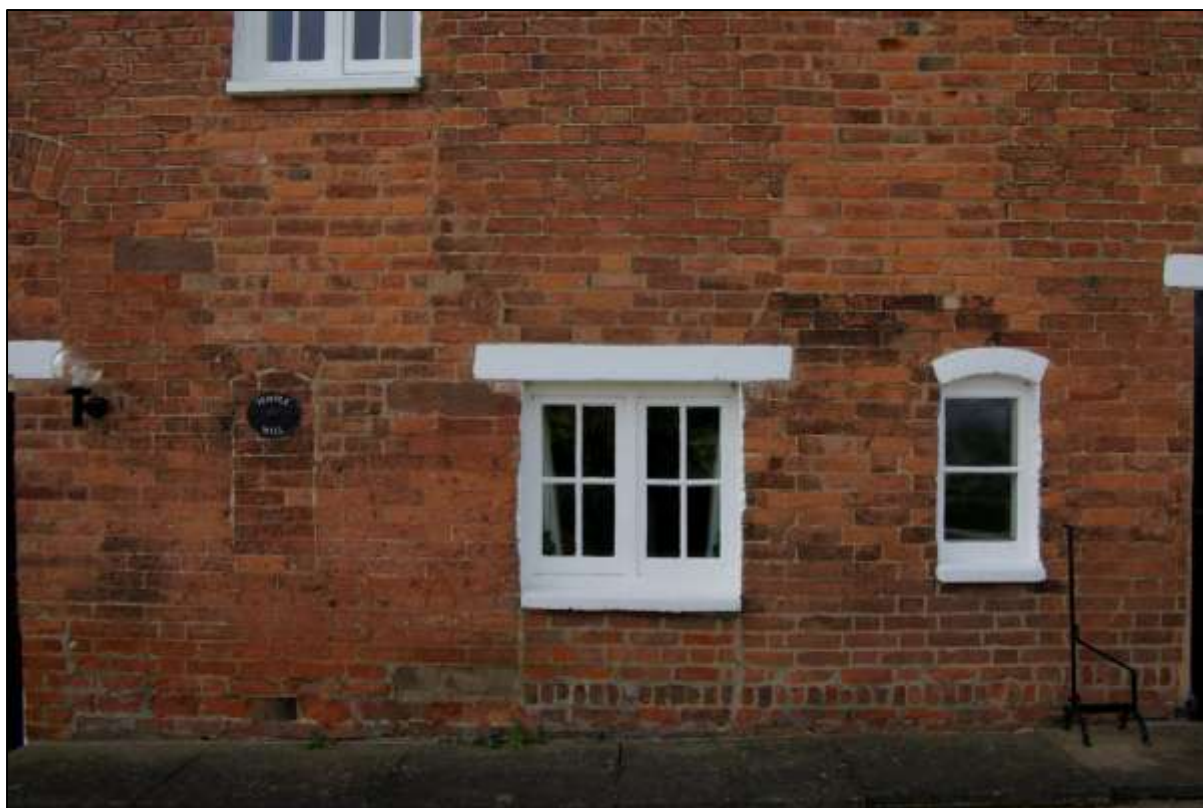
Figure 21. Front elevation, former doorway in central position, looking west.

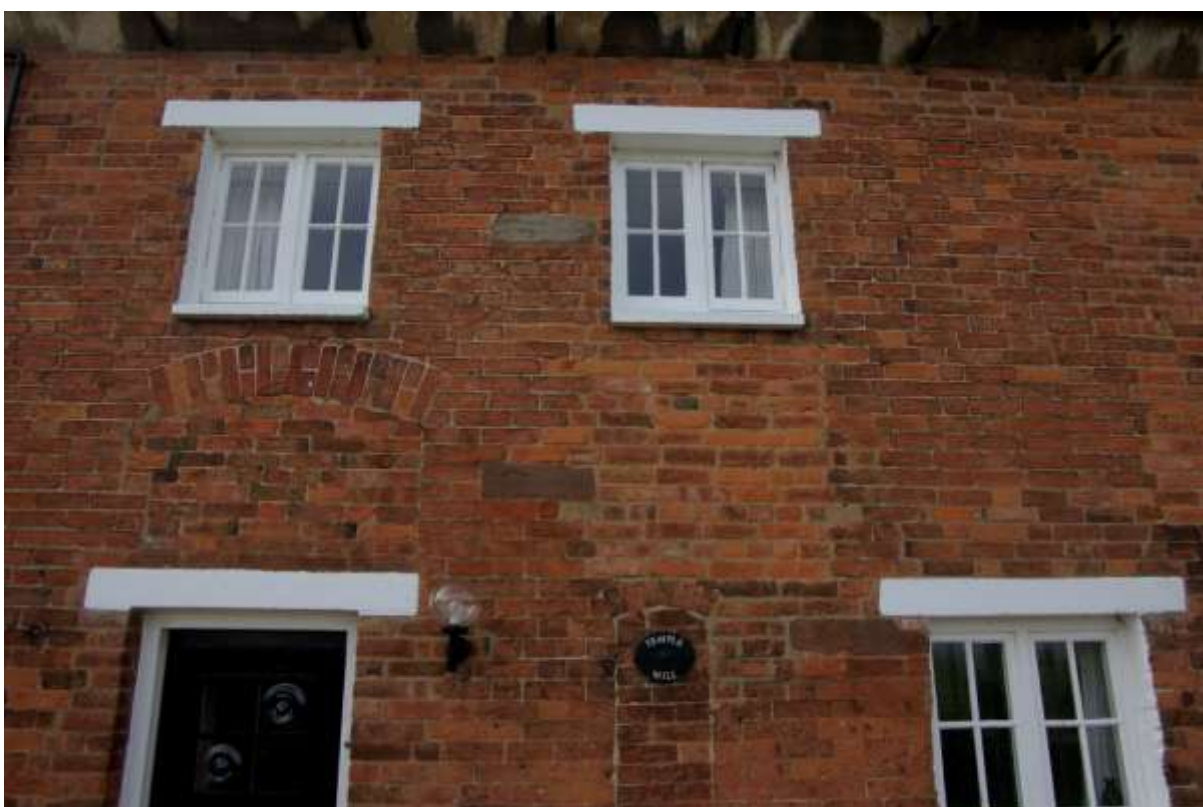
Figure 22. Front elevation with blocked doorway opening at first floor level, looking west.

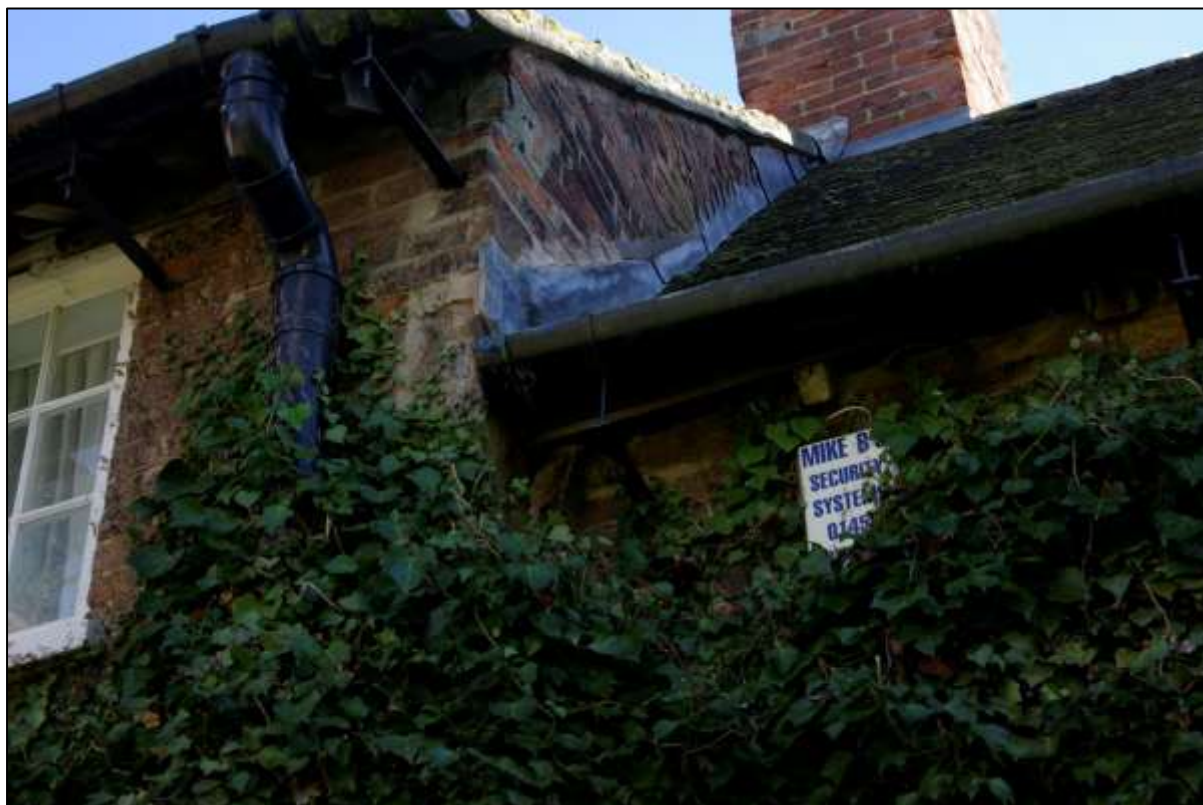
To the rear of the building, a short range projecting at right angles from the west-facing façade appears to be a later addition. The remains of a structural timber post located at the western corner of the north-facing elevation of this range can just be seen below the line of the eaves, and this relic represents scant but compelling evidence to indicate that the building originated as a timber-framed structure, with the side walls later rebuilt in brick. Here the elevations were raised using a combination of Flemish Garden-Wall bond with Monk bond, using two or three stretchers between header bricks, with queen closers to the wall returns. Brick dimensions are typically 9 ¼ inches x 4 ½ inches x 2 ¼ inches and the fabric would indicate a date in the first half of the 18th century. With reference to the documentary evidence, it would seem reasonable to suggest that the walls were rebuilt shortly after 1730, following the purchase of the mill by John Hall (1699-1763).

Figure 25. Timber post at corner of rear extension, looking south.

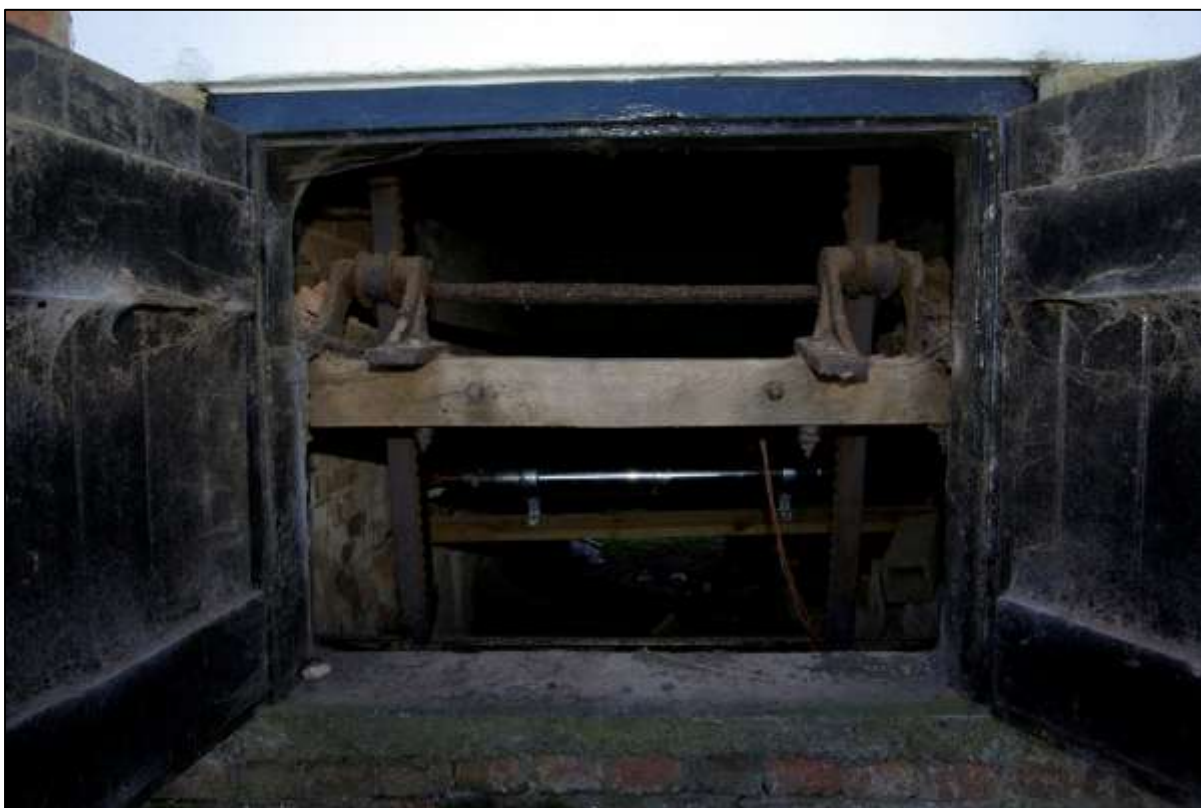
Figure 30. Sluice-gate mechanism in wheel-house. Looking east.

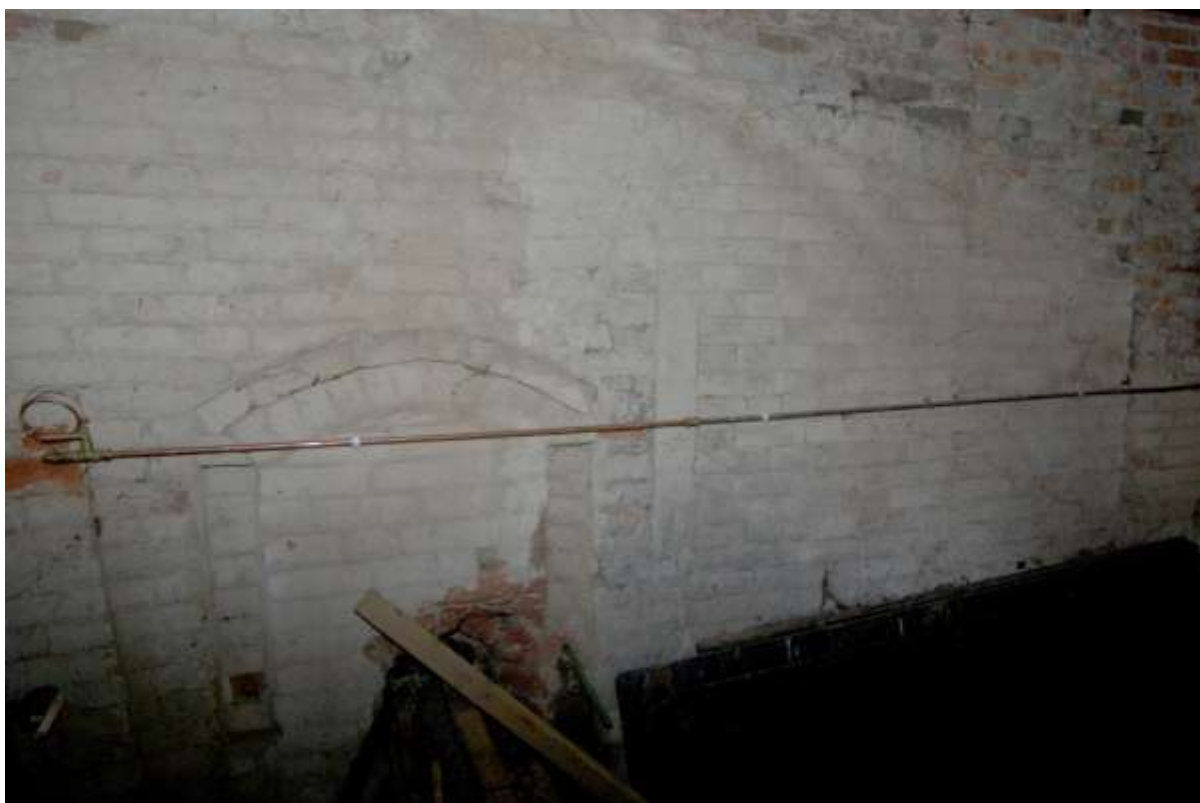
Figure 31. Axle for water-wheel and blocked openings in wheel-house wall, looking south.

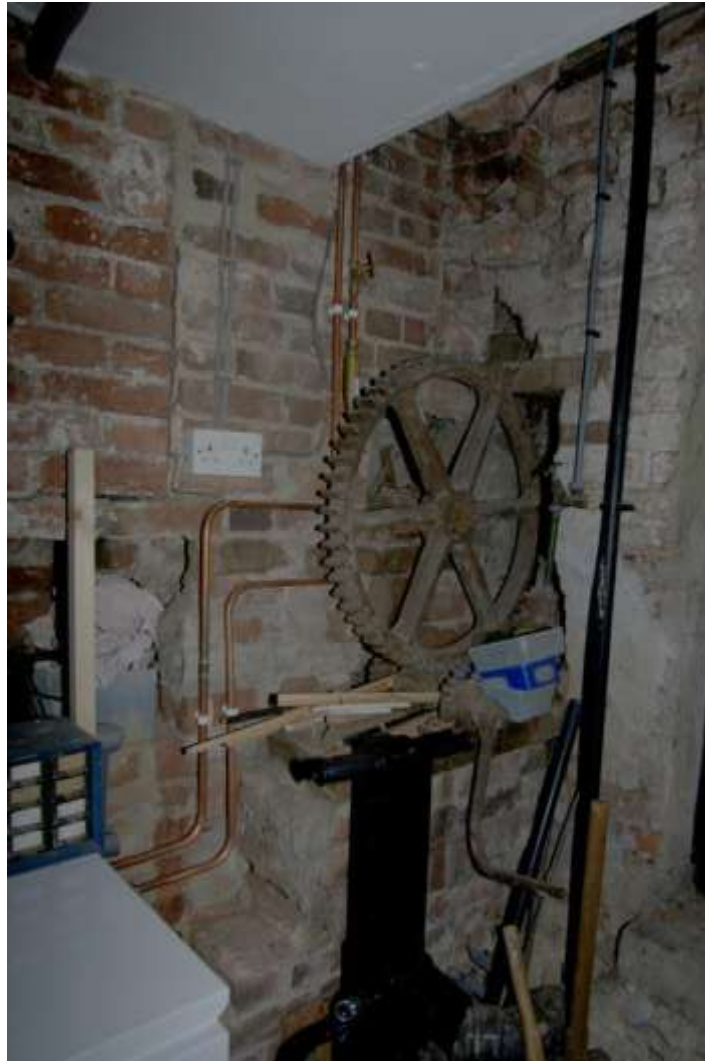
Figure 33. Turning wheel and handle for sluice-gate, in workshop, looking north-east.

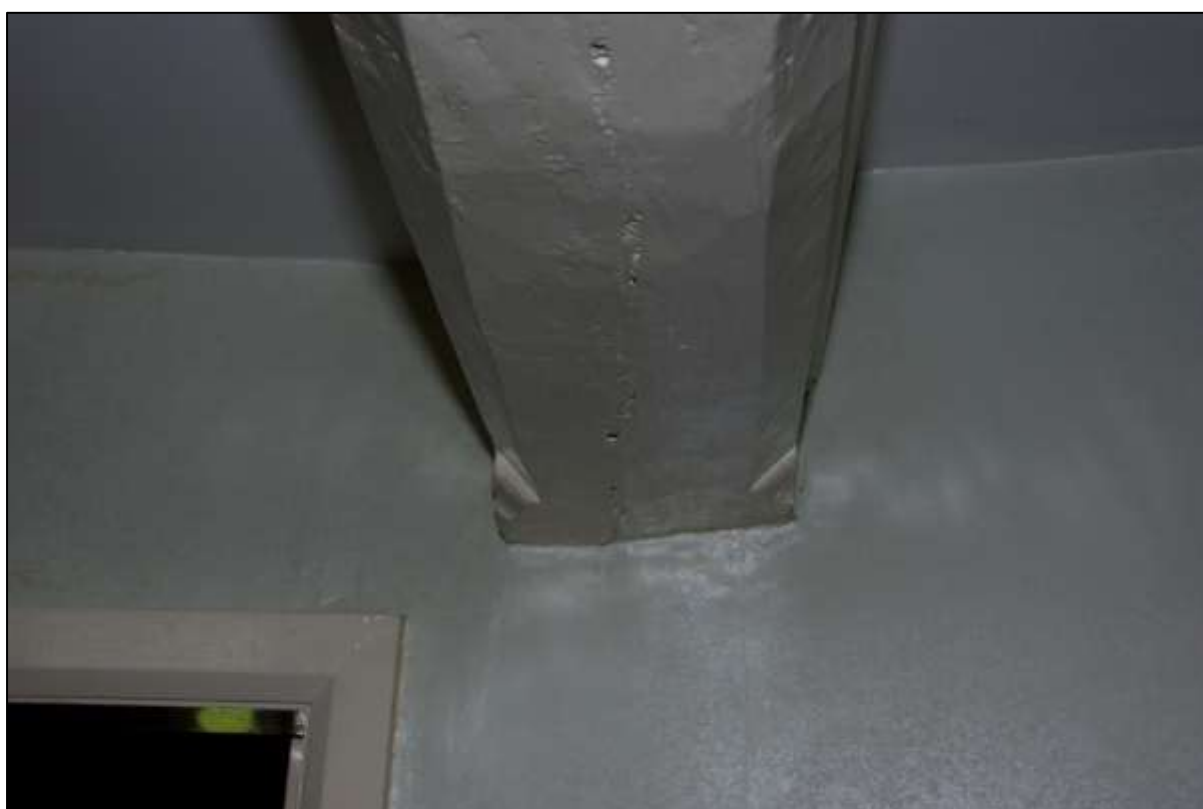
Figure 35. Chamfered axial beam over former living kitchen, with scroll stops. Looking north.

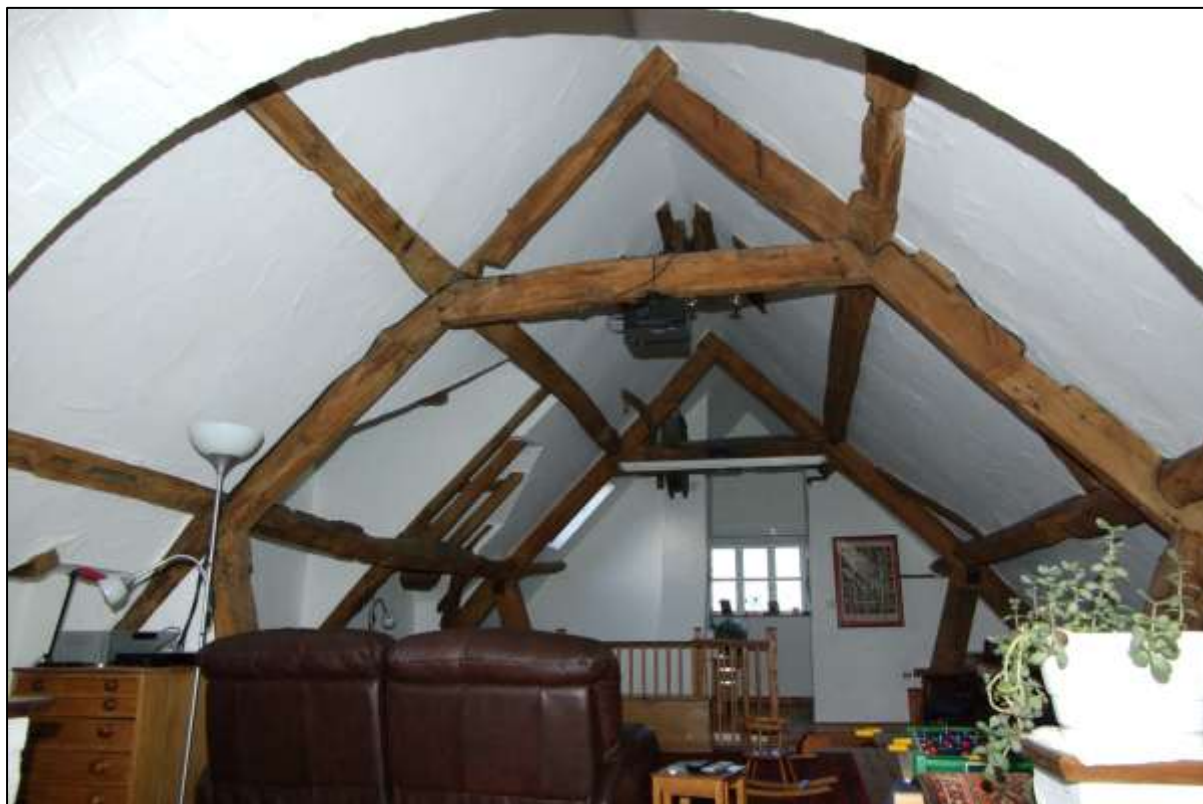
The second floor is dominated by a pair of interrupted tie-beam roof trusses, which provided the height needed for the milling process. The form of the roof trusses is of a type that began to evolve after about c.1650 and are commonly seen towards the end of the 17th and throughout the 18th century, within buildings where increased roof height was a requirement. (N. Finn pers. comm.). Here the central part of the tie-beams are omitted, and the ends are tenoned into raking braces, which rise from the axial beams of the floor to meet the principal rafters. The principal rafters are pegged at the apex and supported by a collar. Two orders of purlins rest in notches on the backs of the principals to support the rafters, and there are wind-braces to provide lateral stability to the frame. Wooden pegs are used throughout. All of the timbers have redundant sockets and jointing to indicate their re-use within the present structure. Although the empty sockets were only briefly inspected, the presence of lap-dovetail jointing can be considered as evidence that the timbers were previously part of a box-framed structure – whilst it is entirely plausible that the timbers may have been sourced from an earlier form of this mill building, this cannot be established with any certainty.

Figure 44. Principal-rafter room trusses at second floor level, with interrupted tie-beam. Looking north.

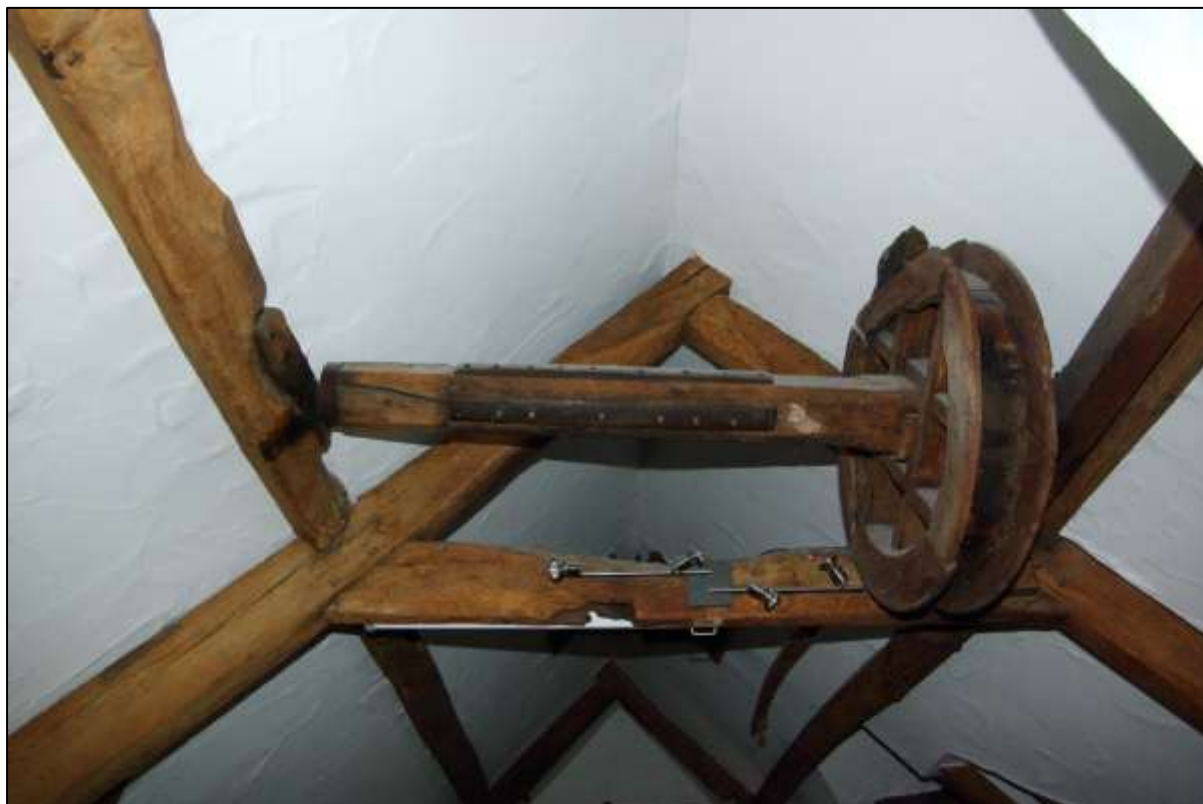
Adjacent to the northernmost roof truss is a timber pulley wheel for a sack hoist, which was used to lift the sacks of grain up to the second floor, where there would have been hoppers to feed the corn to the millstones below. The small, unheated room located within the short projecting range at this level has been described as the miller's bedroom.

Figure 46. Timber pulley, part of sack hoist. Looking south.

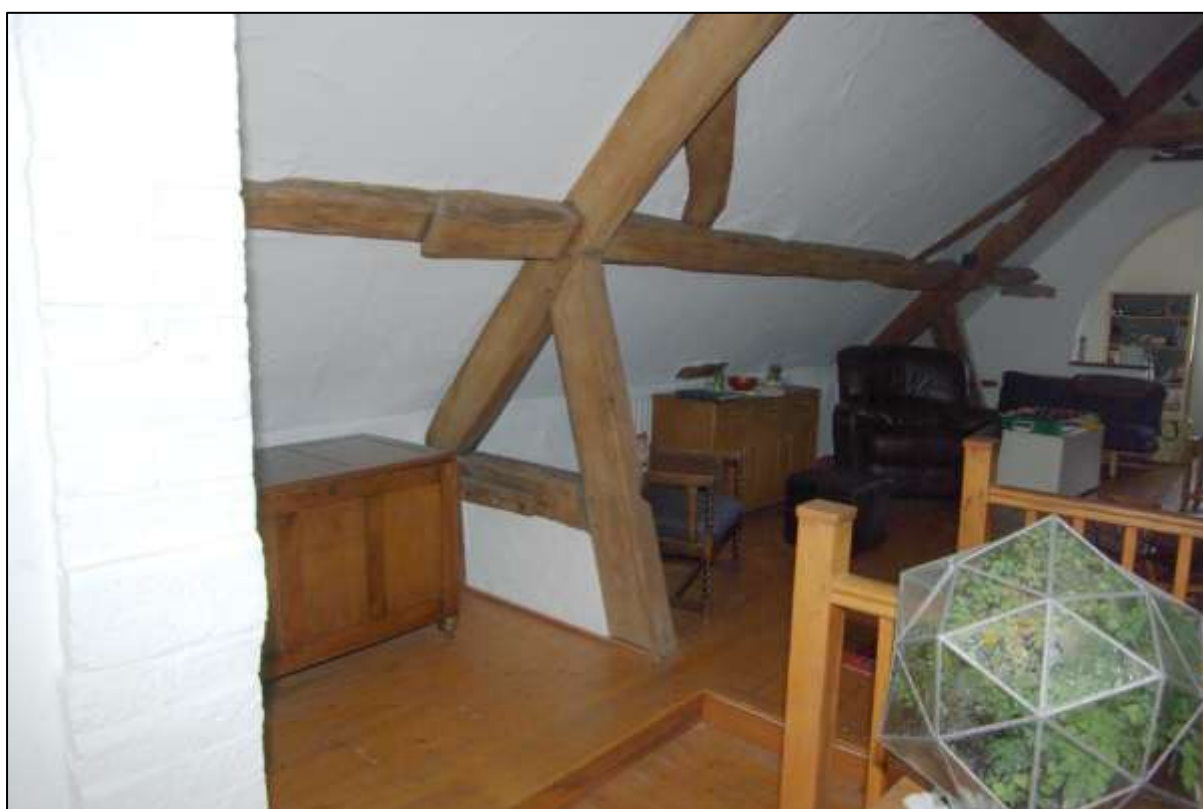
Figure 47. Interrupted tie-beam and wind-braces, looking south-east.

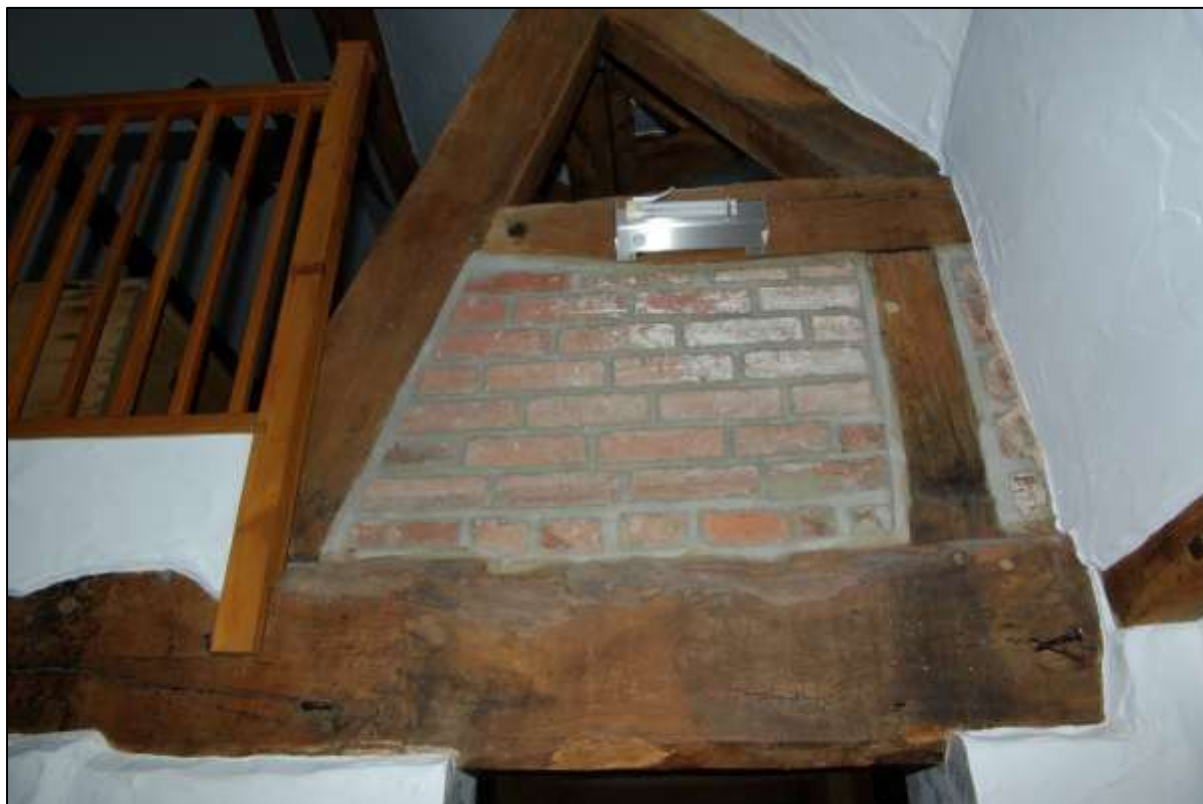
Figure 48. Interrupted tie-beam supported by short post, which is tenoned into the transverse axial floor beam. Looking south.

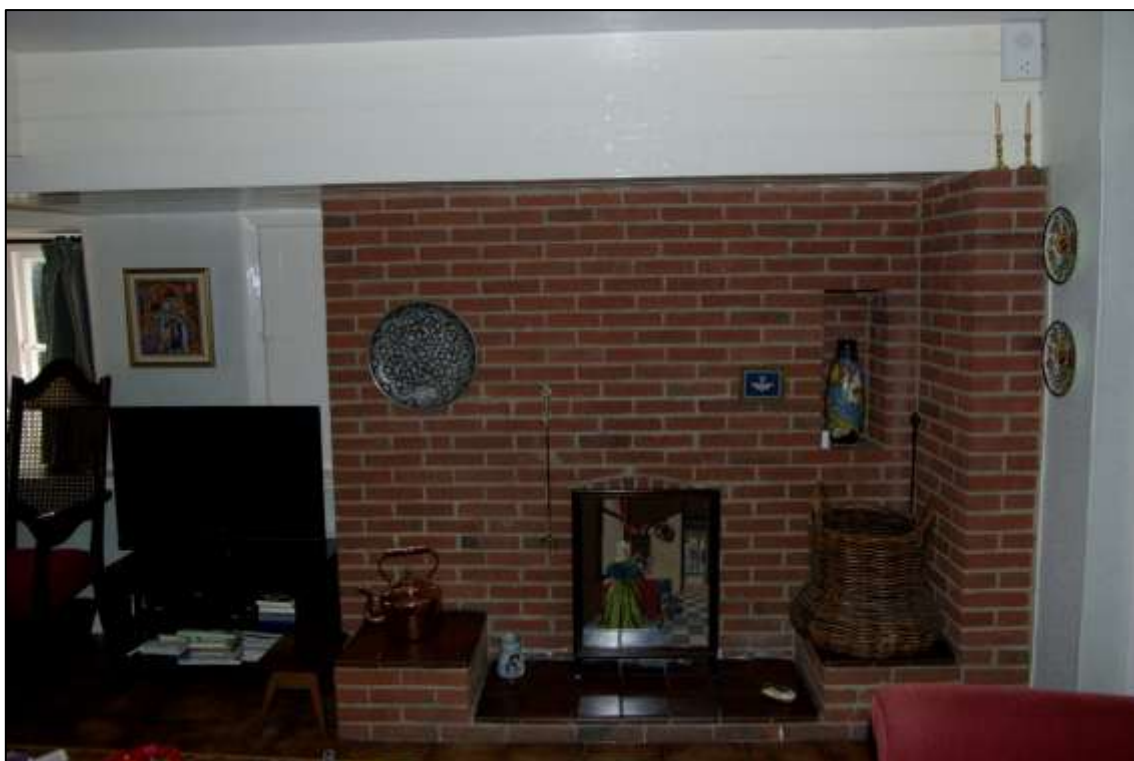
During the course of the fieldwork, Mr and Mrs Cullen instructed a builder to remove the 1970s brick fireplace from the former living kitchen, with a view to installing a fireplace more in keeping with the historic character of the building. This work revealed evidence of two earlier phases for the form of the fireplace, in addition to a substantial timber bresummer beam, which would have been constructed as part of an original timber inglenook. The northern end of the bresummer was supported on a brick pier, finished with apparently 18th century beaded wood panels. The southern end of the beam has been sawn off and is presently supported by a steel I-beam. It is likely that the beam would have been originally supported by a timber post, tenoned into the underside, but any evidence for this has been removed.

Figure 49. Brick fireplace of 1970, prior to removal, looking west.

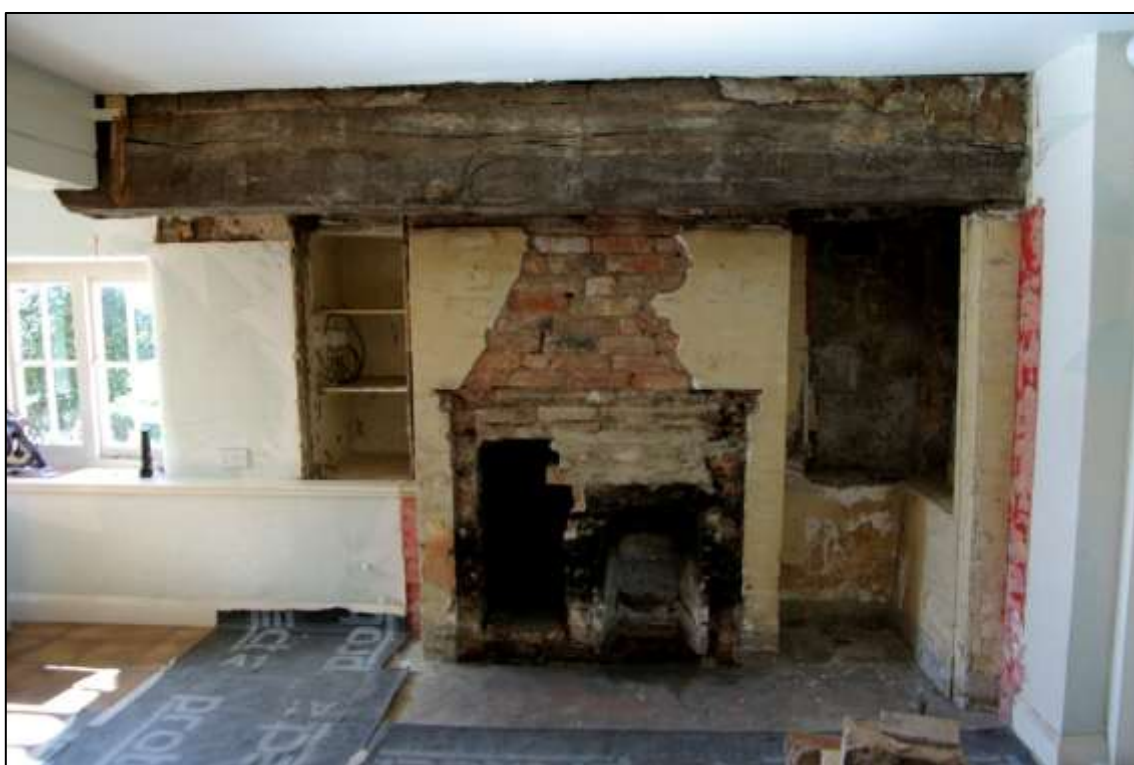
The original inglenook fireplace is likely to have been open, with the bresummer providing support for a chimney hood and upper stack. During the 18th century rebuilding, the opening was reduced in scale. A brick chimney stack was constructed to provide the upper rooms with heating, supported by a brick arch at ground floor level. The arch is likely to have been supported on a brick pier, which was removed at some point during the 20th century, following the insertion of the I- beam.

Figure 50. Timber bresummer and 19th-century brick stack exposed following removal of modern brickwork

On Tuesday 25th March, the Conservation Officer from Hinckley and Bosworth Borough Council came to inspect the works and it has been agreed that the Victorian stack may be removed without Listed Building Consent, as part of the restoration of the fireplace.

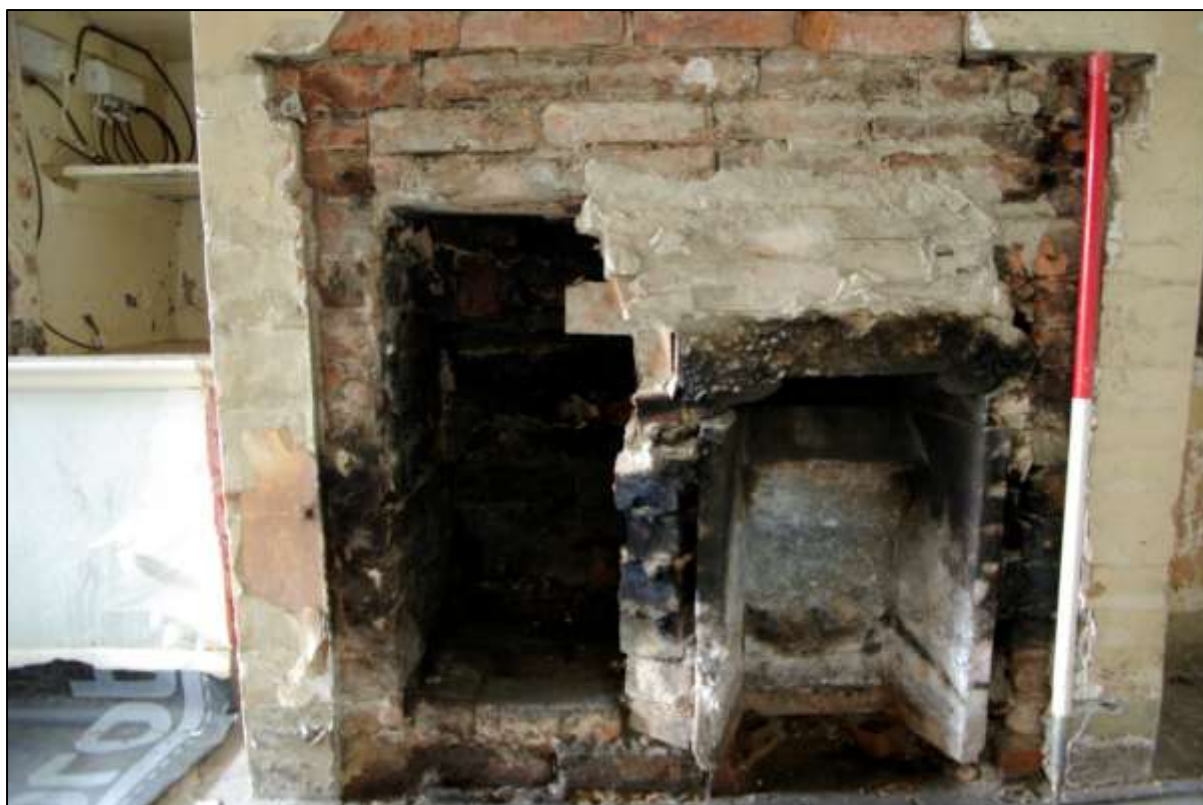
Figure 51. Outline of earlier fireplace and partially blocked opening showing position of earlier range stove, with modern fire-bricks to right hand side.

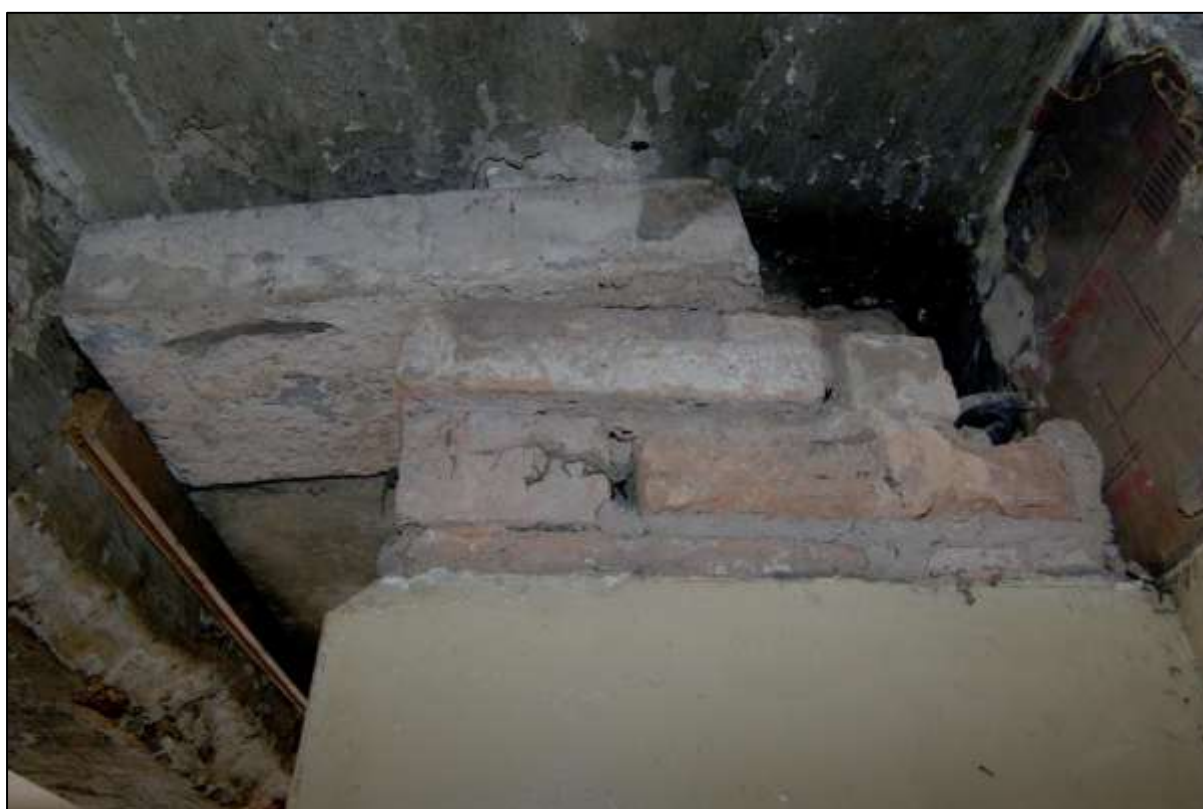
Following the removal of the modern brick cladding, a brick stack was revealed within the former inglenook, which rose from the floor to the level of the brick arch. The stack was constructed of narrow, 18th century brick, roughly mortared in place. Brickwork at the base of the stack appeared to have been tied into the brickwork behind. The presence of a mid-19th century brick used within the construction of the stack was taken as evidence for its being a relatively late insertion. The partially blocked recesses for a cast-iron range oven were evident in the stack, and pieces of this were recovered by the builder from the loose rubble within the openings.

Figure 52. Roughly mortared 18th century brick infill between 19th century stack and 18th brick arch above. Looking south.

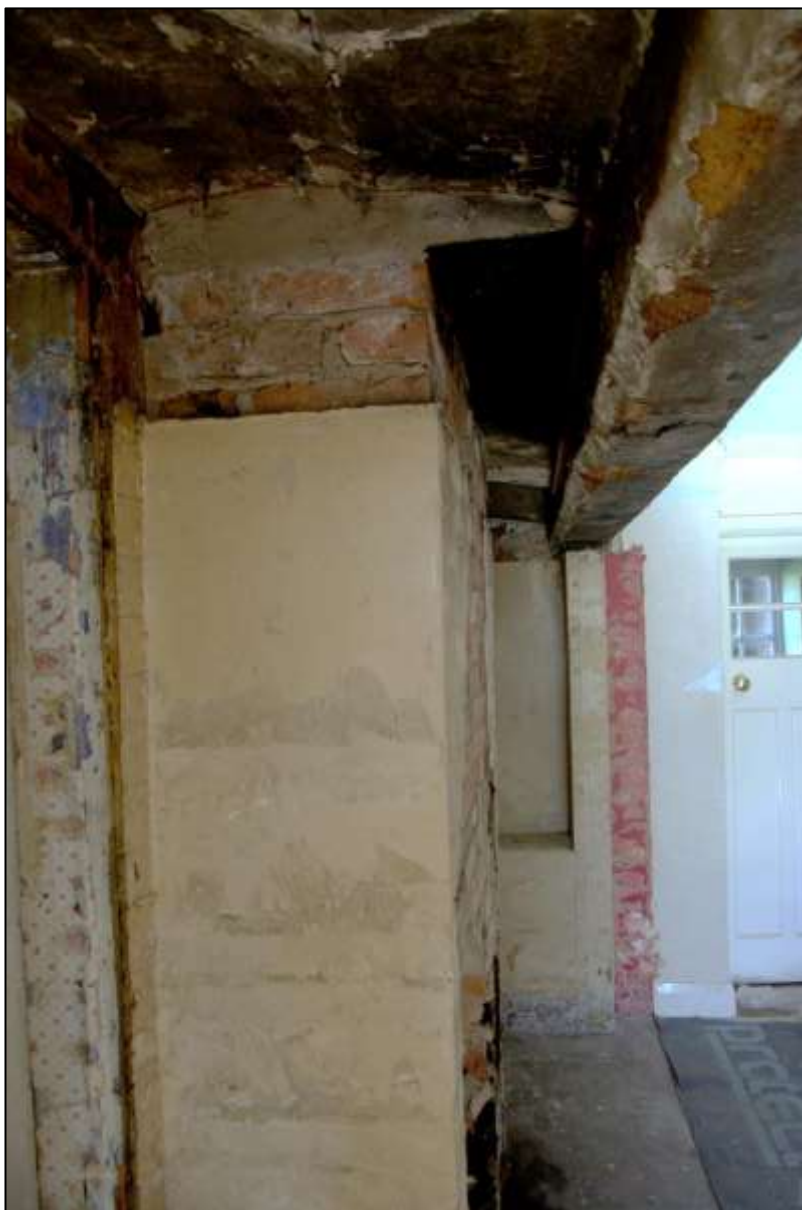
Figure 53. 19th-century brick stack, with 18th-century bricks and mortar infilling up to 18th century structural arch above. Looking north.
