**An Historic Building Survey at
The Whittle Estate, Cambridge Road,
Whetstone, Leicestershire
NGR: SP 5565 9685 centre**

ULAS Report No. 2012-205
©2012

For: EDP/Revelan Ltd

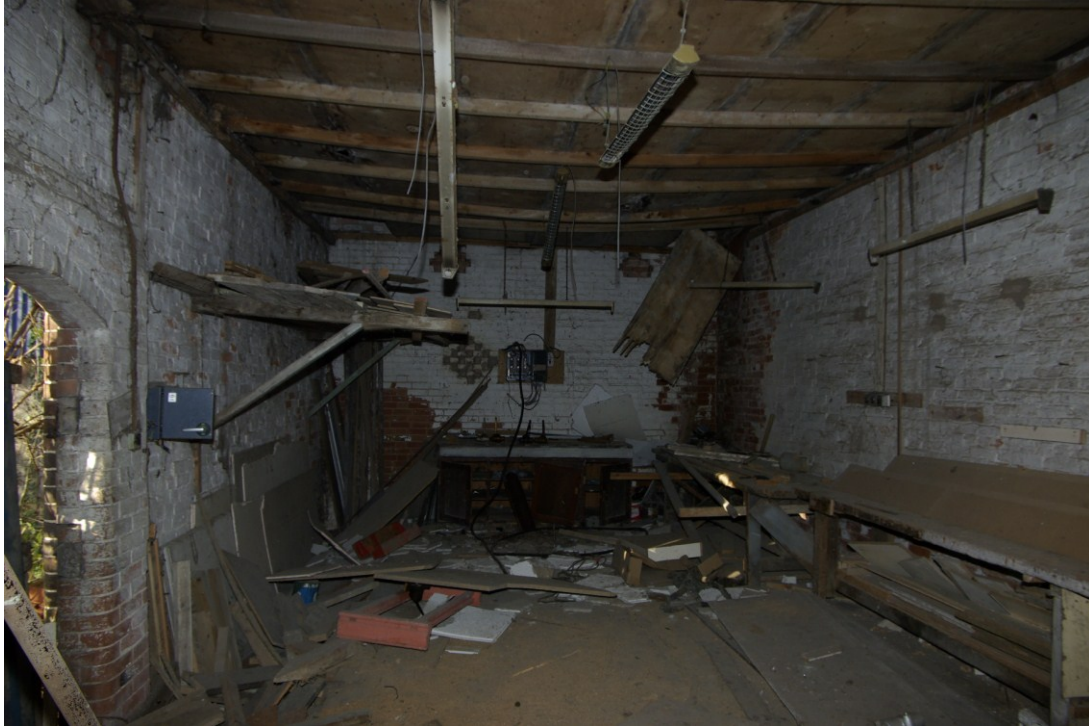
Figure 13 Western roof of east to west range
Looking west. Note blocked air bricks in west wall

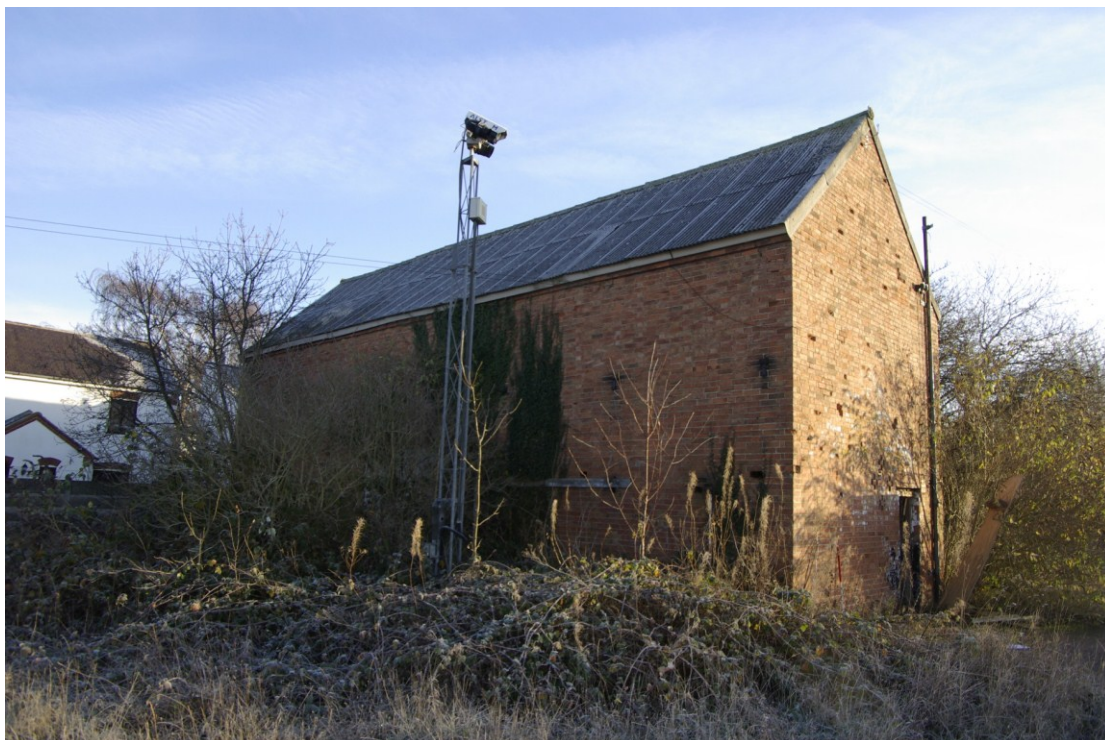
This range is set at right angles to the east to west range and has slightly smaller bricks than that range. It has flat gable ends to the north and south and large double doors which may be threshing doors to the east and west. With the exception of a round-headed doorway in the south-east corner all of the other door and window openings are flat-headed and do not match the style of the other range (Fig.18). A hayloft door opens onto Warwick Road but there are no other openings on this elevation. There is evidence of a single storey building being attached to the south facing gable which has since been demolished (Fig. 19).

Figure 18 South and west elevations, north to south range
Looking north-west

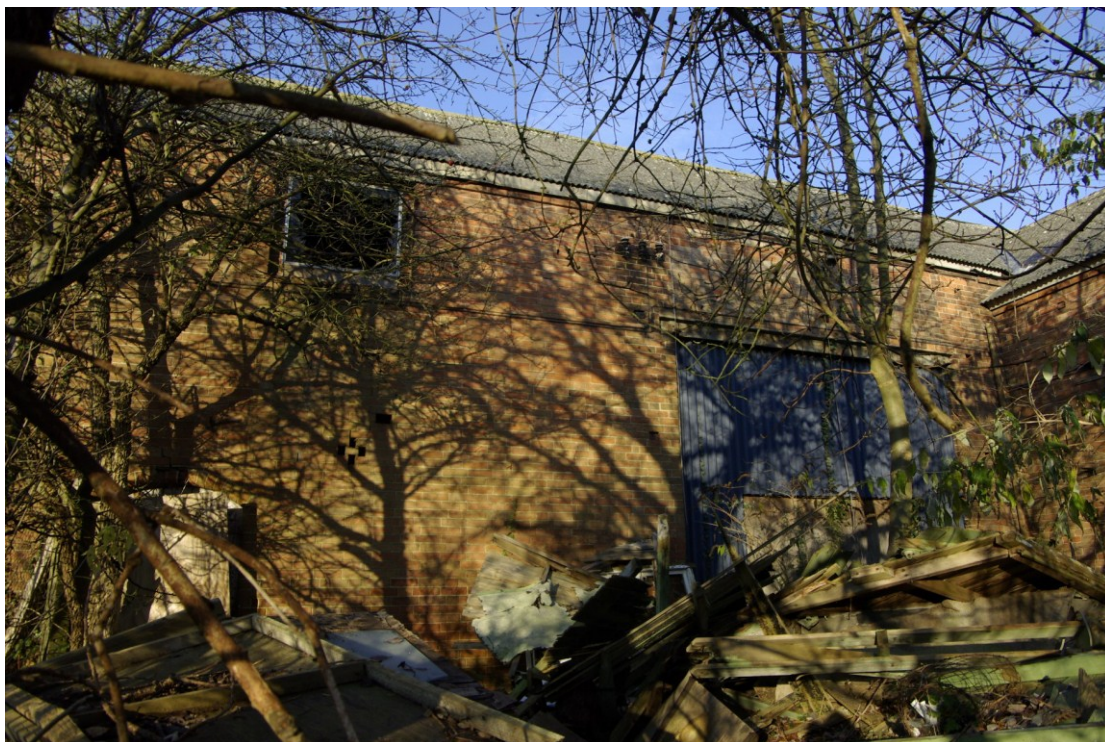
Figure 19 East facing elevation, north to south range
Looking north-west

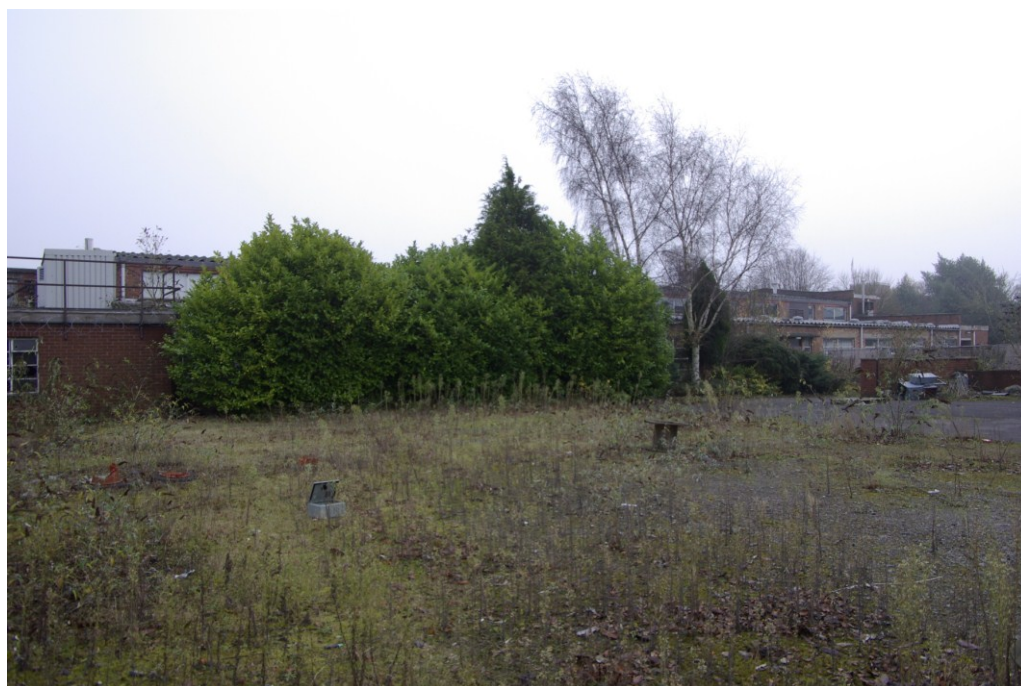
Figure 23 Block 5 west facing elevation
Looking south-east

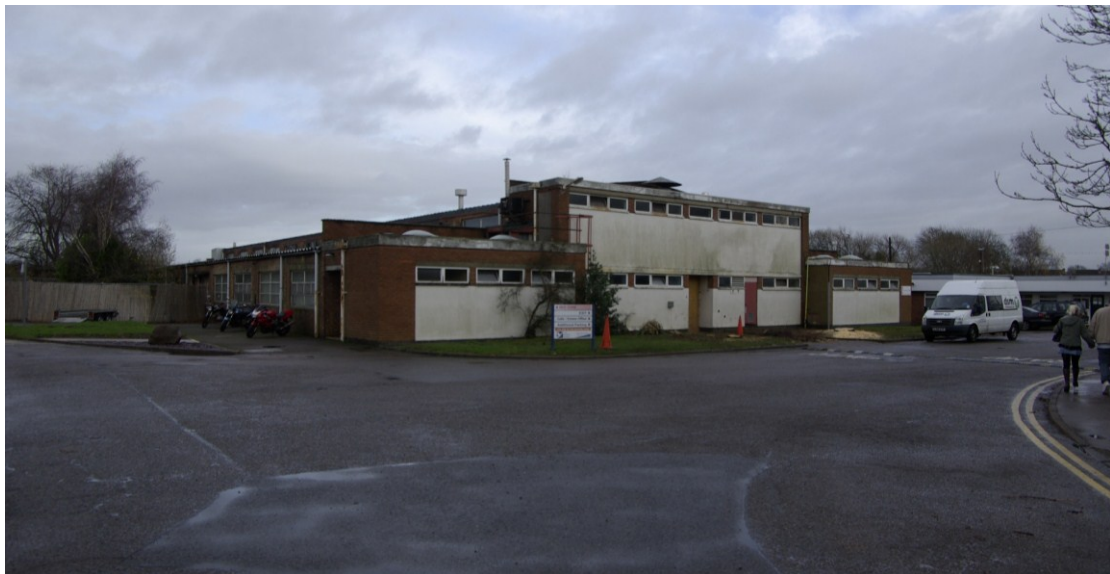
The original south facing elevation has been completely obscured by the later extension noted above (Fig. 27). The extension houses a small foyer with toilets and cloakrooms which only have small windows which results in the brick and render facade having a quite plain aspect which is rather out of keeping with the rest of the building. It has two single-storey flat-roofed flanking blocks either side of a slightly recessed two-storey central block.

Figure 27 South facing elevation
Looking north-east

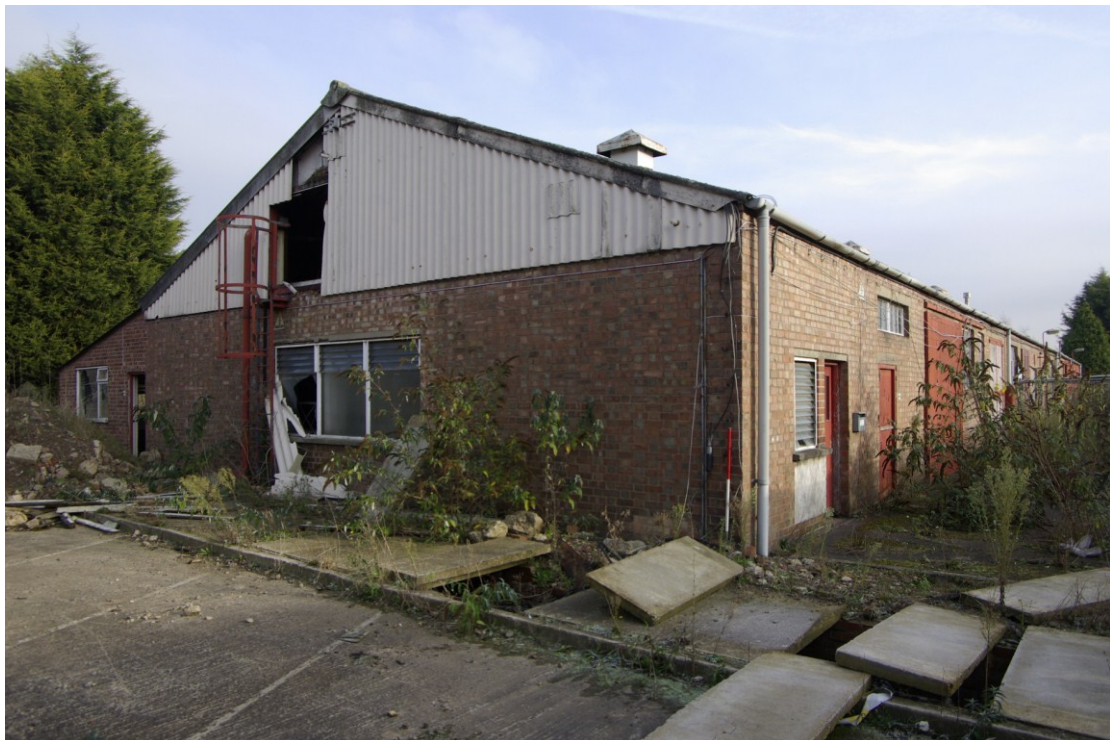
This is the main frontage of the building as it faces into the estate to the south. At the extreme western end of the elevation a single door and window appear to have replaced the original doors but this seems to be the only significant alteration of the whole elevation (Fig. 38). Along the elevation are a number of metal-framed windows of varying sizes but all following the same matching style with rounded brick sills and concrete lintels each presumably designed and located to suit the activities within the building (Fig. 39). Similarly there are a number of sliding and conventionally opening doors set at intervals along the elevation ending in a large set of sliding doors, used for the garage, at the east end (Fig. 40). These doors are the only external evidence of the original use as a garage.

Figure 38 West and south facing elevations
Looking north-east. 1m scale

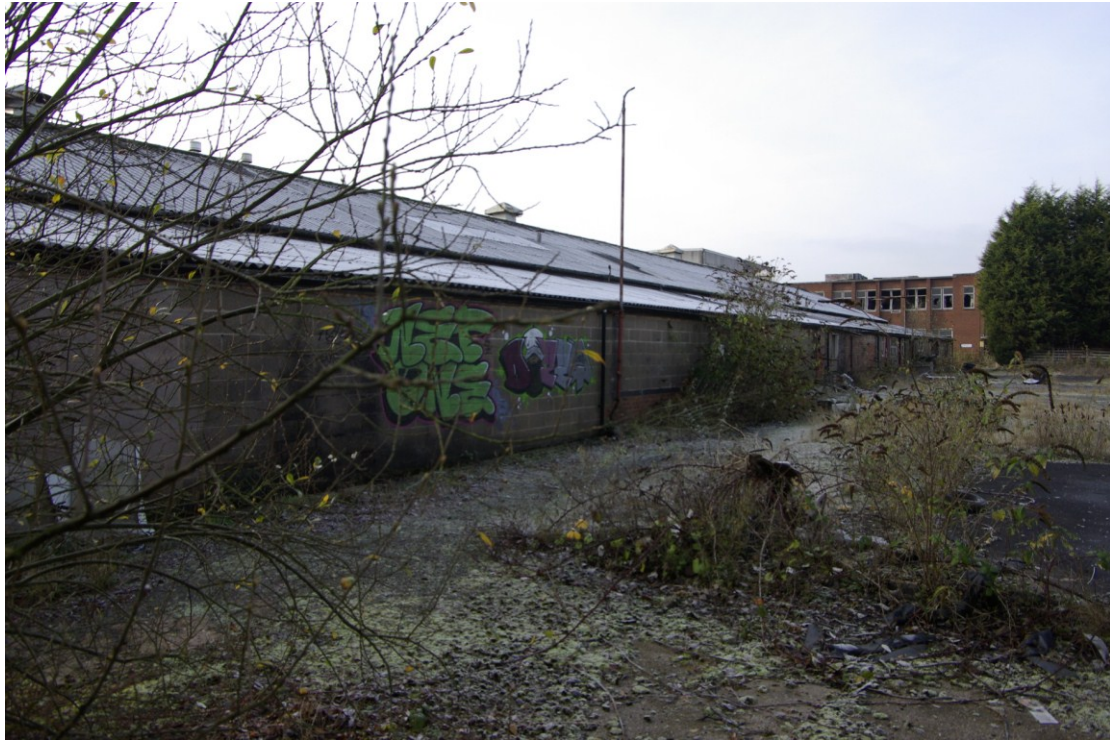
All of the original north facing elevation has been obscured by the lean-to extension mentioned above. This appears to have been built in a piecemeal fashion from a variety of breeze-blocks and brick (Figs. 42 and 43). Few of the wooden and metal-framed windows match each other in style or size and none match those seen on the rest of Block 6. Some of the breeze-blocks are on a brick foundation whilst the central portion of the extension is entirely of brick. The 1967 OS map appears to show only some of this extension in place by that date so it would seem that this range has been added to and extended since then. The western corner of the extension contains a small office and is built entirely from bricks of a better quality than those used elsewhere on this face and suggest a later, probably 1970s, addition.

Figure 42 North facing elevation
Looking south-west

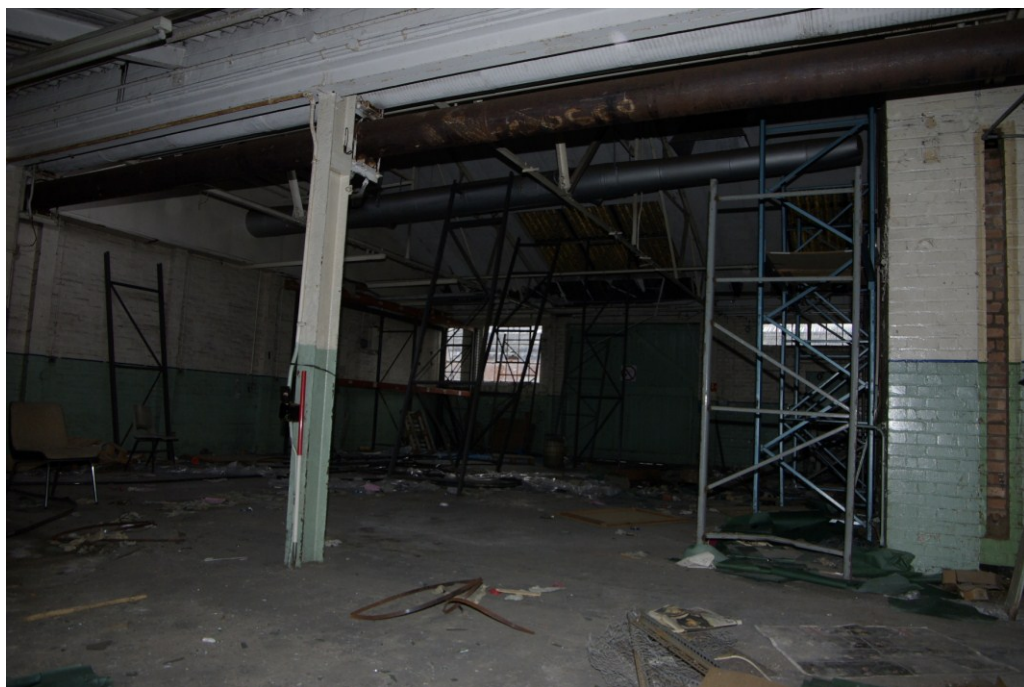
Room 1 is a large open space with a blocked double doorway on the east wall which now cuts across a window on the south elevation (Fig. 49). Most of the wall on the north side has been knocked down leaving only a small portion in the north-east corner which retains an original doorway and small eaves height windows of the same pattern as seen on the south elevation. A large sliding wooden door opens out onto North Road. There are no fittings in this room relating to its former uses.

Figure 49 Room 1 (Looking south-east. 1m scale)
