**An Historic Building Survey (Level 2) at
Cold Comfort Farm, Rogues Lane,
Barwell, Leicestershire.**

ULAS Report No. 2013-051
©2013

For: Corporate Architecture Ltd

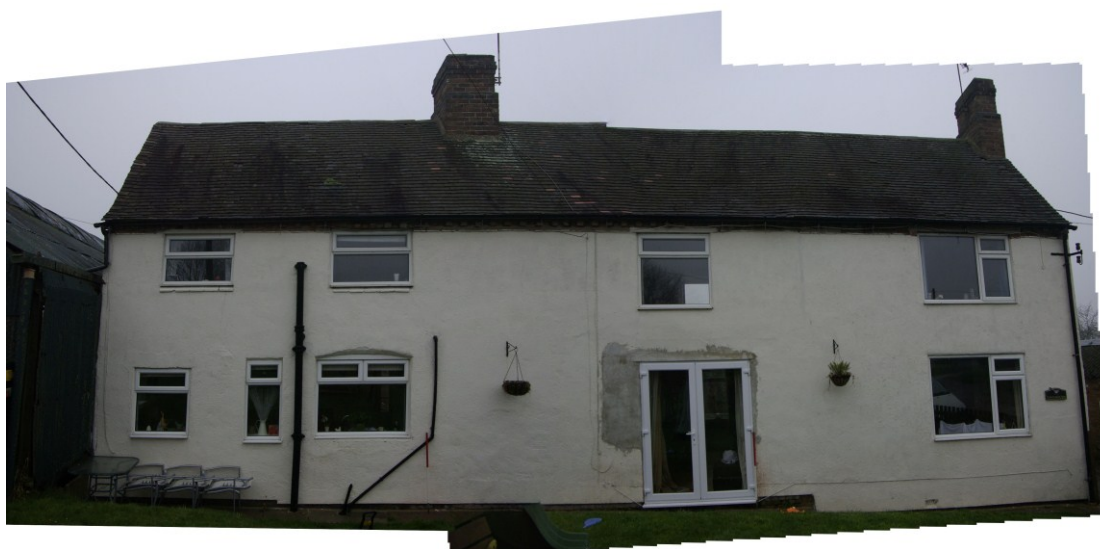
The main elevation of the house is the south-west facing elevation which faces away from the courtyard to the north (Fig. 8). The building has a tiled roof and a cement render finish over red brick walls. The render appears to mask a number of blocked and modified openings. The most noticeable being a modified patio doorway altered from a window. A small window towards the west end of this elevation may be a blocked doorway. Brick dentil detailing consisting of alternating projecting bricks runs along the eaves but is broken at each window suggesting that the lintels have been modified. The central chimney stack is large and must contain a number of flues, whereas the gable end one, to the east, only appears to contain two. All the windows on this, and all other elevations, are modern uPVC.

Figure 8 South-west facing elevation of the farmhouse
Composite photograph. Looking north-east. 1m scales

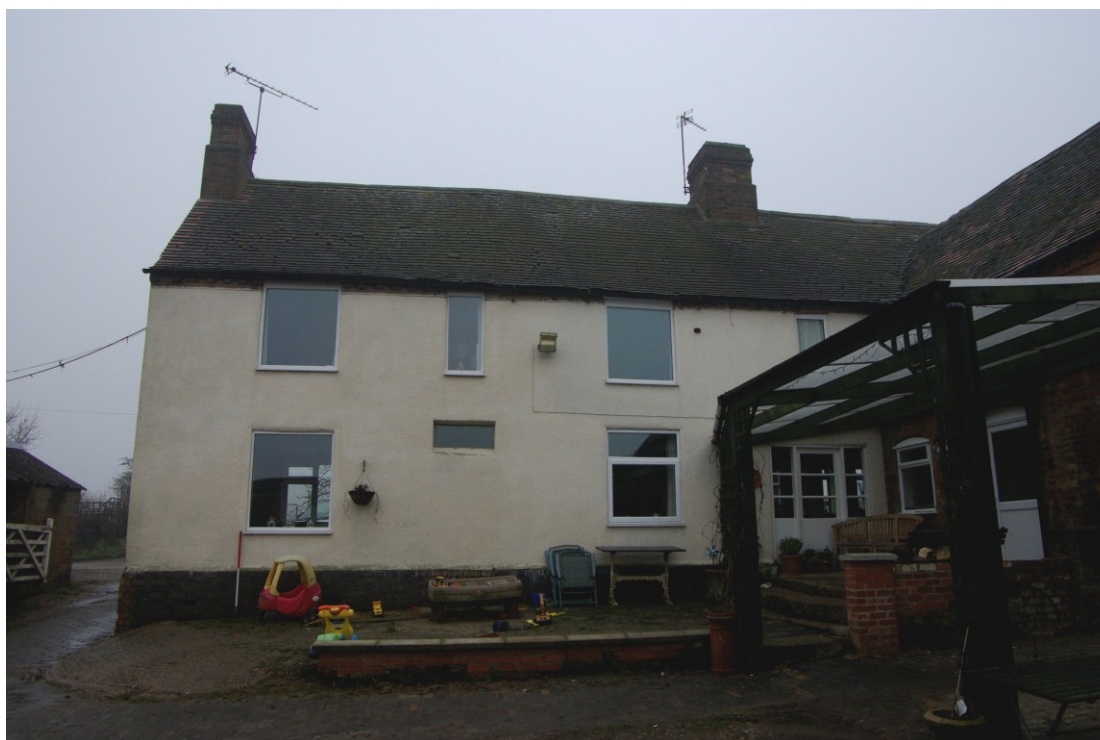
The south-east facing gable end is a plain rendered façade broken by a blue brick plinth at its base. The bricks have been laid in a rough attempt at an English Bond and continue round to the north-east facing elevation which faces into the small courtyard (Fig. 9). A single width doorway has been blocked leaving only the rectangular fan light above it. The doorstep has been removed and the gap in the brick plinth has been infilled. A wide opening in the northern corner has wooden partition-like doors and windows and may represent an earlier opening into the former mill (Fig. 10).

Figure 9 North-east facing elevation
Looking south-west. 1m scale

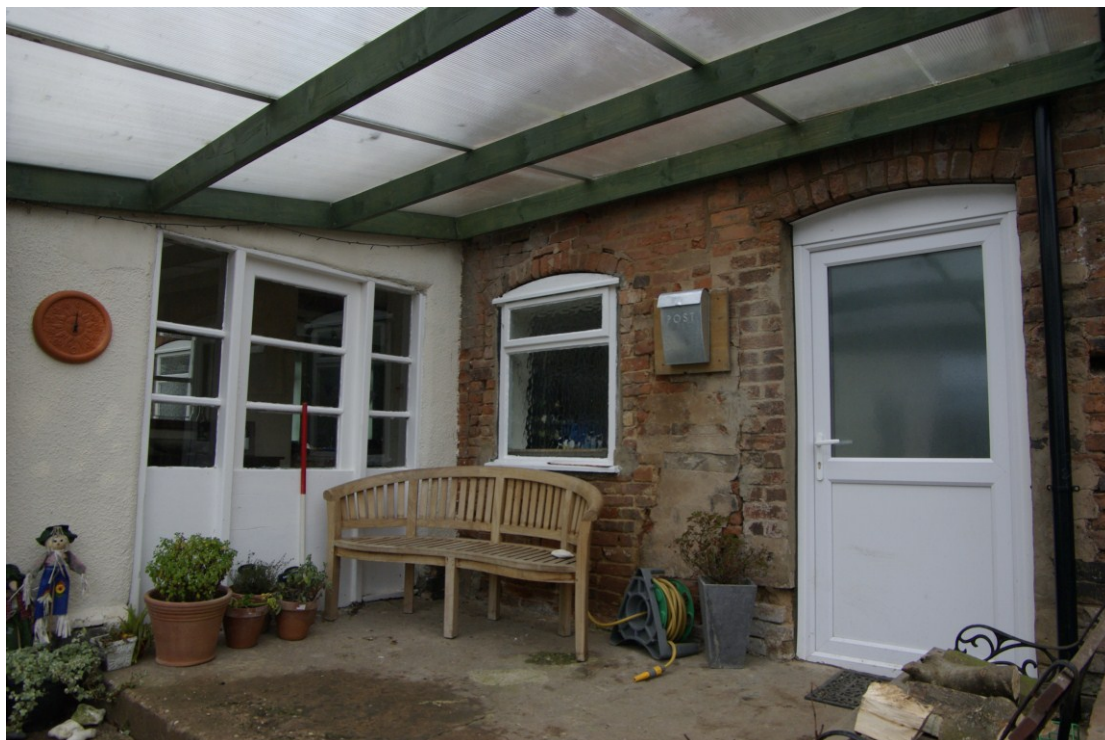
Figure 10 Former doorway in north-east facing elevation
Looking west. 1m scale

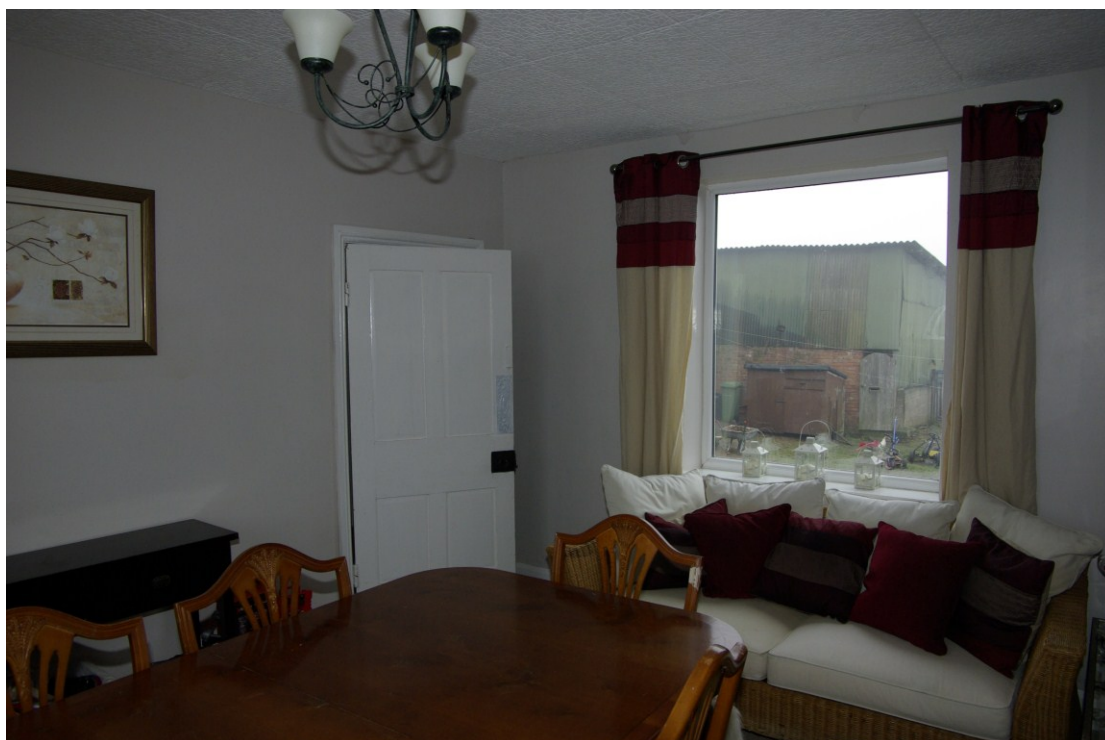
The most southerly ground floor room has been quite heavily modernised with little evidence of any earlier features. A panelled door leads into a small hallway behind the blocked door seen on the north-east facing elevation (Fig. 11). The stairs are narrow and steep and lead up to a small landing. At ground floor level in the hallway another panelled doorway leads northwards to a larger living room with a wide and high fireplace in the north-east corner (Fig. 12). A north-west to south-east timber beam runs across the middle of the ceiling and has a stop-chamfer at its southern end.

Figure 11 Ground floor southernmost room
Looking north

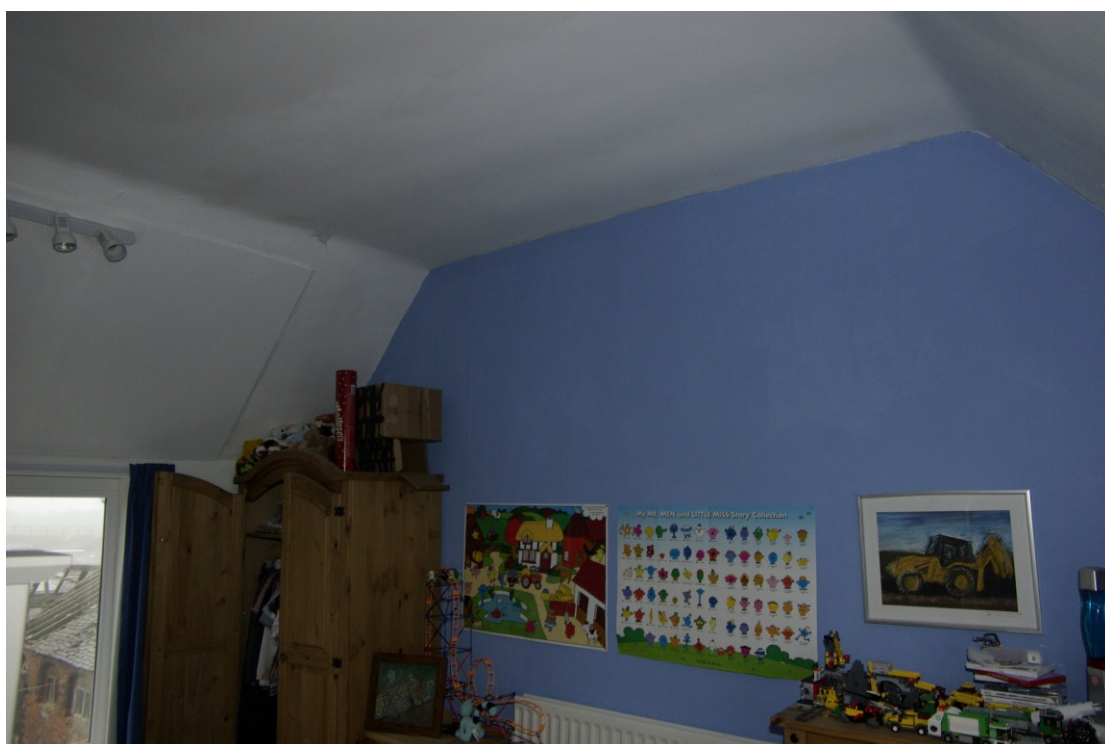
On the first floor two similar sized bedrooms flank the central staircase located towards the south-east end of the building. The end bedroom with the external south-east facing gable end wall has an unusually thick wall which appears to box in the chimney breast. The reason for this is not clear (Fig. 15). The bedroom to the north of the end bedroom does not show any evidence of any earlier phases, although it does have panelled doors possibly dating to the first half of the 20th century. A doorway in the north-west corner of this bedroom leads out onto a small landing containing the enclosed stairs down to the kitchen. The landing and bathroom would presumably have originally formed a third bedroom when the house was first built (Fig. 16). A large beam in the ceiling above the top of the stairs and a stepped arrangement in the north-east wall of the northern end bedroom indicate the presence of a first floor entrance into the barn range. No evidence of this can be seen in the plasterwork on the house side but a blocked doorway is visible from the barn (see later). There was no access to the roof space during the survey.

Figure 15 South-eastern bedroom gable end wall
Looking east. Note boxed-in chimney breast

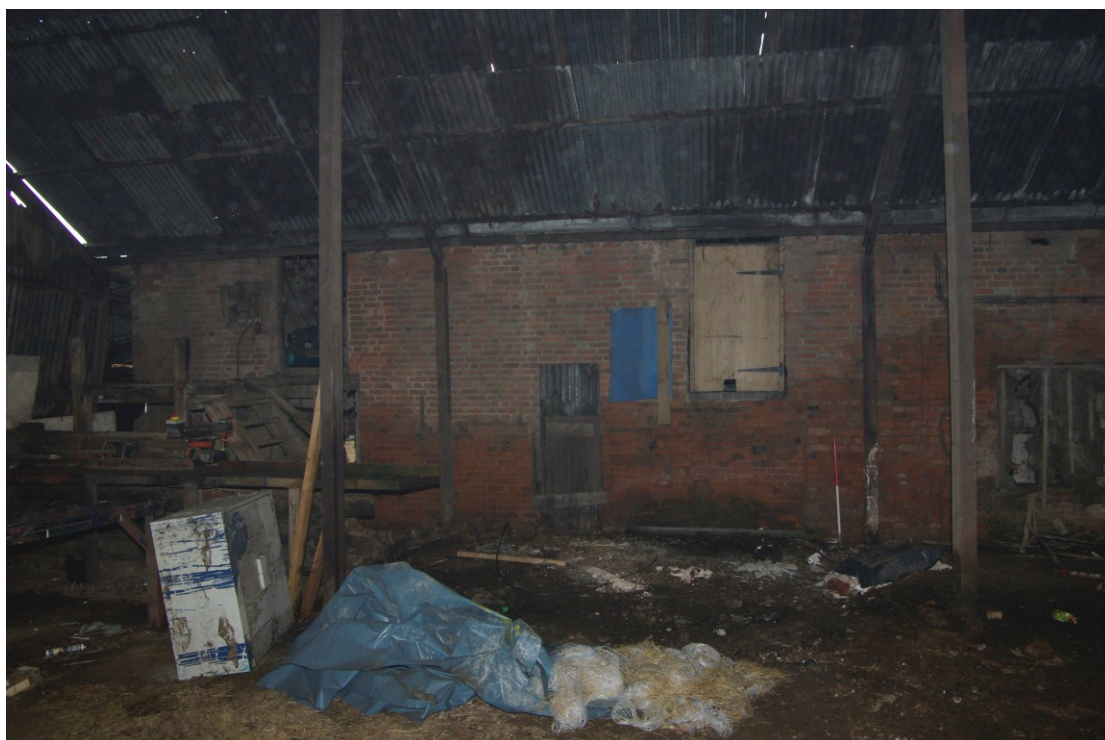
The north-east facing gable end of the barn range is obscured by the later modern barn running at right angles across this face. The north-west facing elevation is also partially obscured by the corrugated metal barn running alongside it but enough of the ground floor is visible to show that a number of earlier doors and windows have been blocked up with later brick and block work (Fig. 18).

Figure 18 Barn range, north-west facing elevation
Looking south-east

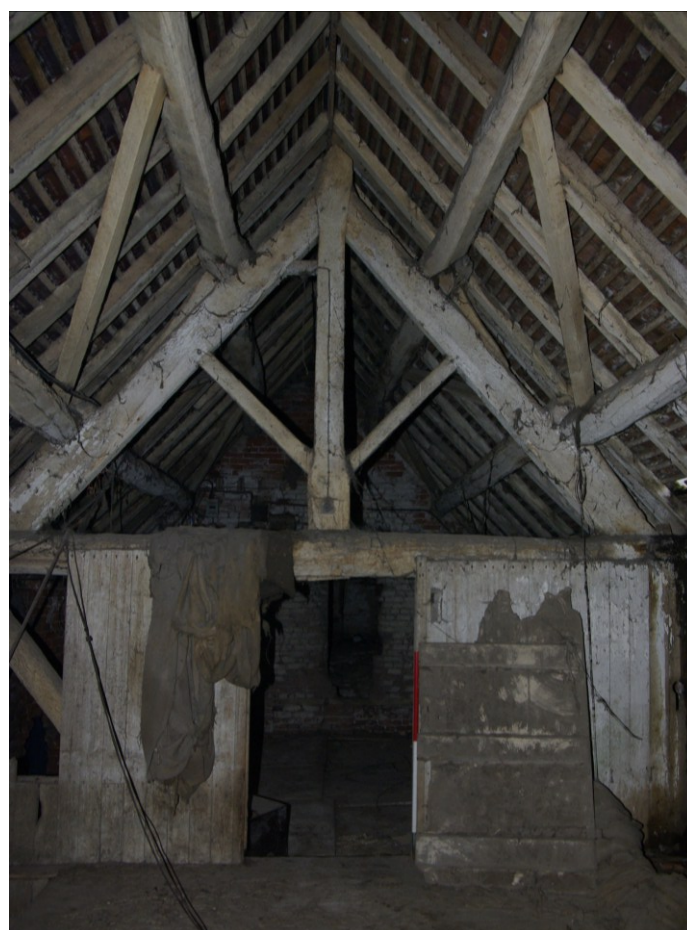
The north-east first floor room has a more conventional king post with pegged raking struts supporting cleated purlins (Fig. 24). The purlins have the same socketed windbraces as in the adjacent room which could suggest a similar date for the two sections of roof. A wooden partition built below the tie beam partially divides the room into two. The northern half of the room has a slightly higher floor and has a number of holes where chutes and trapdoors were once located.

Figure 24 Barn, first floor, north-east room, roof structure
Looking south-west. 1m scale

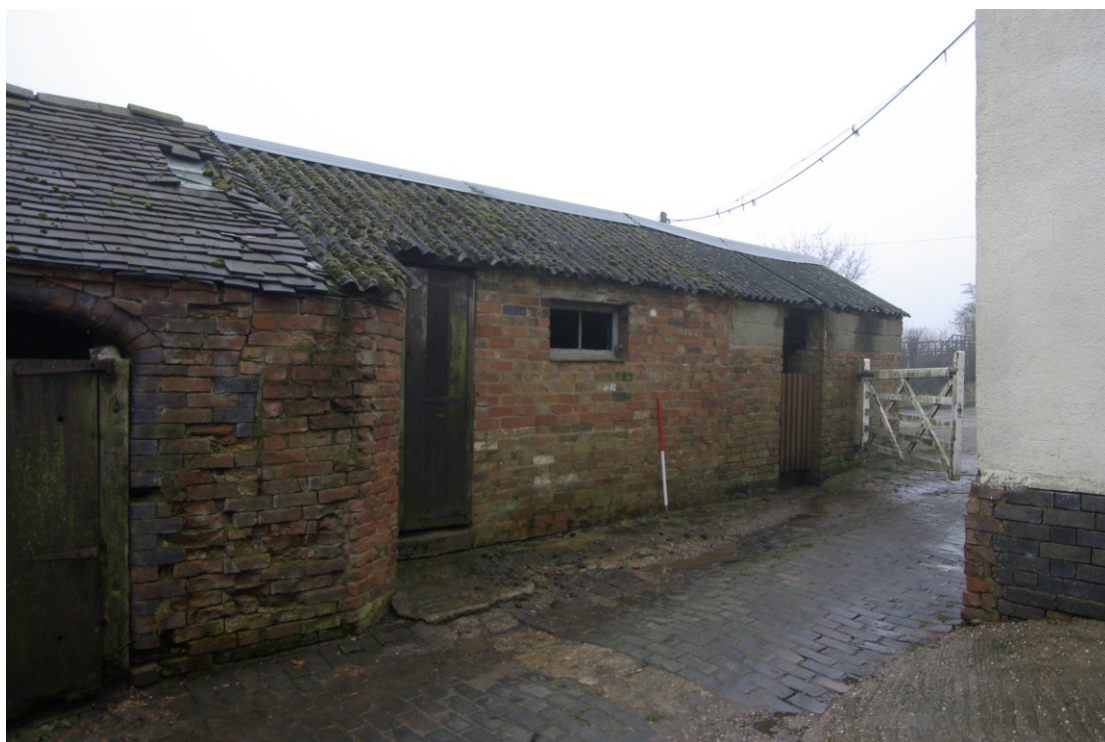
The stable block forms an elongated L-shape on the south-east side of the courtyard and runs parallel to the barn range. It is a single storey structure built of red brick with blue brick detailing around the arched window and door openings (Figs. 25, 26 and 27). The south-western end of the range steps back a little and has a corrugated asbestos roof rather than the tiles used on the rest of the building. The stepped back portion is clearly a later addition or rebuild as the remnant of a blue brick window surround can be seen in the brickwork just before the step in the wall. It also has a more shallow pitch to its roof. At the south-east corner the building makes a short turn to the north-west to partially enclose the courtyard. This turn is of the same phase as the main part of the stable block.

Figure 26 Stables, north-west facing elevation, south-east extension
Looking south. 1m scale

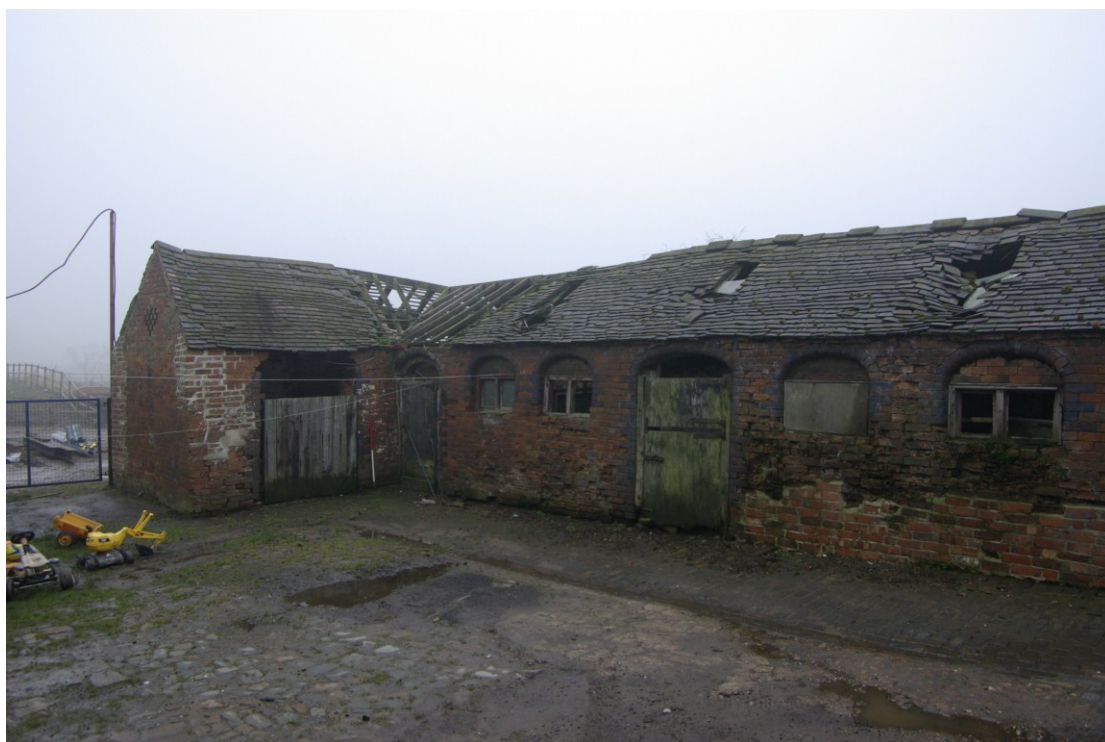
Figure 27 Stables, north-west facing elevation, east corner
Looking south-east. 1m scale

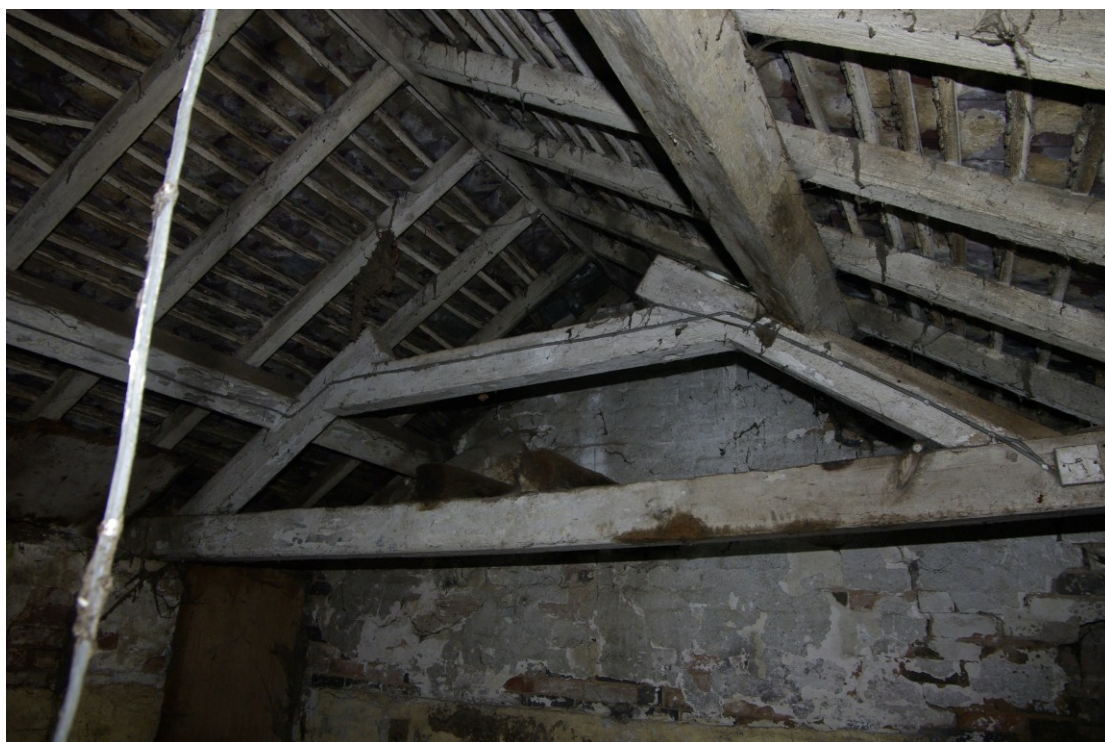
Internally the stable block is divided into a number of bays. The dividing walls are made from a variety of modern materials but may represent the positions of earlier dividers. The roof has a series of trusses supporting cut-down principal rafters joined near the top by tie beams (Fig. 28). Substantial purlins are clasped onto the backs of the principals. The south-west end addition has a roof supported by narrow section timbers resting on the gable end which appears to be in a state of imminent collapse.

Figure 28 Stable, main roof detail
Looking south

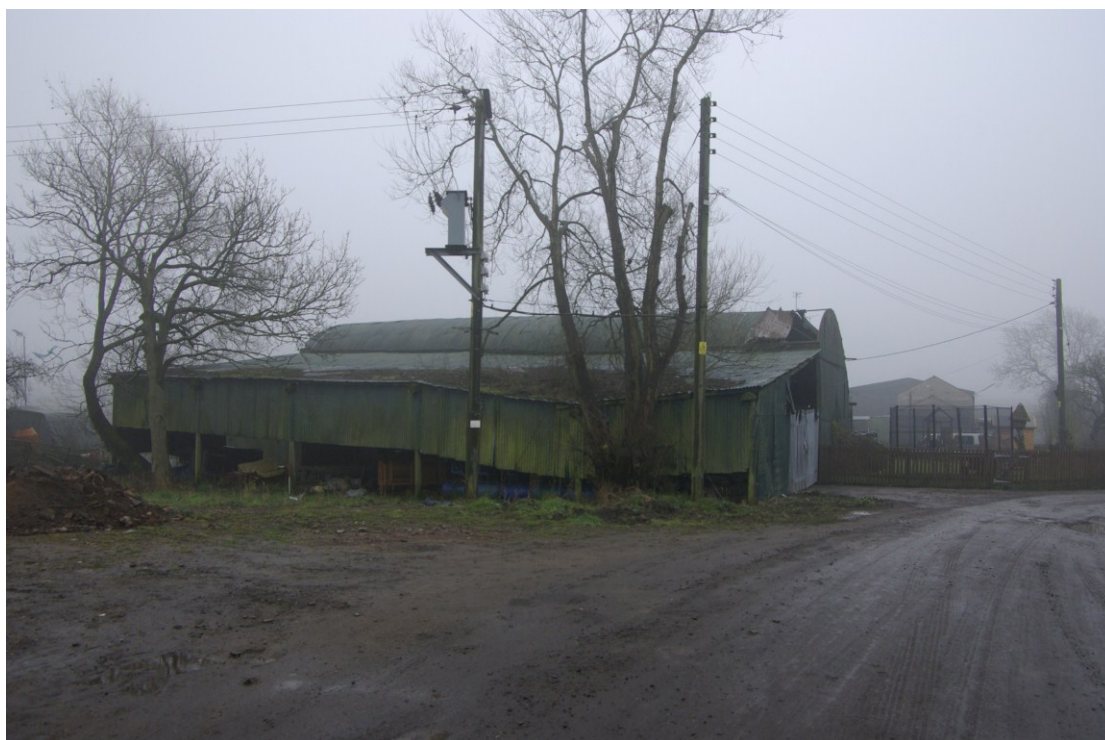
The corrugated metal clad barn running alongside the farmhouse and barn range is typical of the Dutch barn with lean-to attachment seen on many farms in the region (Fig. 29). It is supported by metal box-section posts with timber roof members and has metal trusses helping create the distinctive curved roof profile. The outer edge of the lean-to is supported by wooden posts which may be re-used telegraph poles. It has an earth floor.

Figure 29 Metal barn to north-west of farmhouse and brick barn
Looking east

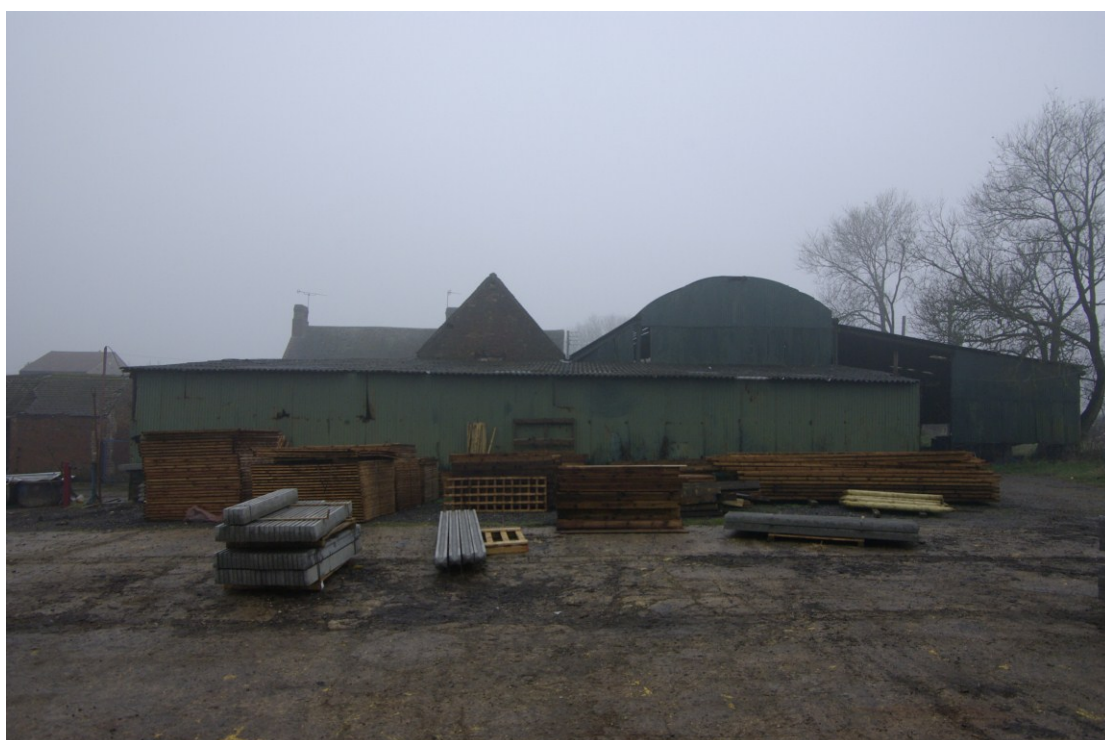
To the north-east of the main barn, and running across the north-east gable end of the brick barn is another modern barn (Fig. 30). Most of this metal-framed building is covered in corrugated sheet metal and appears to have been made and patched over a number of different phases and repairs. The stub of a brick wall survives in the south-west corner and has a number of blocked openings on it. This may be the surviving remnant of an earlier brick-built barn.

Figure 30 Metal barn to north-east of brick barn
Looking south-west

The metal covered barns are typical of the farm structures erected during, or after, the Second World War. From the map evidence it would appear that they replace earlier structures and the heavily patched stub of wall in the north corner of the courtyard would certainly point towards this.
