**Archaeological Survey and Recording of Rampart Erosion
at Burrough Hill Hillfort, Burrough-on-the-Hill, Leicestershire**

ULAS Report No 2014-006

**Archaeological Survey and Recording of Rampart Erosion
At Burrough Hill Hillfort,
Burrough-on-the-Hill,
Leicestershire
NGR: SK7605 1195 centre**

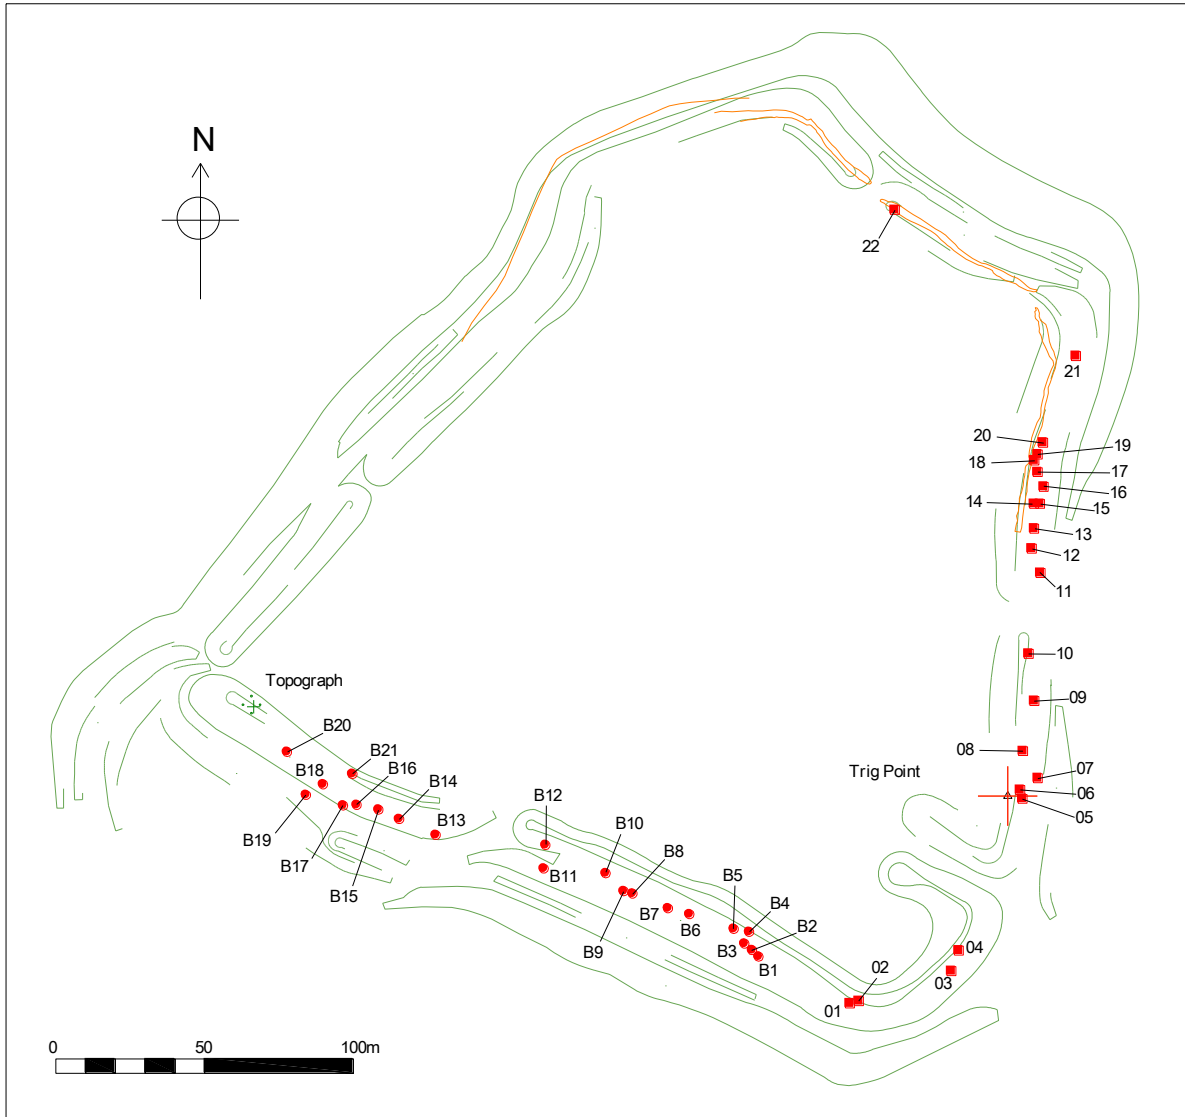
Figure 3. Plan of Burrough Hill showing the location of recorded erosion holes (red squares) and rabbit/badger holes (red circles)

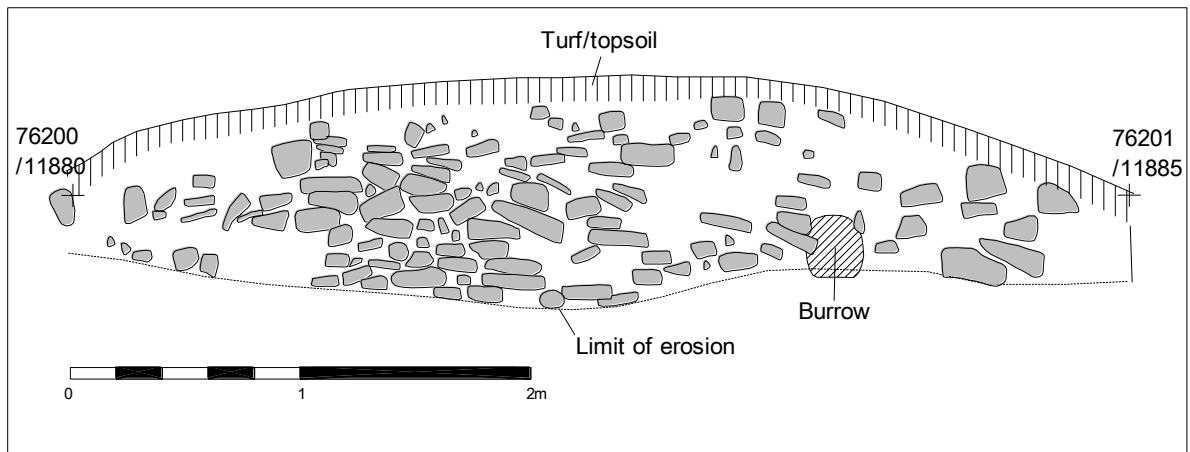
Figure 6 Exposed drystone walling in Location 05.

More convincing evidence for drystone walling was revealed at locations 05 and 20. In both of these areas carefully laid flat pieces of ironstone, surviving several courses high, formed substantial sections of wall that conceivably may have once faced the eastern rampart of the hillfort.

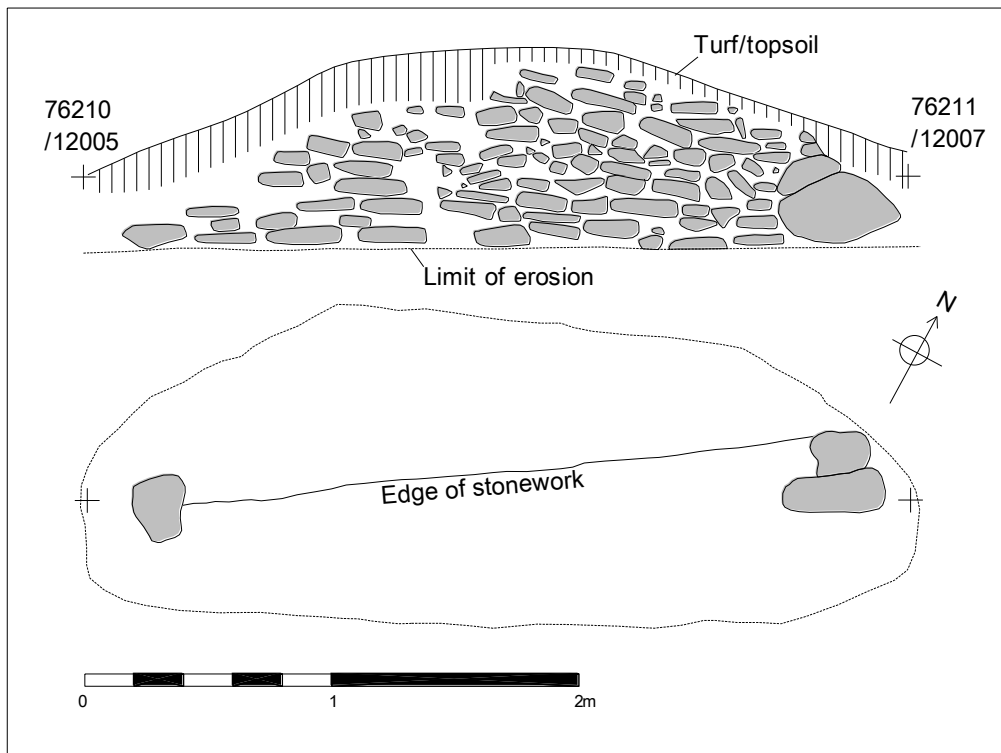
Figure 7 Exposed drystone walling in Location 20.

Large area of erosion towards the top of the rampart measuring *c.*3.00m wide x 0.80m x 1.50m deep. Approximately 8 courses of drystone walling exposed here with a coherent face aligned NE-SW along the width of the area. This area provides the most complete evidence for rampart facing exposed within the erosion areas.

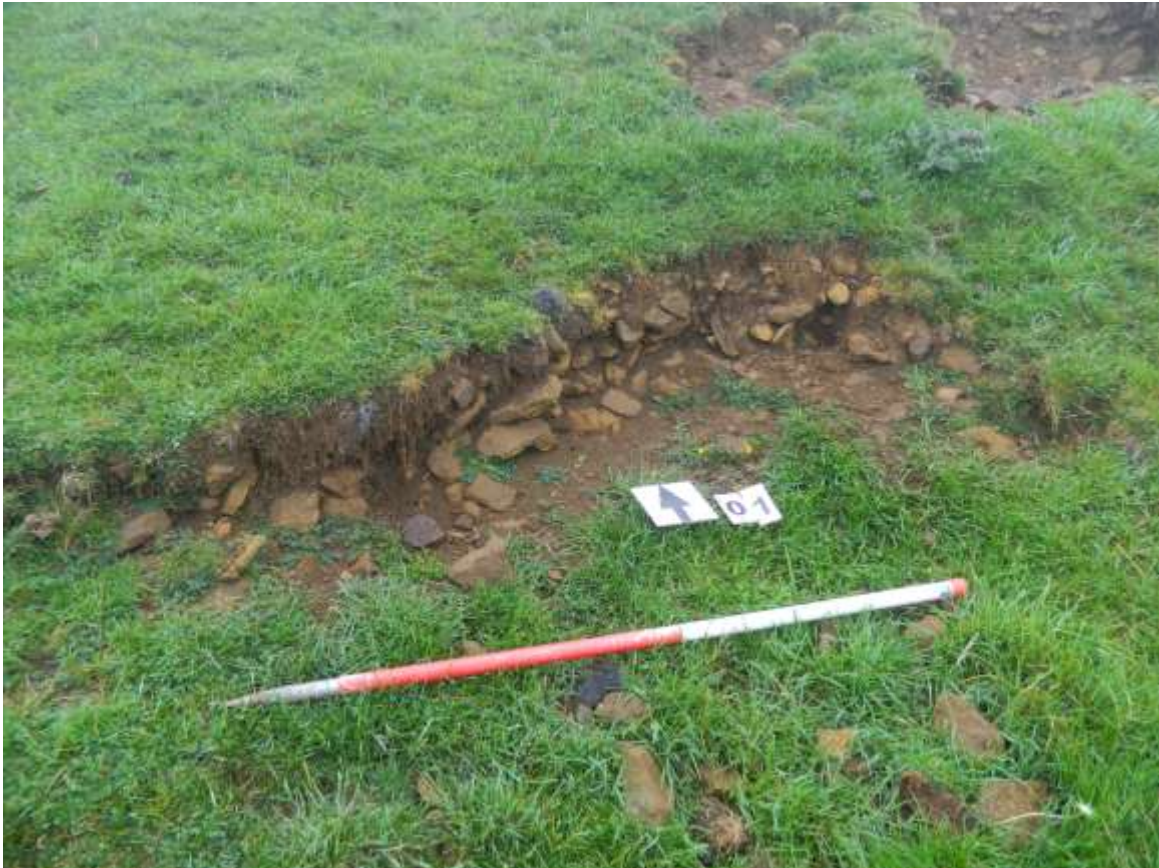
Location 01 (SK 76146 / 11816)

Medium-sized crescent area of erosion on the south eastern side of the hillfort measuring *c.*2.20m wide x 0.33m high x 0.42m deep. Erosion and sheep scraping here has exposed small and medium-sized ironstone rubble from the rampart, none of which appears to have been deliberately laid. A spread of loose stone beyond the area indicates continued erosion of this location.

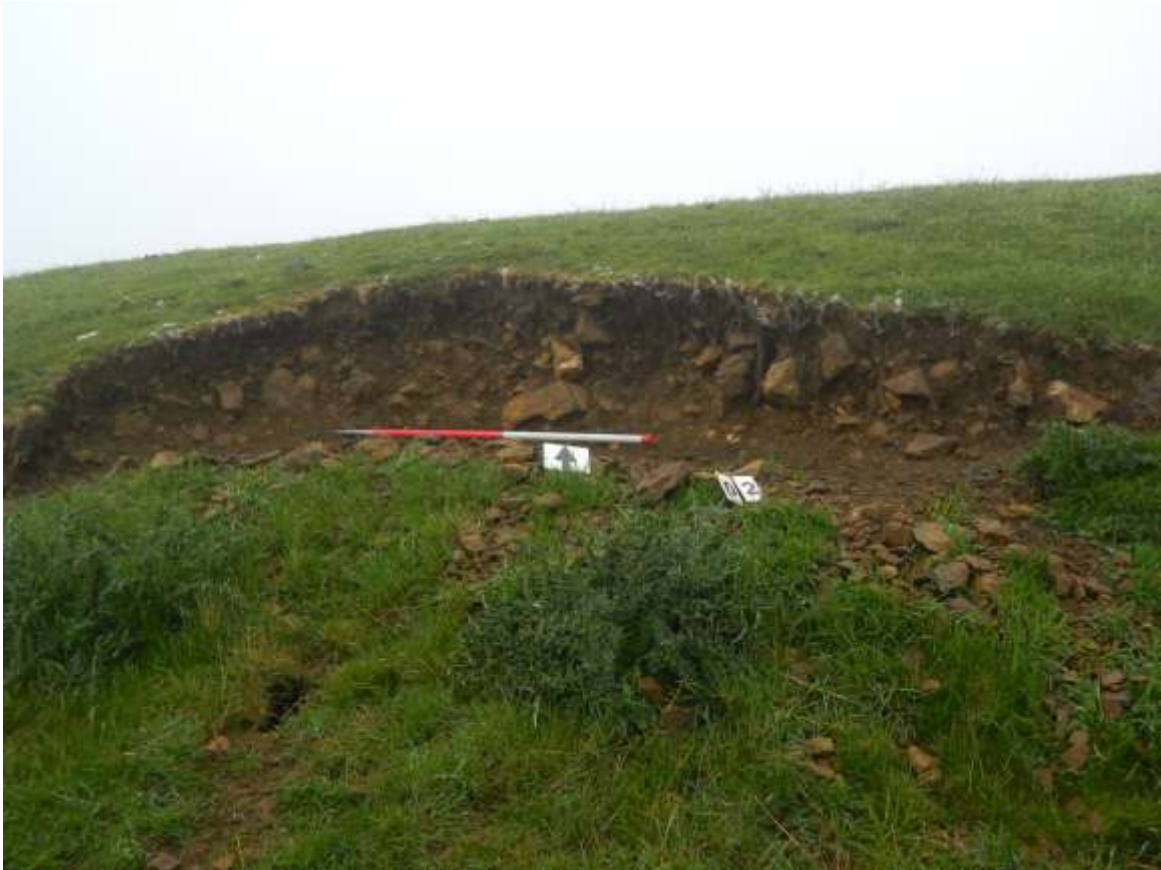
Location 02 (SK 76149 / 11817)

Two large conjoined crescent-shaped erosion areas measuring *c.* 5.50m wide x 0.60m (max. height) x 1.10m (max. depth). Erosion has exposed mixed rubble comprising small, medium and large ironstone pieces (up to *c.* 0.35m x 0.15m x 0.15m in size) probably forming part of the rampart core materials. Loose stone to the south of the area indicates continued erosion.

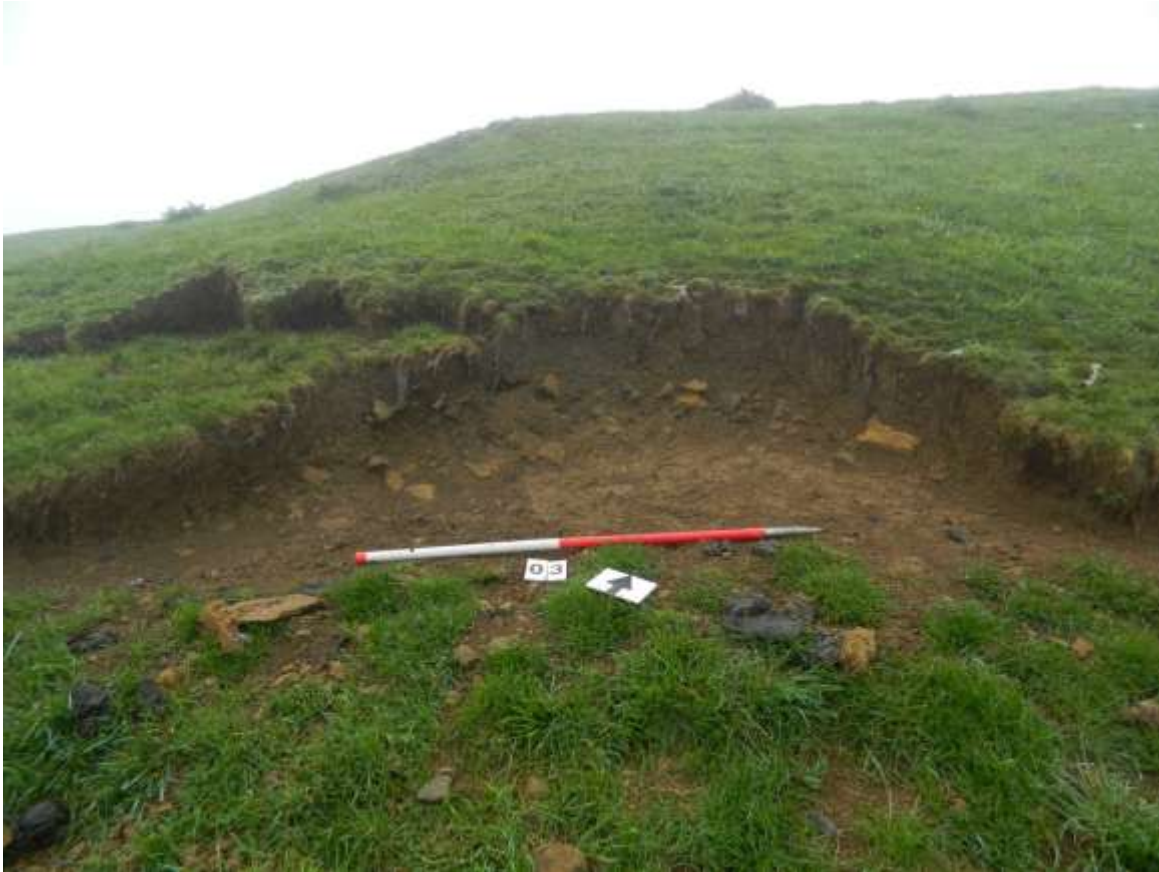
Location 03 (SK 76180 / 11827)

Large crescent-shaped area, measuring *c.*3.60m x 0.60m x 1.20m deep. Damage here has apparently been caused by turf slippage and animal scraping. Erosion has exposed mainly smaller stones within a matrix of topsoil and subsoil (reddish-brown silty clay). No stones are visible on the exposed base of the area.

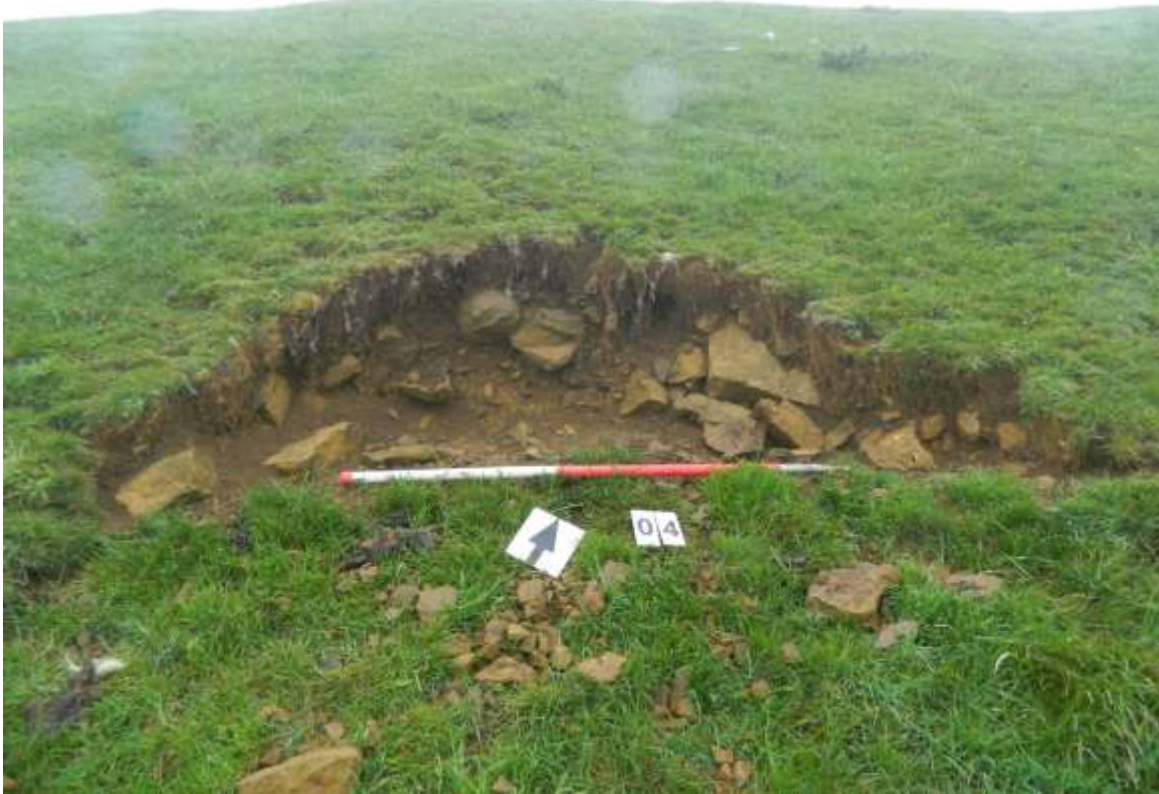
Location 04 (SK 76182 / 11834)

This area consists of two animal scrapes measuring *c.*1.00m wide and 2.20m wide respectively, x 0.55m high x 0.70m deep. Larger rubble exposed in this area within a matrix of smaller rubble and reddish-brown silty clay. Stonework also exposed within floor of exposed area, probably relating to rampart core materials.

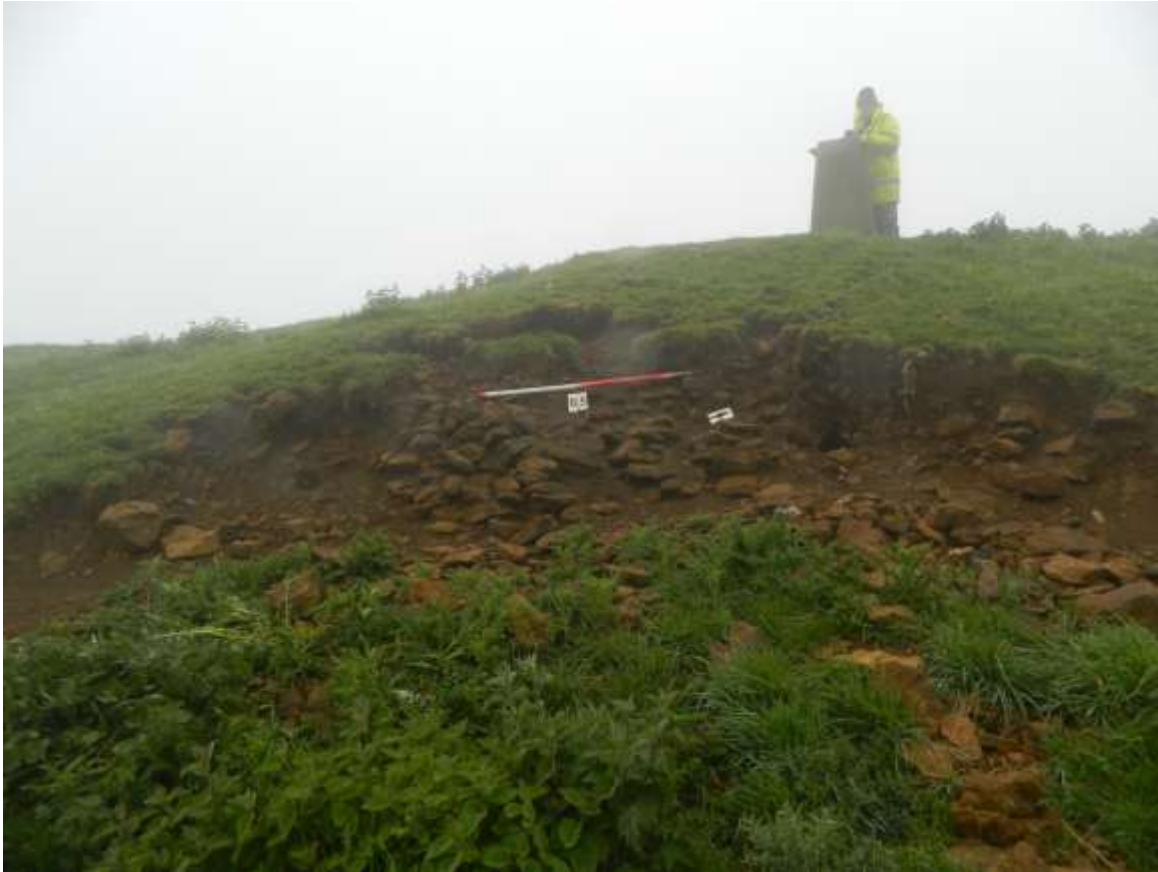
Location 05 (SK 76204 / 11885)

The largest area of erosion located on the eastern rampart slightly north of the main hillfort entrance. This location is a large crescent-shaped area measuring *c.* 6.50m wide x 1.20m high x 2.30m deep. This substantial area of turf and soil slippage has been gradually further eroded by animal scraping and burrowing. Rubble and soil rampart core materials are exposed here along with 6-7 courses of drystone wall that may have originally faced the rampart.

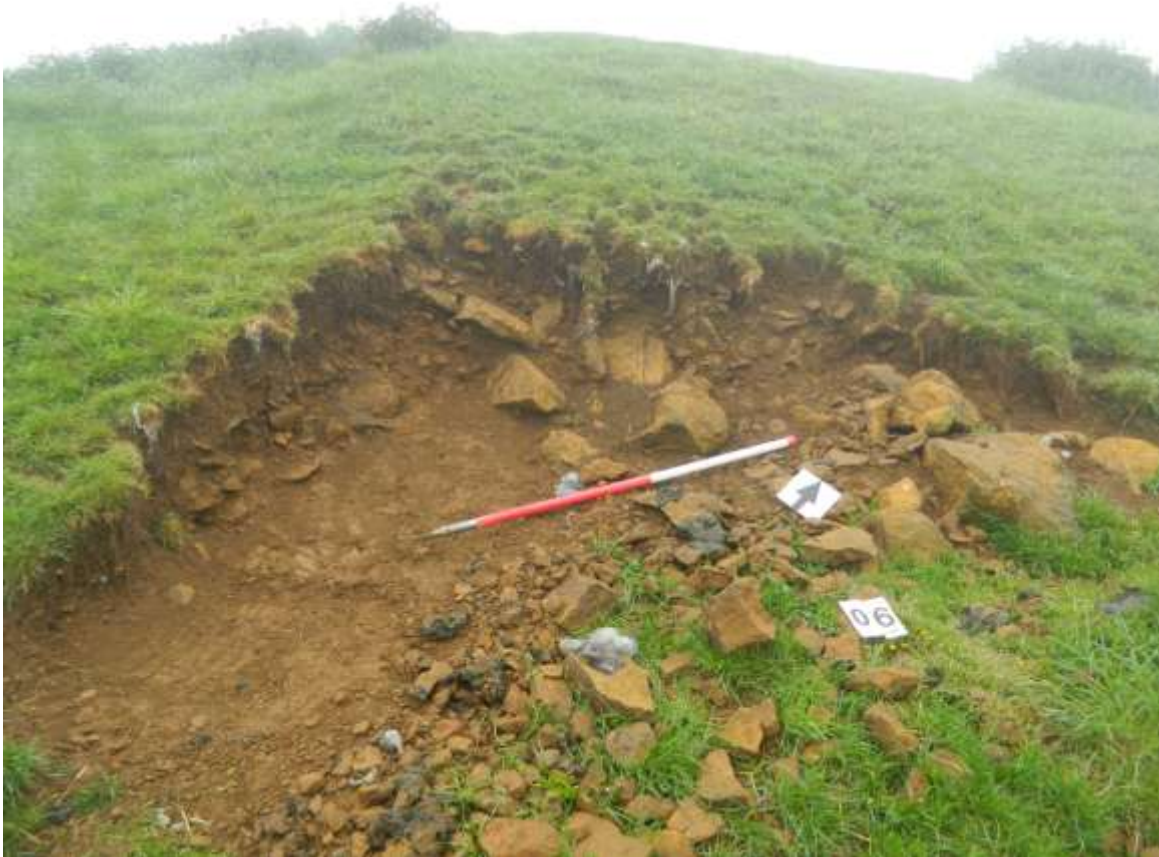
Location 06 (SK 76203 / 11888)

Crescent-shaped area measuring *c.* 3.20m x 0.65m x 1.10m deep, created by soil slippage and animal scraping. A number of large ironstone blocks present here measuring up to 0.58m x 0.36m x 0.15m. Although these stones do not form a coherent wall there are similar sized stones within an area of slipped loose rubble immediately beneath the erosion area. Within the erosion hole the larger stones appear to lie immediately in front of rubble core material consisting of small ironstone rubble in a matrix of reddish-brown silty clay.

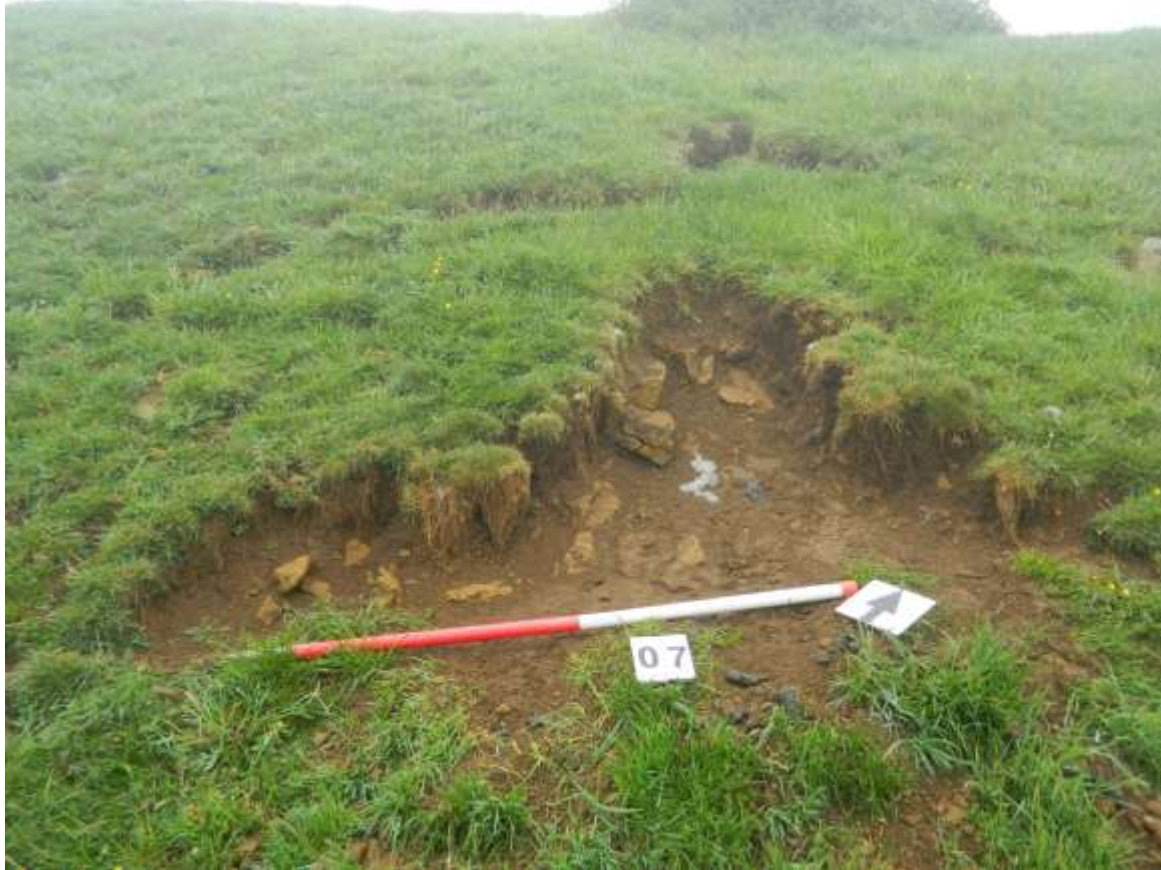
Location 07 (SK 76209 / 11892)

Small crescent-shaped area measuring *c.*1.90m x 0.50m high x 1.10m deep. Some exposed rubble in this area but no coherence to the stones. Two large stones are evident protruding through the turf to the north of the area and a spread of loose stones exists beneath the area on the lower slopes of the rampart.

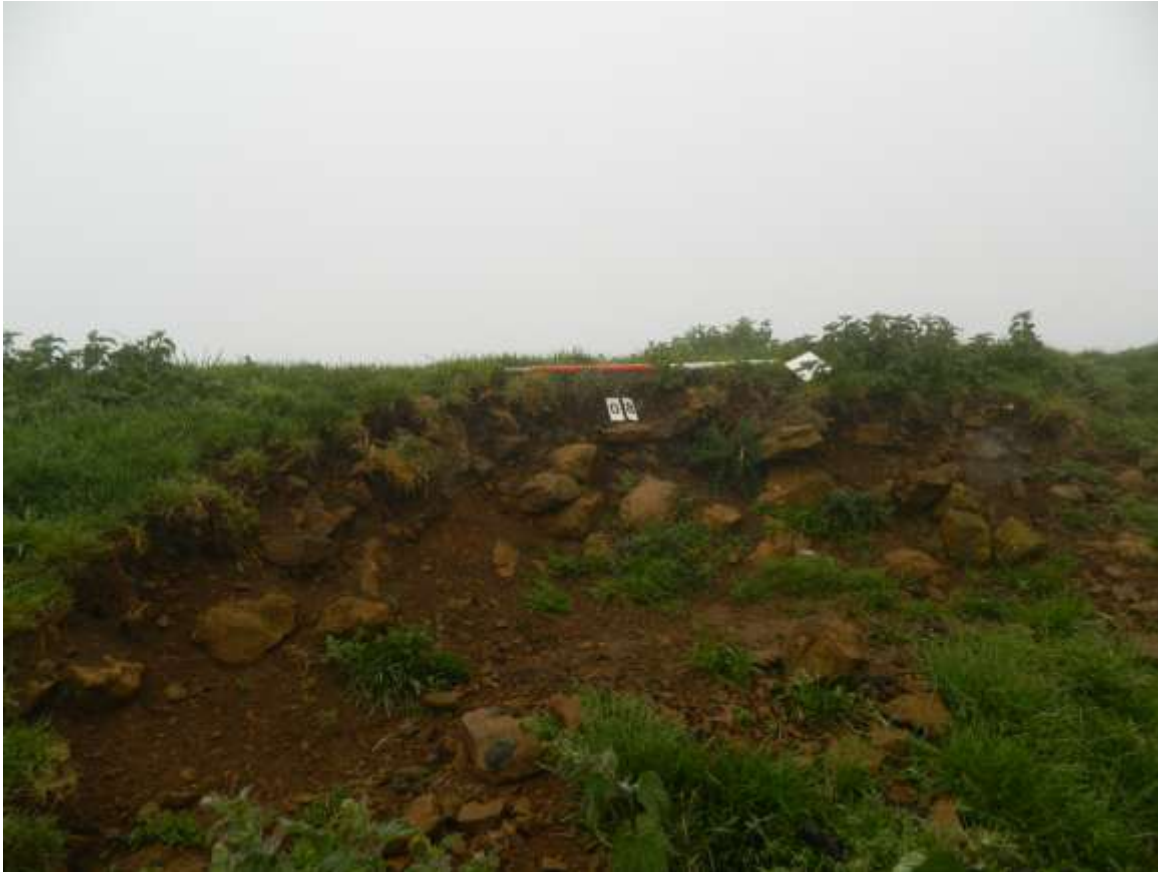
Location 08 (SK 76204 / 11901)

Large rectangular area of erosion near the top of the rampart measuring c.6.00m x 0.80m high x 1.40m deep. Larger stones exposed here as well as smaller rubble / soil mix. There is no evidence for coherent coursing or deliberate lying of the stones so it is possible that they relate to rampart core materials. The overall area affected by the erosion here is approximately half the height of the surviving rampart earthworks.

NB This area had been the site of previous erosion management works with a shoring construction of planking still surviving.

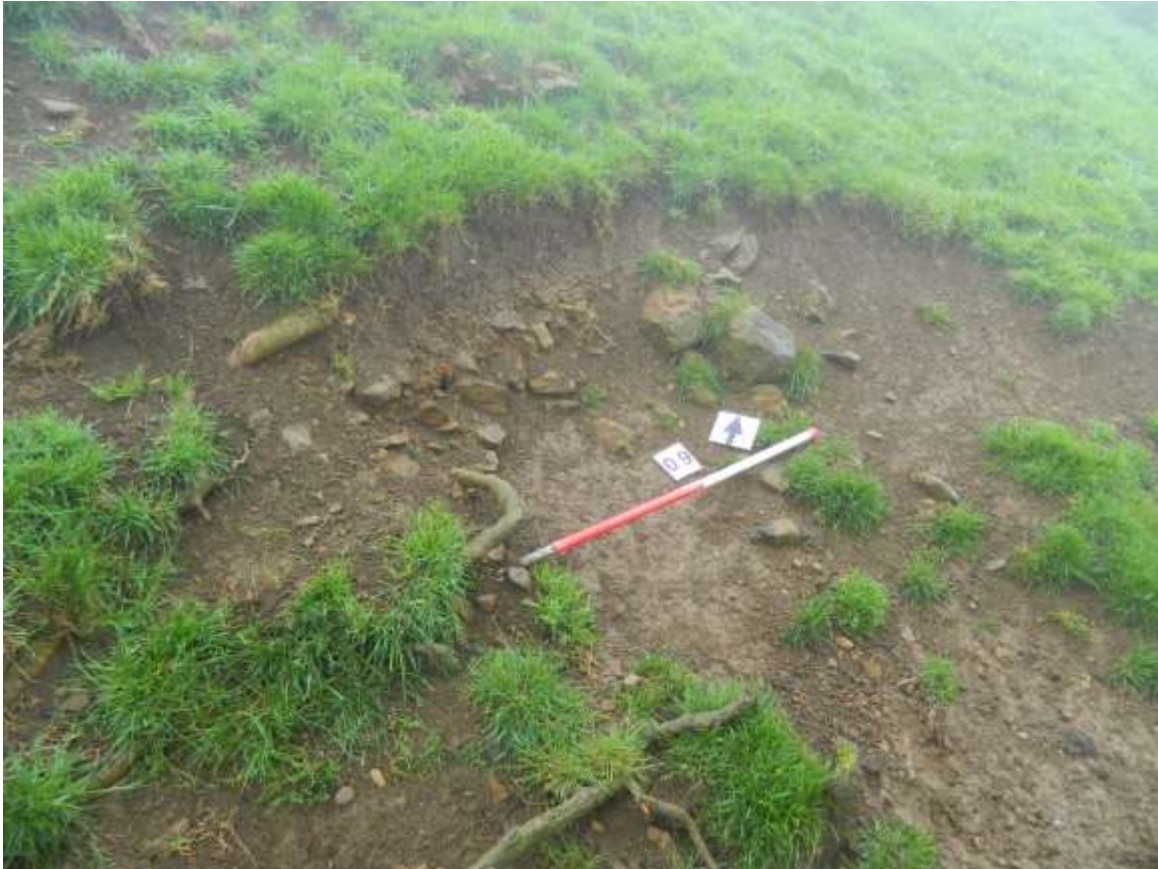
Location 09 (SK 76208 / 11918)

Large circular area of erosion (*c.*4.00m diameter) encircling the base of a large tree growing on the rampart. Some disturbance must have been caused by the trees roots but essentially the main erosion here has been through animal use of the area as a shelter. The area has exposed a large part of the rampart from its base to within a metre of the earthwork's top. A number of a large stones are exposed that are potentially rampart facing stones but it is difficult to be sure. These lie in front of (and below) subsoil-type material of reddish-brown silty clay.

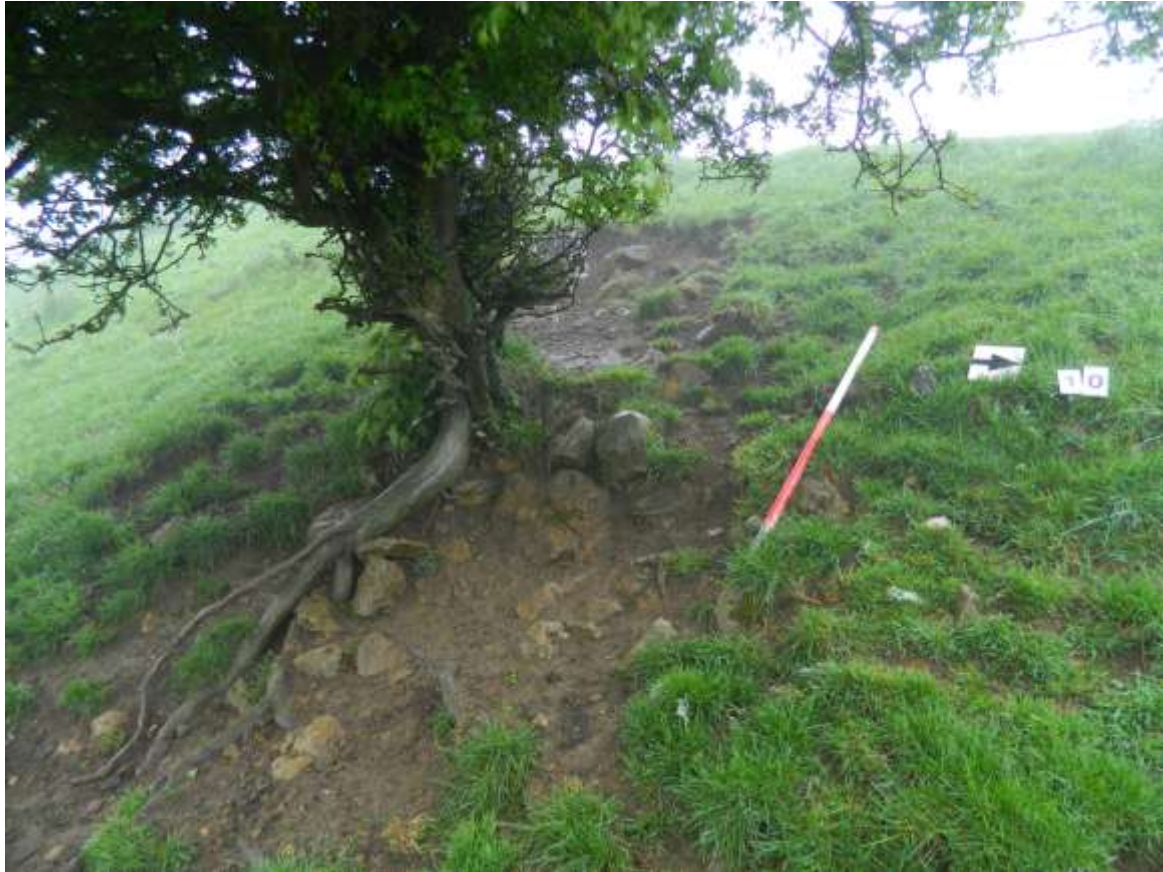
Location 10 (SK 76206 / 11934)

Oval area of erosion measuring *c.* 5.00m x 3.00m concentrated around the base of a small tree growing on the rampart earthworks. As above the area has been eroded due to its use as a sheep shelter along with root disturbance. A number of large stones exposed within a reddish-brown silty clay matrix. No coherence of form to them.

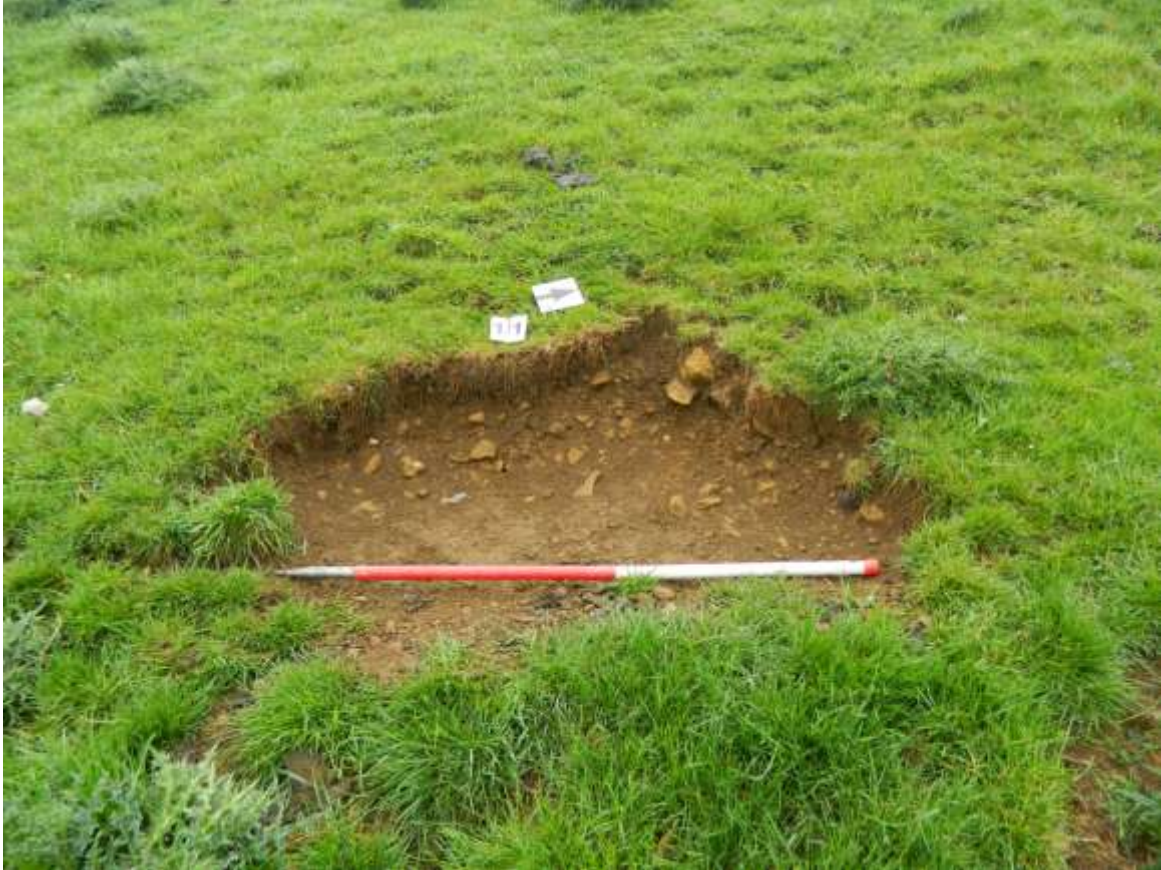
Location 11 (SK 76210 / 11961)

Small area of soil slippage and erosion approximately halfway up the rampart, measuring c.1.55m x 0.36m x 0.90m deep. No stonework exposed but small ironstone rubble in a reddish-brown silty clay matrix.

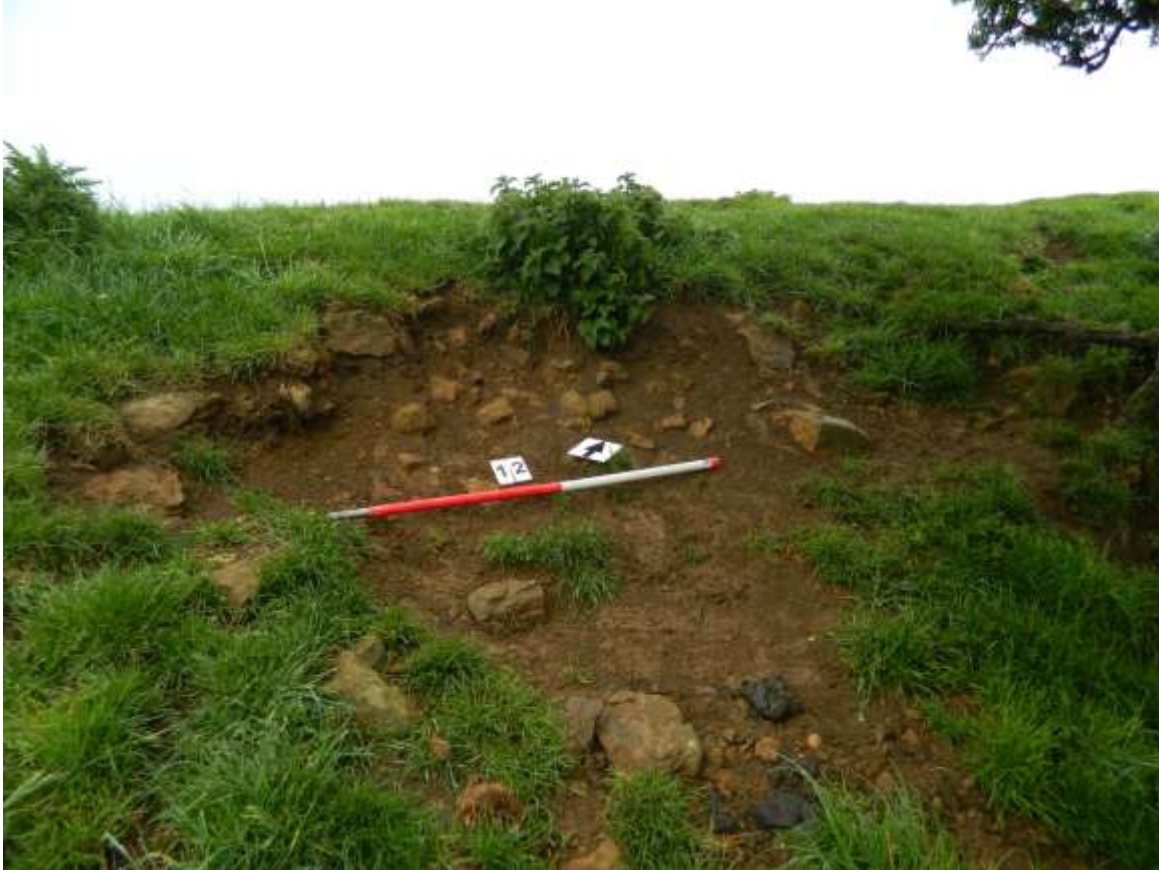
Location 12 (SK 76207 / 11969)

Oval area of erosion at the top of the rampart measuring *c.*2.80m x 0.60m x 1.50m deep. A concentration of medium to large stones revealed in this area – also evident at the base of the hole. No clear evidence for deliberate coursing is evident here but a similar pattern of larger stones in front of more rubble / soil mix is apparent, perhaps indicating remains of rampart facing. A spread of loose stones in front of the area and on the lower banks indicates continued erosion of this area.

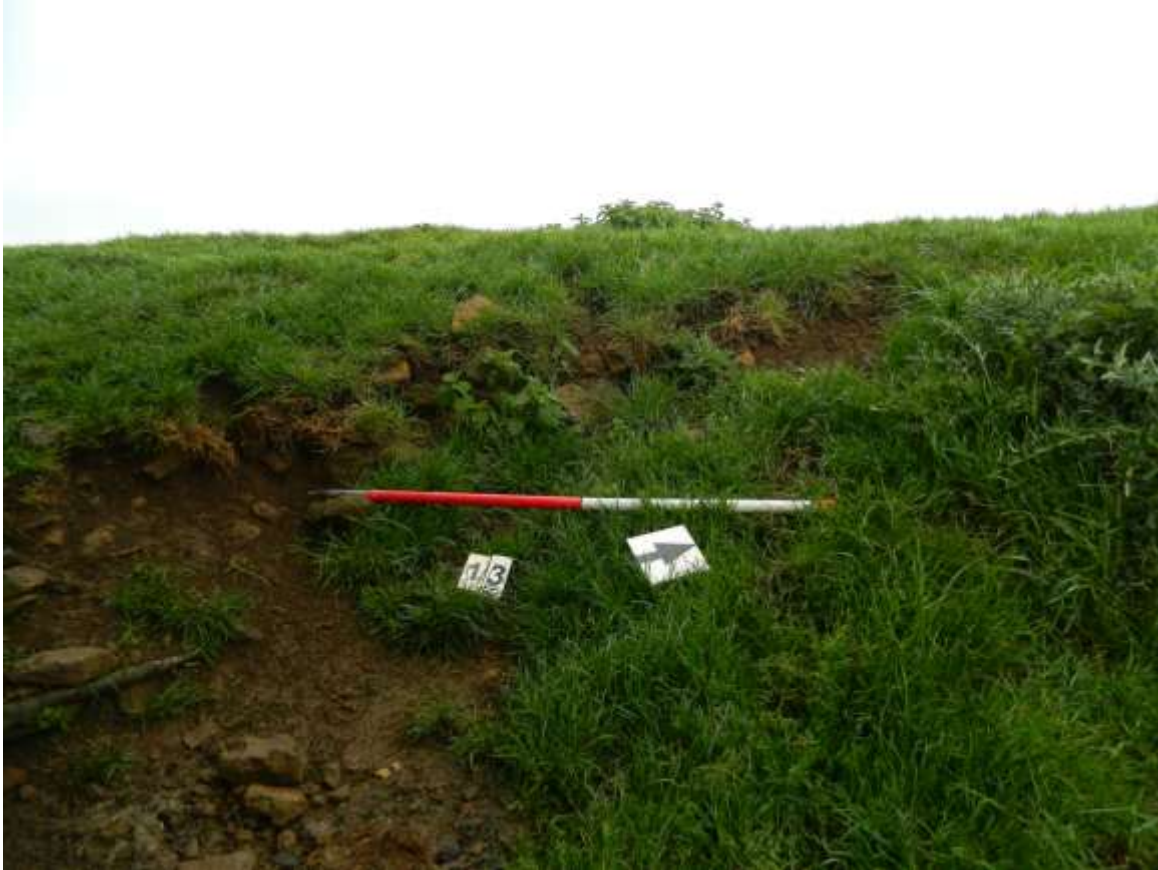
Location 13 (SK 76208 / 11976)

Oval area of erosion measuring *c.*2.00m x 3.00m surrounding the base of a small hawthorn tree growing near the top of the rampart. The area has developed as a result of root disturbance and sheep scraping through use as a shelter. Larger stones revealed here but in no coherent pattern. The stones lie in a similar silty clay matrix seen in the other areas.

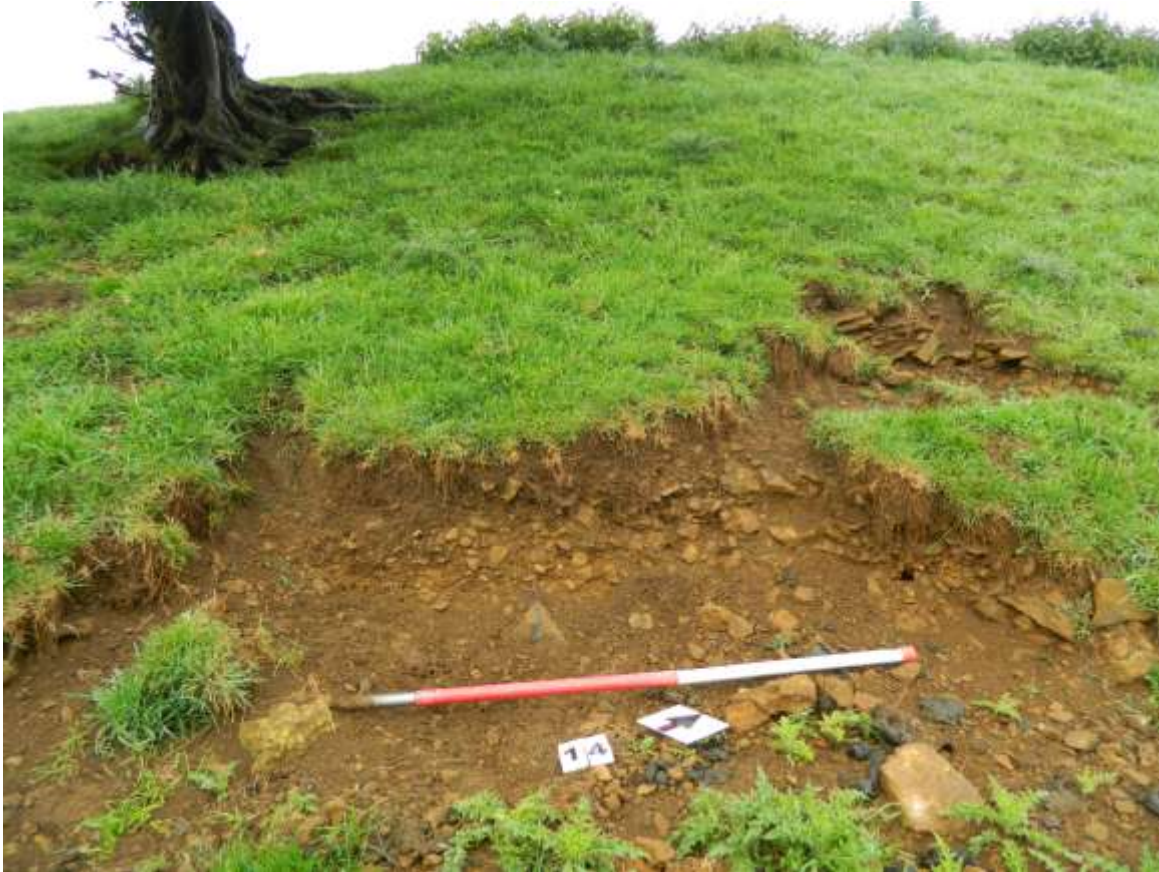
Location 14 (SK 76210 / 11984)

Animal scrape below hawthorn tree growing near the top of the rampart. The area is crescent-shaped and measures *c.* 1.30m 0.30m x 0.80m deep. A few stones exposed but they are not in a coherent form and may not be *in situ*.

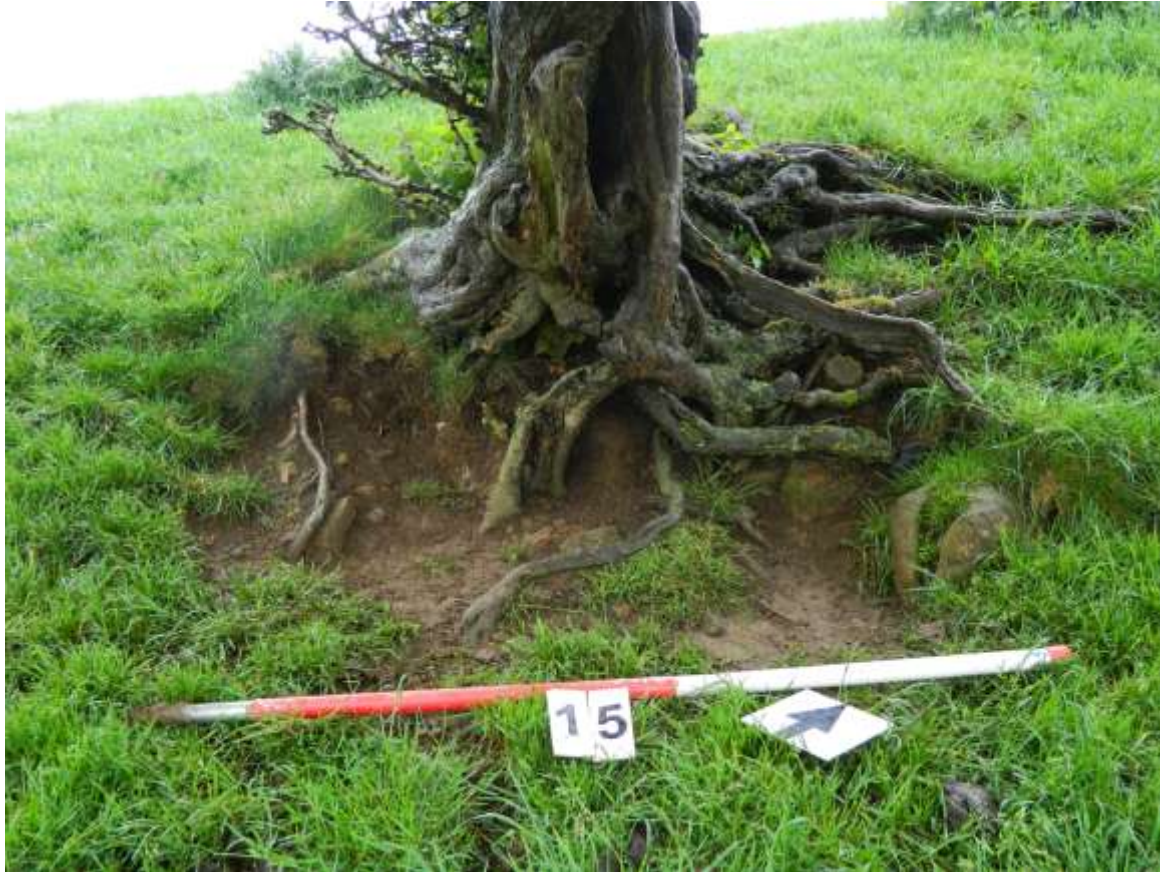
Location 15 (SK 76208 / 11984)

Crescent-shaped area measuring *c.*2.40m x 0.45m x 1m deep. Some possible stone coursing evident towards the top of the hole with smaller (?slipped) rubble below.

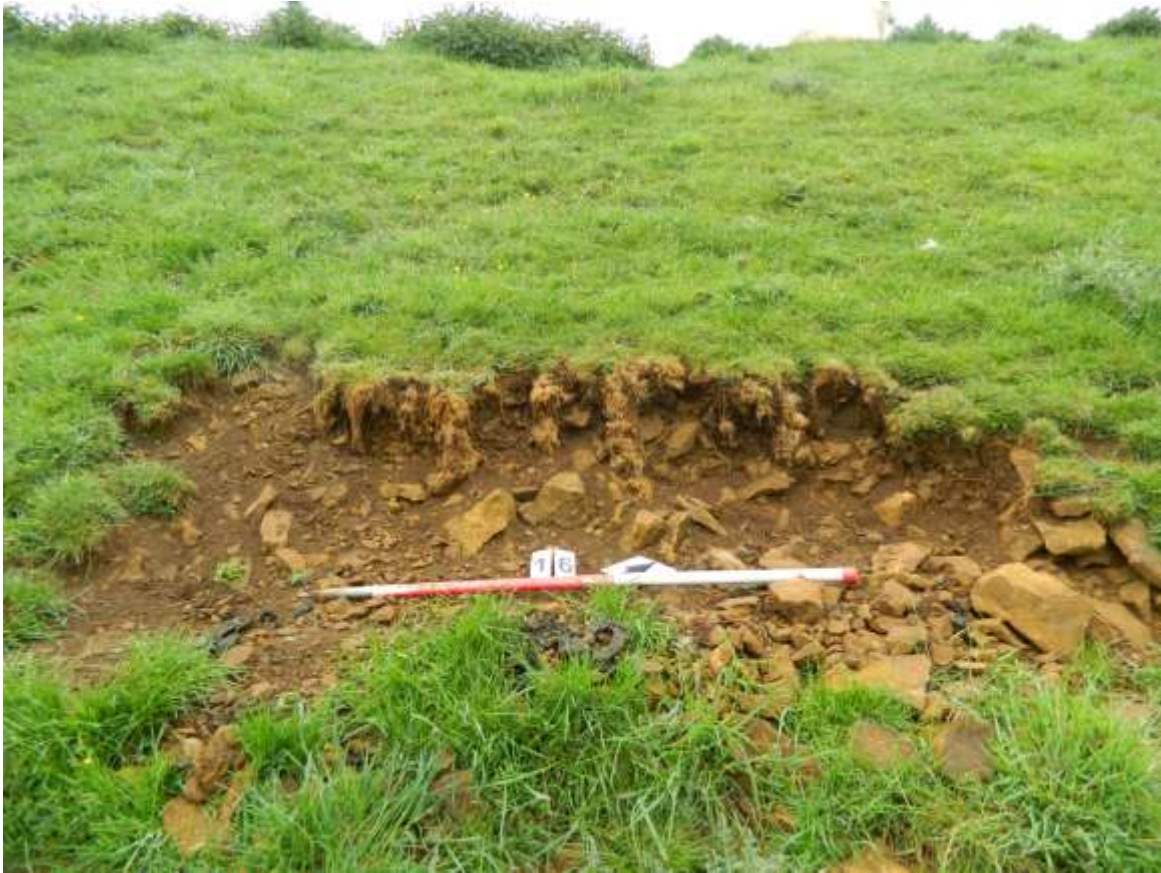
Location 16 (SK 76211 / 11990)

Crescent-shaped area of erosion measuring *c.*2.50m wide x 0.45m x 0.80m deep located midway down the rampart earthwork. Mixture of large stones and smaller ironstone/silty rubble exposed but with no real coherent form. Several loose large stones have tumbled down from this area to the slopes below.

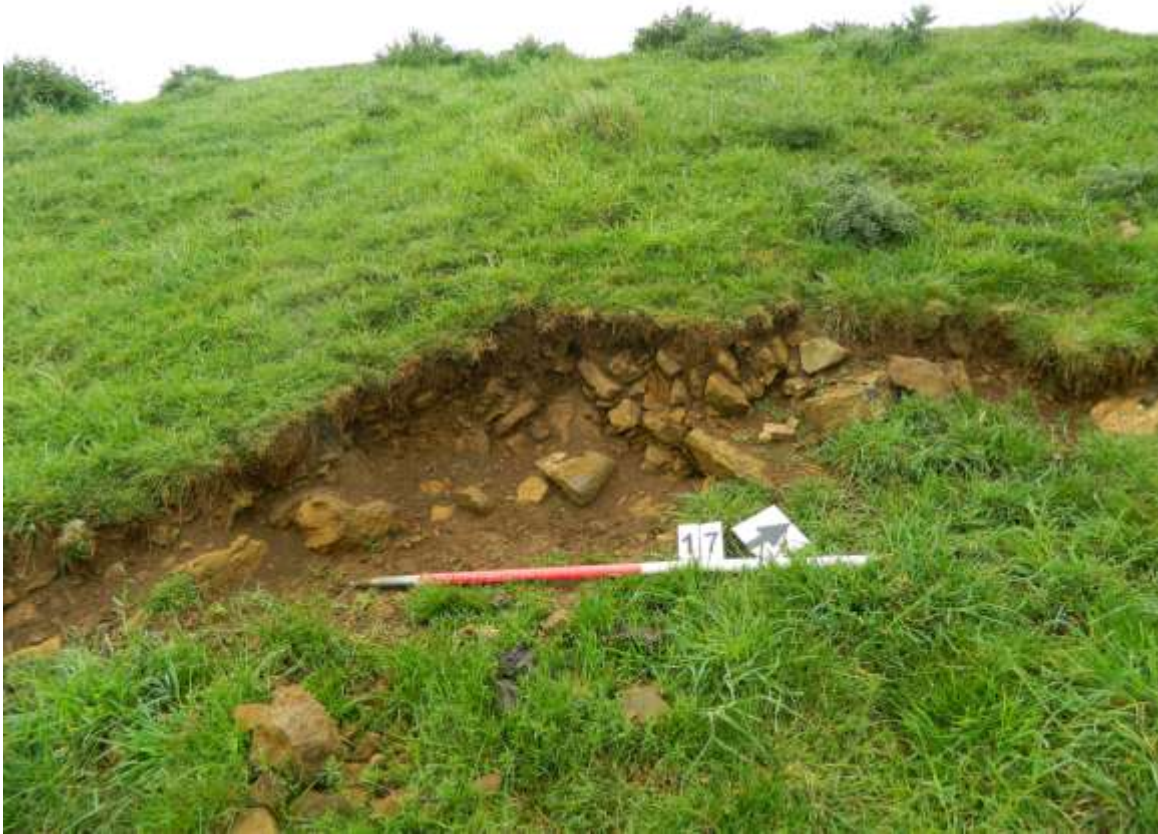
Location 17 (SK 76209 / 11995)

Large crescent-shaped area of erosion measuring *c.*3.20m x 0.45m x 0.80m deep. A fairly coherent spread of large stones revealed but no coursing apparent.

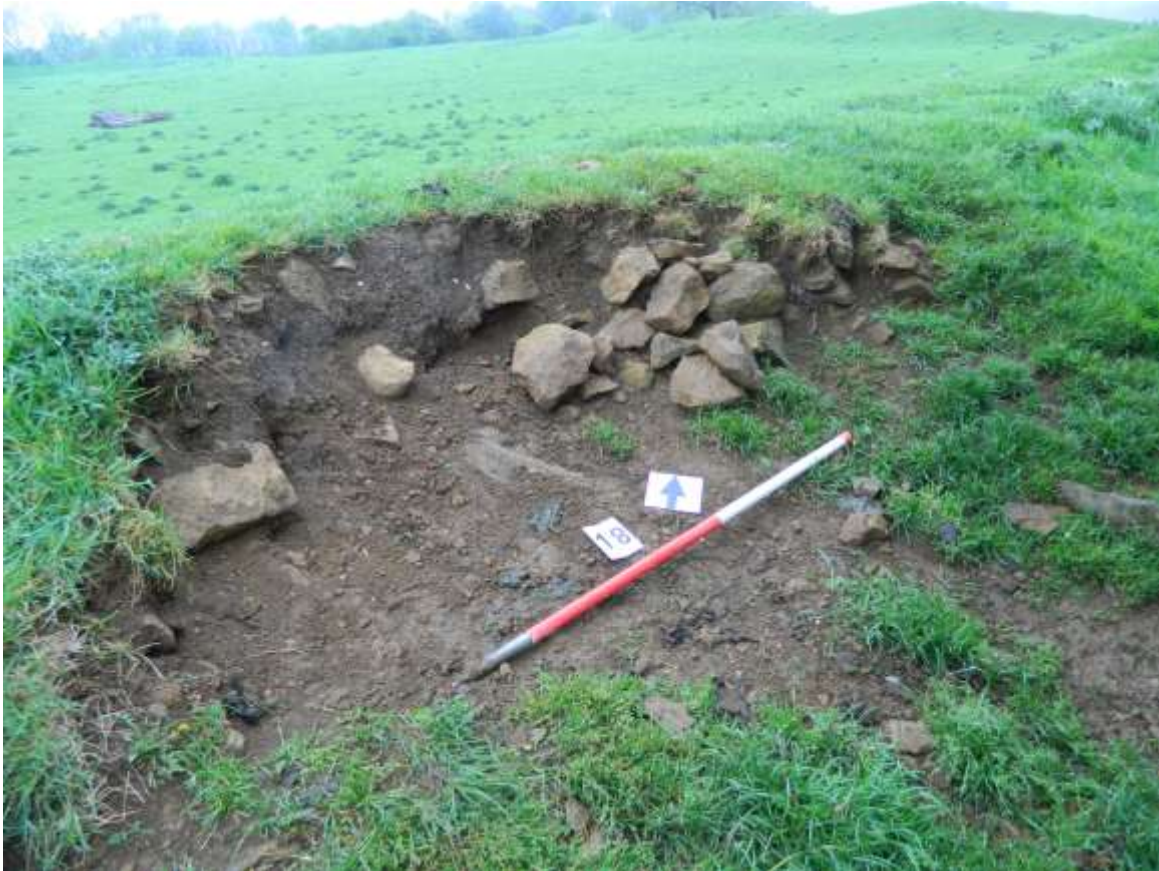
Location 18 (SK 76208 / 11999)

Circular erosion area below hawthorn tree growing near the top of the rampart. The area measures *c.*2.30m diameter x 0.35m x 1.20m deep and is a result of tree root disturbance and animal scraping. Several large stones exposed but no real pattern to them.
