**Archaeological Survey and Recording of Rampart Erosion
at Burrough Hill Hillfort, Burrough-on-the-Hill, Leicestershire**

ULAS Report No 2014-006

**Archaeological Survey and Recording of Rampart Erosion
At Burrough Hill Hillfort,
Burrough-on-the-Hill,
Leicestershire
NGR: SK7605 1195 centre**

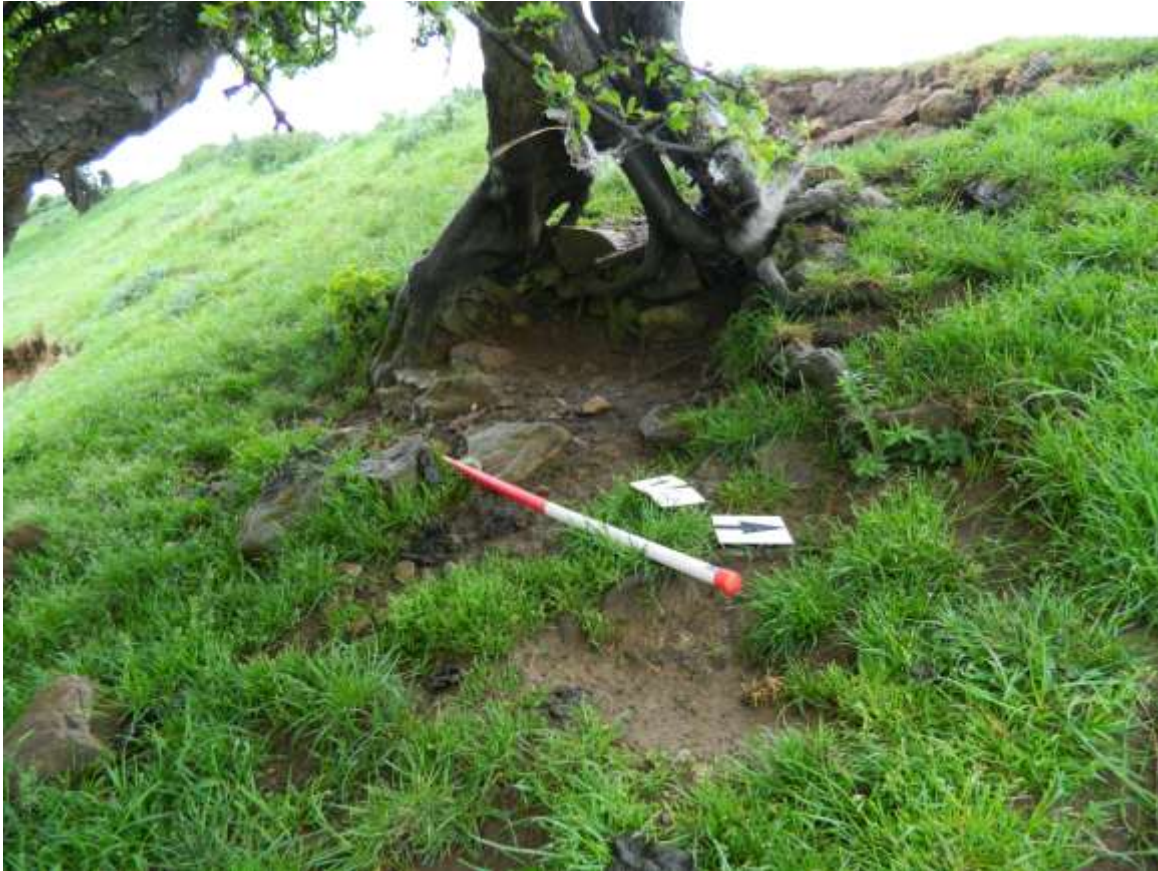
Location 19 (SK 76209 / 12001)

Crescent-shaped area on top of the rampart measuring *c.*2.20m x 0.40m x 1.20m deep. A loose collection of large stones is evident here, all looking recently disturbed. No coherence to any of the stones exposed.

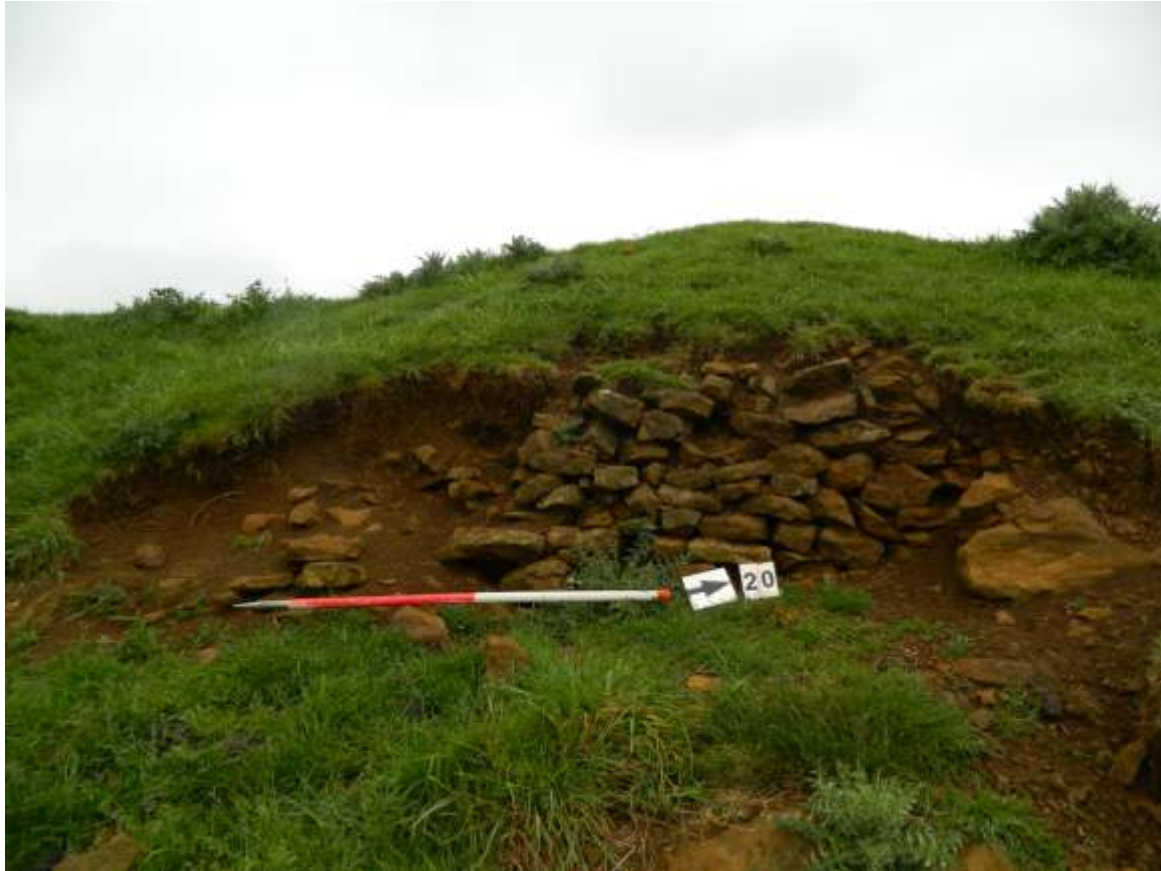
Location 20 (SK 76211 / 12005)

Large area of erosion towards the top of the rampart measuring *c.*3.00m wide x 0.80m x 1.50m deep. Approximately 8 courses of drystone walling exposed here with a coherent face aligned NE-SW along the width of the area. This area provides the most complete evidence for rampart facing exposed within the erosion areas.

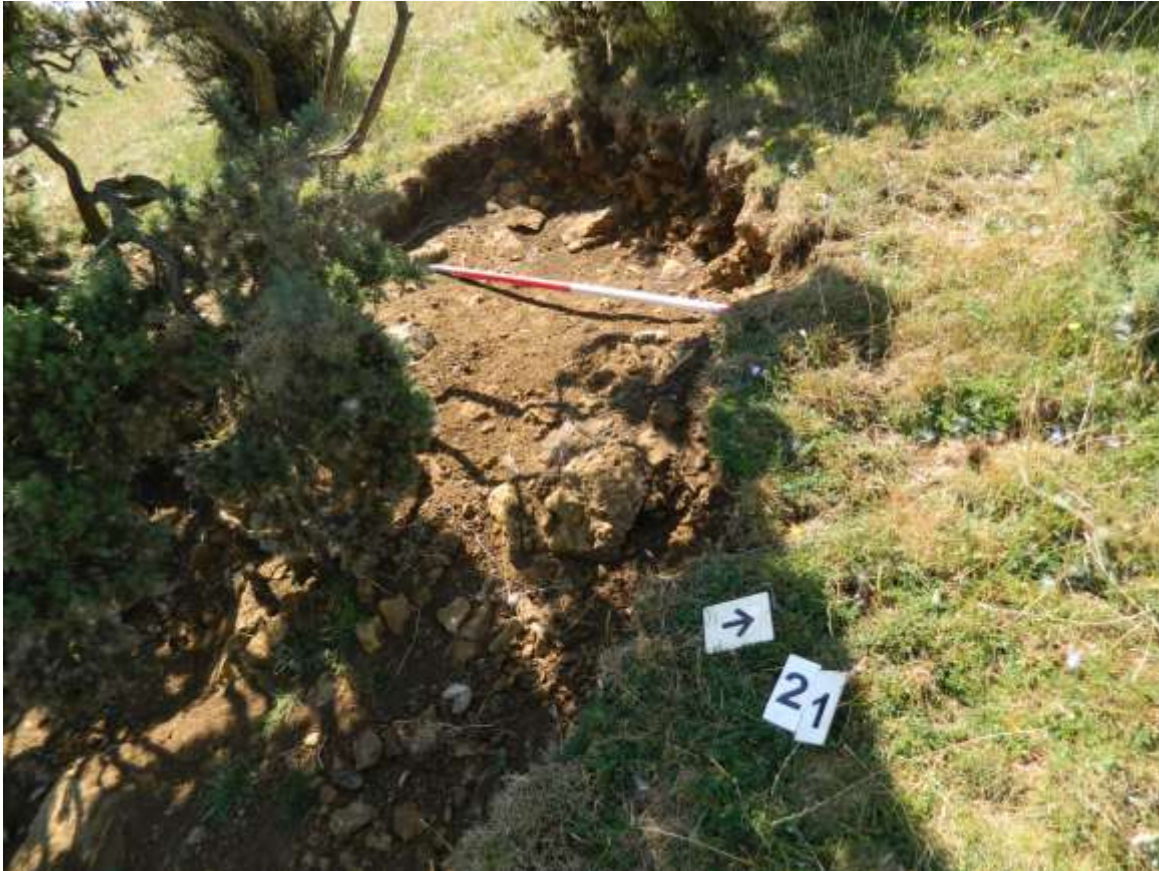
Location 21 (SK 76220 / 12034)

Circular area of erosion surrounding a small tree on the NE ends of the eastern rampart. The area measures *c.*3.00m x 0.40m x 2.70m deep and formed through root disturbance and sheep scraping. A number of large stones are exposed approximately halfway down the area and smaller rubble exists towards the upper area of the rampart. No real coherence to the exposed stones.

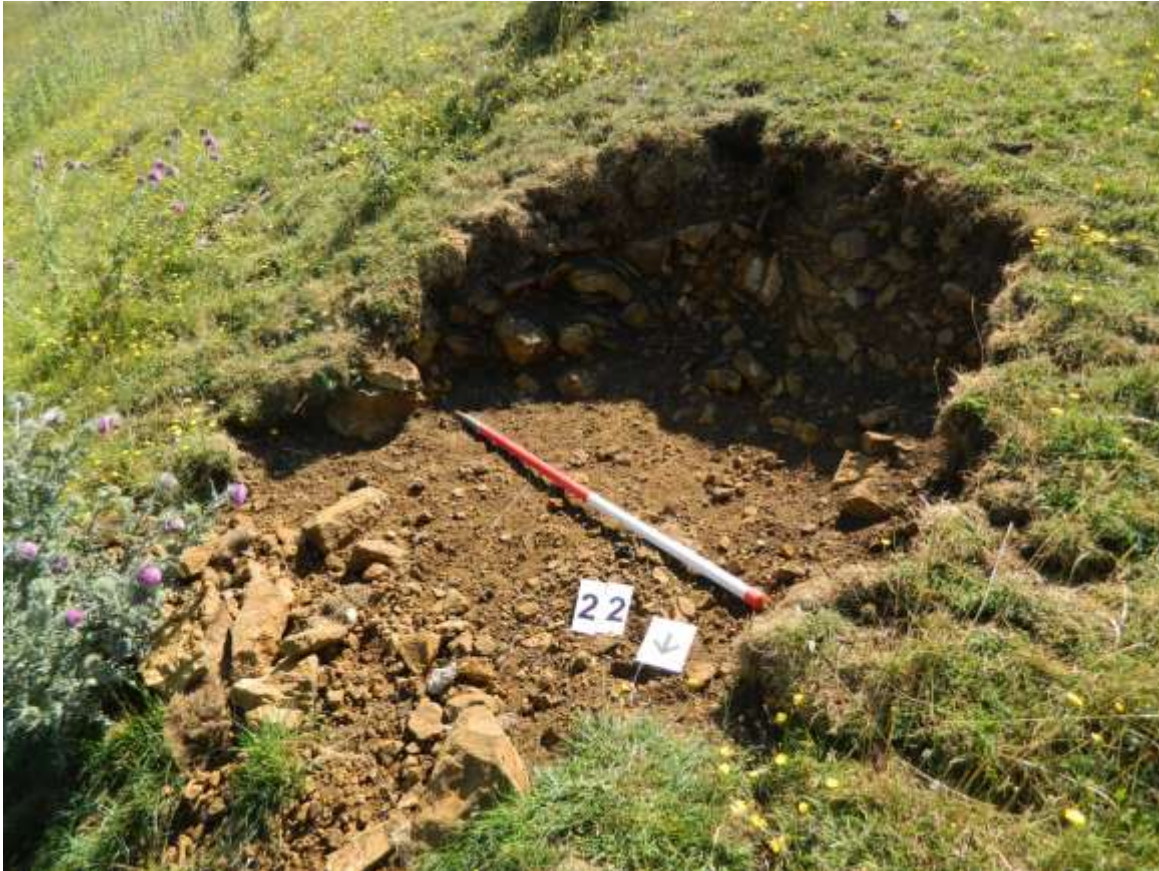
Location 22 (SK 76161 / 12003)

This is a square erosion hole/sheep scrape on the northern rampart near the NW corner of the hillfort. It measures *c.* 1.5m wide x 0.50m x 1.50m deep and contains apparently laid stones forming part of the rampart. In a similar sequence to some of the other erosion areas larger (?facing) stones are backed by tightly-packed medium sized rubble in a matrix of smaller ironstone chunks and soil.
