**A Photographic Building Survey and  
Watching Brief  
on two barns at Broad Street,  
Enderby, Leicestershire**

**NGR: SP 53690 99307**

Jon Coward and Andrew Hyam

ULAS Report No 2013-214

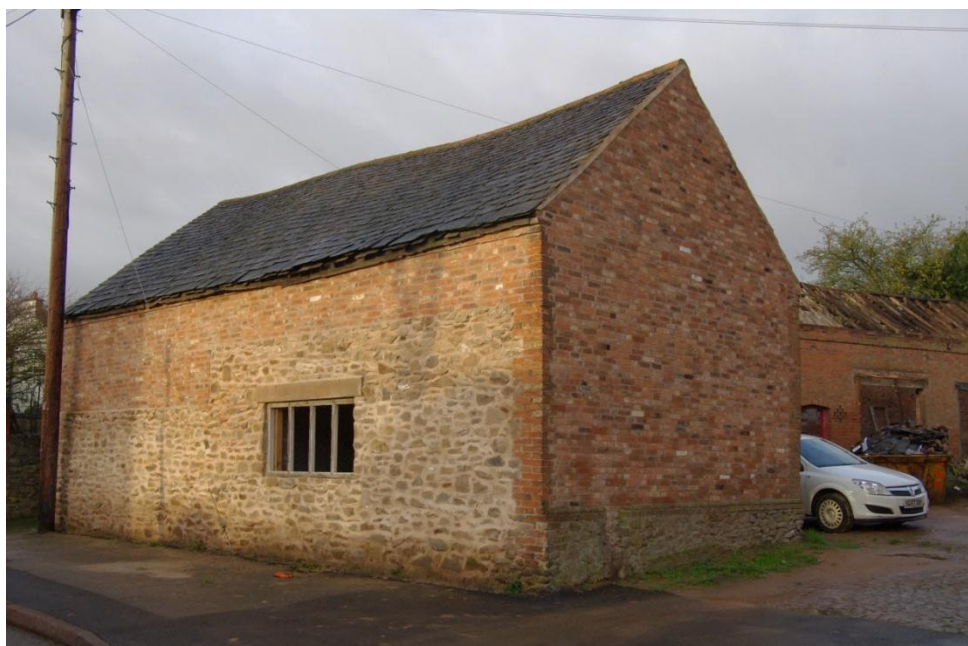
This is a two-bay unit running along the street front. The frontage and north east gable had been re-built by the time of the survey to a design which echoes the original, judging by the photographs in the Heritage Statement (CDR Architects; Figs 4-5). The interior of the north east bay had also been largely finished, but the back, south-west gable and south-west bay interior appeared to be largely intact.

Figure 4 Barn A, looking west

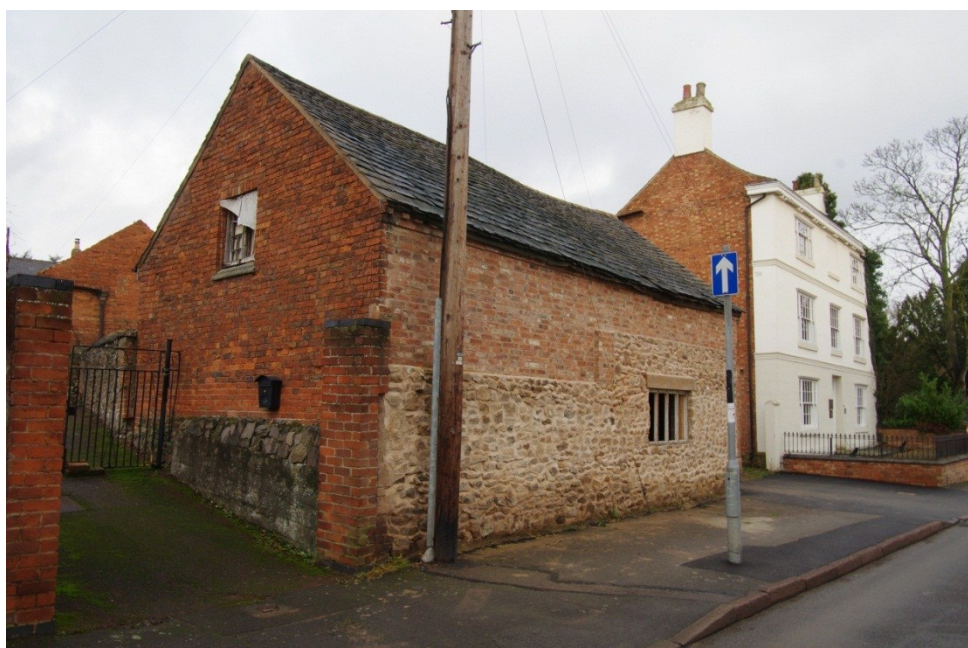
Figure 5 Barn A and 'The Cedars', looking north

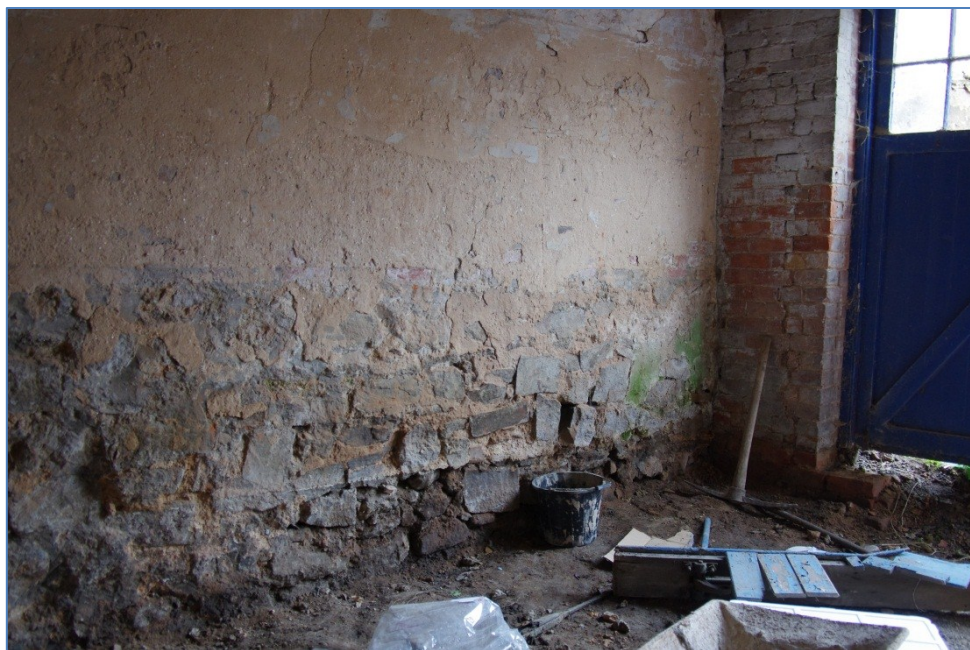
The barn is largely built of red brick, the rear and south-west gable appears Victorian whereas the north-east and frontage probably earlier. It seems to have been a rebuild of an earlier stone building, as part of the frontage and most of the wall bases (e.g. Fig. 9) are random coursed stonework. The original photographs of the gable before its present rebuild show an earlier roofline on the north-east gable, dropping to the height of the stonework in the frontage, which presumably represents the first rebuild of the stone barn in brick; later the roof was raised. The southwest gable shows no such rebuild and so is likely to be contemporaneous with the second rebuilding. The rear is apparently all of one build. There are indications that the original building was two separate builds as there is was subtly differing coursing half way along the frontage, visible to the left of the window where part of a brick pier is evident within the wall fabric (Fig. 6). This could account for the change in level of the stonework at this point. The raising of the roof was presumably to incorporate a floor, now gone; on the south-west gable there is a window at first floor level which has been covered over on the inside. This window appears to be domestic in style, which might indicate domestic habitation at one time although opportunist re-use after alterations to the house adjacent is perhaps more likely. The major roof timbers are painted; there is a substantial purlin either side, which could be earlier than the deal tie-beam and struts. The covering is Swithland slate. Swithland slate becomes progressively rarer for utility buildings from the early 1800's as cheaper Welsh slate became available, but it is often re-used in later buildings, and so is not a particularly good indicator of date in itself.

Figure 9 Barn A interior, south west bay, looking west

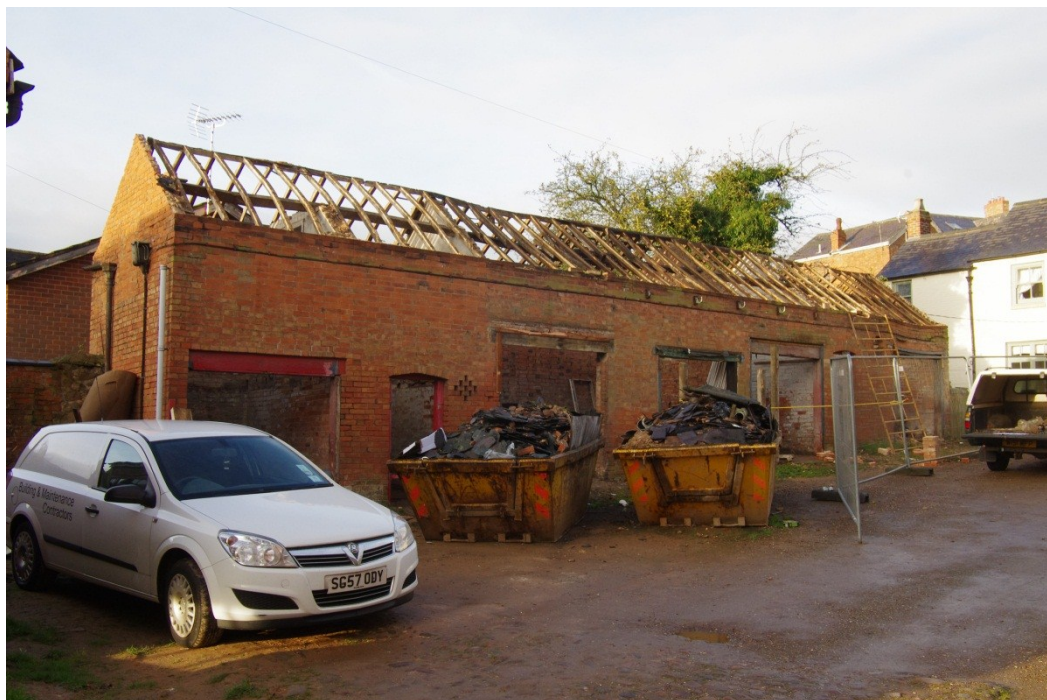
Barn B is a longitudinal block (Fig. 11) with various subdivisions, built mostly in 19th century brick although there are occasional courses of earlier brick low down in the walls. The frontage wall and gable are in better quality brick than the rear, which includes many mis-fires. The roof covering had been removed at the time of the survey, but the contents of the skip showed it to have been Swithland slate. The roof is common rafter with one purlin either side, a tie beam has been used in garage 2, which is wider than the other units.

Figure 11 Barn B, looking west

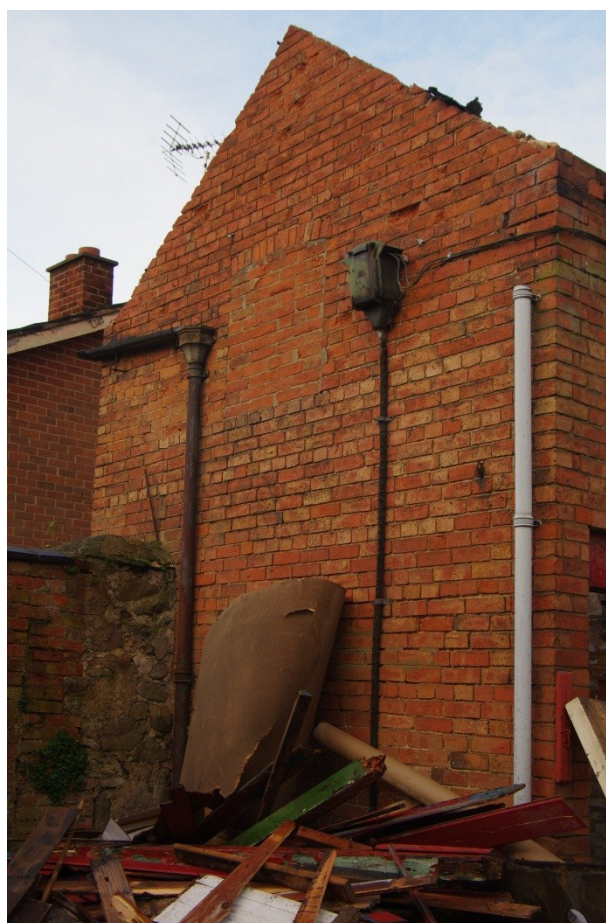
The building has had some alteration: the top of the south-east gable (Fig. 12) shows a re-build line which can be discerned to run intermittently across several bays of the long north-east face above the doors, probably the floor inserted into the south end of the block necessitated removal of original arched openings, replaced by lintels. A doorway at this level has a surviving door (Figs 13-14) of curious construction, probably not original to the building. The well-made vertical planks have beading on both sides, there are potentially later rails, the wooden lockcase has been moved, and re-attached with nuts and bolts. The hinges and furniture could be 17th/18th century or earlier. It is very likely this is a domestic door, re-used when the floor was inserted. Another anomaly is that there appears no obvious access/ egress to this door from the north unit; perhaps a set of steps was in use, and this unit (i.e. garage 1) was originally free standing, certainly the pointing on this wall could have been meant to be exterior, in contrast with the obvious 'internal' pointing on the wall opposite (Figure 16 15). Also, there is a change in brickwork visible in Fig. 11 between garages 1 and 2 (running up the LHS of the double doors) which adds weight to this idea. On the south gable a window serving the floor has been blocked.

Figure 12 Barn B, south gable, looking north west

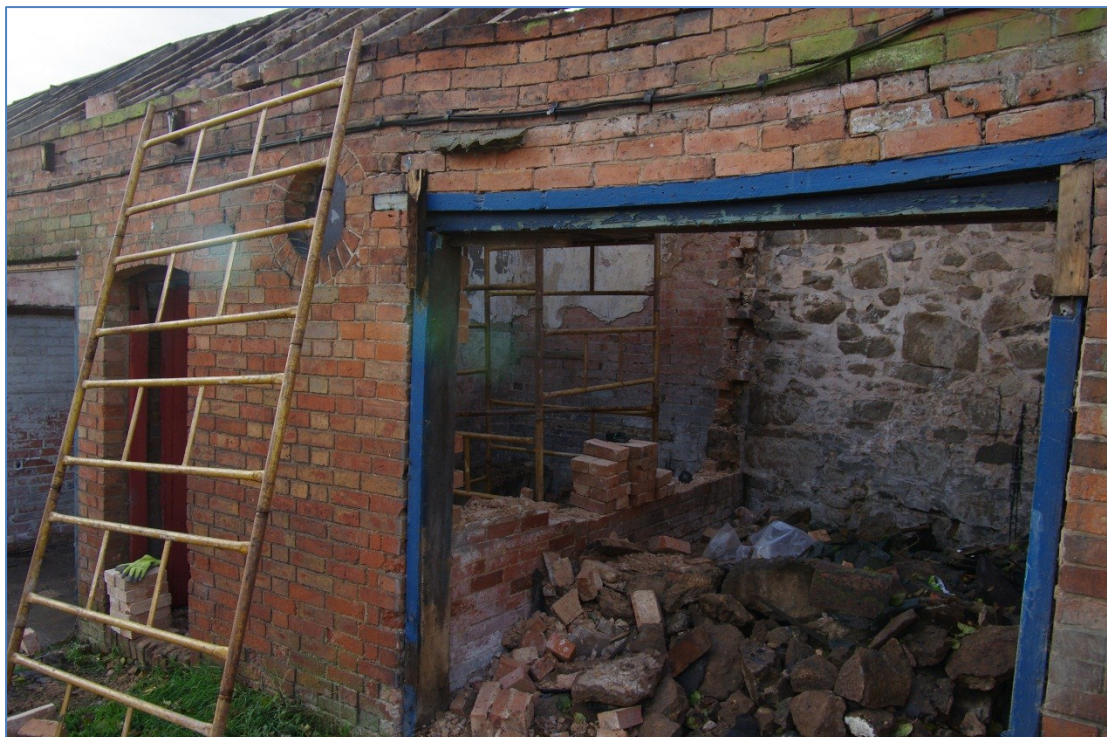
As a whole, the range of units is in dangerous condition. Apart from the failure visible in Figure 18, the weight of the Swithland roof appears to have splayed the longitudinal walls so that they are parting company with the transverse walls.

Figure 18 Barn B, garages 4-5, looking south west

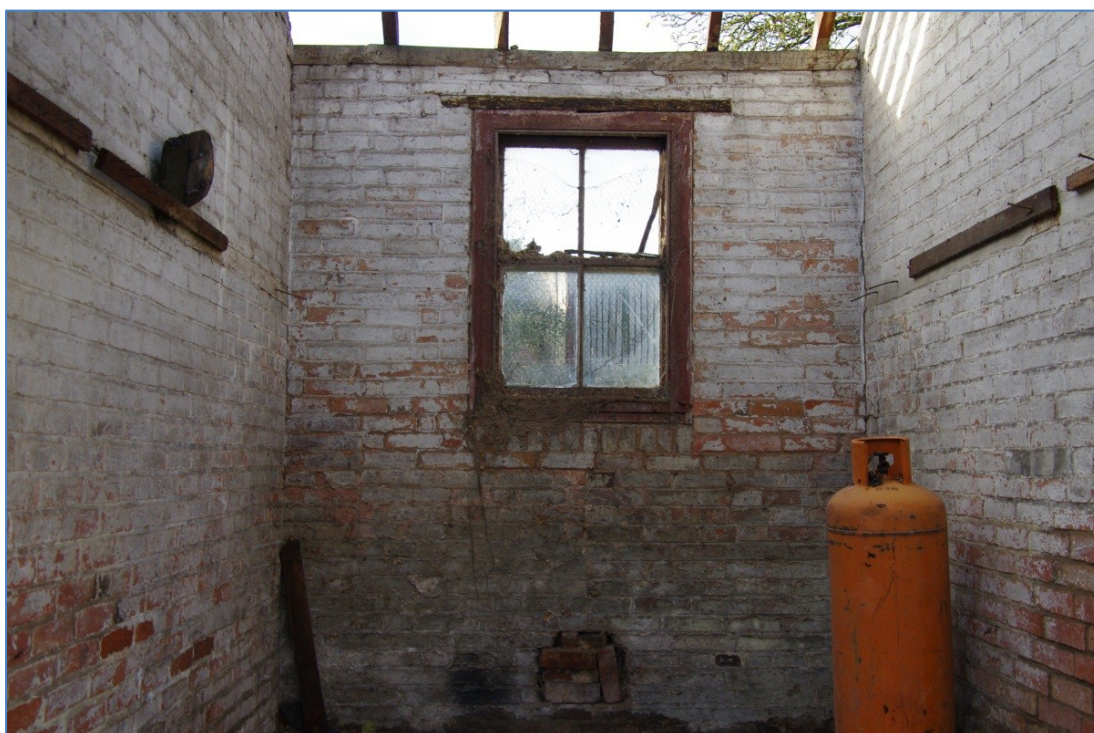
The rear wall of garage 5 is anomalous, being random coursed rubble, presumably retained from a previous structure. Not having access to the next door property, it was not possible to check whether this stone wall has a brick skim on the other side, as implied in the plan elevation in Fig. 20. The dividing wall between 4 and 5 was in the process of removal (Figs 17-18). On the northwest corner of the gable a blocked animal door is visible, so this part of the structure could have been in use as a sty at some point. Garage 3 has a domestic-style timber window in the rear wall, again a probable re-use of a house window (Fig. 19/ Figure 19).

Figure 19 Barn B, garage 3, looking west

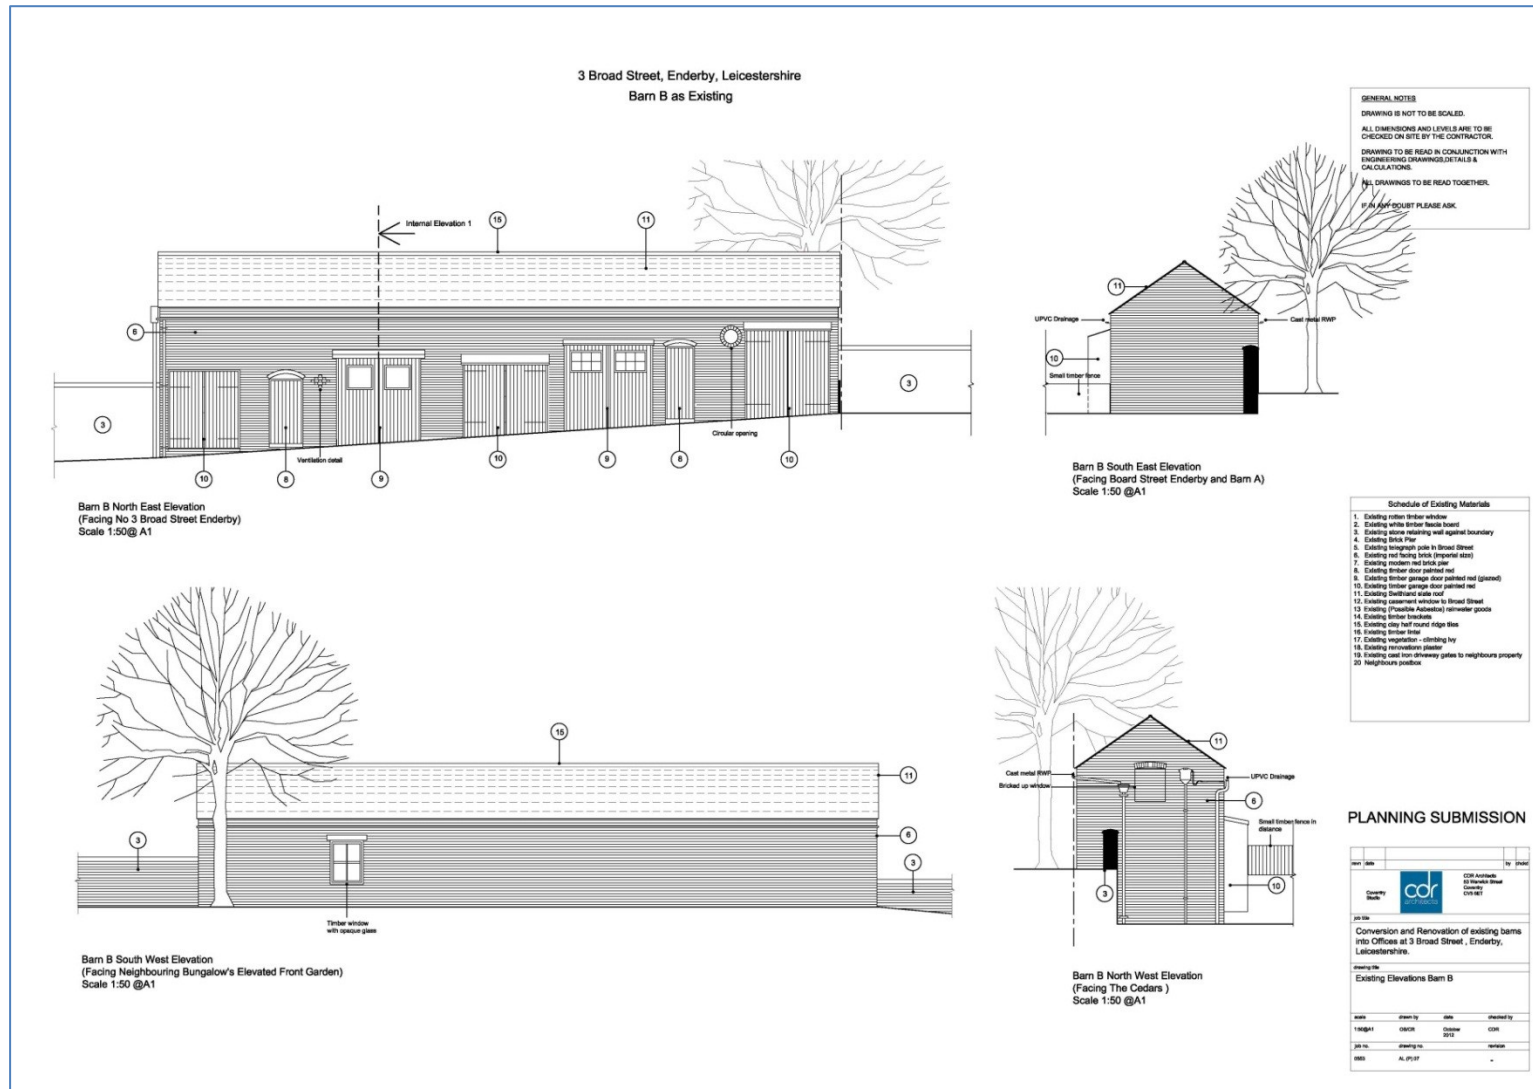
Figure 20. 'As existing' barn B plans provided by the developer.

Nb. The gable elevations on this plan have the wrong orientation, and the timber projection shown had been removed. On the south west elevation the LHS end may be stone rather than brick

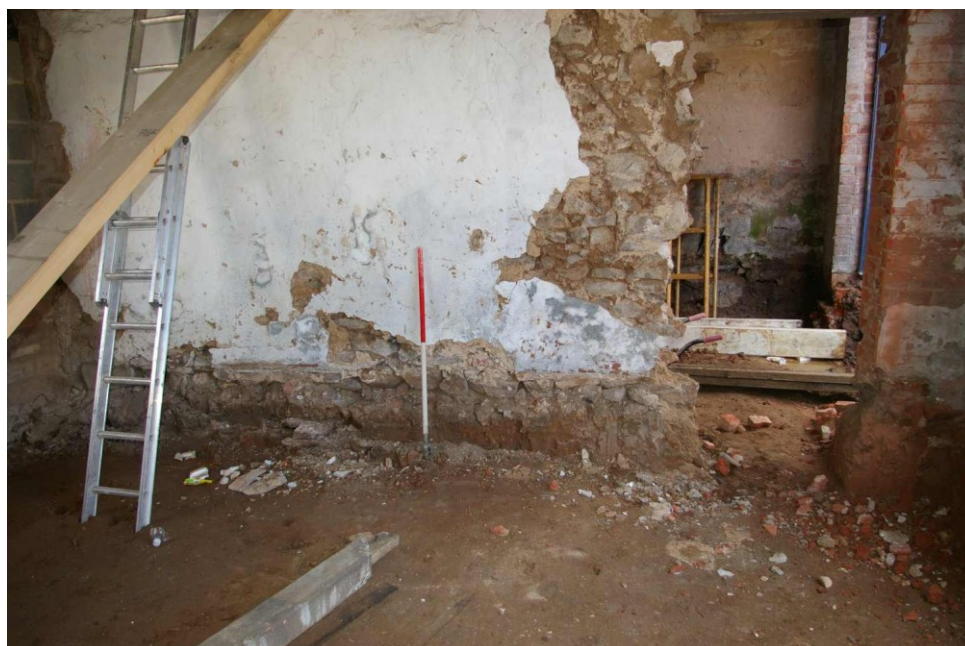
On arrival the floor within both the eastern and western rooms of Barn A had been reduced by approximately 0.5m to expose the foundations of the barn walls. The walls were seen to have extremely shallow foundations and barely cut into the original ground surface. The southern and eastern walls had rubble limestone footings consisting of large boulders laid directly onto the natural substratum. The northern wall, built of brick, had slightly deeper brick foundations. The ground reduction appeared to have removed a single homogenous deposit of undisturbed mid orange brown sandy clay which continued below the exposed limit of excavation. This deposit is likely to be the undisturbed natural substratum. No evidence of any features, modern or archaeological, was seen in the excavated floor of the eastern room. A new, single width doorway has recently been cut through the central wall dividing the two rooms (Fig. 25). This has exposed the rubble-built core of the wall but no other structural details.

Figure 25 Reduced floor level and knocked-through doorway  
Looking west. 1m scale

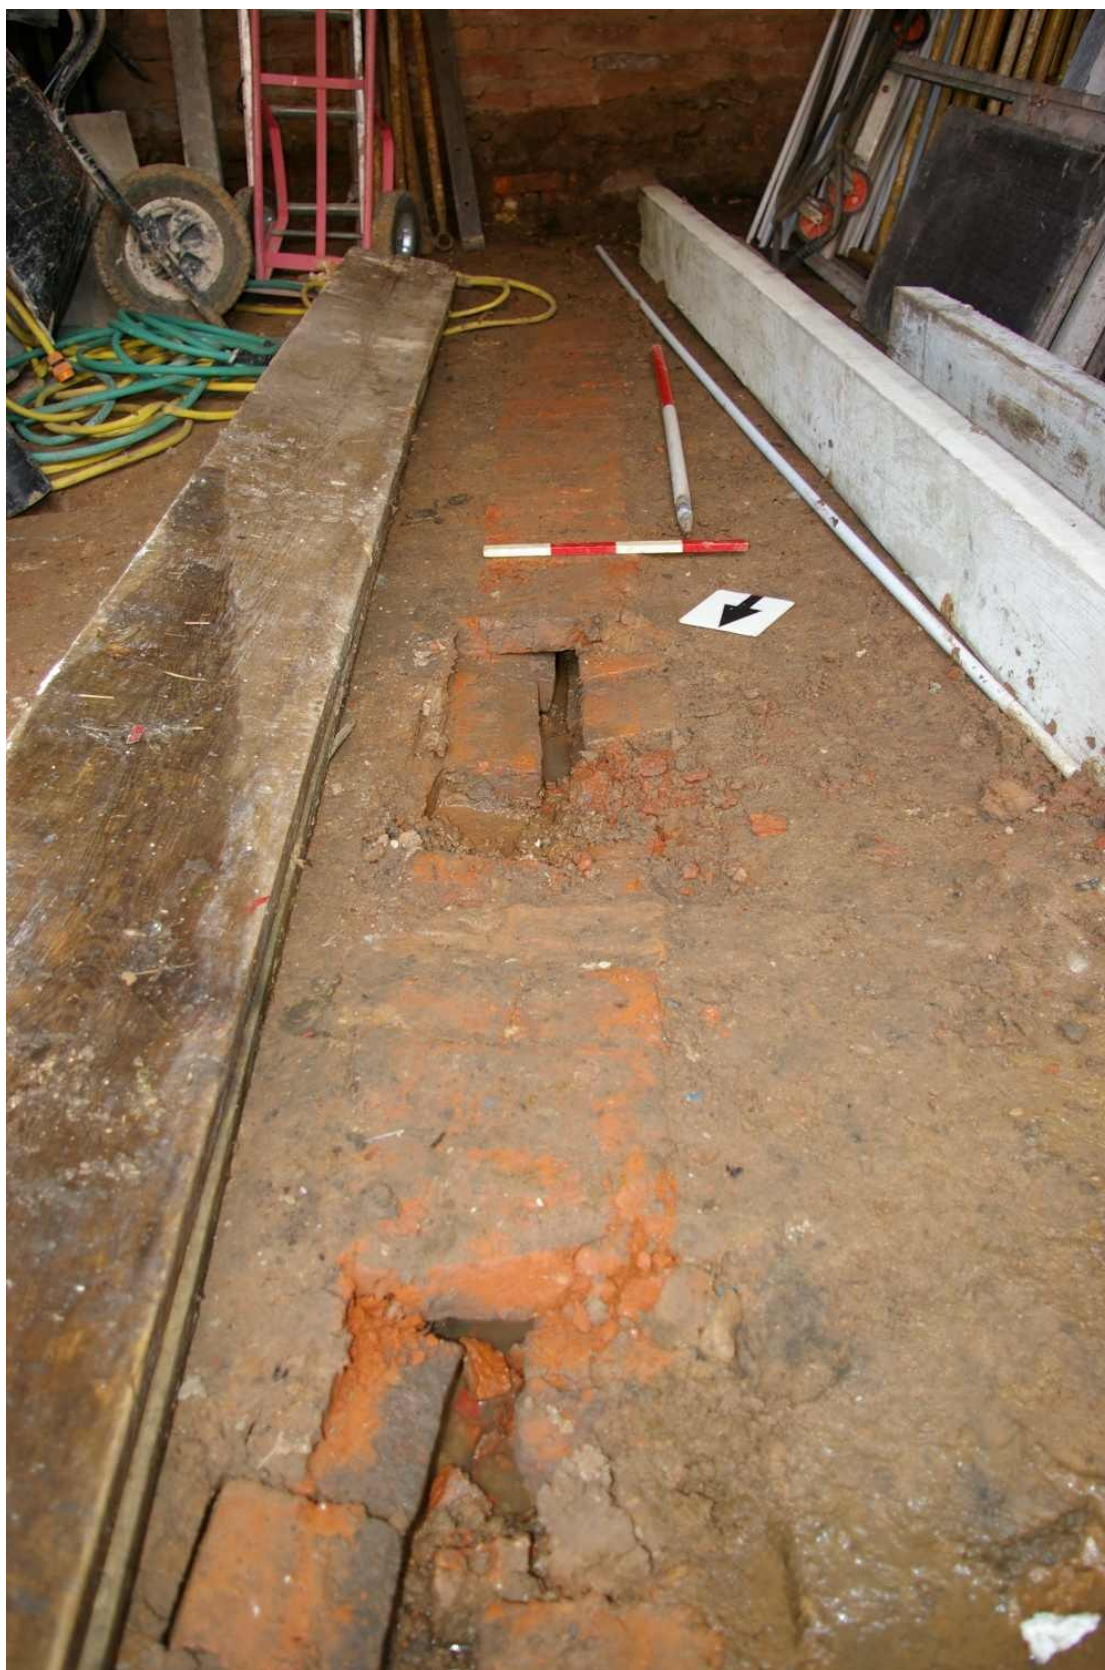
The western room also had approximately 0.5m of floor deposits removed in advance of pouring a new concrete floor. Again the shallow wall foundations of the barn were exposed. Running from north west to south east across the centre of the excavated floor was a brick-built drain or conduit (Figs. 26 and 27). This seemed to run from a well or pump in the courtyard located to the north of the barn. The drain then ran through the southern barn wall through a hole which had been clearly knocked through and modified with bricks indicating that this was a later modification to the wall. The bricks measured 230mm in length, 50mm high and 110mm wide and are probably early 19th century in date. No other features or deposits were observed.

Figure 26 Brick drain running across western room  
Looking south east. 1m and 0.4m scales

Although parts of Barn A were modified and rebuilt during the later 19th century and beyond, it would seem that the stone-built walls are considerably earlier. The use of early 19th century bricks for the brick drain which clearly cuts through the barn wall would suggest that, unless the bricks have been re-used at a later date, the walls date to at least the turn of the 18th and 19th centuries.

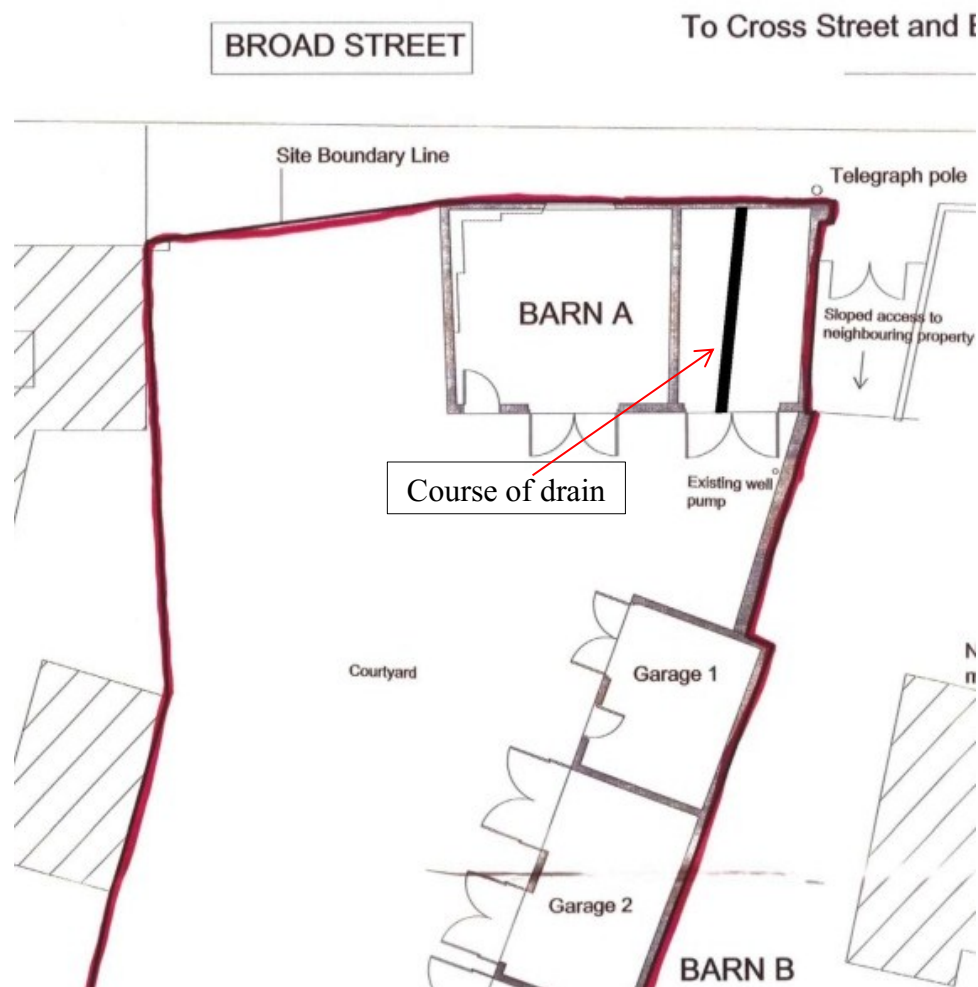
Figure 27 Course of brick-built drain in Barn A  
Modified from client's site drawing
