**A Level 2 Historic Building Recording
at Dairy Farm, St. Andrew's Lane,
Cranford St. Andrew,
Northamptonshire.**

NGR: SP 92284 77334

ULAS Report No. 2015-052
©2015

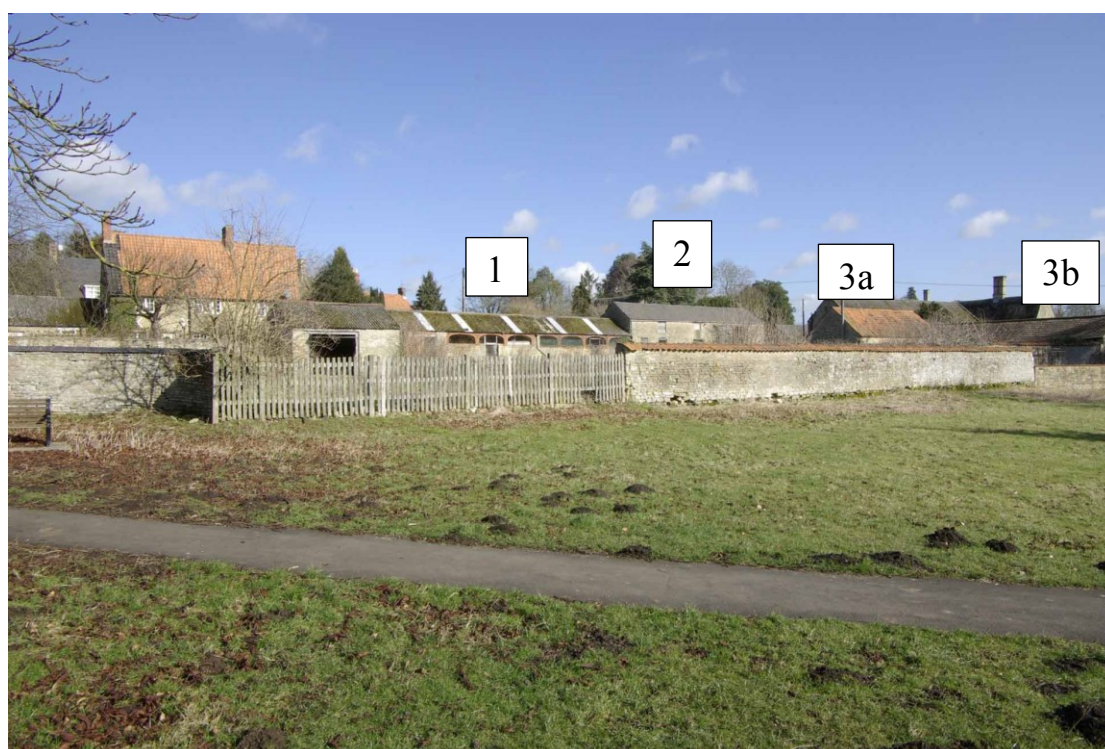
Figure 8 Farmyard viewed from park
Looking north east. Building locations numbered. Picket fencing indicates former gateway into parkland

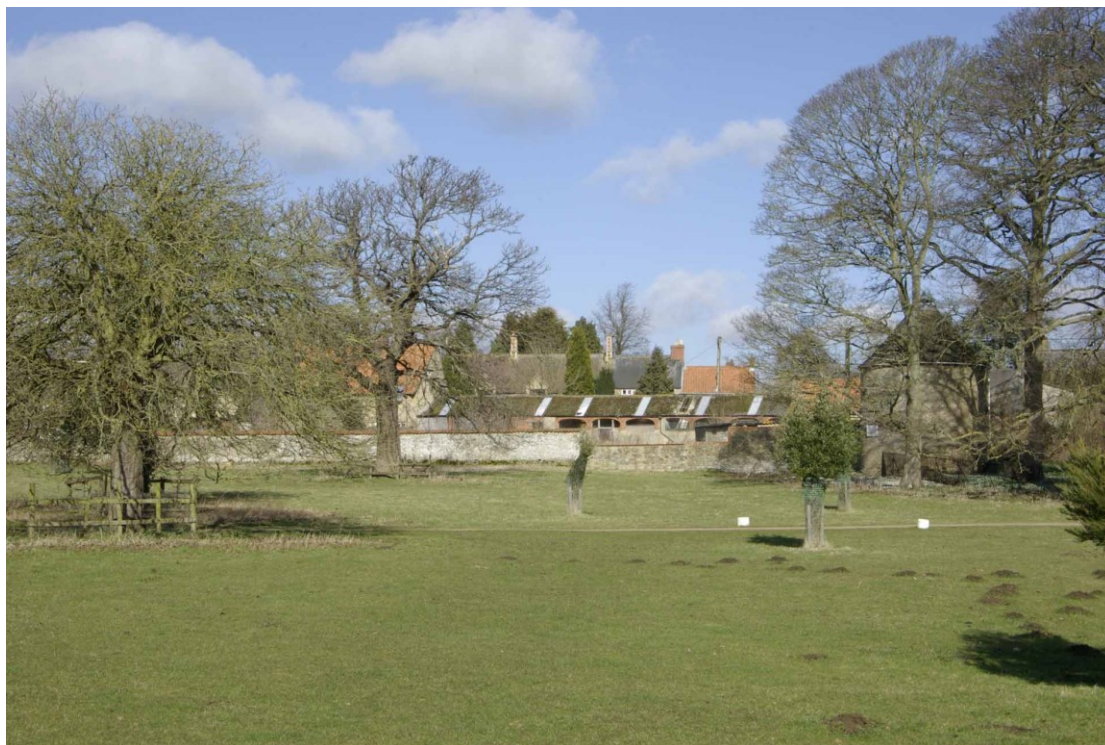
Figure 9 Farmyard viewed from park
Looking north. Note circular dovecote on right of picture

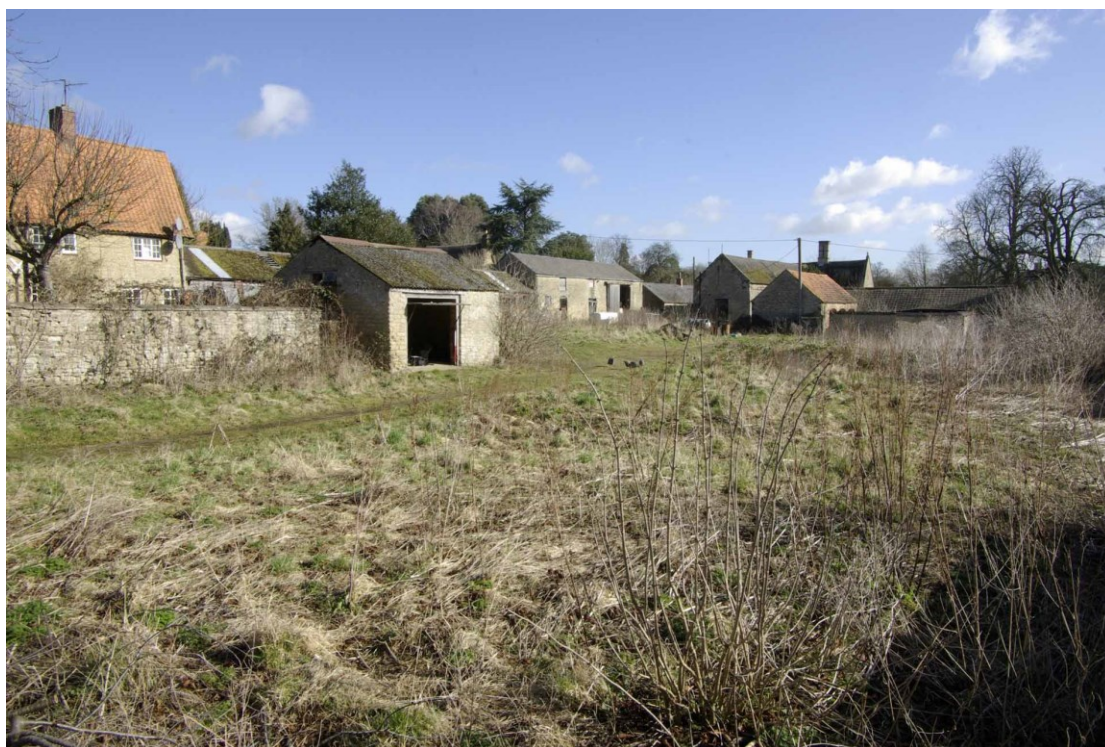
Figure 10 General view of farmyard
Looking north east. Building 3a is the orange pan tiled building right of centre

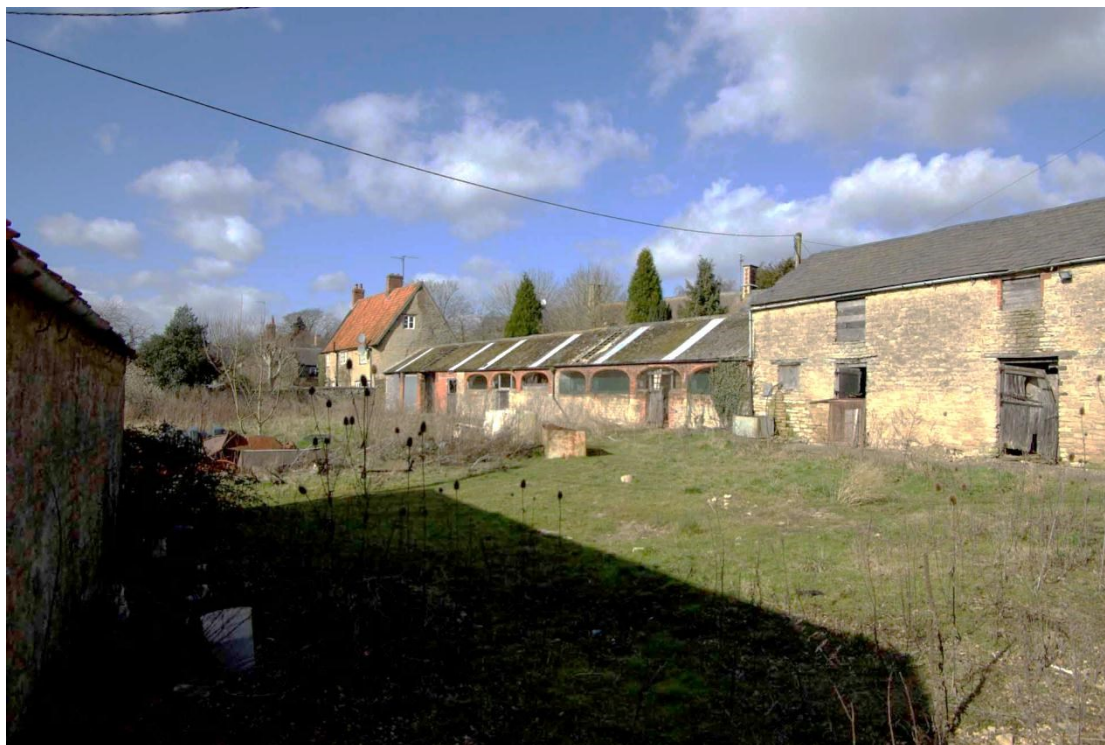
Figure 11 Farmyard

Looking north west. Building 2 on far right, corner of Building 3a just visible on left

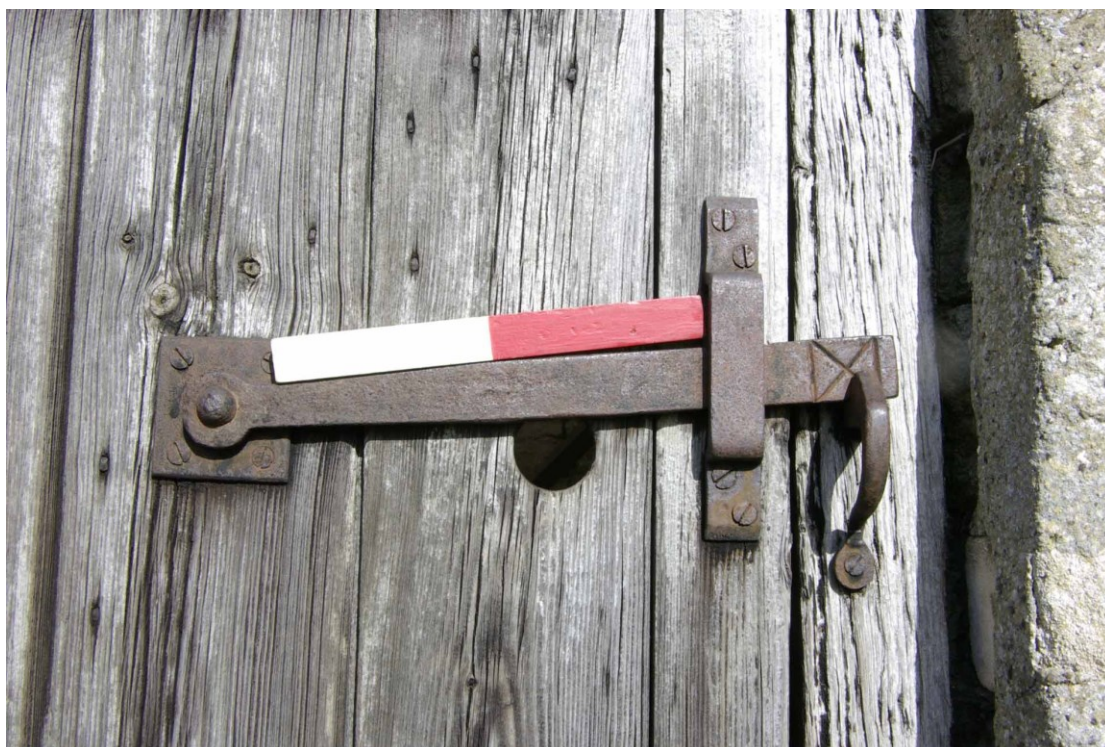
Figure 16 Latch on converted stable door
10cm scale

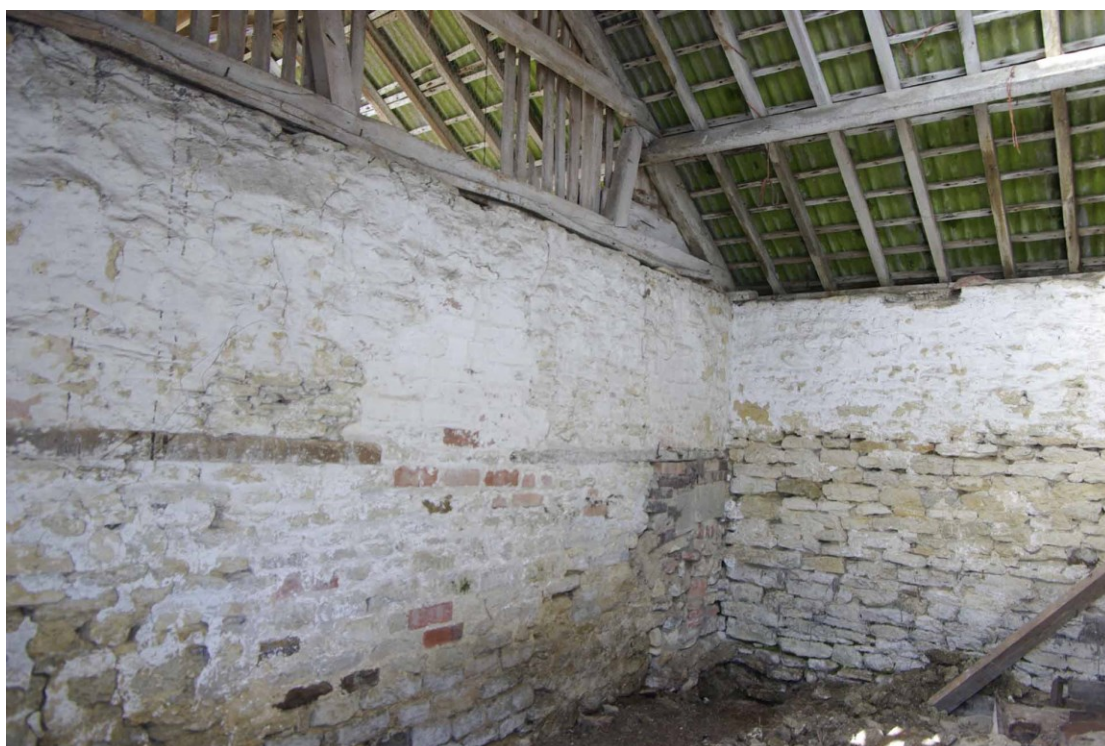
Inside, the western open bays have been divided into smaller spaces by a modern plywood partition and by an inserted wall of brick and limestone in the stable room (Fig. 18). The western end of the building has a distinct bulge on the eastern wall of

Figure 18 Building 1, inserted wall creating stable room from open bay
Looking north west

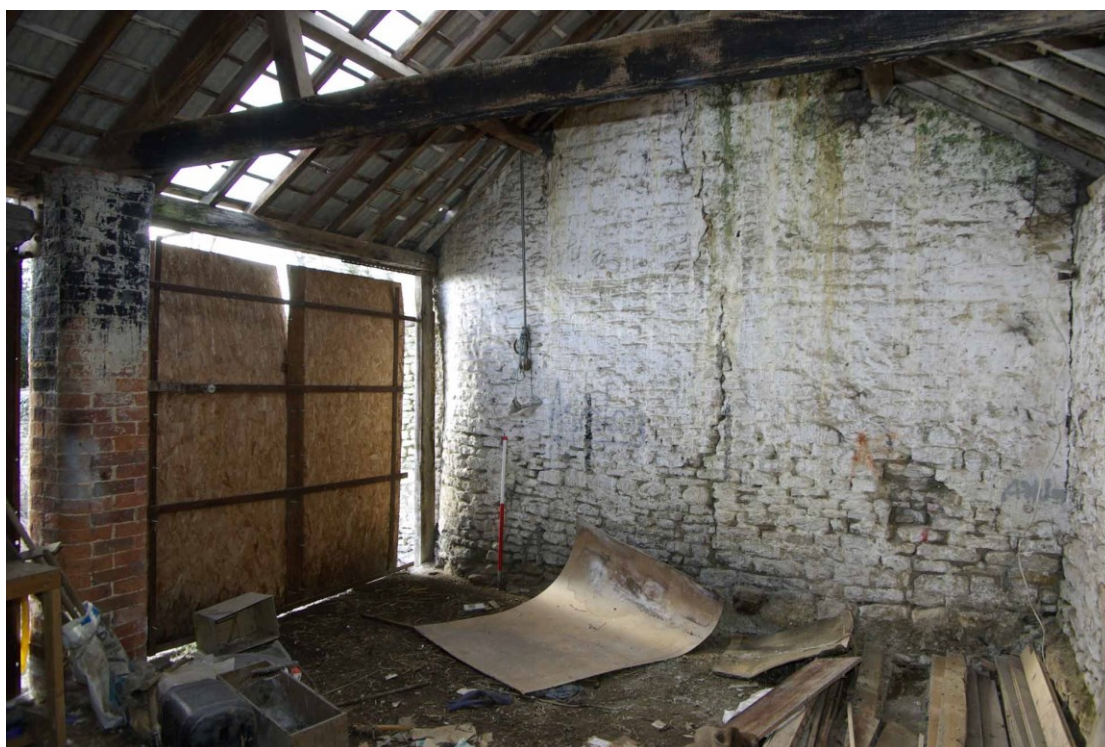
the farmhouse (Fig. 19). It is not clear what this is but may be part of a bread oven or similar feature within the house. The roof timbers appear to be of mid 19th century design with bolted raking struts and clasped purlins set below the principal rafters (Fig. 20). The collars in the western bays appear to be re-used as they have wide bird-mouth type notches cut into their upper sides. Possible apotropaic marks can be seen on the most westerly collar which are extremely faint but are in the form of an M and a W (Fig. 21). The lighting conditions were not good enough to photograph them properly but they took the form of:

Figure 19 Building 1, western end wall
Looking south west. 1m scale. Note curve on house wall to left of ranging pole

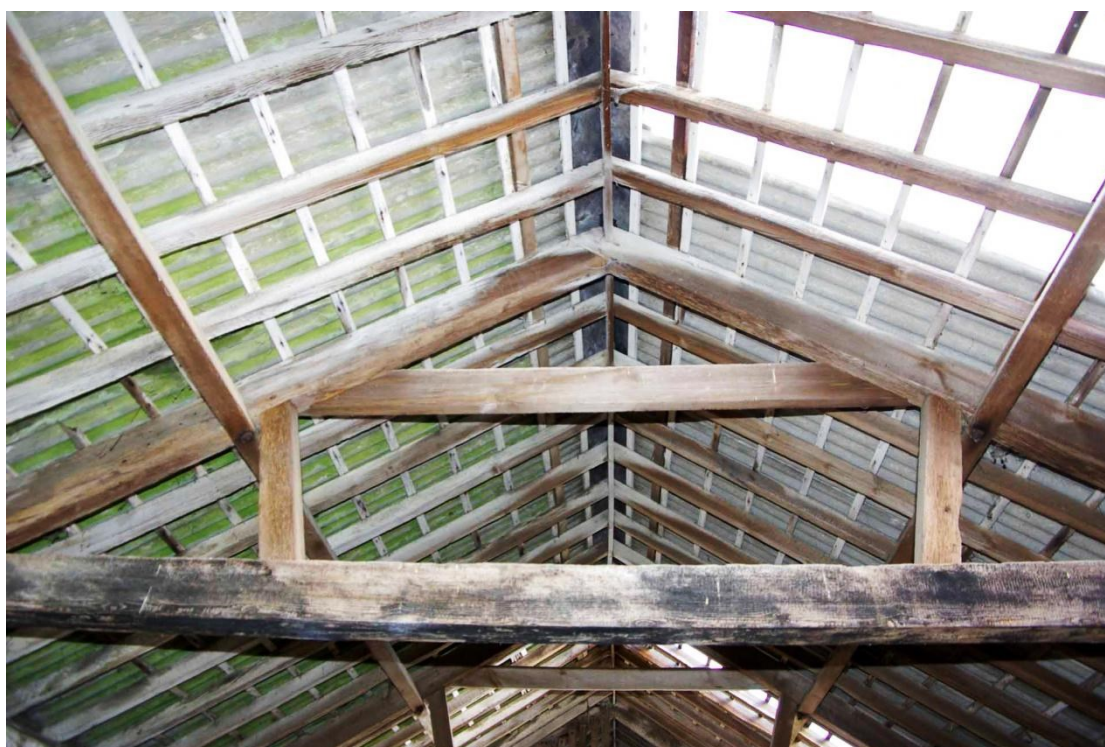
Figure 20 Building 1, roof structure
Looking east from west end of open bays

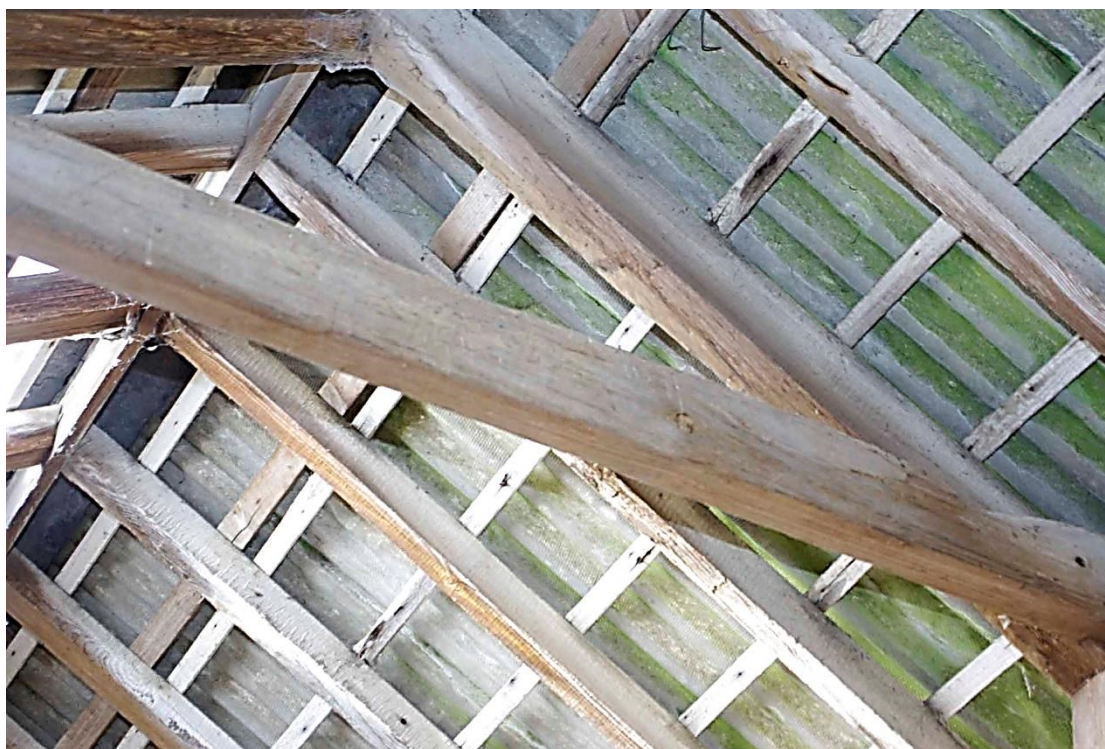
M W //

Figure 21 Building 1, westernmost roof truss
Re-used collar with apotropaic marks on (see text for details)

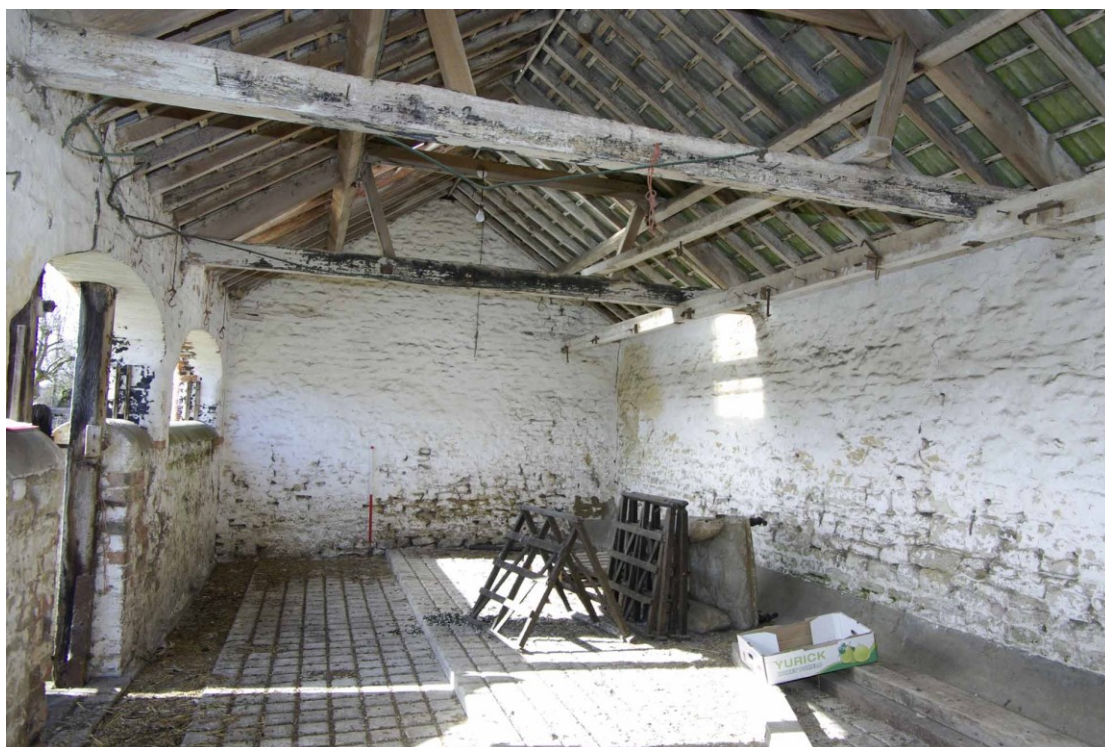
Figure 22 Building 1, west room of enclosed rooms
Looking north west. 1m scale. Note beam with hooks/latches attached to underside of
truss on right of picture

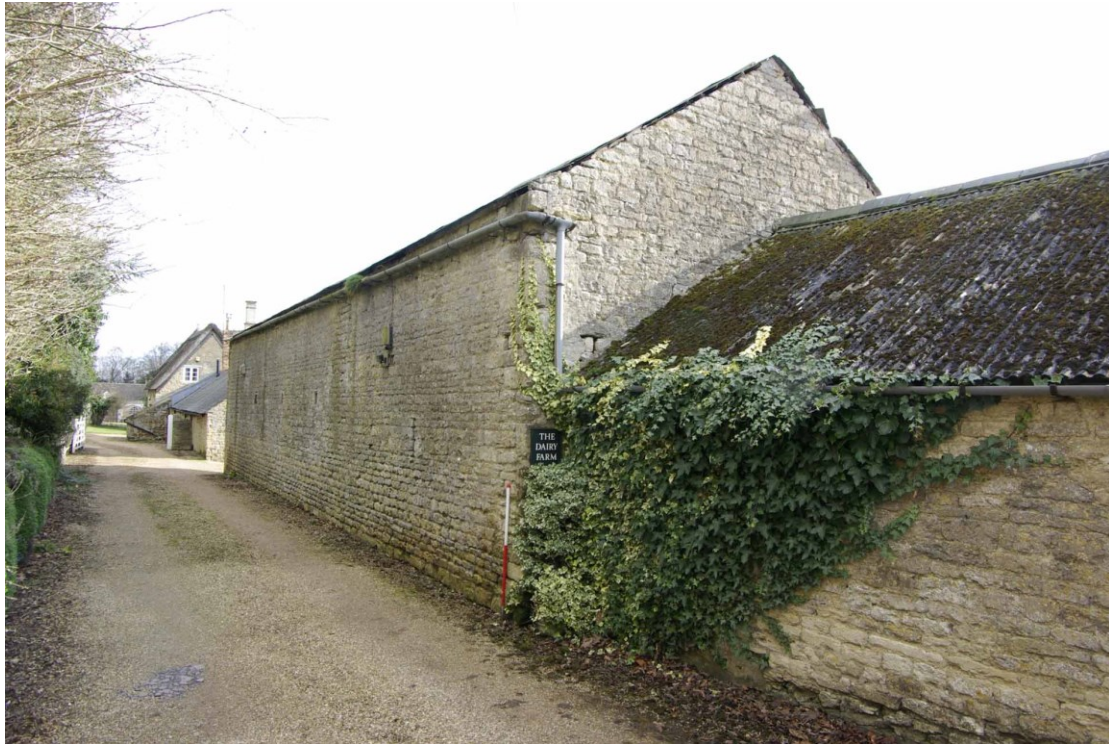
Figure 28 Building 2, north facing elevation
Looking south east. 1m scale. Building 1 on right of picture

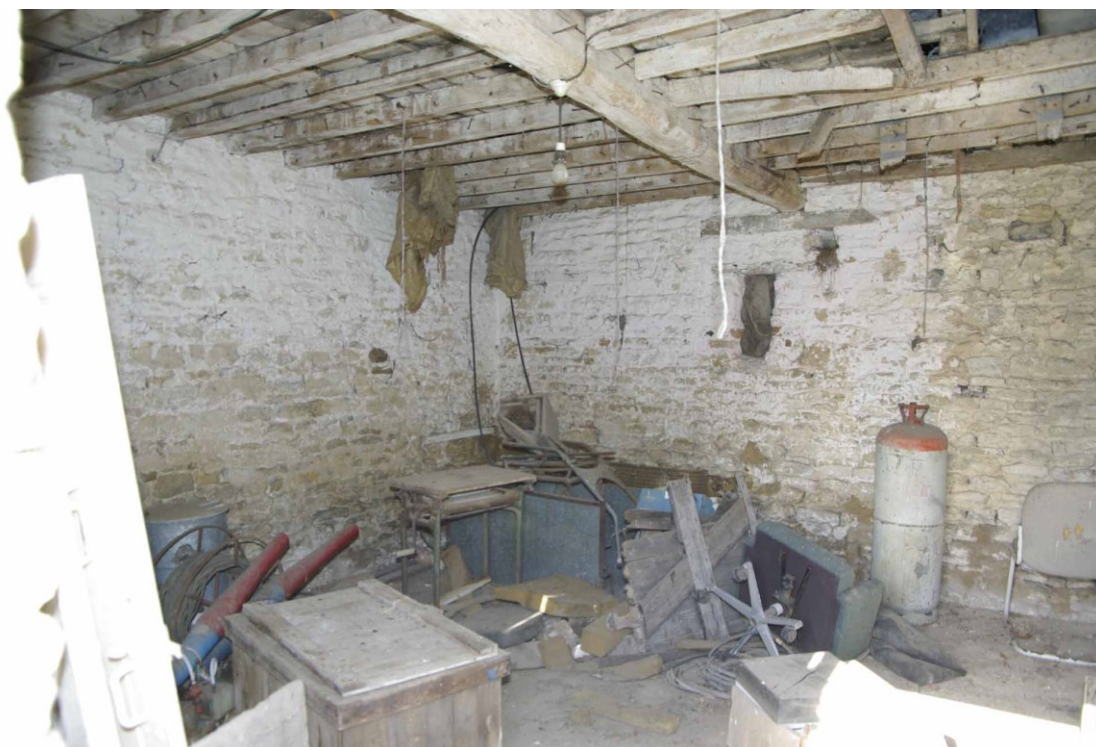
Inside the main part of the barn is of full height with a mezzanine type floor to the west and a separate ground and first floor at the far west end of the building (Figs. 32 and 33). The roof timbers appear to be of mid to late 19th century origin. The mezzanine floor leads to a wooden door through to the first floor of the western room (Figs 34 and 35). Much of the floor in this room is missing. The door appears to be reused and has handmade gate hinges and a wooden lock plate. The ground floor room below this is a plain room but the timbers supporting the first floor appear to be reused (Fig. 36).

Figure 36 Building 2, western ground floor room
Looking north west

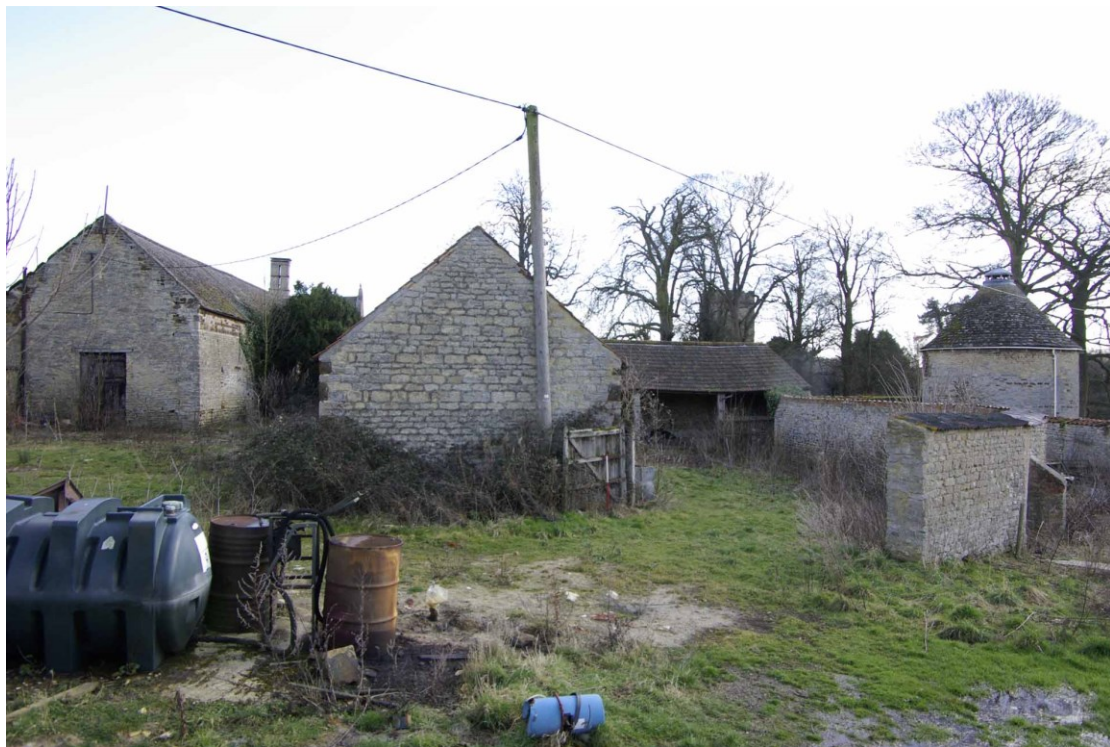
Figure 37 Building 3a location

Looking east. Building 3a in centre of picture, 3b to right with Dovecote on extreme right. The barn on the left belongs to the farm house and is not part of the survey. The listed farmhouse building chimney can be seen to the left of Building 3a

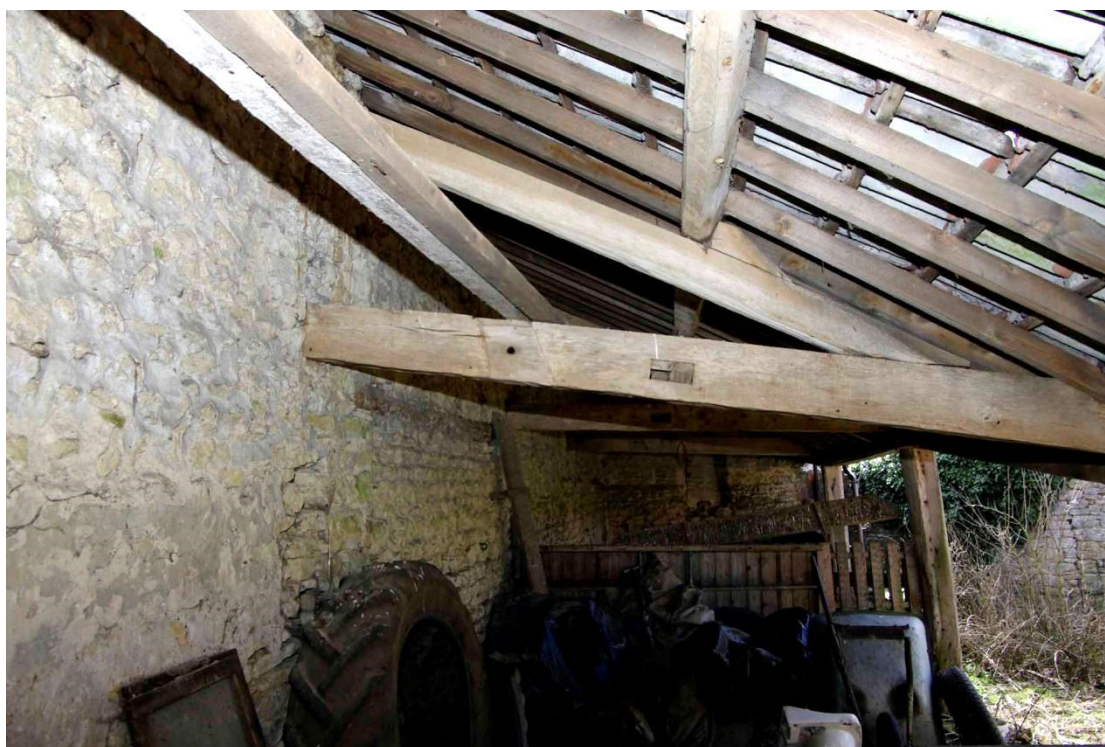
Figure 44 Building 3b roof structure
Looking south. Note re-used timbers

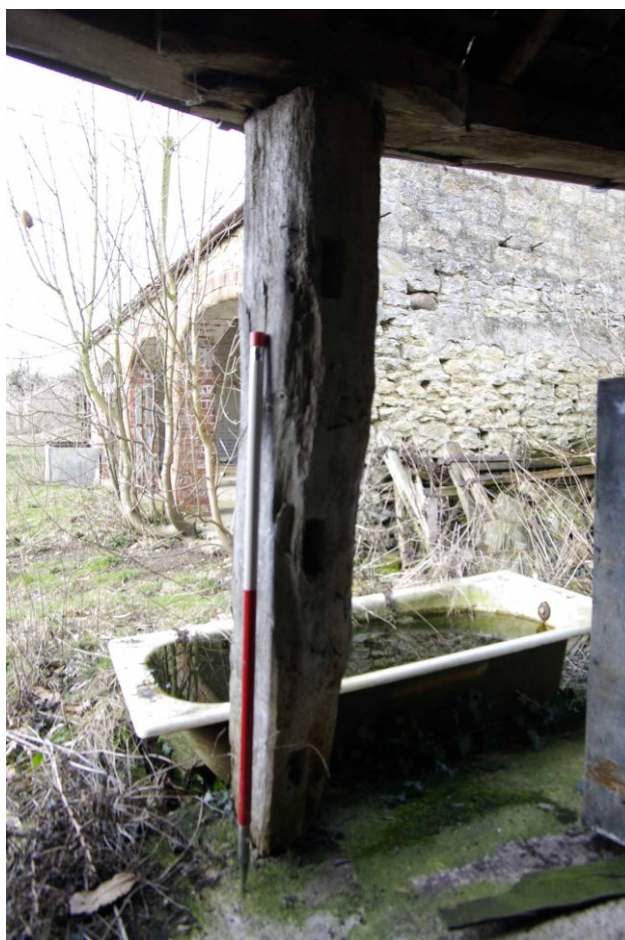
Figure 45 Building 3b, timber post
Looking north west. 1m scale. Note Building 3a behind

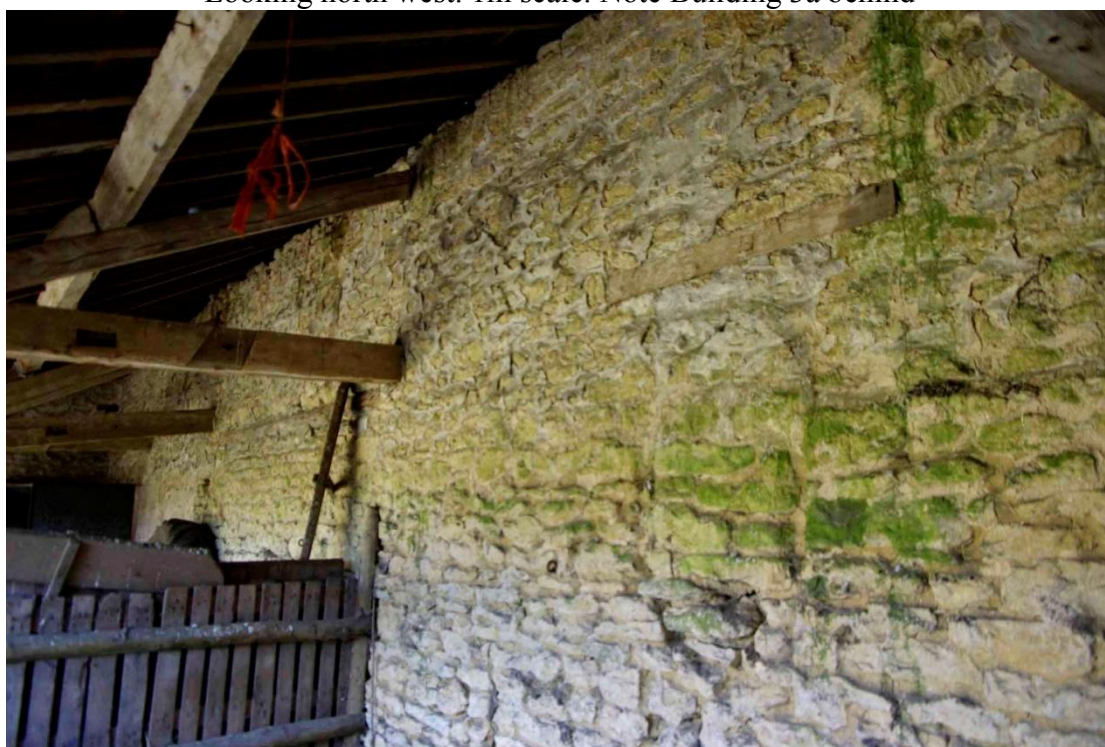
Figure 46 Building 3b, blocked window
Looking north east. Not also re-used roof truss.

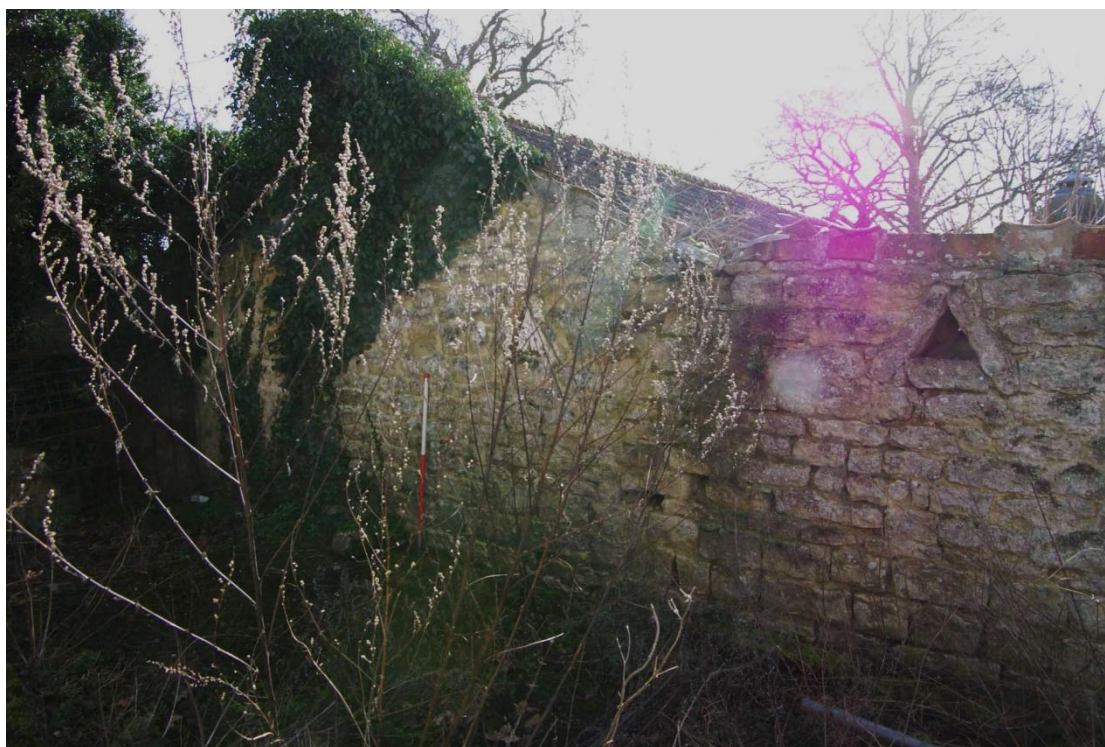
Building 3b is a long single-storey lean-to type structure on the south eastern side of the site. It consists of a pitched roof supported by a limestone rubble wall on the east side and timber posts on the west side (Fig. 43). Much of the timber, including the posts, appears to be re-used from elsewhere. The roof trusses have redundant mortice holes and the principals and cleated purlins are of varying sizes (Fig. 44). The support posts along the front of the building have stop chamfers (badly worn) and are again of different sizes (Fig. 45). The eastern wall has evidence of two blocked windows and a blocked door near to the southern end. The openings, which have timber lintels, have been blocked with coursed limestone rubble and, due to the weathering of the stone, appear to have been closed for a considerable time (Fig. 46). The east facing elevation of this wall is on private property so could not be inspected. Another blocked window can be seen on the south facing elevation. A short length of stone wall joins the north east corner of Building 3a and the north west corner of Building 3b. The joining wall appears to be keyed into both buildings although there are irregularities in the joint with Building 3b which suggests that this is a later modification possibly added when Building 3a was built. The joining wall has a partially blocked small triangular opening near to the centre (Fig. 47).

Figure 47 Wall joining northern ends of Buildings 3a and 3b
Looking south east. 1m scale resting against north wall of Building 3b. Note
triangular opening in wall
