**A Level 2 Historic Building Survey
The Coach House,
9b Misterton Way,
Lutterworth,
Leicestershire.**

ULAS Report No. 2015-037v2
©2015

**A Level 2 Historic Building Survey at
The Coach House, 9b Misterton Way,
Lutterworth,
Leicestershire.**

For: Life Space Design Studio Limited

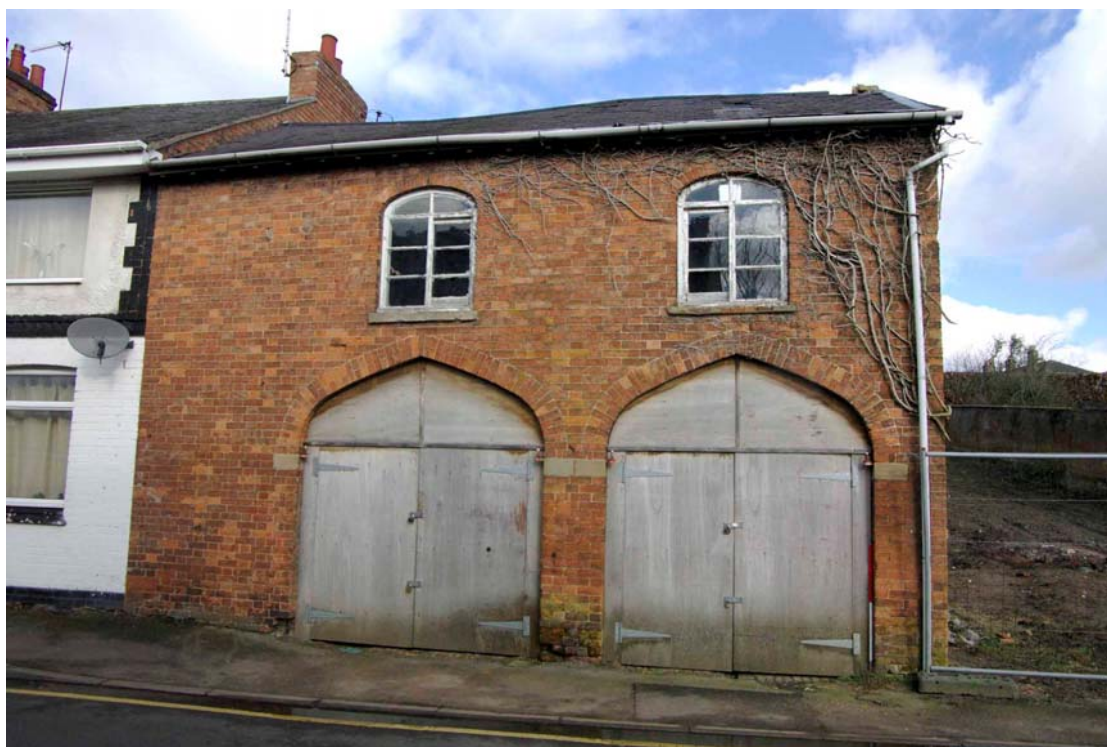
The two-storey building is built of red brick laid in courses of alternating headers and stretchers. The pitched and gabled roof is covered with slate and has a single chimney stack on the north side. The south-facing elevation onto Misterton Way, is the principal elevation and has two ground-floor coach doors with wide four-centred Gothic arches made of segmental brick (Fig. 9). The arches are pointed but quite shallow and are of equal width. The pintles for the original hinges are still present with the upper pairs being set on top of limestone blocks giving a slight decorative effect (Fig. 10). The original doors have been replaced by modern plywood doors. The first-floor windows appear to be original and are wood-framed horizontal sliding sashes with three panes in each and with two upper panes set below brick arches. The sills are brick with later cement repair.

Figure 9 Coach House south facing elevation
Looking north. 1m scale

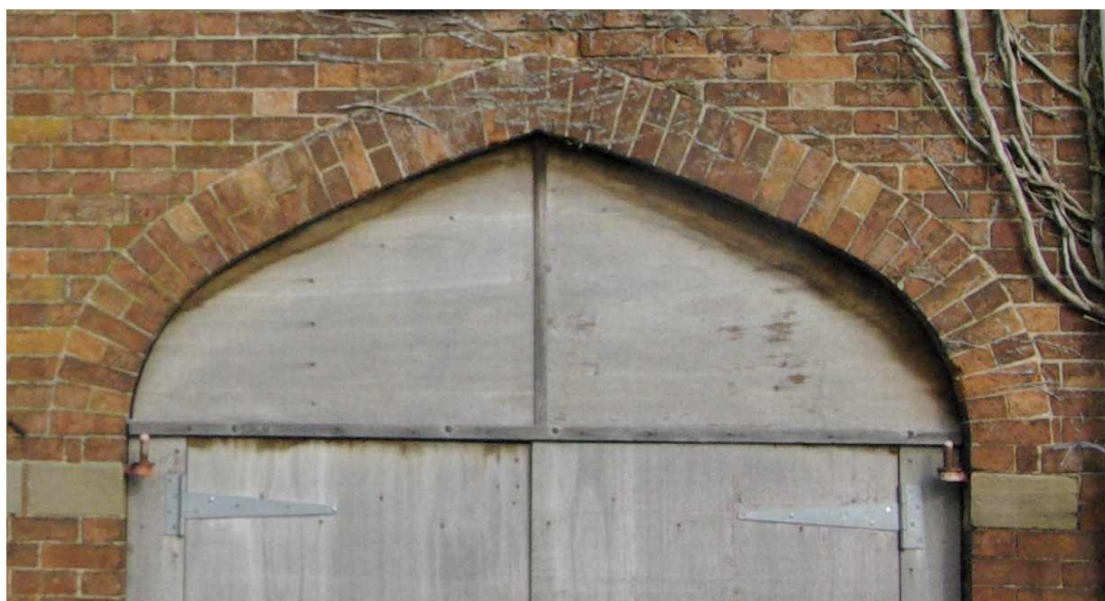
Figure 10 Arch and pintle detail

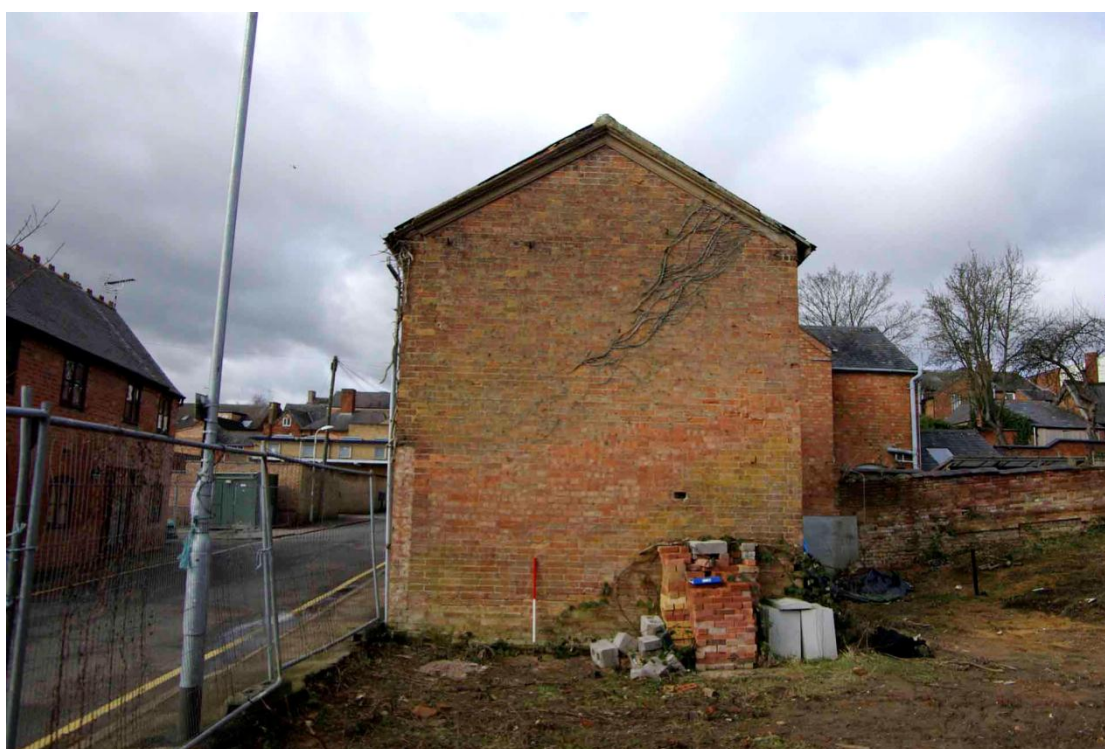
The west-facing elevation is obscured by the later row of terraced houses which butt against the Coach House and which also have a higher roofline than the Coach House. The east-facing elevation consists of a plain flat gable end (Fig. 11). The top of the gable has a moulded decoration which is not repeated on any of the other elevations (Fig. 12). This appears to be made of limestone although it is also possible that it is of cement.

Figure 11 East facing elevation
Looking west. 1m scale. Note wall scar on south corner of the Coach House

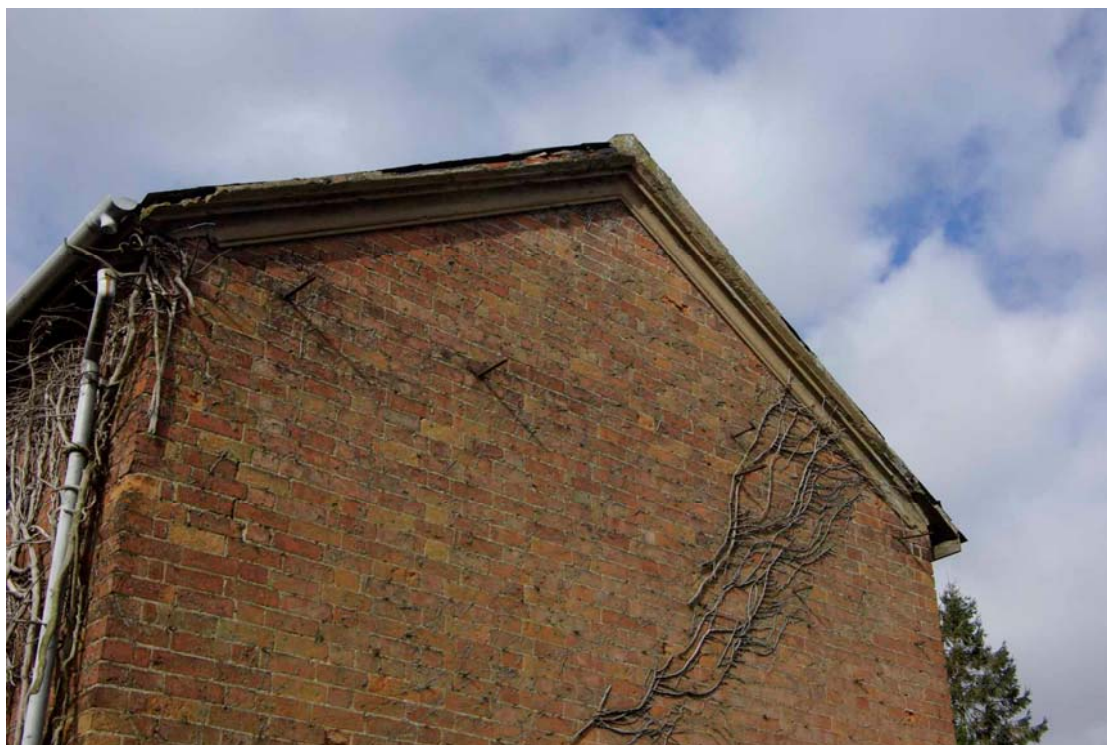
Figure 12 Moulding detail on east facing elevation

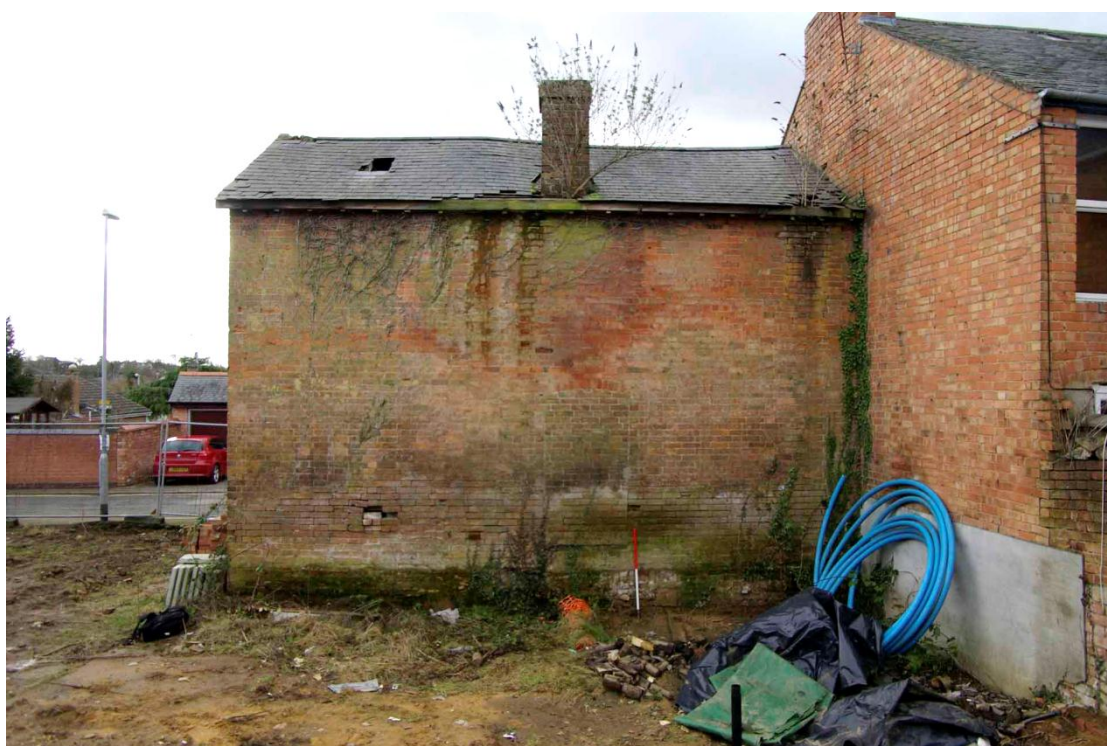
The north-facing elevation is plain brick but has a blocked single-width doorway in the centre (Figs. 13 and 14). The blocked doorway has a brick arch made of brick headers and is set approximately 0.75m above current ground level. There is no evidence of a ramp or steps associated with the door. Presumably this was used to reach the pump shown on the First Edition Ordnance Survey map. Approximately 1m east of the blocked door at ground level, and partially covered by soil, is the top of a brick arch (Fig. 15). The function of this is unclear although it may be a relieving arch supporting the internal north to south wall. Alternatively it may be an entrance to a cellar although this seems a little unlikely. There is no evidence of a corresponding arch on the south elevation. A single-flue brick-built chimney stack rises out of the roof at gutter level.

Figure 13 North-facing elevation
Looking south. 1m ranging pole is just to right of blocked door

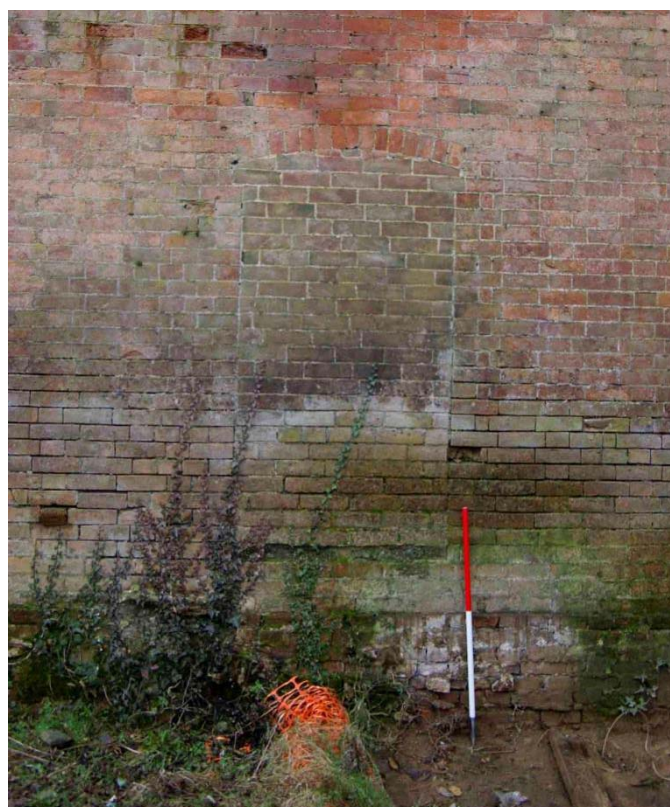
Figure 14 Blocked doorway, north-facing elevation
Looking south. 1m scale

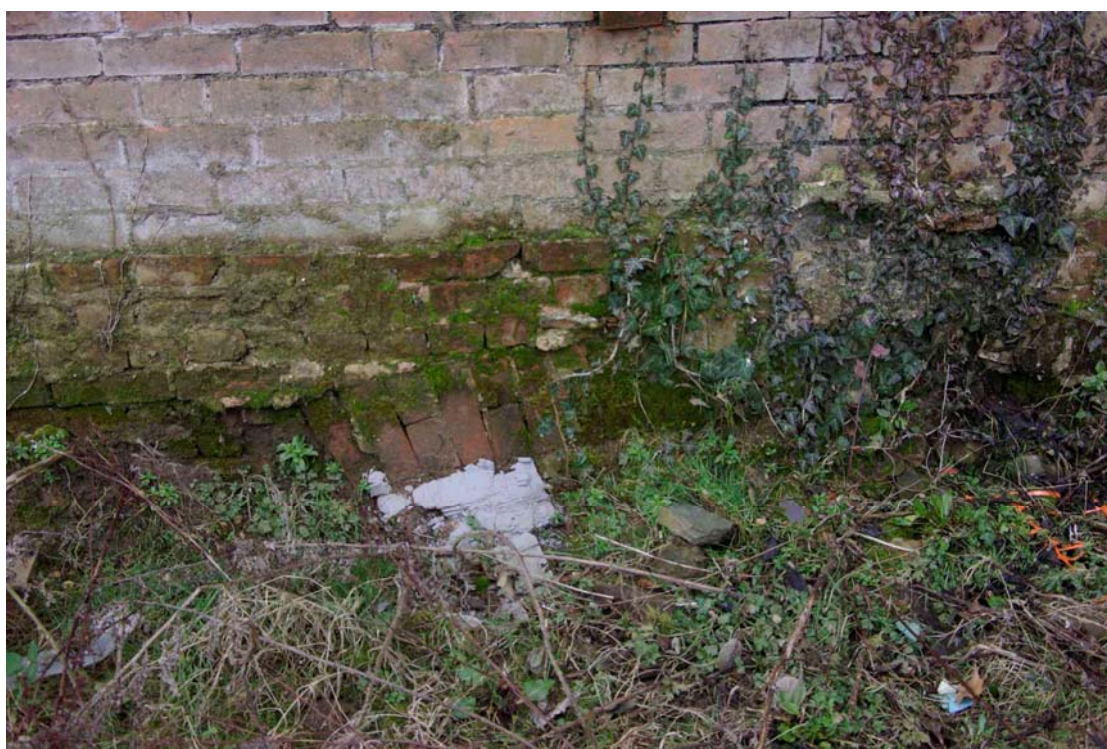
Figure 15 Arch at ground level on north-facing elevation
Looking south

The style of the building and the choice of materials indicates a mid to late 19th-century construction date. The four-centred Gothic arches would suggest the most likely period being the 1860s or possibly as late as the 1870s. Despite the lack of fixtures and fittings the building has managed to survive relatively intact until the present day. The blocked doorway and later chimney stack on the north wall being the only evidence of different phases. The brick arch seen at ground level on the north wall is not a blocked entrance to a cellar as suspected. It seems more likely to be an attempt at strengthening the shallow foundations at the point where the building was slightly heavier.

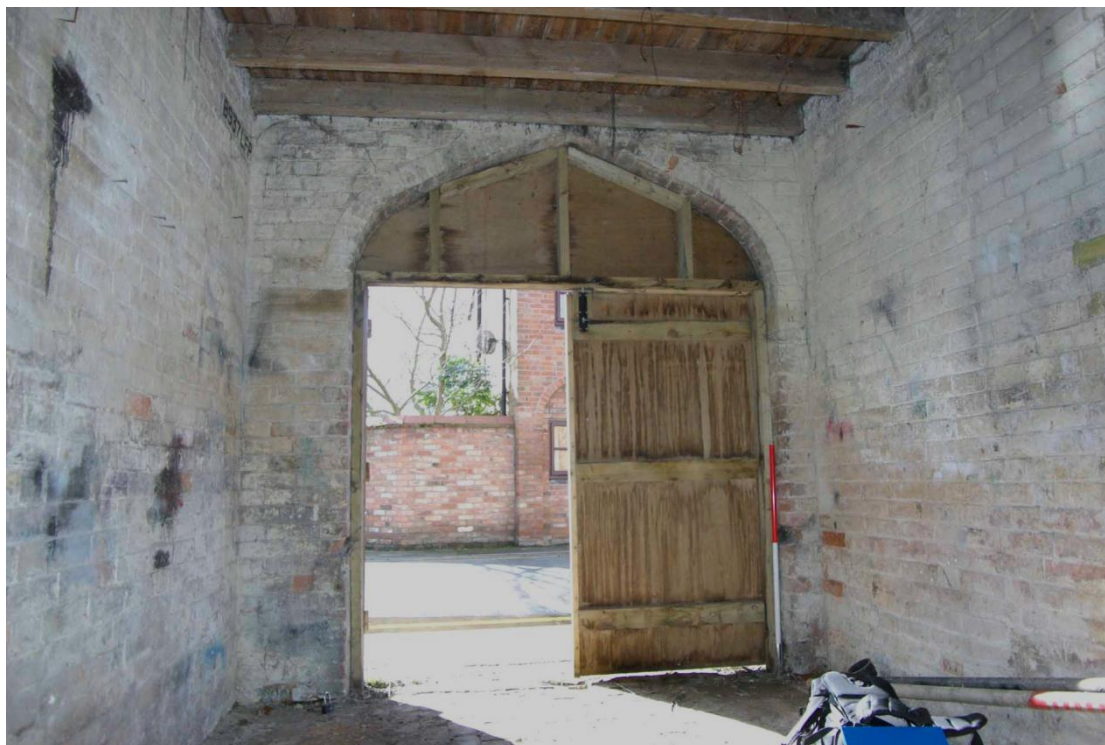
The ground floor is divided into two rectangular rooms of unequal size. The eastern room is the smallest and has a blue-brick floor with a truncated chimney stack cut off just below ceiling height on the west (outside) wall (Figs. 16 and 17). The top of the ground level arch seen on the north facing elevation can just be seen in the north-west corner of the room. The floor joists of the first floor are exposed showing the underside of the floor boards. There is no evidence of any fixtures and fittings.

Figure 16 Ground floor east room
Looking south. 1m scale

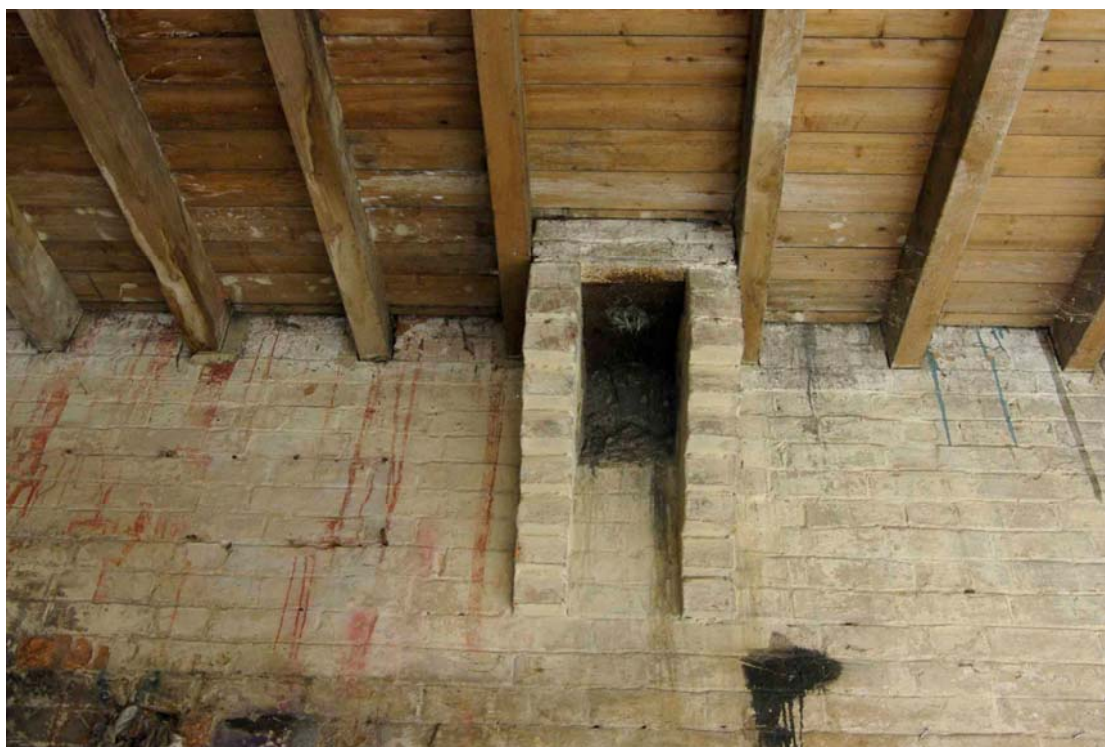
Figure 17 Ground floor east room, truncated chimney on west wall
Looking west

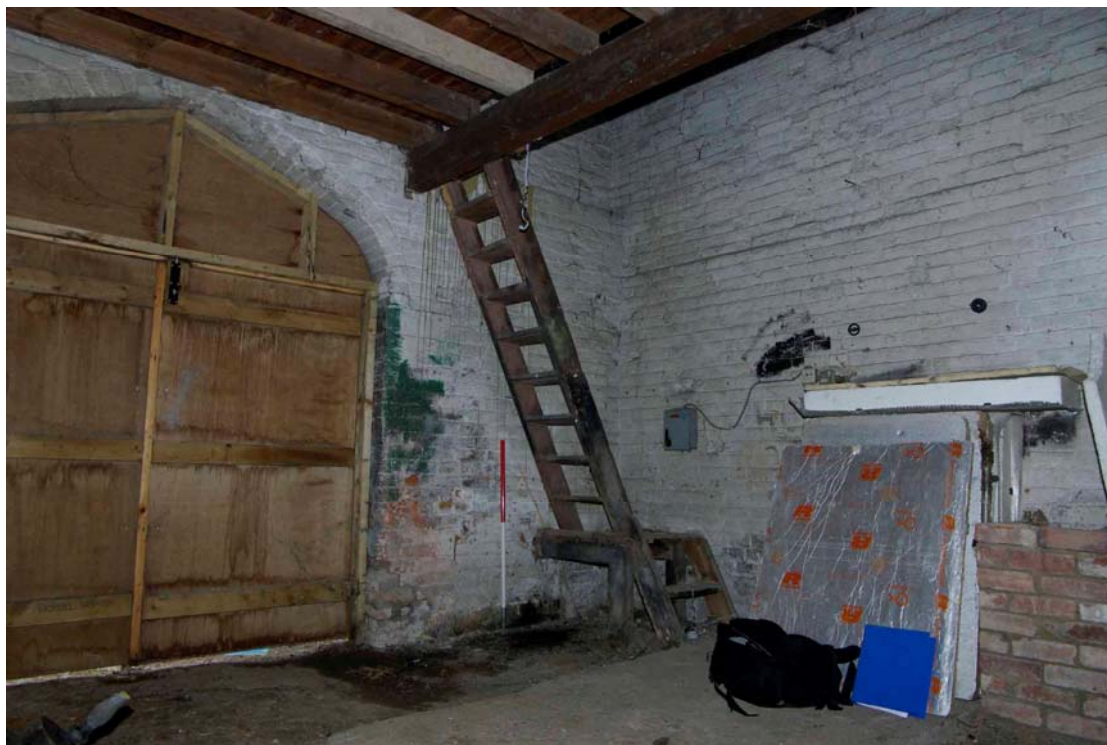
The western room is slightly larger as this contains the wooden staircase leading up to the two first floor rooms. The stairs are at the west side of the room where the first floor stops short to create a mezzanine type floor (Figs. 18 and 19). The floor is quite uneven and has a mix of cement and earth. The doorway on the south wall has rounded bricks at either side unlike the east room which has squared bricks. Two plinths made from modern bricks have been built against the west wall which appear to have served as a small bench. The north wall has another truncated chimney which partially overlies the blocked doorway indicating that the chimney is a later addition. The top of the ground-level arch can be seen in the north-eastern corner. The fact that this does not sit directly below the dividing wall suggests that it may not be a relieving arch. As in the eastern room there are no fixtures and fittings which relate to any former uses of the room.

Figure 18 Ground floor, west room
Looking south-west. 1m scale

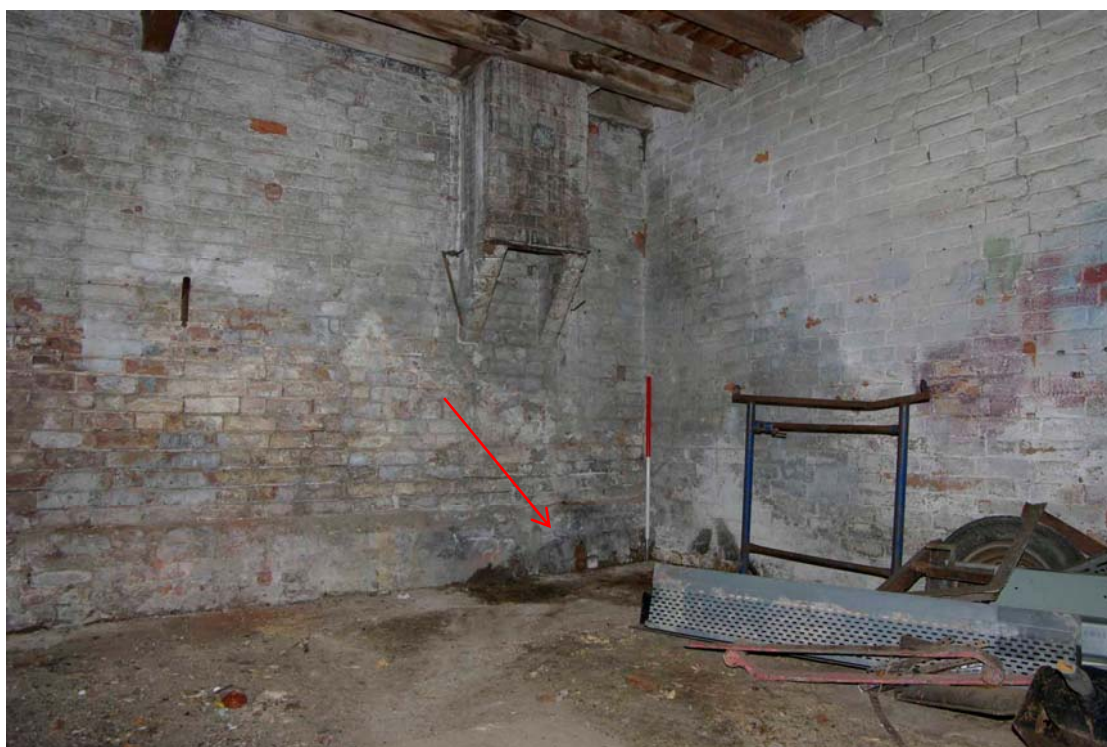
Figure 19 Ground floor, west room
Looking north-east. 1m scale
Note truncated chimney and ground floor arch (arrowed)

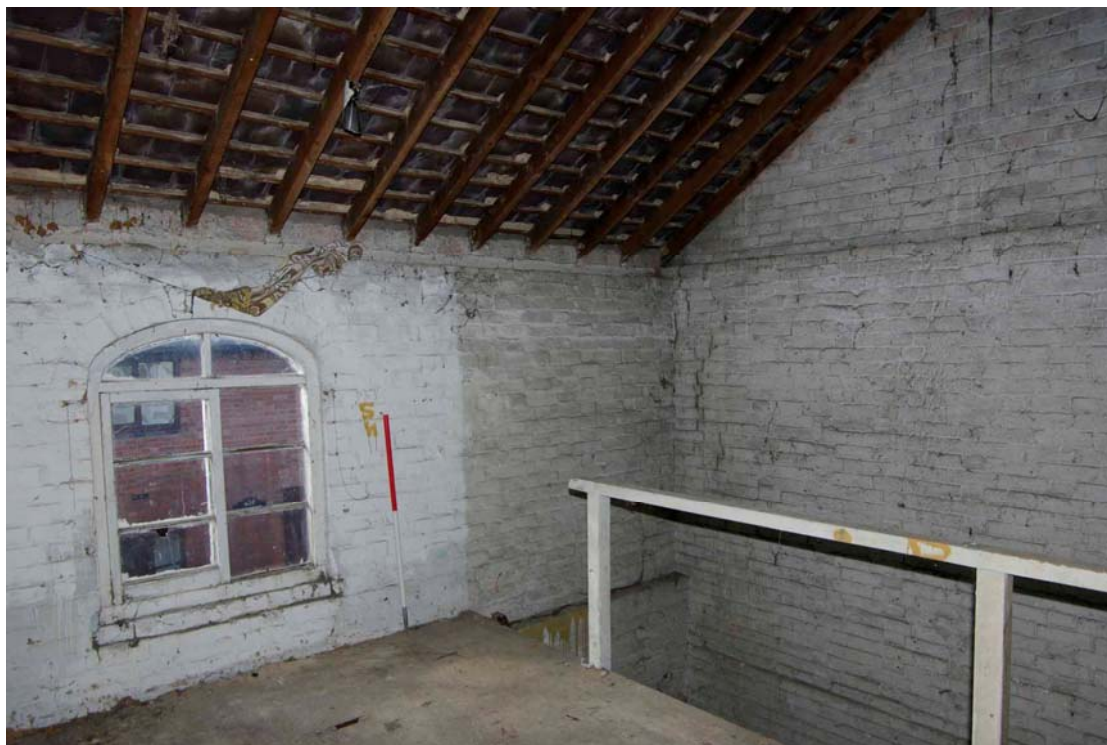
The open wooden stairs lead up to the first floor west room. As noted, the floor of this room only covers approximately two thirds of the space with the westernmost end being open down to the ground floor (Figs. 20 and 21). The window on the south wall has a horizontal sliding sash (Fig. 22). The chimney stack extends up through the roof on the north wall. The doorway into the east room is the only access to this room and is a simple rectangular opening. The roof is supported on common rafters with no evidence of purlins or other supporting timbers. The rafters appear to be in a good condition and may be 20th century replacements.

Figure 20 First floor, west room
Looking south-west. 1m scale

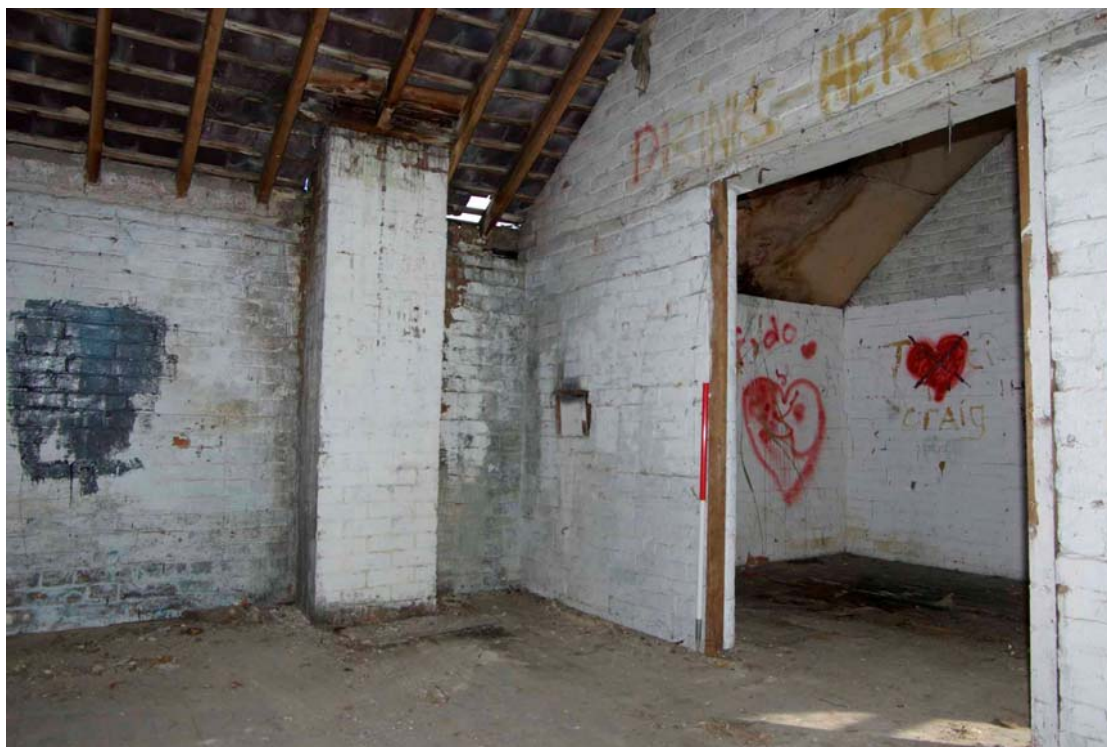
Figure 21 First floor, west room
Looking north-east. 1m scale

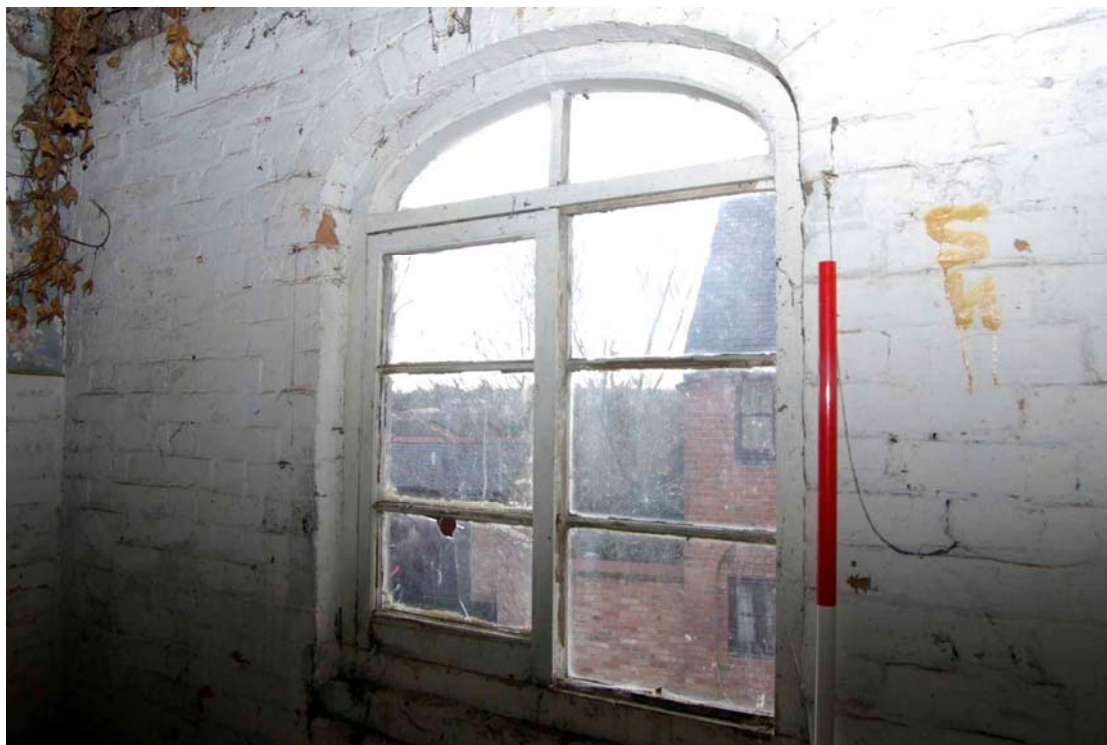
Figure 22 First floor, west room. Sash window
Looking south-east. 1m scale

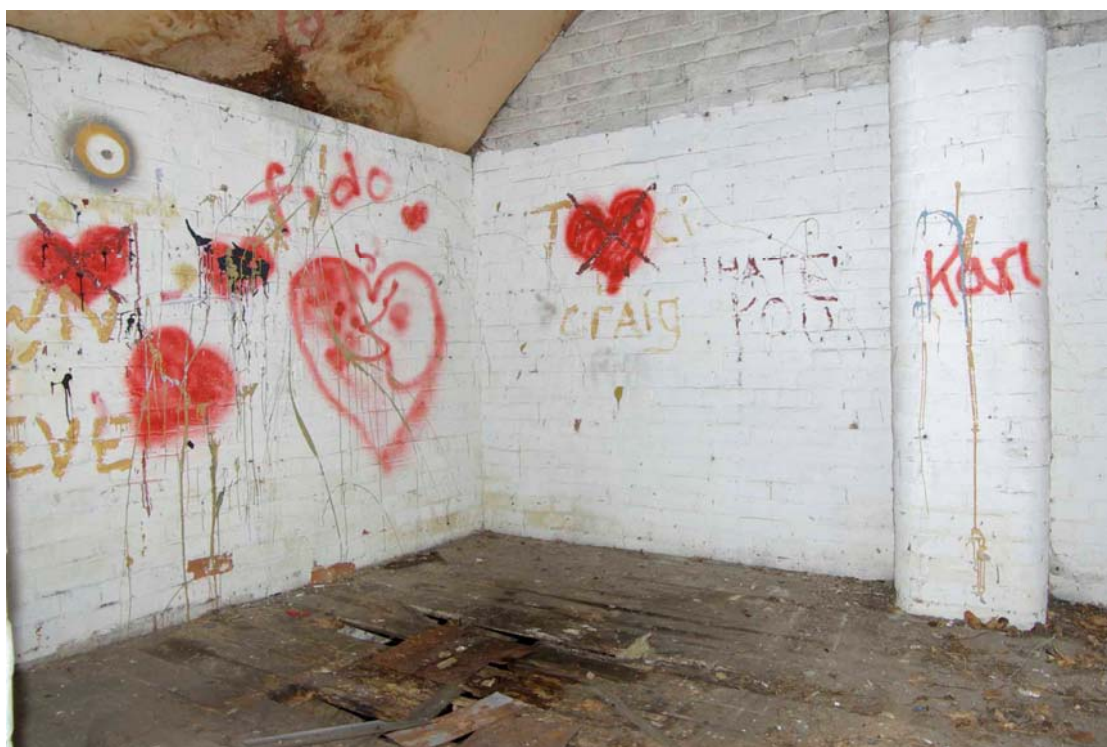
Missing slates in this room has caused the floor to rot and partially collapse. The room has the same design horizontal sliding sash and has a chimney stack in the centre of the east wall (Figs. 23 and 24). Unlike the stack in the west room this has rounded bricks which suggests a different construction date.

Figure 23 First floor, east room
Looking north-east

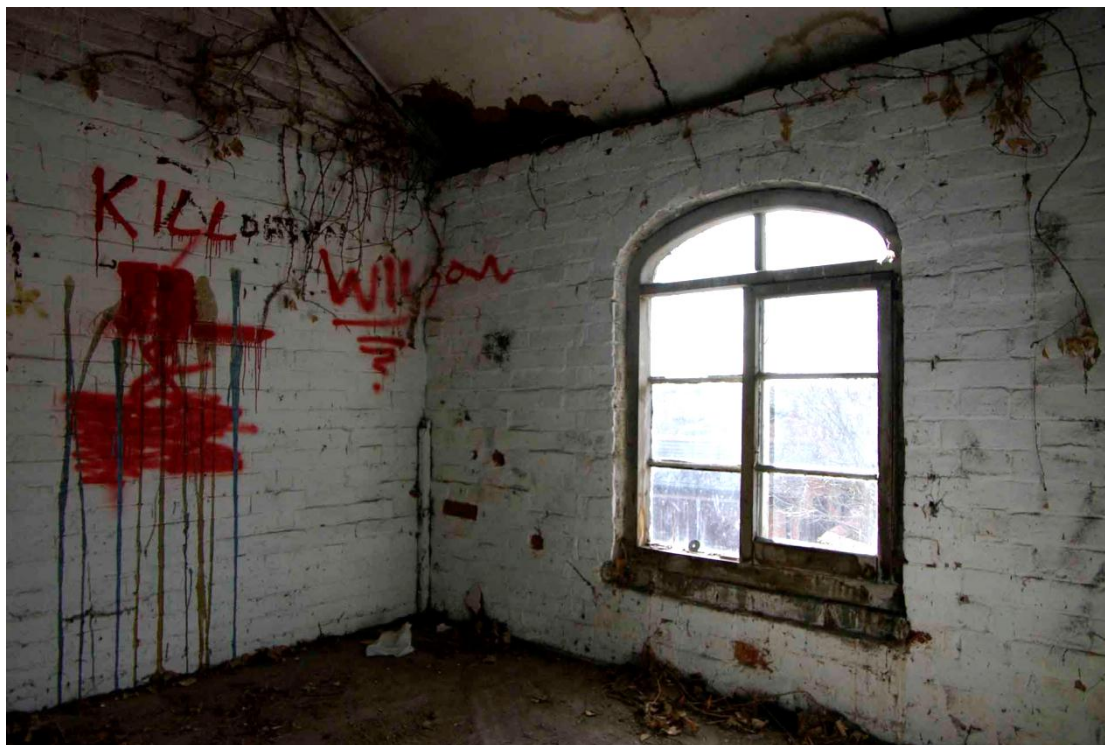
Figure 24 First floor, east room
Looking south-east

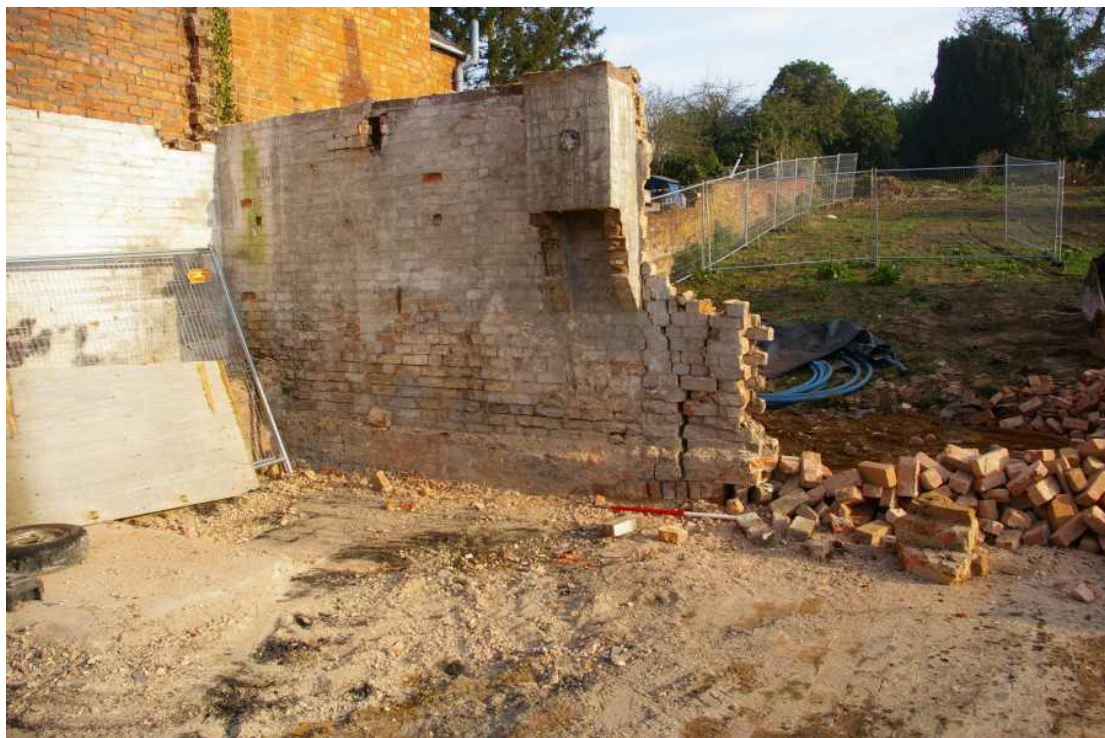
A return visit to the site was made on the 10th of April 2015 in order to further investigate the reason for the brick arch seen at ground level on the north facing elevation. The previous day the front (south) wall and roof had been removed and taken away in large lorries which were using the floor of the Coach House as a hard-standing loading area. No sinking or collapse of the floor could be seen which suggested that no cellars would be present. The north wall was taken down on the 10th in a controlled way using a 360⁰ mechanical excavator taking particular care around the area of the arch (Fig. 25). Complete removal of the wall showed it to have minimal foundations of only three bricks below current ground level. These bricks rested on the natural orange brown clayish sand substratum (Fig. 26). The brick arch also sat directly on the natural leading to the conclusion that it was designed to be a rather crude attempt at a relieving arch designed to support the additional weight of the internal cross wall and the chimney stack at this point. As a further check for a possible cellar part of the floor was removed in both rooms which revealed more undisturbed natural clayish sand natural (Fig. 27).

Figure 25 North wall during demolition
Looking north west. 1m scale

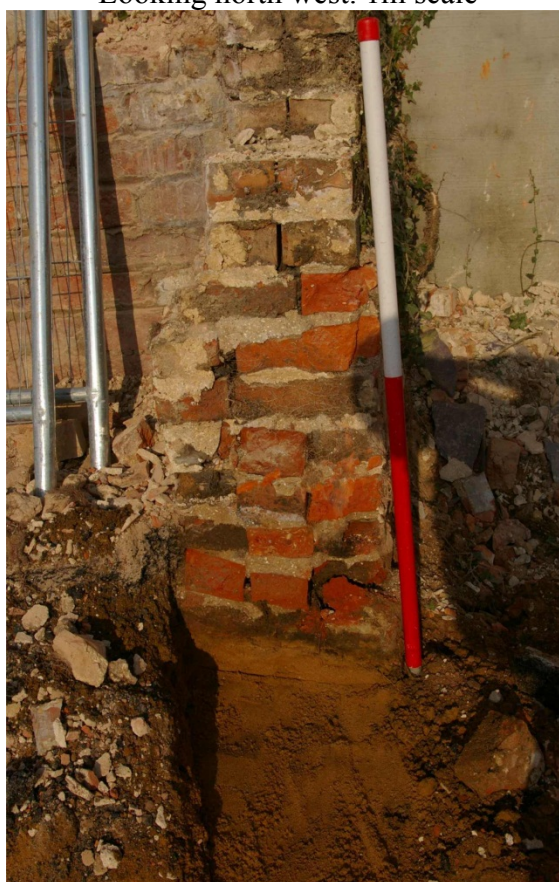
Figure 26 Section across north wall
Base of metal fencing is resting on the internal ground floor level.
Looking west. 1m scale

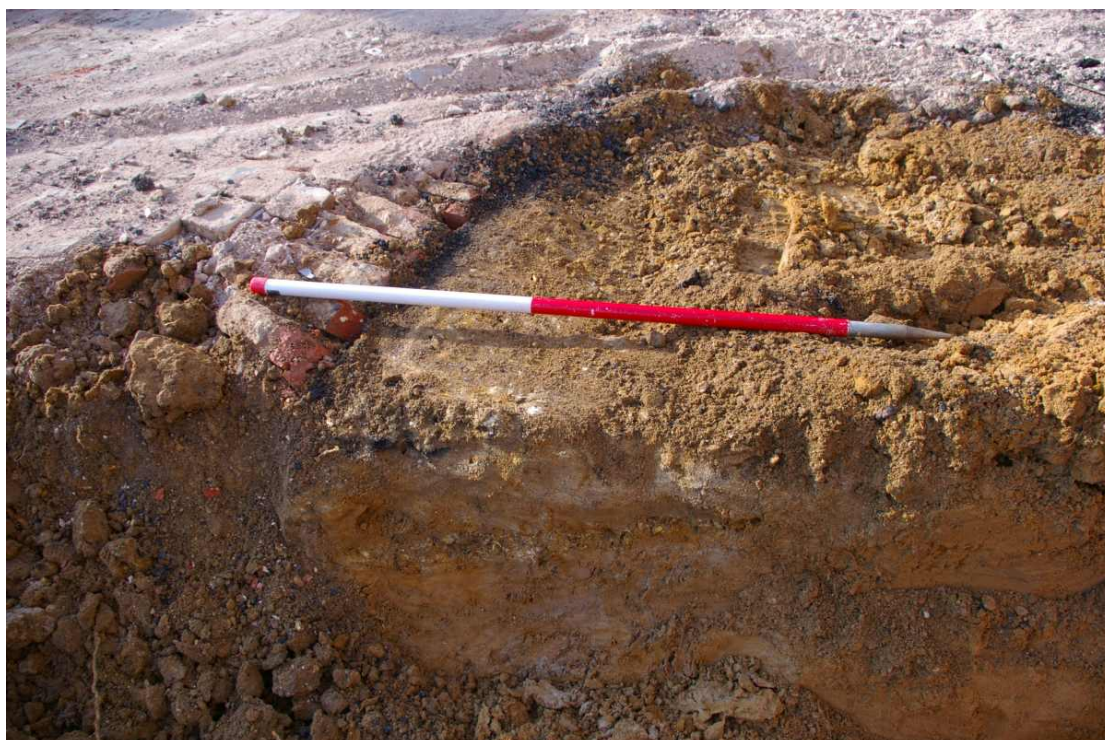
Figure 27 Section through floor after removal of the brick arch
Looking south. Bricks at end of 1m scale are the base of the internal cross wall
