**A Level 2 Historic Building Survey at  
The Old Barn,  
Merry Tom Lane, Brixworth,  
Northamptonshire.**

**NGR: SP 744 694**

**ULAS Report Number 2016-022**  
©2016  
Event Number ENN108218

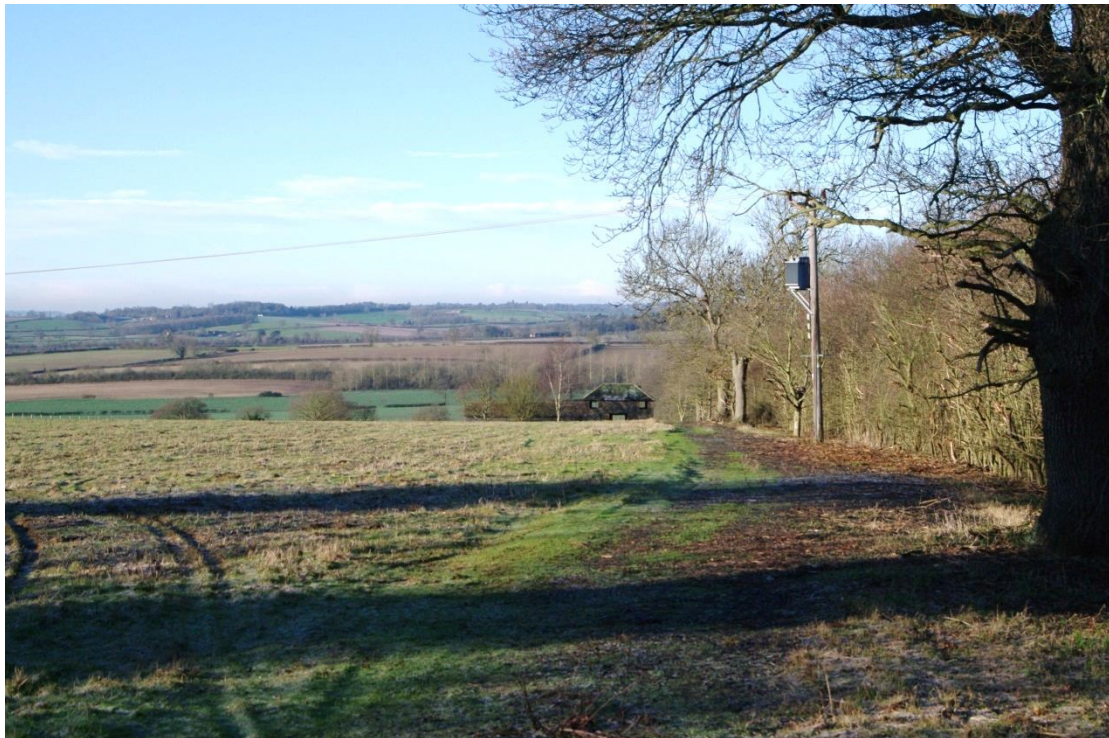
Figure 5 The Old Barn seen from Merry Tom Lane  
Looking west

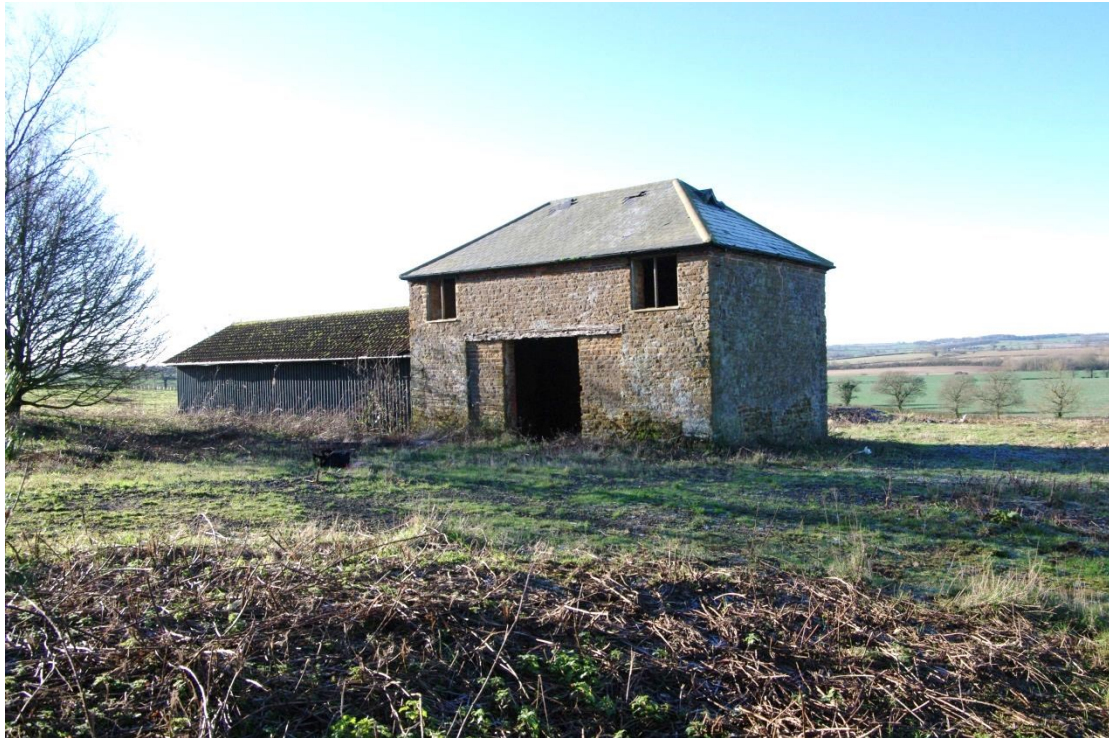
Figure 6 General view of both barns  
Looking south-west

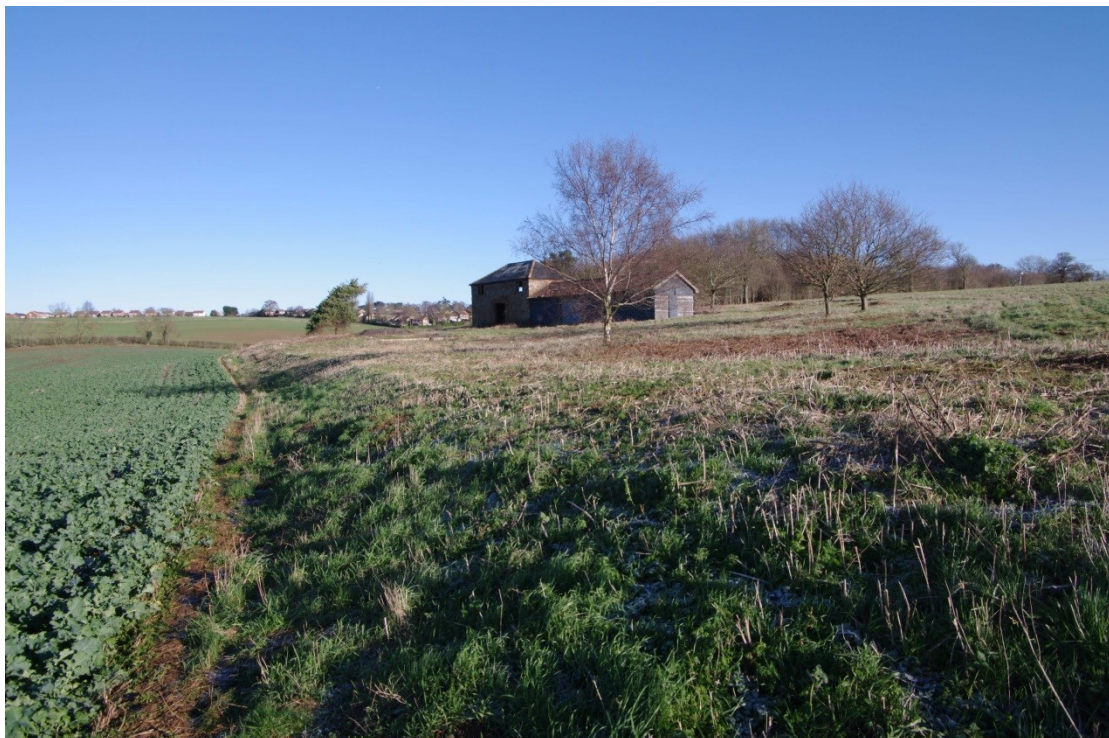
Figure 7 General view of both barns  
Looking north-east. Note earthwork embankment for building terrace. Outskirts of  
Brixworth on the horizon

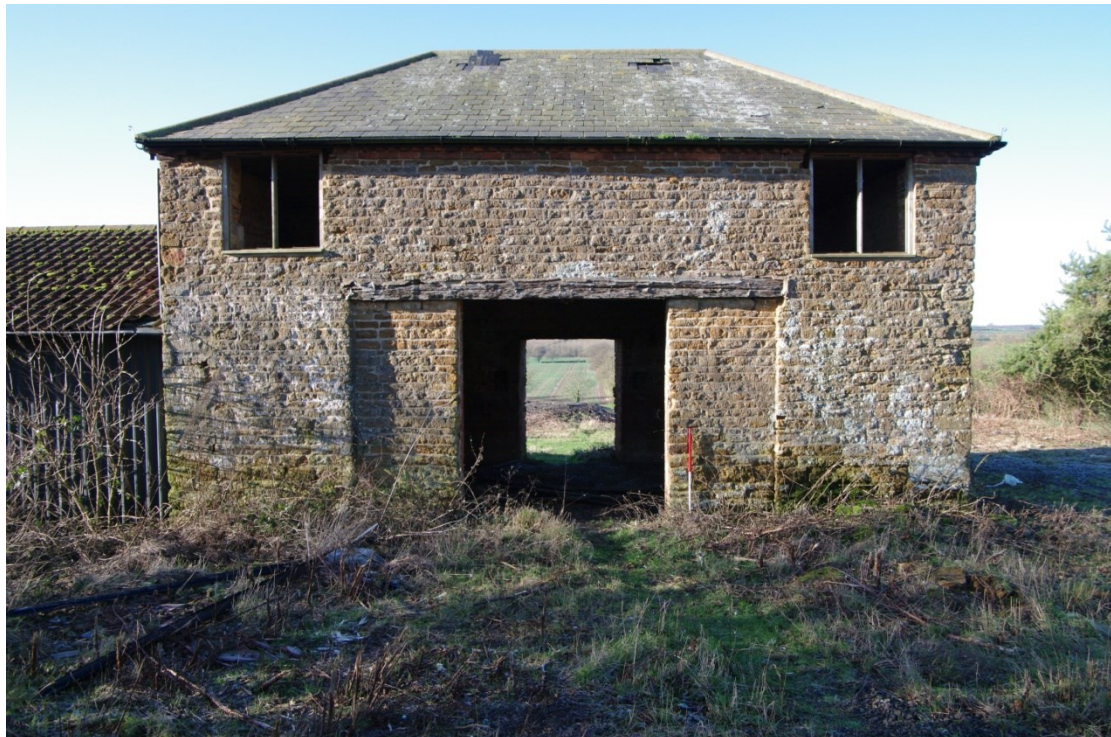
The east facing elevation looks up the track towards Merry Tom Lane (Fig. 9). At ground floor level there is a wide recessed section with a timber lintel. Within the recess is a doorway which has no evidence of a surviving doorframe or fittings. The timber lintel, which is made from three separate re-used lengths of wood, sits on top of the recessed stonework and is not embedded in the thicker part of the wall (Fig. 10). This suggests that the entire doorway has either been rebuilt or that the original design incorporated this recess perhaps to accommodate sliding doors which would not catch the wind in such an exposed spot. There is no other evidence of a rebuild so it is concluded that the doorway was originally built in this fashion. The internal parts of the door jambs are brick lined and are discussed in more detail below. There are no ground floor windows, blocked or otherwise. Close to the southern corner the initials AEF have been carved, quite crudely, into one of the stones. It is not clear if these are very old.

The slated roof is in a reasonable state of repair although there are two patches where the slates are beginning to slip.

Figure 9 Old Barn, east facing elevation  
Looking west. 1m scale

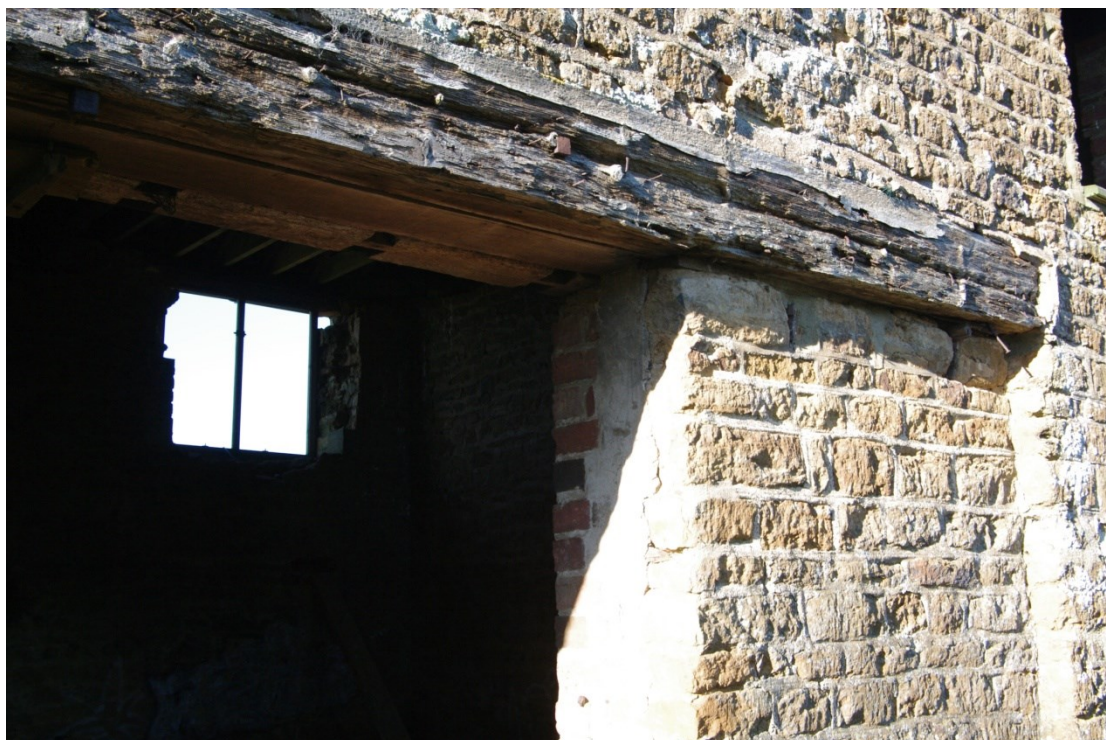
Figure 10 Old Barn, east facing elevation door detail  
Looking north-west

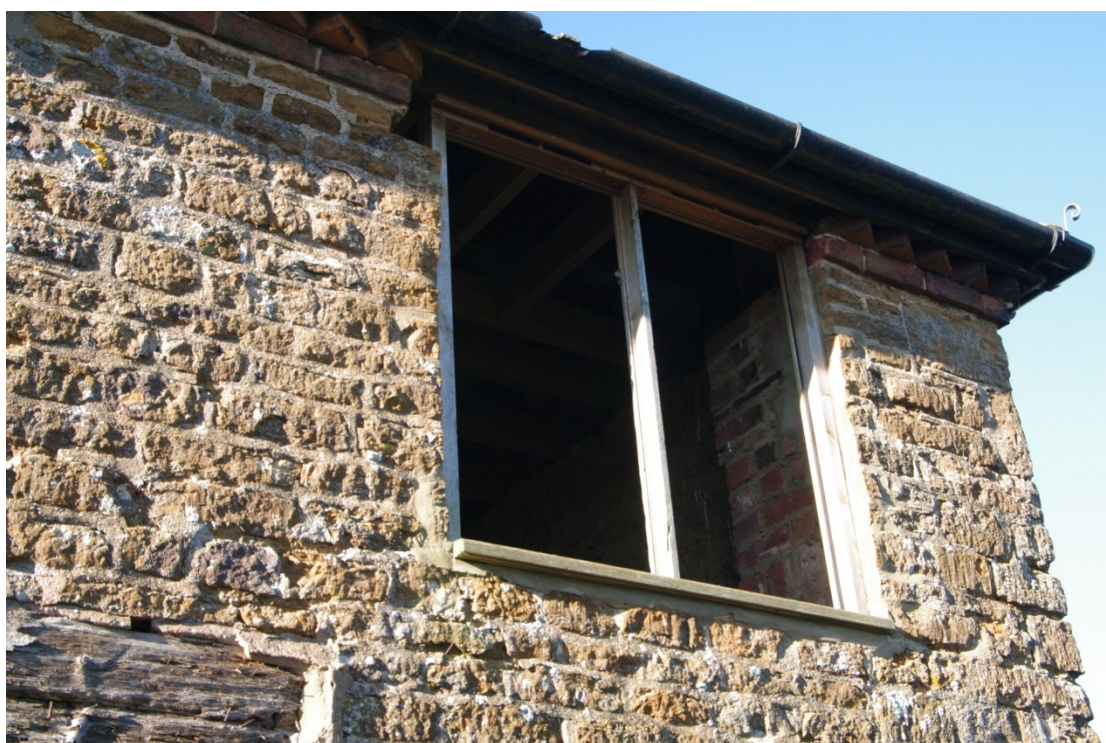
At first floor level are two rectangular openings housing modern window frames. These are not the original openings as the sides appear to cut through the stonework and the insertion of the lintels has removed part of the brick courses at the eaves (Fig. 11). Rather than being knocked through the stonework has been cut with a power tool creating a very smooth surface and sharp edges suggesting that this has happened in the last few years. The internal sides of both windows have been re-laid with red brick and modern mortar. The modern window frames that have been fitted are in a poor condition and are suffering from both vandalism and the effects of weather. The window openings may or may not replace earlier and smaller openings.

Figure 11 Old Barn, east facing elevation window detail  
Looking north-west. Note the sawn stonework at either side of the window and how  
the window cuts the brick eaves

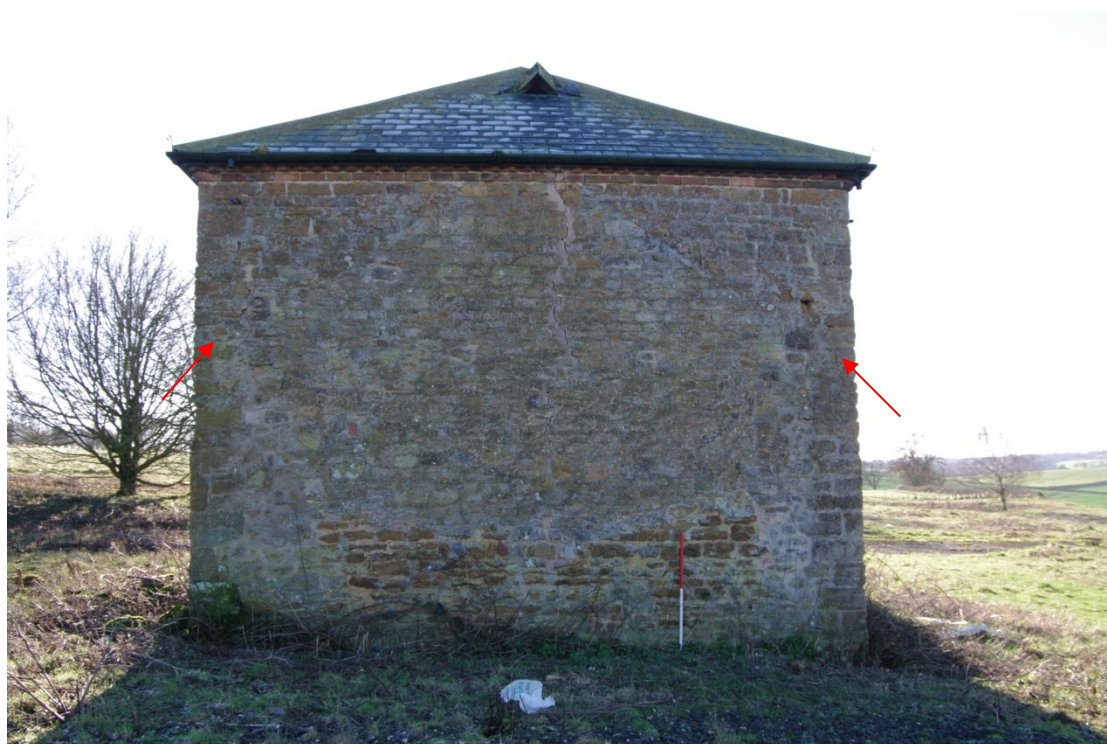
The north facing elevation of the Old Barn is a plain elevation with no evidence of any openings. There is however the trace of the roofline of a gable ended building which butted against the barn (Fig. 12). The stonework of the barn is not as weathered within the confines of the scar and there is a slight trace of render or plaster. This is probably the building shown on the 1884 Ordnance Survey map. It also shows that the now-demolished building was constructed at a later date than the Old Barn. A cursory inspection of the ground to the north of this elevation failed to pick up any traces of the floor plan of the building.

Figure 12 Old Barn, north facing elevation  
Looking south. 1m scale. Note highlighted scar of former building roofline

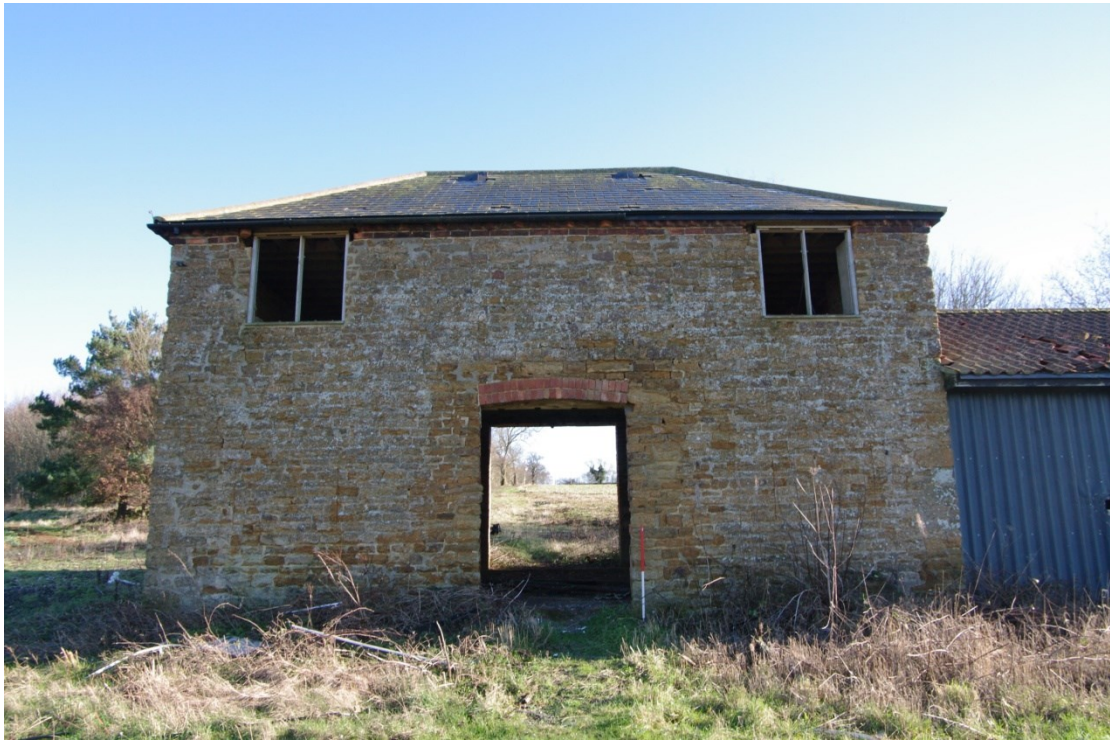
The west facing elevation faces down into the shallow valley which runs from north to south. The doorway on this elevation is not as wide as on the east facing elevation and this side does not have a recessed section (Fig. 13). The doorway has a curved brick lintel made from two courses of red brick headers and a timber beam inside (Fig. 14). The timber beam has joist holes indicating that it has been re-used from elsewhere. The door jambs are lined with brick and have a slight inward splay. A rectangular area of clean stonework can be seen around the doorway suggesting that something was built against this elevation although what it was is not clear. There are

Figure 13 Old Barn, west facing elevation  
Looking east. 1m scale

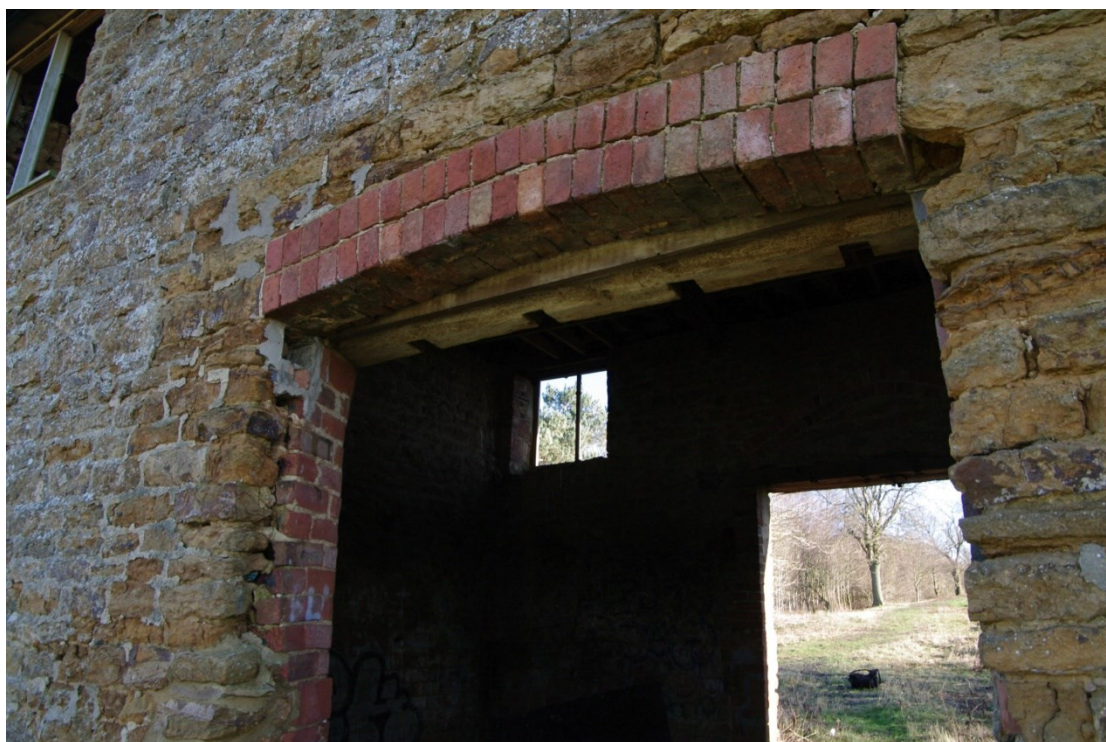
Figure 14 Old Barn, west facing elevation doorway detail  
Looking north-east

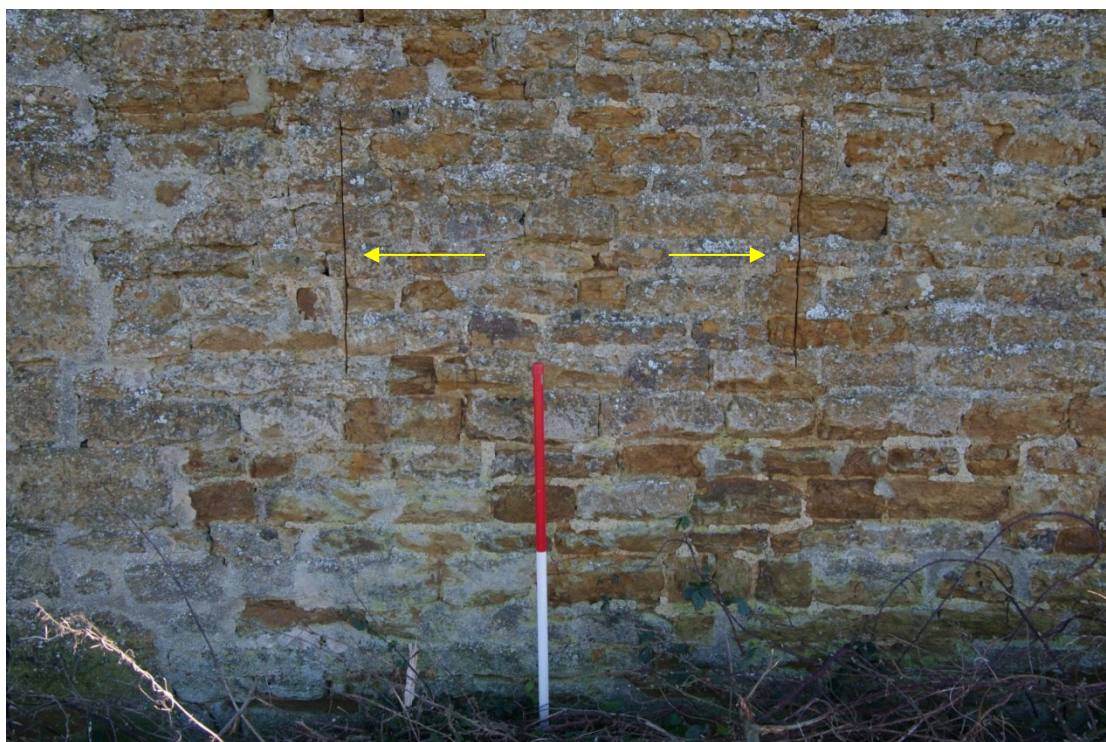
At first floor level are two windows which match those on the east facing elevation. These windows have also been cut with a modern saw and have modern frames. At ground floor level immediately below both windows are two pairs of cut slots showing where an attempt was begun to cut two more window openings (Fig. 15). The slots do not reach all the way through the wall and there are no horizontal cuts.

Figure 15 Old Barn, west facing elevation cuts for new ground floor windows  
Looking east. 1m scale. Arrows point at the two cuts

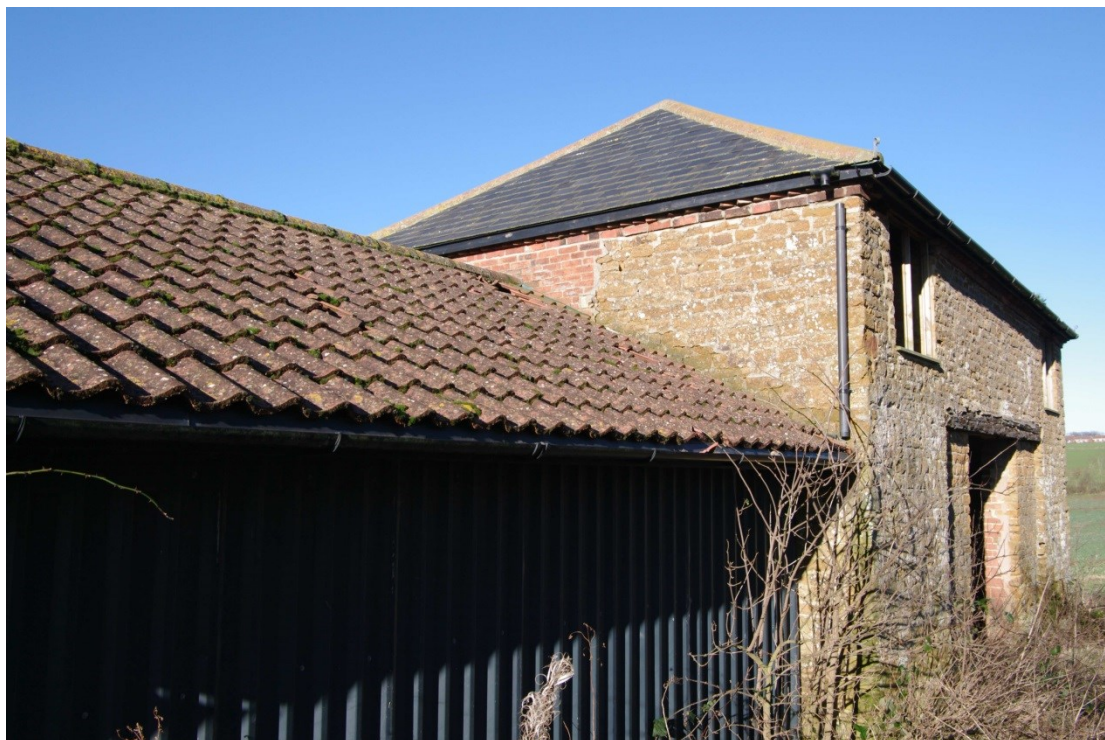
Much of the south facing elevation is obscured by the modern barn which reaches almost to the eaves of the Old Barn (Fig. 16). From the outside it can be seen that there is a doorway, possibly a hayloft door, blocked with red bricks. From the inside of the modern barn the ground floor of the south facing elevation has two single width doorways (Fig. 17). The doorways have brick thresholds and the rough stonework on each internal jamb suggests that they have been knocked through rather than being part of the original design. The presence of two doors indicates that either the Old Barn had two rooms or that a building which pre-dates the modern barn had two rooms.

Figure 16 Old Barn, south facing elevation  
Looking north-west

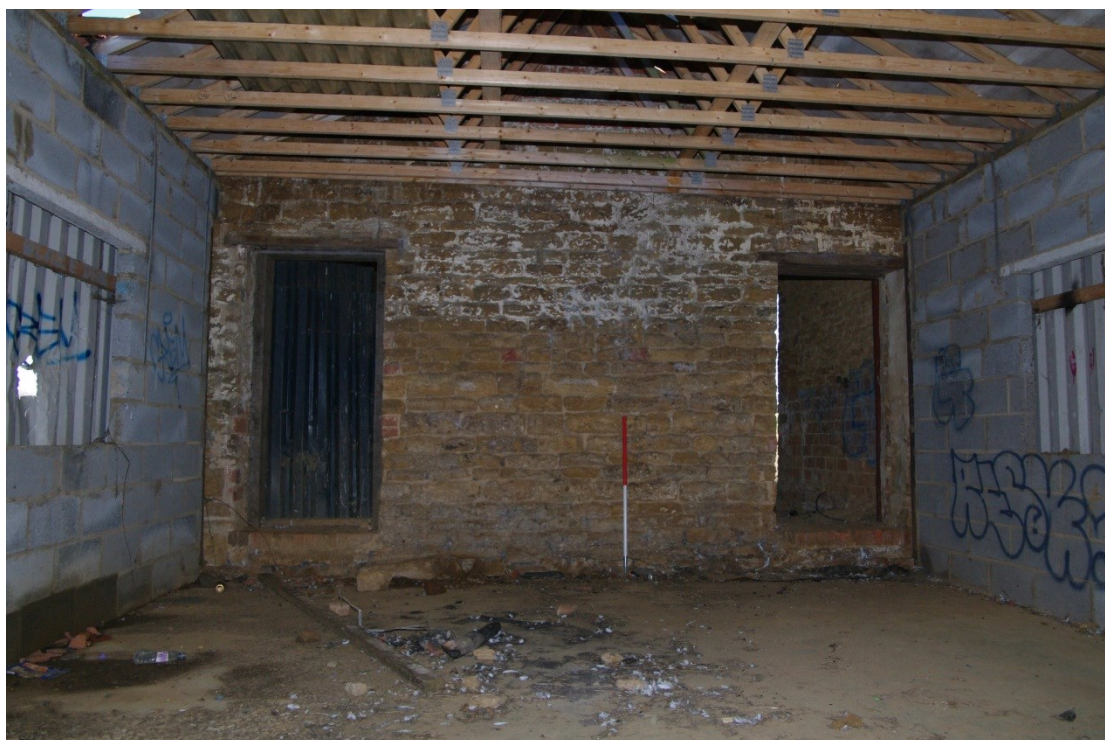
Figure 17 Old Barn, south facing elevation inside modern barn  
Looking north. 1m scale

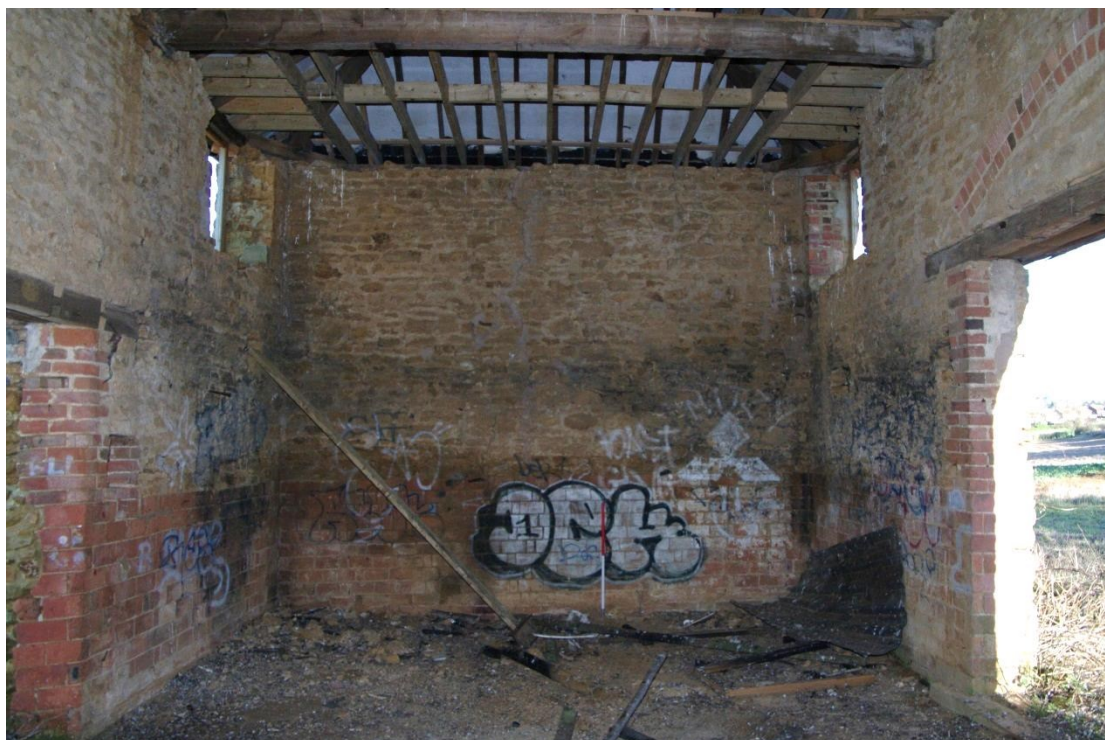
The inside of the Old Barn is a single open space up to the roof (Figs. 18 and 19). The floor is made from beaten earth but this has been disturbed in places which suggests that a paved surface may have been removed. The walls are lined with bricks laid sideways on to a height of approximately 1.3m above ground level. The lining indicates that the walls may have been intended to house animals which would otherwise rub against the soft ironstone walls. The doorway on the eastern side has a brick relieving arch directly above the opening which again indicates that this is the size of the original opening (Fig. 20). The timber lintel on the inside has numerous joist slots from an earlier use. The bricks on either side of the doorway are slightly splayed. The doorway on the western side also has splayed brickwork and another re-used timber lintel. There is no relieving arch above this doorway.

Figure 18 Old Barn, inside  
Looking north. 1m scale

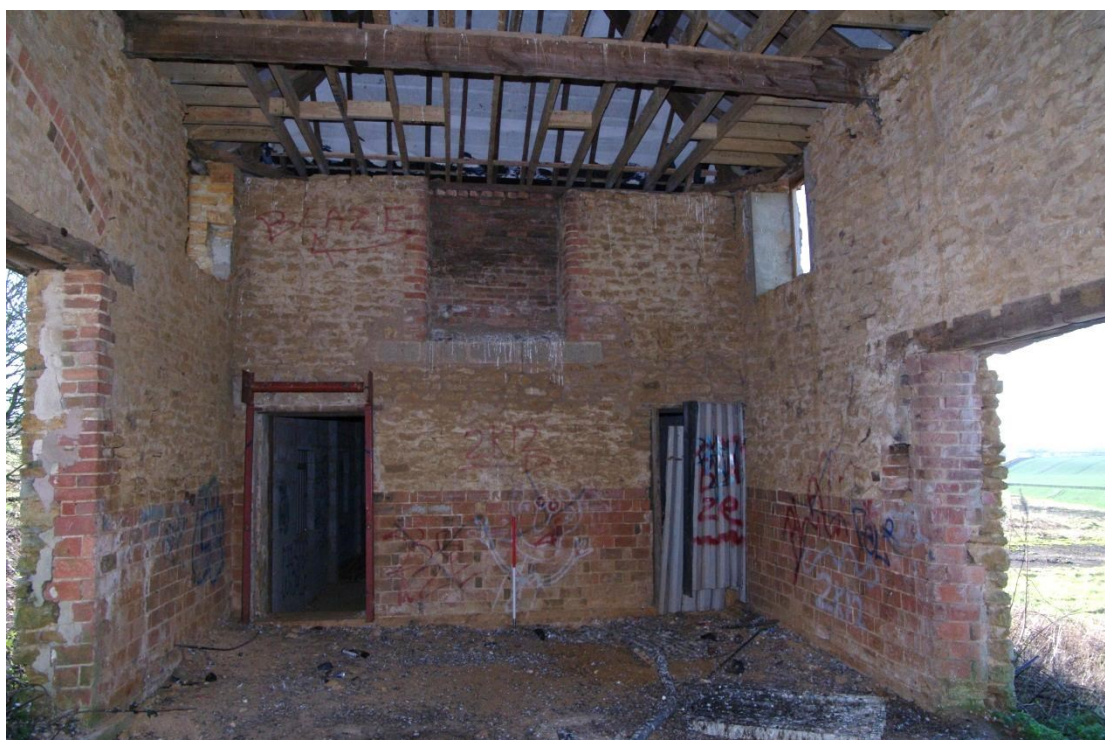
Figure 19 Old Barn, inside  
Looking south. 1m scale

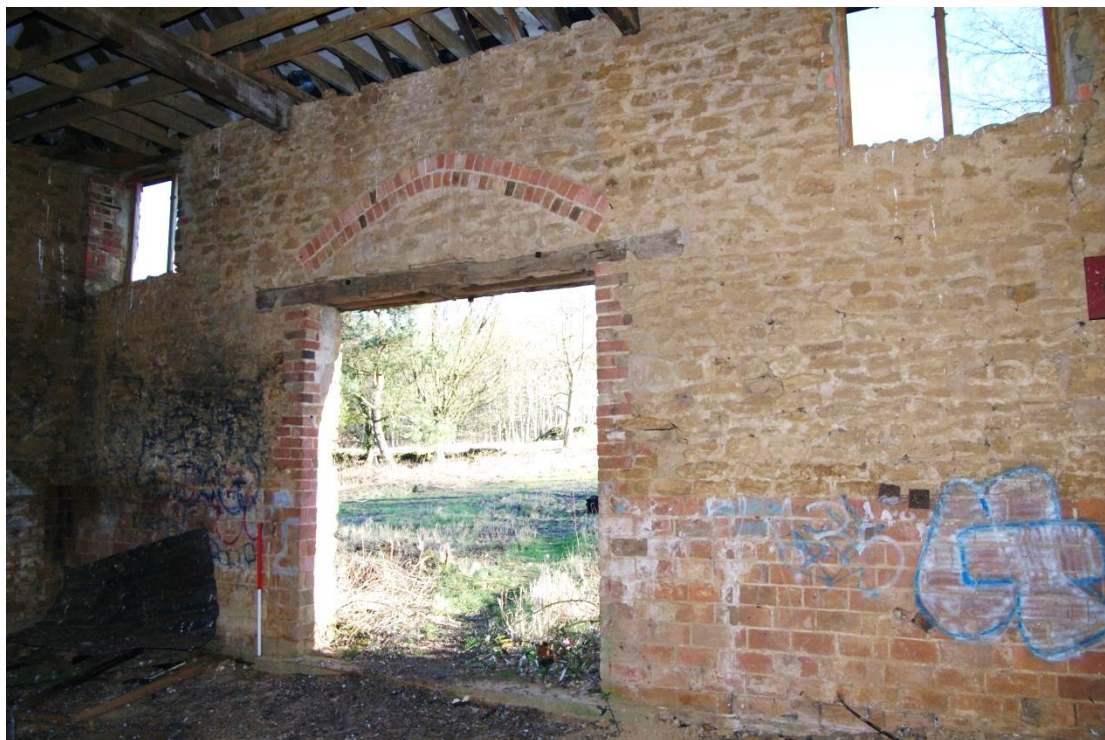
Figure 20 Old Barn, inside of east wall  
Looking north-east. 1m scale

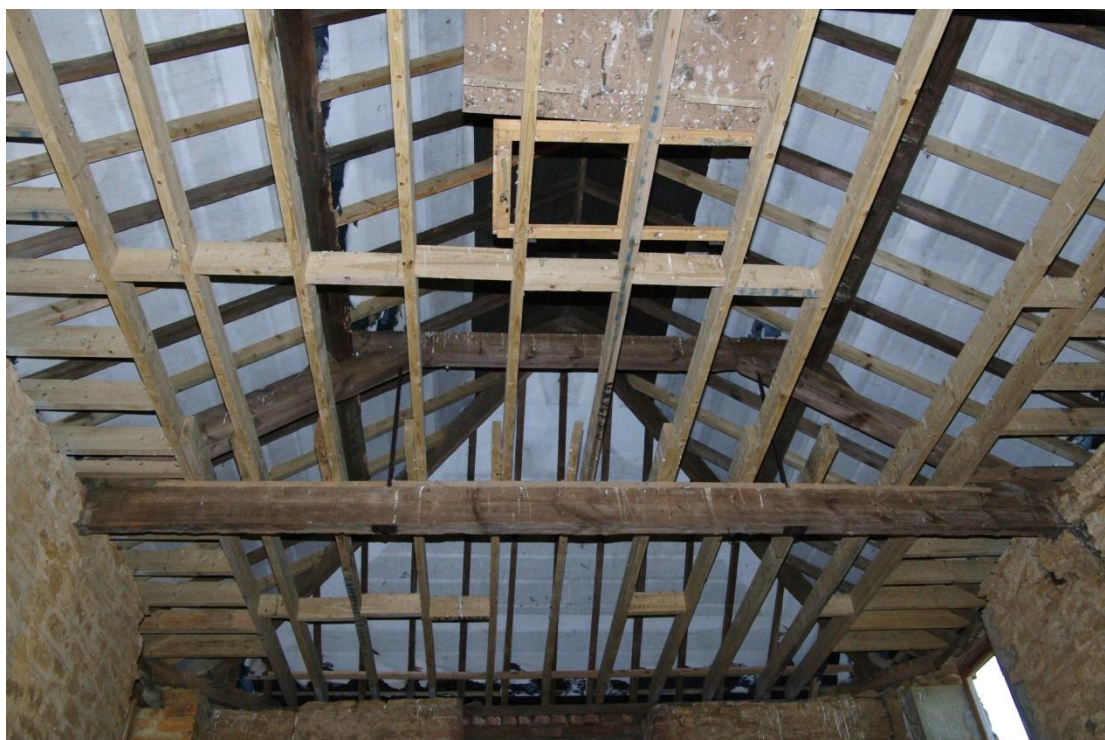
Modern looking joists have been inserted at eaves level to create a frame for a ceiling which is still open to the roof (Fig. 21). There is no evidence of burning which suggests that this has been added since the fire reported in the David Smith 2013 report. Two trusses run from east to west across the barn and appear to be original. There is no sign of burning on these beams. The roof structure is supported by truncated principal rafters joined by a short tie-beam or intermediate truss. Cleated purlins sit on the back of the principals. The principals and tie-beams are attached to the truss by bolted rods. Most of the common rafters appear to be quite modern. The slates sit on modern felt showing that they have been laid relatively recently. The small dormer vent on the north hip appears to be constructed from relatively new wood but may replace an earlier similar feature (Fig. 22).

Figure 21 Old Barn, roof structure  
Looking south

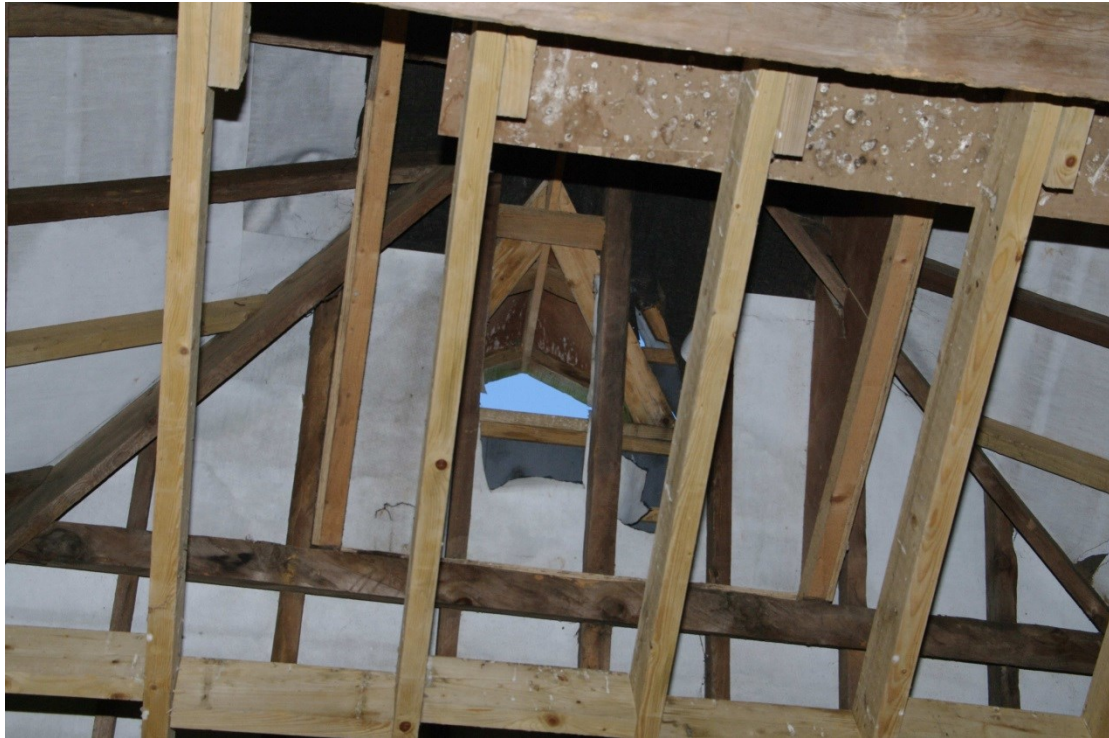
The north side of the hipped roof has a small dormer or vent set slightly off-centre near to the ridge. From the outside the woodwork of this feature appears to be relatively modern.

Figure 22 Old Barn, vent in roof  
Looking north

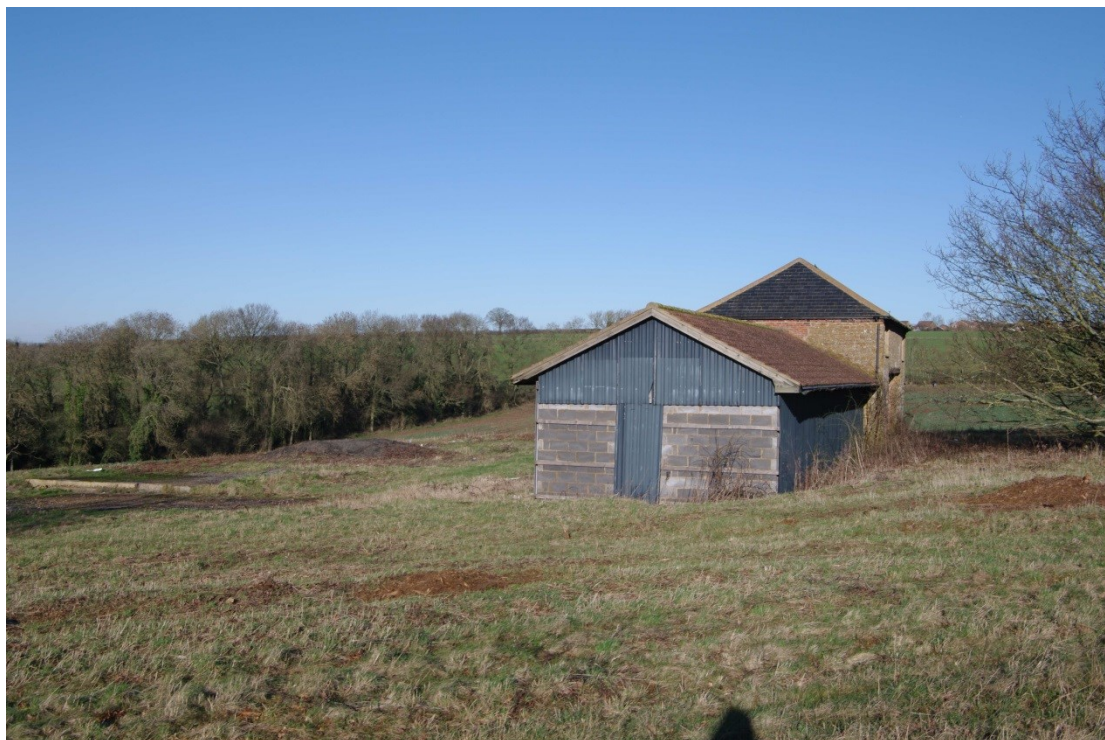
The modern barn has been cut into the slope of the ground so that the ground level to the east and south is approximately 0.5m higher than the barn floor level. The north end of the barn butts against the southern end of the Old Barn (Fig. 23). It is constructed from modern breeze block with a skin of corrugated sheet metal. Internally it can be seen that the floor is made of concrete (Fig. 24). A wide doorway is located on the west facing wall. The metal skin is a later addition as it covers a number of window openings on both the east and west walls. The roof is covered in ceramic pan tiles. The building has no historic value.

Figure 23 Modern barn  
Looking north-west

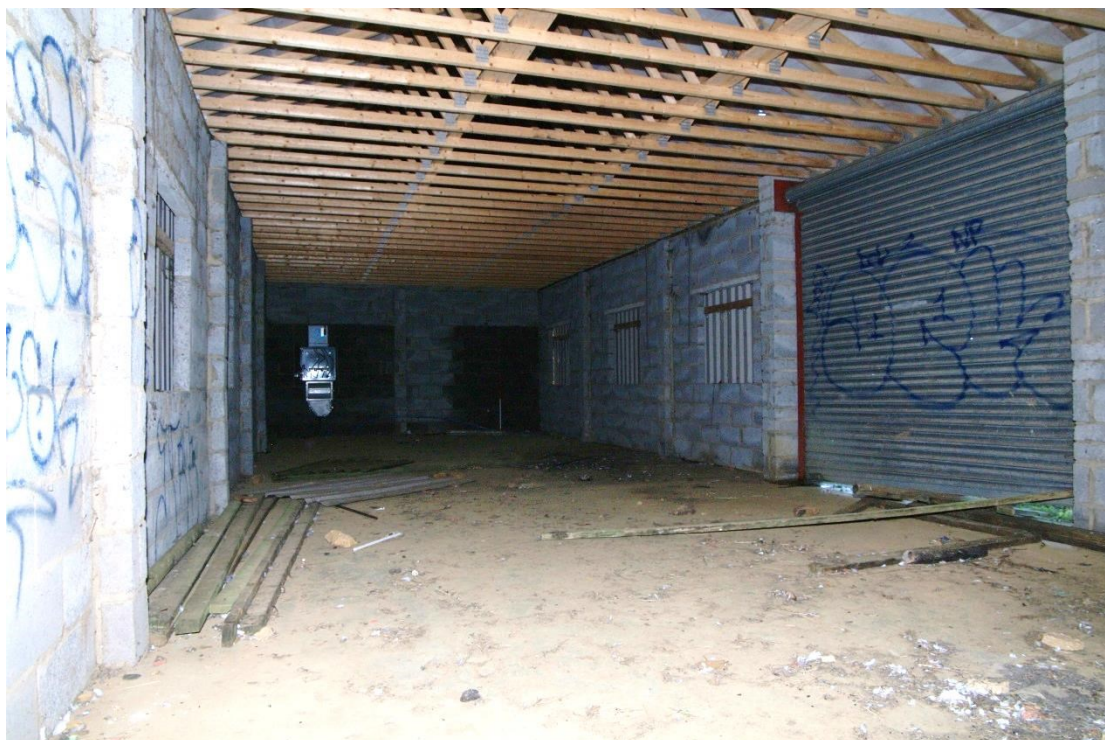
Figure 24 Modern barn, inside  
Looking south-west
