An Historic Building Recording (photographic survey) at The Clubhouse Stand, Leicester Tigers, Welford Road, Leicester.

ULAS Report No. 2015-035 ©2015

For: Leicester Rugby Football Club

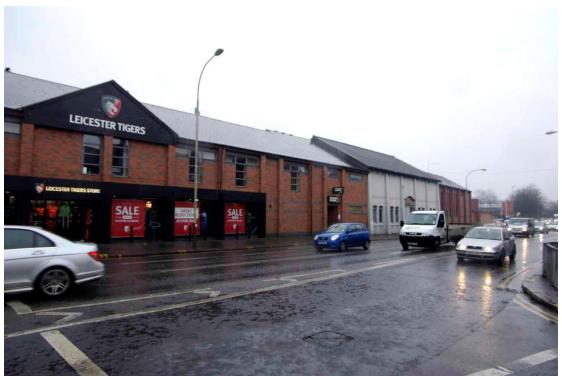
Figure 3 Clubhouse from Aylestone Road Looking south-east

The building at the north end of the range is a very modern brick-built structure which houses the Tigers' merchandise shop (Fig. 3). The roofline is slightly lower than the central block but matches that of the building at the southern end. Bands of blue bricks have been used to create a decorative effect running across the elevation which is partially matched by the southern building. A decorative gable has been built into the roof above the shop entrance which holds the Leicester Tigers name and logo. Shallow brick pilasters emulate the buttresses used in the original building

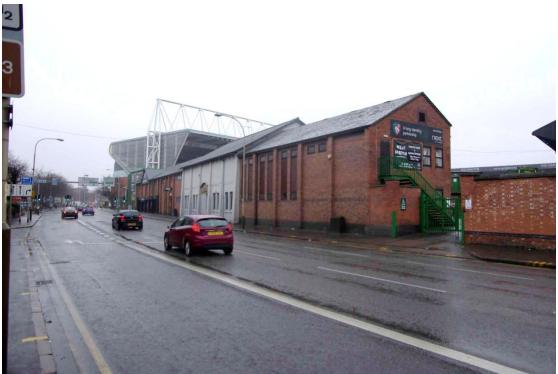
Figure 4 Clubhouse from Aylestone Road Looking north-east

The southern building uses the same modern red bricks as on the northern building but again attempts to match the buttresses on the central, original, building (Fig. 4). A mix of full height and quarter height windows are used across the elevation. The windows appear to be of the same age as the building.

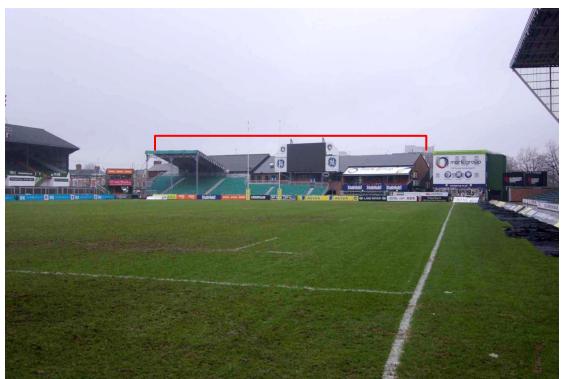
Figure 5 Clubhouse seen from east stand Looking west. Clubhouse buildings are highlighted

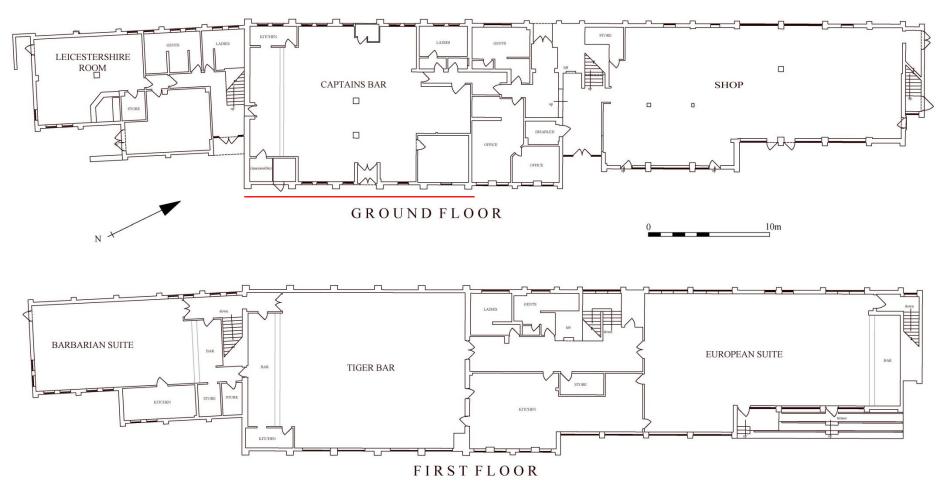
The central clubhouse building has a modern corrugated sheet metal roof covering whilst the two flanking buildings have slate roofs. All three buildings consist of two floors and are interconnected with little evidence inside to indicate the division between each building (Fig. 6).

Figure 6 Clubhouse Stand plans Modified from client's drawings. The red line indicates the width of the 1909 Clubhouse

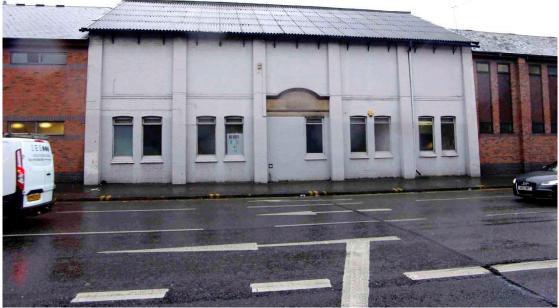
The central block, as noted, is the original 1909 structure and is built of bricks laid in courses of alternating headers and stretchers (Fig. 7). The bricks have been painted a pale grey colour. The west facing elevation is divided into five bays separated by six sloping brick buttresses. A horizontal decorative string course has been produced by a band of slightly projecting bricks above the ground floor windows. Although the building has two storeys there are only windows at ground floor level with no indication of any blocked windows at first floor level. The centre bay has a limestone lintel with an arched head with *1909* and *Leicester Football Club* carved into it (Fig. 8). Chamfers on the lower edge indicate that there was once a doorway and window below. The door has been blocked with later brickwork. The present window is a later replacement, as are the others (Fig. 9). The windows have sloping brick sills and arched lintels made of brick.

Figure 7 Central building of clubhouse Looking west-south-west

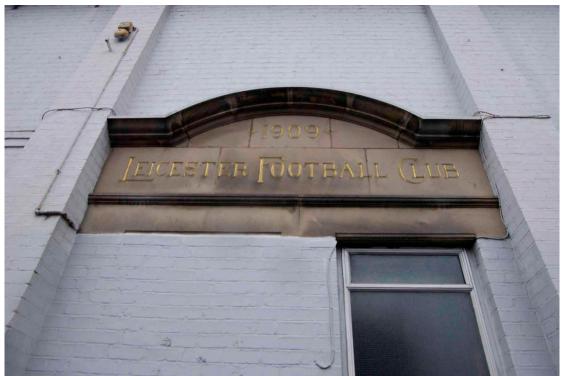
Figure 8 Former Clubhouse entrance Note blocked doorway on left of picture

The main access to the 1909 Clubhouse building is through a central doorway on the east elevation with the original doorway onto the Aylestone Road having been blocked up. The date of the blocking is not clear although it could coincide with the move of the changing rooms to the Crumbie stand in 1985. The ground floor is occupied by a large open space with a bar along the south wall and is known as the Captains Bar (Figs. 19 and 20). A small internal porch survives on the west wall which used to lead to the Aylestone Road doorway. The false ceiling partially covers the upper ends of the windows. Trophy and memorabilia cabinets surround the walls along with photographs of past captains. The boiler room which housed the heating equipment for the baths and changing room is in the north-east corner (Fig. 21). The stub of the chimney still survives and extends up through the north-east corner of the roof. A short corridor leads past the ladies toilets, on the west side, to go through the north wall of the 1909 building and into the northern building.

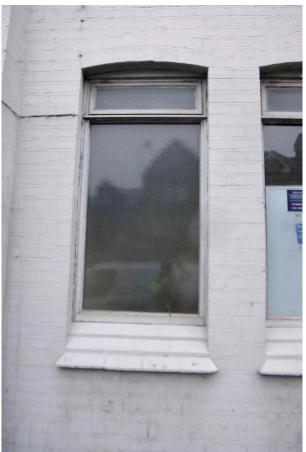
Figure 9 West facing elevation window detail Clubhouse building

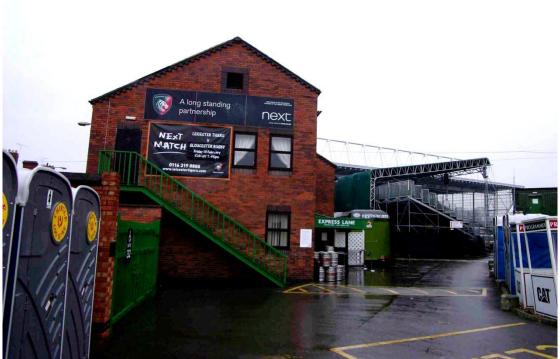
Figure 11 South facing elevation Looking north-east. Temporary stand between the Clubhouse and the pitch is on the right of the picture

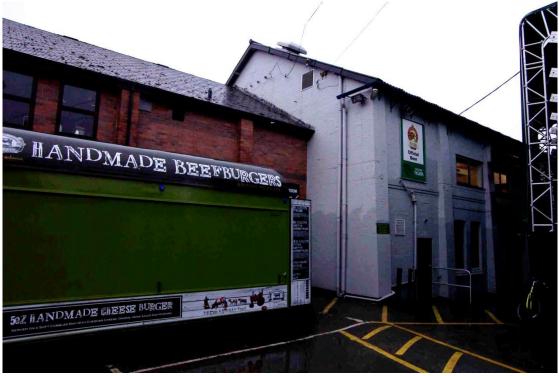
Figure 12 Junction of 1909 Clubhouse and southern building Looking north-west

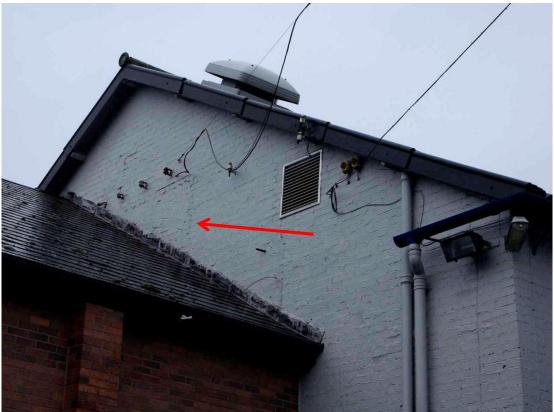
Figure 13 South gable end of 1909 Clubhouse Looking north-west. Blocked window arrowed

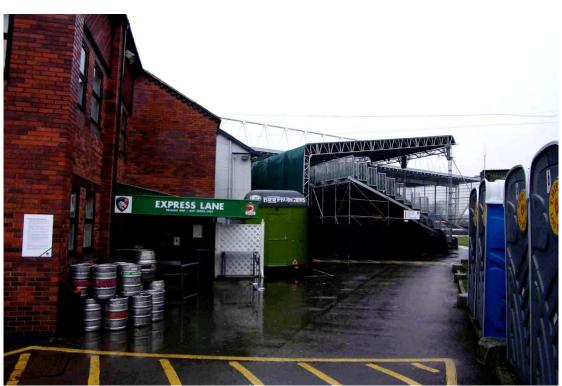
is therefore difficult to inspect due to the close proximity of the temporary seating stand. The southern building has a wide ground floor doorway and a stepped frontage which partially cuts the south eastern corner of the building off (Fig. 14). As with the other elevations on this building the windows appear to be of a similar age to the building. The 1909 Clubhouse has ground floor windows which match those on its Aylestone Road elevation but has quite shallow rectangular windows on the first floor (Figs 12 and 15). Some of the windows on the northern end of the 1909 block have been modified to suit the needs of a kitchen which has been built in the south west corner of the building. The centrally located doorway appears to be original.

Figure 14 Southern building Looking north. Note step in wall line

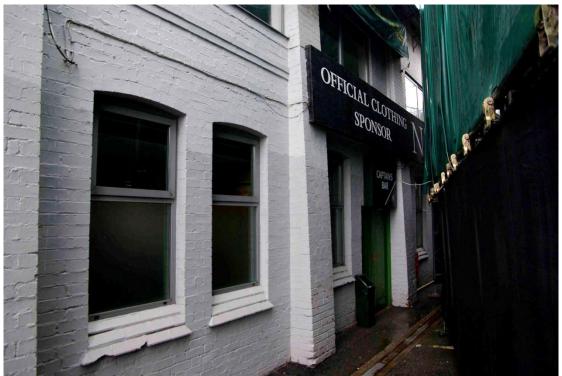
Figure 15 1909 Clubhouse, east facing elevation ground floor windows Looking north

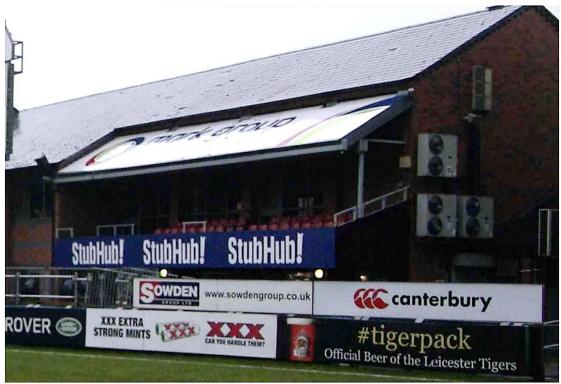
Most of the northern building at ground floor level is taken up with the full height glass doors and windows of the merchandise shop. The first floor has a covered balcony with VIP seating (Fig. 16).

Figure 16 Northern building, east facing elevation Looking south-west

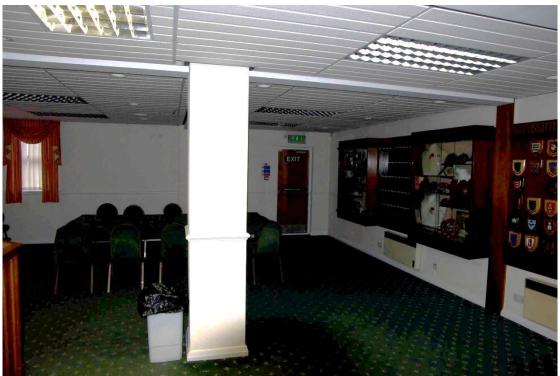
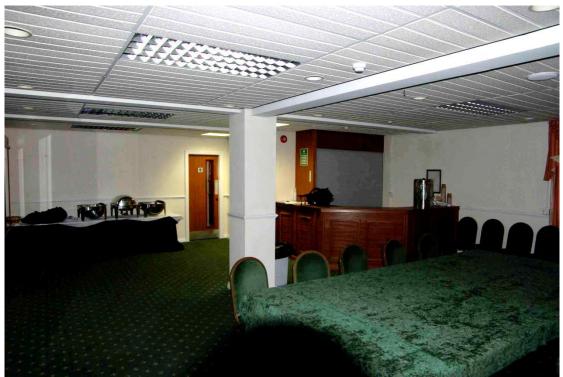
Figure 17 The Leicestershire Room Looking south-west

Figure 18 The Leicestershire Room Looking north-east

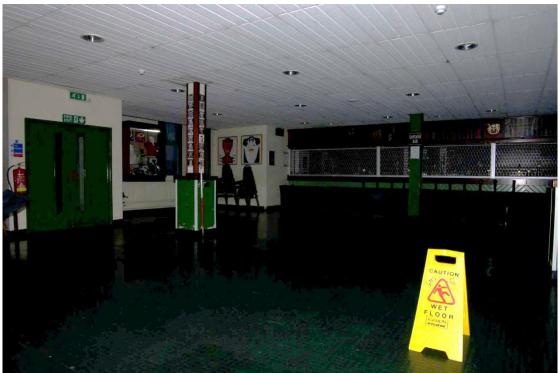
Figure 19 The Captains Bar Looking south-west. Doors to pitch on left of picture

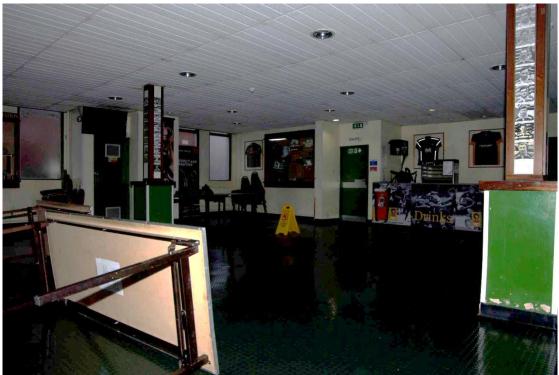
Figure 20 The Captains Bar Looking north. Doorway leading to the offices in centre of picture. Porch to blocked Aylestone Road door on left

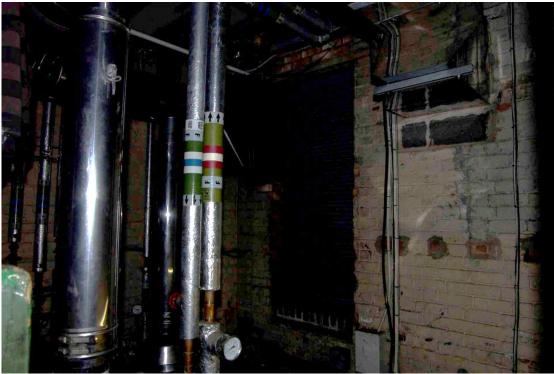
Figure 21 Boiler room Looking north-east. Note blocked window

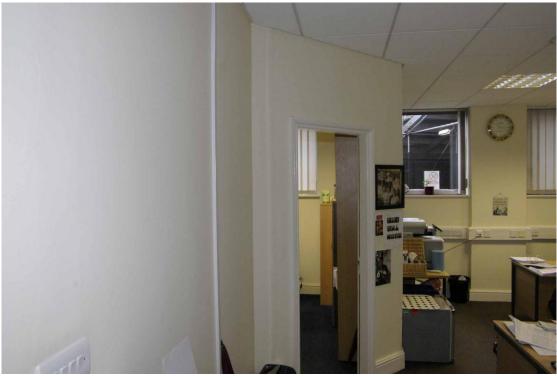
Figure 22 Offices in the northern building Looking east

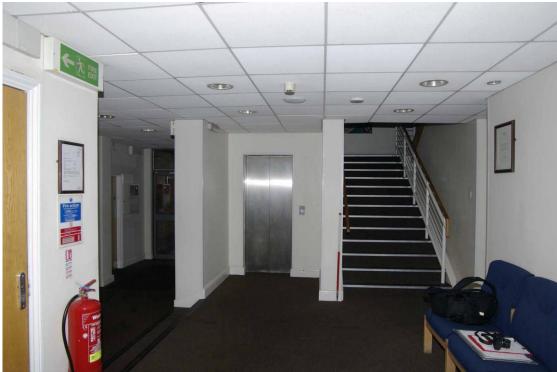
Figure 23 Entrance hallway into northern building Looking west. Shop doorway is to right of photograph at the bottom of the stairs

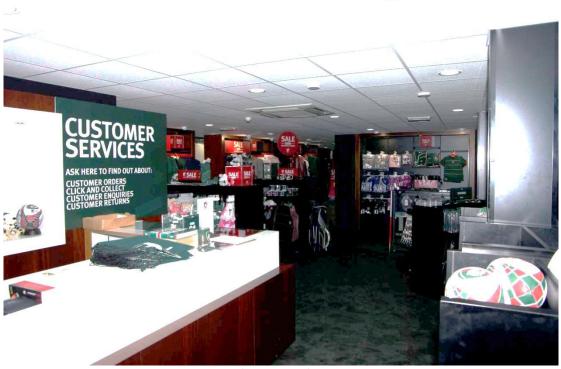
Figure 24 Shop Looking north-west

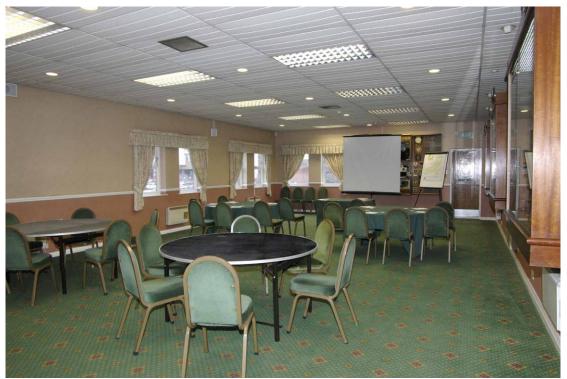
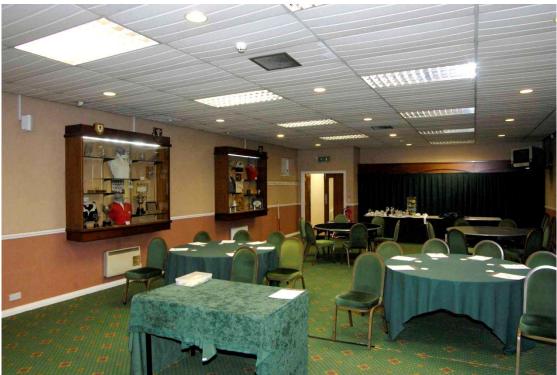
The southern building has a larger suite than the ground floor Leicestershire Room which is known as the Barbarian Suite (Figs. 25 and 26). In common with the other function rooms and suites the Barbarian Room has its own dedicated bar and a small kitchen area. This room has a number of memorabilia cabinets around the walls. A small landing leads north past the stairs and into the 1909 first floor room which is called the Tiger Room or Tiger Bar (Fig. 27).

Figure 25 Barbarian Suite Looking south

Figure 26 Barbarian Suite Looking north

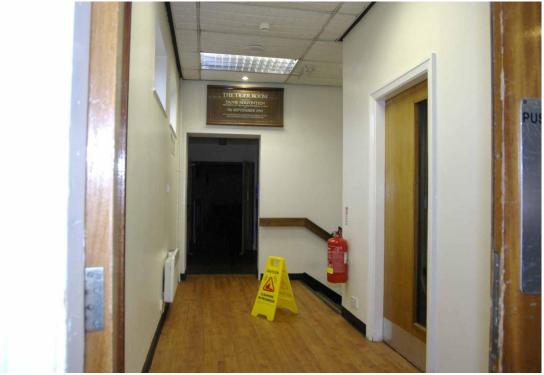
Figure 27 Landing between Barbarian Suite and The Tiger Room Looking north-east

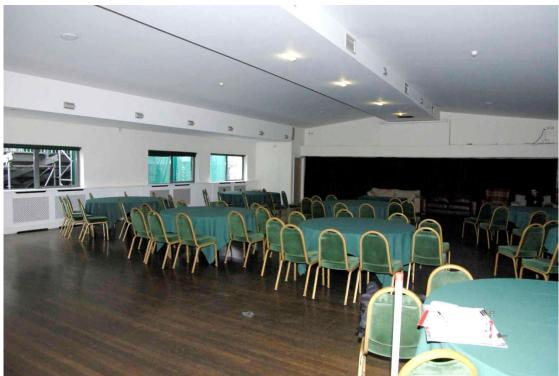
With the exception of a small kitchen in the south-eastern corner the 1909 Clubhouse first floor consists of a single open room which has a relatively low ceiling following the shallow pitch of the roof (Fig. 28 and 29). The only windows lighting this room are on the eastern side which is partially obscured by the temporary stand outside. Doors on the north wall (which is the original north wall of the 1909 Clubhouse) lead out to the main kitchens and a large landing (Figs. 30 and 31).

Figure 28 The Tiger Bar Looking south-east. Note pitch of ceiling

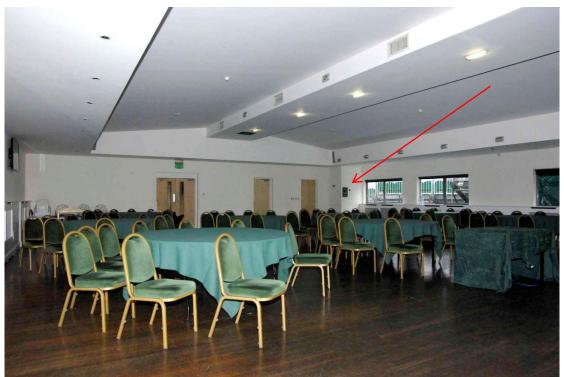
Figure 29 The Tiger Bar Looking north-east. Arrow points to chimney leading up from boiler room

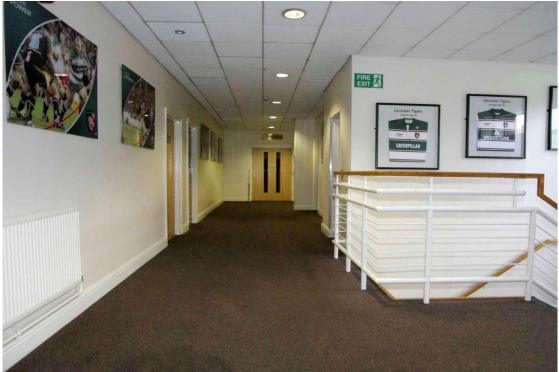
Figure 30 First floor landing Looking south towards Tiger Bar entrance. Kitchens on left of photograph

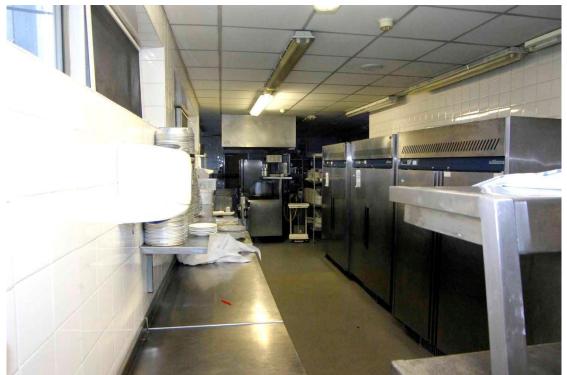
Figure 31 First floor main kitchen Looking south

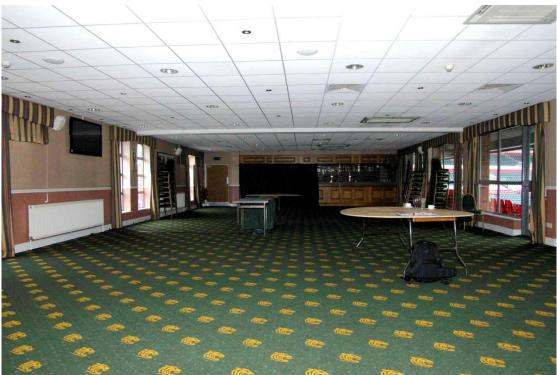
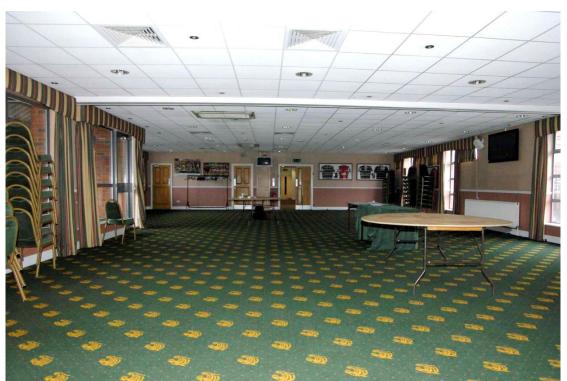
The landing is the first part of the northern building and has kitchens on the east side and toilets, a lift and stairs on the west. To the north of the landing is a large open suite called the European Suite (Figs. 32 and 33). The room has a large bar along the north wall with a small corridor leading out to a fire escape built against the outside of the north wall. A small balcony with terrace seating for VIPs is fitted into the north east corner of the room to provide covered seating (Fig. 34).

Figure 32 The European Suite Looking north

Figure 33 The European Suite Looking south

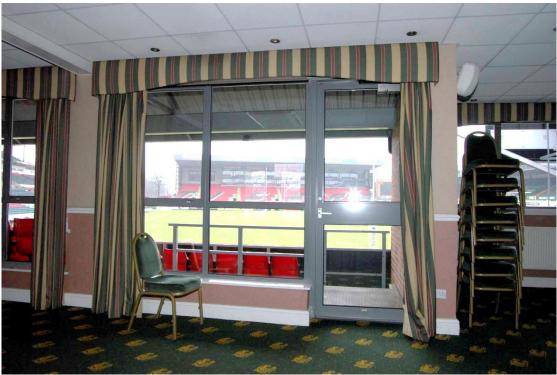
Figure 34 The European Suite balcony Looking north-east
