A Schedule of Internal Historic Features at the former Towers Hospital, Gypsy Lane, Leicester.

ULAS Report No. 2015-177 ©2015

# A Schedule of Historic Features at the former Towers Hospital, Gypsy Lane, Leicester.

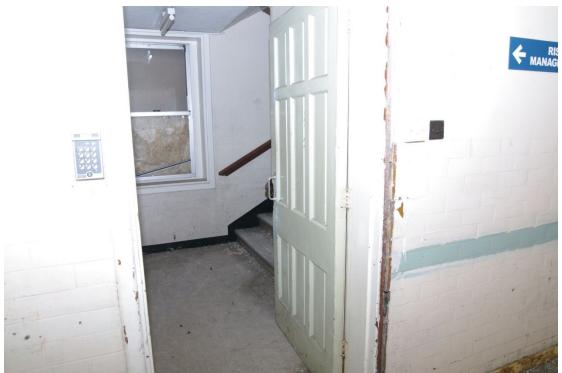
- At the north-eastern end of the Zone is a set of stairs with an original panelled door and moulded pine hand rail (Figs 2, 3 and 4).
- Supporting ceiling joists in the former wards have beading and decorative bolts along their length. This feature is seen throughout all ground floor zones (Fig. 5).

Figure 3 Zone 1 ground floor photo 1. Panelled door

Many of the former cell doors appear to be the original panelled doors. Although the full details of the redevelopment are not known it seems unlikely that the small cells will remain and the doors will therefore need to be removed. The doors are substantial and from cursory inspection seem to be in a relatively good state of repair and may be suitable for re-use elsewhere in the building.

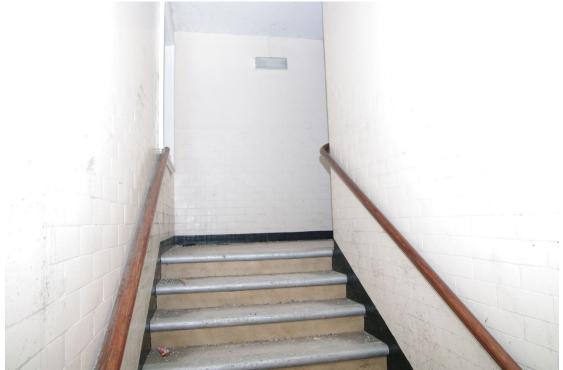
Figure 4 Zone 1 ground floor photo 2. Stairs with pine hand rails Note also painted over glazed wall bricks

The wooden hand rails at each set of stairs are original and could be retained in-situ if the proposed design permits. If this is not the case it may be possible to install them in any new stair cases.

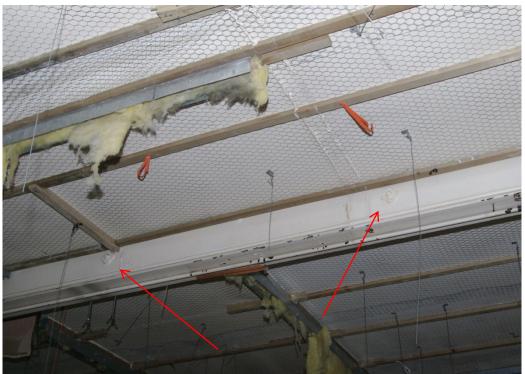
Figure 5 Zone 1 ground floor photo 3 ceiling joists Note decorative bolts (arrowed)

The beaded joists with decorative bolts should be left in-situ wherever possible unless they need to be replaced for structural reasons. It is appreciated however that false ceilings may be installed which will hide them from view. The few surviving ventilation grilles are unlikely to be suitable for retention in-situ but should be considered for re-use elsewhere if at all possible.

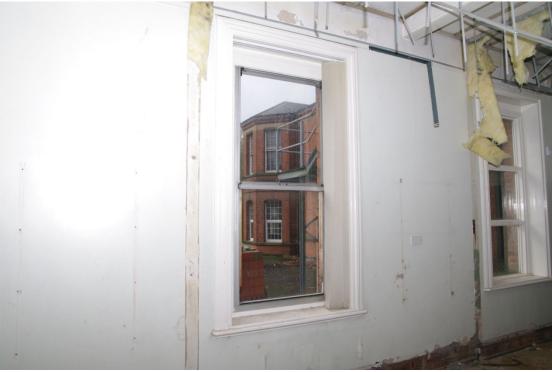
- Most external windows still have their moulded surrounds and wooden sills in place even where a replacement a window has been fitted (Fig. 6). Many sash windows also survive but most are in a poor state of repair and are unlikely to be suitable for restoration (Fig. 7).

Figure 6 Zone 1 ground floor photo 4 moulded window surrounds

Although the existing sash windows are unlikely to be suitable for modern domestic dwellings the moulded surrounds should be retained wherever possible. The mouldings around the windows and the surviving skirting boards are typical of the style of the late 19th and early 20th centuries and as such perfectly reflect the style of the building.

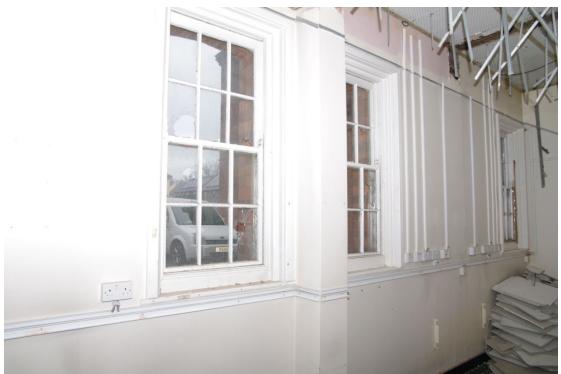
Figure 7 Zone 1 ground floor photo 5 sash windows

Outside, the building has managed to keep a relatively unchanged appearance which is a theme which should continue in the redevelopment wherever possible. This should include the careful selection of replacement windows to match the style and form of the original sash windows.

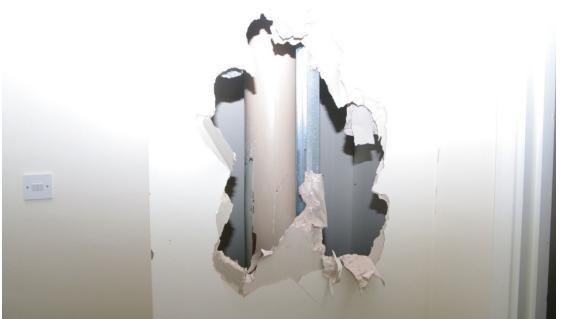
- One of the wider wards has cast iron columns concealed behind plasterboard (Figs. 8 and 9). The heads appear to have flared circular decoration.
- The westernmost day room of Zone 1 has most of its wall panelling intact up to dado rail height (Figs. 10 to 13). This has been papered over and painted but appears to be relatively intact despite the room being subdivided in more recent times.

Figure 8 Zone 1 ground floor photo 6 cast iron column

The cast iron supporting pillars seen on both floors in Zone 1 should be left exposed if at all possible rather than being boxed-in or removed. These again reflect the institutional nature of the former hospital.

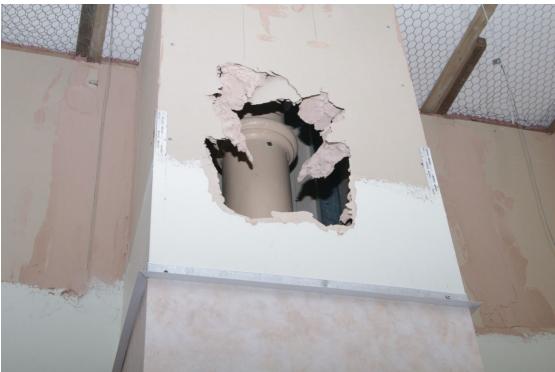
Figure 9 Zone 1 ground floor photo 7 head of cast iron column

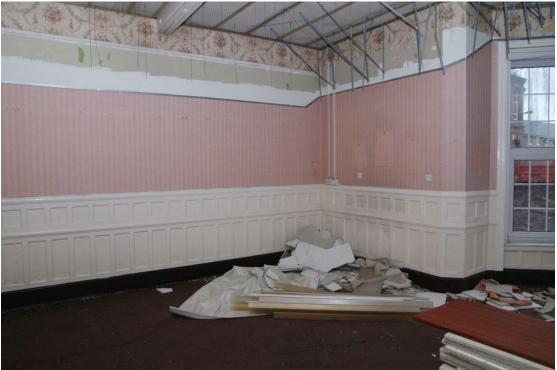
Figure 10 Zone 1 ground floor photo 8 day room panelling

Very few historic fixtures and fittings have survived in the former Towers Hospital. The most readily identifiable feature is the wooden panelling in the day rooms. The panelling is one of the more surprising aspects of our perceived attitudes to late Victorian mental health care. It shows that the City Corporation was willing to spend a considerable amount of money and effort to improve the surroundings and accommodation of their patients. This aspect should be recognised in the proposed redevelopment. Over time much of the panelling has been damaged or truncated but a large proportion appears still to be a in a reasonable state of repair. Some panelling also survives beneath later coverings which will need to be removed in order to assess the state of preservation. It is likely that during the redevelopment work the panelling will need to be removed to install modern wall insulation and services but should be replaced wherever possible.

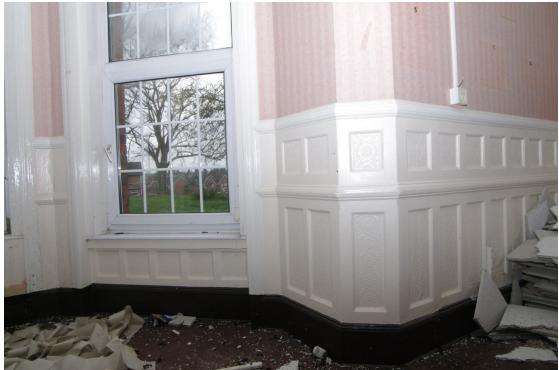
Figure 11 Zone 1 ground floor photo 9 day room panelling

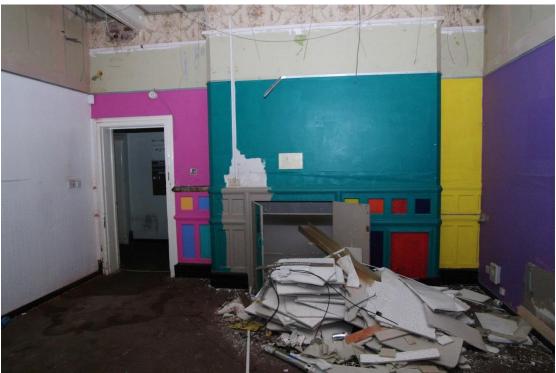
Figure 12 Zone 1 ground floor photo 10 day room panelling

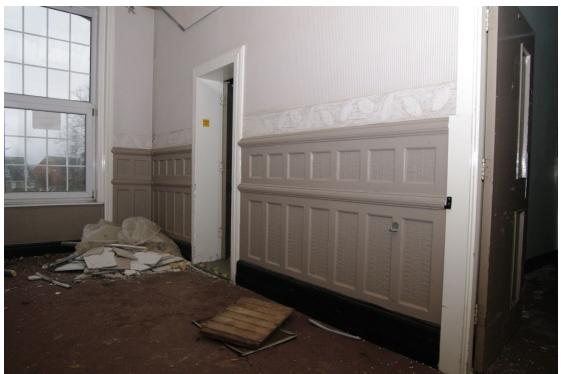
Figure 13 Zone 1 ground floor photo 11 day room panelling

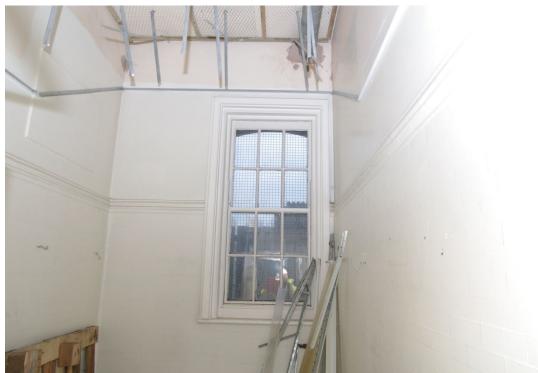
- In places individual isolation cells remain which have their sash windows, glazed wall bricks and moulded tiles which have been overpainted (Fig. 14).

Figure 14 Zone 1 ground floor photo 12 sash window and glazed bricks of an individual cell

The glazed bricks are an integral part of the design and history of the building but their institutional brown colouring may not be suitable for a residential redevelopment. If they do not form part of the final décor it would be desirable at the very least to leave them in place wherever possible behind more suitable and contemporary wall coverings.

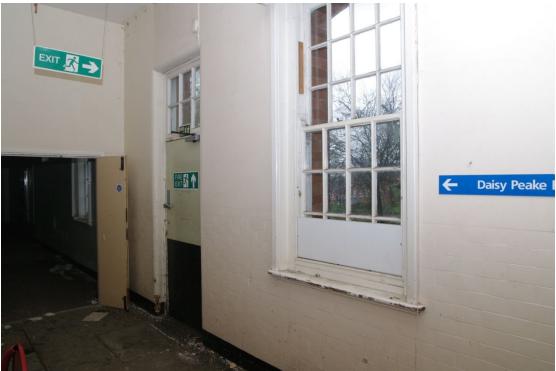
- An outside door remains which has had a hardboard cover nailed to each side to mask the original panelled door (Fig. 15).

Figure 15 Zone 1 ground floor photo 13 boarded panelled door and sash window

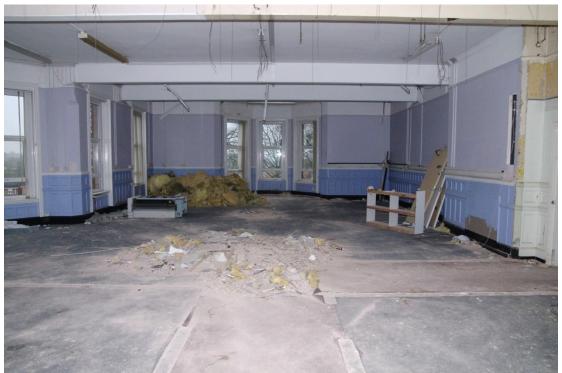
- As with the ground floor the eastern day room has half-height pine panelled walls. Again the panelling has suffered from later attachments and partial truncation (Figs. 16 and 17).
- In a few places the high skirting boards with moulded tops remain as do some moulded door jambs (Fig. 18).
- The cast iron columns seen on the ground floor continue up to the first floor and have also been boxed in (Fig. 19).
- The western day room of Zone 1 has panelling but nothing else of historic importance (Figs 20 to 21). The room also has large multi-pane sash windows (Fig. 22).

Figure 16 Zone 1 first floor photo 14 day room panelling

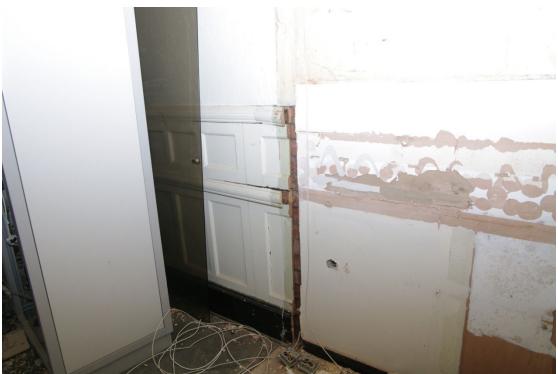
Figure 17 Zone 1 first floor photo 15 truncated panelling

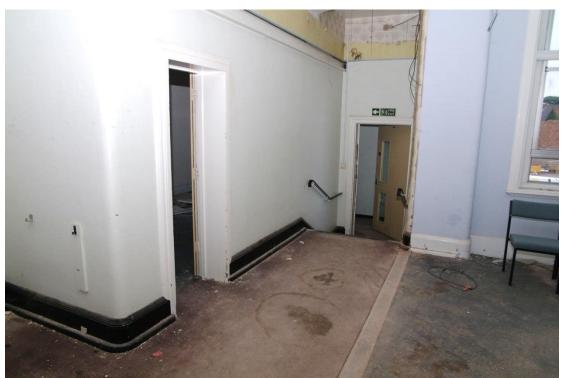
Figure 18 Zone 1 first floor photo 16 moulded door jambs and skirting

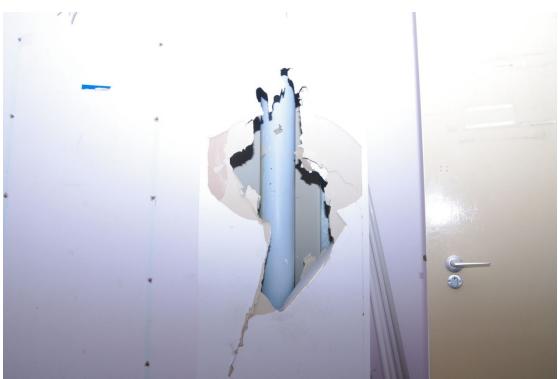
Figure 19 Zone 1 first floor photo 17 cast iron column

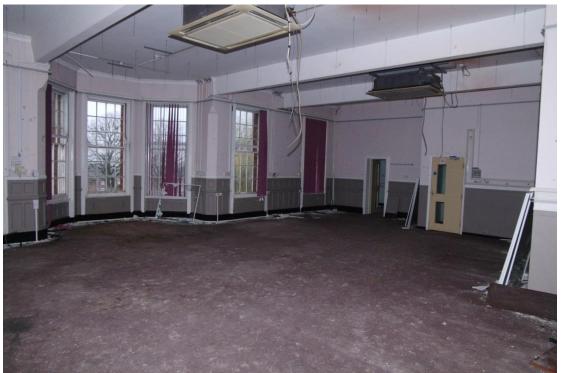
Figure 20 Zone 1 first floor photo 18 day room panelling

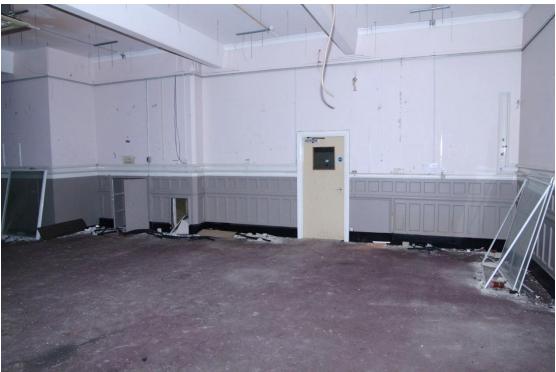
Figure 21 Zone 1 first floor photo 19 day room panelling

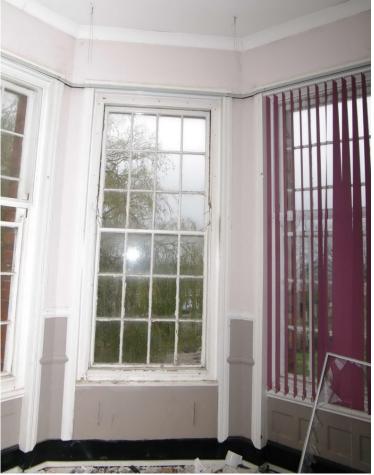
Figure 22 Zone 1 first floor photo 20 sash window Note panelling below windows

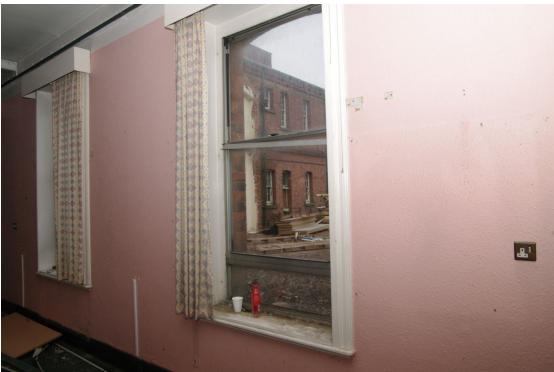
- Most timber window surrounds survive as do the remaining toilet windows. All have moulded edging although many have indications of rot (Figs. 24 and 25).
- The day room in this zone has had shaped hardboard sheeting nailed over the original wooden panelling (Figs 26 and 27). The later covering has been removed in places to reveal the panelling which survives in places although much appears to have been truncated or damaged.
- The original high skirting board with moulded tops can be seen in some of the cell corridors (Fig. 28).
- As with Zone 1 the connecting corridors and cells retain their glazed brick walls which have been painted over with white emulsion (Figs 29 and 30).

Figure 24 Zone 2 ground floor photo 21 typical window surround

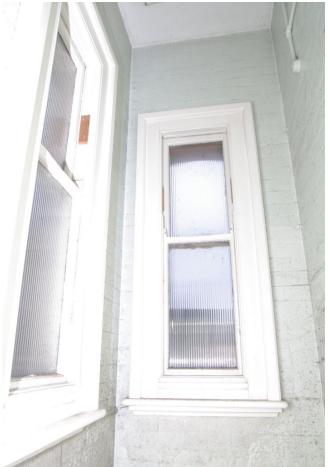
Figure 25 Zone 2 ground floor photo 22 toilet block windows

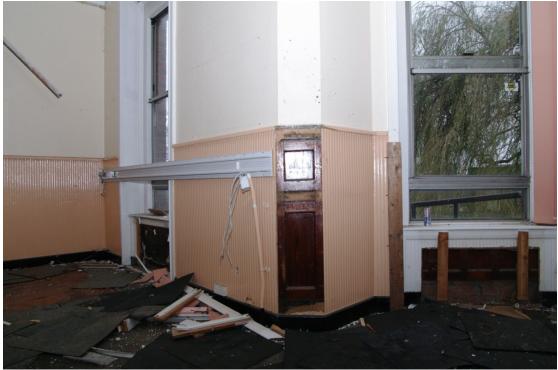
Figure 26 Zone 2 ground floor photo 23 day room panelling behind later sheeting

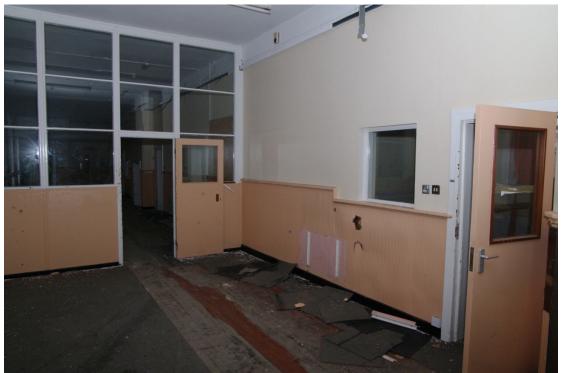
Figure 27 Zone 2 ground floor photo 24 day room possible panelling behind later sheeting

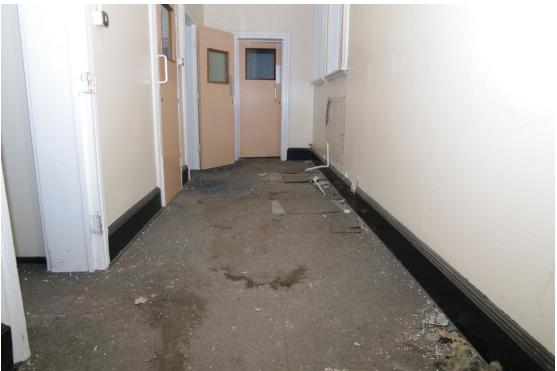
Figure 28 Zone 2 ground floor photo 25 skirting boards

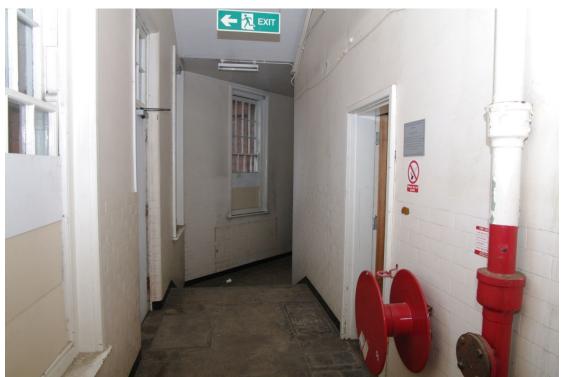
Figure 29 Zone 2 ground floor photo 26 corridor with glazed brick walling

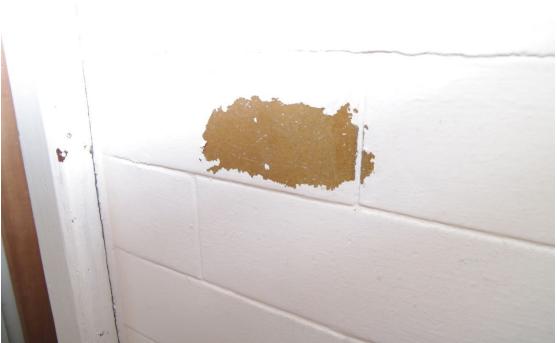
Figure 30 Zone 2 ground floor photo 27 glazed bricks with paint removed

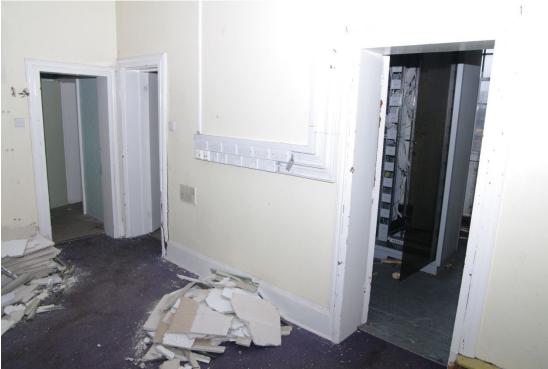
- As elsewhere many doors have their original moulded surrounds and, in places, the high skirting survives (Fig. 31). Where the woodwork has been hidden it can be seen that the wood was varnished and polished rather than painted.
- The day room and gallery have panelling which appears to survive in a fairly reasonable state. The cell doors also have their original panelled doors although all, with one exception, have had modern sheeting nailed to each face (Figs. 32 to 37).
- A small corridor which housed individual cells has a cast iron vent grille at floor level (Fig. 38). Only one grille remains in place whereas all were present at the time of the 2014 survey.

Figure 31 Zone 2 first floor photo 28 skirting boards and door surrounds

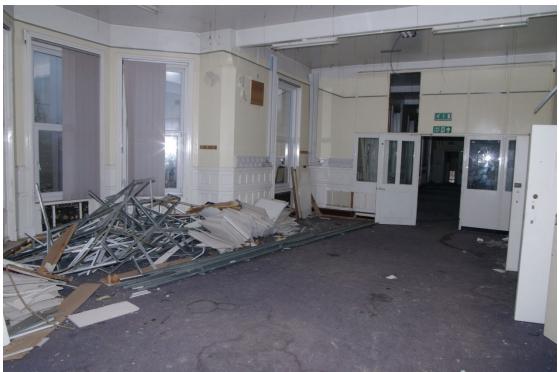
Figure 32 Zone 2 first floor photo 29 day room panelling

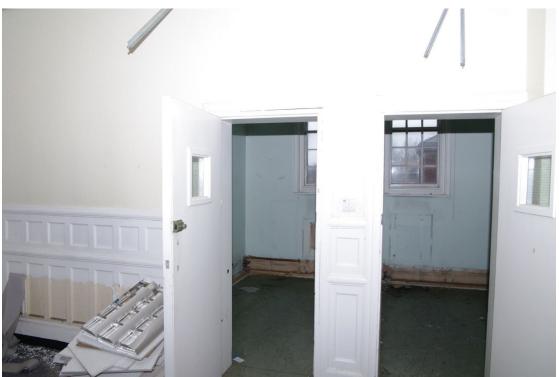
Figure 33 Zone 2 first floor photo 30 day room panelling and probable panelled doors to cells

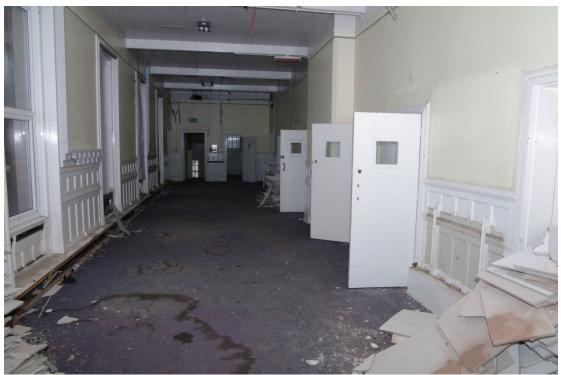
Figure 34 Zone 2 first floor photo 31 corridor attached to day room with panelled cell doors and walls

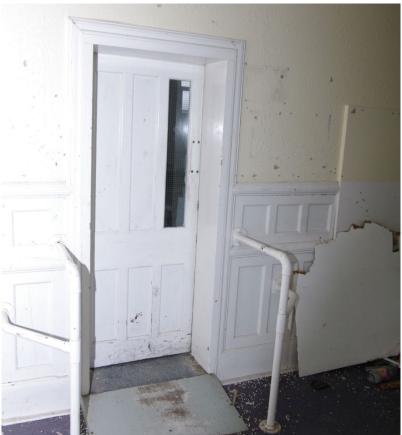
Figure 35 Zone 2 first floor photo 32 panelled cell door

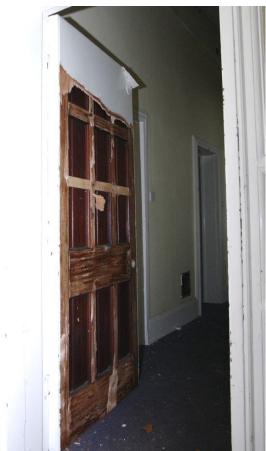
Figure 36 Zone 2 first floor photo 33 panelled door with modern covering removed

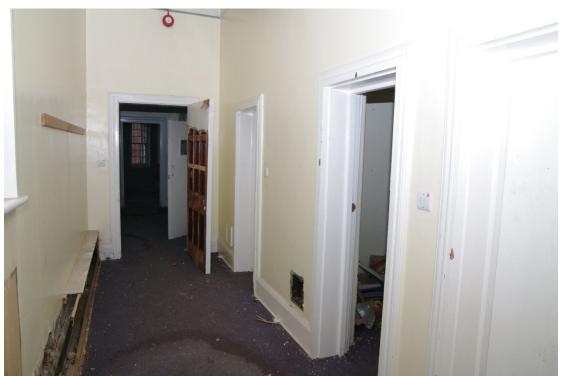
Figure 37 Zone 2 first floor photo 34 cell corridor with panelled doors, surrounds and skirting

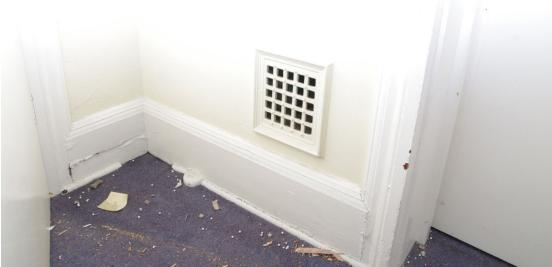
Figure 38 Zone 2 first floor photo 35 cell corridor vent

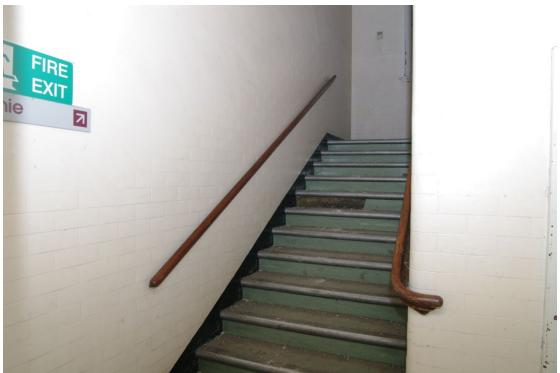
- The staircases still retain their wooden hand rails and glazed brick walls (Fig. 40).
- The open wards have beaded and bolted joists as seen in Zone 1.

Figure 40 Zone 3 ground floor photo 36 stairs and hand rails

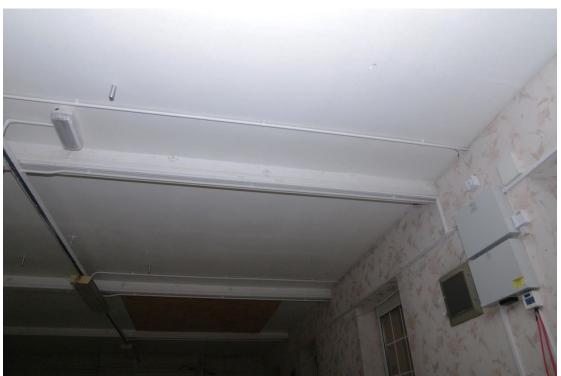
Figure 41 Zone 3 ground floor photo 37 ceiling joists
