**An Historic Building Assessment at  
Sleath Farm,  
Ashby Road, Gilmorton,  
Leicestershire.**

**NGR: SP 570 882**

ULAS Report No.2016-026  
©2016

**ULAS Report Number 2016-026**

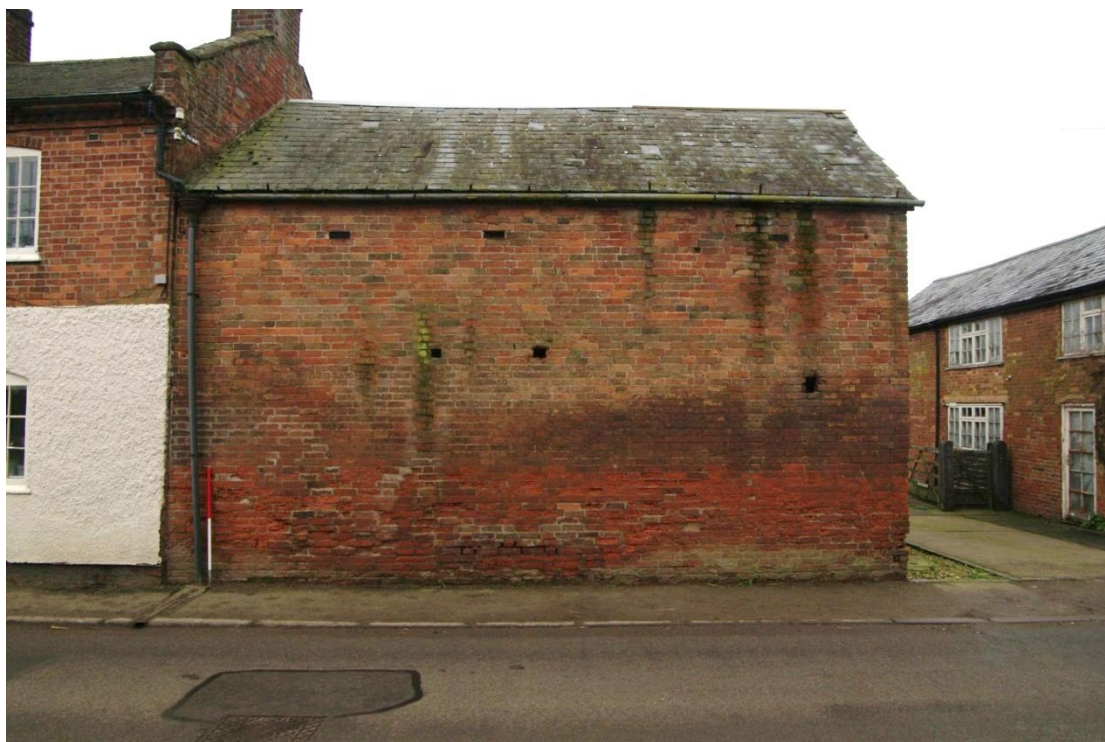
The east facing elevation faces onto Ashby Road and has no window or door openings (Fig. 9). The elevation is stepped back by approximately 50mm from the corner of the farmhouse and the bricks do not appear to be bonded between the two buildings. There are three air vents with cast iron grilles set into the wall at eaves height. Three more vents have been created by knocking out bricks at first floor level. The roof butts against the north gable end of the house and has a narrow cement flashing sealing the joint of the house wall and the slates (Fig. 10). Such a joint is likely to cause significant damp problems for the joining wall.

Figure 9 The barn, east facing elevation  
Looking west. 1m scale

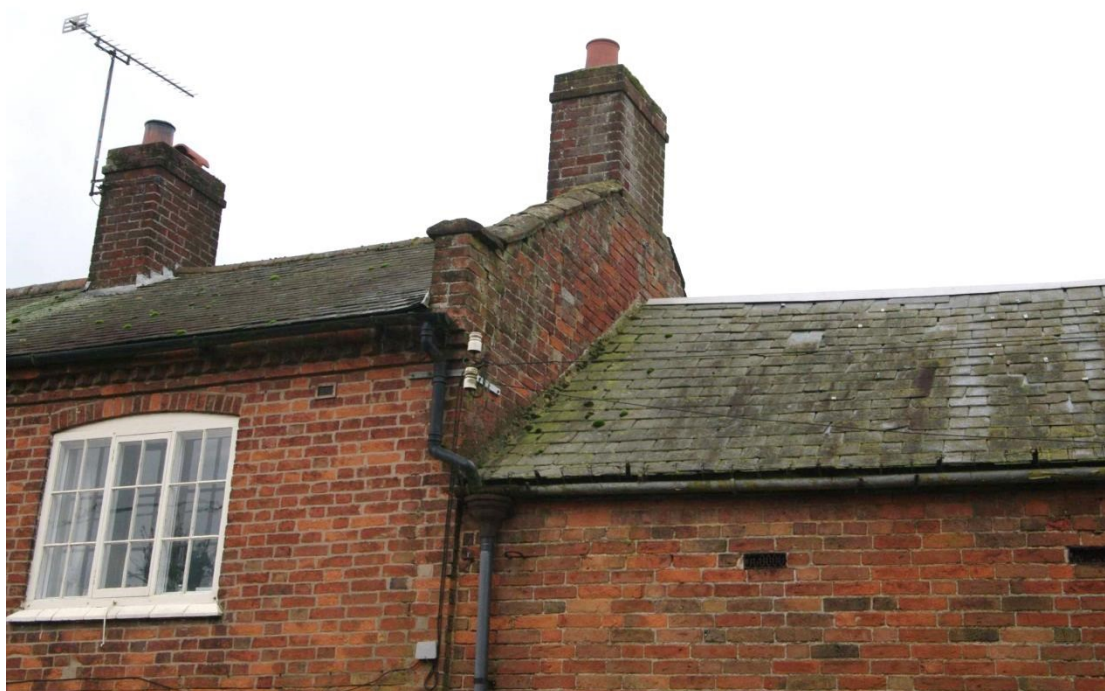
Figure 10 East facing elevation joint between barn and house  
Looking south-west

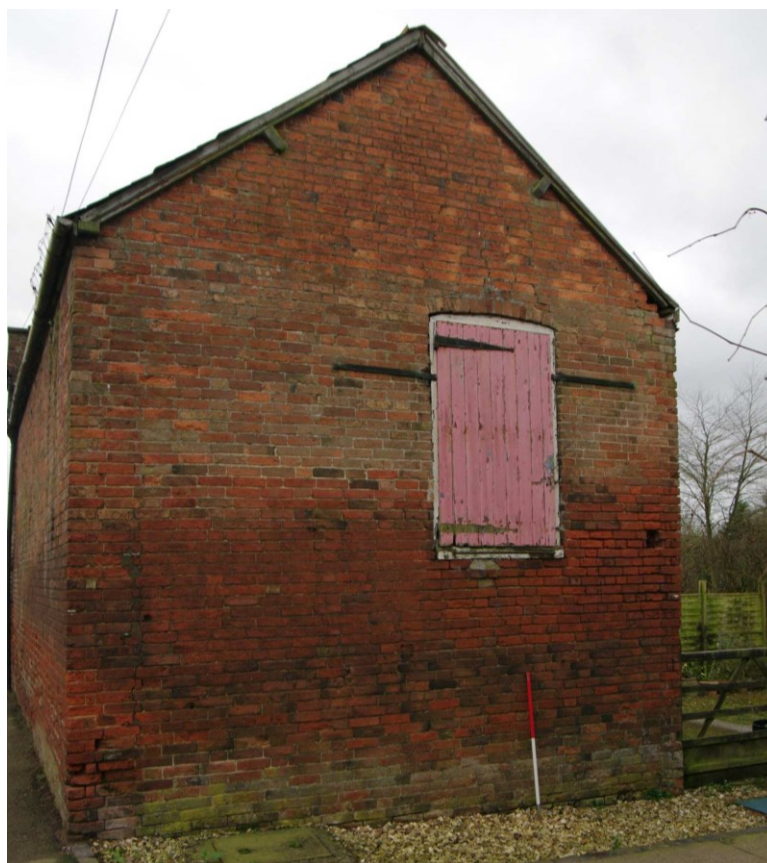
The north facing elevation has a full height hayloft door but has no other openings on this gable end (Fig. 11). The door has strap hinges which appear to be late 19th century in design. An iron hoop is attached to the timber threshold of the doorway which may be a loop to protect the door or for holding a ladder or ramp. The brickwork within the apex of the gable appears to be slightly darker than the brickwork below which may indicate a rebuilding episode or simply that the brickwork below has been repointed.

Figure 11 Barn, north facing elevation  
Looking south-west. 1m scale

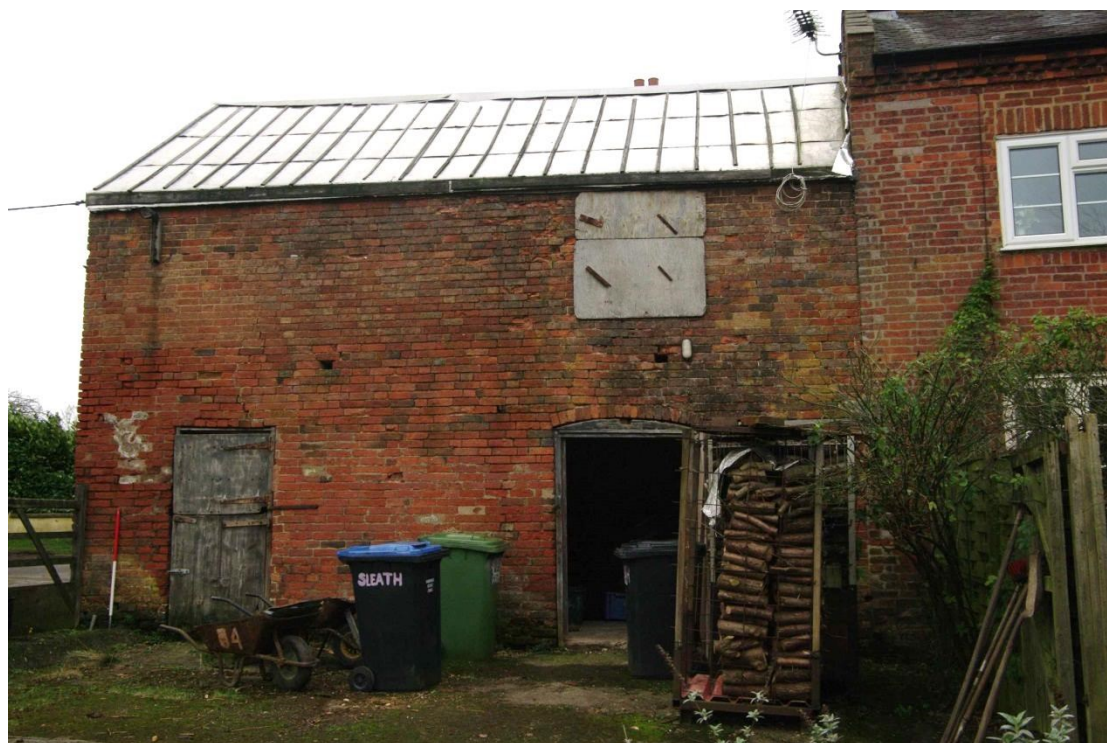
The west facing elevation of the barn faces down into the cobbled yard (Fig. 12). As the two buildings follow the curve of Ashby Road the barn is on a slightly different angle to the house and the flush, but slightly angled, joint between the two buildings is particularly noticeable on this elevation. At ground floor level near to the north corner a stable style doorway leads into the northern room of the two-roomed ground floor. The doorway has a flat lintel with brick headers visible from the outside. The door and fittings are modern. The doorway near to the southern corner has a shallow arched lintel of brick headers over a slightly wider doorway. The wooden frame appears to be either original or from early in the building's development while the door and fittings are modern. To the south of this doorway is a rectangular window with a timber lintel (Fig. 13). The two glass panes are set directly into the surrounding masonry in a style sometimes seen in early to mid-19th century agricultural buildings. A small rectangular window opening close to the eaves at first floor level has been boarded up following a deterioration of the surrounding brickwork.

Figure 12 Barn, west facing elevation  
Looking east. 1m scale

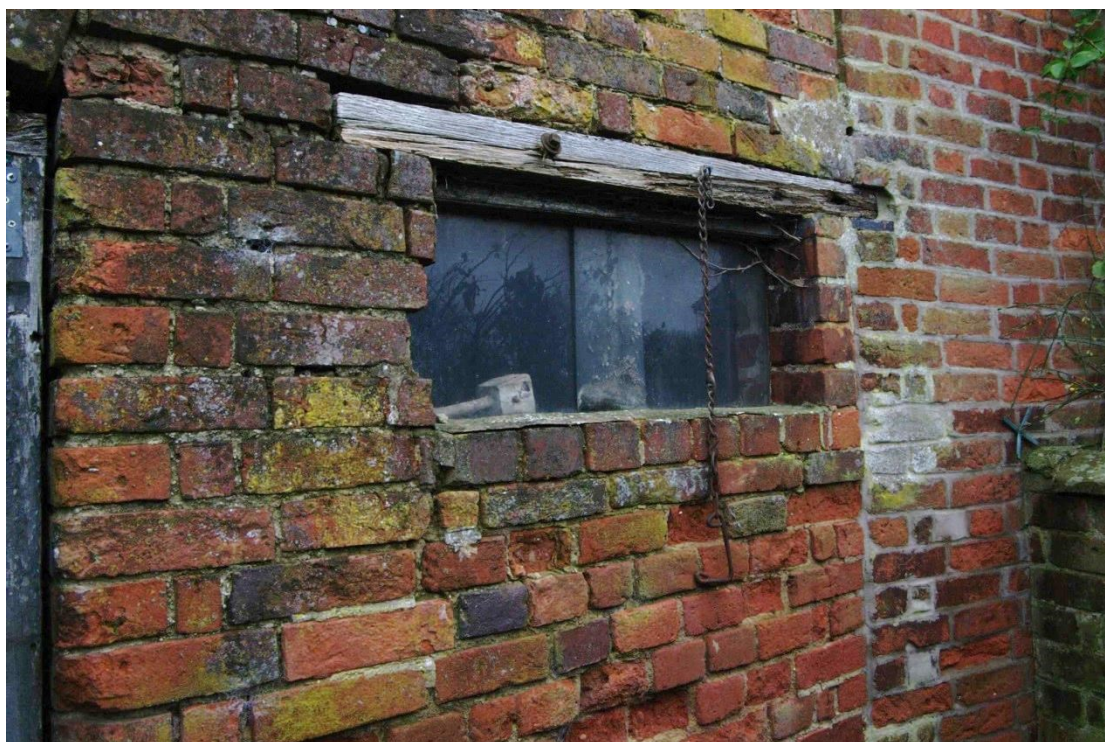
Figure 13 Barn, east facing elevation ground floor window  
Looking south-east. Note joint with farmhouse to right of window

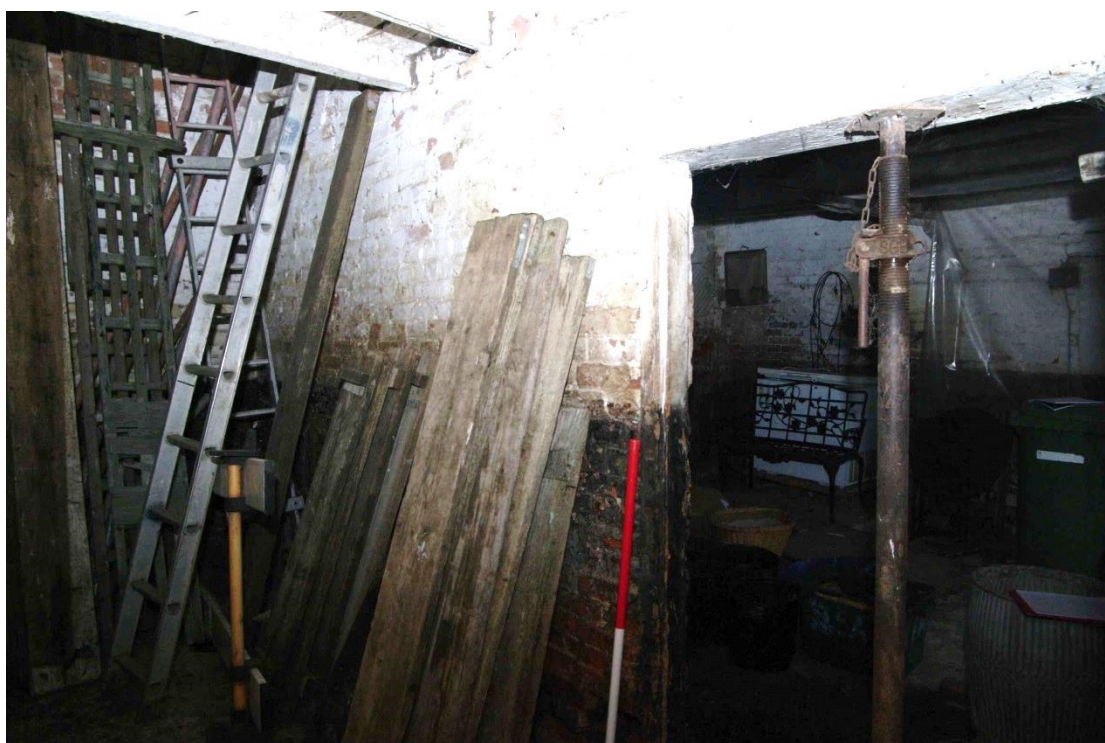
Inside the barn the north room, which is the smaller of the two rooms, has a concrete floor (Fig. 14). There are no fixtures or fittings to indicate what the former use of the room was. Joist holes in the walls show where a first floor used to be located but this has been removed and replaced by a narrow timber walkway leading from the hayloft door to the first floor southern room (Fig. 15). The walkway is suffering from rot and woodworm. A doorway leads through the brick dividing wall into the south room. The doorway does not have a door and there is no evidence of there having been one. The brickwork above the doorway is unstable and has been supported by temporary steel props.

Figure 14 Barn, north room  
Looking south-east into southern room. 1m scale

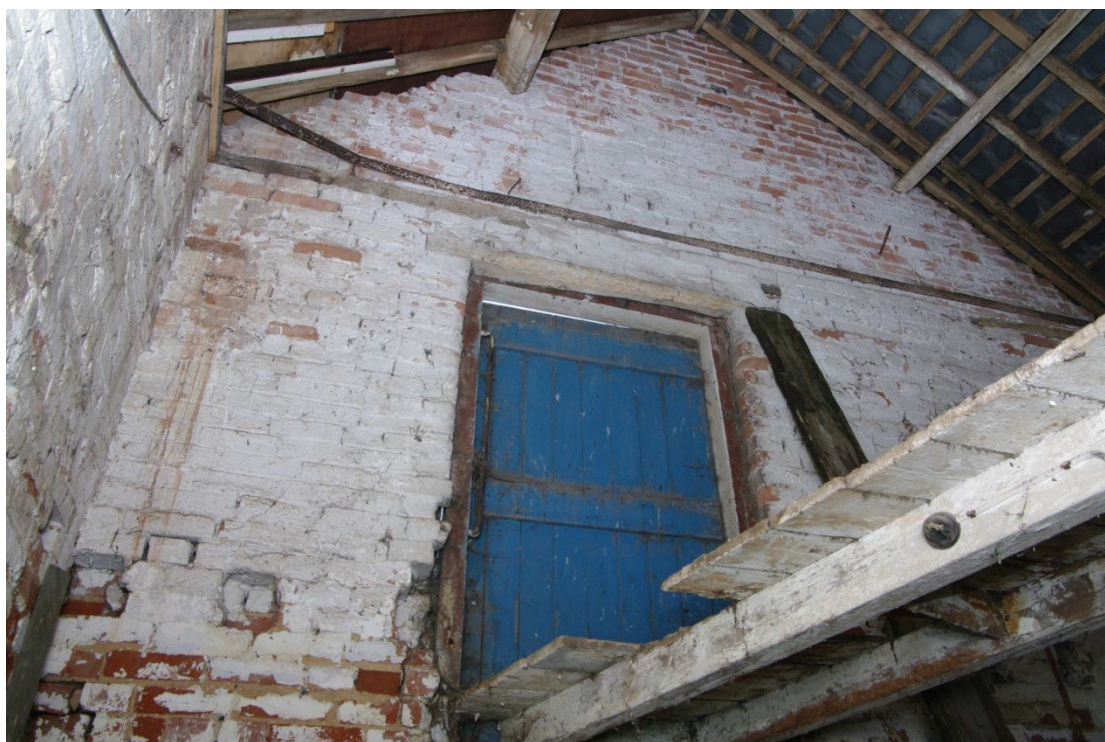
Figure 15 Barn, north room hayloft door  
Looking north-east. The timber walkway from the hayloft door leads to the first floor of the south room

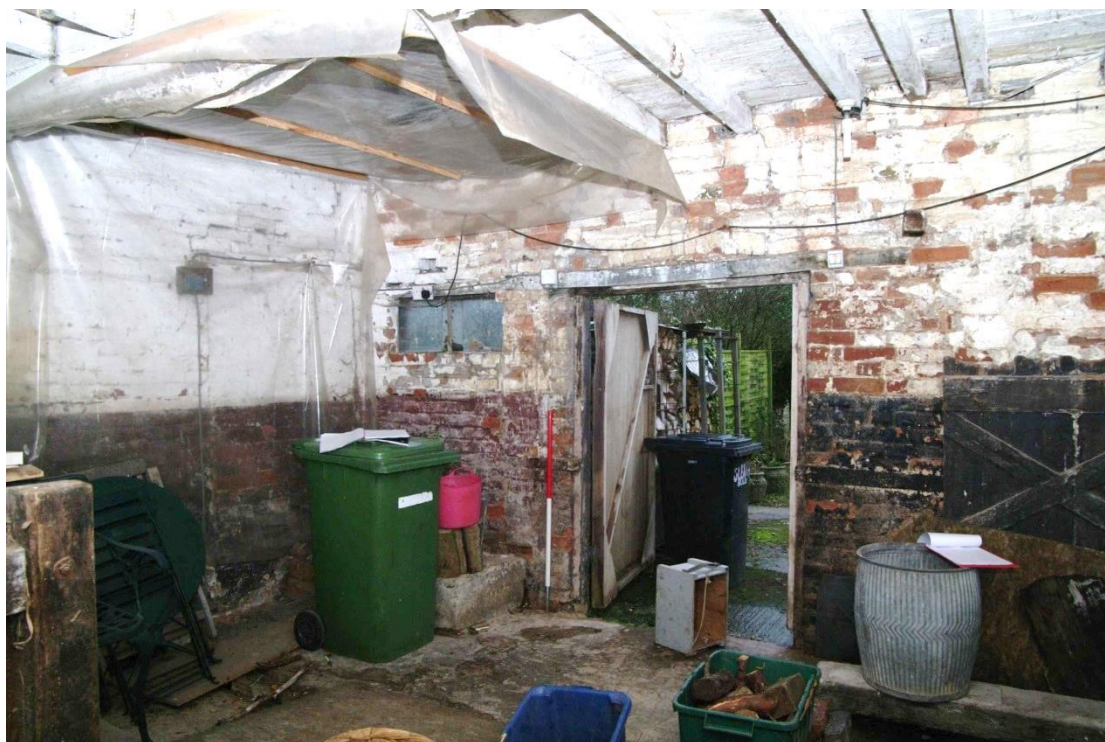
Figure 17 Barn, south room  
Looking south-west. 1m scale. Note plinth for milling machine beneath pink bucket.  
Blocked doorway into farmhouse behind green bin and plastic sheeting

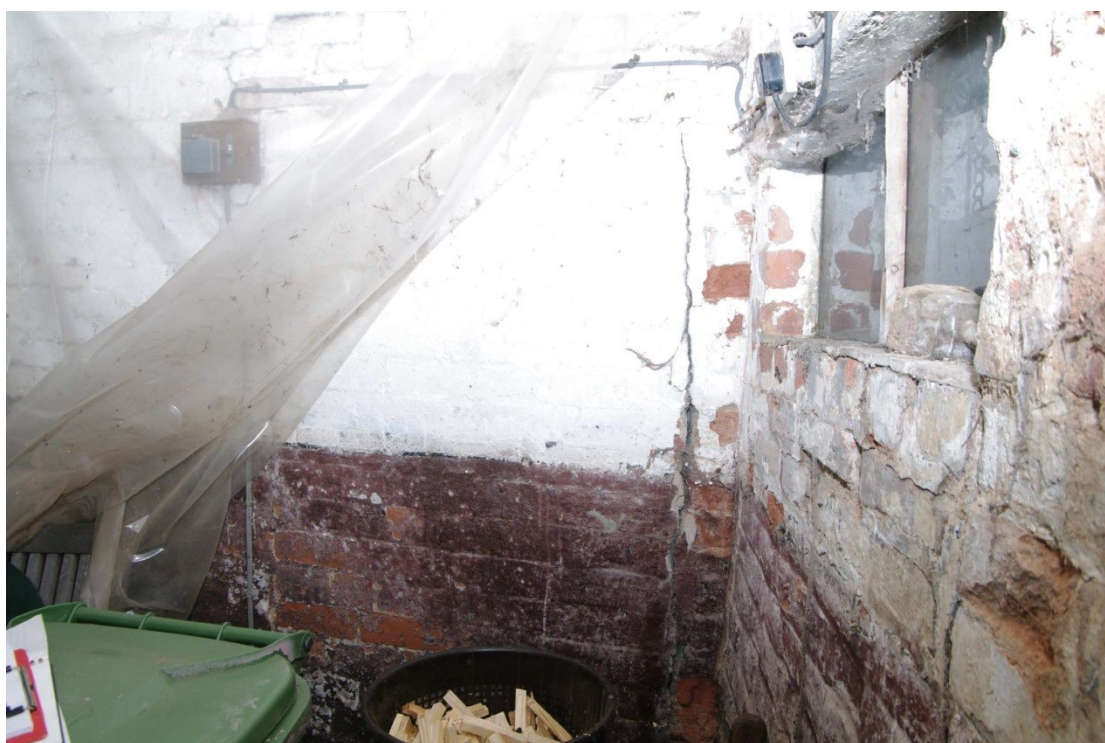
Figure 18 Barn, south room blocked doorway into house  
Looking south

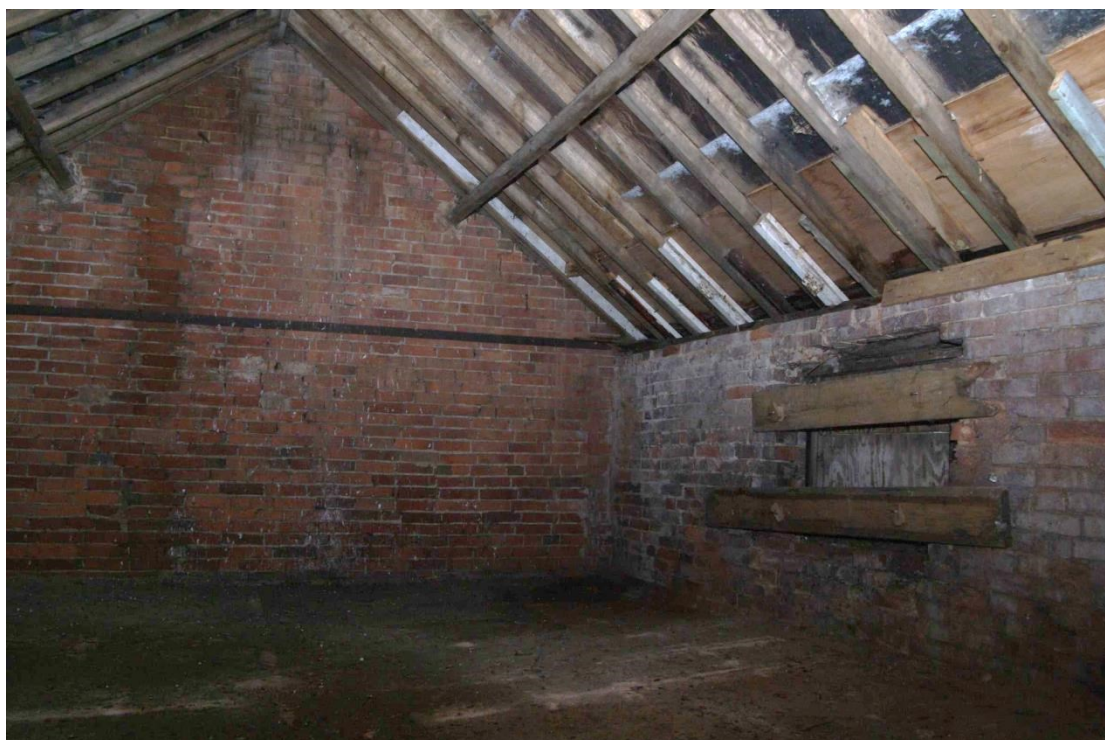
The first floor was only inspected from a ladder propped against the doorway from the north room. The room has no fittings and has a single window on the east wall. The brickwork above the window is collapsing and is supported by timber planks (Fig. 19). The roof structure consists of two purlins on which rest the common rafters.

Figure 19 Barn, first floor  
Looking south-west

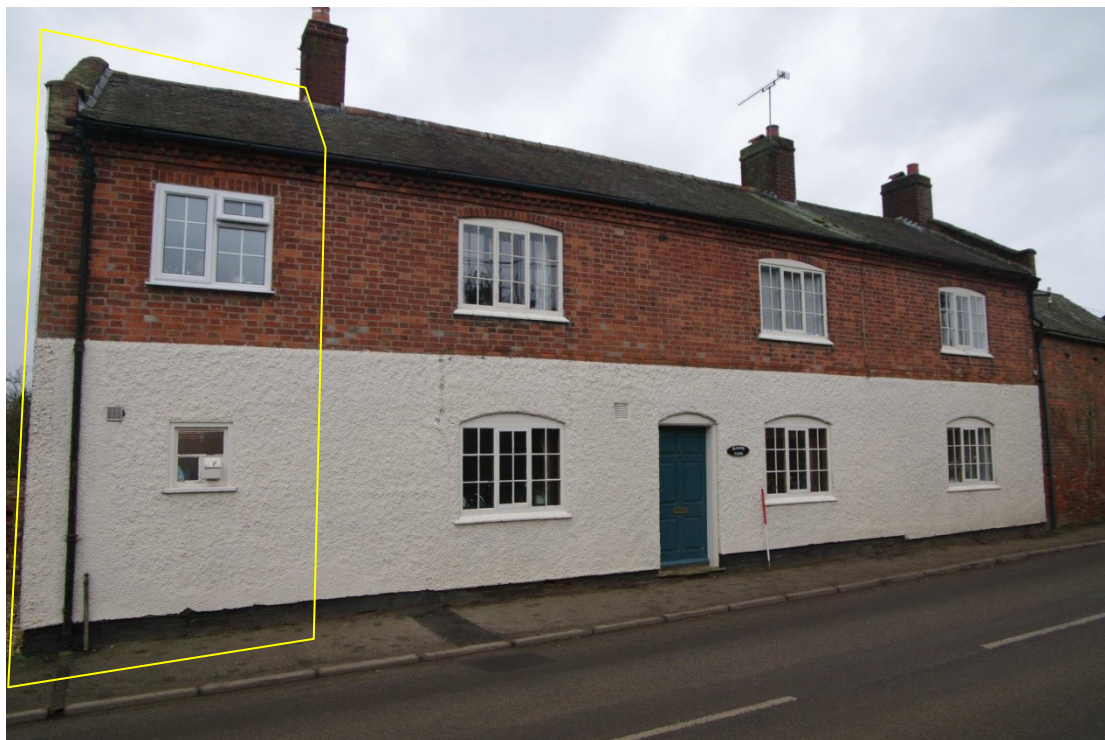
The most recent proposals entail the removal of the southernmost bay of the farmhouse in order to improve site access. The ground floor of the east facing elevation of the farmhouse has been coated with render which has the potential to mask a number of blocked windows or doors (Fig. 20). The east facing frontage consists of four bays with a single doorway in the centre. The ground and first floor windows of the three northernmost bays have shallow arched brick lintels. The southern bay which will be removed has modern looking rectangular windows suggesting some form of modification has taken place. The south facing gable end is completely covered in render to hide the marks left by a much taller building which butted against the farm until it was demolished in the late 1960s or 1970s (Fig. 21). It is not known which building was the earliest.

Figure 20 Farmhouse, east facing elevation  
Looking north-east. 1m scale. Yellow box indicates the portion of the building to be demolished

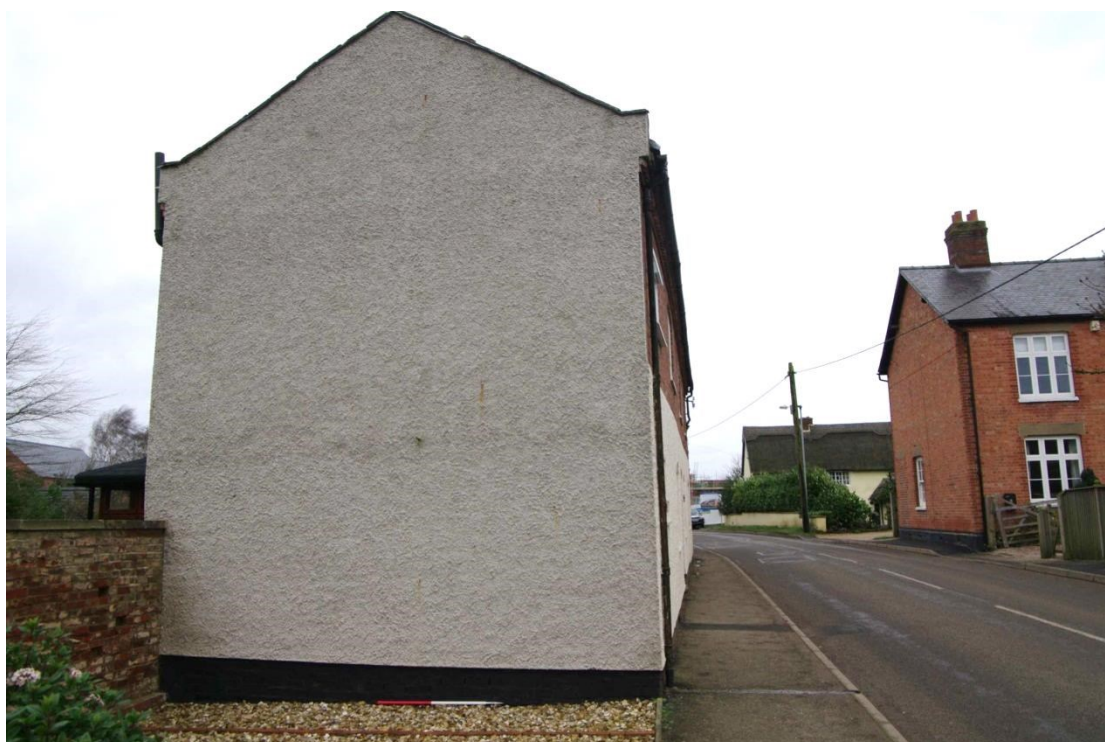
Figure 21 Farmhouse, south facing elevation  
Looking north. 1m scale

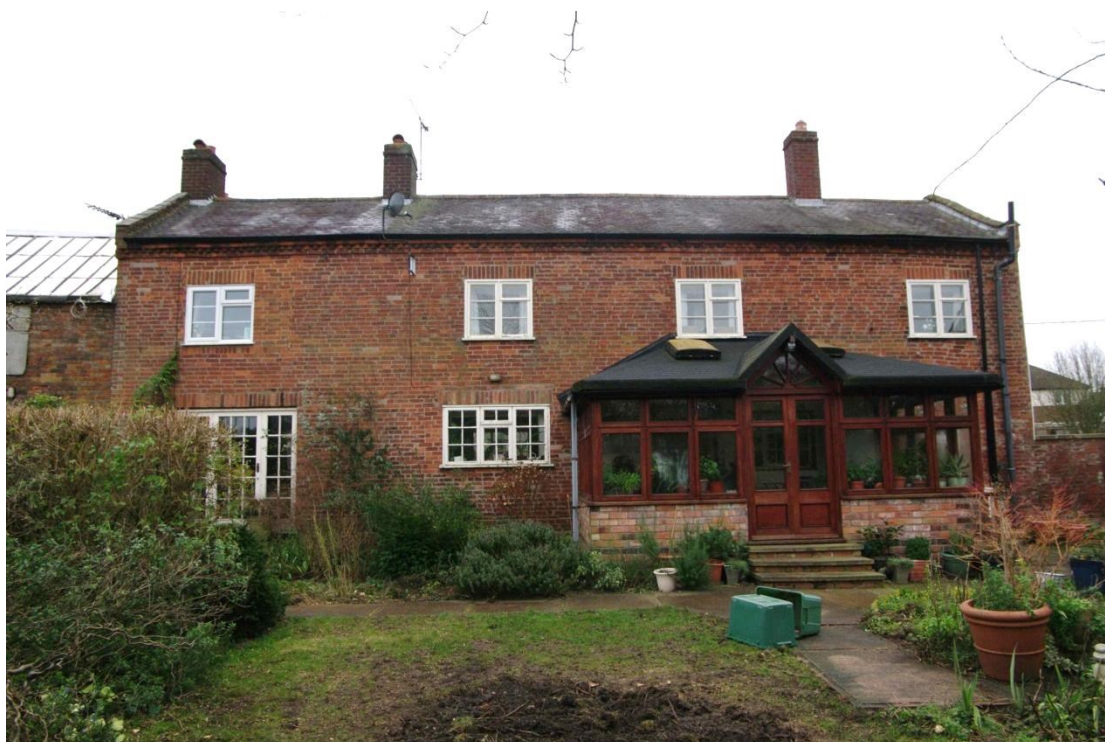
The west facing elevation has exposed brickwork which shows some evidence of modification around some of the windows (Fig. 22). The southern end bay has a similarly styled first floor window to the rest of the first floor windows but the brickwork of the whole bay is showing signs of significant settlement and distortion (Fig. 22). The ground floor window has been modified from an earlier doorway.

Figure 22 Farmhouse, west facing elevation  
Looking east. Barn on left of picture. Bay proposed for demolition on right

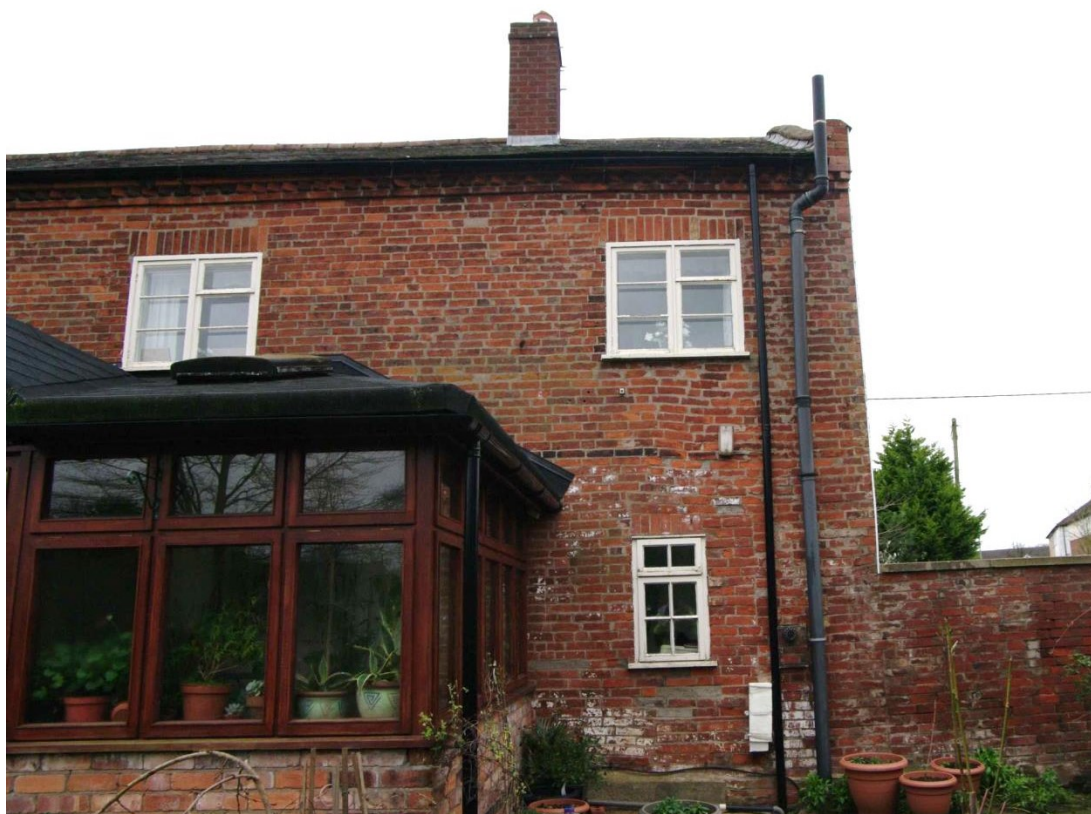
Figure 23 Farmhouse, west facing elevation  
Looking east towards southernmost bay
