**A Level 2 Historic Building Survey at
Limes Farm, Main Street,
Kilby,
Leicestershire**

ULAS Report No. 2016-008
©2016

For: Leicestershire County Council

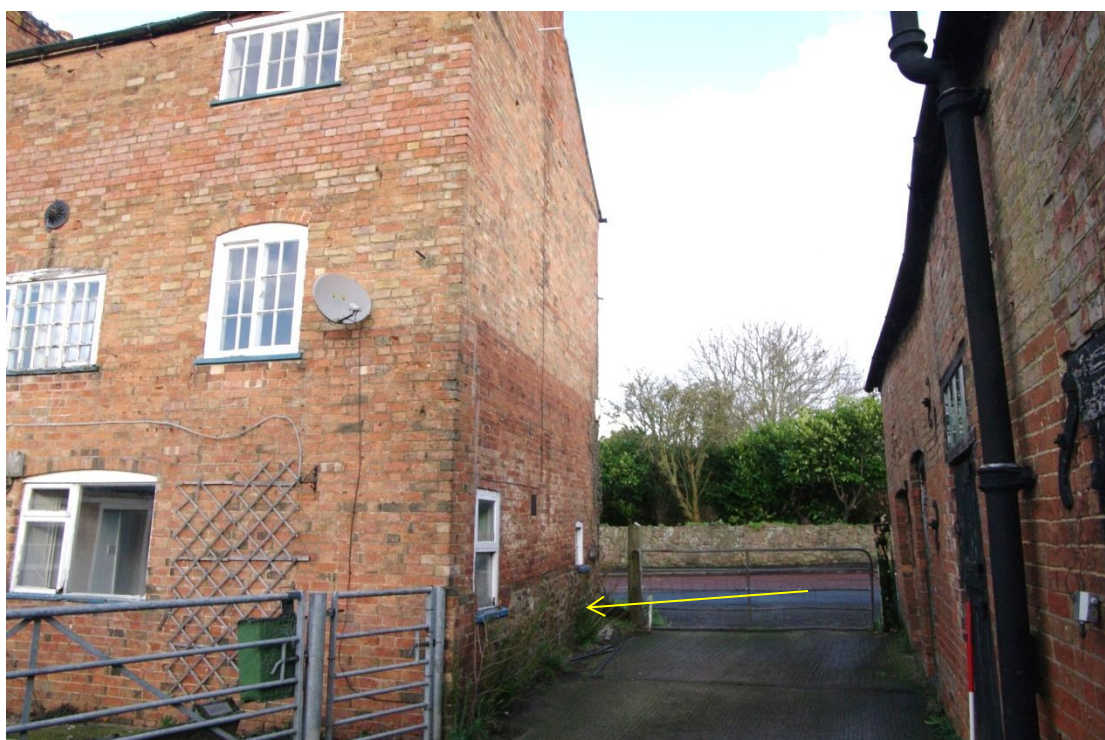
The present house was constructed in the 1770s but may have older origins as there is evidence of a stone platform base on the east facing gable end wall (Fig. 5). The brickwork of the farm also shows evidence of modification since its initial construction date. The farmhouse does not form part of this survey.

Figure 5 East end of Limes Farmhouse
Looking north. Note stone platform (arrowed) and rebuilding line in the brickwork on the gable end. Unit 1 buildings on right of picture

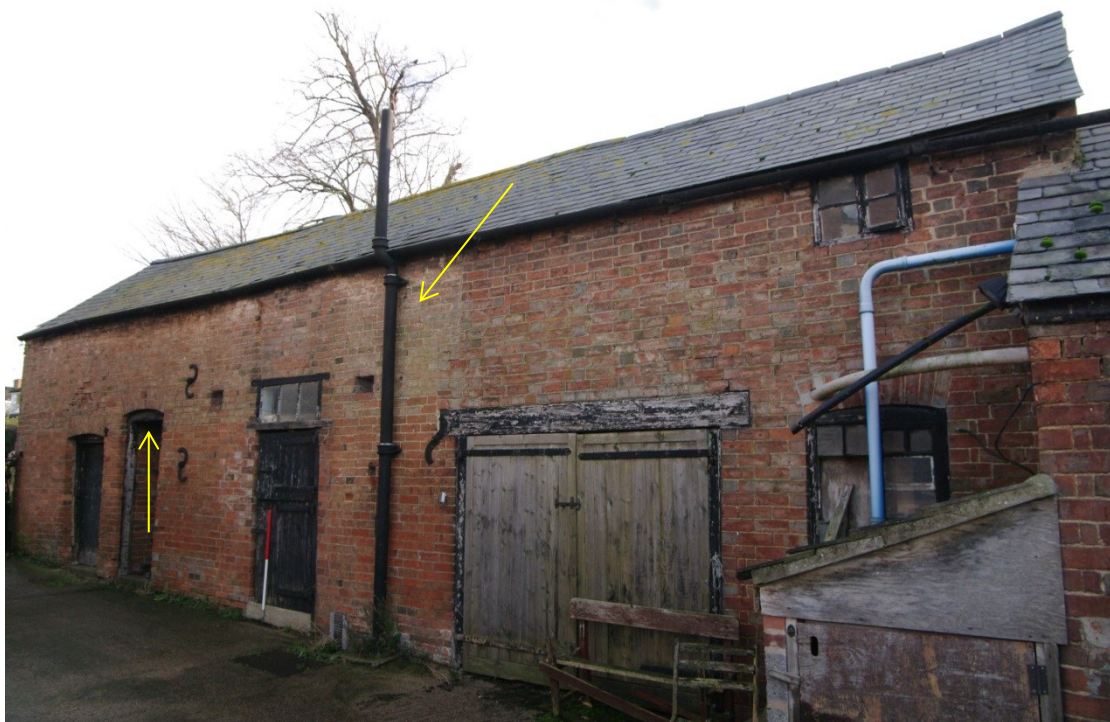
The north-west facing elevation runs parallel to the side of the farmhouse and the top of the long yard. This elevation also shows the difference in colour in the brickwork at ground floor and above (Figs. 11 and 12). There is a vertical joint in the brickwork towards the southern end of the elevation which appears to show that the building was always two storeys at this end. A modern breeze-block built structure with a cement tiled roof has been built into the angle created by Building 1 and Building 2.

Figure 12 Unit 1, Building 1 north-west facing elevation
Looking north-east. 1m scale. Note changes in brickwork (arrowed)

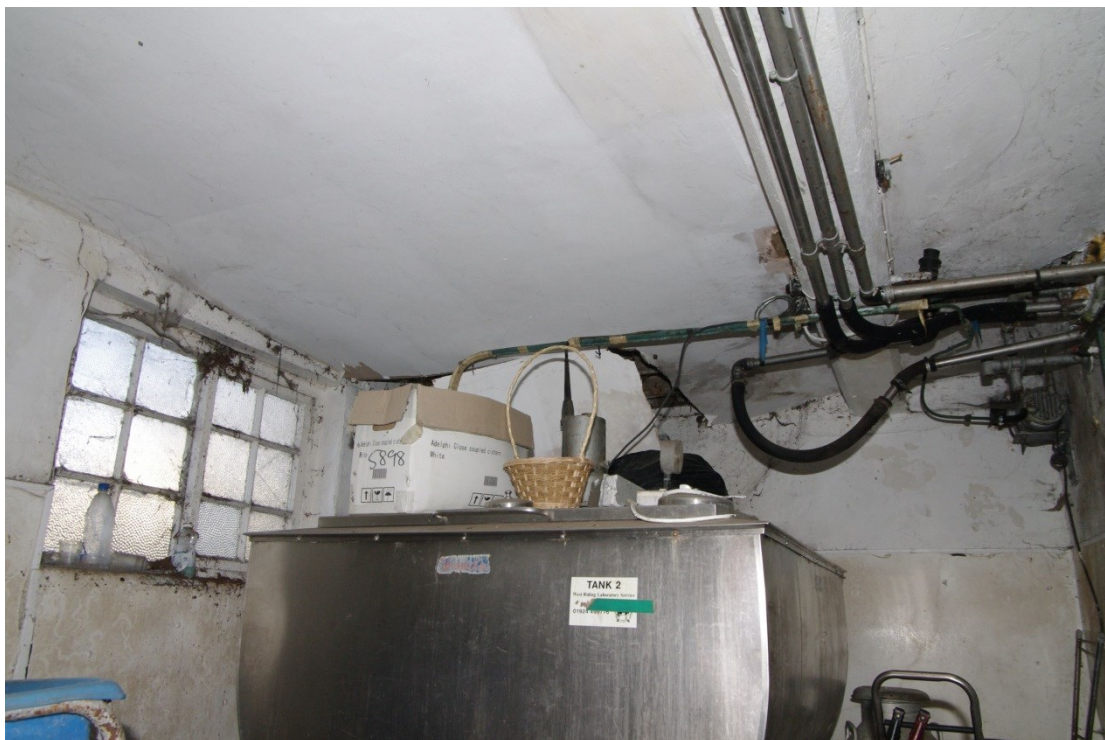
At the northern end of the north-west facing elevation is a low but wide doorway which leads into a small room with modern milk processing equipment inside (Fig. 13). The walls have been covered in a white boarding material presumably to aid cleanliness. The room has a low ceiling which has been plastered and is supported by a substantial chamfered beam. A narrow doorway with a brick-arched head is located to the south of the northernmost room. This doorway leads into a narrow passageway which runs the width of this building although the purpose of this is not clear as there is no evidence of a doorway, blocked or otherwise, on any of the walls (Fig. 14). A number of modern pipes for transporting milk run across the room at ceiling height.

Figure 13 Unit 1, Building 1 northern room
Looking east

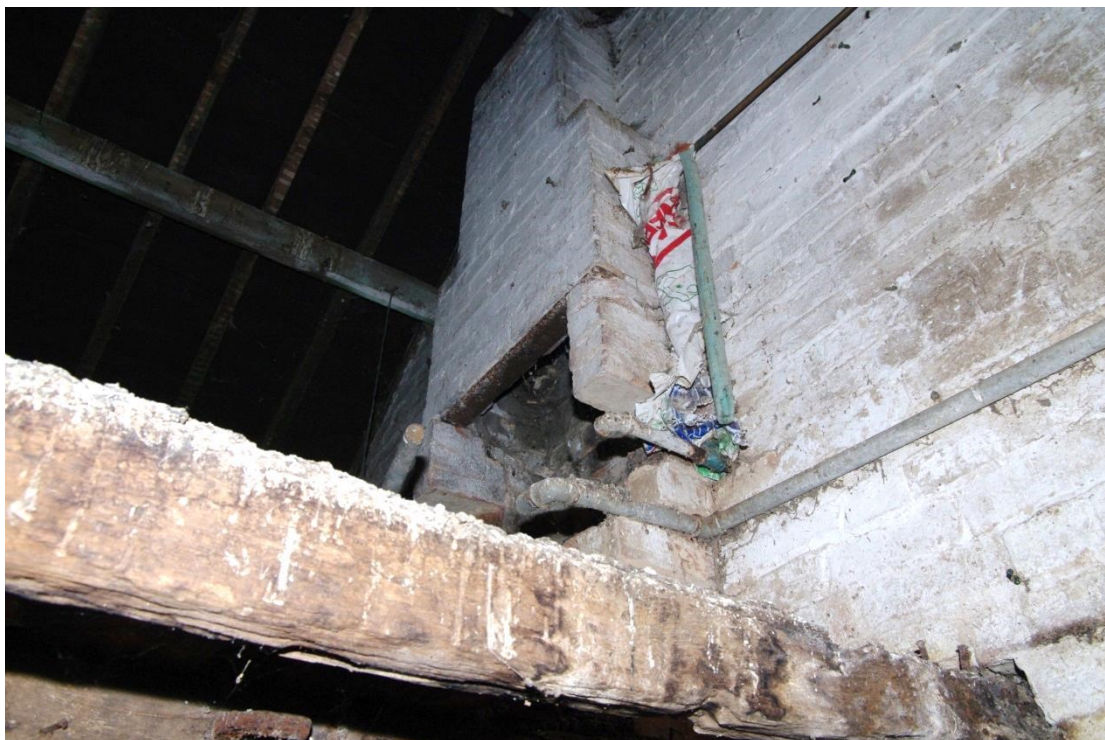
The southernmost room of Building 1 coincides with the vertical joint in the change in brickwork suggesting that this part of the building was always a two-storey structure. The ground floor has a double-width doorway with a large timber lintel and a wooden-framed window to the south. At eaves level is a small four-paned casement window. Inside, the room appears to have been most recently used as an animal pen or chicken house. A thin wooden partition divides the room into two and has a mezzanine floor above it which covers approximately two-thirds of the room leaving only the western third open to the roof. A locked or sealed wooden door leads south into Building 2 (Fig. 16). There was no access to the mezzanine which was also unsafe to walk on but it could be seen from ground level that

there is a small fireplace and chimney located on the south wall (Fig. 17). The chimney stack is not visible from the outside which indicates that the roof has been re-covered.

Figure 17 Unit 1, Building 1 south room mezzanine floor
Looking south from ground floor

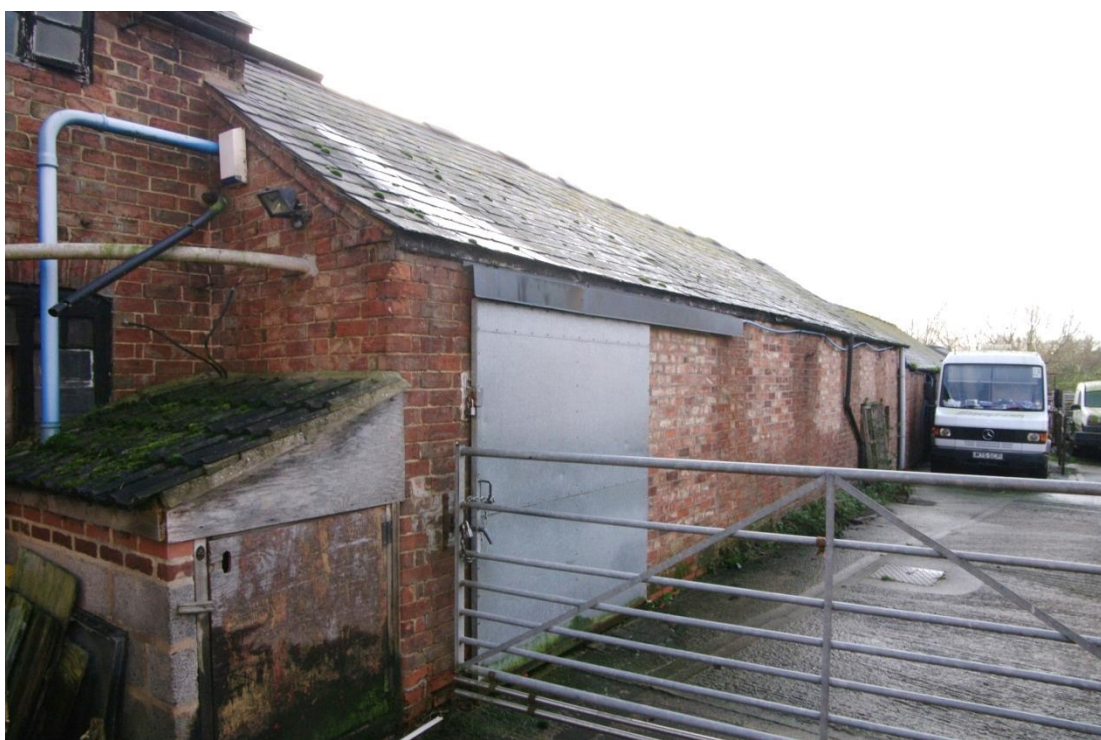
The slate-roofed Building 2 is lower and wider than Building 1 and also partially wraps around the south-western corner of Building 1 showing that it was built at a later date than 1 (Fig. 18). The north-western corner of Building 2 has rounded bricks to prevent damage from vehicles and animals entering the yard from the road. The north-west facing elevation has been significantly modified by blocking at least four windows and a doorway with modern bricks and adding a modern sliding door at the northern end (Fig. 19). Inside the building has been converted to a milking parlour with most of the equipment remaining in-situ (Figs. 20 and 21). The southern end wall has been adapted to take a full-width roller door which appears to have been used to allow the cows to enter and leave the parlour.

Figure 18 Unit 1, Building 2 north-east and north-west facing elevations
Looking south. Note how Building 2 wraps around the corner of Building 1

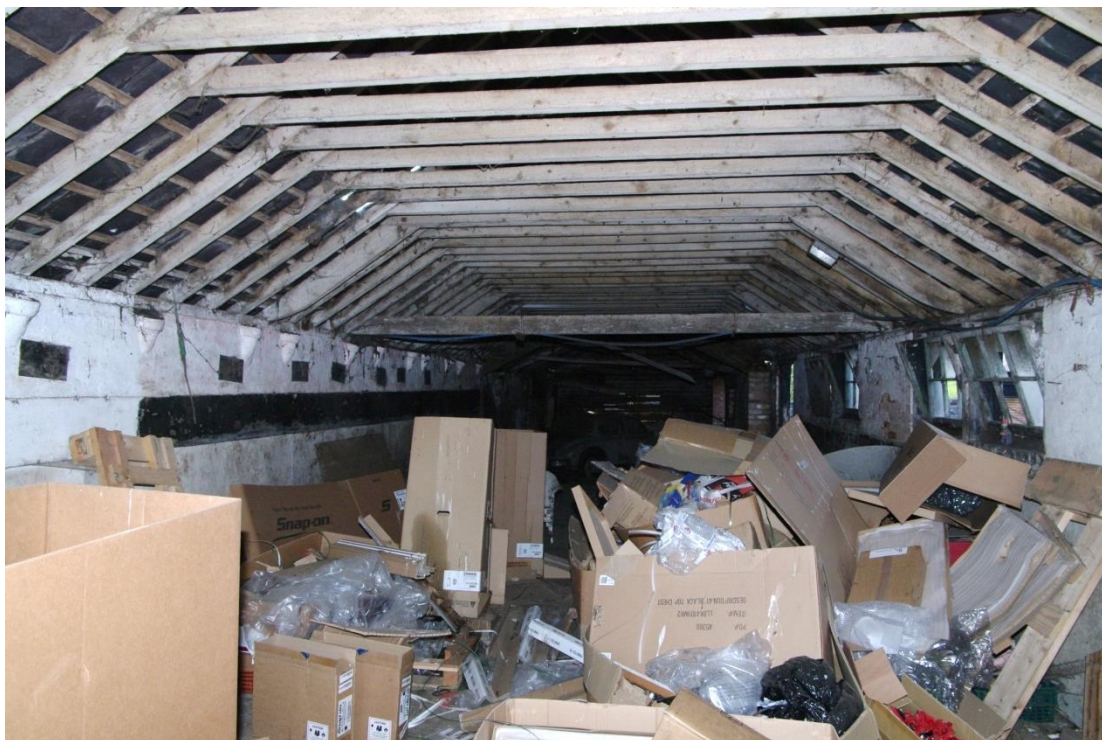
Inside Building 3 is a large open space with bays and small troughs for cows to be tethered (Figs. 23 and 24). Above each stall is a small board where the animal's name was chalked. The roof structure has a very shallow pitch and consists of multiple common rafters all supported by tie-beams set half way up their length. A single timber beam or truss runs across the room.

Figure 23 Unit 1, Building 3 inside
Looking south-west. Note black plaques to hold the cow's names

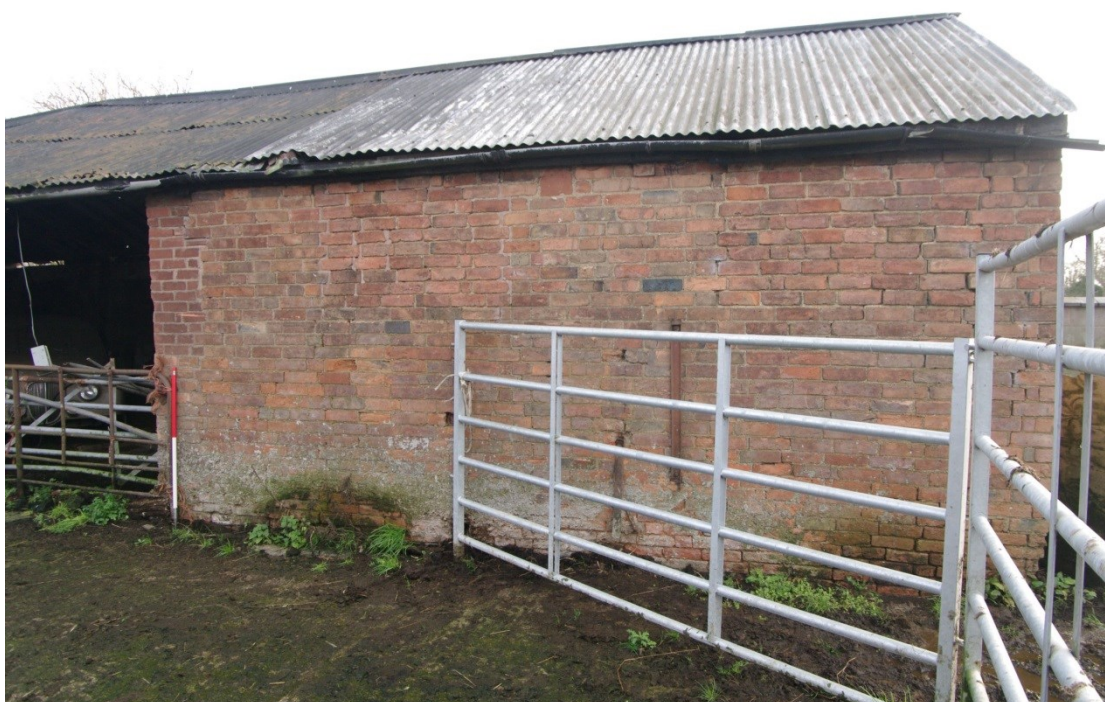
Figure 26 Unit 1, Building 4 north-west facing elevation southern end
Looking south-east. 1m scale. Note multiple brick joints

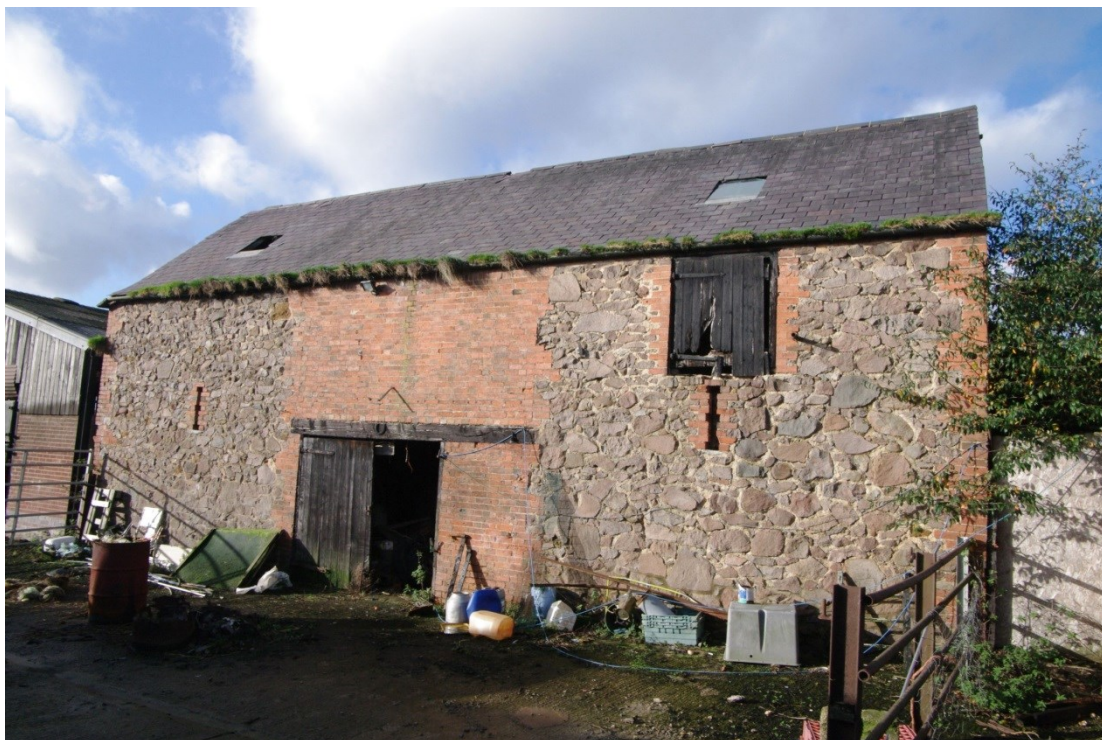
The barn building is built from granite rubble with red brick corners and inserts around the doors and windows (Figs. 30 and 31). The building has a slate roof which, according to the tenant farmer was renewed around fifty years ago. The granite appears to be of the same type as that used for the platform supporting the farmhouse walls and the same as a number of boundary walls seen elsewhere in the village.

The south-east facing elevation of the barn faces into the long yard and is the only elevation which is unobscured by other structures. The brick-built corners appear to be handmade and are keyed into the stonework and are likely to be part of the original design (Fig. 32). Air vents in the form of vertical slits are also likely to be original features especially as the vent has a stone sill (Fig. 33). A set of double doors with a substantial timber lintel is set into a central area of brickwork which is also keyed into the adjacent stonework. The lintel is much longer than the door which suggests that the opening has been modified, perhaps to put in a smaller doorway. A hayloft door, also with a brick surround, is located below the eaves at the northern end of the elevation.

Figure 30 Unit 2, Barn south-east facing elevation
Looking west

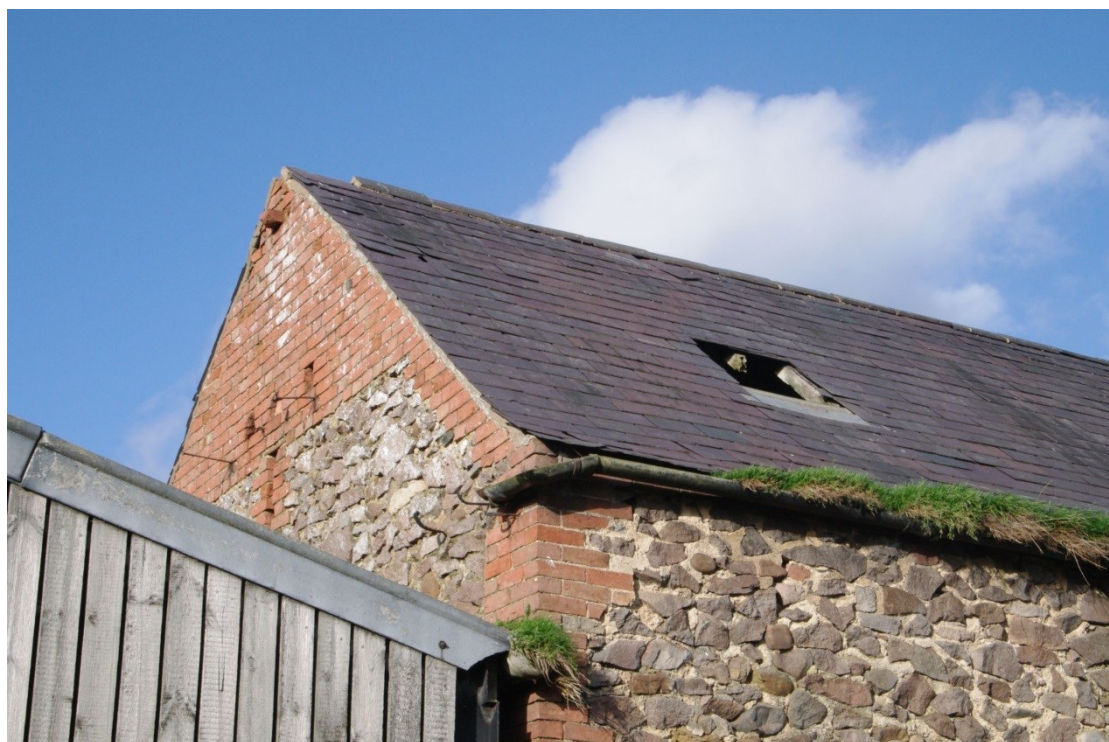
The gable ends of the barn are both of stone with the apexes being built in brick. The south-west facing gable end has a slit vent just above eaves height suggesting that the buildings attached to this end shown on the 1886 map were lower than this. The rest of the gable end is obscured by the modern barns. The north-east facing gable end has exactly the same details but is obscured by a set of brick outbuildings built against it.

Figure 32 Unit 2, Barn south-west facing gable end
Looking north

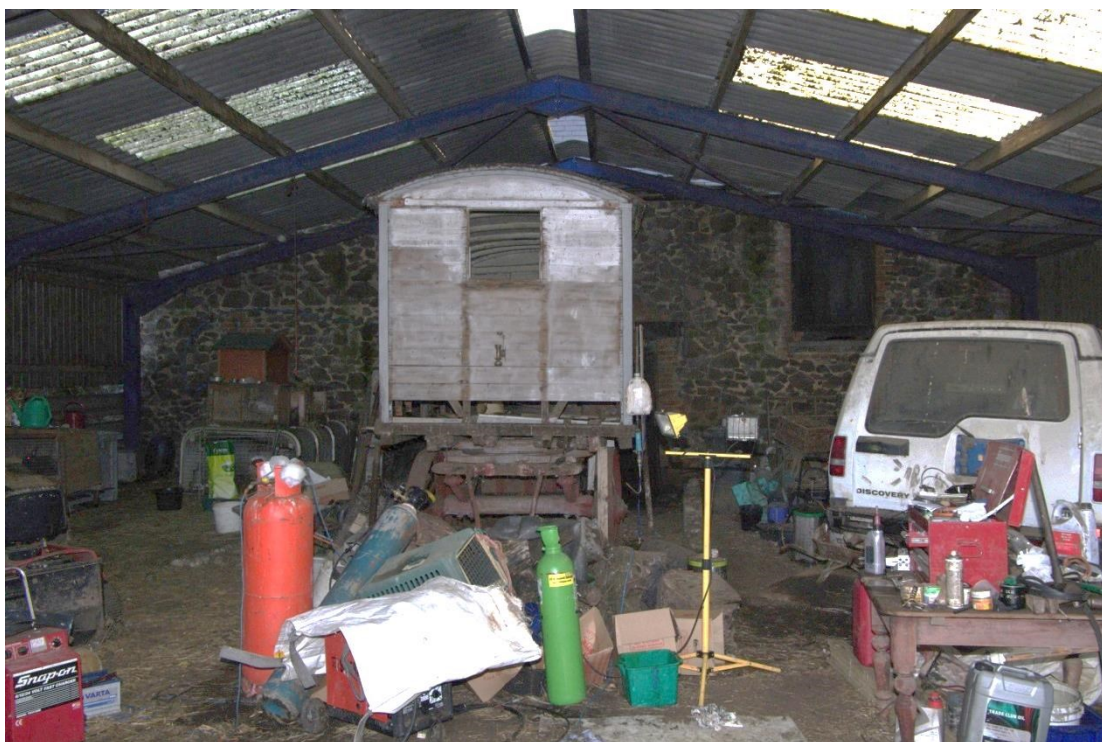
The north-west facing elevation of the barn is partially within the adjacent barn and can only be partially inspected (Fig. 34). The details of stone and brickwork appear to be the same as the south-east facing elevation although on this elevation the doorway has only a small amount of brickwork above it with the rest being stonework. The timber lintel is supported on brick pillars. A full height hayloft door is located at first floor level to the south of the doorway.

Figure 34 Unit 2, Barn north-west facing elevation
Looking south-east. Central doorway is behind the living van

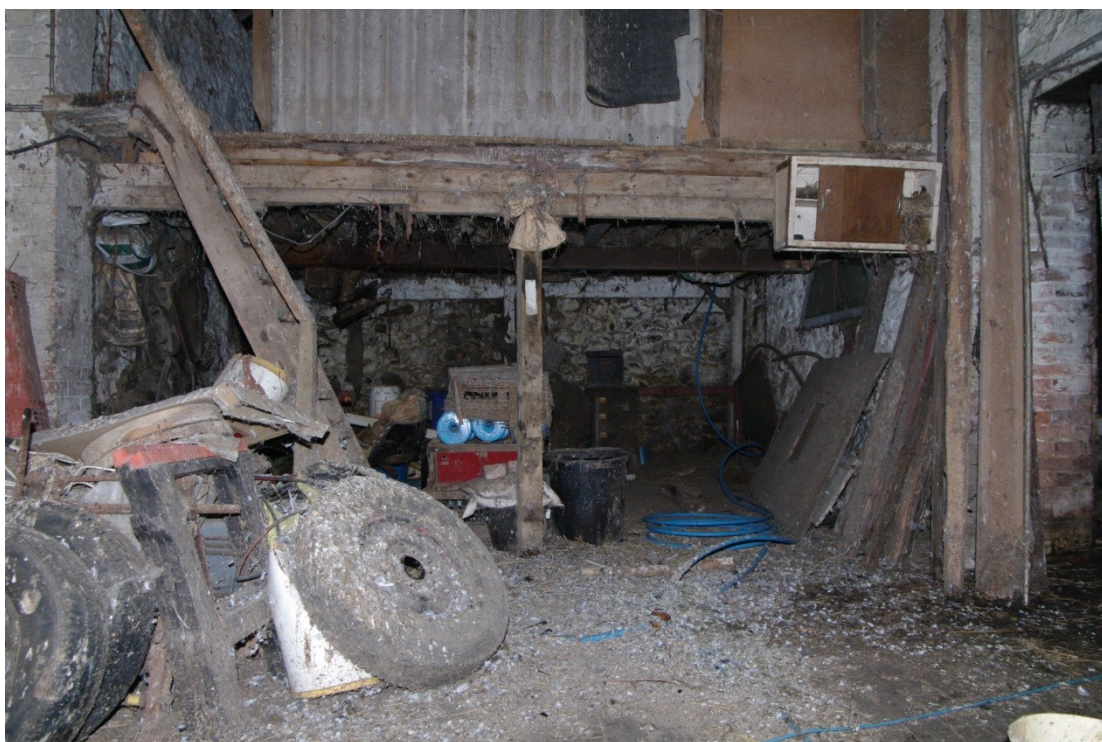
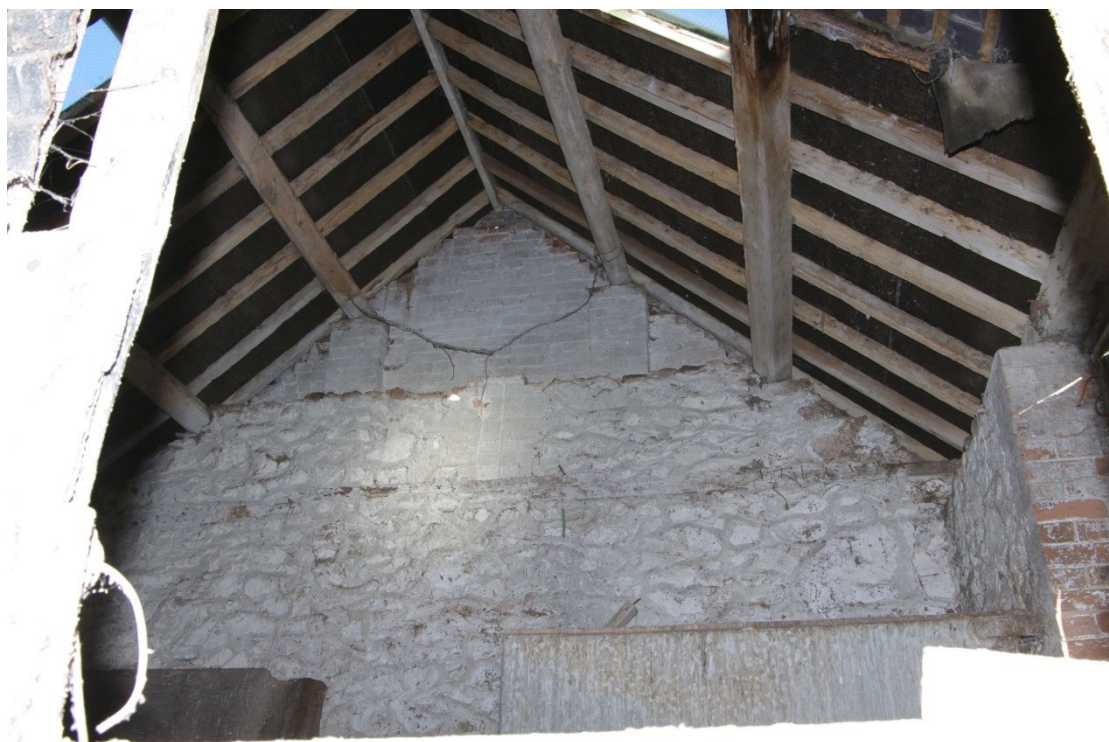
Inside the barn is a full-height central area with mezzanine floors at both ends (Figs. 35 and 36). The barn is used for storage and is in a fairly poor state due to a leaking roof. The mezzanine floors, which have wooden partitions at the end, can be reached via sets of wooden steps but the floors appeared to be in varying stages of rot so only a cursory inspection was made from the ground floor.

Figure 35 Unit 2, Barn ground floor
Looking south-west

Figure 36 Unit 2, Barn mezzanine
Looking north

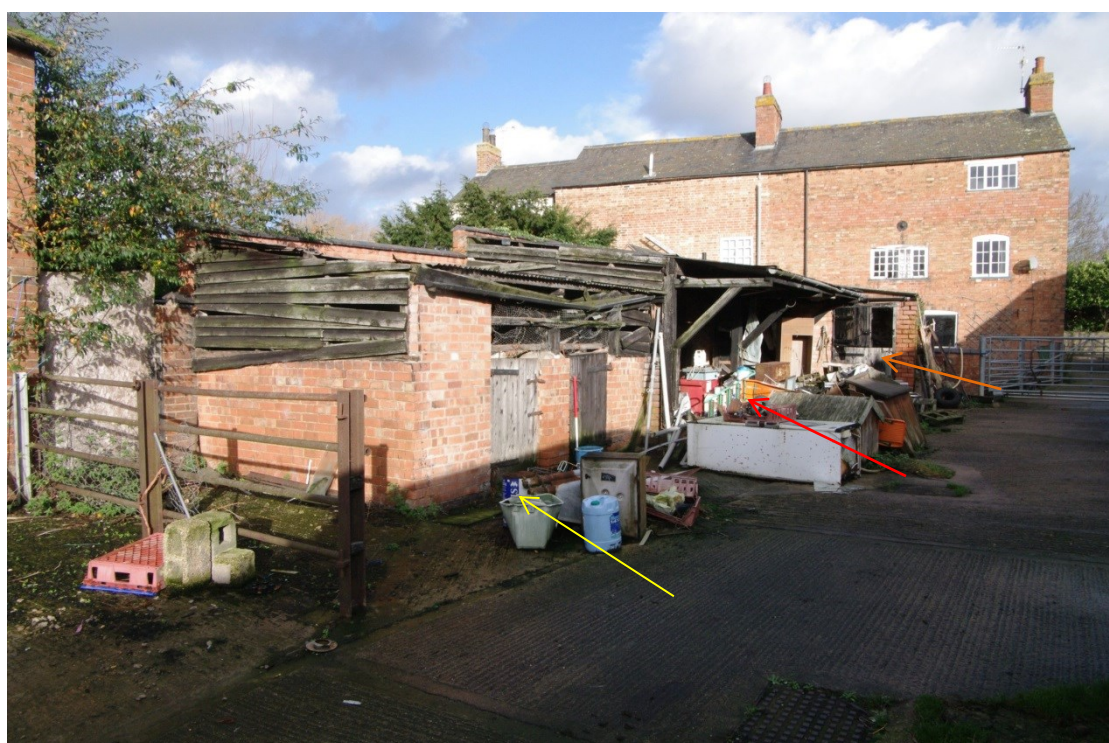
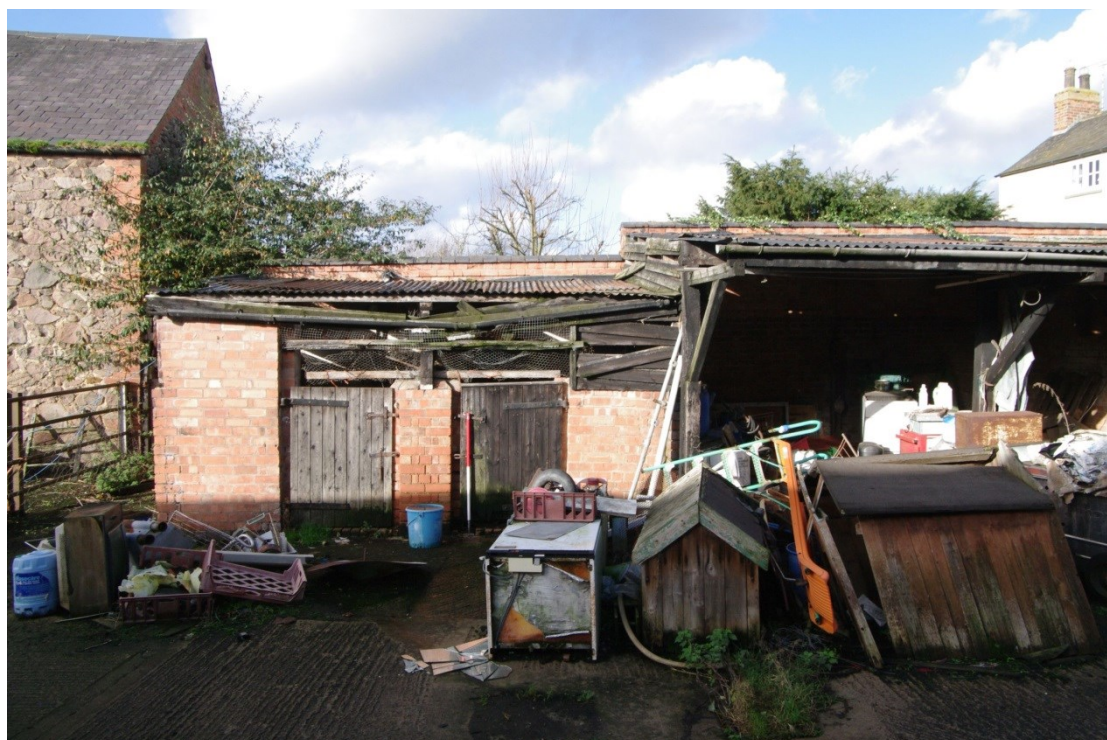
The outbuildings to the north-east of the barn are a group of brick-built structures which share the same common back wall on their north-western side (Figs. 37 and 38). The buildings impinge on the yard to quite an extent and their construction must have represented a significant change of use in this area. Closest to the barn are a pair of sties currently used to house chickens. To the north of this is an open-fronted lean-to shed currently used for storage. There is no indication what this was used for but could have been a small cart shed. At the northern end is a long room with a stable door facing towards the south-west. This is presently used as an office or store.

Figure 37 Outbuildings
Looking north. 1m scale. Yellow arrow shows the sty, red arrow is the lean-to, orange arrow
is the outbuilding

Figure 38 Outbuildings
Looking north-west. Sty on left of picture lean-to on right
