**A Level 3 Historic Building Survey at
98-100 Welford Road,
Leicester**

ULAS Report No. 2017-170
©2017

For: Invicta Universal Limited

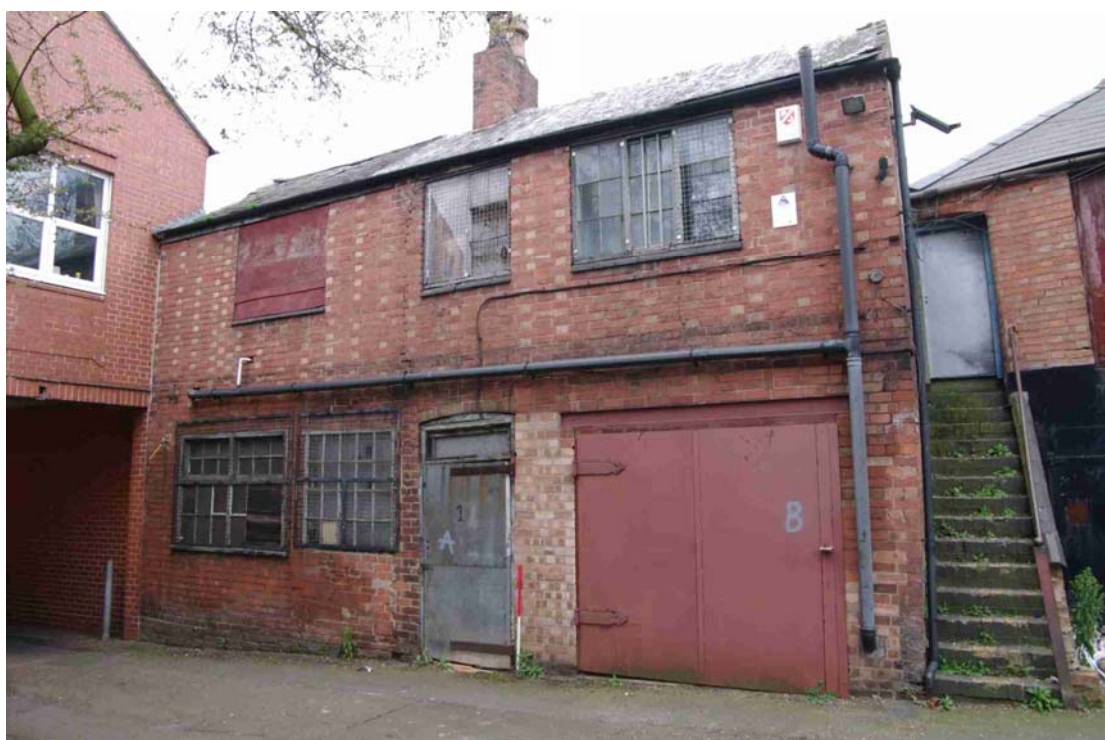
Figure 14 Building A south-east facing elevation
Looking north-west. 1m scale. Steps up to Building B on right

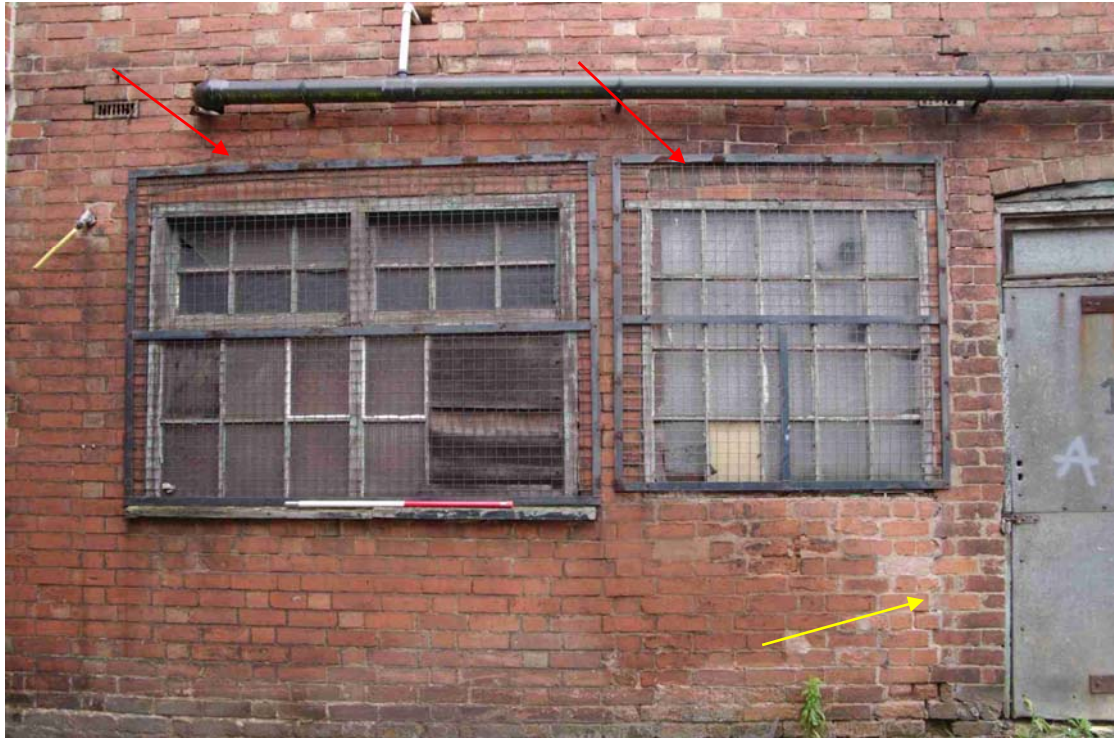
Figure 16 Ground floor of Building A
Looking north-west. 1m scale. Note arches above windows (red arrows) and joint of former doorway (yellow arrow)

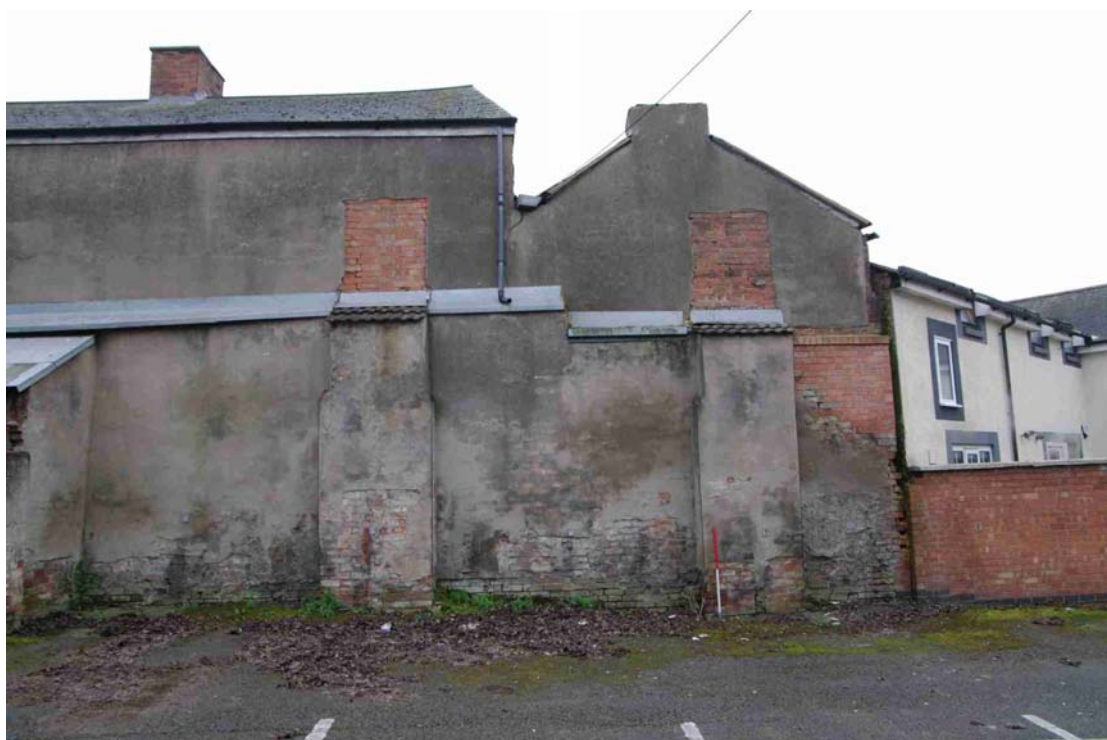
The north-east facing elevation of Building B has a flat gable end and is covered in cement render which obscures most details especially the joint, or lack of joint, between it and Building C. A first floor window has been blocked with poor quality bricks and the chimney stack on the gable end has been capped. All ground floor details are obscured by the remnant of the back wall of the outhouses which has been left in-situ and also reinforced by the addition of brick buttresses. Although it is not too clear the 1844 map does appear to show that the outbuilding walls were present before Building B was constructed which may explain why it was left in place when the rest of the buildings on Regent Road were demolished.

Figure 20 Building B north-east facing gable end
Looking south-west. 1m scale. Building C on left. Note buttresses and remnant of
outbuilding walls against the ground floor walls

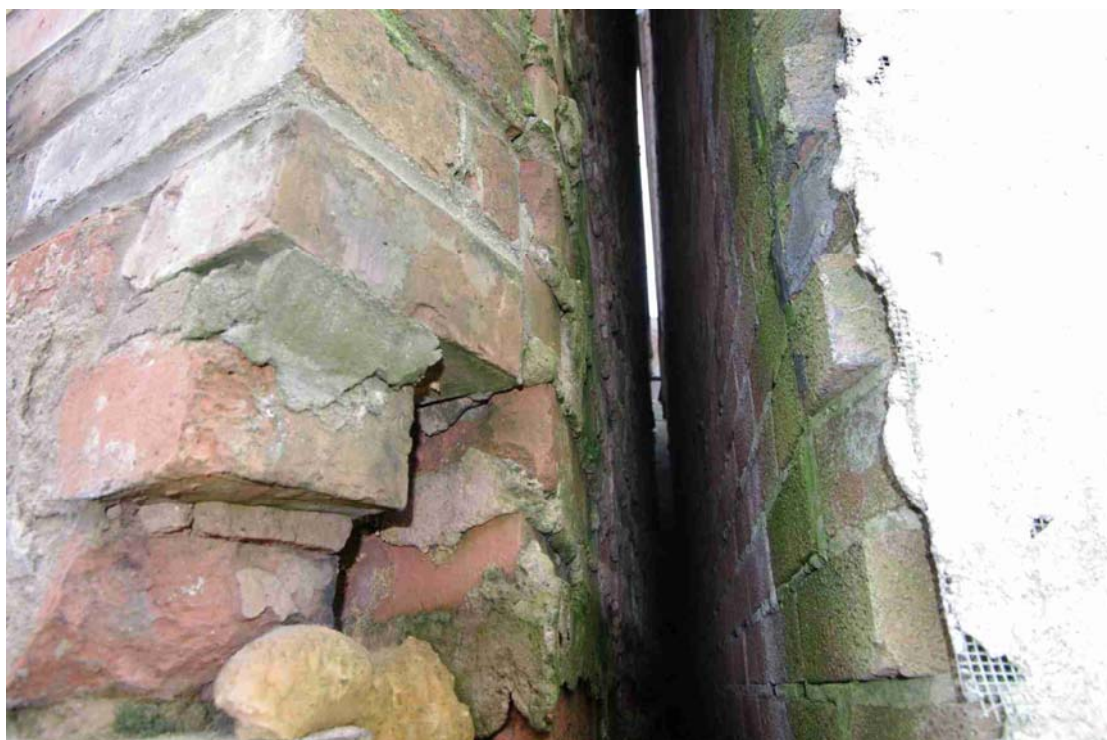
A long and thin angled gap can be seen between the north-west corner of Building B and the building butting against the back of Building A (Figs 13 and 20). The gap continues as far as the corner of Building A leaving a very narrow and redundant space between the buildings (Fig. 22). Although the brickwork on the adjacent building appears to have been replaced or repaired with modern bricks there has been no attempt to point the bricks on the western side of Building B which suggests that the adjacent building may have been present before B was built.

Figure 22 Close up of the gap on the western side of Building B
Looking south

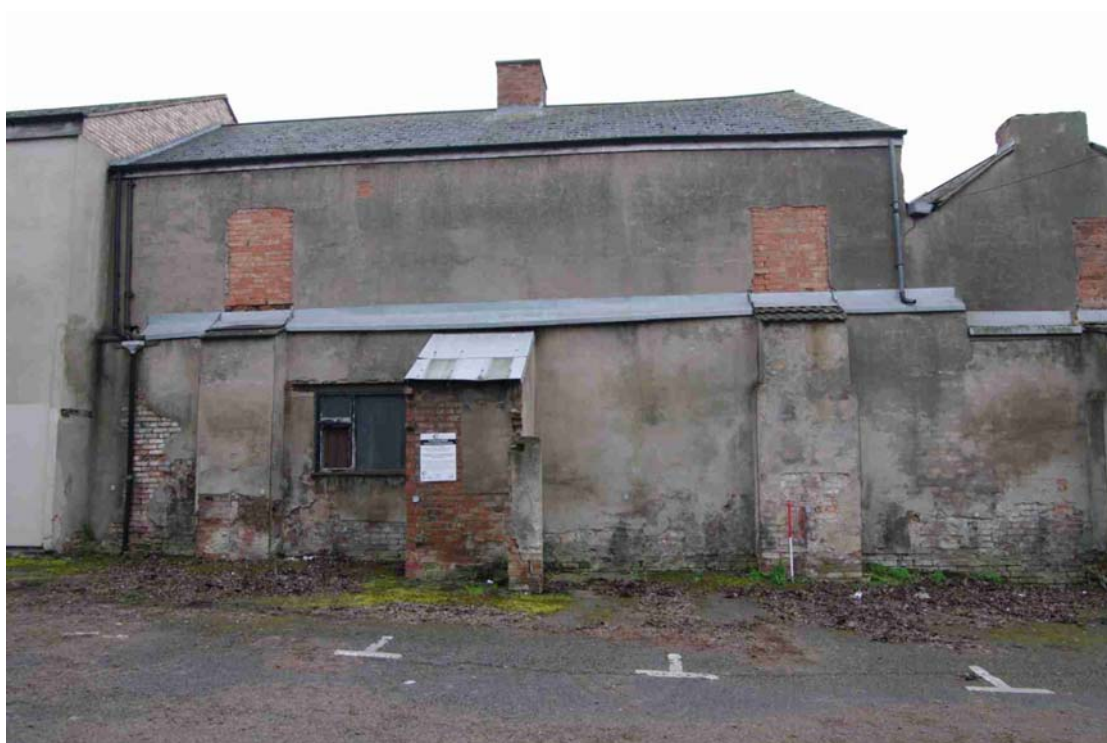
The north-east facing elevation facing out to the Regent Road car park suffers from the same obscuring rendering that Building B has. The ground floor has the remnant of the outhouse wall against it but a window with a modern steel lintel has been inserted through both this wall and the wall of Building C. A small rectangular brick structure, which appears to be part of the old outhouses remains in position too. At first floor level two windows have been bricked in. One has an arched head but the top of the other is partially hidden by render.

Figure 25 Building C north-east facing elevation
Looking south-west. 1m scale. Note inserted ground floor window

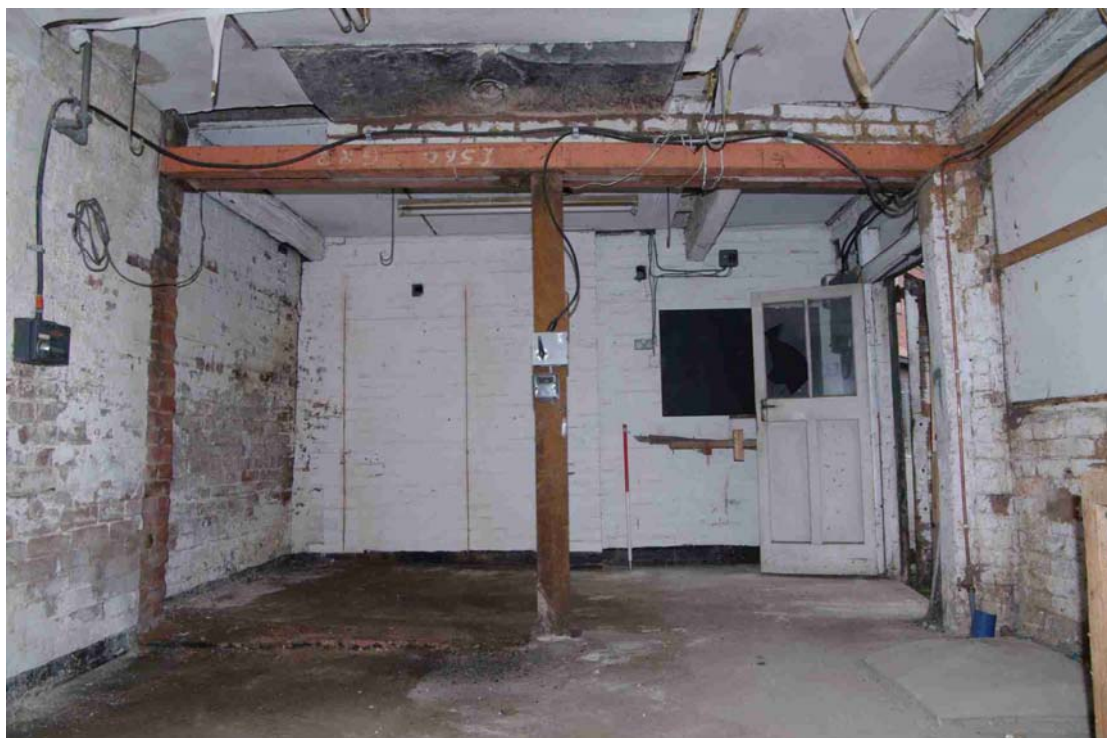
Figure 28 Building A ground floor, Room AG1
Looking north-east. 1m scale. Note steel column in centre of room holding up the
slate base of the chimney stack

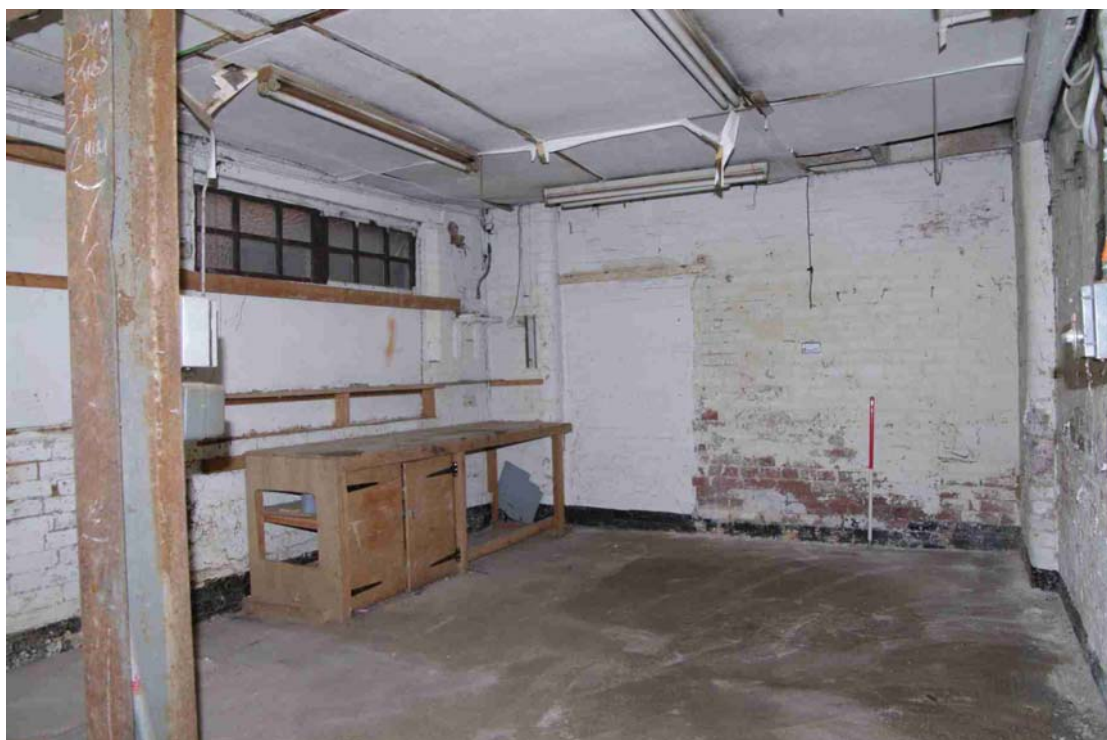
Figure 29 Building A ground floor, Room AG1
Looking south-west. 1m scale. Blocked doorway in corner

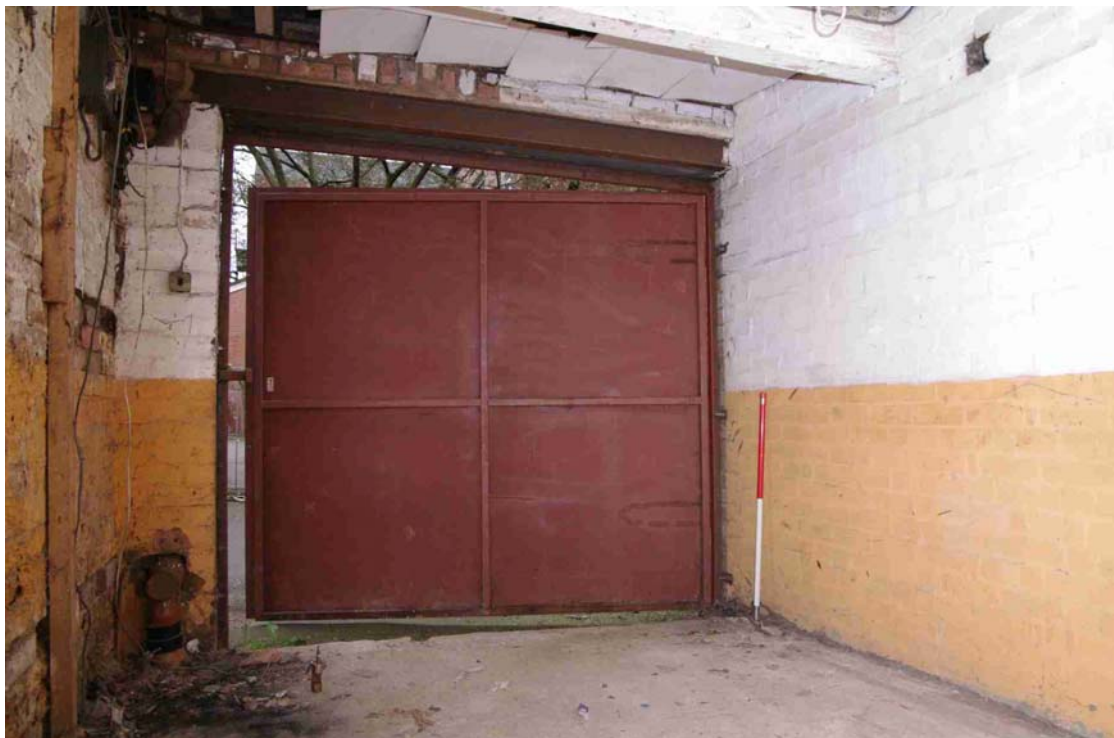
Figure 31 Building A ground floor, Room AG2
Looking south-east towards modern door and replaced lintel. 1m scale

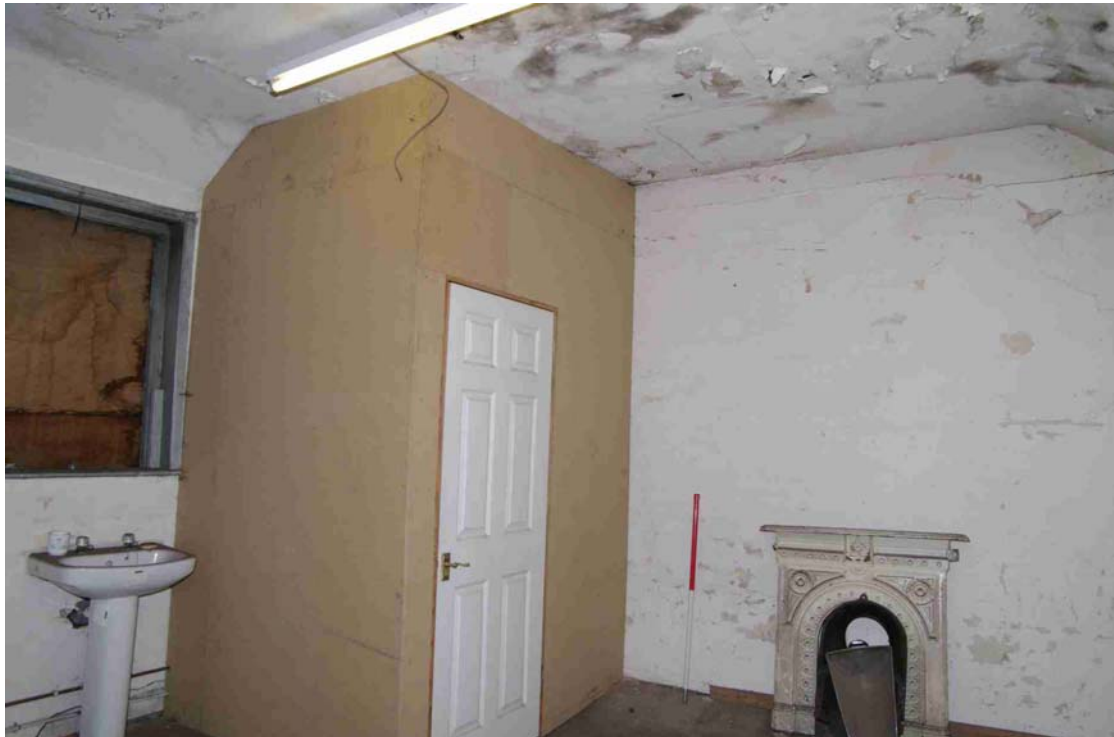
Figure 34 Building A first floor, Room AF1
Looking south-west. 1m scale. Fireplace surround is not in-situ

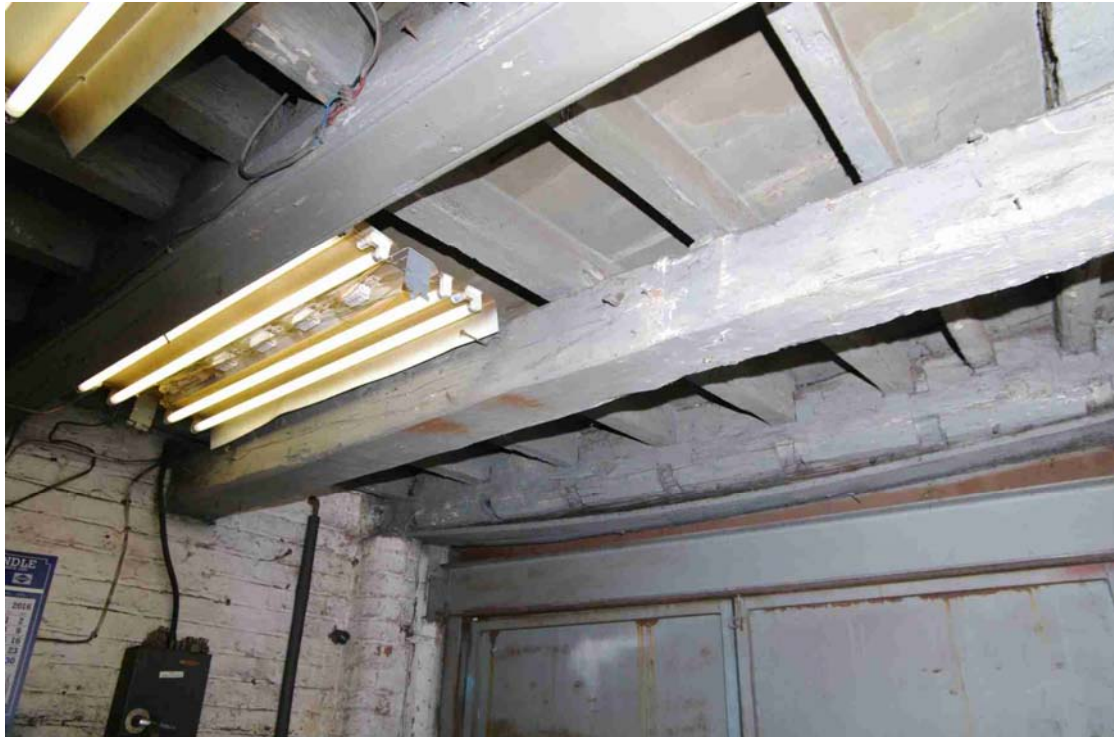
The large doorway out to the yard on the south-east wall is a modern replacement and has a modern steel lintel and support posts. The ceiling/floor joists are a mixture of re-used timbers with one over the main doorway having multiple joist sockets from an earlier use (Fig. 42). Close to this is another roughly shaped timber whilst the next one has beading along its lower edges. Joists at the northern end of the room support the stone hearth of the first floor room above.

Figure 42 Building B ground floor, reused ceiling joists
Looking east above main doorway

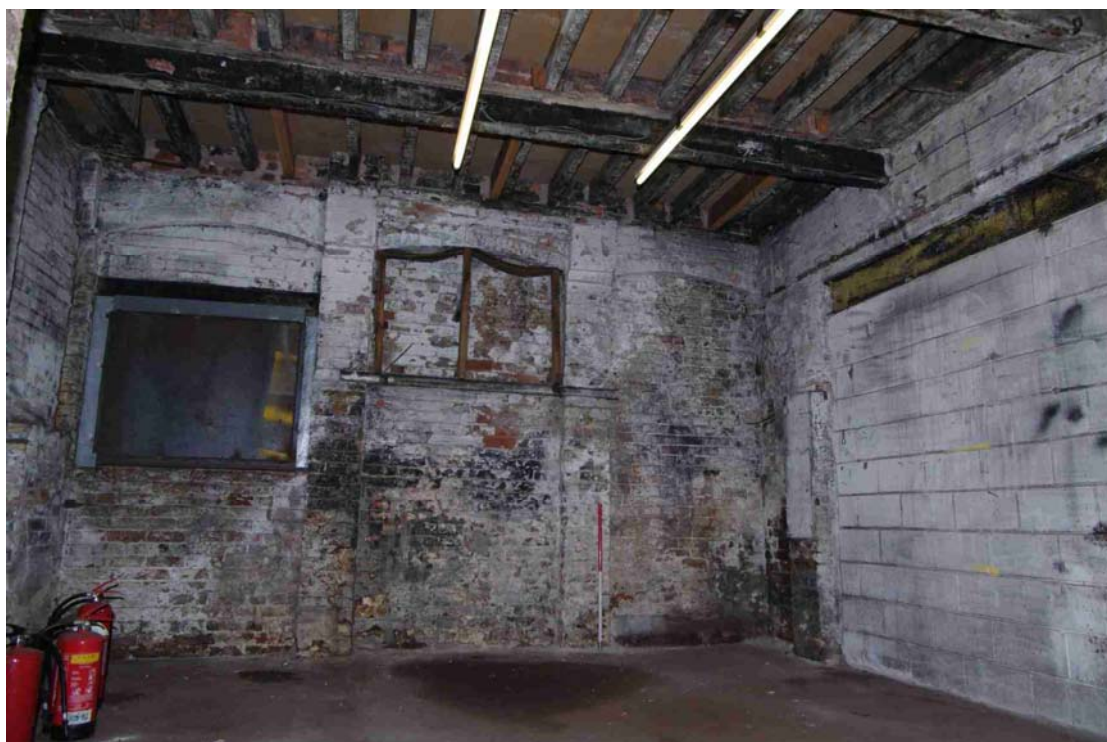
Figure 51 Building C ground floor, Room CG2
Looking north-east. 1m scale. Blocked opening to Building D on right

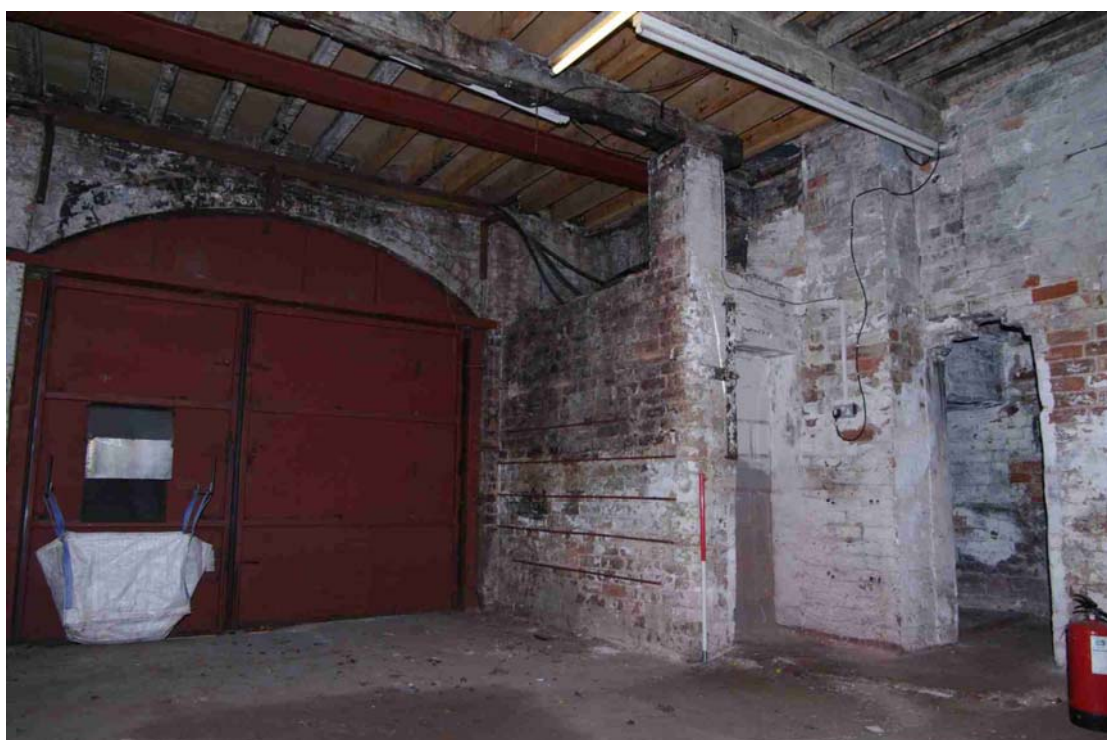
Figure 52 Building C ground floor, Room CG2
Looking south-west. 1m scale. Main outside door on left. Blocked passageway from small outside door to right of ranging pole. Knocked through door into space beneath stairs on right

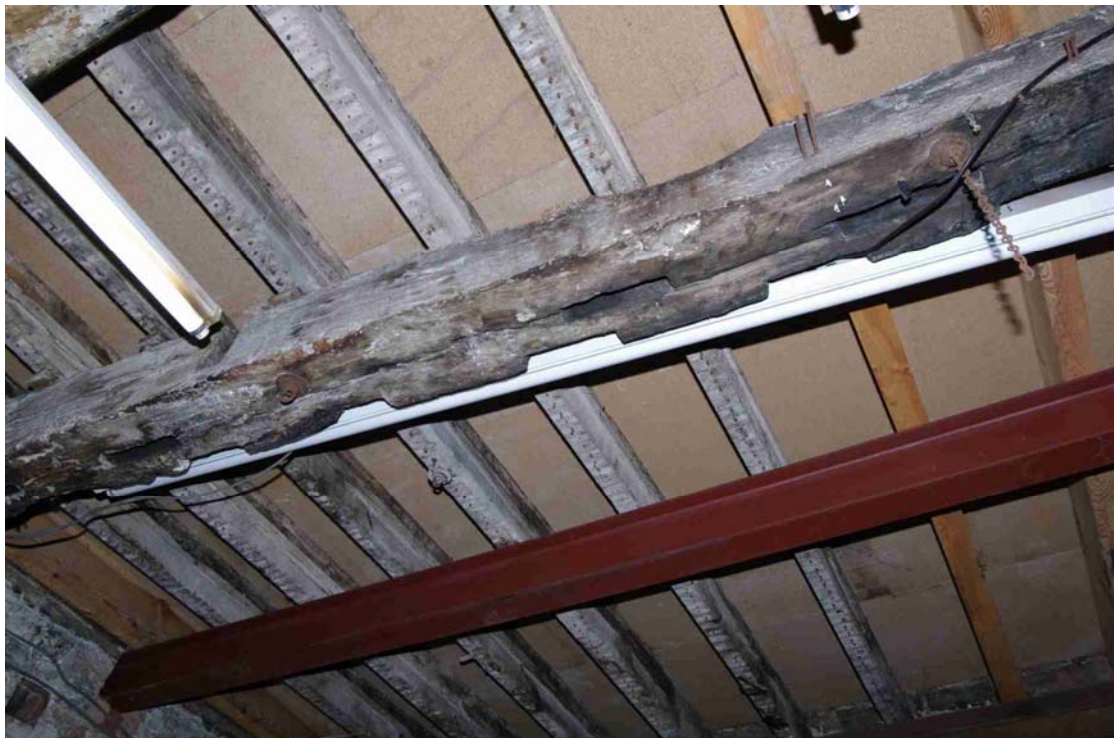
The ceiling is supported by a number of substantial timber beams along with some modern steel replacements (Fig. 54). A number of the timber beams are clearly re-used from elsewhere and have many redundant sockets and holes. There has been a fire at some time in the recent past as one of the timber beams near the main door is extremely

burnt and charred and the floor has been repaired and replaced. This may have been at the same time as when the new steel beams were inserted.

Figure 54 Building C ground floor, Room CG2 ceiling
Southern area of ceiling with replacement steel beam and re-used joists

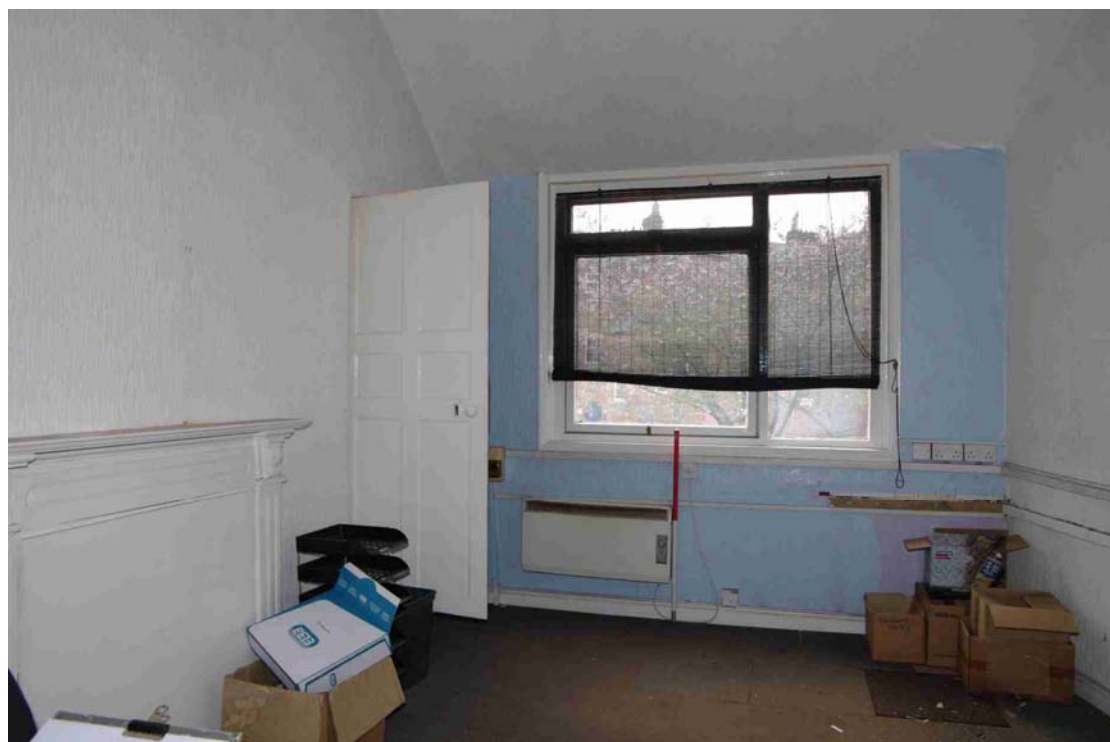
Figure 58 Building C first floor, Room CF1
Looking south-east. 1m scale. Note steel safe door in corner disguised as a panelled door
