**A Level 3 Historic Building Survey at
the Queens Buildings,
37-43 Rutland Street,
Leicester**

ULAS Report No. 2017-100
©2017

For: Staniforth Architects

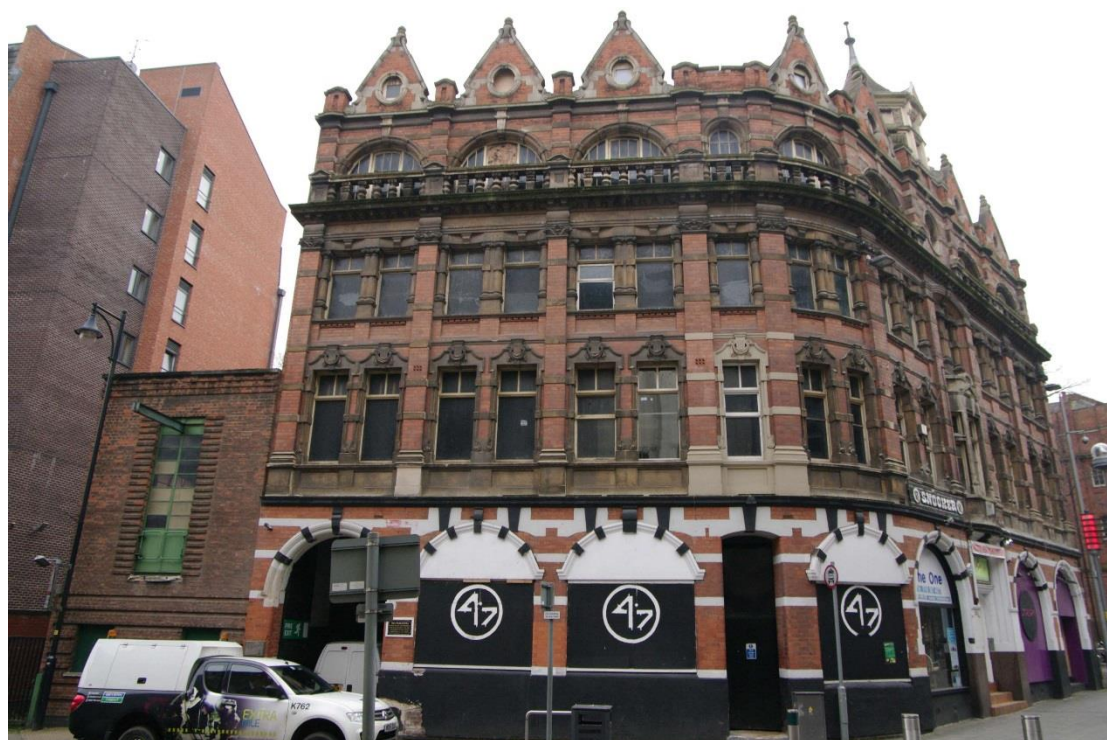
Figure 11 North-east facing elevation
Looking south-west

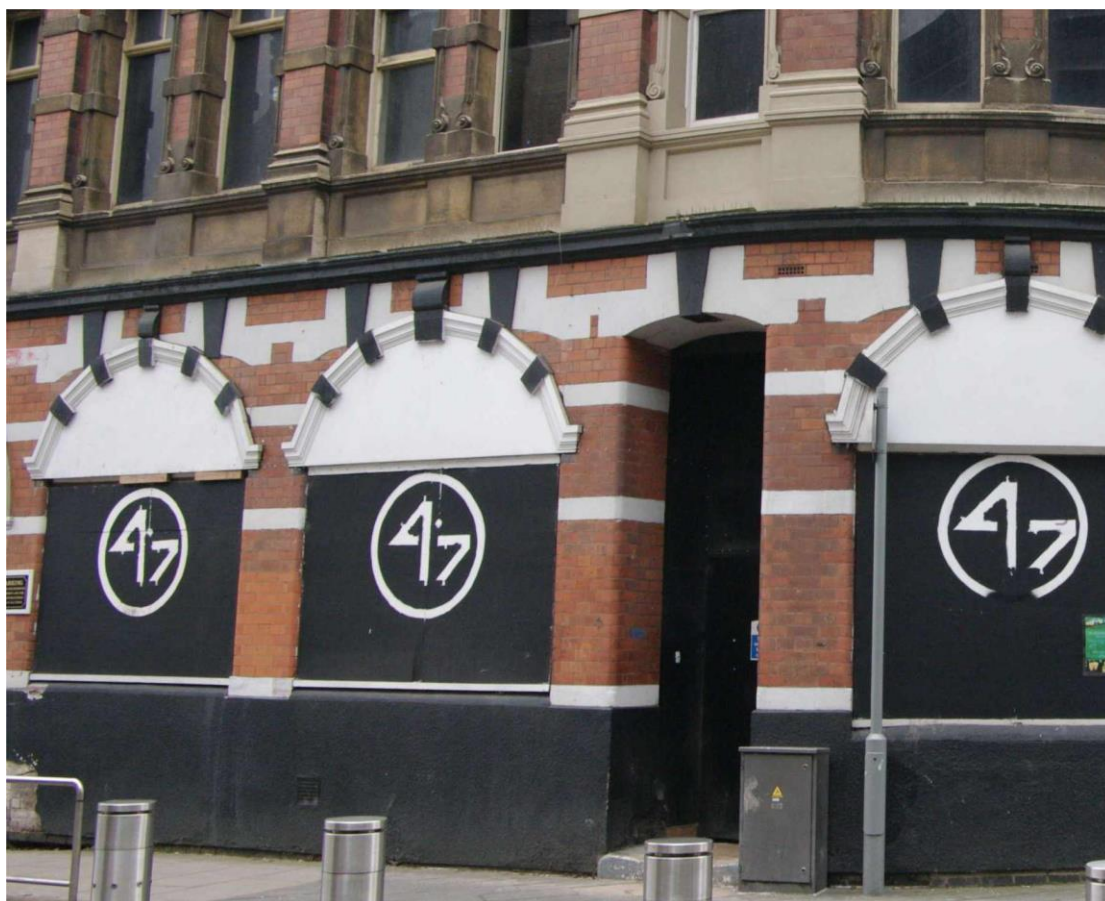
Figure 13 Ground floor detail, NE facing elevation
Looking south-east

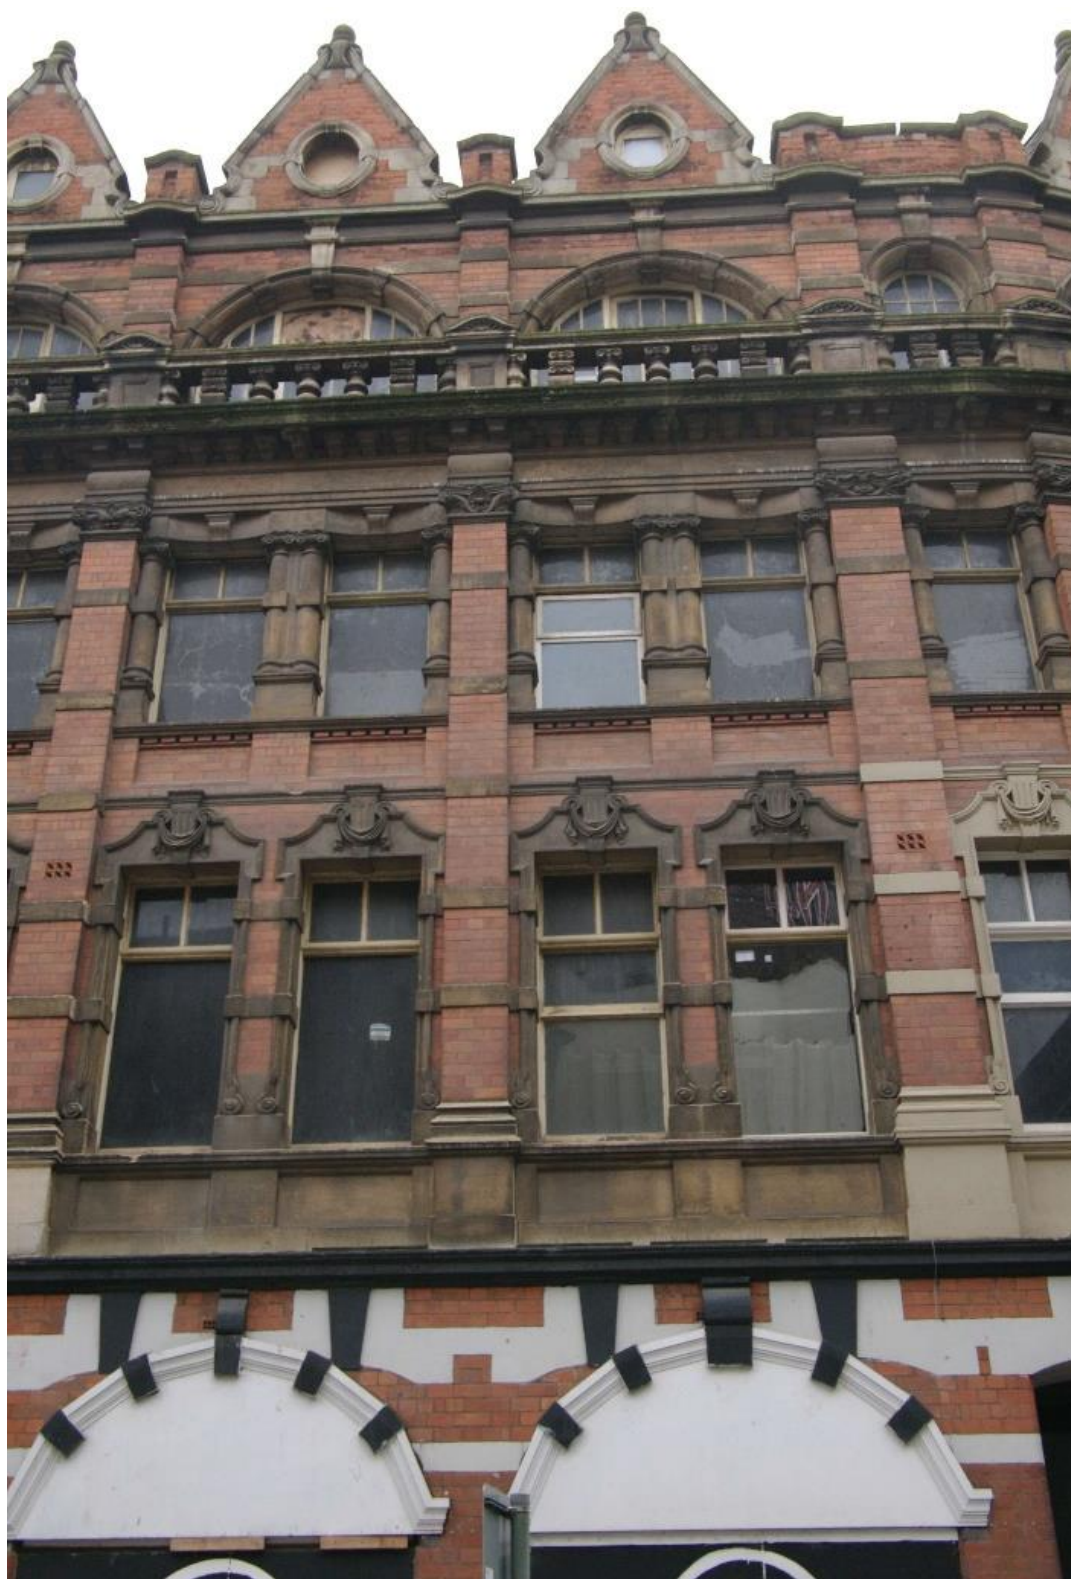
Figure 15 Upper floor details, NE facing elevation
Looking south-east

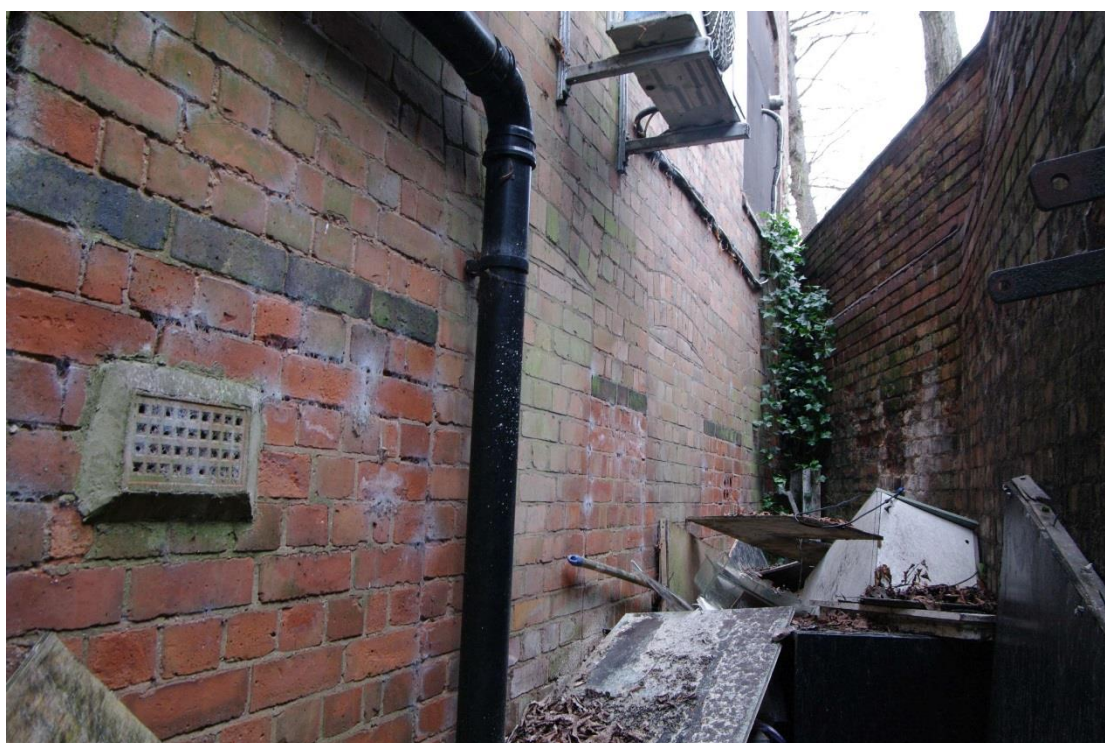
Figure 27 South-west facing elevation, blocked basement windows
Looking south-east

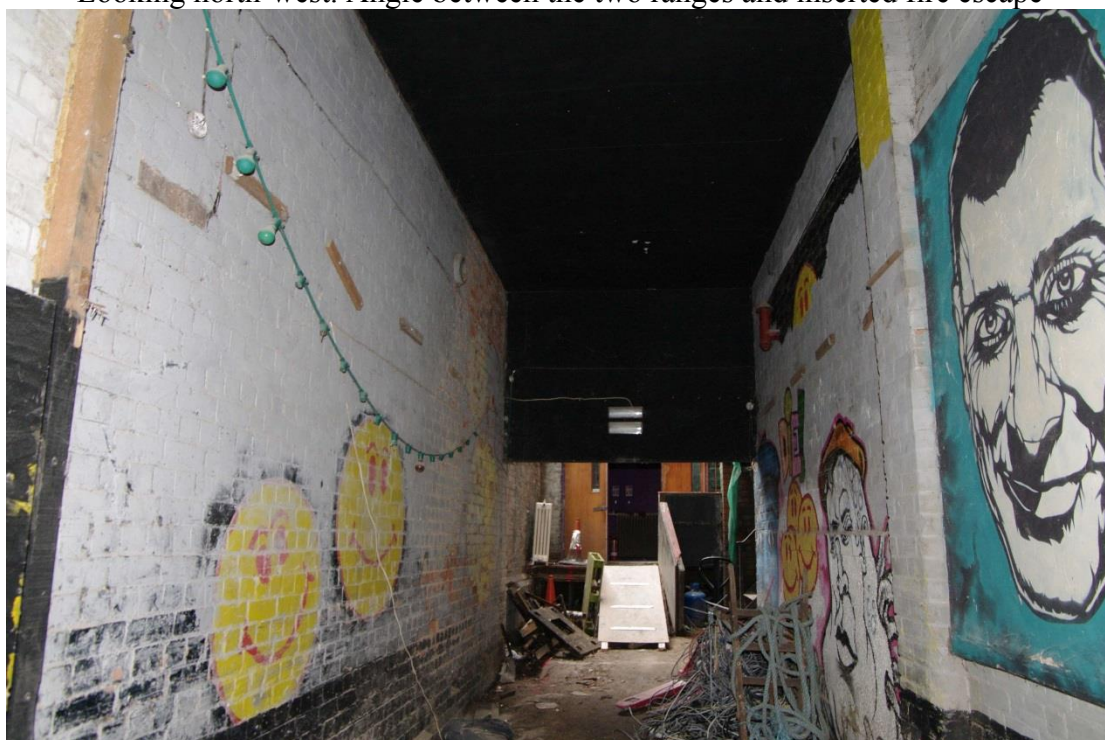
At ground level within the angle of the ranges is a small yard and loading bay which is reached via the passageway from Queen Street (Fig. 31). The walls of the passageway have a variety of modern graffiti and artwork painted on them. The yard is quite compact with steps leading down to the basement on the north-west side. The loading bay is a simple timber platform which has had modern board stairs built against it to allow for pedestrian access (Fig. 32). The loading platform is at the same level as the floor height of the rear range. The platform also serves the outside facing doors of a small goods lift which extends from the basement up to the attic. The 1897 plans show this as a goods hoist suggesting that it was perhaps intended to be a manually operated system. Counterbalance weights removed during the soft strip bear the name of R Waygood and Co London. Richard Waygood opened a factory in London in the 1840s making hand operated hoists and lifts. They changed their name to R. Waygood and Co in 1897 and became Waygood-Otis in 1914 so it is probable that this lift was fitted when the building was first built and not as a later addition.

Figure 31 Passage underneath building to loading bay
Looking south-west from Queen Street

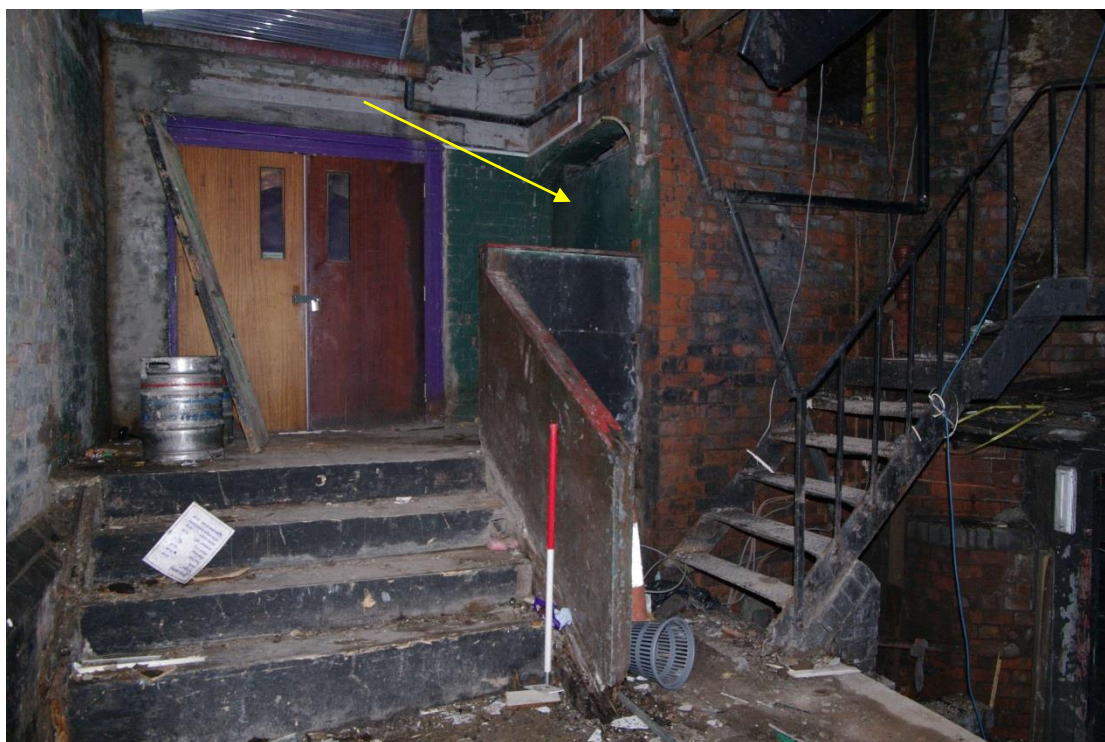
Figure 32 Open air loading bay

Looking north-west. 1m scale. Double doors into rear range on left, doors of lift shaft arrowed, fire escape stairs to right of scale, steps down to basement on right

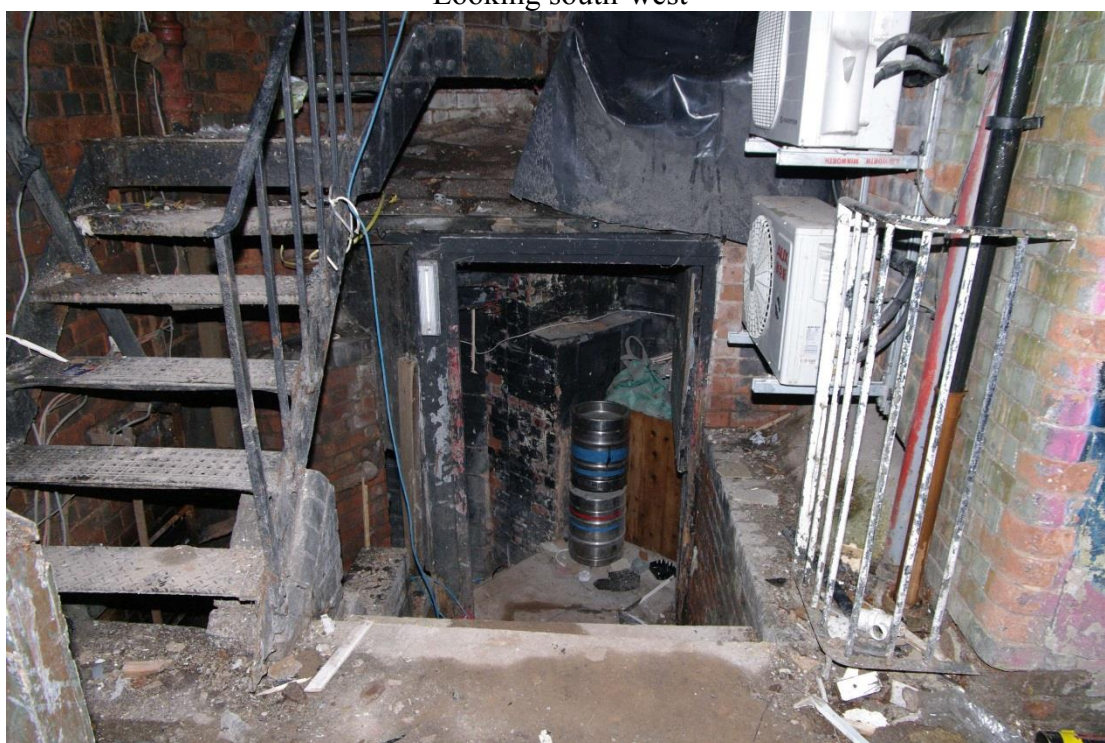
Figure 38 Basement steps from loading bay
Looking west. The original steps were located slightly to the left of their present position and reached ground level where the fire escape is located

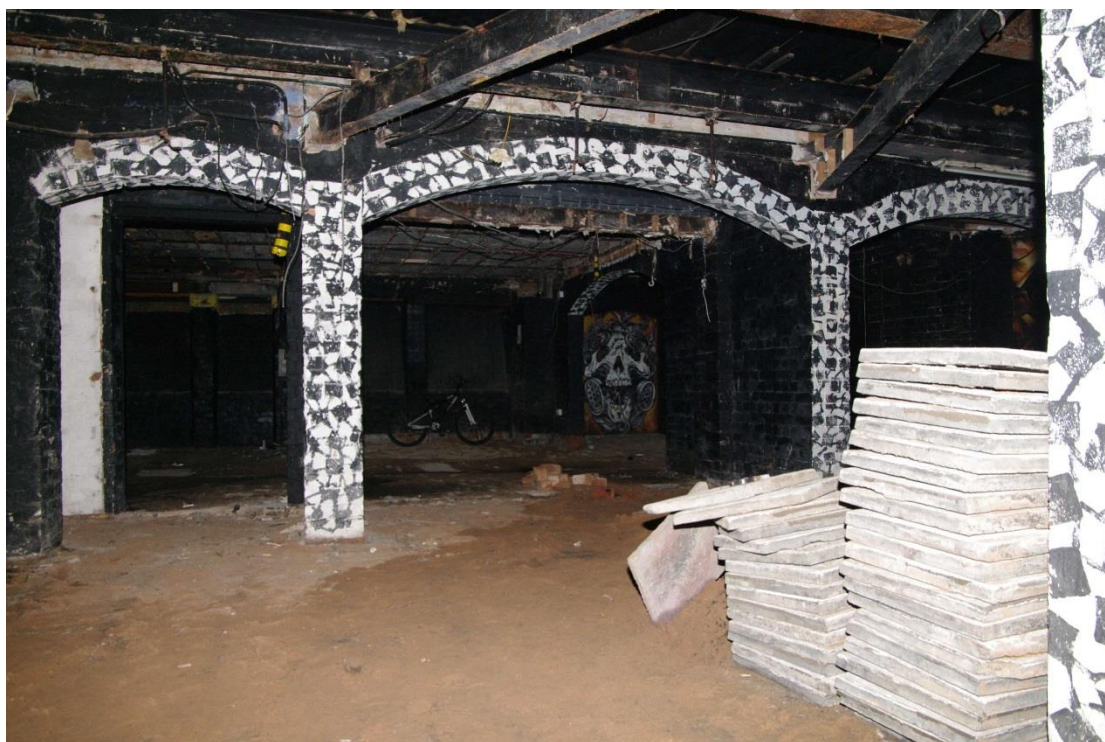
The area beneath the north-west facing range is broken up by a series of wide brick arches supporting the floor above (Figs 39 and 40). As noted much of the ceiling and floor in this part of the basement appears to be original but a number of inserted steel beams and a later brick pillar support the south-eastern part of this area. The north-east wall has the remains of blocked up pavement light well or vents which had either metal gratings or glass bricks set into the pavement (Fig. 41). The openings have been blanked off with sheets of metal and no trace is visible in the pavement outside. Their location can however be seen on the 1897 ground floor plan shown in Figure 45 below.

Figure 39 Basement, space beneath north-west facing range
Looking north. Note later steel beams in front of the arches

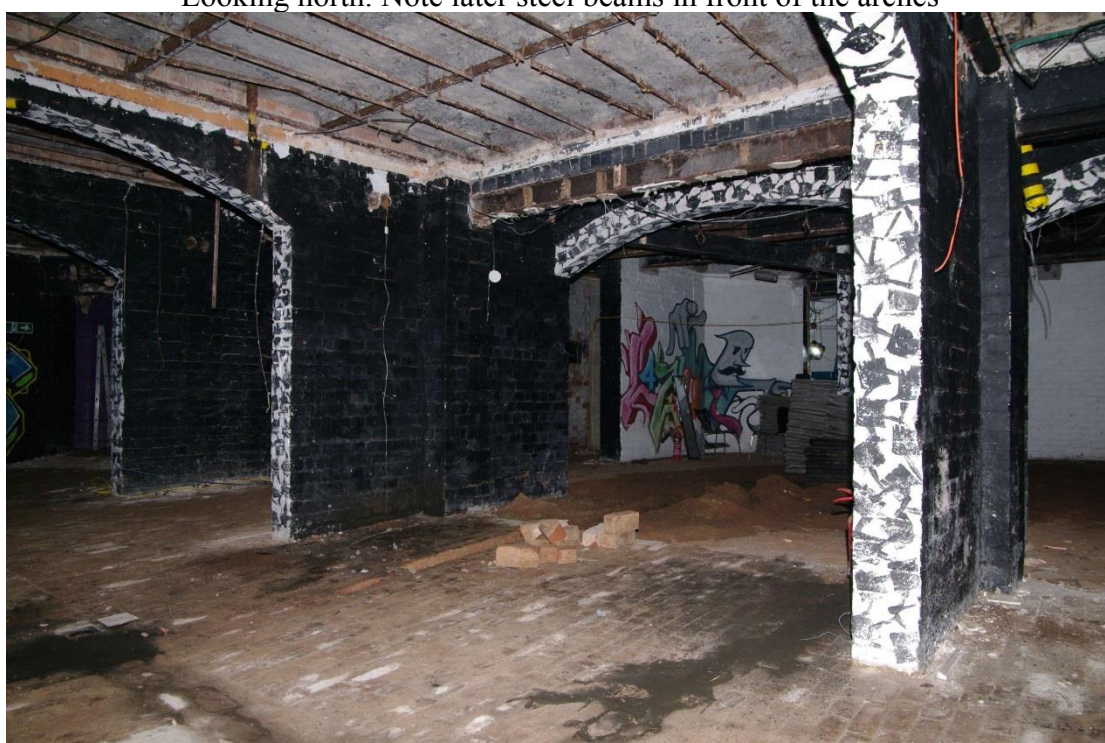
Figure 40 Basement, space beneath north-west facing range
Looking west. Note original reinforced concrete ceiling and brick floor

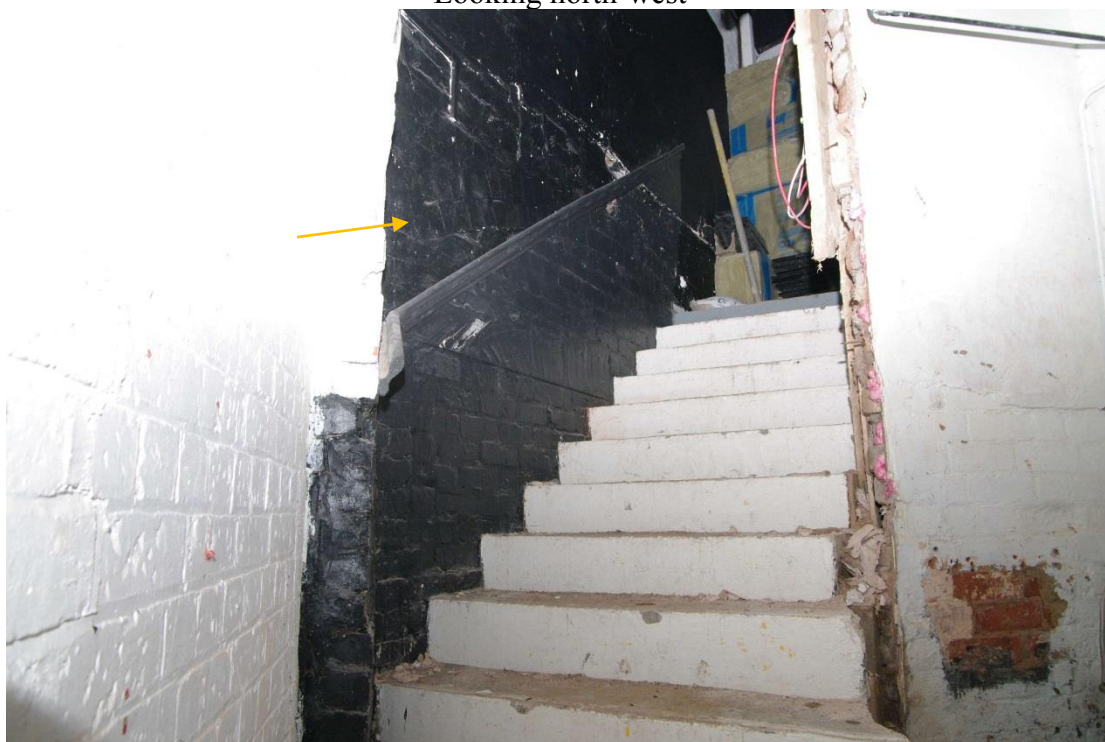
Figure 42 Basement steps up to Queen Street entrance
Looking north. Steps originally ran from north-east to south-west and continued
through blocked arch (arrowed) on left and did not widen at their base

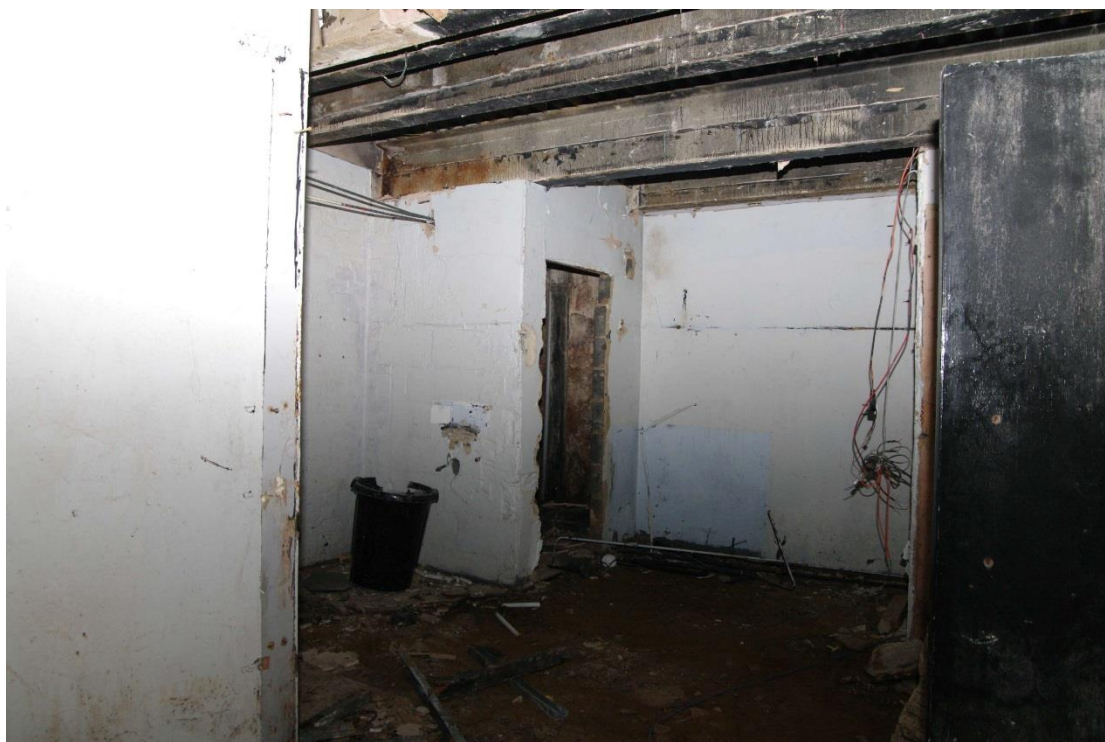
Figure 43 Basement, inserted rooms beneath north-east facing range
Looking east towards the north-east corner of the basement. Note steelwork supports

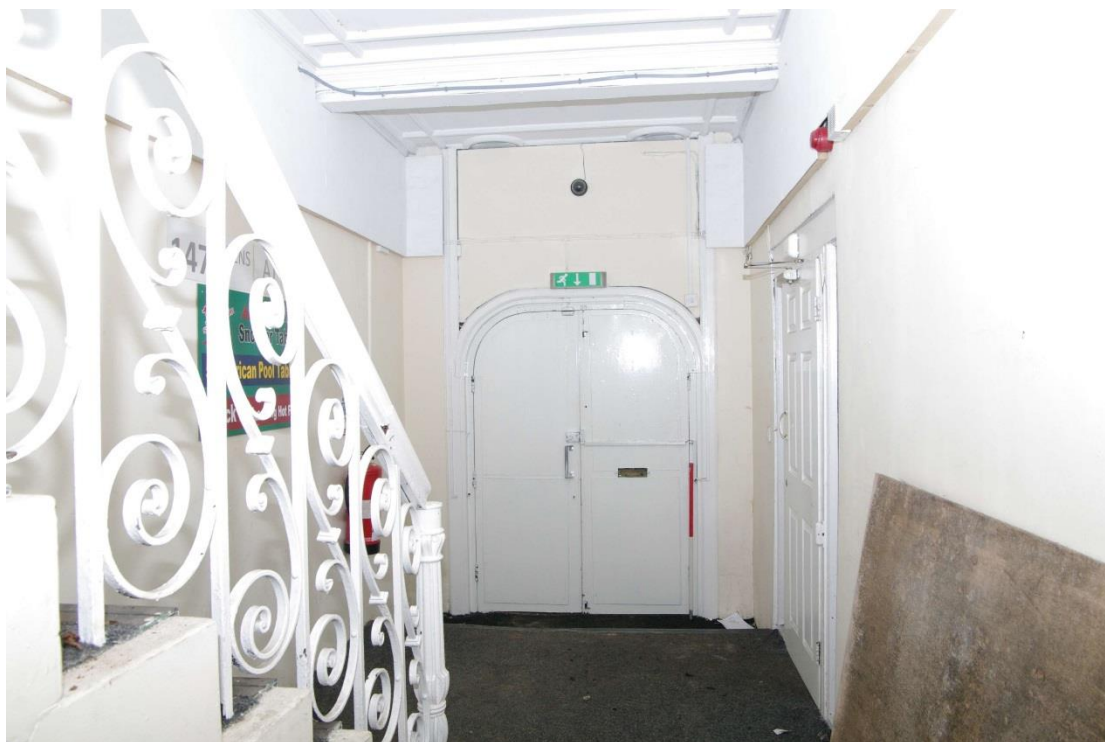
Figure 47 Ground floor, Tyler's principal entrance hall
Looking north-west. 1m scale. Ornamental frieze protected behind boards at ceiling height

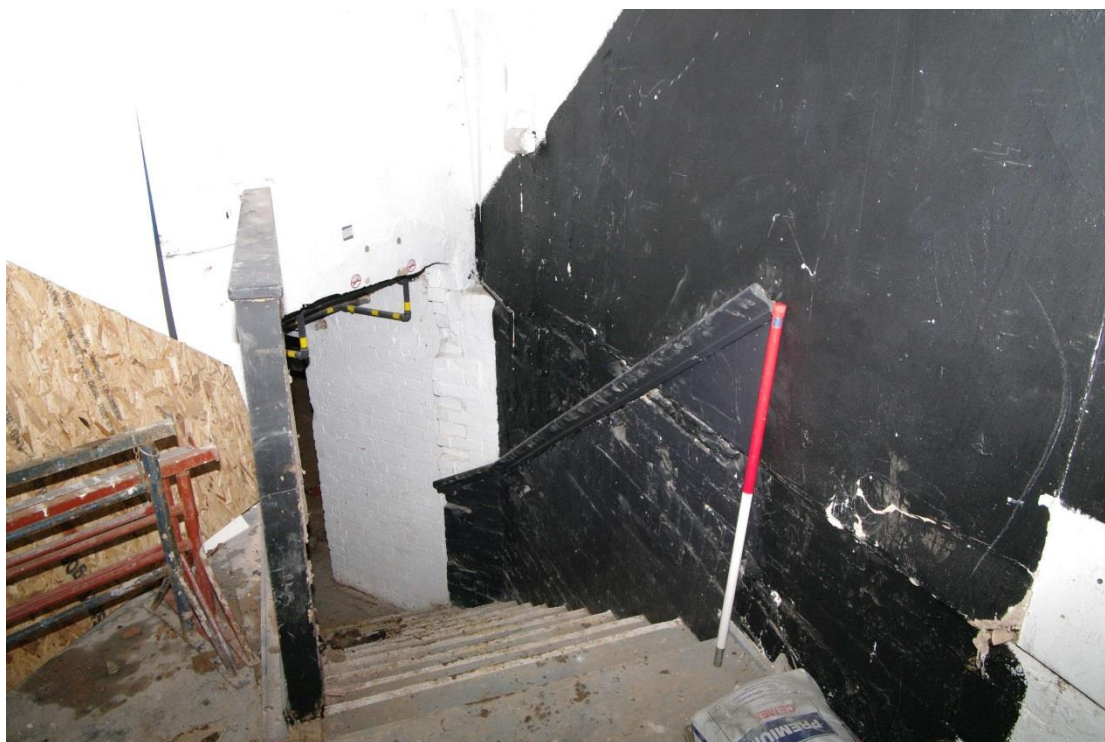
Figure 55 Ground floor, stairs to basement from corner room
Looking south-east. 1m scale. Original stairs ran from where the metal trestles are
standing. See also Figure 42

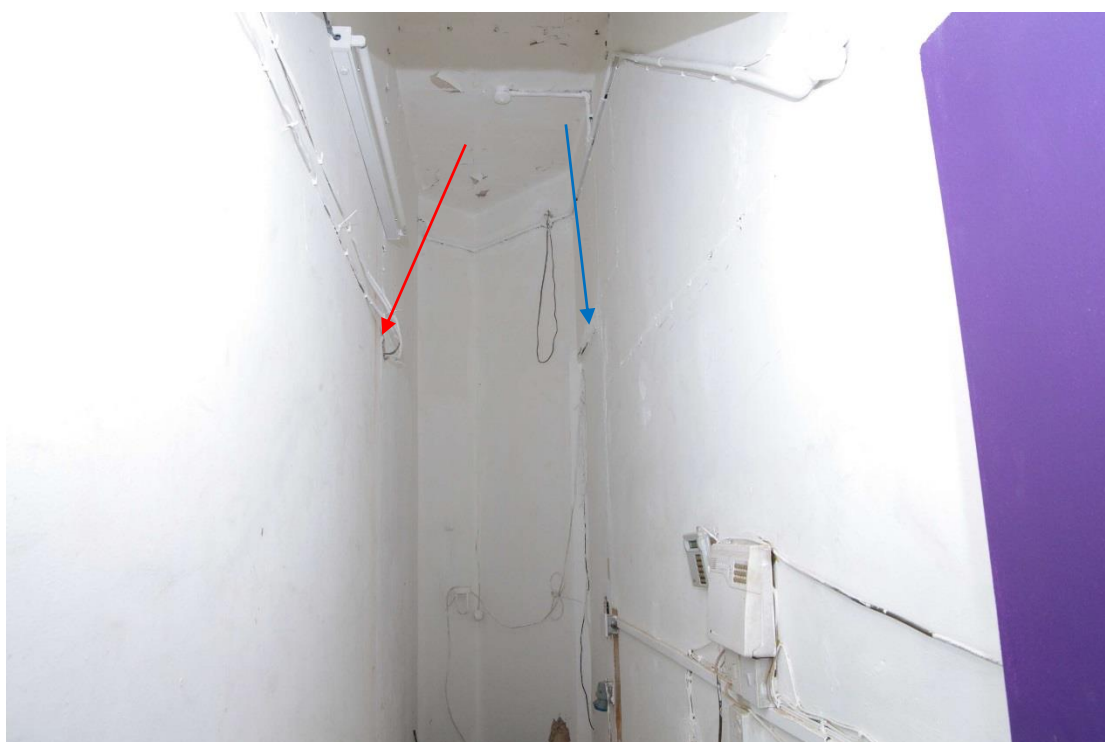
Figure 58 Ground floor rear corridor
Taken from doorway shown in Fig. 57. Trace of blocked doorway into hair salon on left (red arrow), blocked doorway into warehouse of north-east facing warehouse on right (blue arrow)

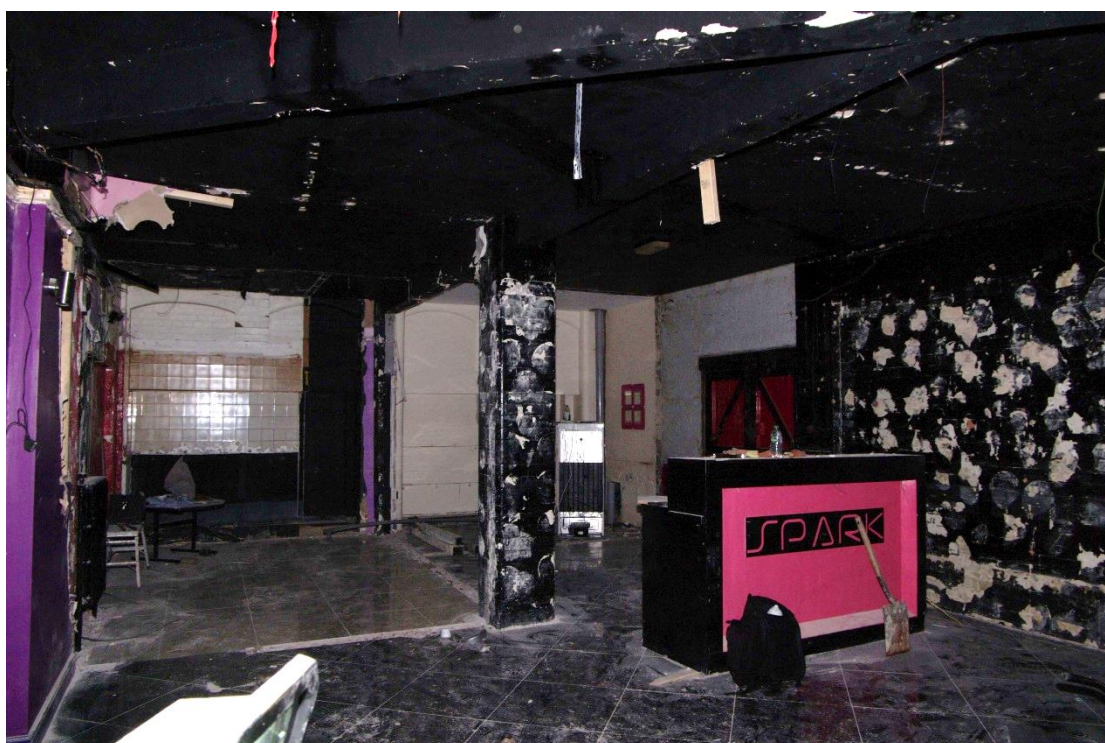
Figure 60 Ground floor north-east warehouse
Looking east-north-east. Former outside windows covered by brown glazed tiles.
Location stairs to basement on left of photo where the metal steps are

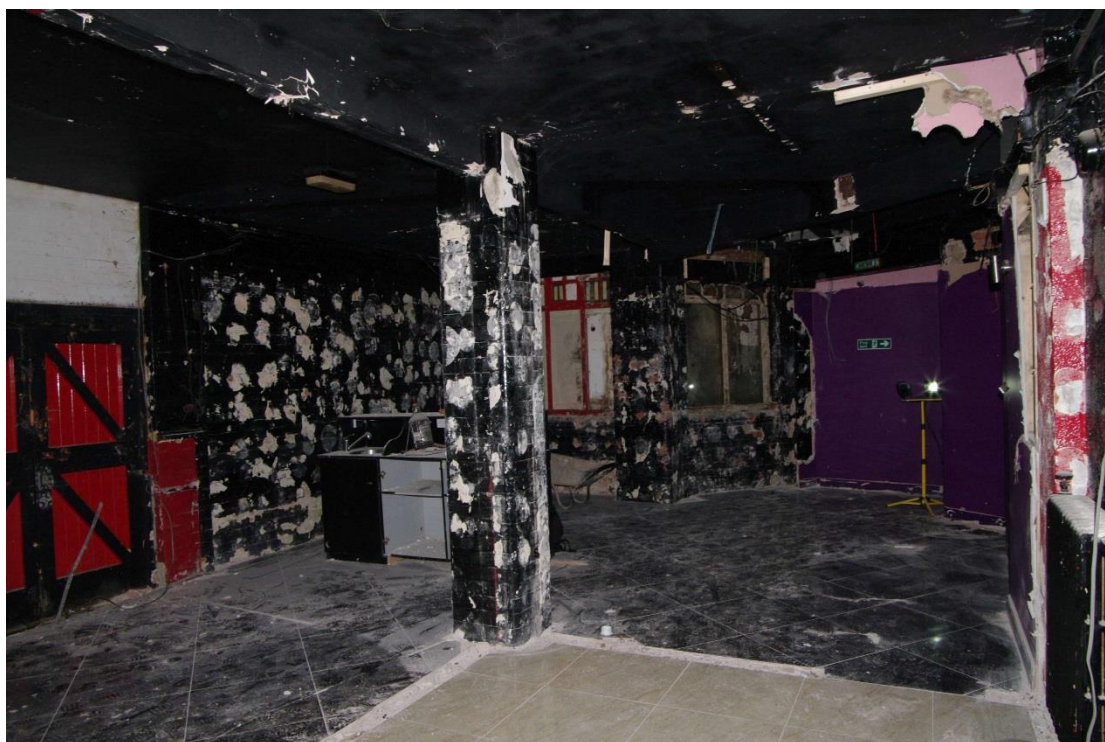
At the southern end of the north-east warehouse are two windows looking out onto the loading bay. The windows have large fixed lower panes and smaller opening panes at the top. The windows have been boarded over on the outside.

Figure 61 Ground floor north-east warehouse
Looking south towards windows onto loading bay area

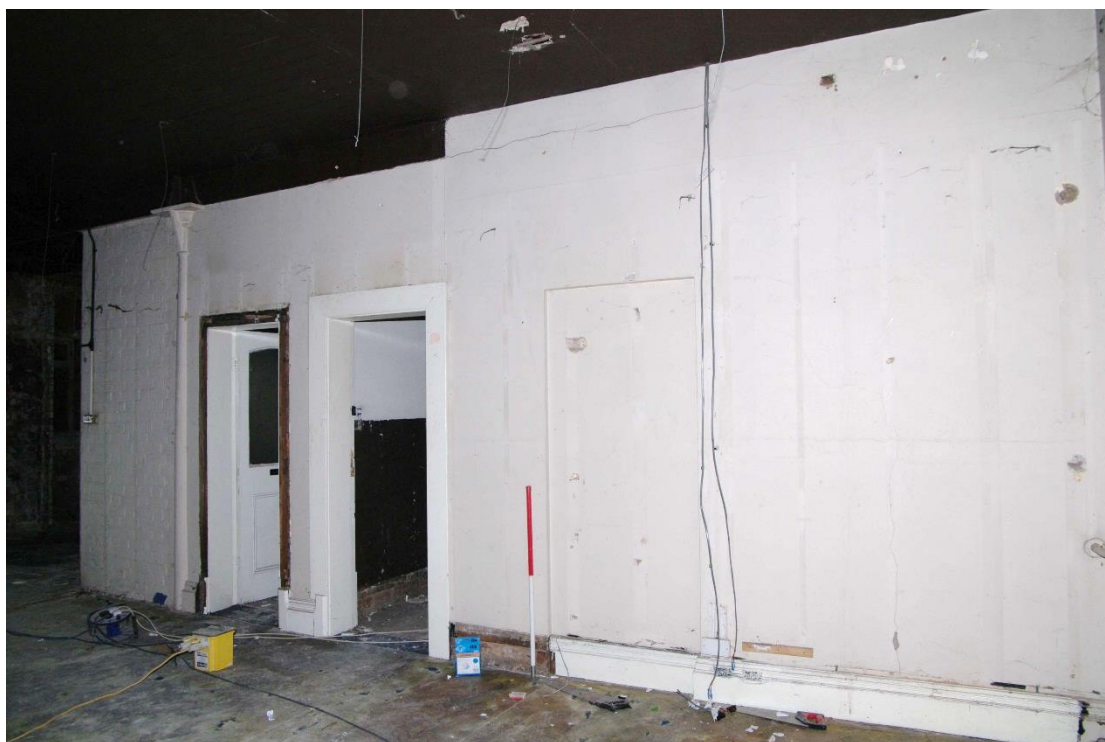
Figure 67 First floor, eastern wall of former reception room
Looking south-west. 1m scale. Blocked doorway from reception to right of scale.
Second doorway into reception room to left of scale. Original toilet door to left. Note
metal column set into wall

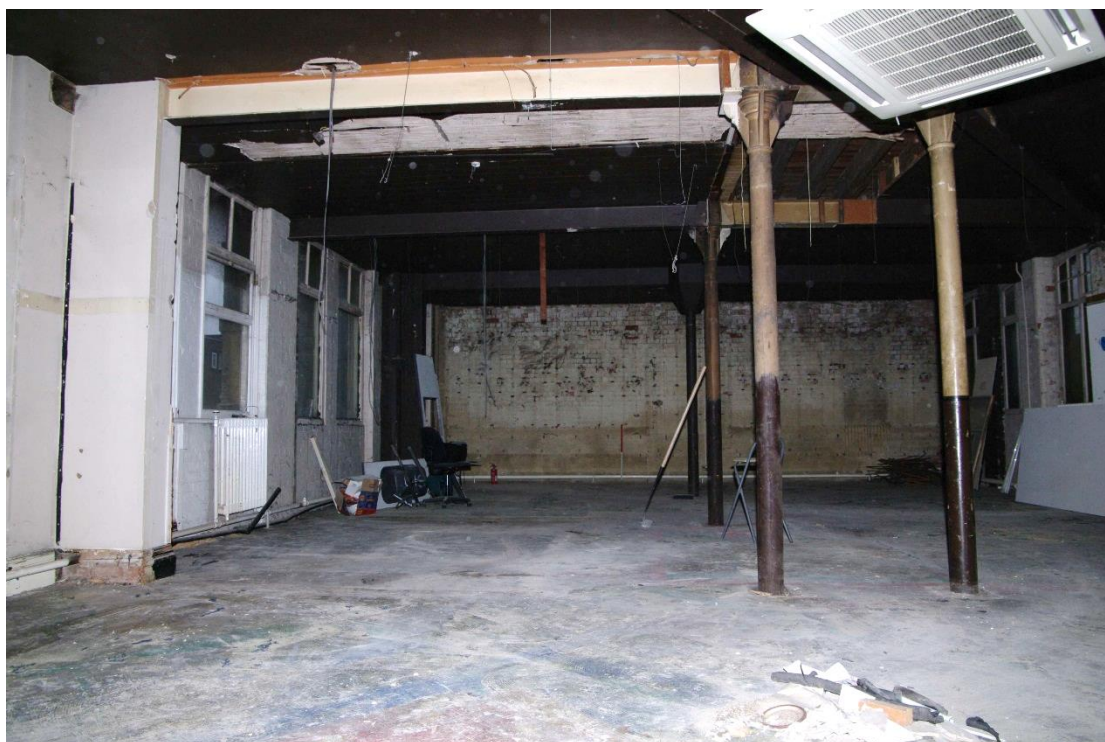
The rest of the warehouse space of the north-east facing range is open and only broken by the presence of cast iron circular section columns supporting steel I-beams which have been boxed-in above the former office locations (Fig. 71). The columns bear the name *S Wright Leicester* on them. Samuel Wright owned a local foundry which specialised in columns and lamp standards who, in 1864, gained a contract with the Leicester Corporation to supply gas lamps. Their products can be seen in many of Leicester's industrial and municipal buildings from around this time.

Figure 71 First floor warehouse behind north-east facing elevation
Looking east. 1m scale

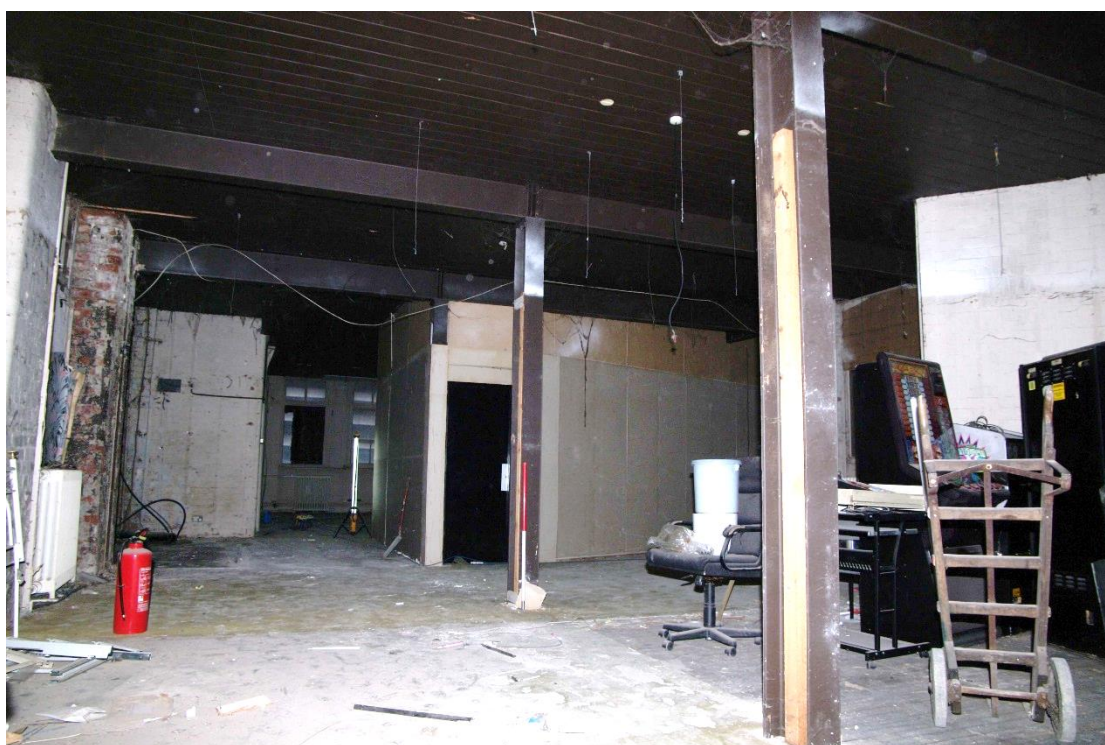
The rear range is also open and has a ceiling supported by I-section pillars (Fig. 72). The ceiling joists in this part of the building are I-section and bear the name of *Leeds Steel Works* on them. The Leeds Steelworks began in the 1860s and were conveniently located next to the Midland Railway for easy transport to growing industrial towns such as Leicester. The floor of the rear range is laid with wooden floorboards which are rather more functional than the herringbone parquet at the front. The windows on the south-west facing wall are simple wooden-framed fixed lower panes and opening upper panes. As with most of the other windows in this building the upper panes are hinged at the bottom and swing out to be secured by thin chains and curving metal stops (Fig. 73). The shaft for the goods lift projects out at an angle to the rest of the room which creates an awkwardly shaped north-east wall and which must have caused storage difficulties when the room was in use as a warehouse. The opening to the lift has a wide brick arch but the rest of the doorway is hidden behind a modern wooden panel.

Figure 72 First floor, rear range
Looking north. 1m scale. Goods lift wall on right of picture

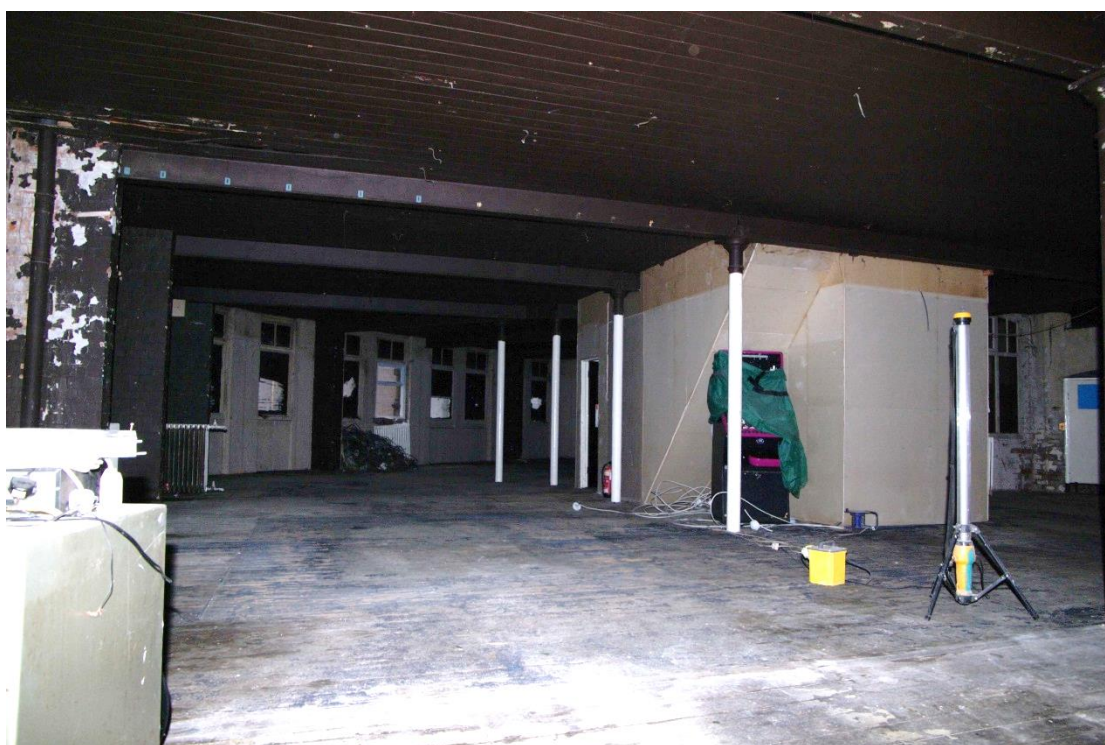
Figure 77 Second floor, general view and stairwell
Looking east. Note original narrow stairs boxed in on left of stairwell

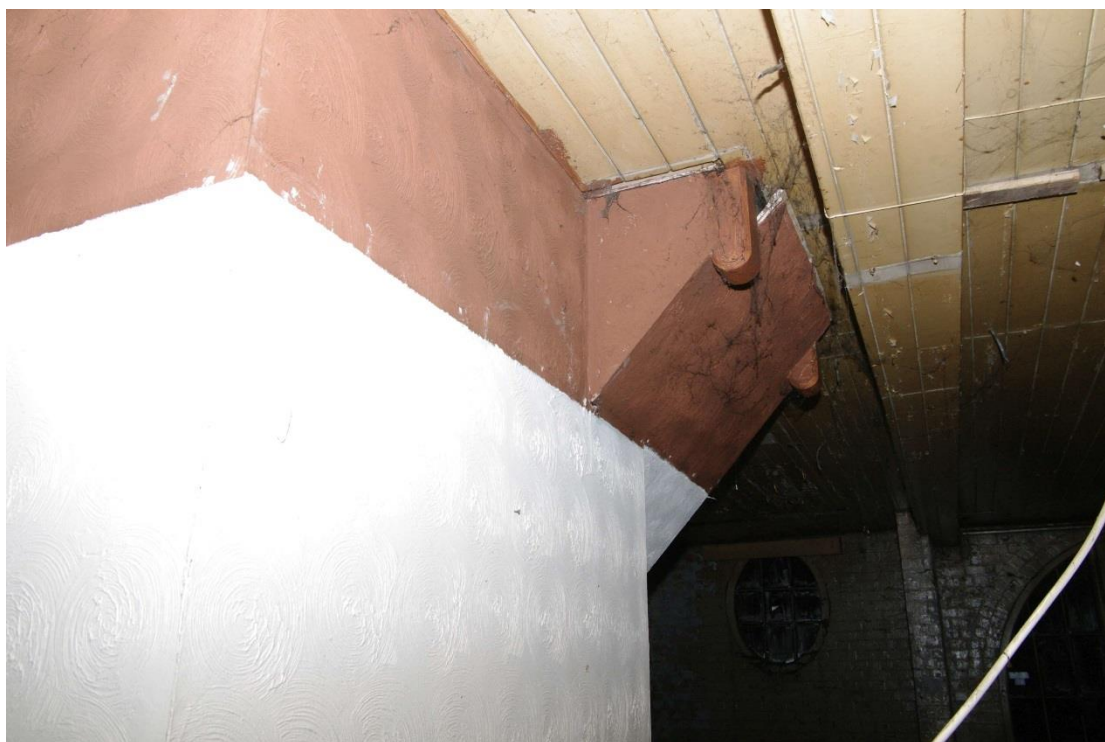
Figure 84 Third floor, boxed in stairs and projecting newels
Looking north-west

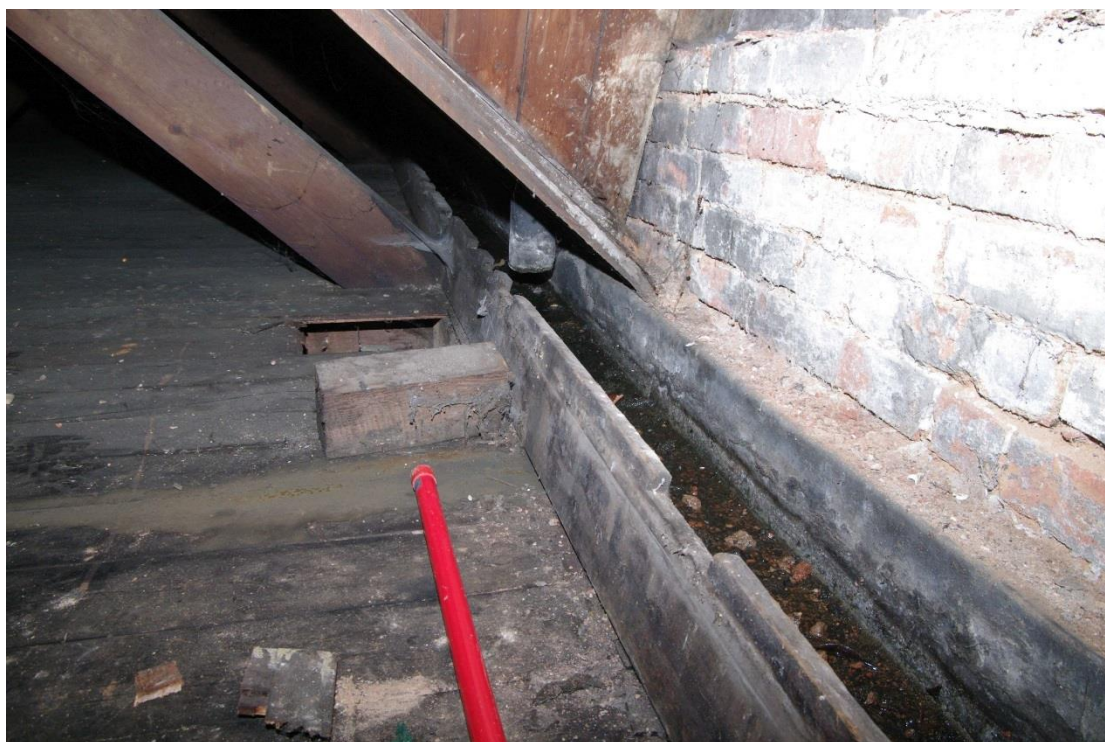
Figure 97 Fourth floor, internal rainwater gutter
Looking west

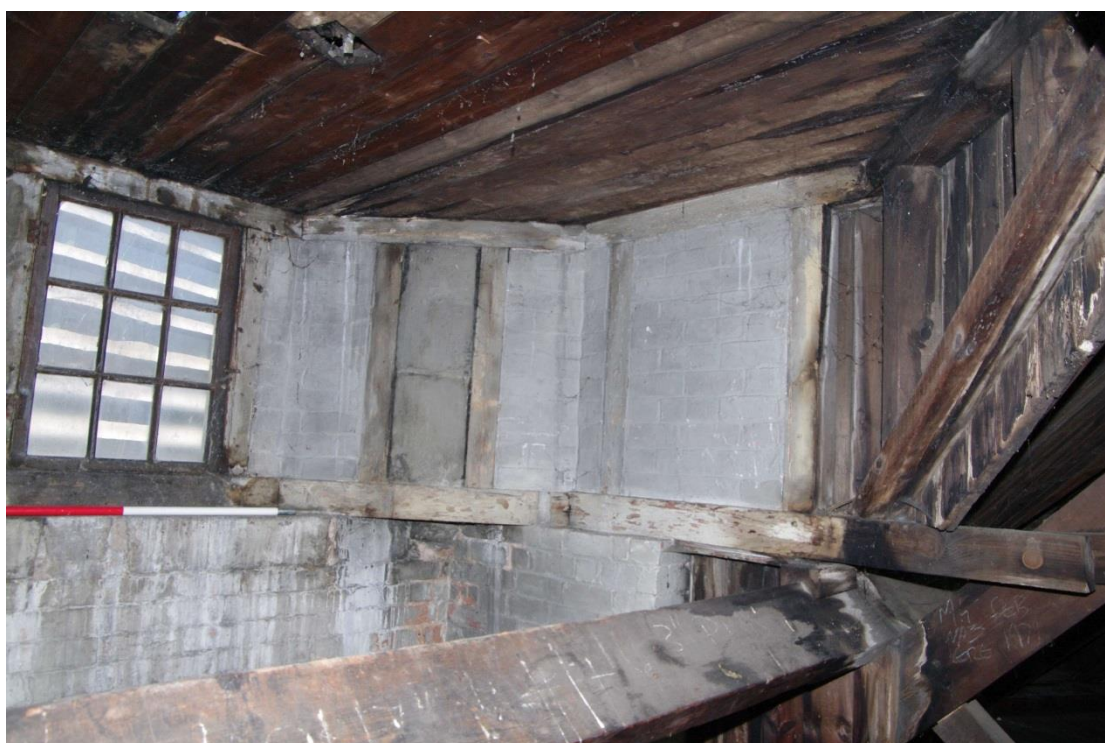
Figure 98 Fourth floor, base of tower
Looking north-east. 1m scale. Note how octagonal tower sits on rectangular bay
