**A Level 3 Historic Building Recording  
at Cedar Lawns,  
Church Street,  
Burbage,  
Leicestershire**

ULAS Report No. 2017-117  
©2017

**For: Tony Morris Builders**

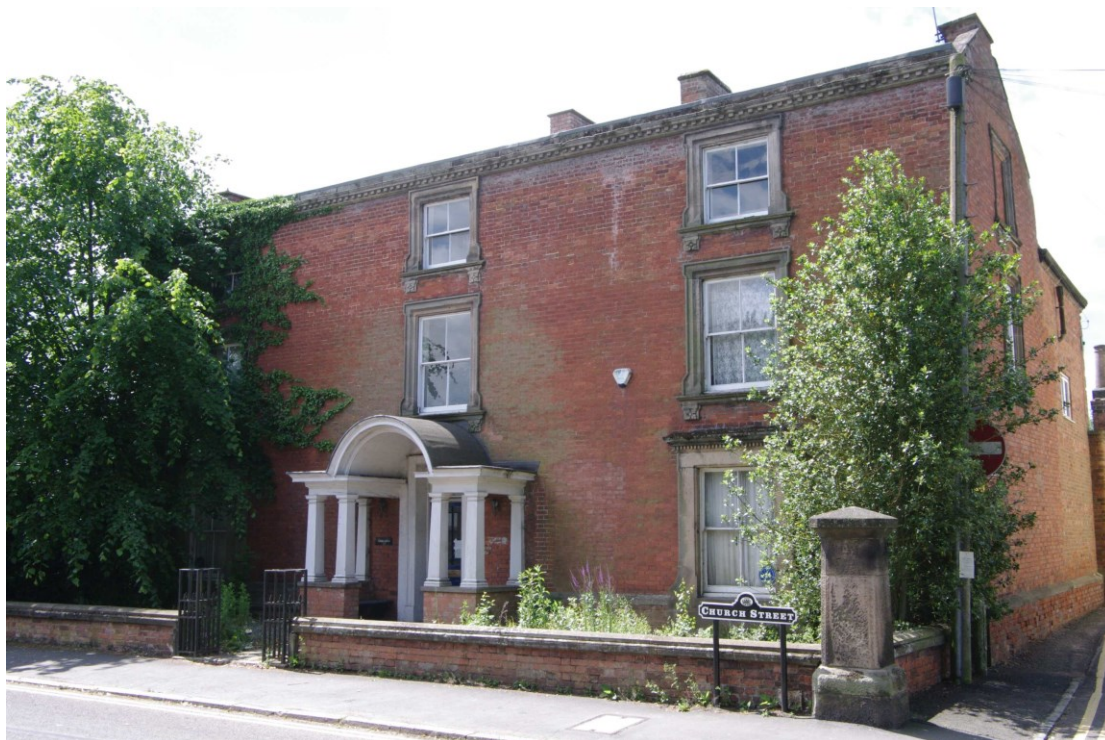
The front garden has a low brick wall running around it with substantial stone pillars at each corner (Fig. 15). The bricks are a similar size to those used on the house and are laid in the same header/stretcher bond. A pair of wrought iron gate posts remain but the wrought iron railings seen in Figure 9 are no longer present. Lead-filled holes in the coping stones and sawn off metal tabs on the stone pillars show where these once were. It is likely that these were removed during the Second World War during the drive for scrap metal.

Figure 15 North-east facing elevation and front garden wall  
Corresponding stone wall pillar on left hidden by the tree. Looking south-east

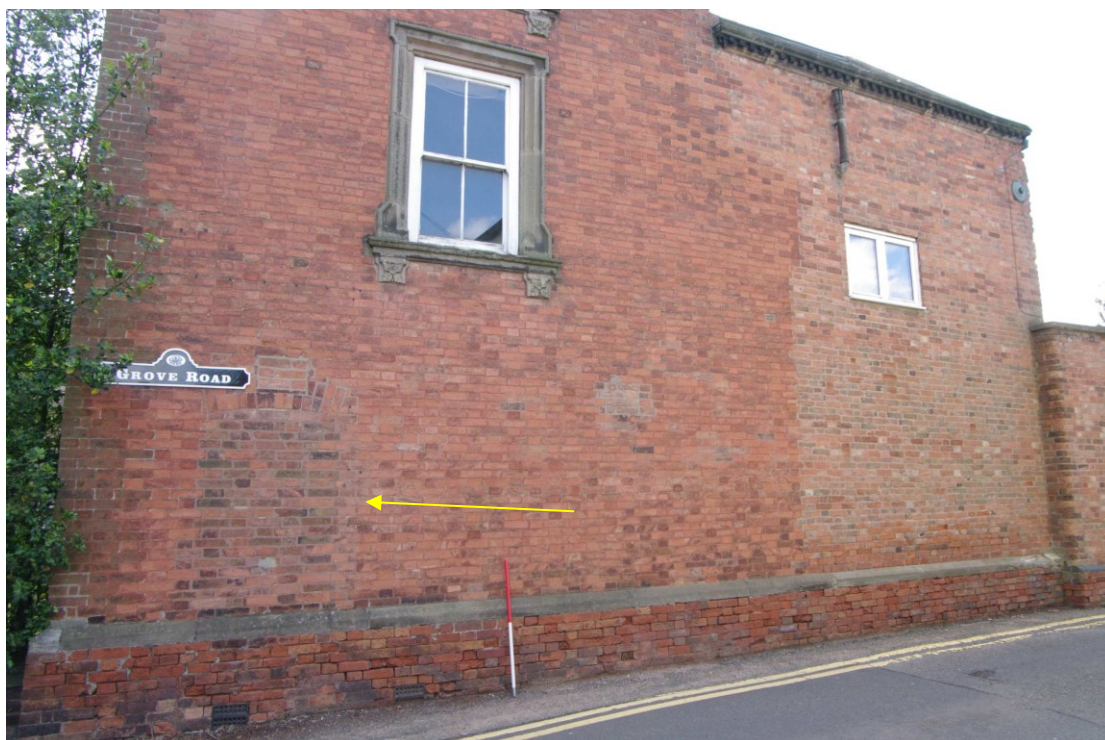
The main gable end of the house is built of red brick and uses the same sized bricks and bonding as seen on the north-east facing elevation. A first floor window has the same moulded surround and sill as used on the front of the house. The same moulded surround is also seen on a second floor window but the opening has been blocked with brick. The bricks match the surrounding wall suggesting a near contemporary date so the surround may have been added simply as a decorative feature. It seems unlikely that it would have been blocked due to a window tax given the early to mid-19th century date of the building. A small window at ground floor level with a brick-arched head has been blocked using similar sized but darker bricks (Fig. 19). This would have been a very plain window when compared to the other windows and may suggest that, when first built, the other windows did not have their moulded surrounds. The off-centre nature of this window would have given the occupants of the ground floor front room an unimpeded view down Church Street. Perhaps the lack of pavement and garden in front of this window reduced the privacy of the room and the window was blocked.

Figure 19 North-west facing elevation, ground floor blocked window  
Blocked window arrowed. Note repointed bricks and modern window on right of  
picture. Looking south-east. 1m scale

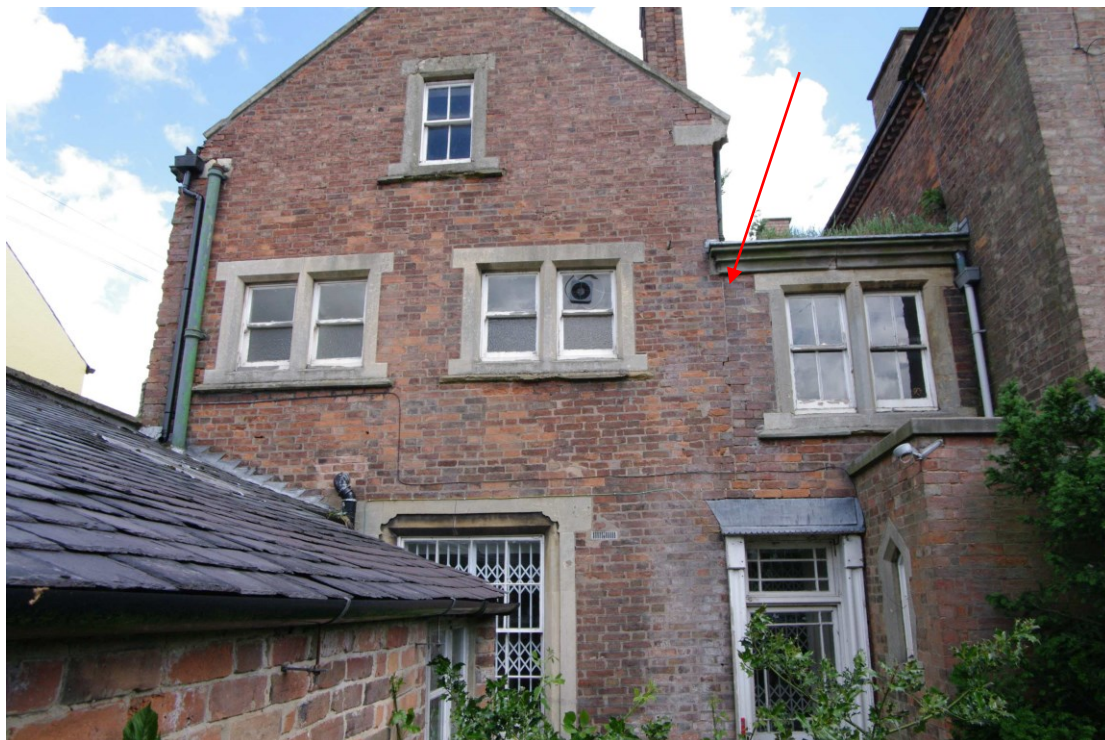
Figure 28 South-west facing elevation of SW rear wing and infill between wings  
Looking north-east. Note brick joint of infill (arrowed). Single storey service range on  
left of picture

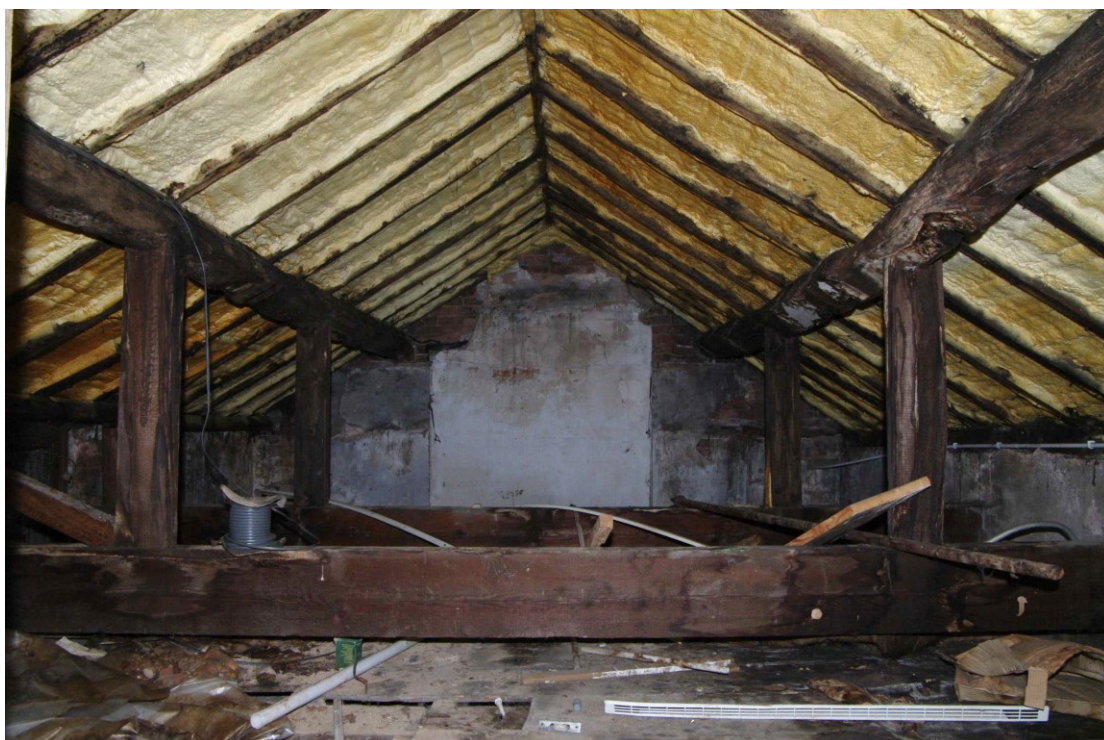
Room S3 is now unused but gives a glimpse of the servant's quarters when the house was first built (Fig. 76). The condition of the floorboards meant that this room was not entered but the hatch from Room S2 allowed a reasonable inspection. The room was clearly intended to be occupied as it has floorboards and the walls have the remains of a white painted plaster coating. The single window on the south-east facing wall is partially cut across its lower half by the high floor level suggesting that visual symmetry from the outside was more important than function on the inside, a feature typical of late 18th and early 19th century buildings. Two large tie beams run across the room just above floor height which would have made moving around in this relatively dark space very awkward. The tie beams support queen posts on top of which sit the substantial purlins. Fairly large section common rafters sit on the backs of the purlins and extend to ridge height, there are no principal rafters. The spacing of the tie beams suggests that one truss may have been removed to create Room S2. It is also possible that before being modernised Room S2 had a similar layout and floor level.

Figure 76 Room S3  
Looking south-east through hatch from Room S2

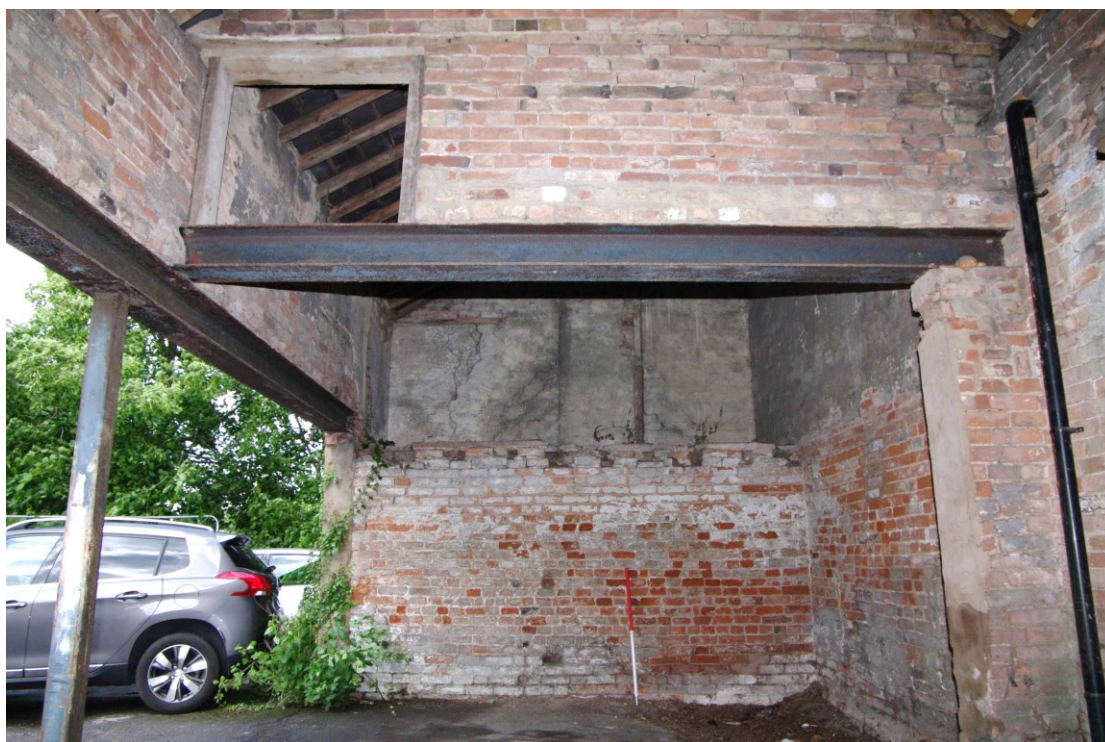
Figure 95 Outbuilding Room OB2 from OB3

Although these rooms were built as two separate rooms they have been changed by removing the lower part of the dividing wall probably when the front wall was removed and the steel beam inserted (Figs 95 and 96). The roof structure in both rooms appears to be a modern replacement. The floor is laid with tarmac but may cover an earlier surface. OB2 clearly had a first floor as the walls at first floor level retain some of their plasterwork. Also, as already noted, the upper part of a blocked window can be seen on the north-west wall. A blocked doorway can be seen at first floor level on the north-east wall which would have led into the now demolished building. The floor above Room OB1 has the remains of a plaster floor. Joist sockets survive on the wall of OB1 indicating that floor joists ran from north-east to south-west across OB2.

Looking north-east. 1m scale. Note remnant of first floor dividing wall supported on modern steelwork in foreground. Also plastered walls above Room OB1 is background

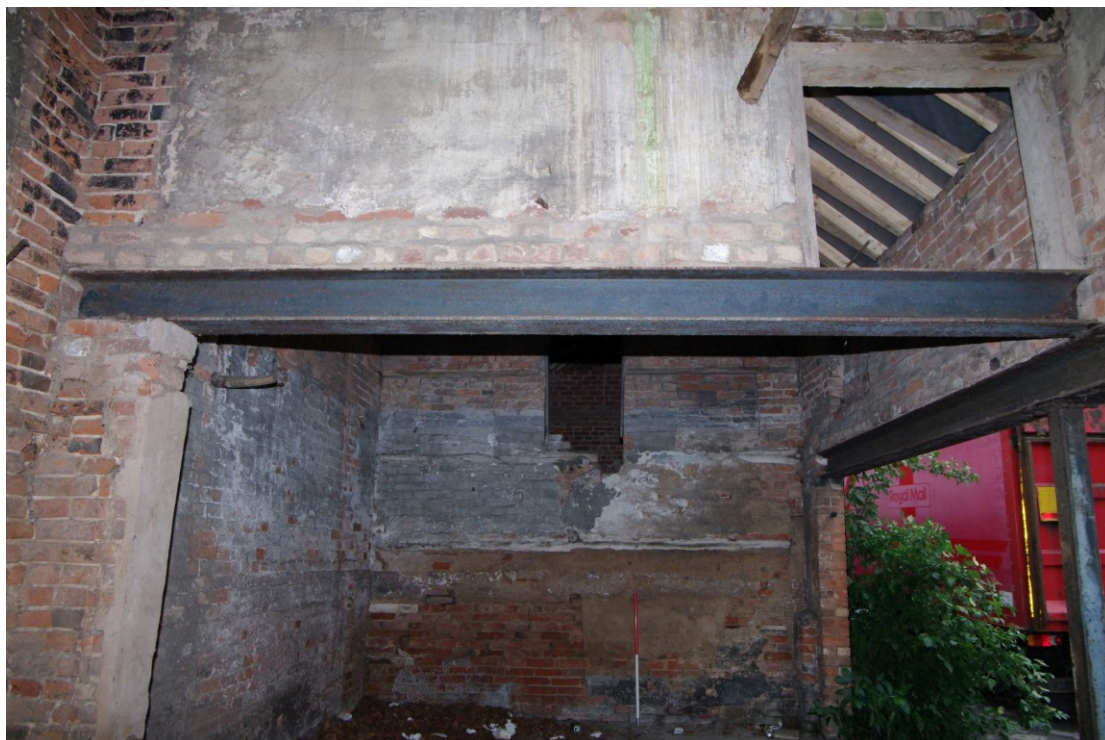
Figure 96 Outbuilding Room OB3 from OB2  
Looking south-west. 1m scale. Note first floor doorway and blocked hatches. Also  
wooden bracket on left for hanging saddles or tack

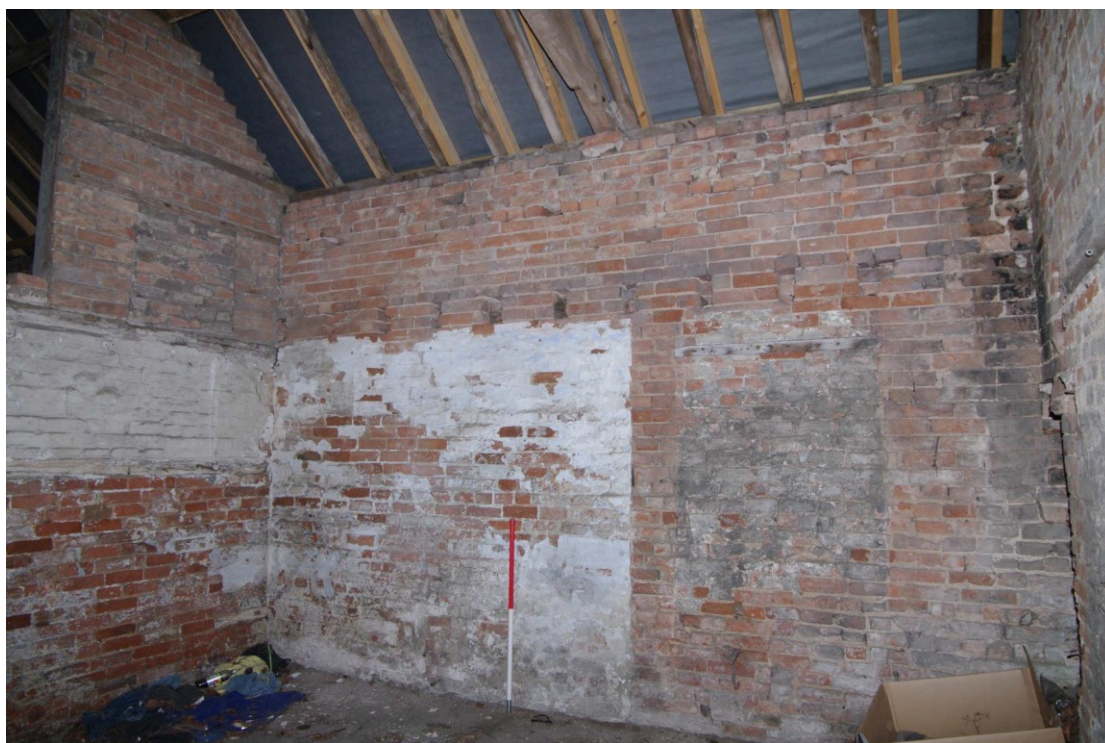
Room OB4 is a small open fronted room which was probably altered at the same time as OB2 and 3. The front has been modified by the insertion of a steel beam but it has retained its supporting brick pillars which still have iron pintles for the missing doors. The room has empty floor joist sockets on the north-eastern wall (Fig. 97). It also has a recently repaired roof although the purlins are probably original and a shallow pitched bolted scissor truss suggests a later 19th century date (Fig. 98).

Figure 97 Outbuilding OB4  
Looking east towards wall with OB3. 1m scale Note empty first floor joist sockets

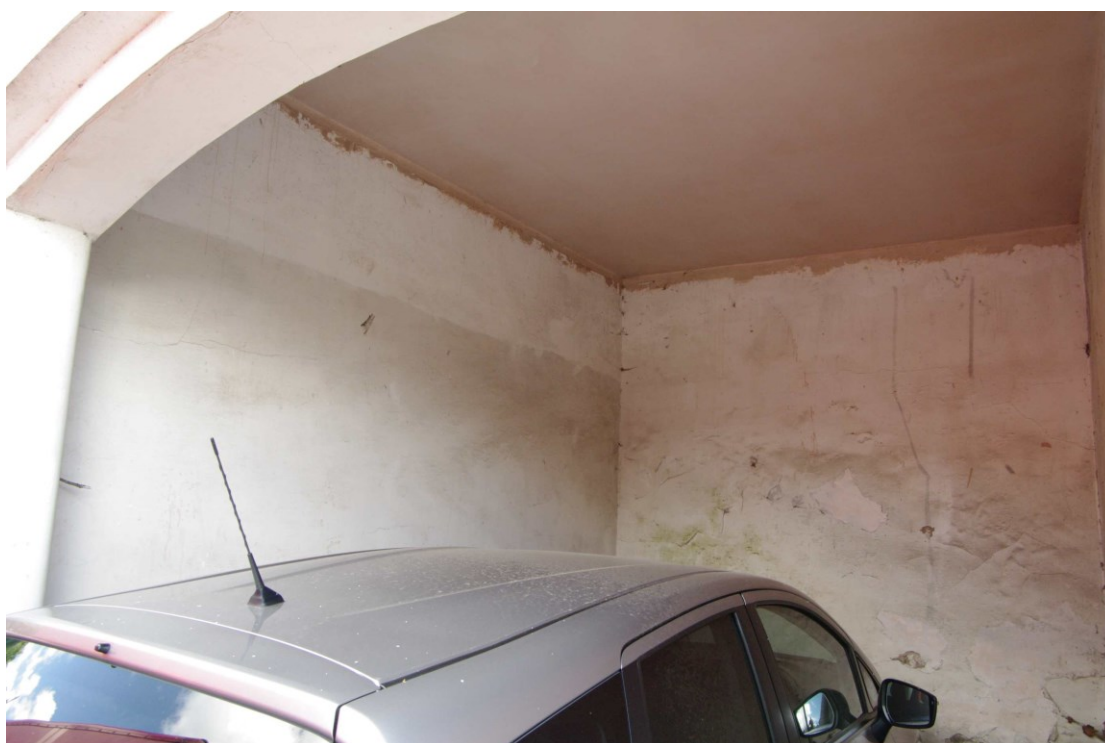
This room has been repaired relatively recently and is fully plastered with a plaster ceiling (Fig. 99). It has a brick floor but does not have any doors. There are no apparent blocked doors or windows within this room.

Figure 99 Outbuilding Room OB5  
Looking east

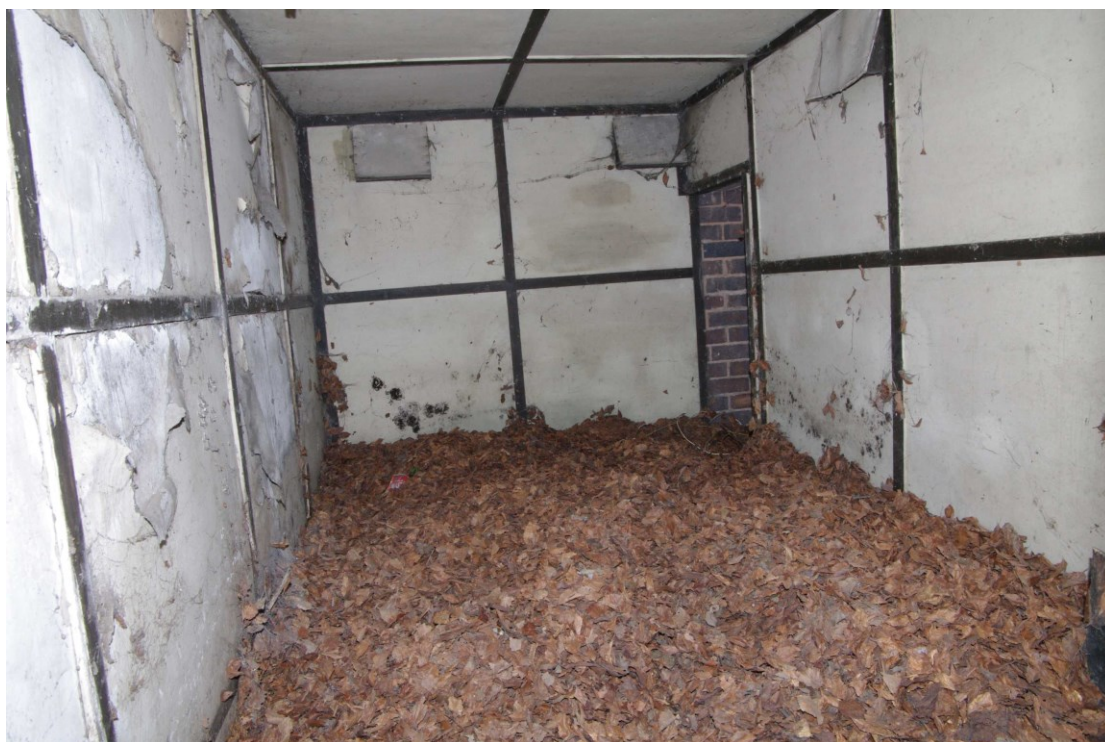
Room OB8 is a single storey brick built air raid shelter with walls around 0.36m thick. It has two narrow doorways which are offset to increase blast protection. Inside the shelter the floor is covered with a thick layer of leaves but enough is visible to show that the walls are covered with a white fibrous boarding material (Fig. 103). Covered vents are visible on the walls which lead out to blue brick air vents. Although not shown on the 1947 Ordnance Survey map this shelter must have been added during the Second World War.

Figure 103 Inside air raid shelter Room OB8  
Looking south-east from NW doorway towards SW doorway
