**A Level 2 Historic Building Record at  
The Memorial and Miner's Welfare  
Institute,  
128 Main Street,  
Markfield,  
Leicestershire.**

**NGR: SK 48925 10205**

ULAS Report No. 2017-129  
©2017

**For: Harbot Builders**

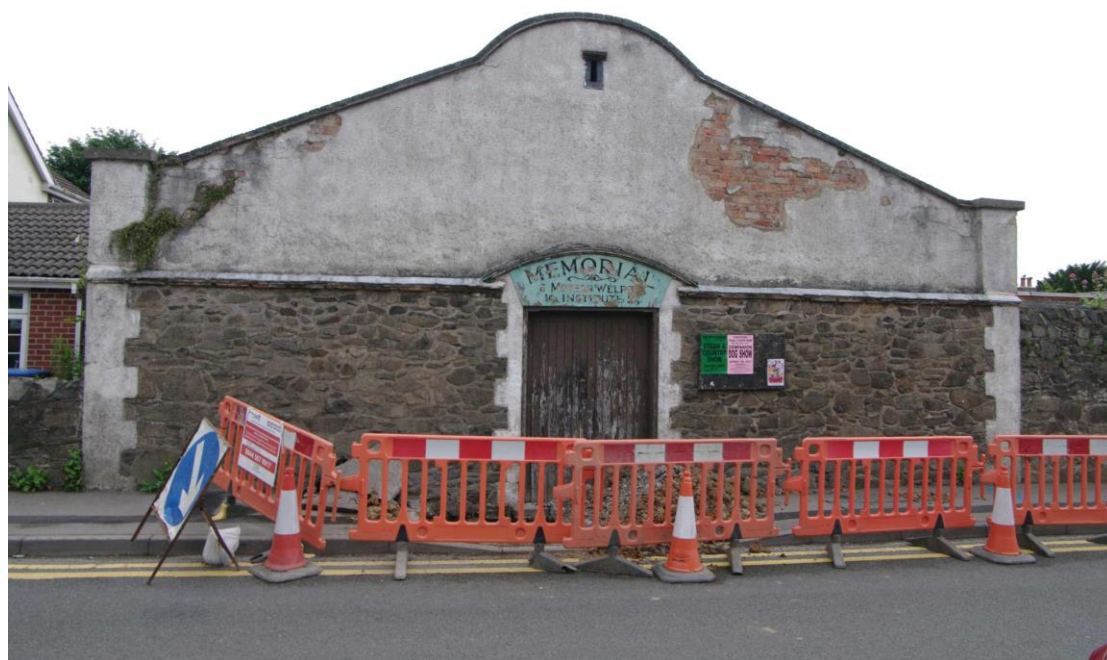
The main hall has a lower half built of granite rubble which continues along to the site boundary wall which has pitched granite copings (Figs 7 and 8). Decorative plaster quoins give the appearance of the hall being separate from the boundary wall but close inspection indicates that the plaster has been applied over a continuous wall (Fig. 9). The wall continues northwards as a low boundary wall for the adjacent property. The upper half of the frontage is built of cement rendered red brick and forms a screened parapet hiding the roofline behind. A set of plain wooden doors leads into the hall but there are no other openings on this frontage. Above the doorway is a stone or cement panel which has the following sign painted onto it (Fig. 10):

Figure 7 West facing elevation  
Looking east across Main Street

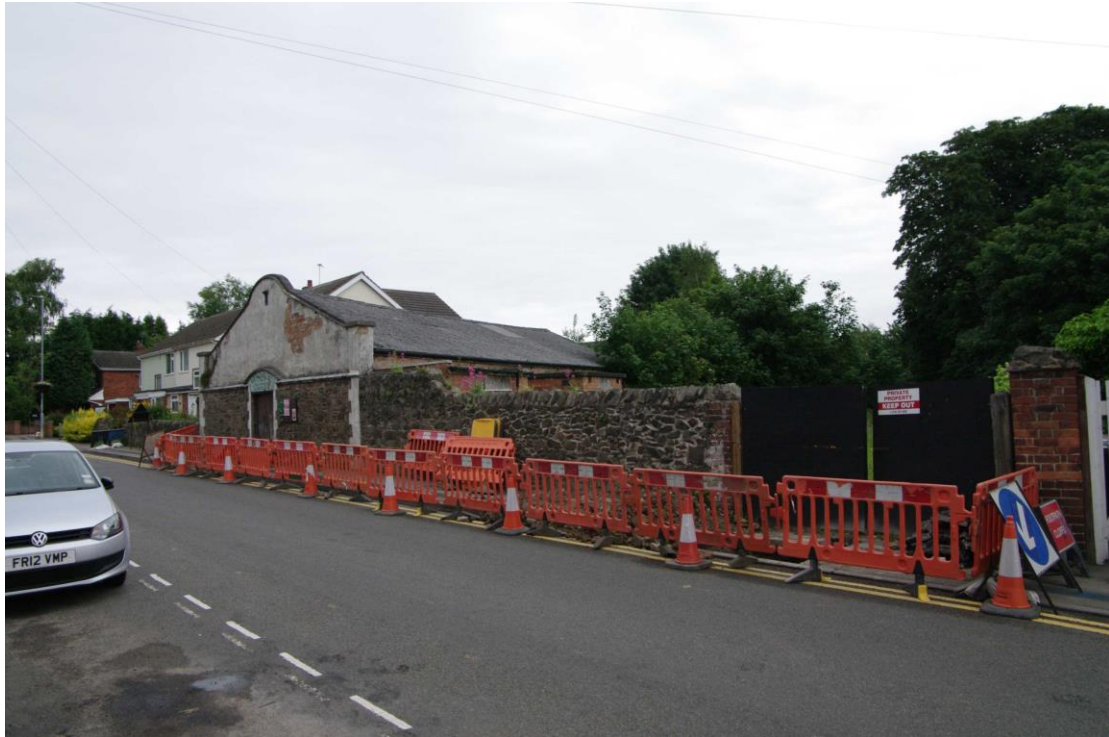
Figure 8 West facing elevation and boundary wall  
Looking north-east

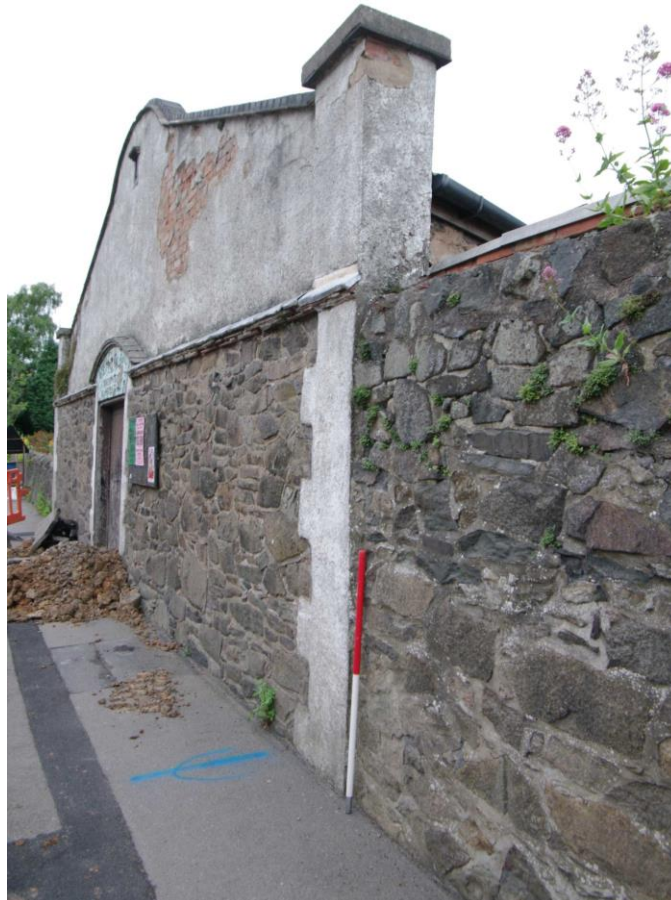
Figure 9 Decorative quoins applied to the west facing wall  
Looking north-east. 1m scale

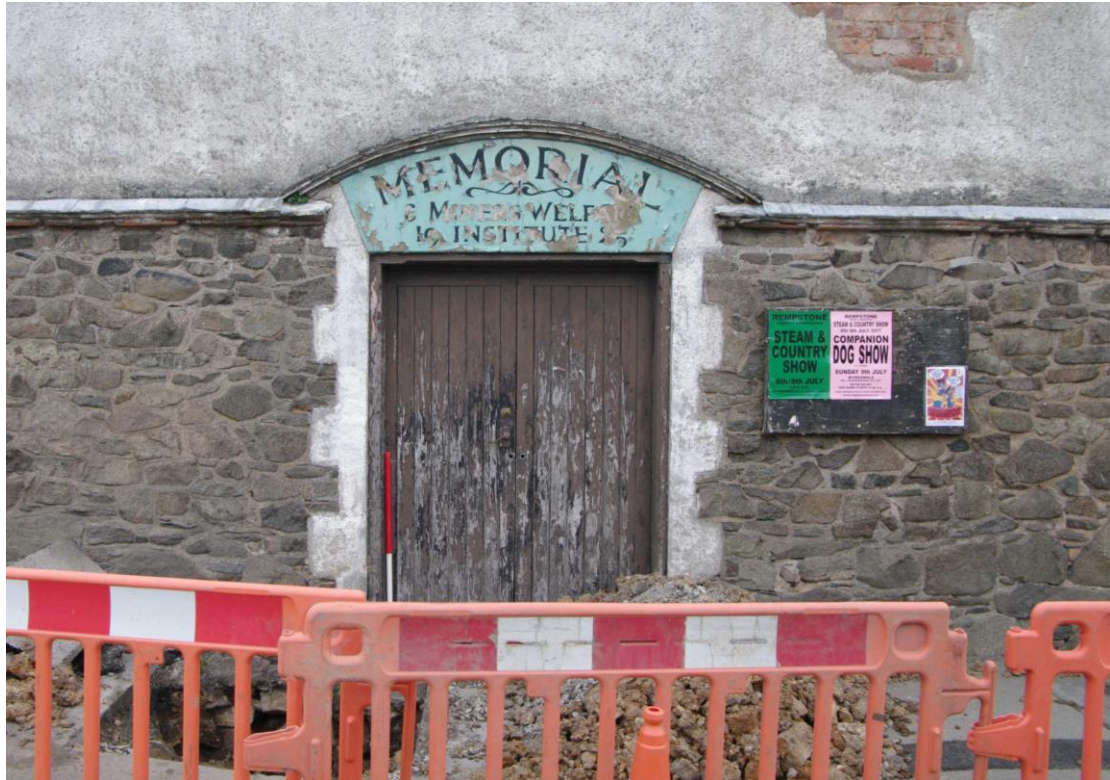
MEMORIAL  
& MINERS WELFARE  
19 INSTITUTE 25

Figure 10 West facing elevation front doors  
Looking east. 1m scale

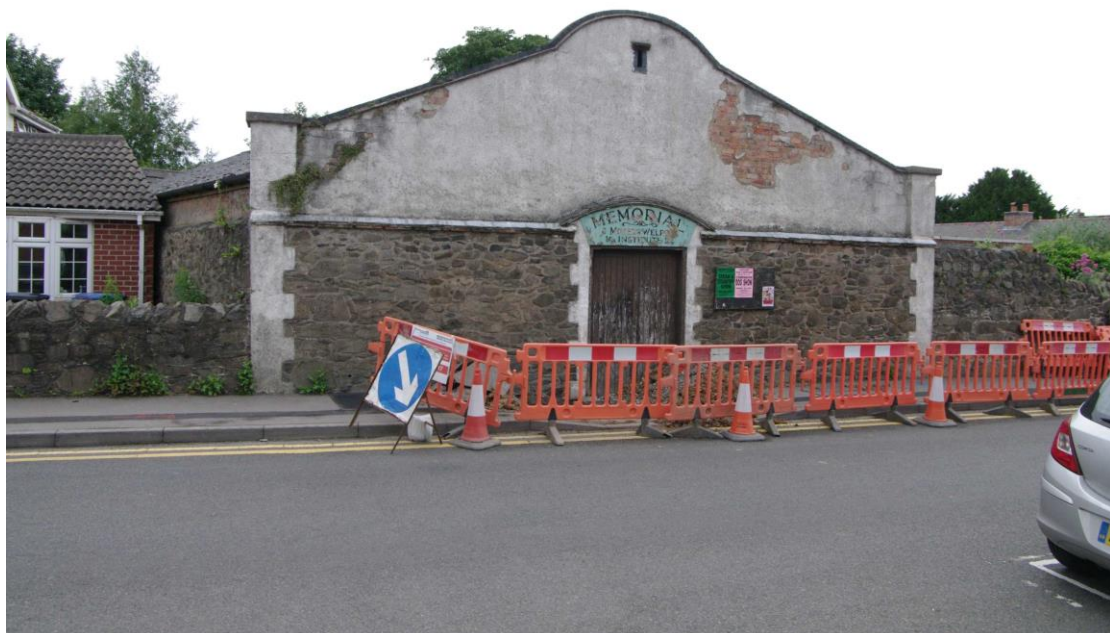
Most of the north facing elevation, which sits along the northern boundary, is obscured by the adjacent house which sits close to the hall wall. Despite this however it can be seen that the north wall is principally constructed from granite rubble with five courses of red brick on top (Fig. 11). The north facing elevations of the end brick buildings cannot be seen.

Figure 11 North and west facing elevations  
Looking south-east. Note the brick courses on the north wall

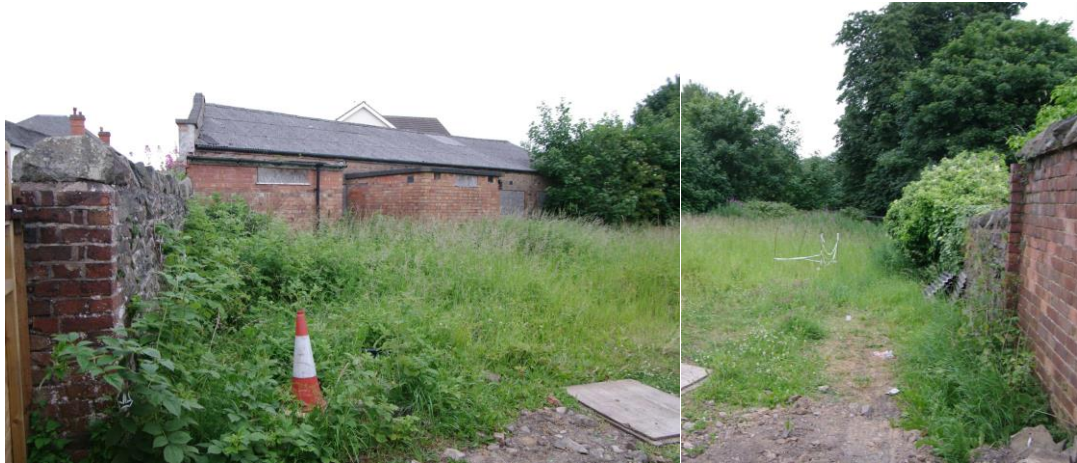
The south facing elevation is a rather jumbled grouping of all the buildings clearly showing the growth of the site and its later additions. At the time of the survey much of the yard was heavily overgrown which partially obscured much of the eastern brick and stone built buildings (Fig. 12).

Figure 12 South facing elevation and car park area  
Looking north-east

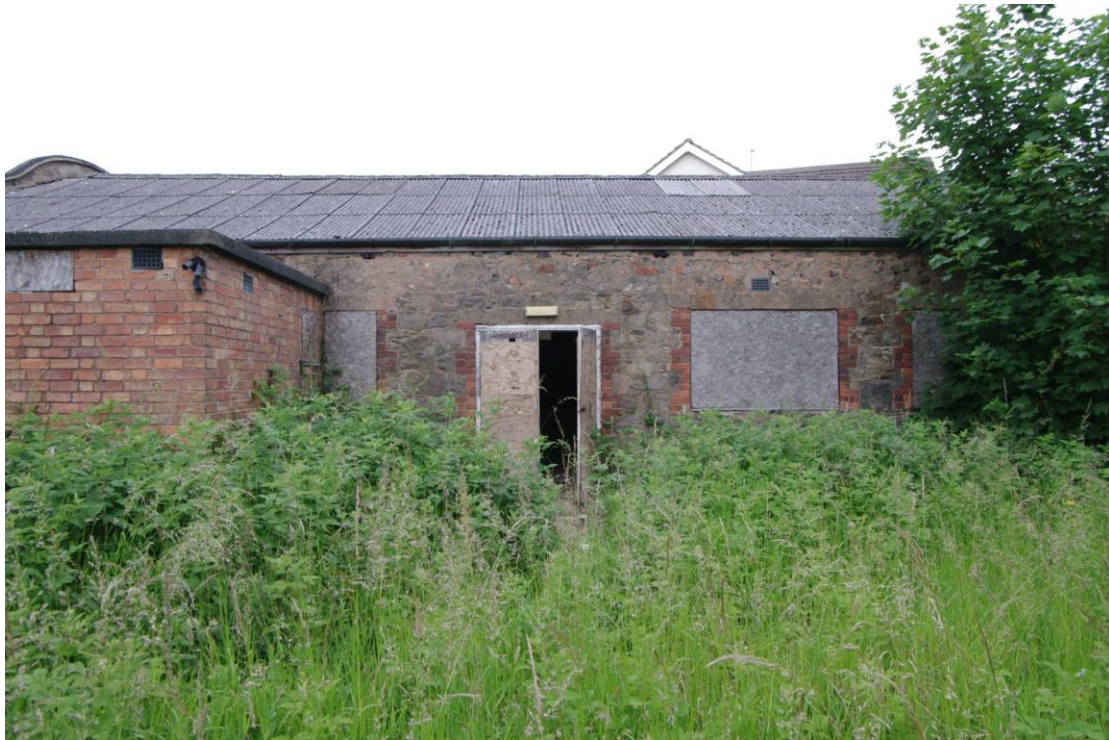
The main hall wall is built from granite rubble with some small infill work and patching of red brick (Fig. 13). Red bricks have been used to form the masonry frames of the doors and windows which run along this elevation. The doors and windows were boarded over at the time of the survey but it could be seen that whilst the window frames appear to be replacements, possibly from the 1960s, they still occupy the original openings. The roof of the hall is corrugated sheet material.

Figure 13 Main hall, south facing elevation  
Looking north. Toilet block extension on left

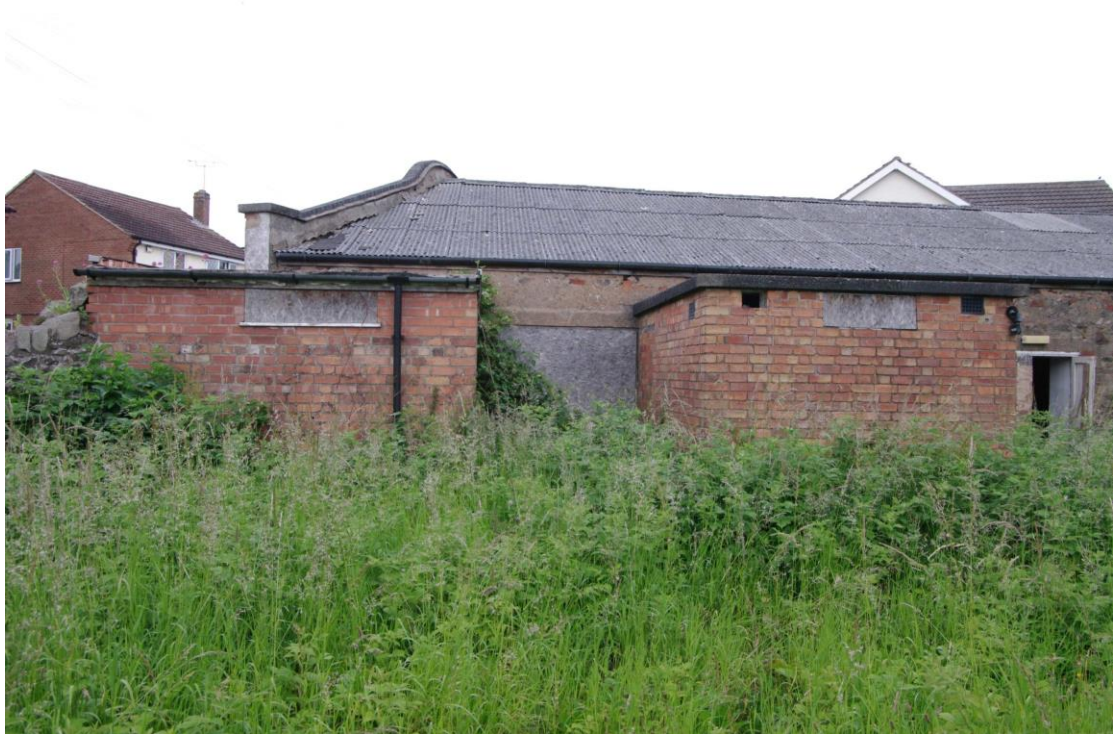
At the western end of the hall are two separate brick-built toilet blocks with flat concrete roofs (Fig. 14). The bricks and coursing are different on the two blocks which suggests that they were constructed at different dates. Their style and map evidence suggest a 1940s or early 1950s design for both blocks so that their age difference may not be great. Their construction date may coincide with the takeover of the hall by the Trustees of the Markfield Miners Welfare in 1952. The westernmost block, as already noted, uses the granite boundary wall as its west wall. The eastern toilet block partially

obscures one of the hall windows and has also had a small outside doorway on its western wall bricked up.

Figure 14 Toilet block extensions  
Looking north

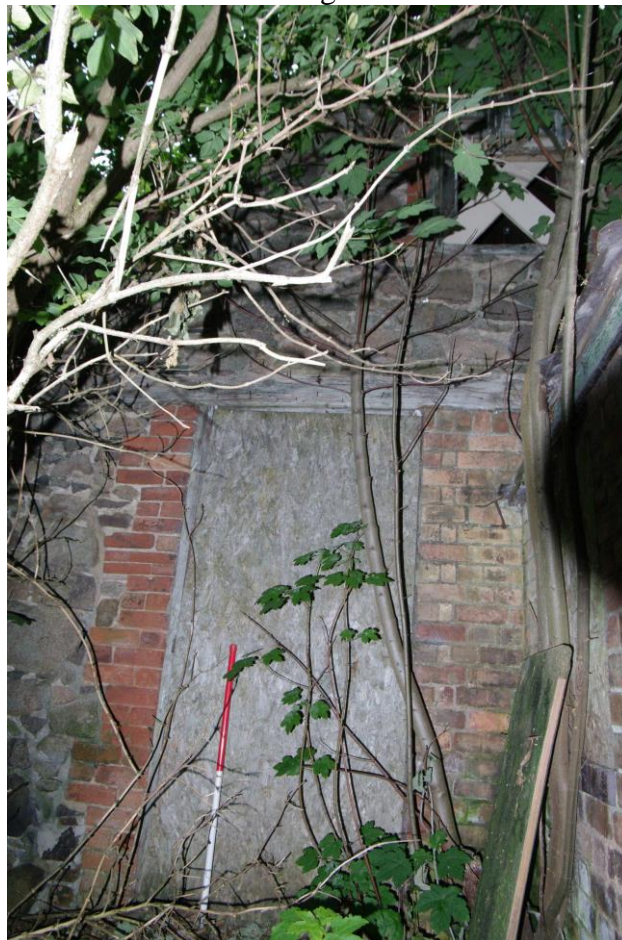
The two structures at the eastern end of the hall can be seen as two gable ends on this south facing elevation. Unfortunately the presence of undergrowth and semi mature trees prevented many photographs being taken during the survey, however it was still possible to carry out a visual inspection. The western building built against the back of the hall is set back from the hall wall and is built of granite rubble with brickwork around the door openings. It has a single doorway modified from what was a double doorway (Fig. 15). This doorway has had to be reduced in width due to the construction of a small boiler house which is discussed below. Set in the apex of the gable is a small hayloft door which suggests that this building had earlier agricultural origins and may be the building shown on the first and second editions of the Ordnance Survey maps.

Figure 15 Gable end wall of western brick built structure  
Looking north. 1m scale. Note former double doorway reduced to single doorway by  
later brickwork. Hayloft door top right

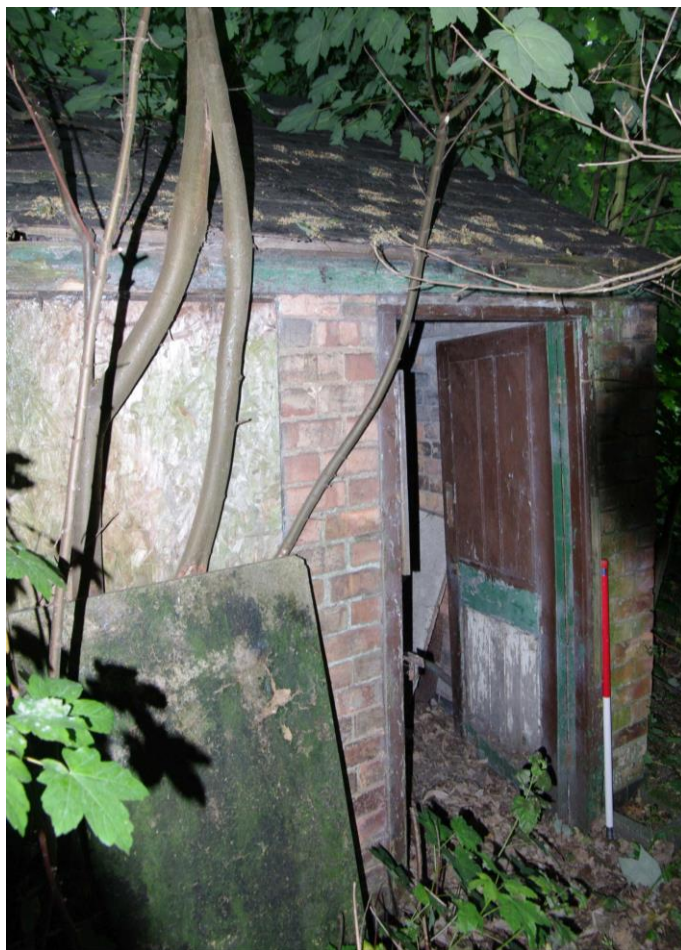
The eastern building has a brick-built gable end with a single ground floor doorway. It projects further southwards than the other gable end which has provided a useful corner in which to insert a small brick built boiler house with a slate hipped roof (Fig. 16). The boiler house is clearly later than the other two buildings as it butts against both. Inside are remnants of a modern boiler and a blocked doorway on the east wall which used to lead into the eastern building (Fig. 17).

Figure 16 Boiler house  
Looking south-east. 1m scale

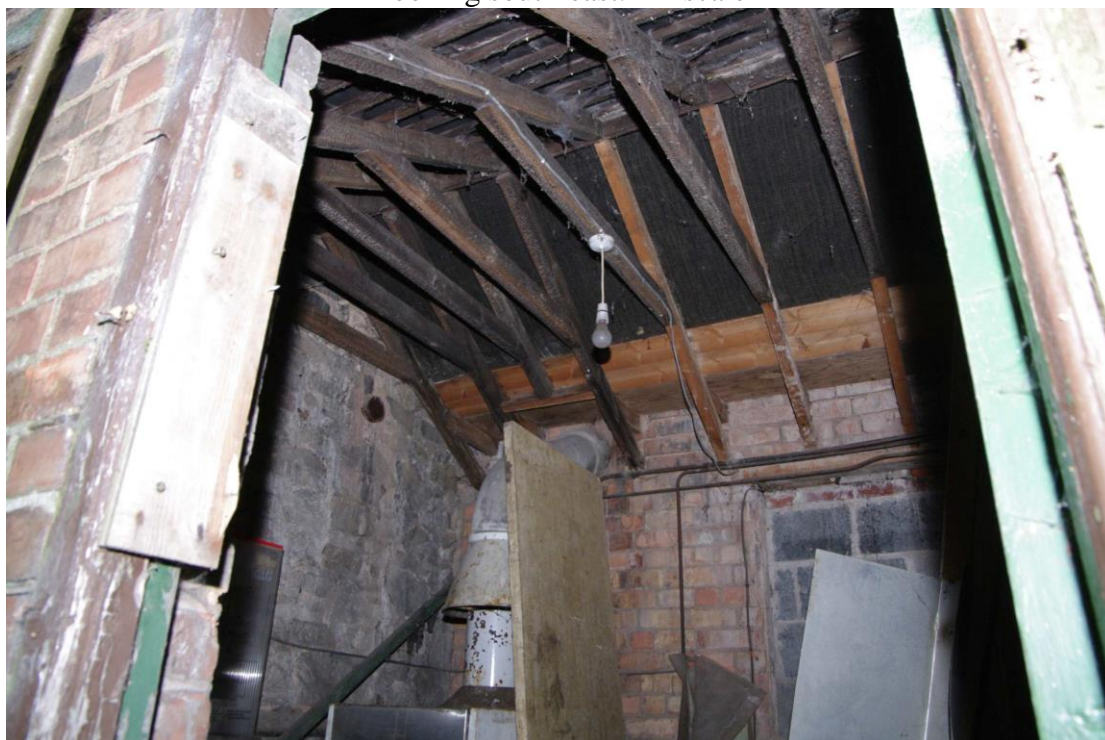
Figure 17 Inside the boiler house  
Looking north-east

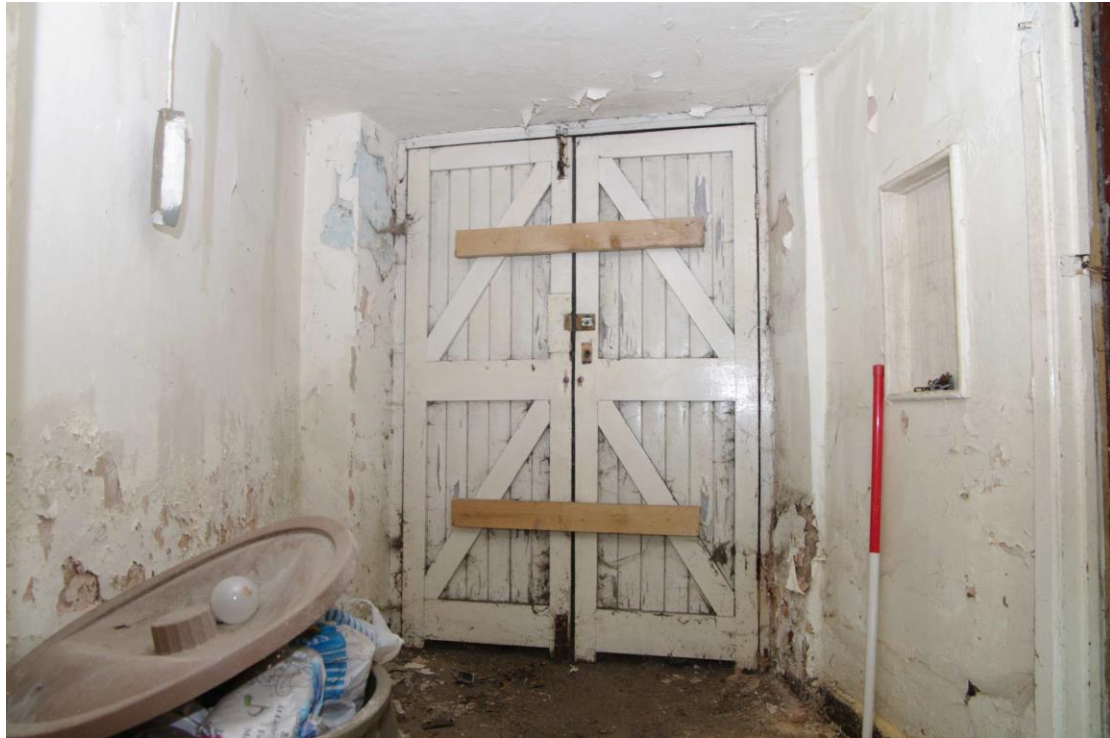
The principal entrance from Main Street leads into a small vestibule with a low ceiling and hatch on the north wall for the cloakroom attendant (Fig. 19). A small doorway adjacent to the hatch serves the cloakroom attendant's room which has an odd shape to allow it to fit into the obtuse angle of the building. The outside (west) granite wall of this room still retain its pitched copings on top of which the brickwork has been built (Fig. 20). A hatch high in the south wall of this room opens into a small store built above the entrance vestibule.

Figure 19 Entrance vestibule  
Looking west towards external doors. 1m scale

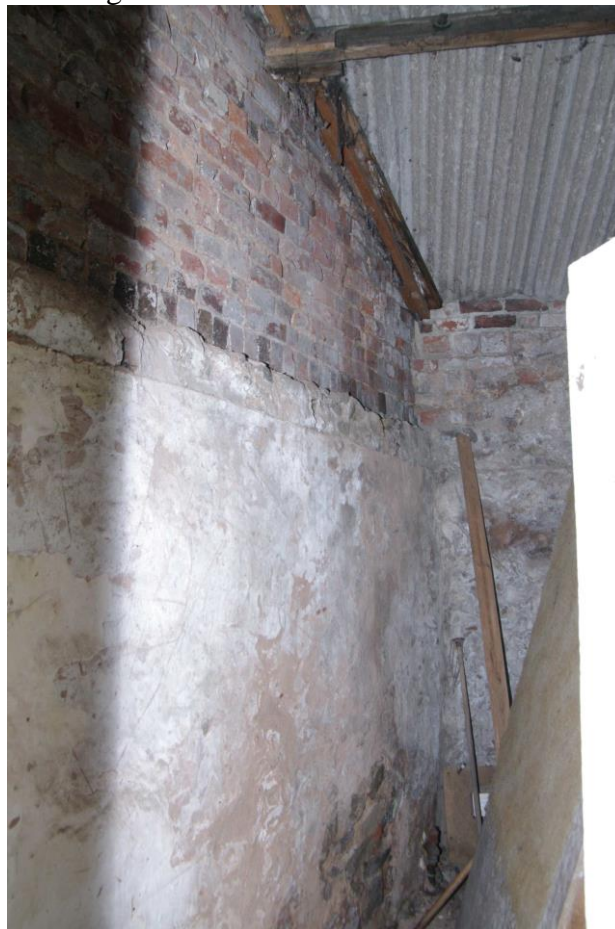
Figure 20 Cloakroom attendant's room  
Looking north through door from vestibule. Note pitched stone copings on outside  
wall beneath brickwork

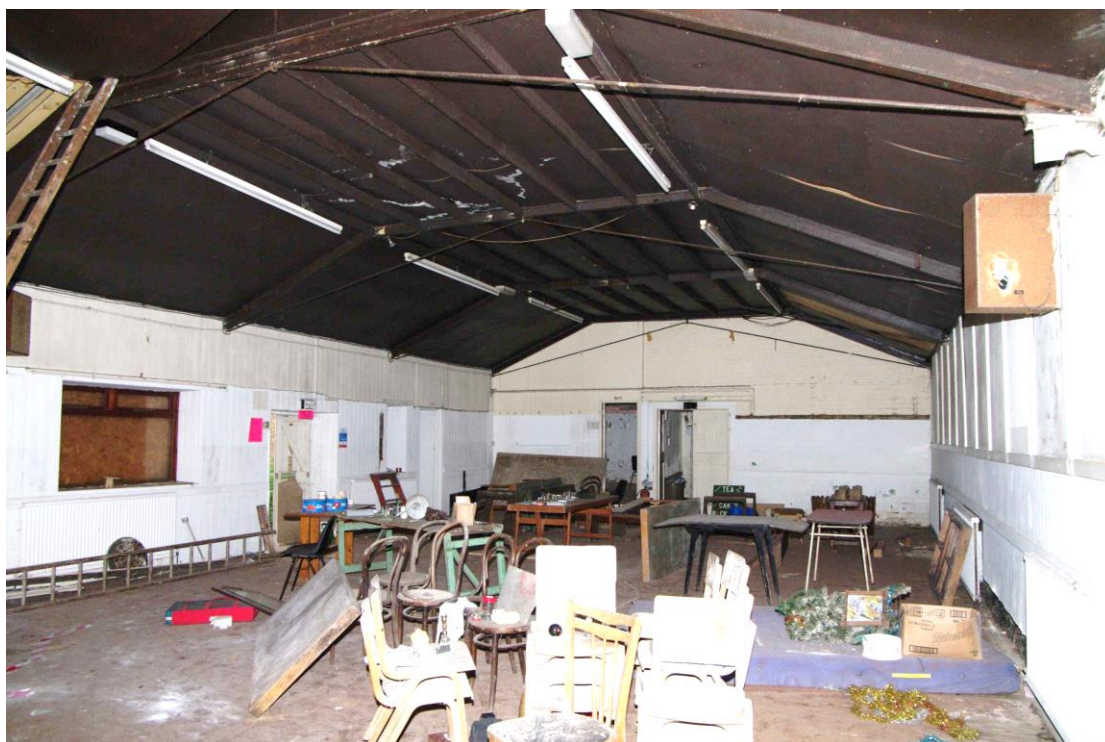
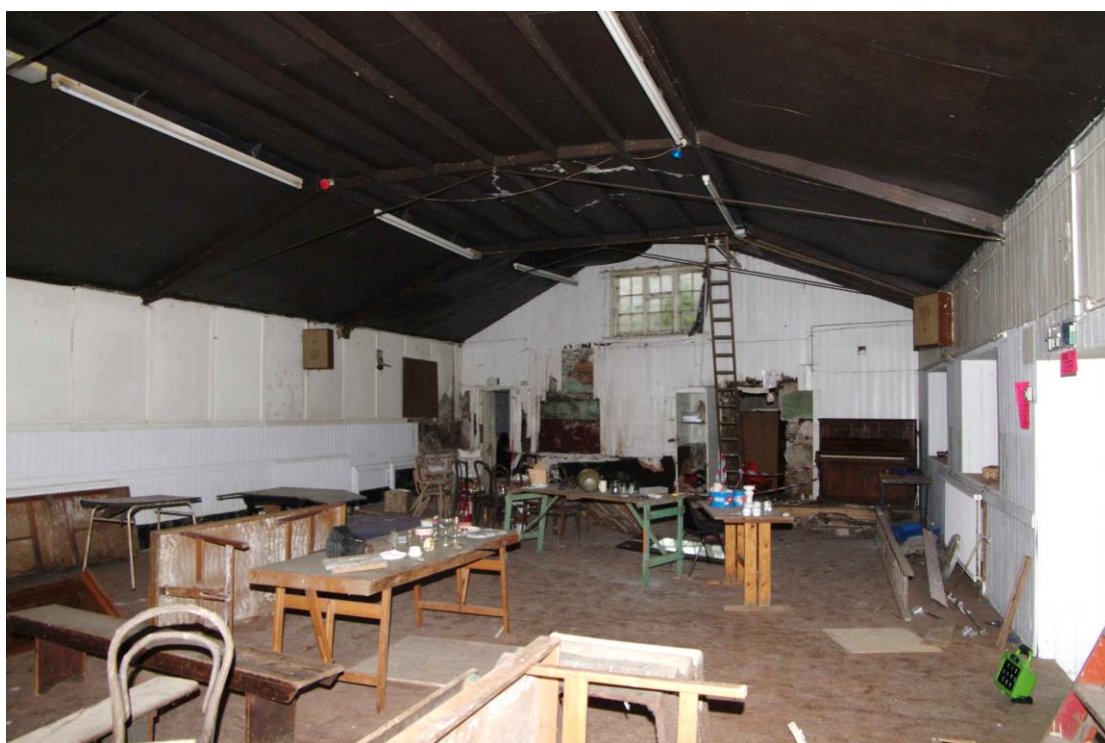
The main hall is a large open single room with windows along the south wall (Figs 21 and 22). The roof is supported by wide wooden trusses strengthened with steel rods. A boarding material has been used between the roof timberwork to hide the underside of the corrugated roof. Matchboard panelling lines the walls but this is a later addition as the original painted plaster colour scheme can be seen where the boards have rotted away (Fig. 23). The windows on the south wall are later replacements and may date to the 1960s (Fig. 24). At the western end of the hall are the double doors leading into the vestibule and another single doorway leading into a small cloakroom with matchboarded walls (Figs 25 and 26). A knocked through door in the corner of the cloakroom goes into the western toilet block. This has been thoroughly modernised leaving no trace of any original fittings.

Figure 21 Main hall  
Looking west

Figure 22 Main hall  
Looking east

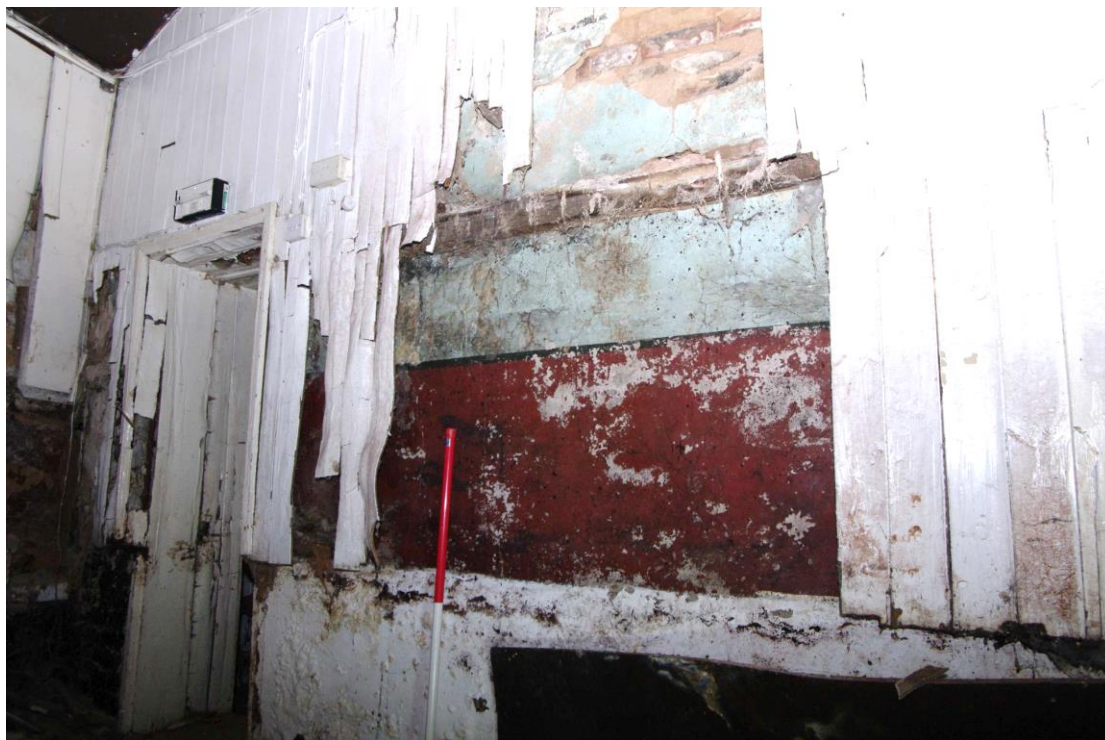
Figure 23 Original wall paint scheme of main hall  
East wall of hall

Internal modifications appear to be quite minimal so that an impression of the original layout can easily be seen. The addition of matchboarding on the hall walls has covered the earlier quite gaudy painted walls. The later windows on the south wall are another small improvement to the hall

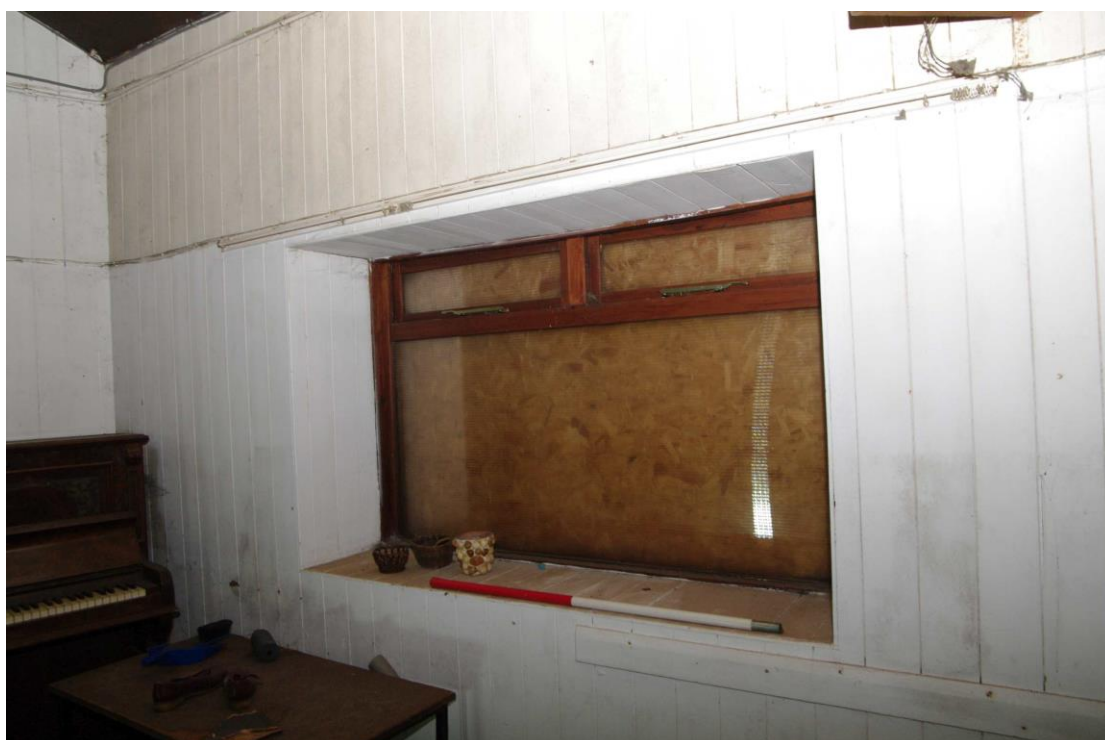
Figure 24 Main hall, south windows  
Looking south-east. 1m scale

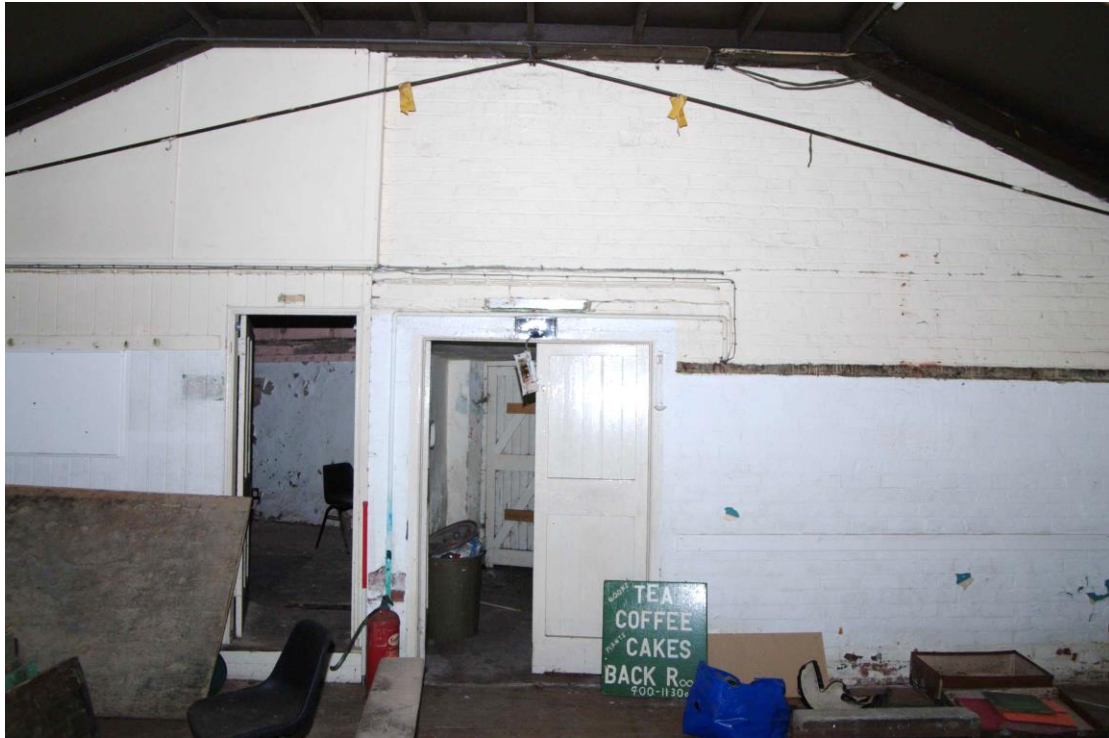
Figure 25 West end of hall  
Looking west. 1m scale. Double doors lead into the vestibule

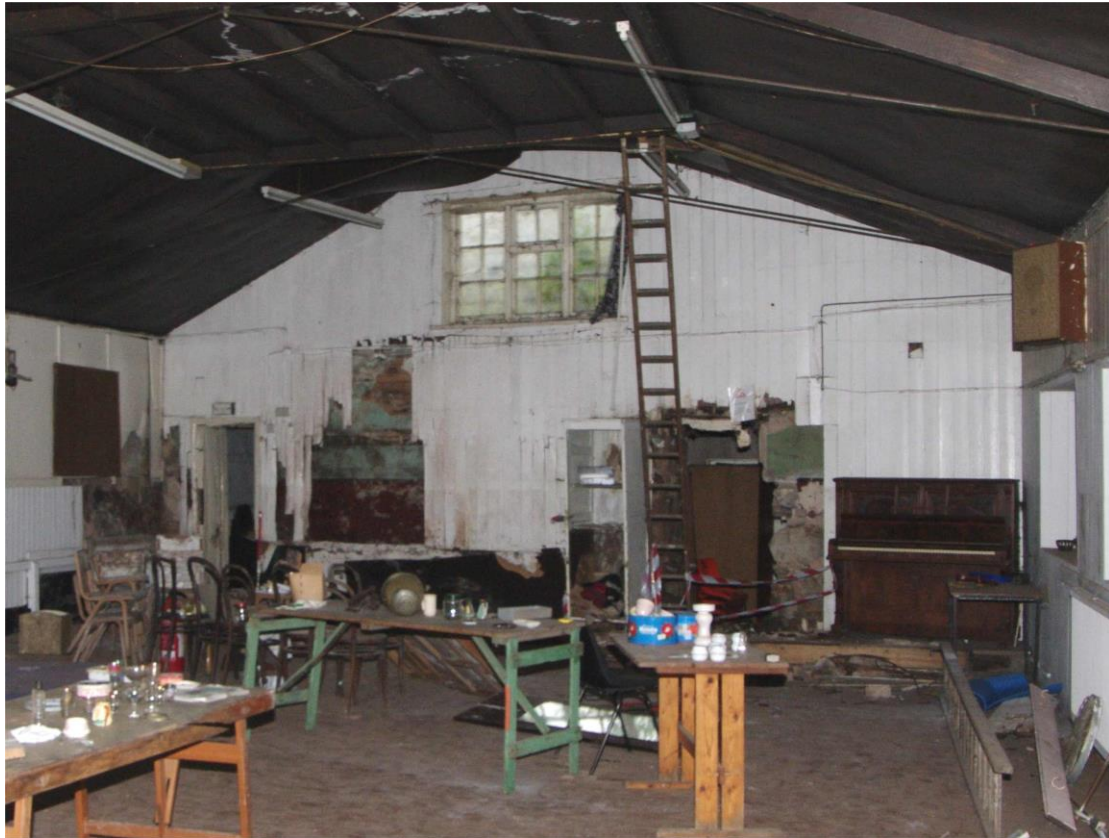
At the eastern end of the hall is a doorway in the north-west corner to the first of the two end buildings which used to be employed as a storeroom (Fig. 27). A second doorway which has been partially demolished leads from a very small raised dias in the south-east corner. The HER suggests that there was a stage in the hall which would have presumably been at this end of the hall but no trace if this remains.

Figure 27 East end of hall  
Looking east.

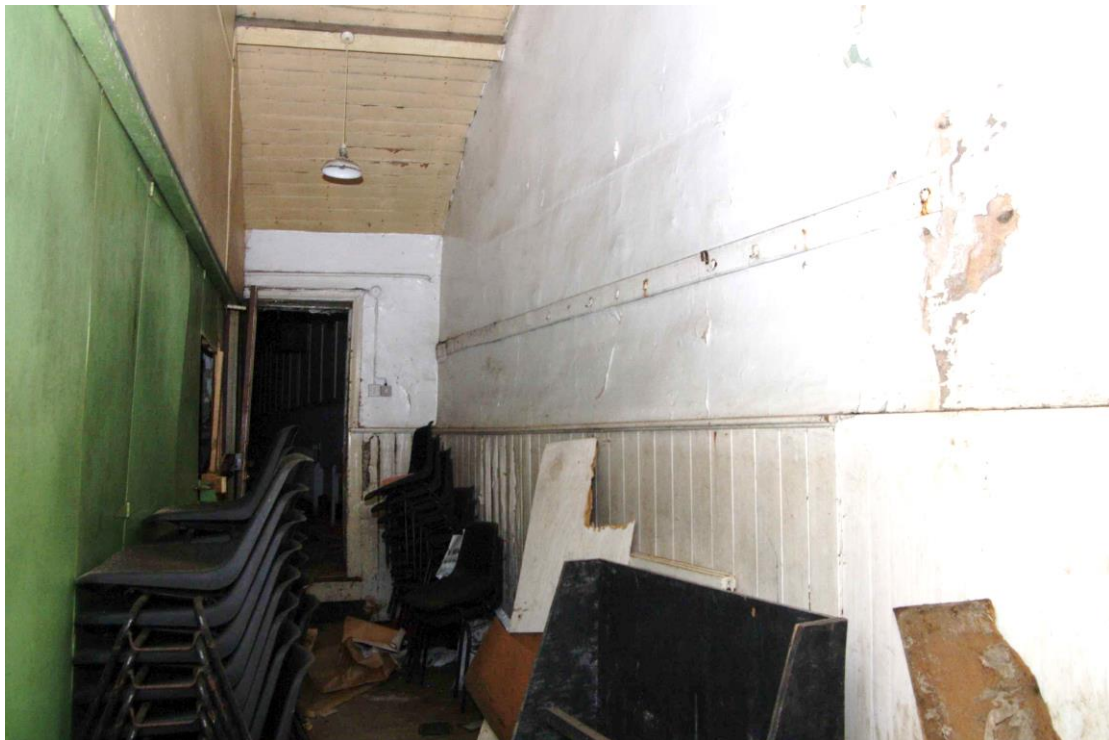
This room has a lower floor level than the main hall and is divided into two main spaces. The space on the north side of the store acts as a corridor from the main hall to the canteen to the east (Fig. 28). The north wall of the corridor is partially matchboarded with a row of coat hooks. The south side of the corridor has folding leaf hardboard doors to allow large items to be placed in the larger, south, side of the store. The southern part of the store appears to be a former barn and has a late 19th century roof truss of typical agricultural design (Fig. 29). The walls have matchboards over bare granite to around 1m above floor level and painted plaster to the roof. The partially blocked double doors blocked by the boiler house can be seen on the south wall.

Figure 28 Storeroom, corridor  
Looking west towards main hall

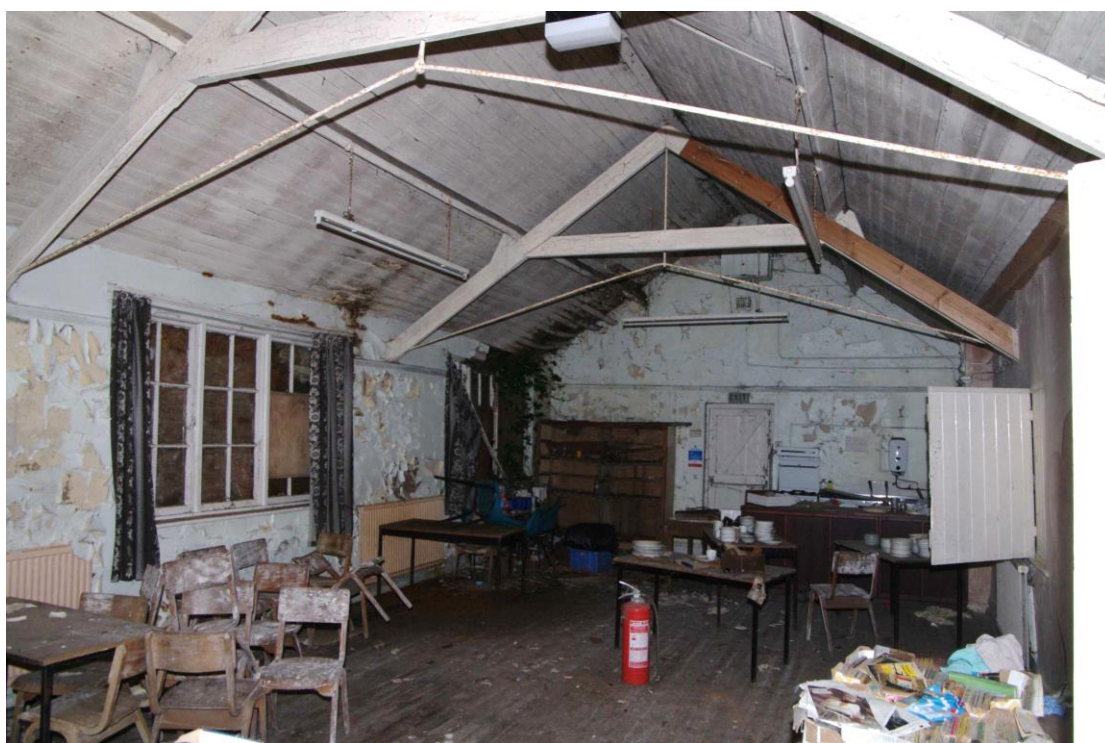
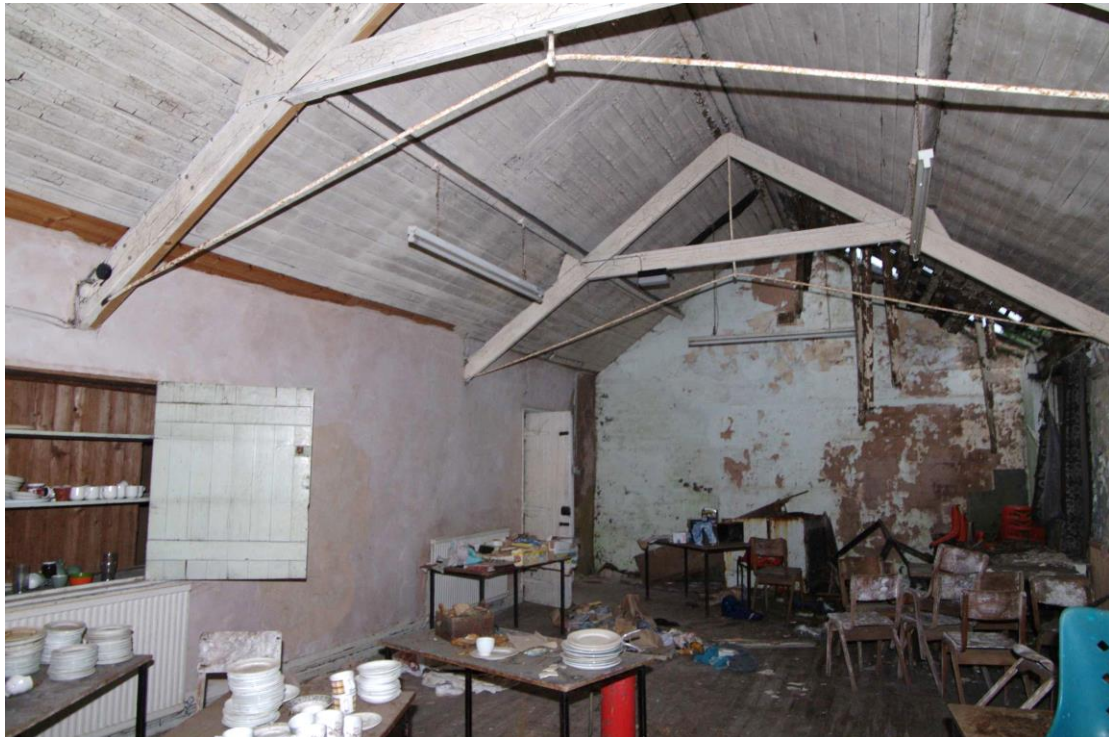
The canteen may also be a former agricultural structure but may have been added at the time of the hall being built. It is a large single room with plastered walls (Figs 30 and 31). The brick walls of the canteen butt against the walls of the storeroom and appear to use the eastern stone wall of the storeroom showing that this building is later than the storeroom. The roof is supported by a simple truss with a raised tie beam and additional steel rods. It is possible that the raised tie beam was used to give the impression of a lighter and higher roof. This type of structure would not normally be used in an agricultural building. The purlins are quite thin lengths of timber but appear to be original. The roof is boarded with sarking boards. The three windows on the south

Figure 30 Canteen  
Looking south. Door to car park in centre of picture

Figure 31 Canteen  
Looking north. Doorway to storeroom in left hand corner

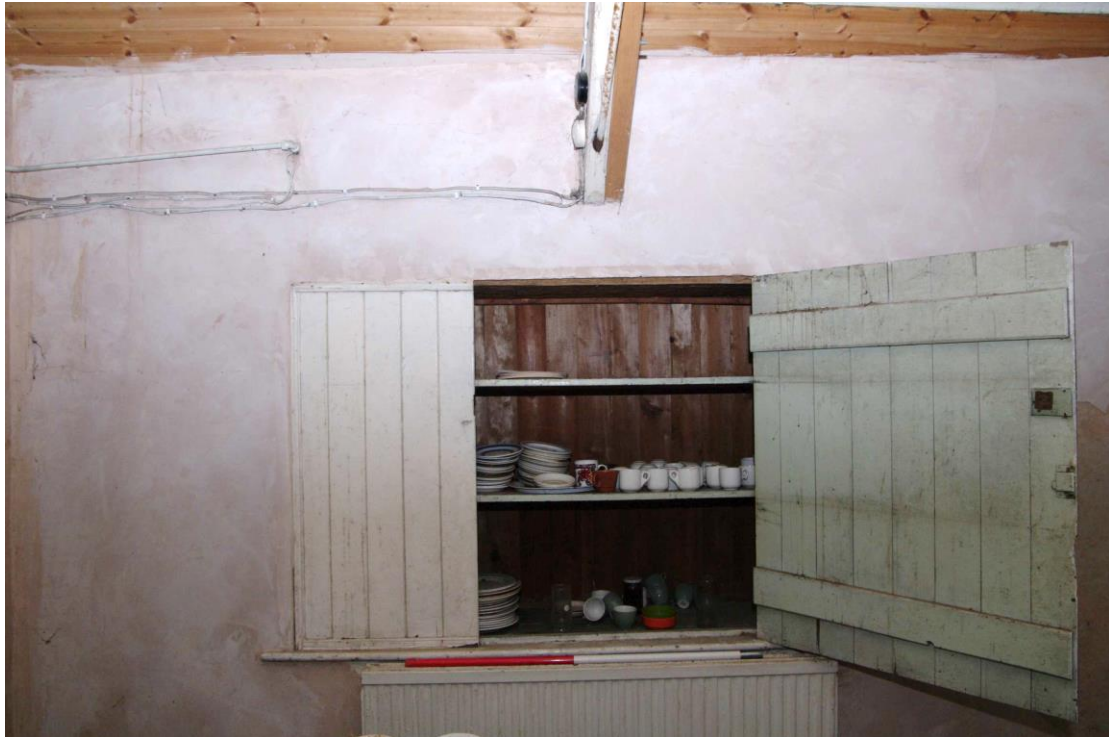
wall are wooden casement windows with 1920s fittings. On the west wall is a large cupboard built into a recess in the wall which may have originally been a window on the side of the storeroom (Fig. 32).

Figure 33 Canteen, recessed cupboard  
Looking west. 1m scale
