**A Photographic Survey of Buildings at
9 Lady Gate,
Diseworth,
Leicestershire**

NGR: SK 45328 24256

ULAS Report No. 2017-131
©2017

Planning Ref: 16/01071/FUL

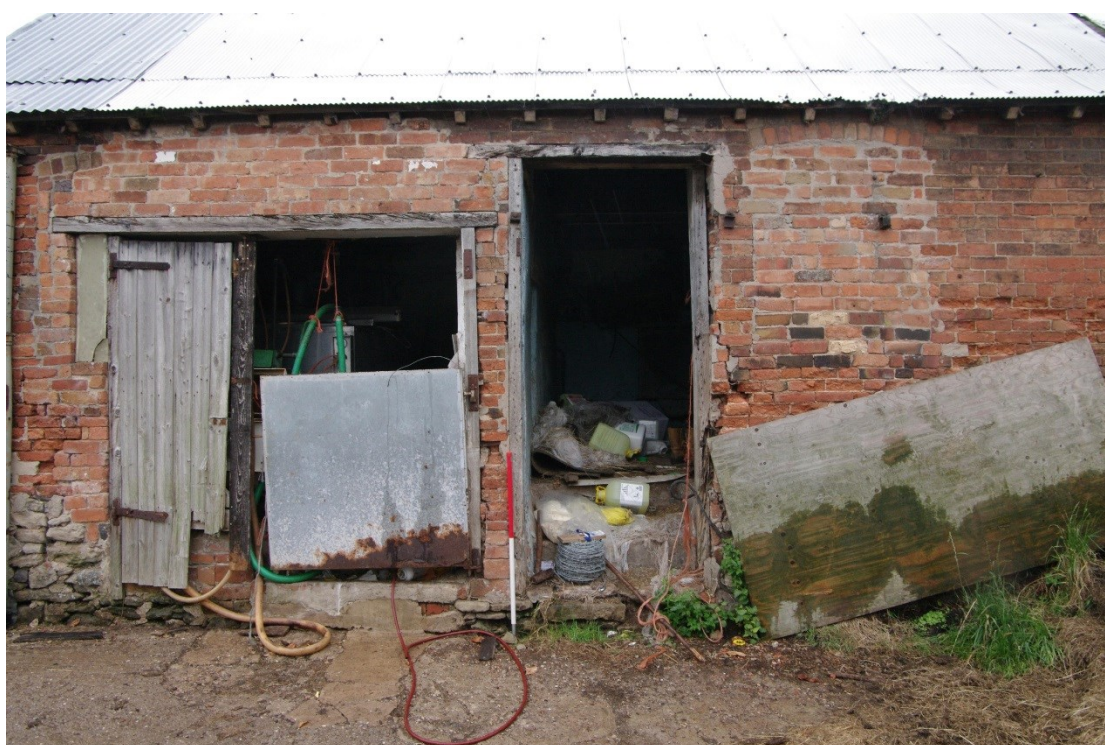
Figure 12: Barn A, western doors on south facing elevation
Looking north. 1m scale. Note modified doors and blocked windows

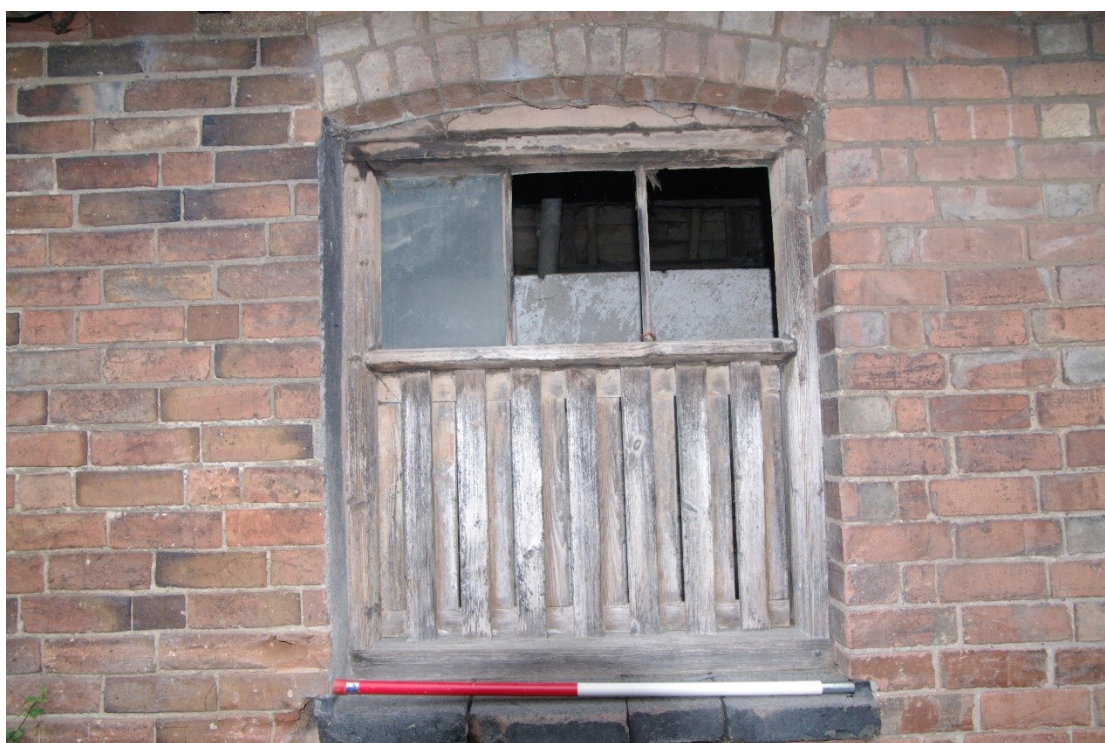
Figure 14: Barn A, south facing elevation window detail
Looking north. 1m scale

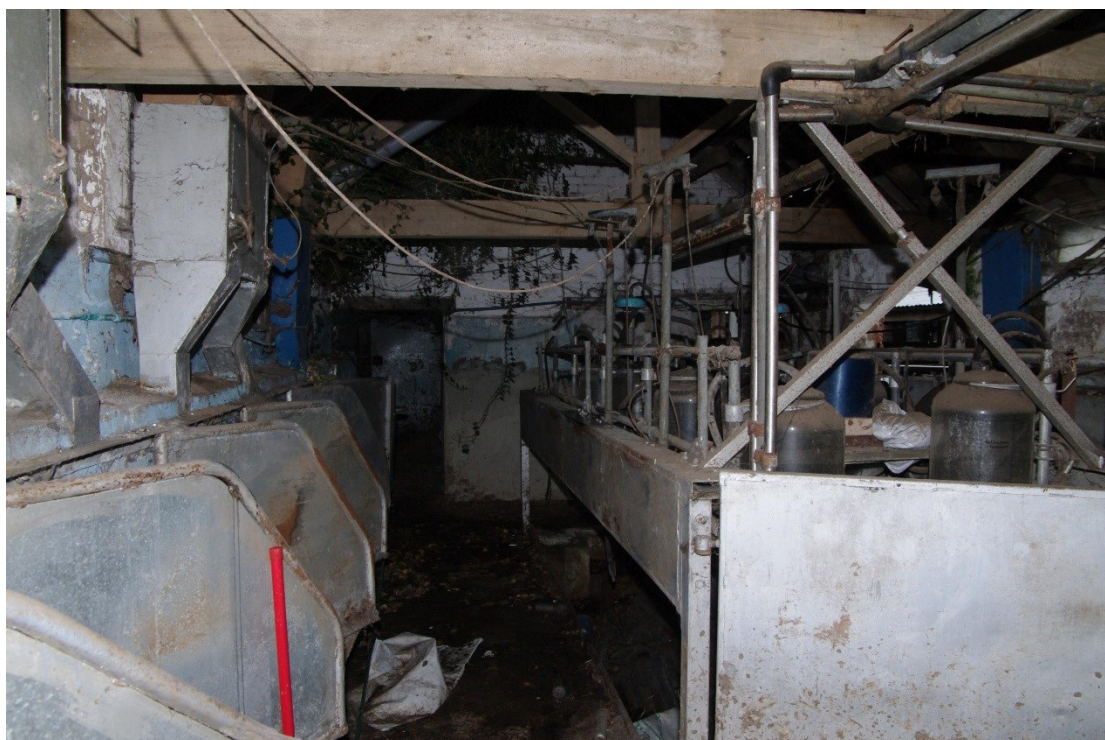
Inside Barn A has a small milking parlour which is no longer in use. The southern arm of the building is currently used as a chicken coup. The roof structure appears to be of mid to later 19th century.

Figure 21: Barn A, milking parlour
Looking east

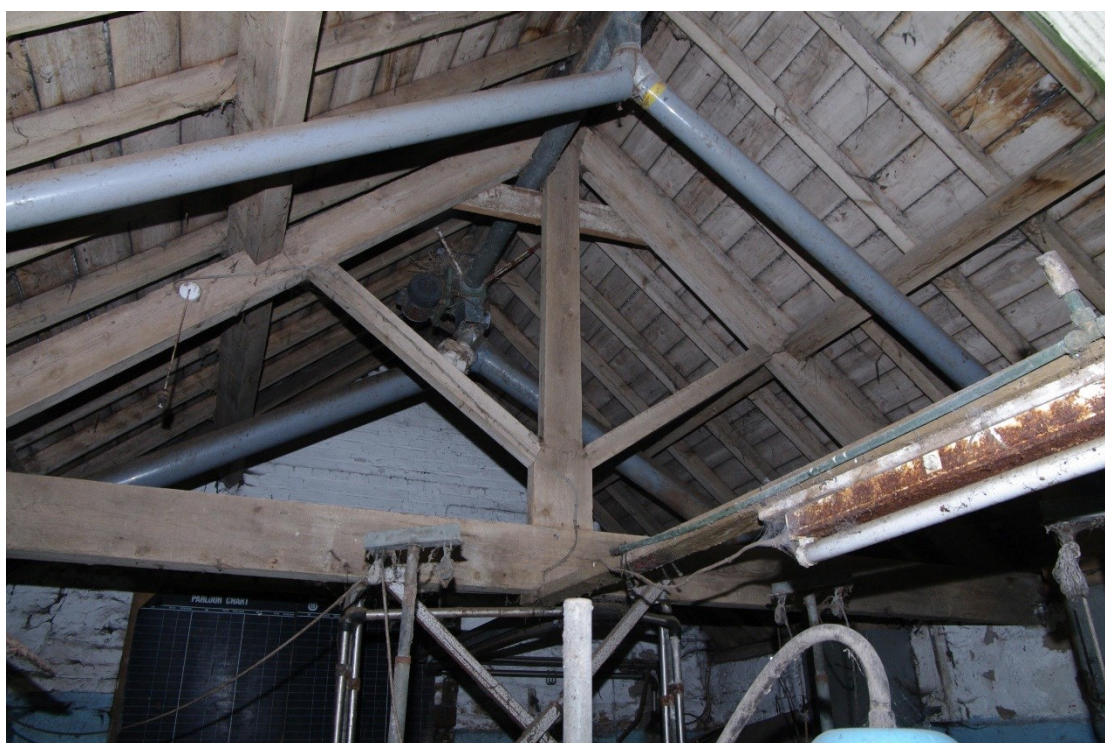
Figure 22: Barn A roof structure in milking parlour
Looking west

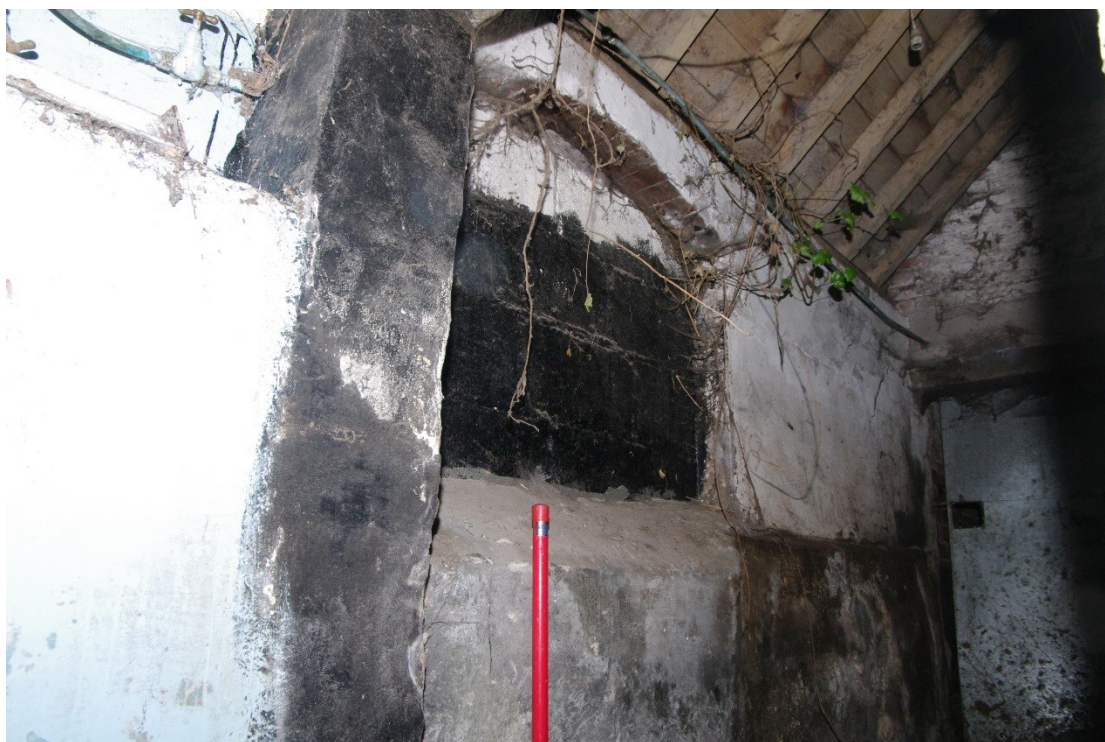
Figure 23: Barn A, blocked window on north wall in silo room
Looking north-east

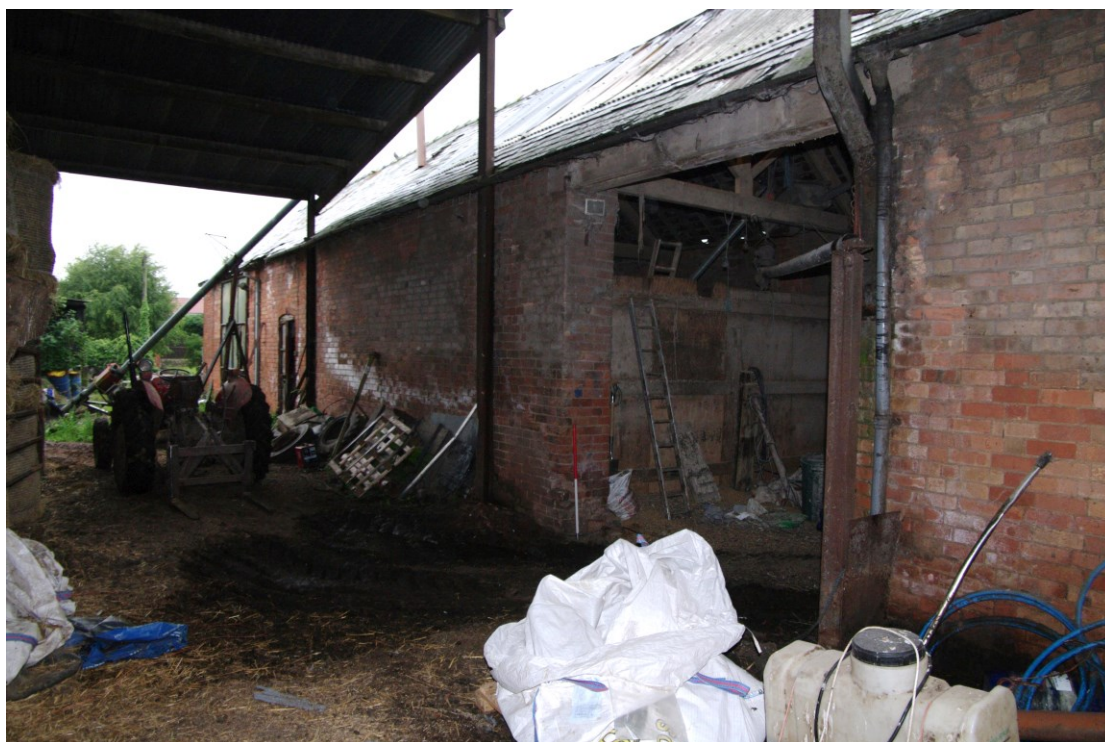
Barn B is built entirely of brick and has a slate roof. The main east to west building has a single storey and has a set of double doors approximately half way along its length and was presumably originally used as a threshing barn. The eastern end of the building has been extended by another brick built building with a north to south axis.

Figure 29: Barn B, south facing elevation (centre portion and threshing doors)
Looking north-west. 1m scale

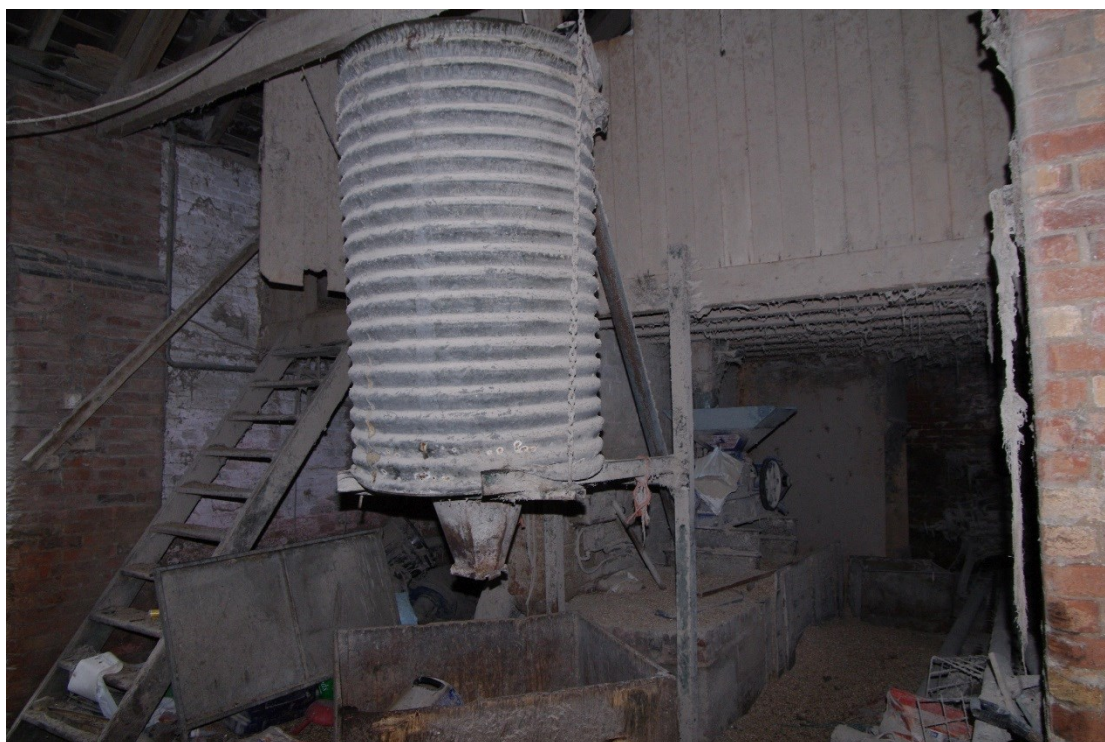
The western end of Barn B houses a workshop and store. To the east of the double doors is a room with a first floor which was associated with grain processing. As with Barn A the roof structure appears to be of mid to later 19th century date.

Figure 39: Barn B, grain processing equipment to east of double doors
Looking north-east. Note wooden steps up to first floor
