**A Historic Building Assessment to
Level 2 at
Welham Lodge,
Cranoe Road,
Welham,
Leicestershire**

ULAS Report No. 2017-155
©2017

Preplanning Application Number: PREAPP/17/00149

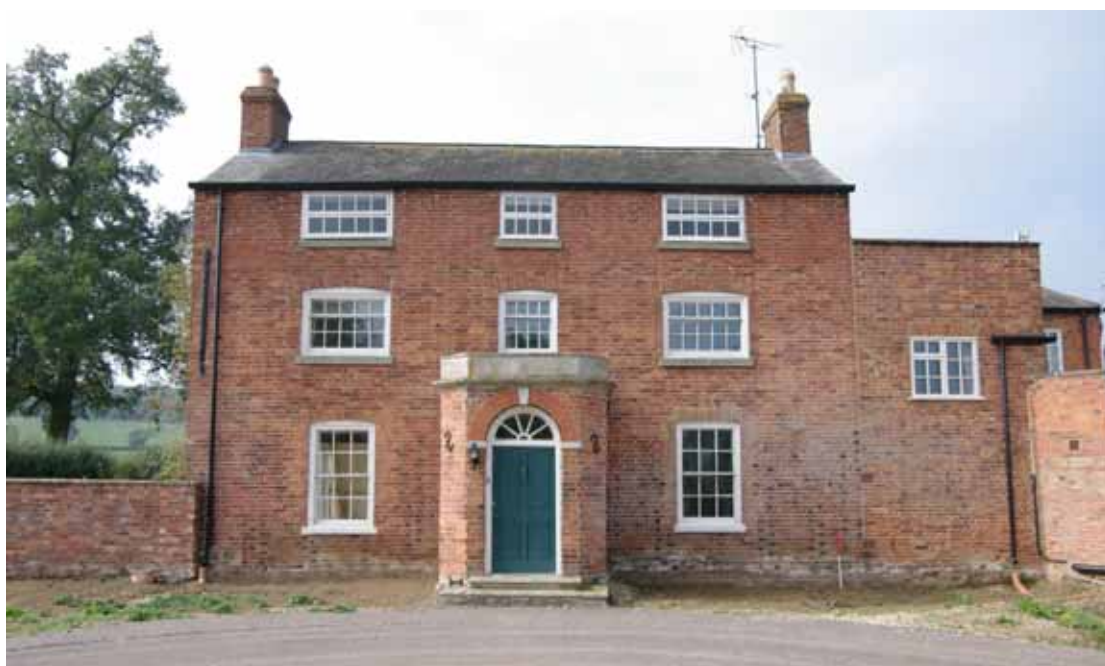
The south-east facing elevation is the principal elevation of the house and is the only elevation which shows the entirety of the original late 18th-century building (Fig. 14). The relatively narrow red bricks are generally laid in courses of three stretchers to one header. The roof has a shallow pitch and is covered with graded Swithland slates. The brickwork around the ground-floor sash windows shows evidence of repointing which suggests that they have been modified at some time (Fig. 15). It is not entirely clear how they may have been modified but could have happened when the porch was added. The ground floor windows, which are not as wide as the first and second floor windows, have six over six pane sash windows without horns which suggests that they date to the first half of the 19th century. The first-floor sash windows are probably 20th century copies as they have multiple panes and incongruous horns. The second-floor windows are casement windows and are also likely to be later copies. They do however form part of the history of this elevation. The refurbishment plan is to replace all of the windows with suitable copies.

Figure 14 South-east facing elevation
Looking north-west. 1m scale. Note butt joint of low two storey extension on right

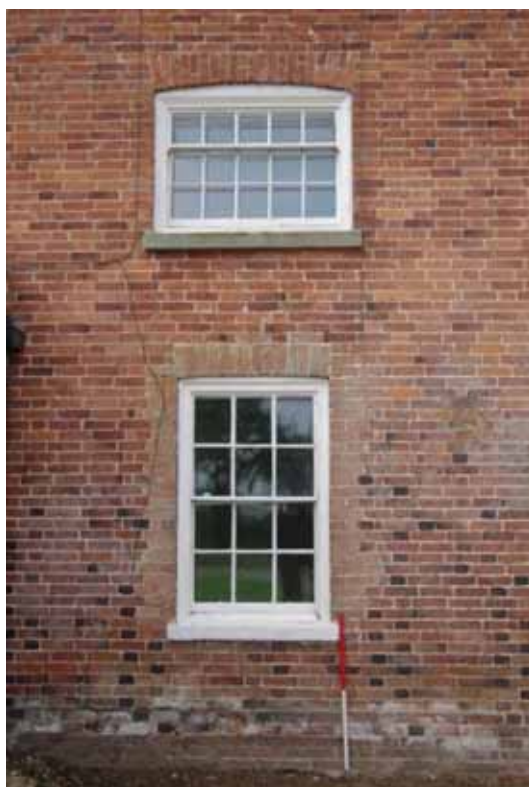
Figure 15 South-east facing elevation ground and first floor window detail
Looking north-west. 1m scale

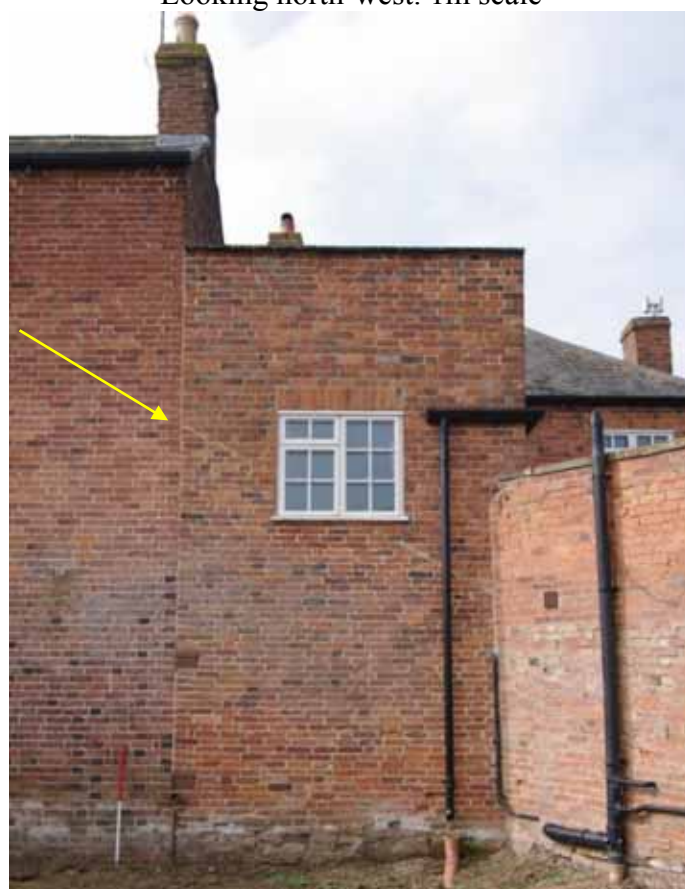
The front of a two-storey extension to the north-east of the house is built flush with the main house but is only butted against it rather than having bonded brickwork (Fig. 16). The extension has a flat parapet on the south-east face masking a lean-to style roof behind it. The ground-floor part of the extension lacks any windows but there is a modern casement window on the first floor. A diagonal line in the brickwork shows where the extension began life as a single storey lean-to which was subsequently raised to create a two-storey structure. The ground-floor brickwork uses quite narrow bricks suggesting a relatively early construction date, perhaps even quite early in the 19th century. The first-storey brickwork uses larger bricks although is still probably mid-19th century. The proposal is to remove this extension and replace it with a slightly larger two-storey structure which will be set back from the main house façade. The advantage of the butt joint is likely to suggest that removal of the extension will cause minimal damage to the remaining brickwork.

Figure 16 South-east facing elevation extension
Looking north-west. 1m scale. Arrow indicates the original height of the extension
and its subsequent raising

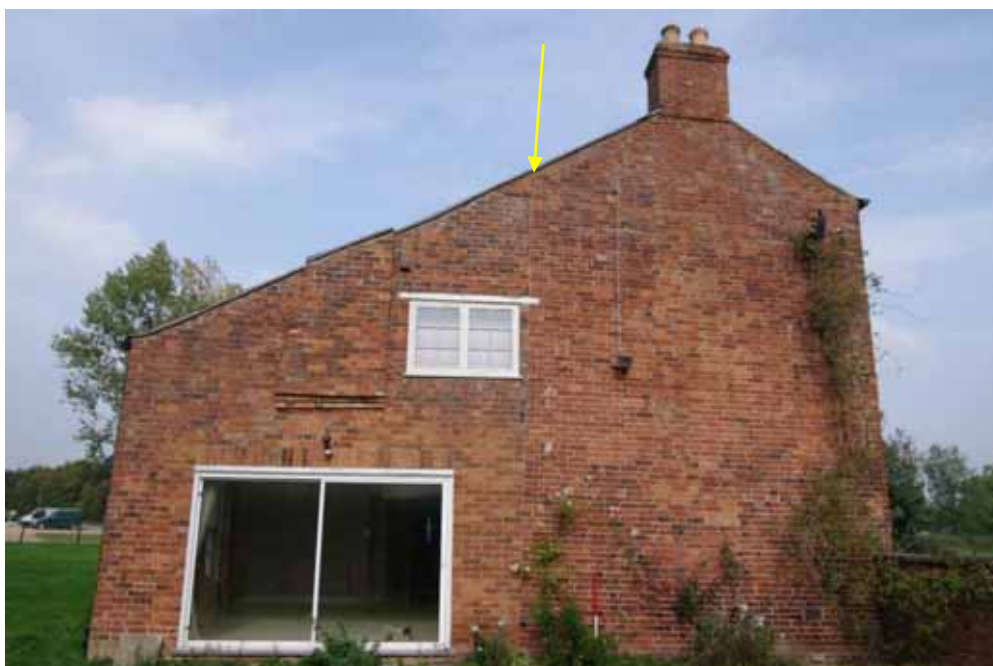
The gable end of the original house on this elevation contains no windows (Fig. 17). The brickwork matches the brickwork on the south-east facing elevation. There is evidence of a repair in the brickwork in the form of a straight joint (Fig. 18). The repair does not appear to be a blocked window and may be a settlement repair of the brickwork.

Figure 17 South-west facing elevation
Looking north-east. 1m scale. Arrow marks joint of original house and rear extension.
Note also truncated chimney stack over modern French windows

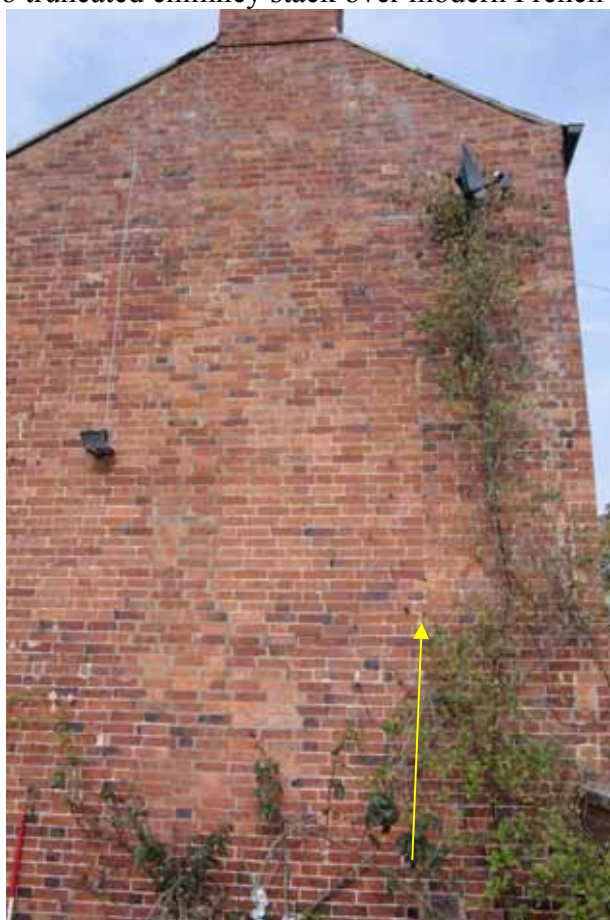
Figure 18 South-west facing elevation
Looking north-east. Arrow points to joint/repaired brickwork

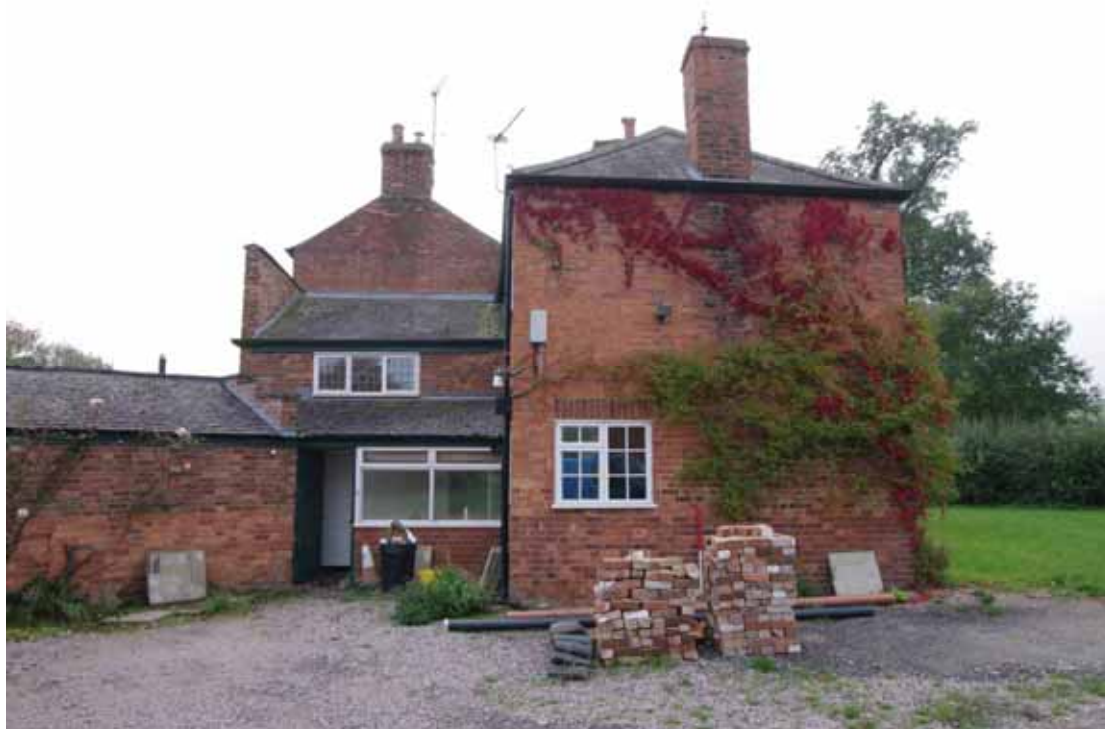
The north-east facing elevation shows the gradual development of the buildings with the flat gable end of the original house with the two storey extension butting against its northern wall (Fig. 21). From this side of the building the flat-topped south-east facing parapet can clearly be seen screening the sloping roof of the extension.

Figure 21 North-east facing elevation
Looking south-west. 1m scale. Original house on left. Note parapet wall in front of
lean to extension. Outbuilding on far left

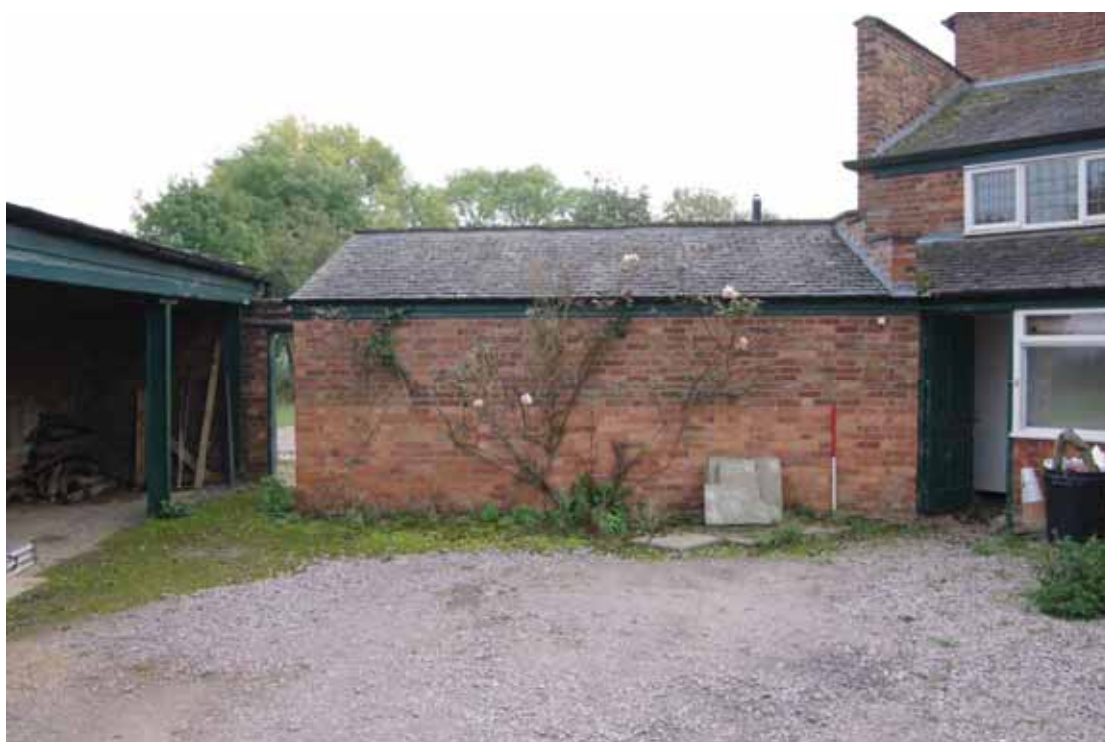
Figure 28 Outbuilding, north face
Looking south. 1m scale. Note upper rebuilt/extended wall (at top of scale)

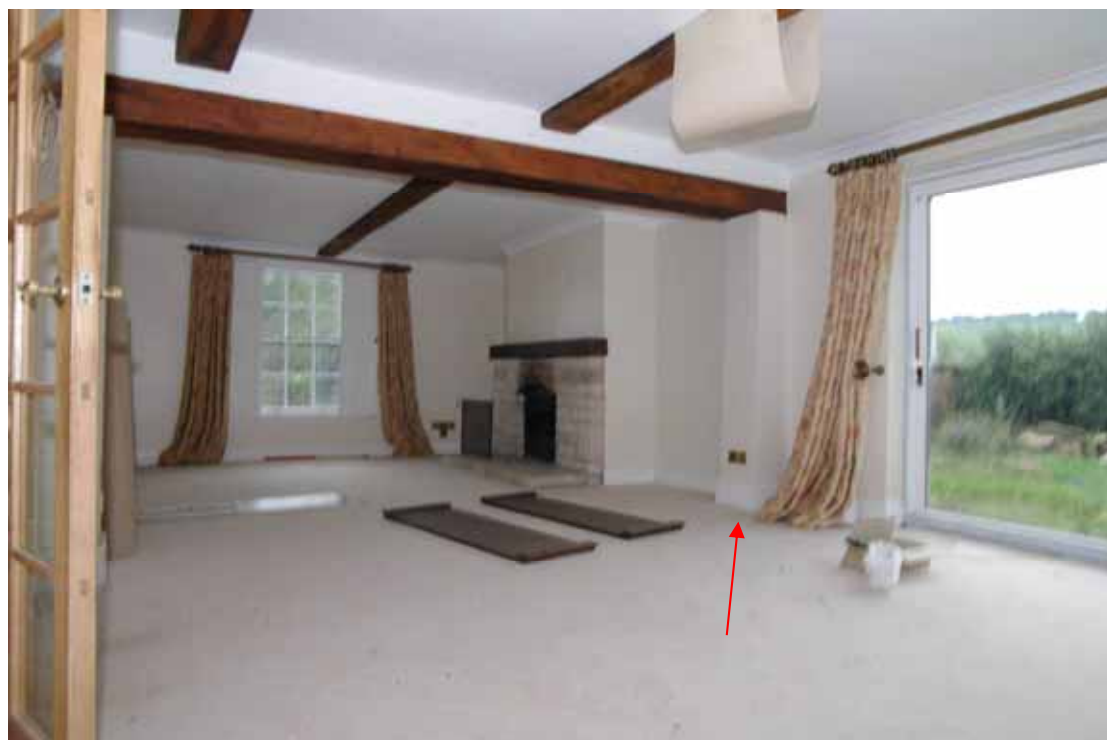
Room G1 is one of the original rooms although it has undergone extensive modifications (Fig. 29). One of the most significant alterations has been the knocking through of the rear, western, wall to create a large combined room with G2. The Wall at this point is supported by a boxed-in beam. It is possible that the boxing hides a modern RSJ but this cannot be stated with any certainty. A north-west to south-east timber beam supports the ceiling. This is surprisingly plain and may be a later addition or replacement. The fireplace has been remodelled and has a late 20th-century surround probably added when the wall was knocked through. This will be replaced in the planned refurbishment. The skirting board is quite low and probably of 20th-century date as is the plain cornice.

Figure 29 Room G1
Looking south from Room G2. Back wall line of original house is arrowed

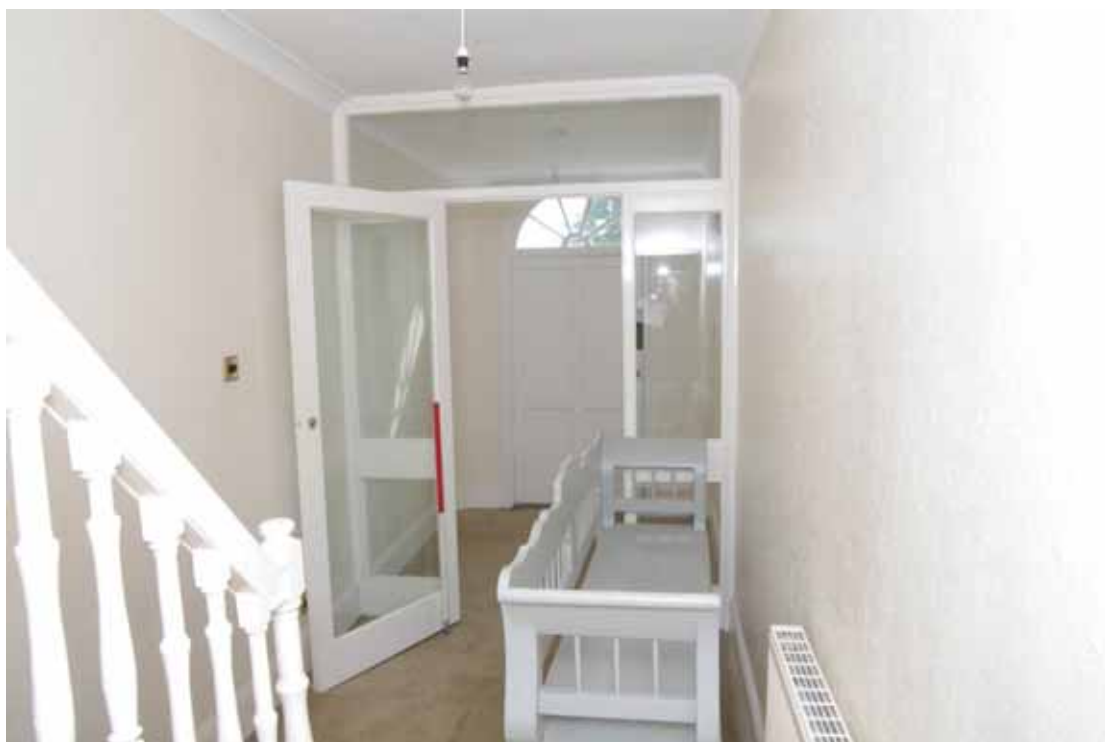
on the wall plaster of any blocked doors. A modern wood and glass doorway and surround leads into the front porch and dates to the second half of the 20th century (Fig. 34). This will be removed. The front door, which is of early to mid-19th century design may be replaced with a modern facsimile.

Figure 34 Room G3 hallway and porch
Looking south-east. 1m scale. Modern doorway marks the start of the porch

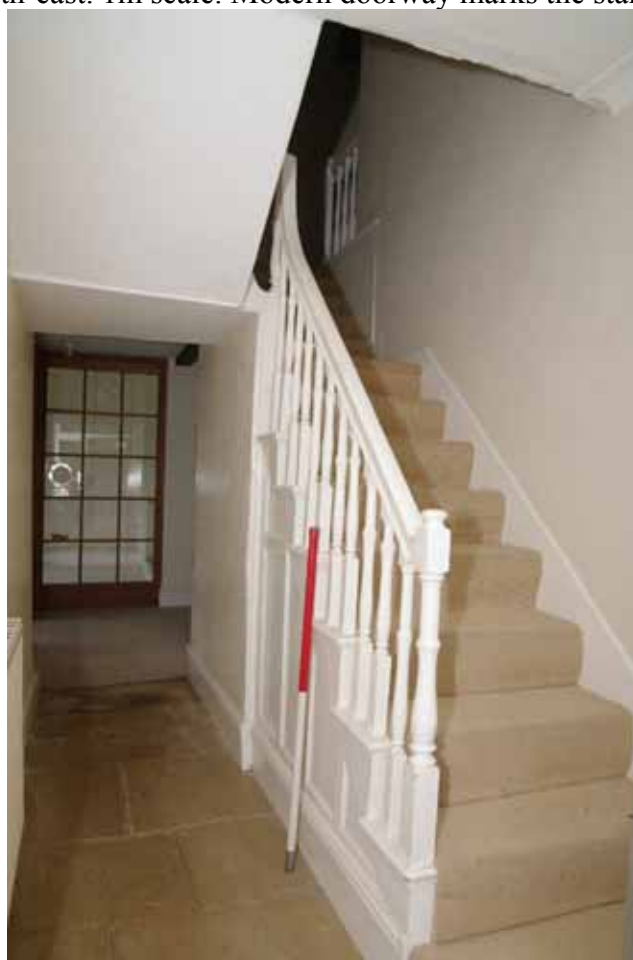
The staircase balusters are quite graceful and are likely to be original (Fig. 35). No changes are proposed to this.

Figure 35 Room G3 stairs
Looking north. 1m scale

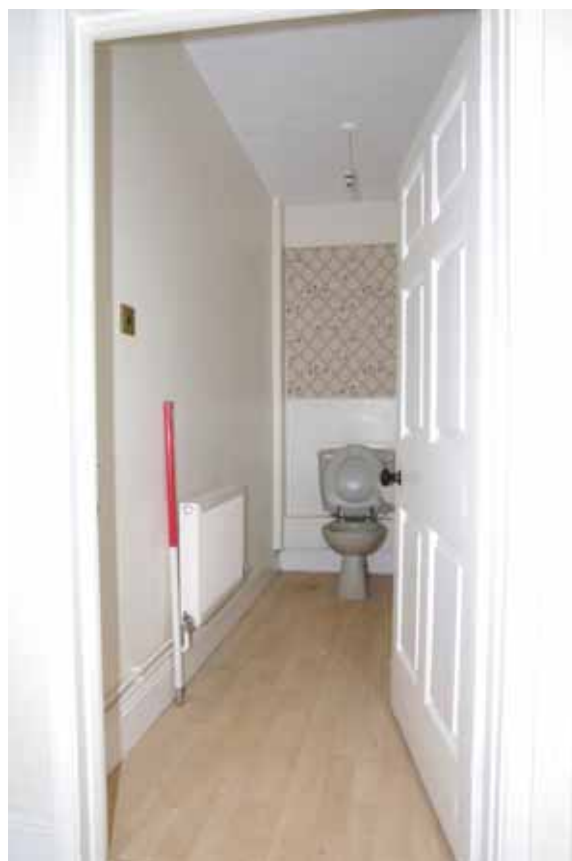
Figure 36 Room G4

Looking north-west. 1m scale resting against wall which will be removed

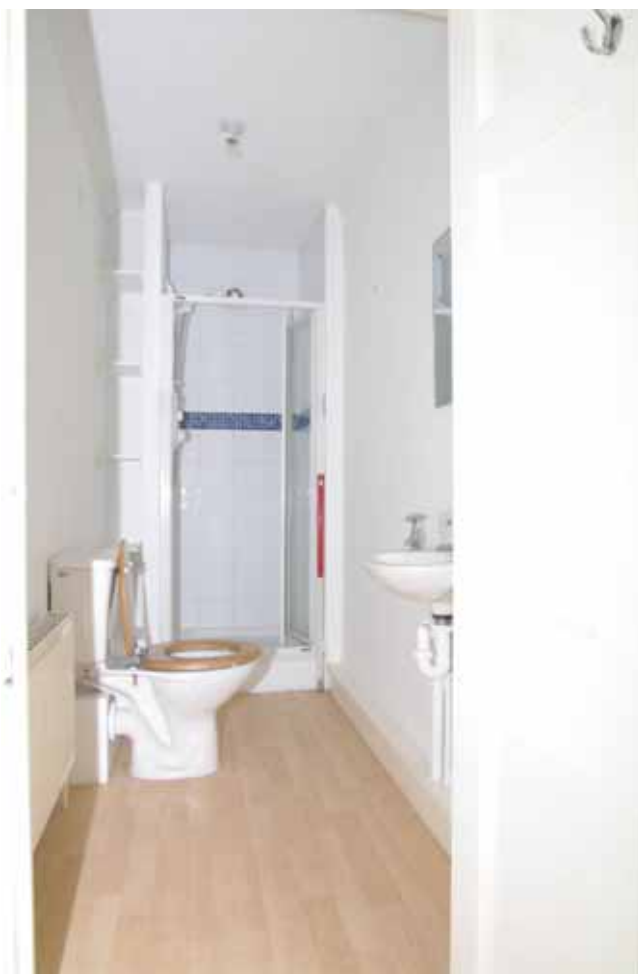
Figure 51 Room F5
Looking north-west. 1m scale. Blocked window behind shower tiles

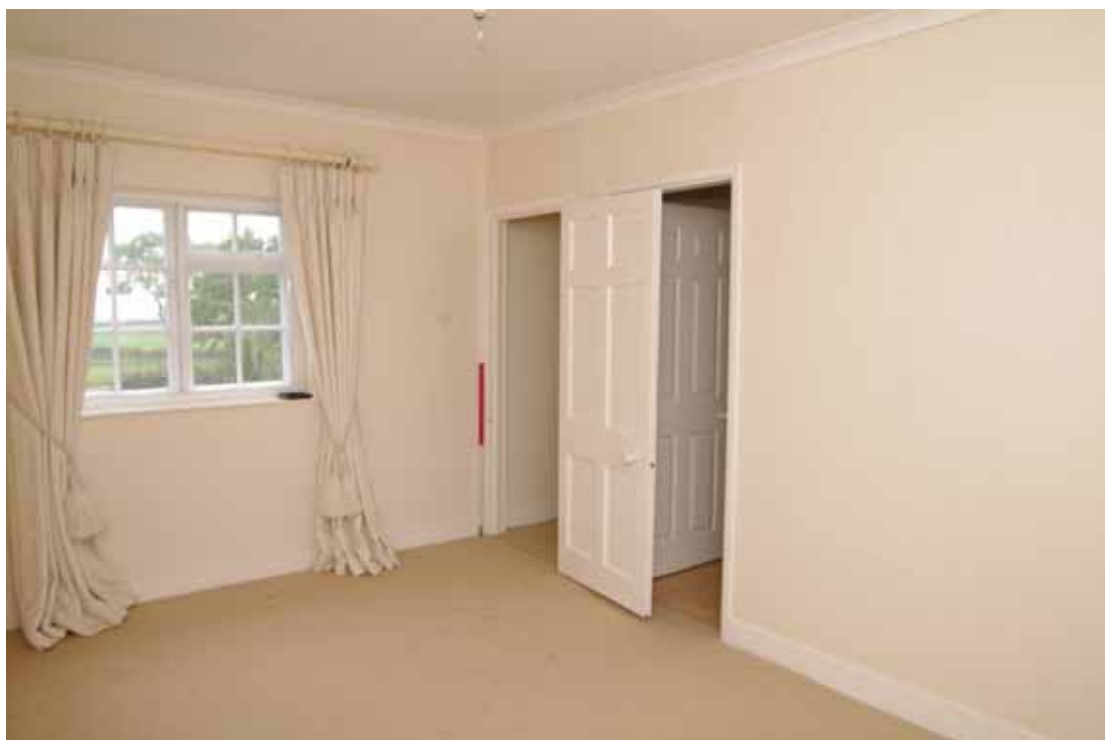
Figure 55 Room F10

This room is the end room of the later 19th-century extension and uses F9 as its bathroom. As with most other doors on this floor it has a 19th-century panelled door to the corridor but the door into Room F9 is a modern copy (Fig. 55). The casement windows are also modern. Under the proposals the southern corner of the room will be modified to incorporate the remodelling of Room F9. A small chimney breast on the north-east wall will also be removed which will result in the loss of the stack seen on the hipped roof outside as noted earlier. The window on the north-west wall may be repositioned slightly and the window on the north-east wall will be altered to a doorway to gain access into the proposed new extension.

Looking south. 1m scale. Doors and wall to be removed and realigned. Left door leads to corridor, right door to Room F9

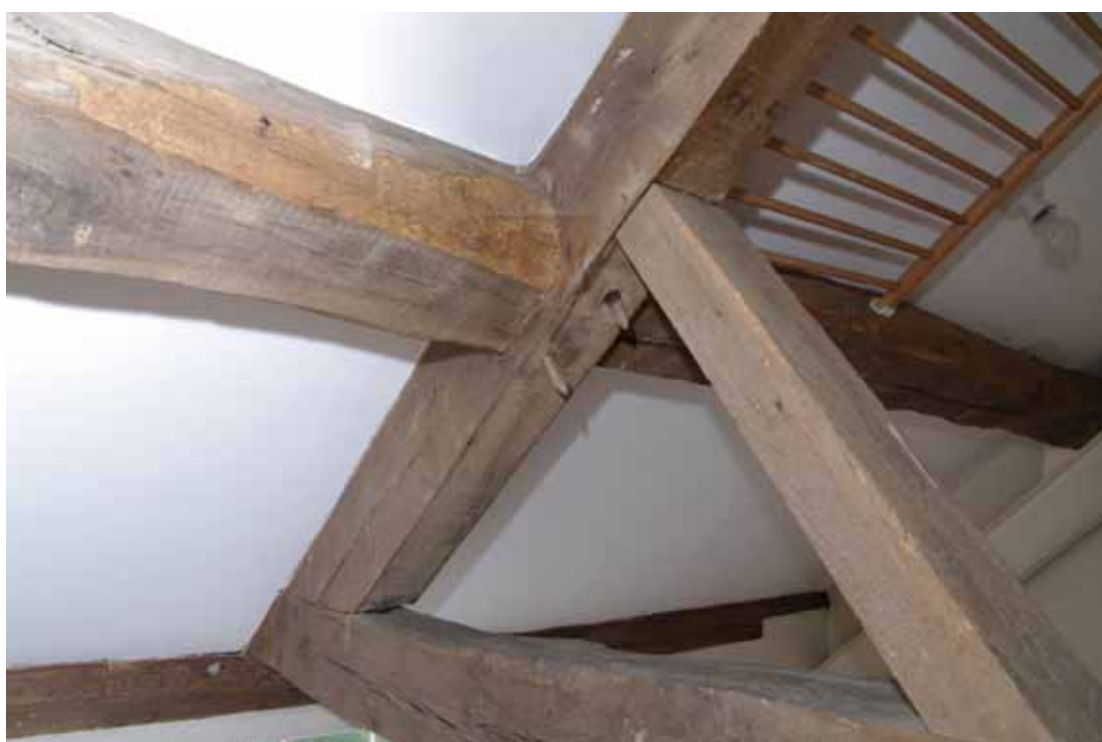
Figure 59 Second floor, detail of pegged roof timbers
Southernmost truss. Note steel inserted to support the corner of the roof.
