An Historic Building Survey at the Former War Memorial Hospital, Ankle Hill, Melton Mowbray, Leicestershire.

For: Sowden Developments

Date:06.04.2016. Revised 08.07.2016

ULAS Report Number 2016-063v2 ©2016 Accession Number X.A25.2016

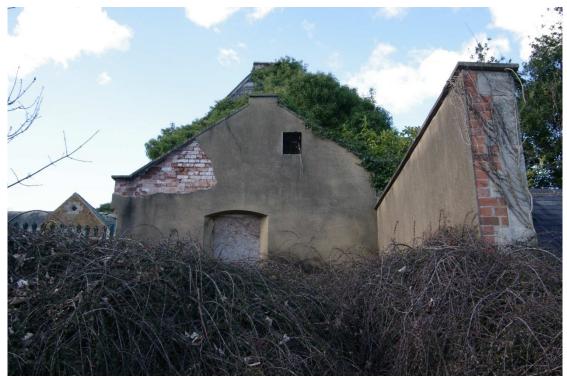
Figure 158 Stable block, east facing elevation of gatehouse room Looking west. Note brick and stone wall on right which is all that remains of the demolished east range

Most of the east range of the stables has been demolished as discussed earlier. However, a window on the east side of the entrance gateway room shows where this was once attached to the east range (Fig. 158). The wall has been rendered but damage to the render shows that the wall is built of brick and was once therefore an internal wall. The height of this wall has also been modified to form a parapet which seals the ends of the roof. The remnant of the north wall of the east range can also be seen at this point (Fig. 159). This wall has an outer skin of ironstone with an inner skin of brick and appears to have been retained because it forms the south end wall of the 1930s brick shed discussed above.

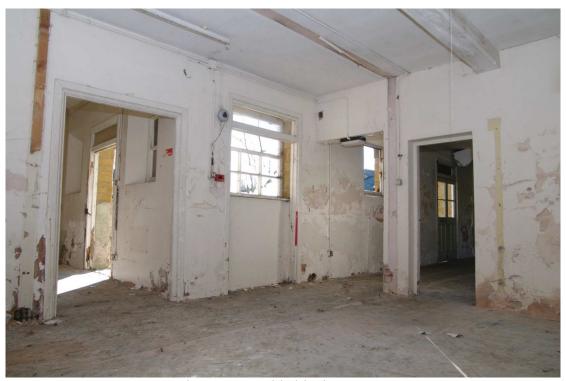
Figure 167 Stable block Room D
Looking south-east. 1m scale. Blocked doorway to left of scale. Knocked through doorway on right

doorway which appears wide enough to allow a horse to enter which suggests that this range housed the stable loose boxes (Fig. 167). The south wall of the room has two doorways into Room E, the original being the easternmost. The second doorway has been knocked through the masonry wall to give access into Room E without needing to go into the corridor created by the plasterboard partitions.

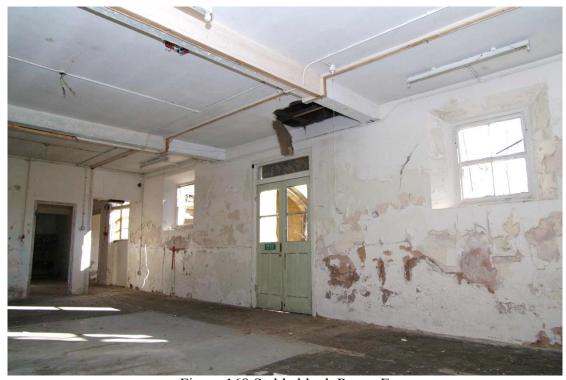
Figure 168 Stable block Room E
Looking north-east. 1m scale. Hole in ceiling above doors shows the location of the hayloft trapdoor

Room E has had its modern plasterboard partitions removed to reveal its original size which extends for three window bays (Fig. 168). This was presumably the room where the majority of horse loose boxes were located. Two east to west stop-chamfered timber beams support the ceiling. A partial collapse of the plasterboard ceiling near to the courtyard double doors has exposed the underside of a wooden hatch which appears to have been the hayloft door.

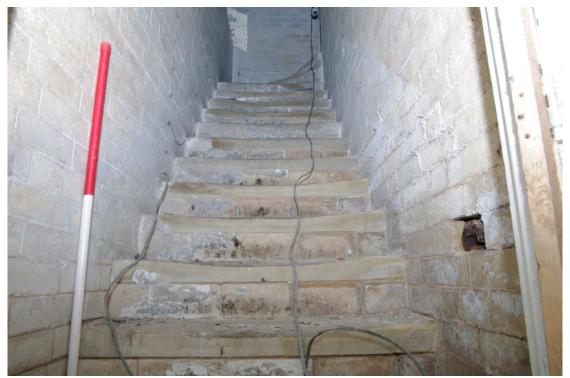
Figure 170 Stable block staircase Looking west. 1m scale

To the south of Room F is a set of narrow stairs leading up to the first floor (Fig. 170). The stairs have well-worn stone treads with yellow brick risers and turn at the top. They appear to have had a door at their base although this may be a later addition.

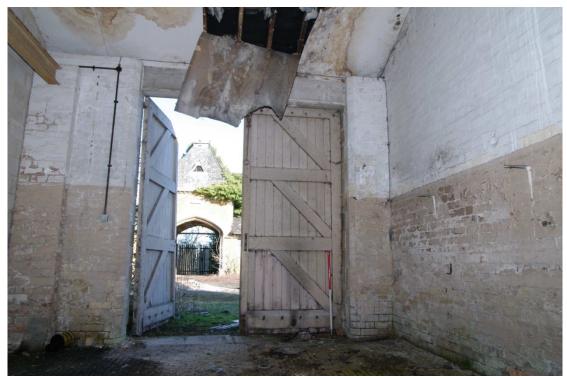
Figure 176 Stable block Room K Looking north. 1m scale

This room was original part of a larger room with Room J before it was subdivided by the insertion of a breeze-block wall. It retains its double doors on the north wall which have chamfered brick pillars at each side (Fig. 176). The lintel above the double doors on the north wall appears to be a modern concrete replacement. The floor is laid with narrow yellow bricks set in a geometrical pattern centred on a drain in the south of the room (Fig. 177). The east wall is built of brick and appears to be part of the original design. The roof structure is supported on a steel I-beam and consists of a king post with two queen posts supporting truncated principals and purlins (Figs. 149 and 178). It is not clear if this is a modification although the use of steel beams in Wyndham Lodge suggests that this may be part of the original structure.

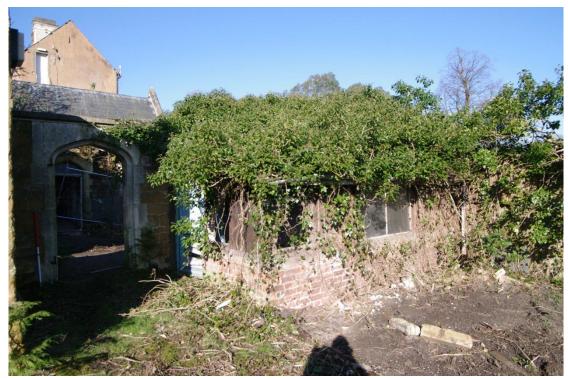
Figure 192 Outbuilding built into the corner of the garden wall Looking north-west. Gable end of Wyndham Lodge service range on left

Close to the western end of the garden wall a brick and timber outbuilding has been inserted into the corner where it turns south (Figs. 192 and 193). The timberwork has floral decorations and may have begun life as a small summer house. The roof structure rests on a row of projecting stone corbels built into the wall suggesting that the building is part of the original layout. The first edition 1886 OS map appears to show a similar sized structure in this location. Other projecting stone corbels on the south side of the garden wall may indicate where the glass houses shown on the early OS map were once located.

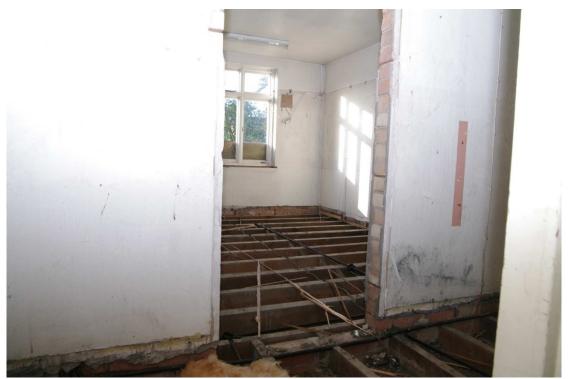
Figure 209 Nurse's home, first floor Looking south-west from top of stairs

As noted earlier all of the floorboards have been removed on the first floor and a number of floor joists have rotted through (Fig. 209). This prevented a detailed inspection of this floor but a cursory look indicates that it is virtually the same as the ground floor. However it is not known where the stairs to the attic room with the dormer window over the entrance are located.

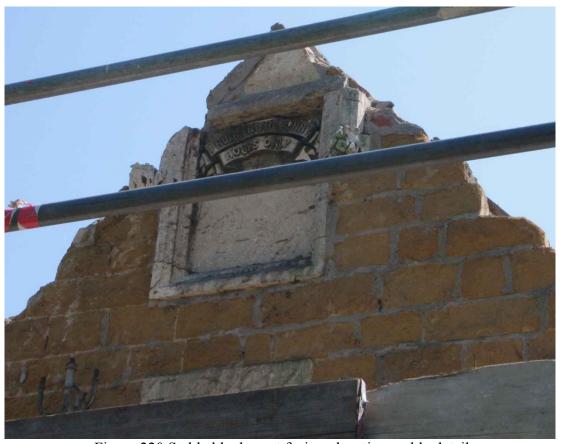
Figure 220 Stable block west facing elevation, gable detail

As noted, at the time of the June visit the stables are much as seen in February 2016. However, the removal of the ivy has given the opportunity to take some less-obscured elevation photographs of the north and west facing elevations (Figs. 218 and 219). The largest gable on the west facing elevation appears to have held a sundial as a small stone plaque in the apex has the following motto *I NUMBER THE SUNNY HOURS ONLY* (Fig. 220). There is no trace of the sundial face or gnomon.
