**An Historic Building Recording at
The White Lion Inn,
1 High Street,
Moulton,
Northamptonshire.**

ULAS Report No. 2016-104
©2016

For: Fernbrook Builders Limited

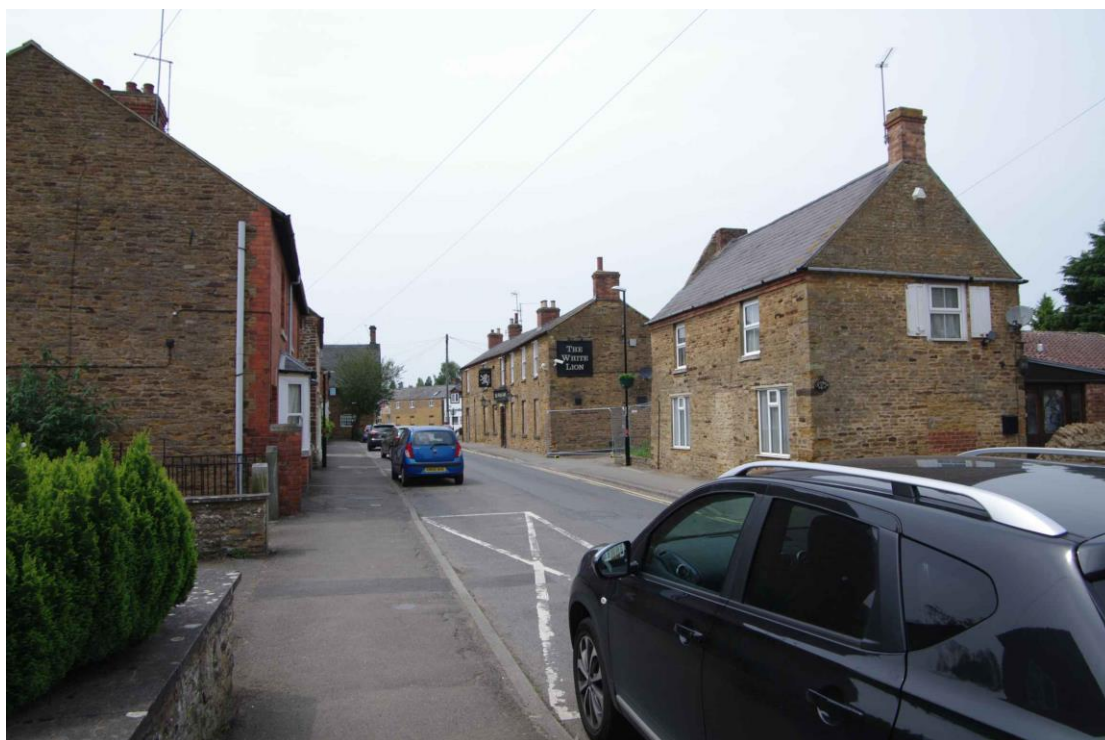
Figure 6 The White Lion seen from High Street
Looking north-west

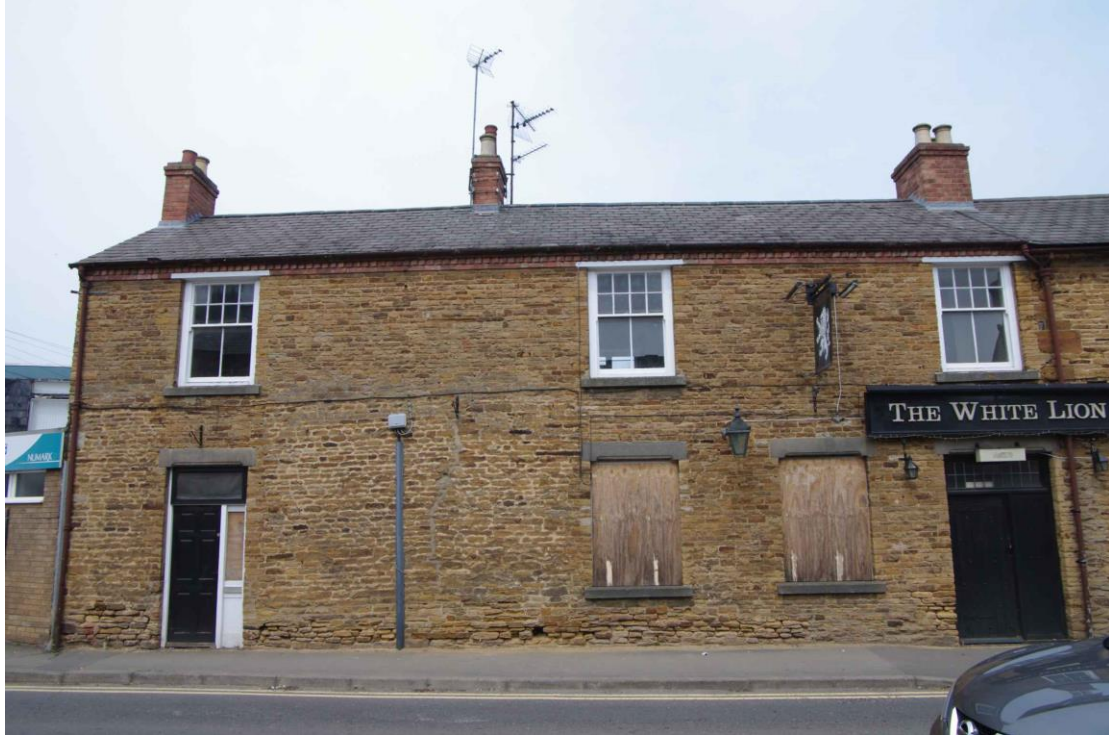
The south facing elevation is the principal frontage of the main buildings which face out onto High Street (Figs. 9 and 10). The street frontage follows the angle of the road and has a pronounced change of alignment to the east of the main entrance doorway where there is a clear joint between the eastern and western sides of the building. At this point large ironstone quoins can be seen at first floor level which form the corner of the eastern component of the inn (Fig. 11). The quoins have been removed at ground floor level and the wall has been rebuilt around the door which suggests that this is a later modification. A brick-built chimney at the ridge of the slated roof appears to straddle the two buildings. The main entrance door lintel is stone, or reconstituted stone, and matches the lintels above all the ground floor windows which again suggests a wholesale remodelling of the frontage at the same time. The first floor sash windows have wooden lintels set just below the eaves. The sash windows have two lower panes and multi-paned upper sashes with horns which indicates that the wooden components at least are likely to be later replacements. The eastern part of the frontage has three windows at ground and three at first floor level which are all set at regular intervals.

Figure 9 South facing elevation (west end)
Looking north

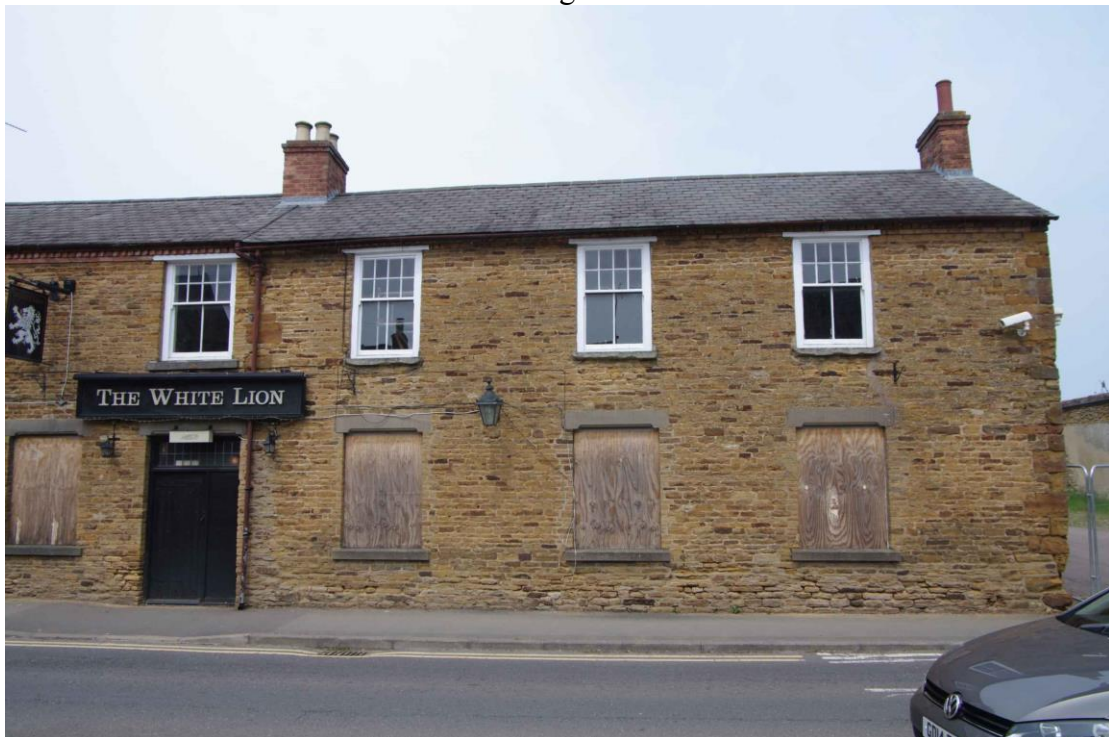
Figure 10 South facing elevation (east end)
Looking north

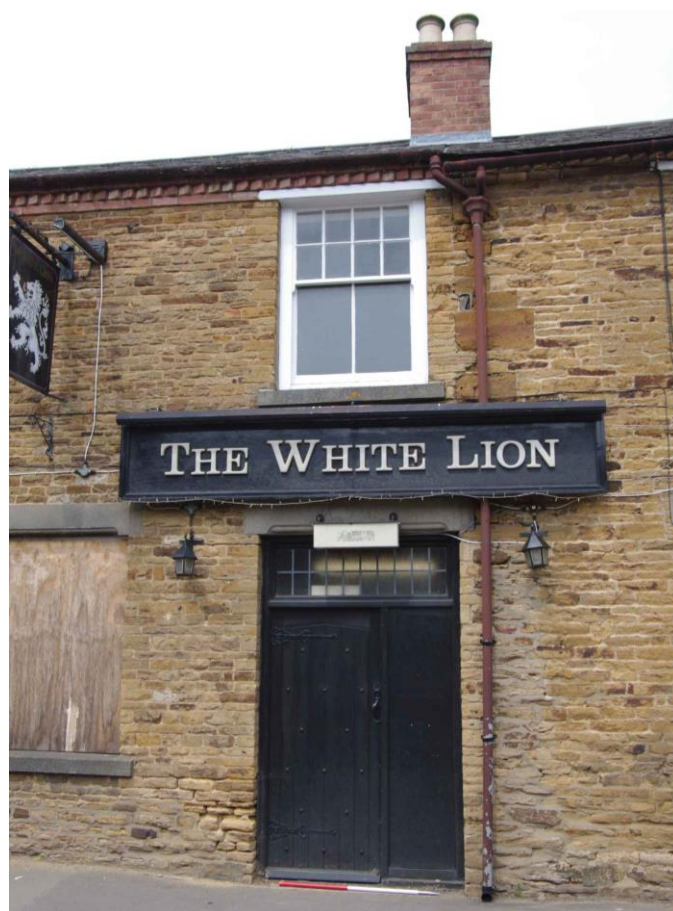
The western part of the south facing elevation has windows and doors set at irregular intervals to respect the internal layout of the building despite having windows and doors built in the same style as on the east side. A repaired crack in the stonework can be seen below a chimney stack which represents the junction of a substantial internal wall. The area around this crack has been heavily repointed but there is no clear evidence of any other blocked or modified openings. Partially hidden by a modern lamp at ground floor lintel height is a square block of dressed stone with a trace of initials and a date which possibly ends in the numbers 76 (Fig. 12).

Figure 11 South facing elevation, joint between east and west portions
Looking north. 1m scale

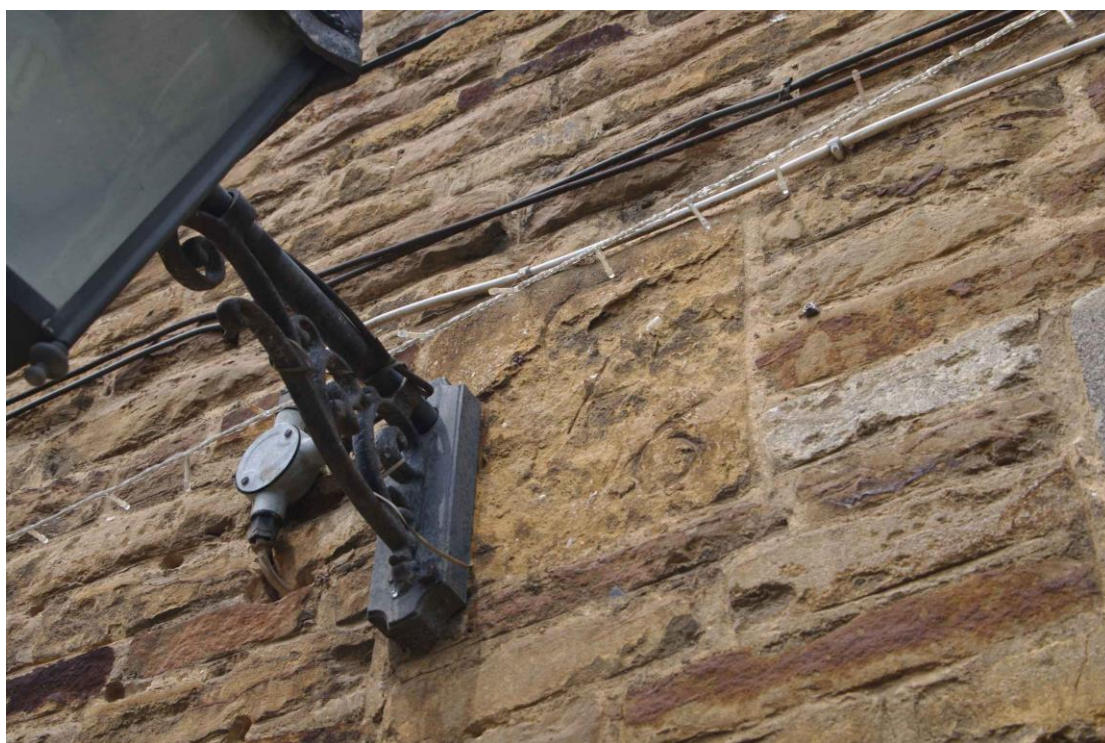
Figure 12 South facing elevation (west side) date stone

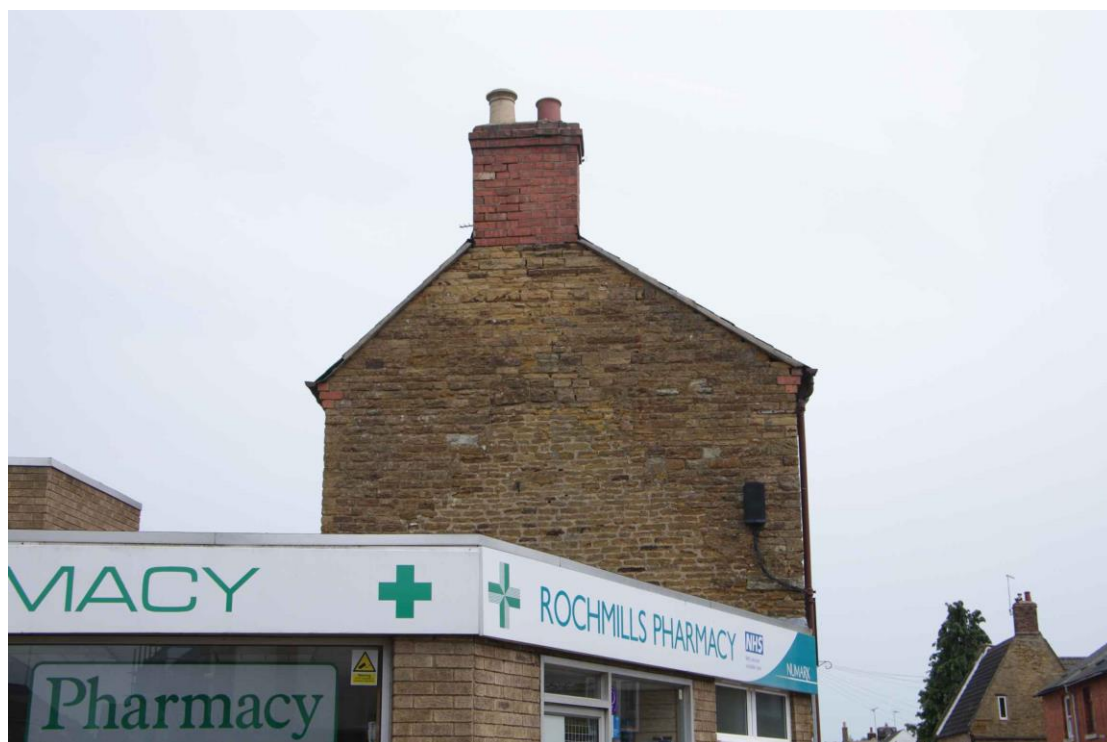
The west facing elevation is obscured at ground level by a modern pharmacy building although the first floor and the apex of the flat gable end can still be seen (Fig. 7). The pitch of the roof is unequal on the north and south sides which may indicate a rebuilding or modification of the roof (Fig. 13). The chimney stack is brick-built and sits at the top of the ridge. A trace of slightly less weathered stone forming the outline of a single storey gable-ended building can be seen on this elevation showing where a later building has been removed to make way for the present modern building.

Figure 13 West facing elevation
Looking east. Note trace of single storey gable end above the pharmacy building

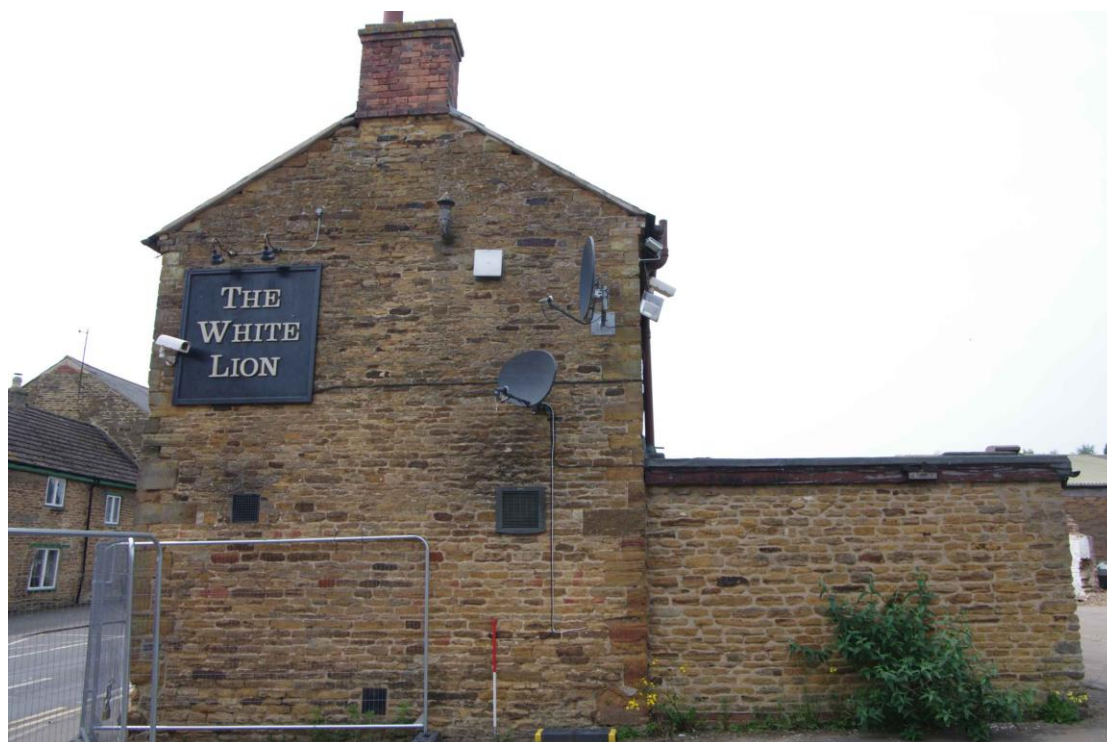
The east facing elevation is built of ironstone and shows no evidence of any blocked or modified openings with the exception of some modern air extraction vents (Fig.14). Large blocks of dressed ironstone have been used as quoins in the same way as seen at first floor level on the south facing elevation. The brick-built chimney stack sits astride the ridge. To the north of the gable end a single storey extension has an ironstone facing on top of brick foundations. This extension is the one seen on the 1977 Ordnance Survey map which extends the 1964 rear extension.

Figure 14 East facing elevation
Looking west. 1m scale

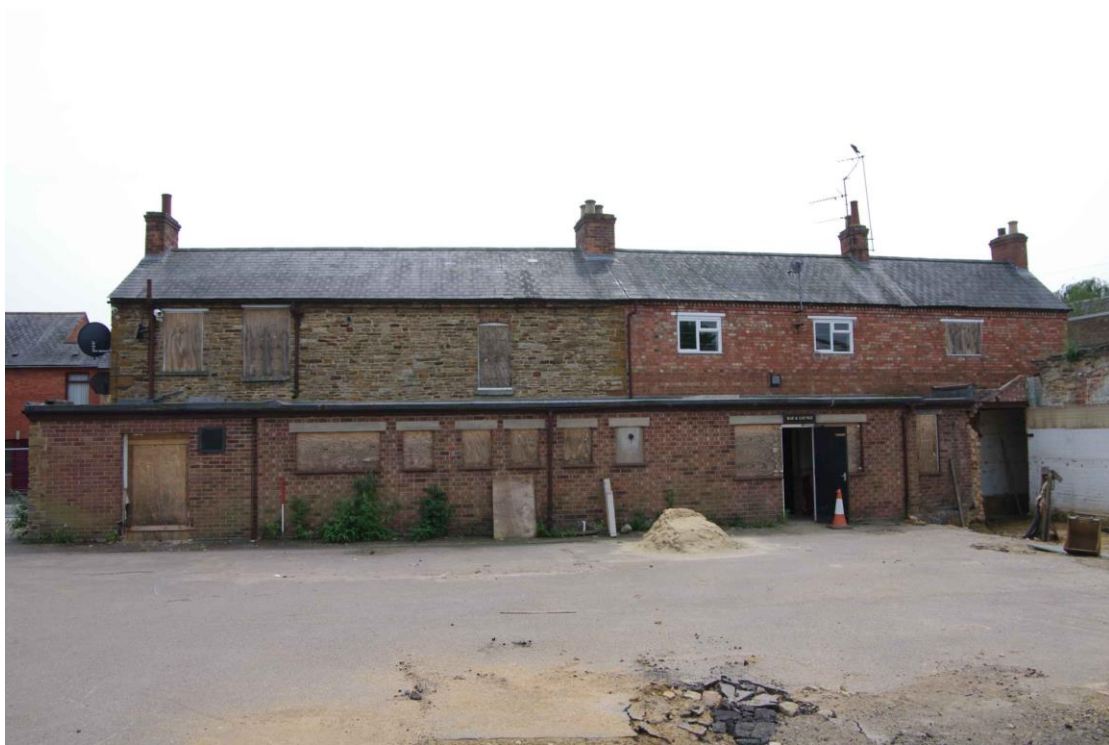
The ground floor of the main building is obscured by a single storey brick-built extension (Fig. 15). The brick extension has a flat roof and has a clear line where it was extended to the east at some time between 1964 and 1977 (Figs. 15 and 16). The ironstone skin of the extension only partially wraps around the wall from the east side to the north. At the extreme western end of the extension the single storey block steps back slightly and it can be seen that the modern brickwork sits on earlier ironstone foundations. Similarly, as the wall returns towards the main building it is built from a mix of stone and brick on earlier stone foundations.

Figure 15 North facing elevation
Looking south. 1m scale. 1970s extension to left of ranging pole. Demolished
outbuildings on right of picture

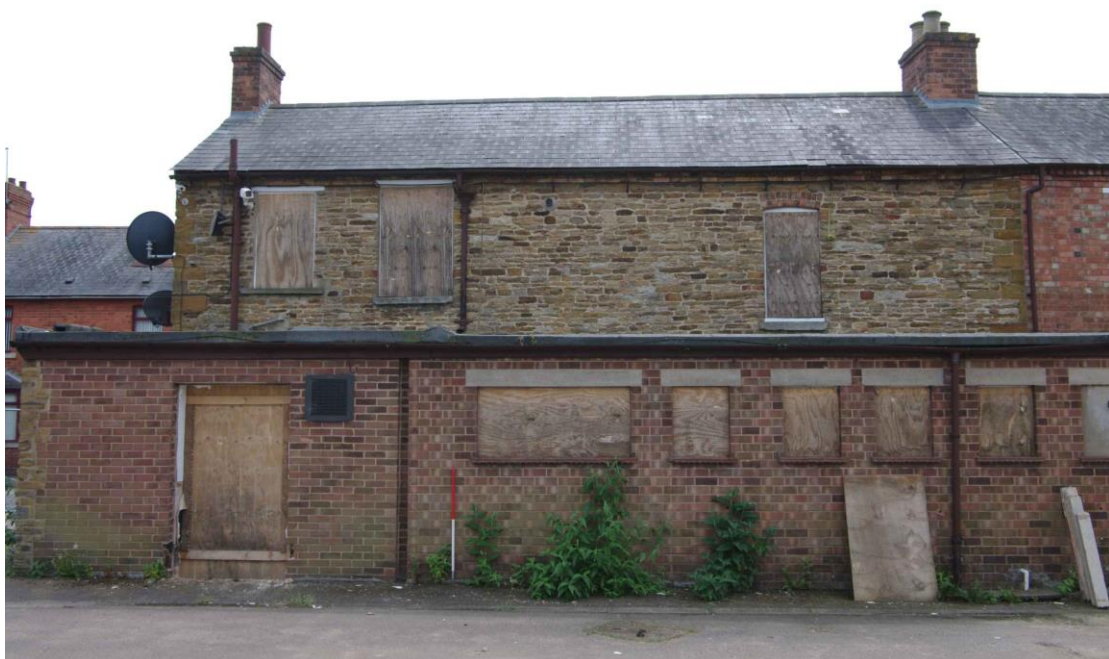
The first floor wall of the eastern half of the main building is built of coursed ironstone rubble and has large ironstone quoins at each corner as seen on the south facing elevation. The east part of the wall has two flat-headed windows (boarded over) with stone or concrete sills very similar in style to those on the front south facing elevation. One of the windows is long enough to be a doorway and may have been modified from a smaller window. A door, which is presently used as a fire escape, has two courses of arched bricks at its head and may also have been extended from a former window.

Figure 16 North facing elevation, east portion
Looking south. 1m scale

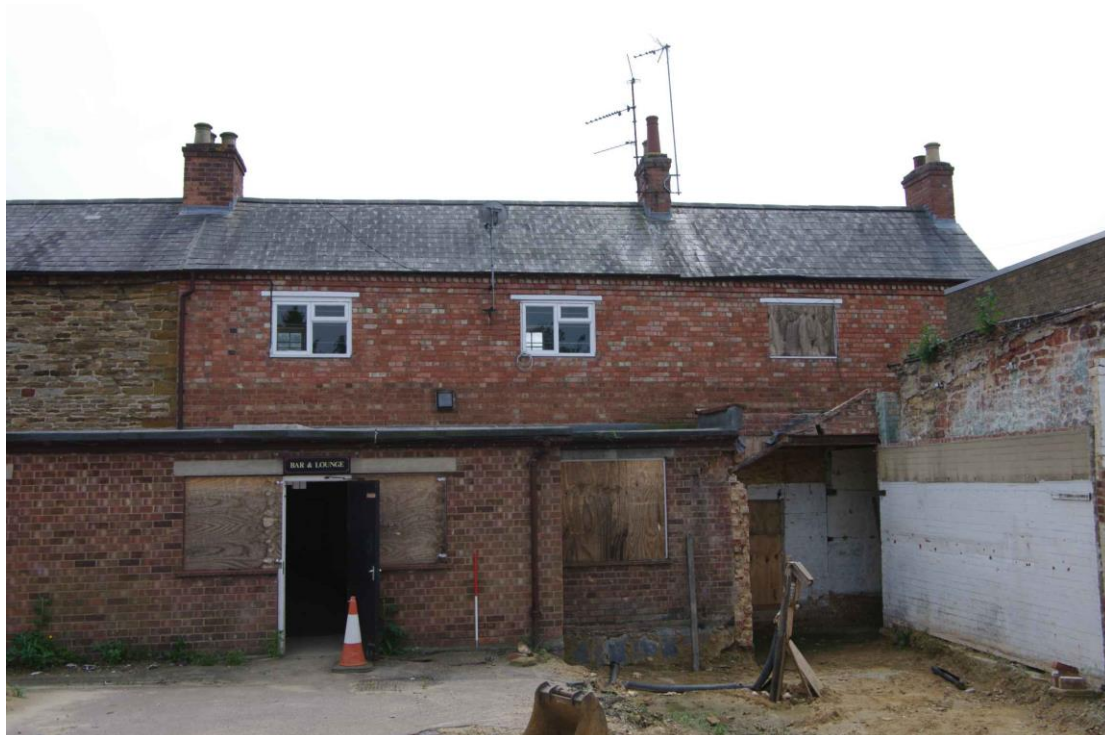
The angle of the north facing elevation changes slightly which matches the change in alignment of the south wall. At the change in angle is a joint in the roof and the first floor wall is built from brick laid in English Garden Wall bond of three courses of stretchers to one course of headers (Fig 17). The bricks all appear to be of late 19th or early 20th century date but there is a suggestion that the upper half of the first floor has been more recently rebuilt as the bricks are cleaner. However, this may simply be due to repointing or cleaning. The three first floor casement windows match each other but are different to those elsewhere on the first floor. At ground floor level the north-western corner of the ground floor was, until recently hidden behind the outbuildings. Now that these buildings have been removed the ground floor rear wall of the western building is visible (Fig. 18). From the bottom of the first floor down to the ground the wall is built of coursed ironstone which indicates that the first floor brickwork is likely to be a rebuild of an earlier stone wall.

Figure 17 North facing elevation, west portion
Looking south. 1m scale

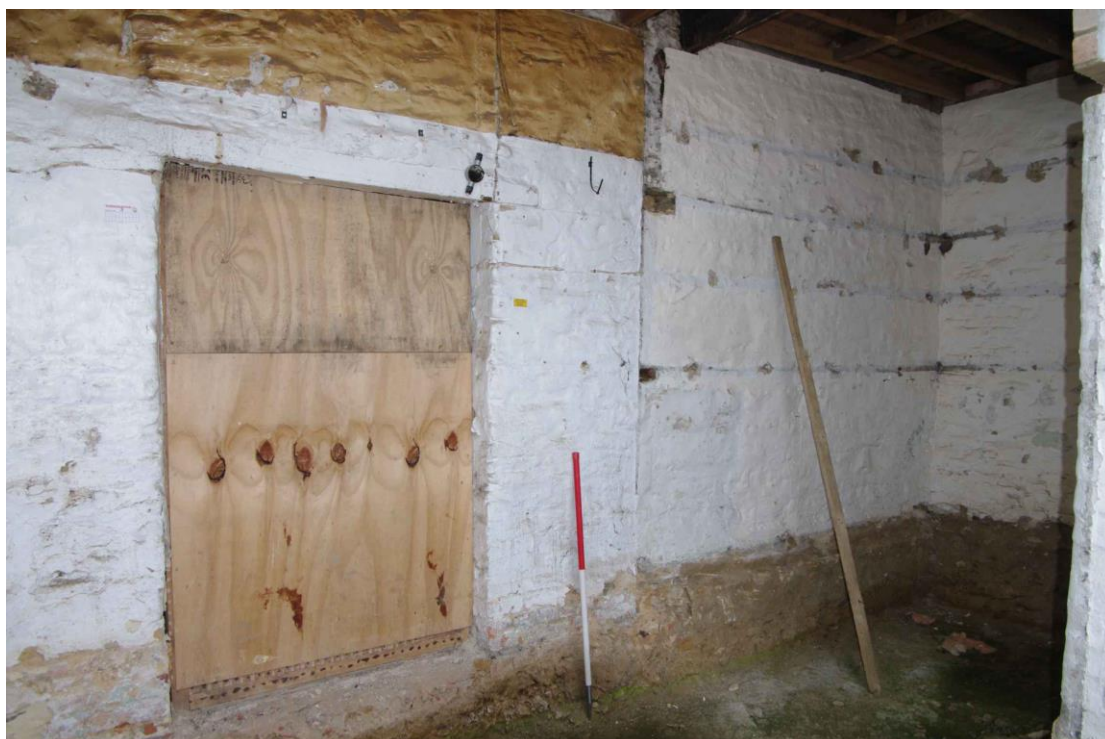
Figure 18 North facing elevation, ground floor wall at west end
Looking south-west. 1m scale

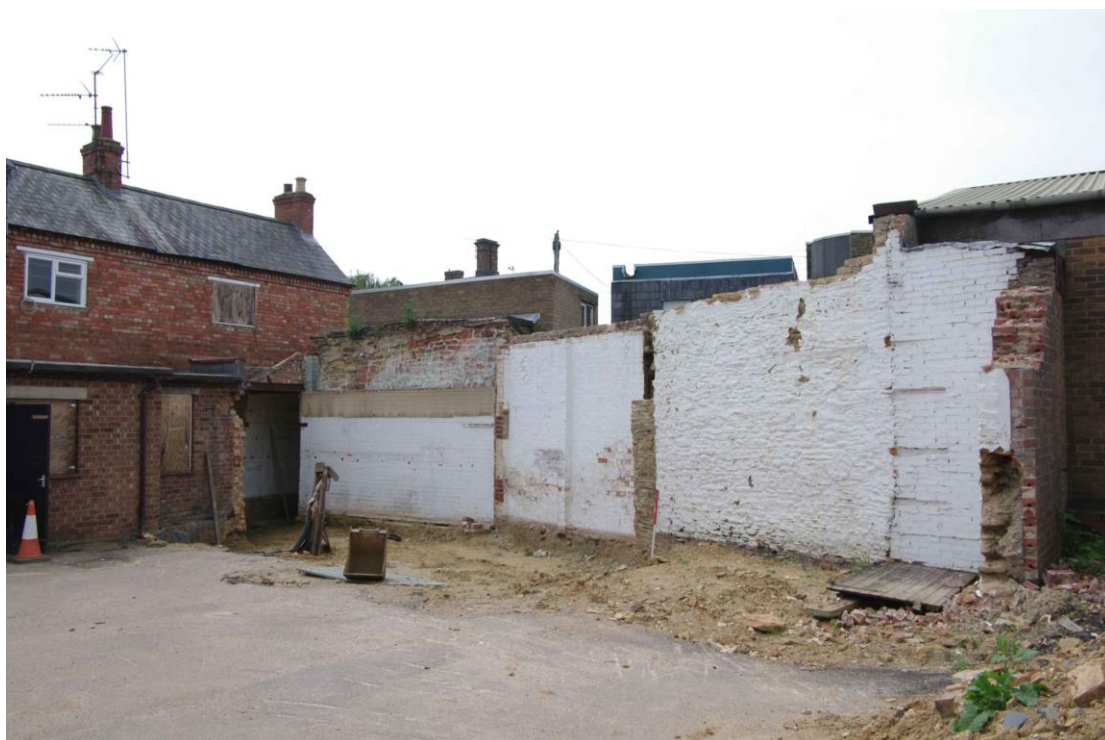
The demolished outbuildings extending from the north-west corner of the main buildings appear to have been built from ironstone with some brick modification and rebuilding (Fig. 19). They also appear to have had a variety of different roof styles and pitches. Surviving labels on the walls indicates that at least some of the rooms closer to the main building were used as a ground level beer cellar.

Figure 19 Demolished outbuildings in north-west corner
Looking south-west. 1m scale

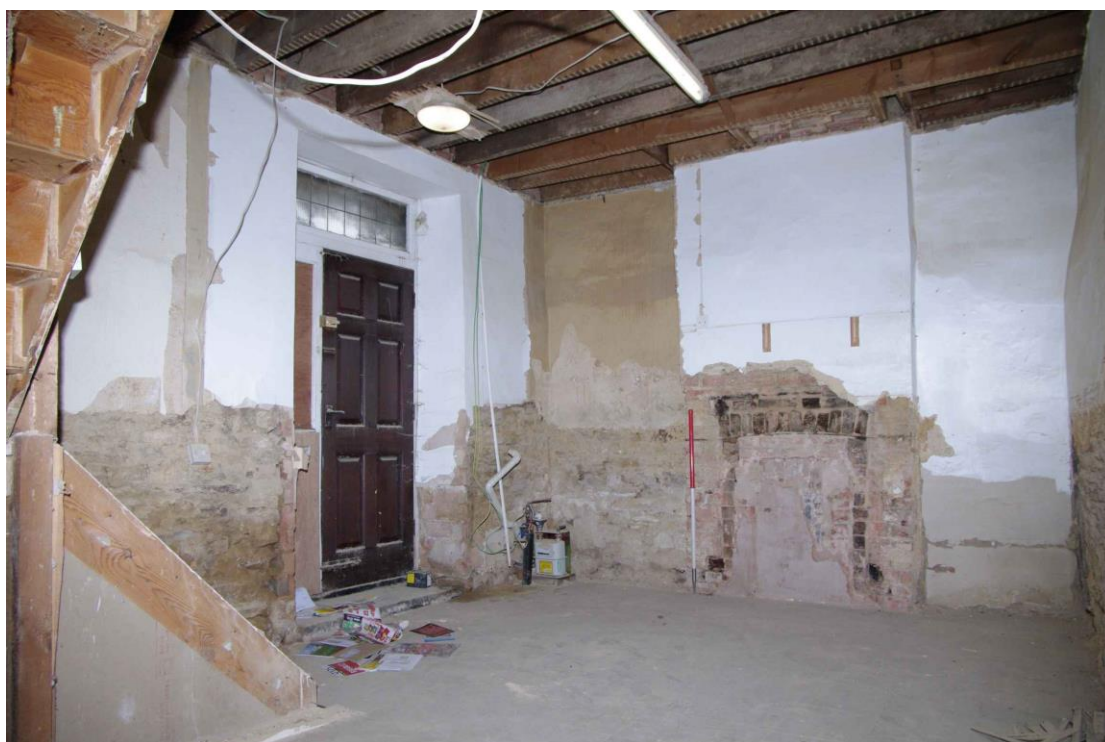
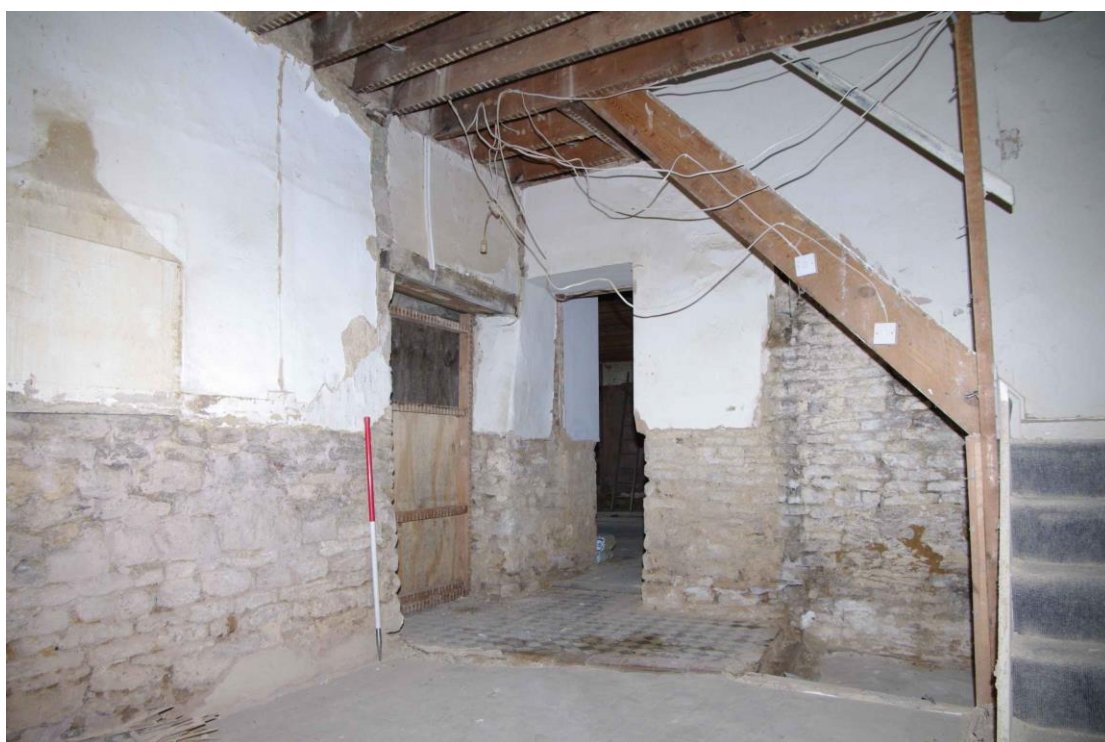
Room G1 is a small room with a rear (north) wall set at an angle to the rest of the room (Figs 21 and 22). Recent stripping of the lower parts of the wall plaster indicate that the walls are all built of ironstone rubble. The ceiling has been removed leaving the exposed floor joists and underside of the first floor floorboards. A set of wooden stairs is built into the south-eastern corner of the room over a filled-in staircase which used to lead down to a small building (pers. comm. Mr S Cherry site manager). The remnant of a small window or vent can be seen below the stairs on the inside wall but there is no trace of this on the outside wall (Fig. 23). The stairs to the first floor were boxed in with a door at the foot of the stairs but this has all been removed recently. Most of the floor is covered in 20th century cream coloured quarry tiles but a small portion in the north-eastern corner has black and white diamond pattern ceramic tiles of later 19th or early 20th century date.

Figure 21 Ground floor room G1
Looking south-west. 1m scale

Figure 22 Ground floor room G1
Looking north-east. 1m scale

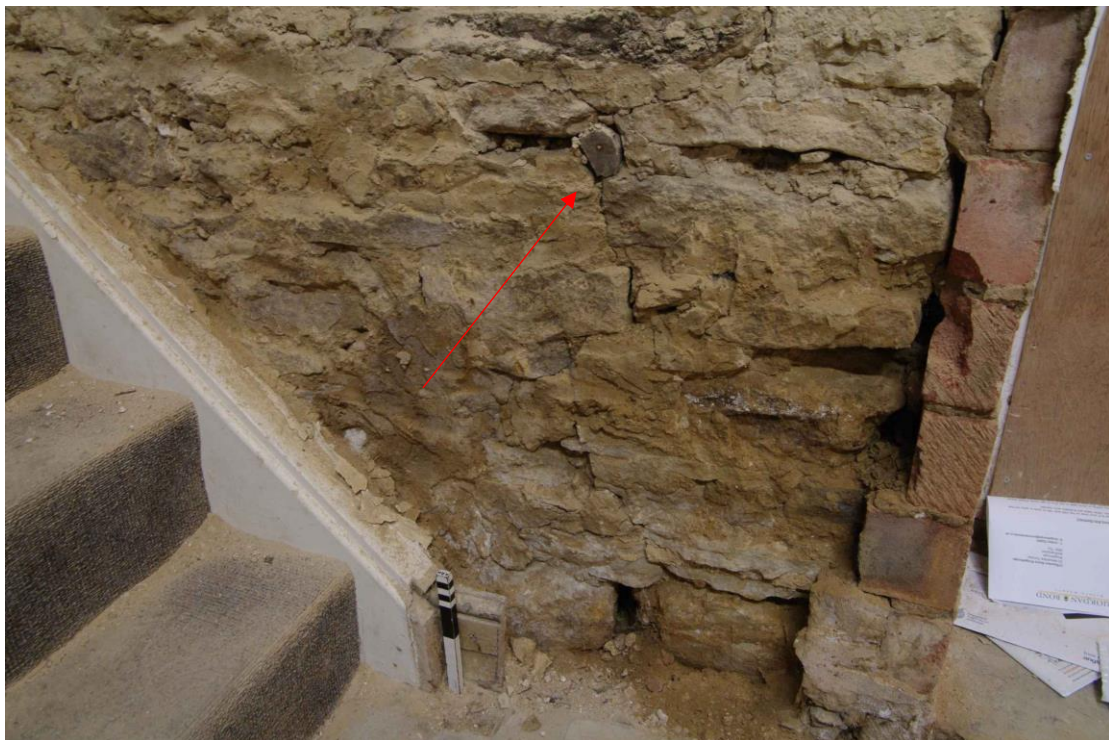
the walls may have had wooden dado panels at one time (Fig. 24). The pegs have been cut of flush with the stonework suggesting that they were removed before the wall plaster was added. The west wall has a blocked fireplace with a chimney breast built of brick. Above the fireplace the brick vaulted underside of the first floor hearth can be seen built into the ceiling.

Figure 24 Room G1 sawn off peg on south wall
Looking south-east. 0.2m scale. Note also remnant of skirting board

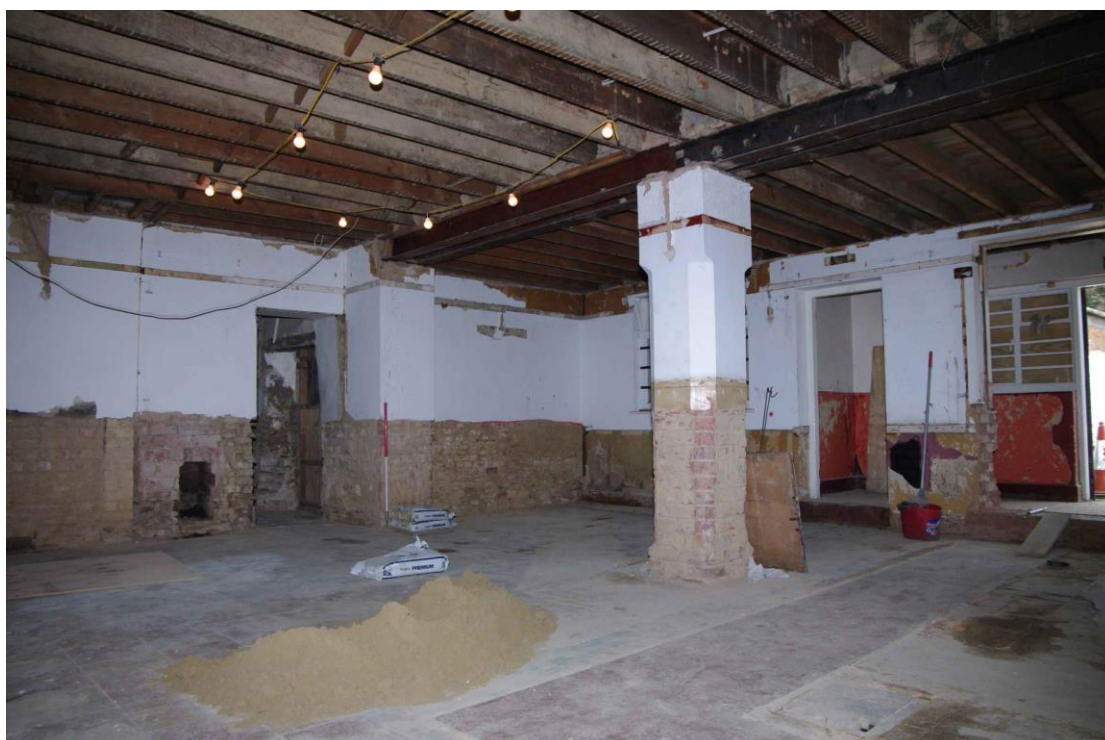
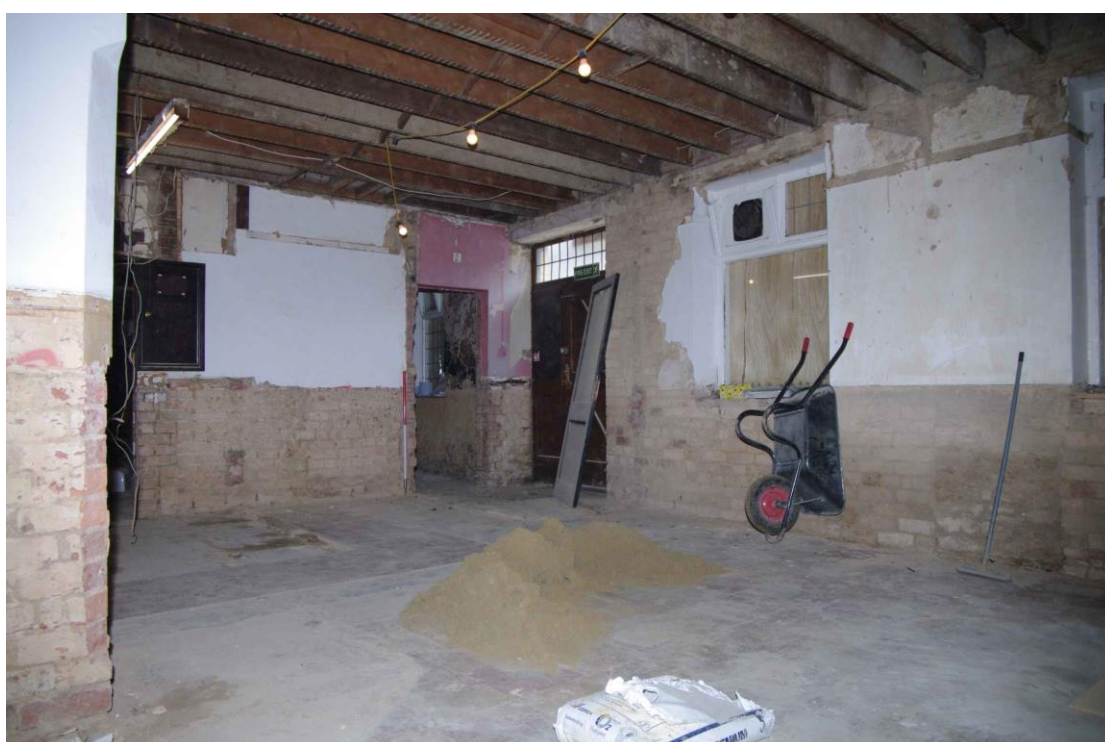
Room G2 is part of the former bar area although no fittings now survive (Figs. 25 and 26). The original back (north) wall has been removed and replaced by a central brick pillar with the rest of the wall being supported by two I-profile steel beams. A single step leads northwards into a rectangular extension area which has wall made from brick and stone built on stone foundations as discussed in the north elevation description above. The west wall of the main part of G2 has a blocked-in fireplace along with a small flue, possibly for a stove, to the north side of it. Another blocked fireplace can be seen in the east wall which appears to have been entirely rebuilt in brick, probably to support the chimney stack which appears to be a late 19th century addition to the building as it straddles both the east and west parts of the main building. Doors either side of the chimney lead into room G3. The south wall onto High Street appears to have a number of rebuilding phases or patches (Fig. 27). Areas beneath the windows appear to be built of brick with areas of stone elsewhere on the wall. None of this patching is evident from outside.

Figure 25 Room G2
Looking north-west. 1m scale

Figure 26 Room G2
Looking south-east. 1m scale

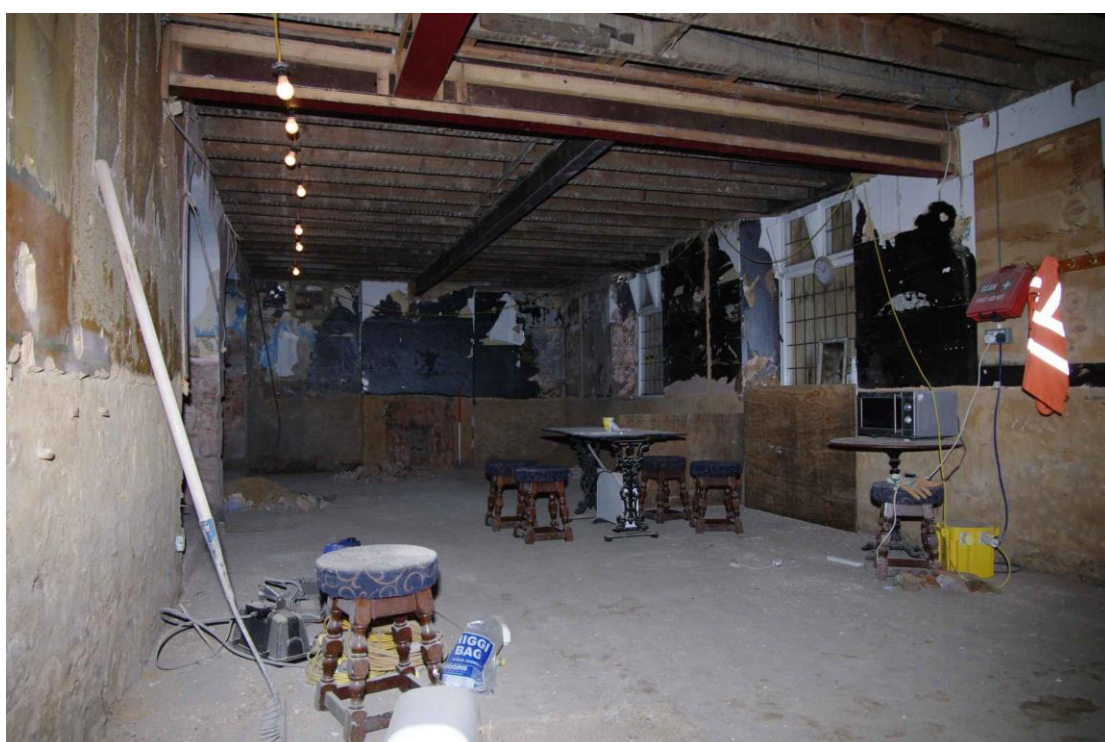
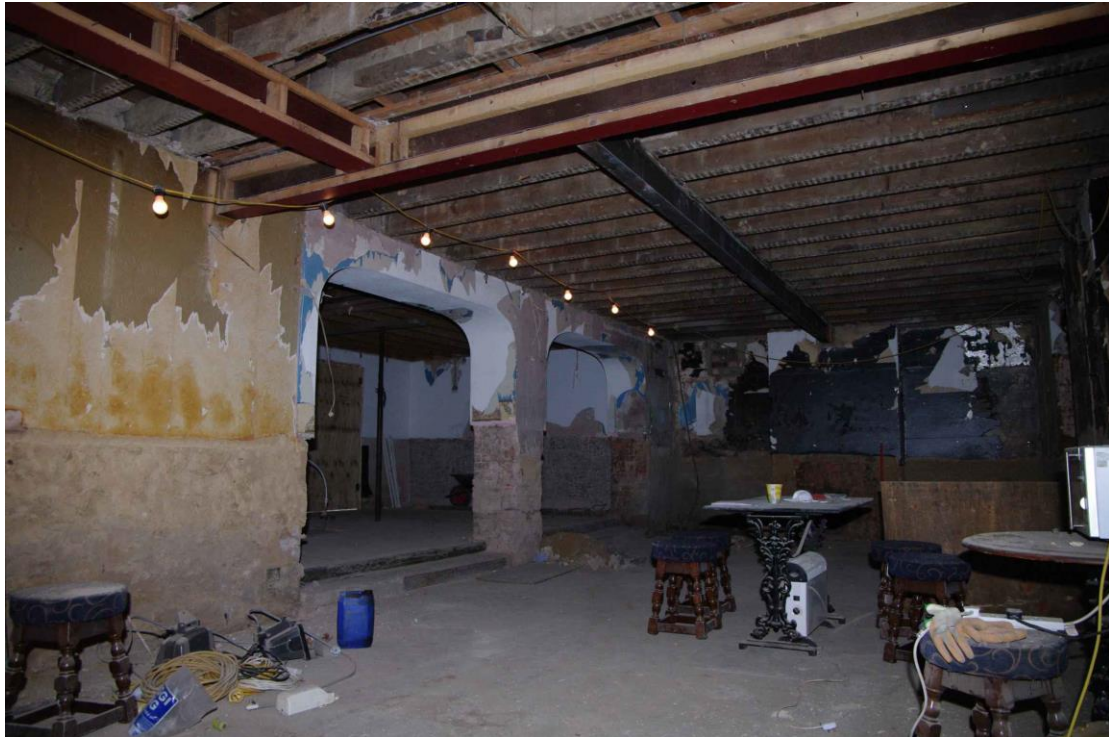
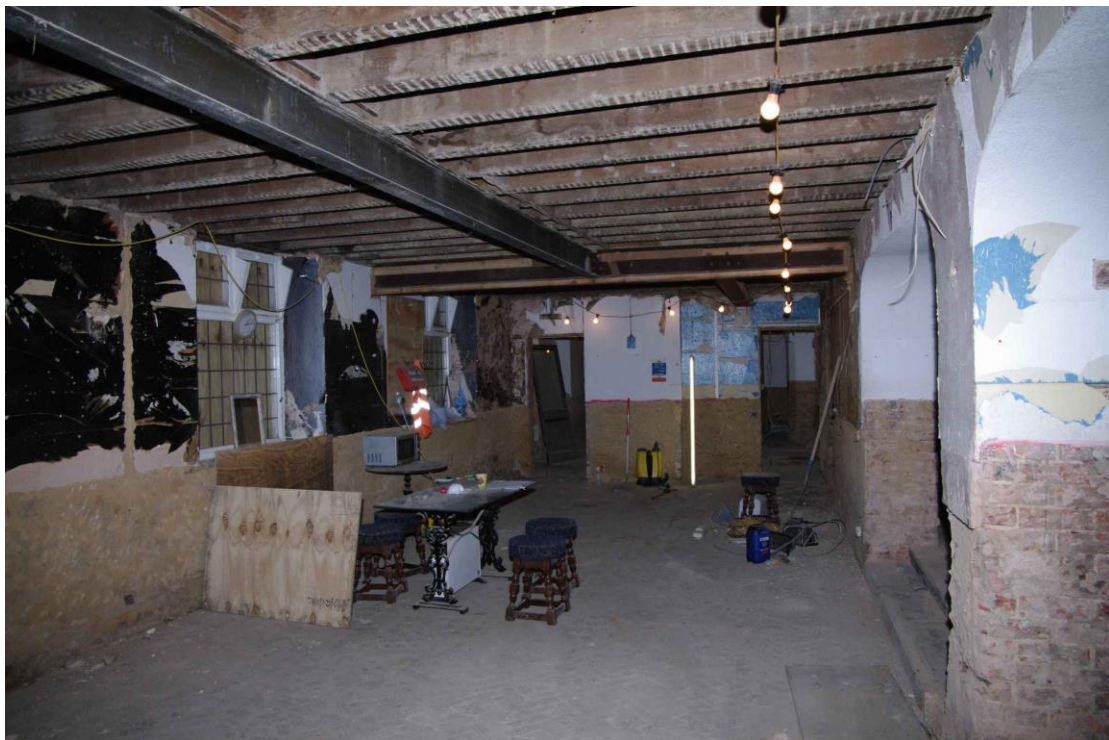
Room G3 was the main bar area and fills the entire ground floor of the eastern part of the building which has the stone quoins on each external corner (Figs. 28, 29 and 30). The south wall onto High Street has three windows with upper opening panels and fixed lower panes. There is no evidence of any blocked doorways or other modifications on this wall. The east wall has a blocked fireplace which appears to have been reduced in size at least twice. The west wall, as noted in Room G2 is brick-built.

Figure 28 Room G3
Looking south-east. 1m scale by blocked fireplace. Arches on left of picture

Looking north-east. Note ceiling joists with modern (painted red) steel in foreground and pre WWI (painted black) steel I-beam to right

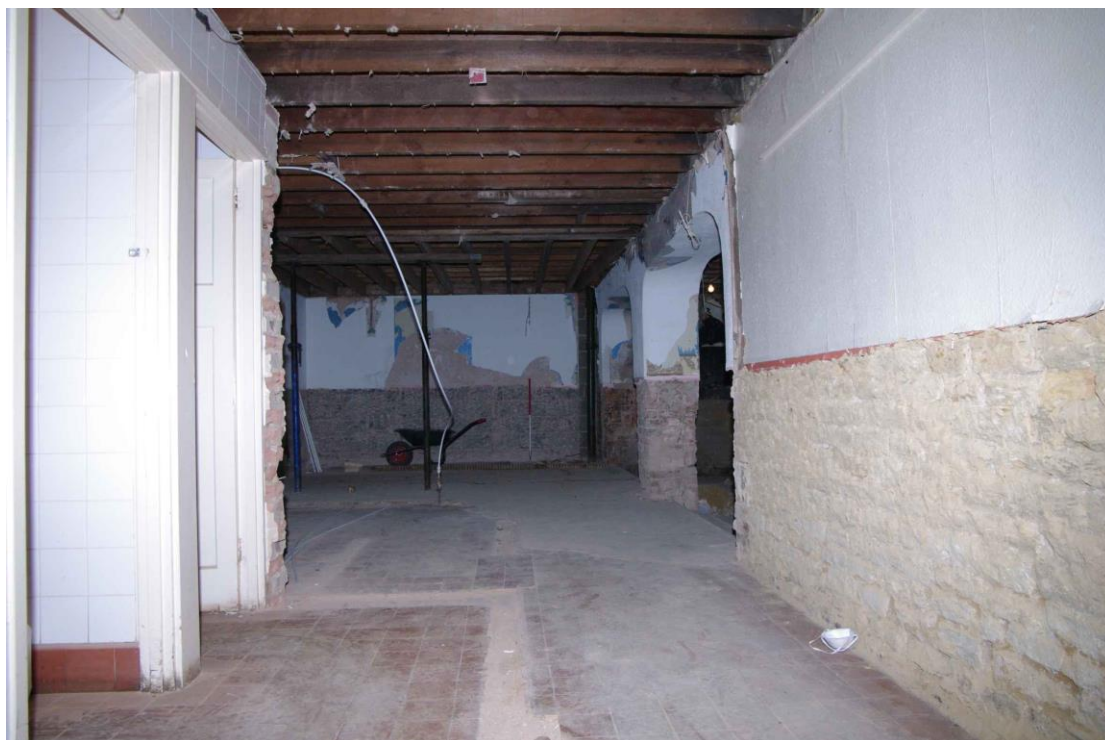
G4 is the modern extension shown on the 1964 and 1977 OS maps (Fig. 31). This area used to house the toilet block and a small foyer area but only a small remnant of the toilets remain leaving a large open space which connects with the extended area of room G2. The extension is built of modern brick and breeze-blocks.

Figure 31 Room G4
Looking west. 1m scale

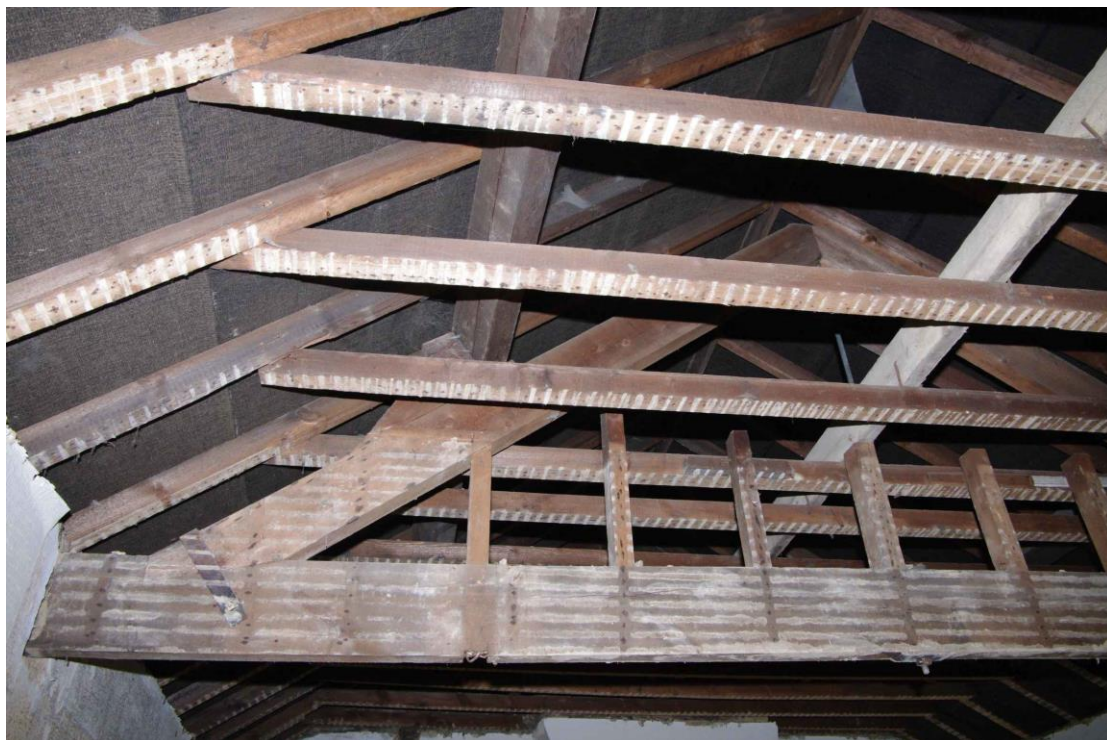
The roof structure has a single truss of mid to late 19th century design with a long metal rod and bolt in place of the central king post. Metal stirrups or straps hold the principal rafters to the tie-beams (Fig. 37). Interestingly the apex of the truss is slightly off-centre to the existing ridgeline of the present roof which indicates that the common rafters and roof covering, including roofing felt, have been replaced.

Figure 37 Room F2 roof detail
Looking west. Note off-centre ridge and truss

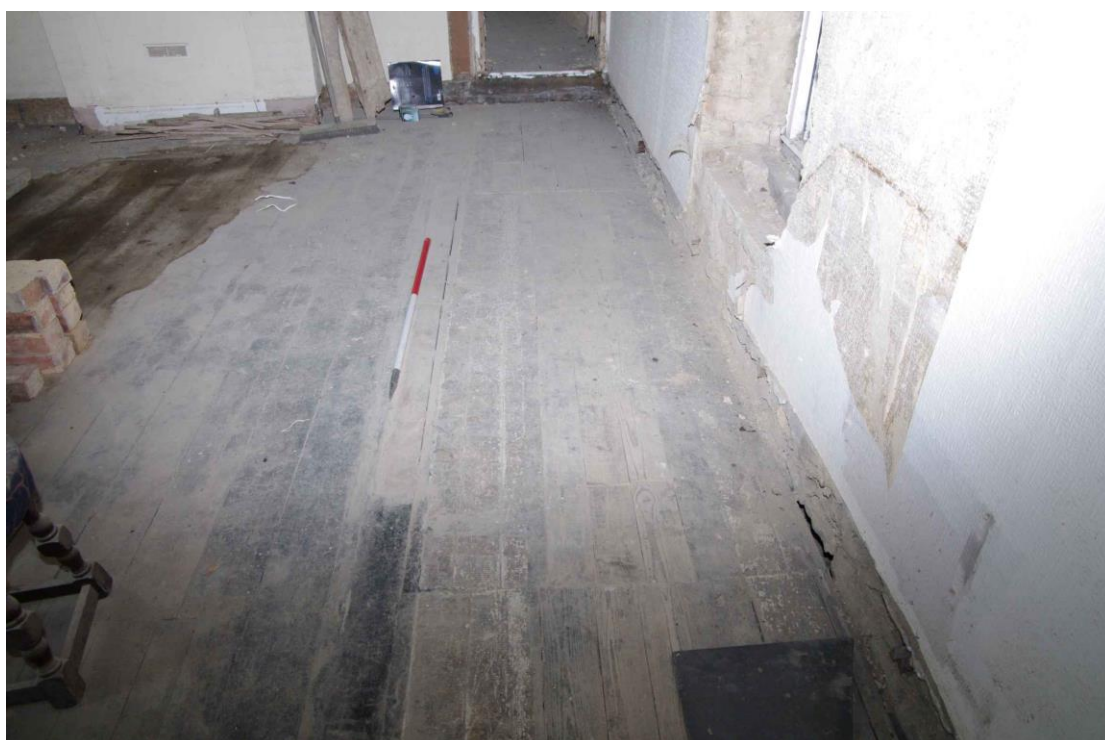
A rectangular patch in the floorboards close to the north-west corner of the room shows where a staircase led up from Room G3 below (Fig. 40). The roof is supported by two trusses which are of a different design to that used in Room F2 (Fig. 41). The king post is bolted to the tie-beam and has two raking struts supporting the principal rafters. The purlins sit on thin wooden blocks or spacers attached to the backs of the principals which suggests a later rebuilding of the rafters and roof covering. As in Room F2 the top of the king posts are out of alignment with the current ridgeline.

Figure 40 Room F3 location of former staircase
Looking west. 1m scale. Doorway to room F2 at top of picture
