**A Historic Building Photographic  
Survey of a barn and sheds and an  
Archaeological Trial Trench  
Evaluation at  
Ashby House Farm,  
Church Lane,  
Hungarton,  
Leicestershire**

**NGR: SK 69130 07245**

**ULAS Report Number 2017-014**  
**©2017**  
**Accession Number X.A136.2016**

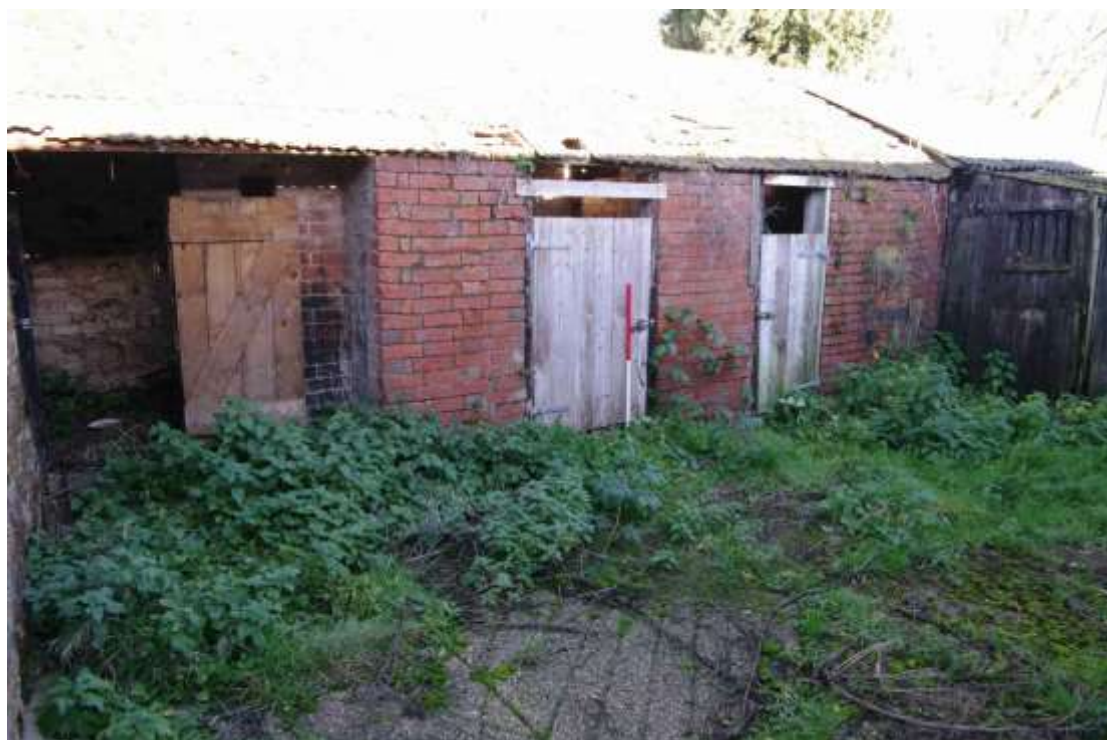
Shed 1 is a brick built lean-to structure with a cement tile roof which appears to have been used as a three bay pig pen. The bricks appear to date from the later 19th century. The roof is supported by a wall running along Church Lane. This wall is built from coursed ironstone rubble on a stone plinth with brick detailing and may be. The building will be converted as part of the redevelopment plan

Figure 9: Shed 1 south facing elevation  
Looking north-east. 1m scale. Shed 2 on right of picture

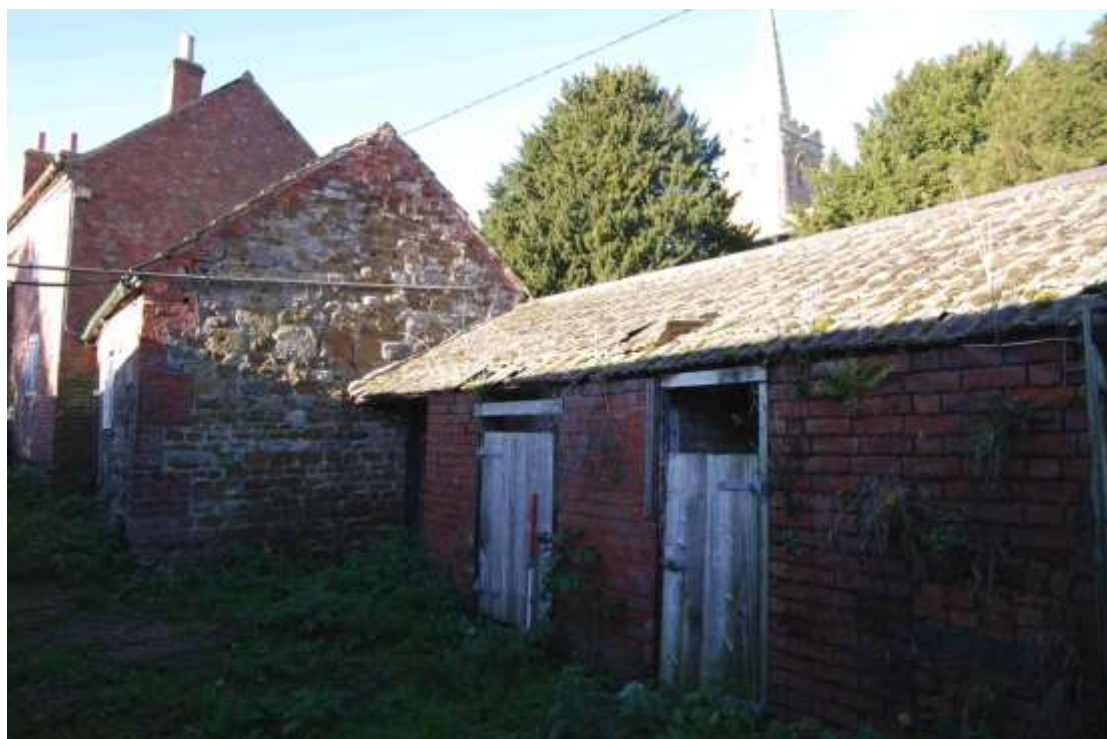
Figure 10: Shed 1 south facing elevation  
Looking north-west. 1m scale. Farmhouse on left of picture

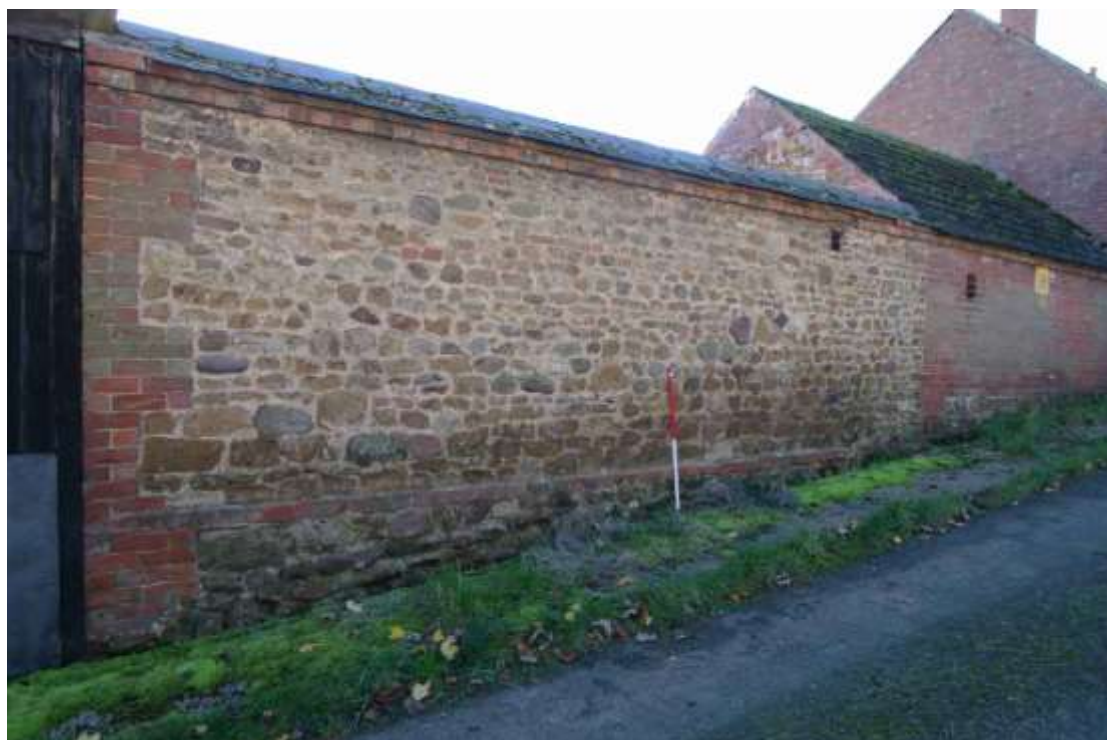
Figure 11: Shed 1 north facing elevation  
Looking south-west. 1m scale

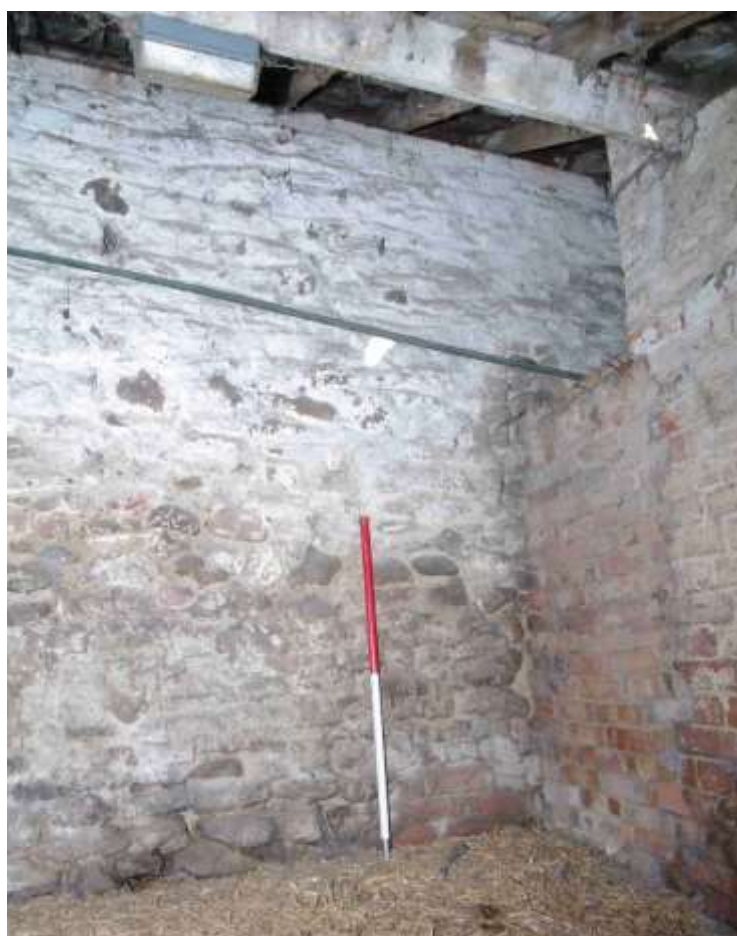
Figure 12: Shed 1, inside  
Looking north-east in middle sty. 1m scale

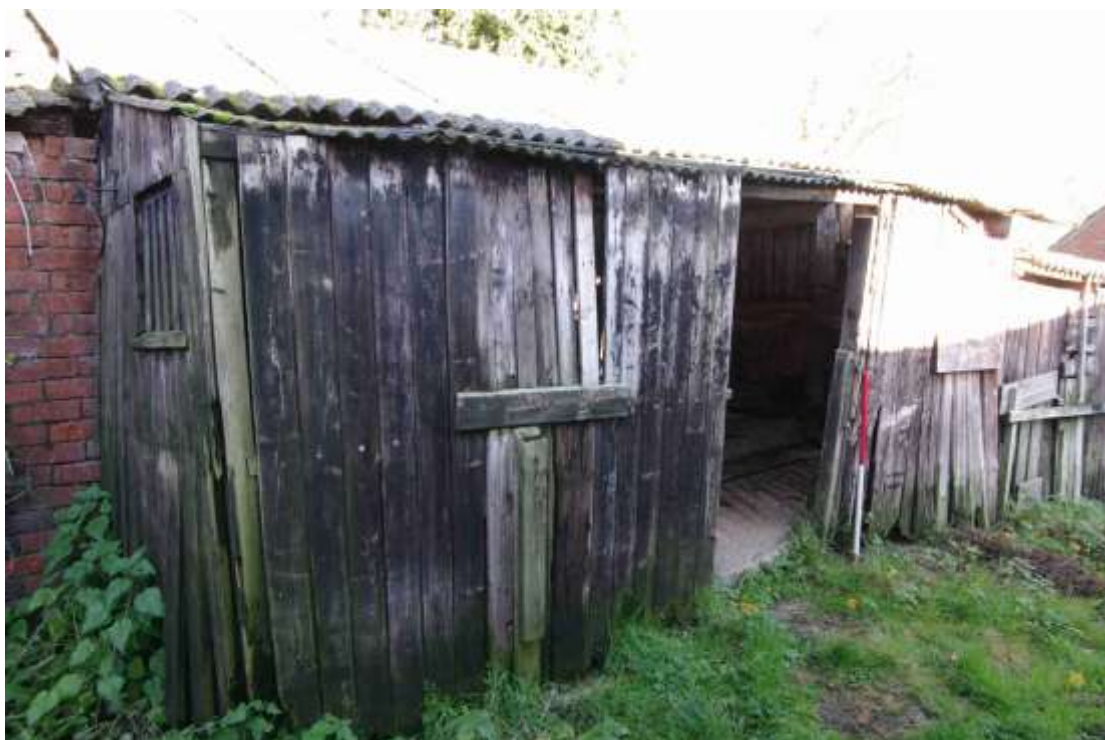
Shed 2 is built entirely from timber and has a corrugated sheet cement roof. Inside is a concrete floor with a bays and feeding troughs for cattle. This building will be demolished.

Figure 13: Shed 2 South facing elevation  
Looking north-east. 1m scale. Shed 3 on right

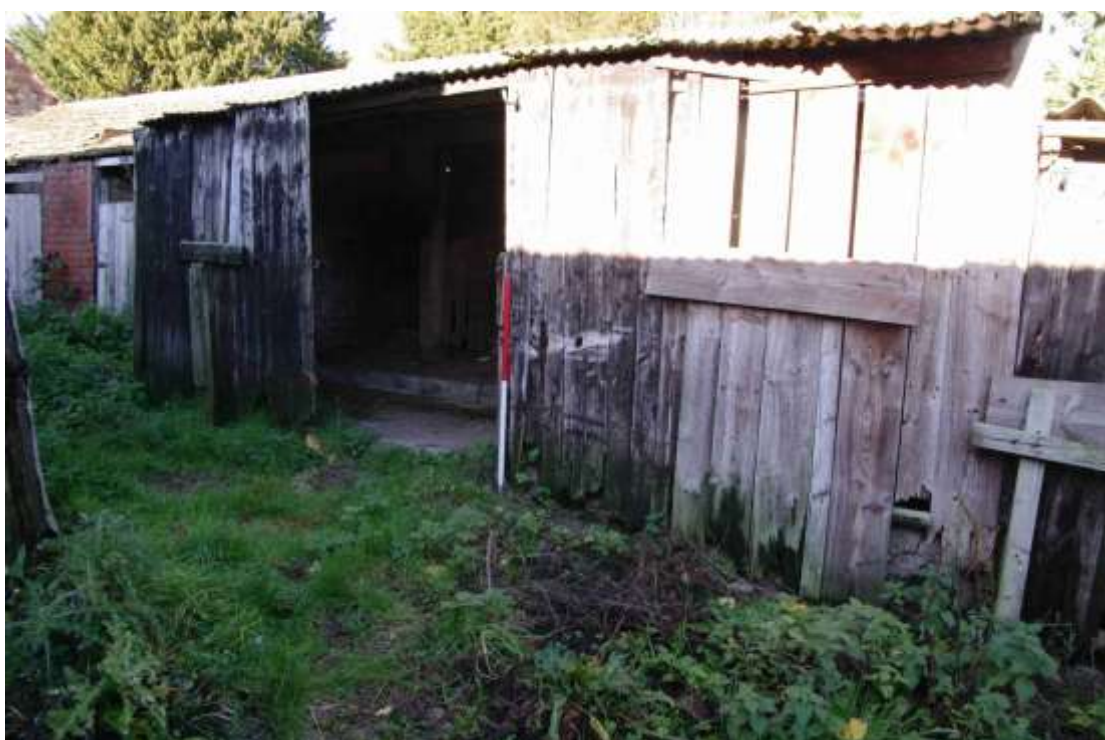
Figure 14: Shed 2 south facing elevation  
Looking north-west. 1m scale. Shed 1 on left, Shed 3 on right

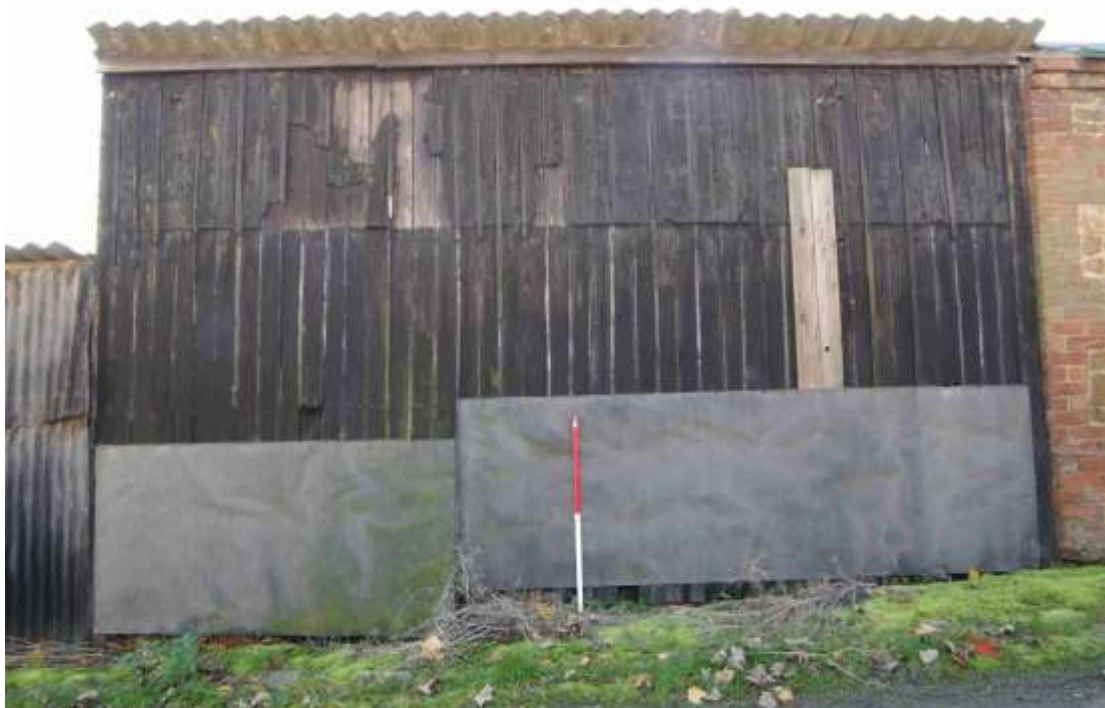
Figure 15: Shed 2 north facing elevation  
Looking south. 1m scale

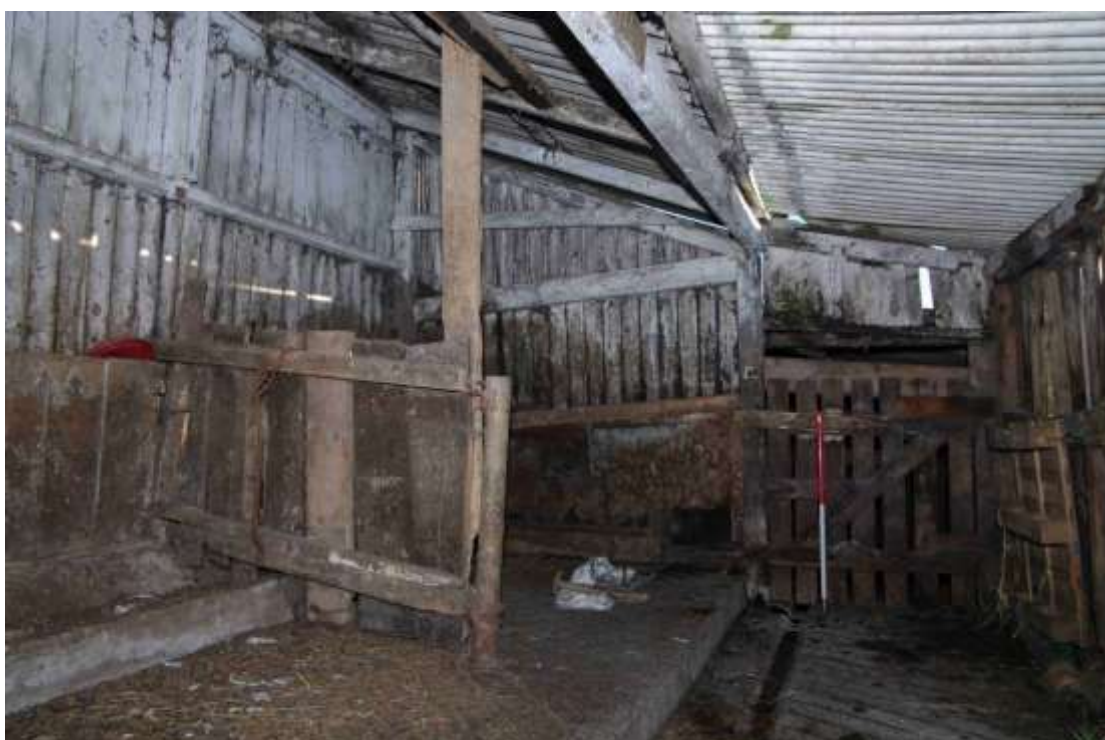
Figure 16: Shed 2, inside  
Looking east. 1m scale

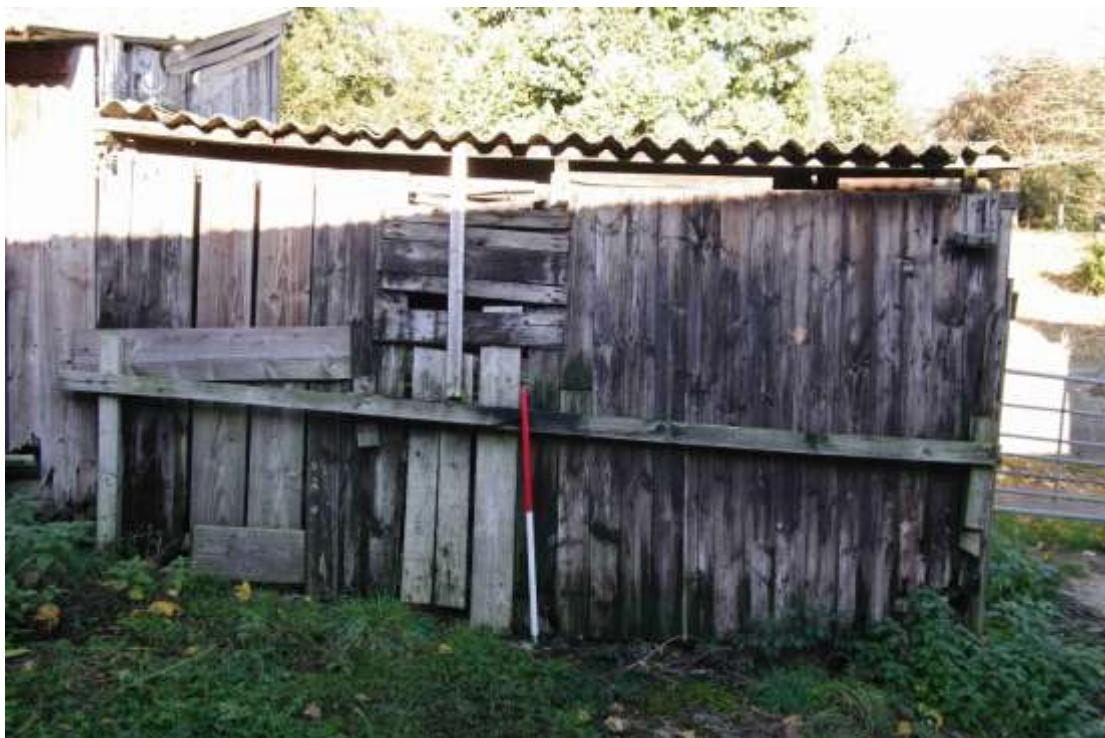
Shed 3 is built against the east wall of Shed 2 and is also built from wood with a corrugated sheet roof. The north wall alongside Church Lane has been clad with corrugated sheet metal to cover holes in the wooden cladding. This building will be demolished.

Figure 17: Shed 3 south facing elevation  
Looking north. 1m scale

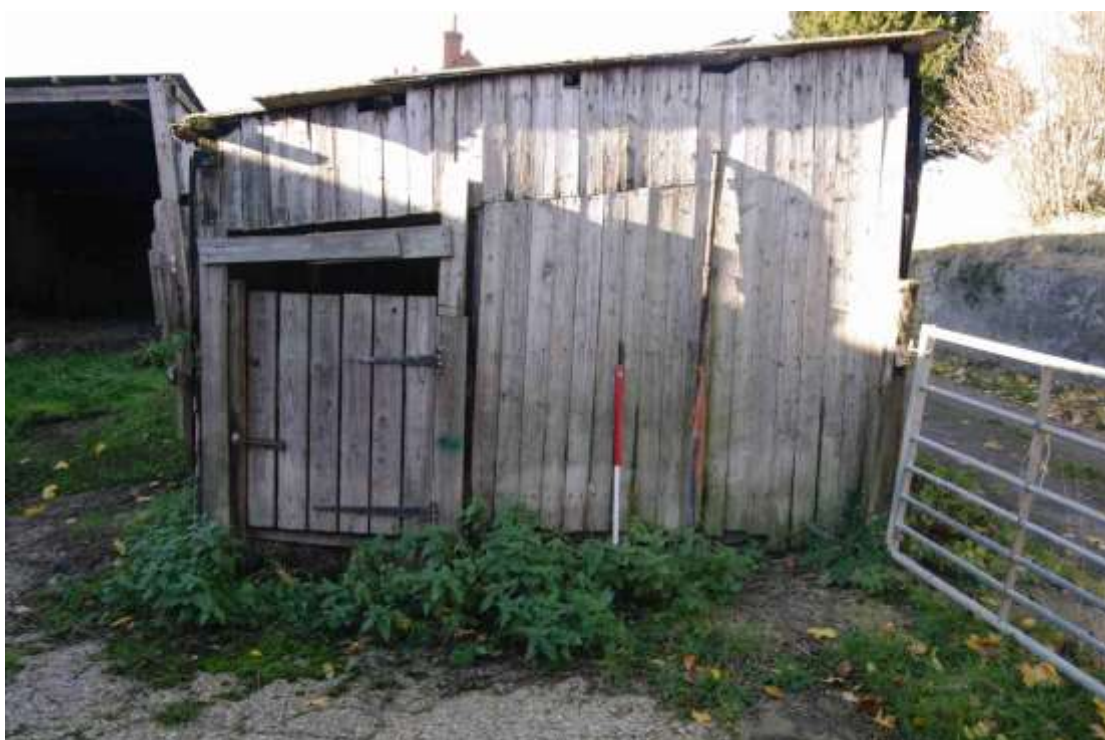
Figure 18: Shed 3 East facing elevation  
Looking west. 1m scale. Shed 5 on left, Church Lane on right

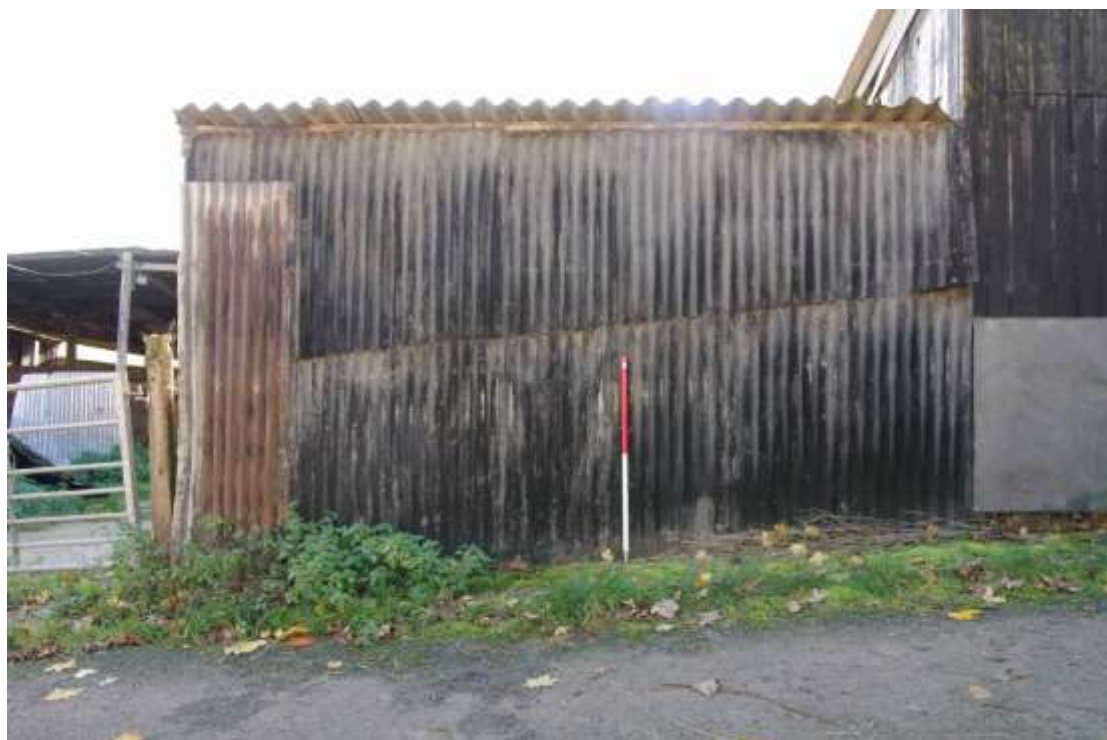
Figure 19: Shed 3 north facing elevation  
Looking south. 1m scale

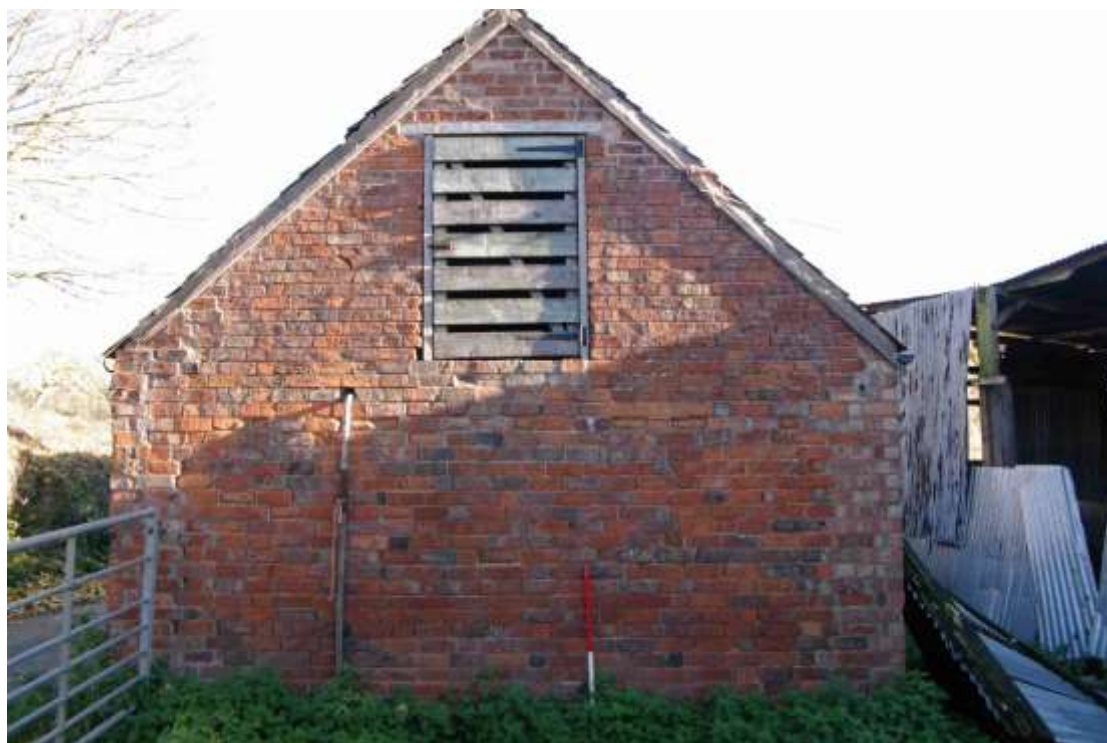
Shed 4 is a small brick built stable with a graded slate roof. Inside are two stalls with a hayloft above. The hayloft floor appears to be lath and plaster. This building will be converted.

Figure 20 Shed 4 west facing elevation  
Looking east. 1m scale. Church Lane to left, Shed 6 to right

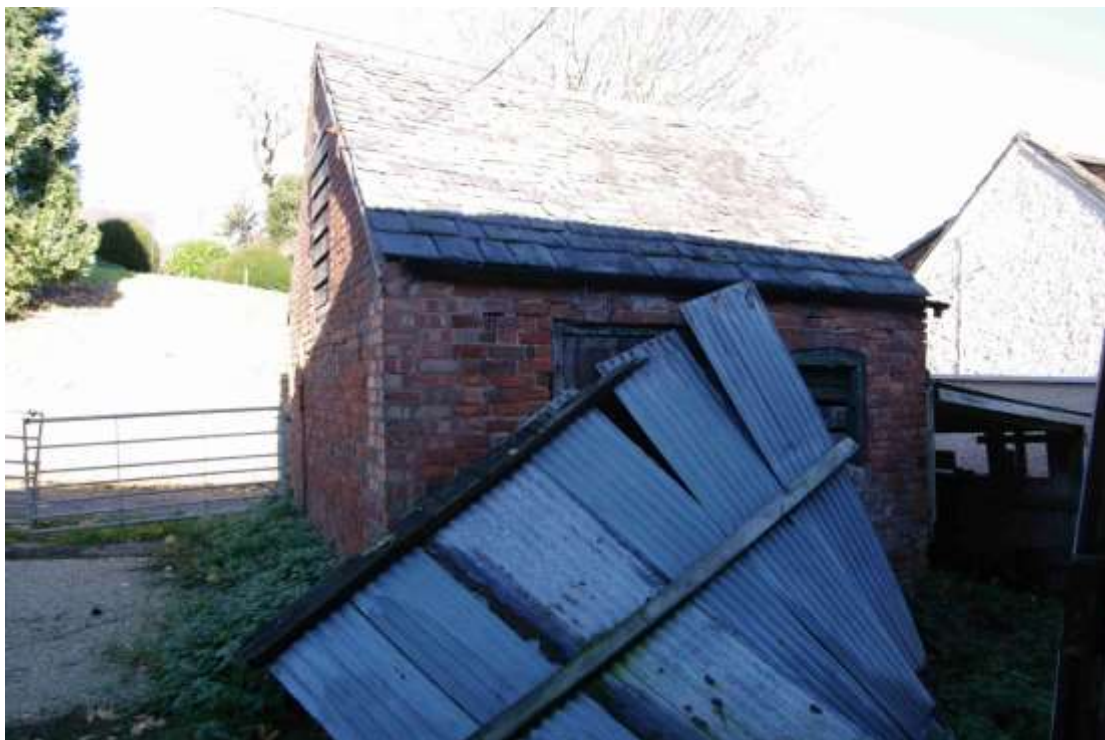
Figure 21: Shed 4 south facing elevation  
Looking north-east

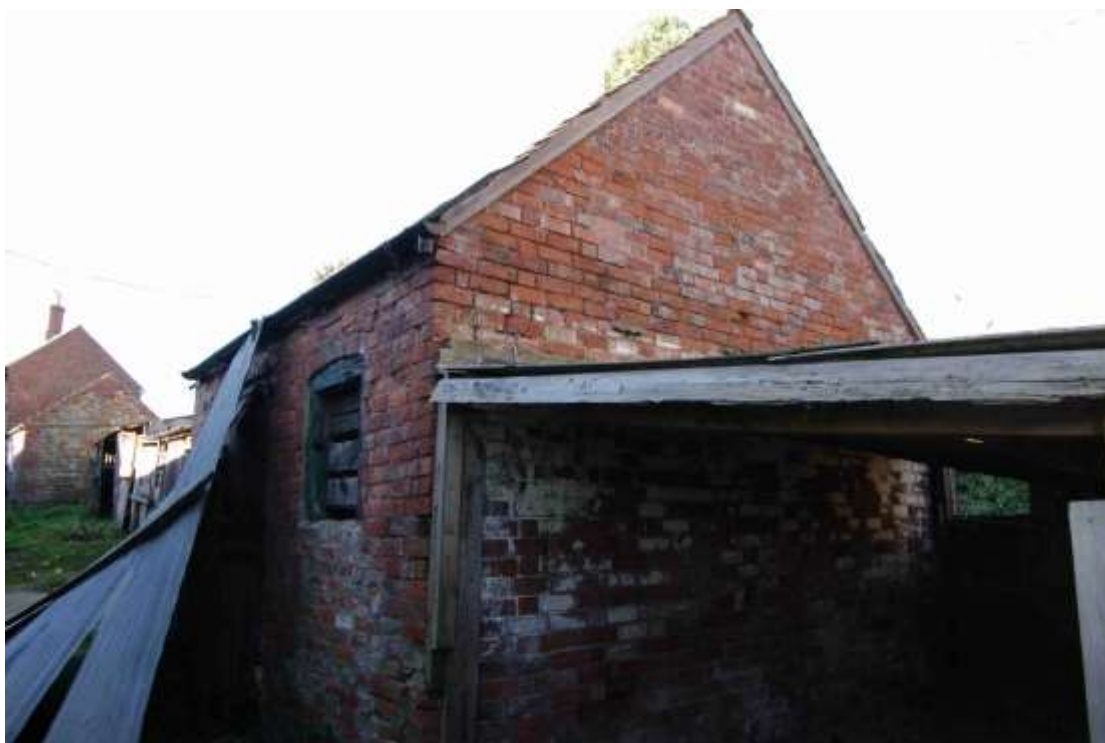
Figure 22: Shed 4 south and east facing elevations  
Looking north-west. Shed 5 on right

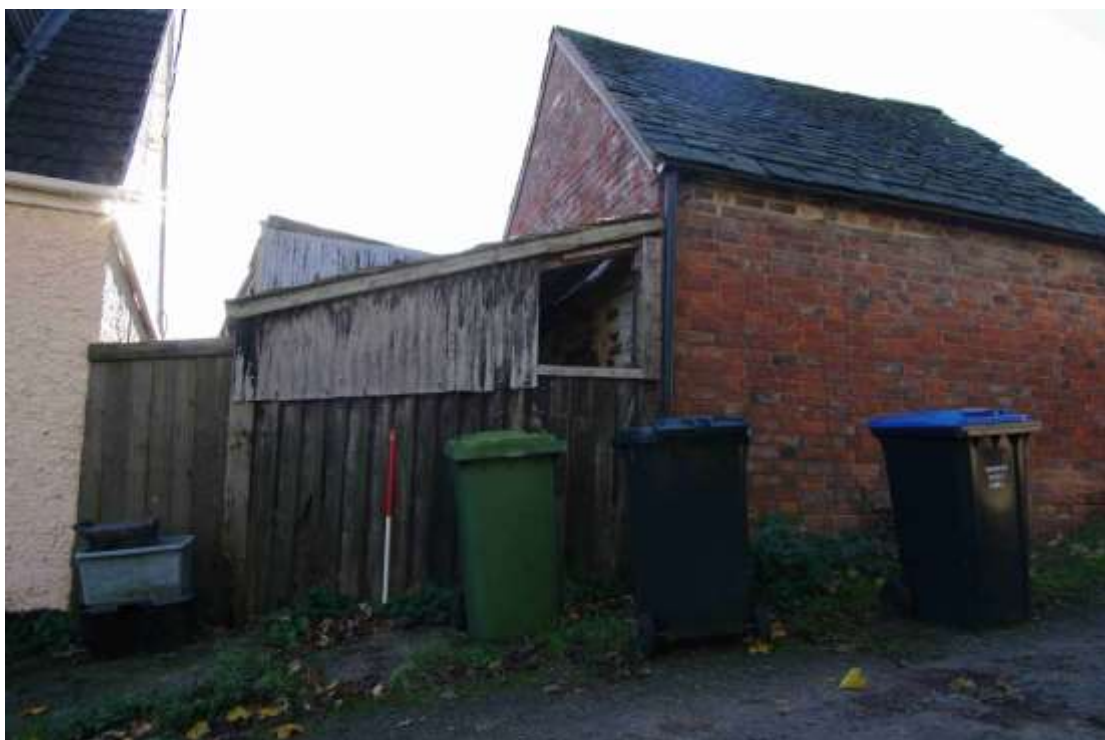
This shed is a roughly built timber lean-to built against the east wall of Shed 4. It has a corrugated cement sheet roof and appears to have been used as an animal pen. This building will be demolished.

Figure 23: Sheds 4 and 5 north facing elevations  
Looking south-west. 1m scale. Shed 4 on right, Shed 5 on left

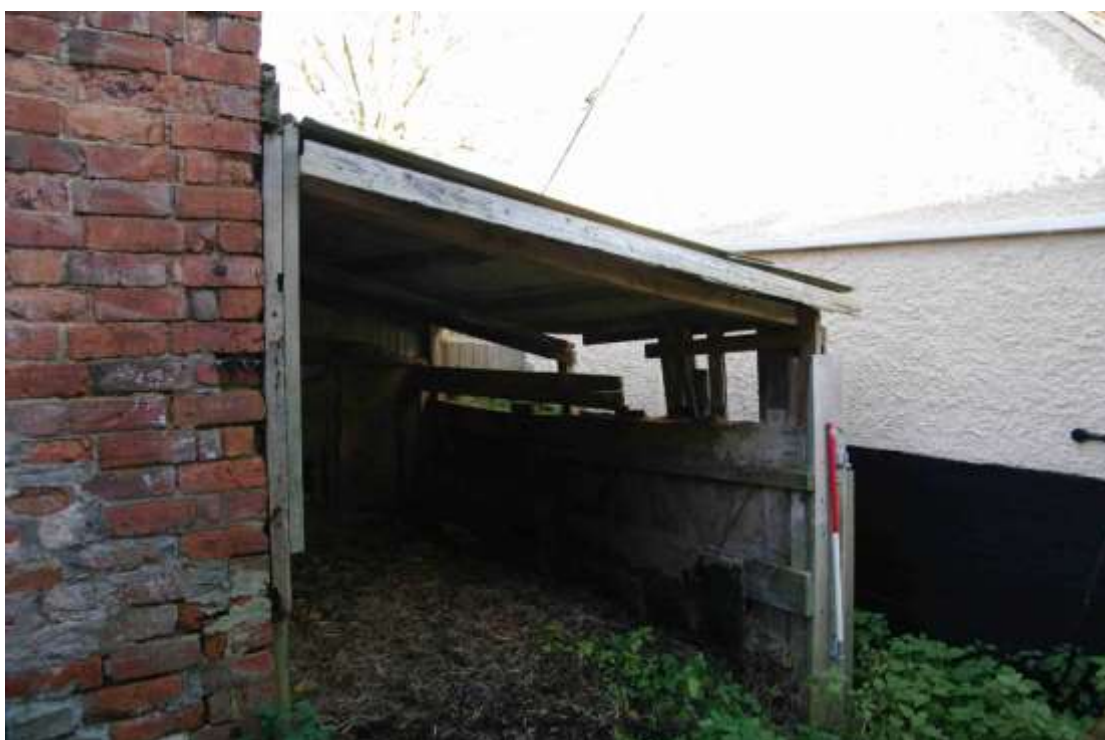
Figure 24: Shed 5 south facing elevation  
Looking north-east. 1m scale

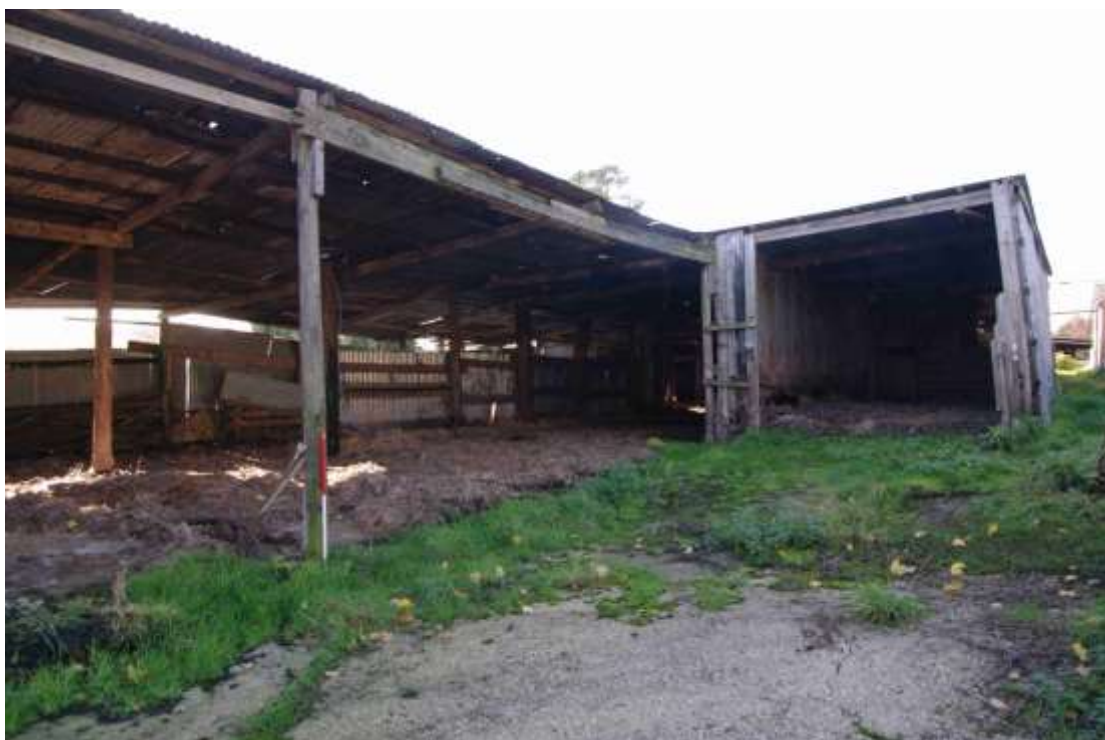
Shed 6 is a large open shed built from telegraph poles and other substantial timber posts. It has a corrugated sheet metal roof and some side walls. Much of the internal space is open but the north-western corner has been enclosed to create two smaller sheds or pens. The southern wall is built along a steep drop in the land which leads down to the stream. This wall is in a state of collapse. The whole structure does not appear to be more than 40 years old. This will be demolished.

Figure 25: Shed 6 north facing elevation  
Looking south-west. 1m scale

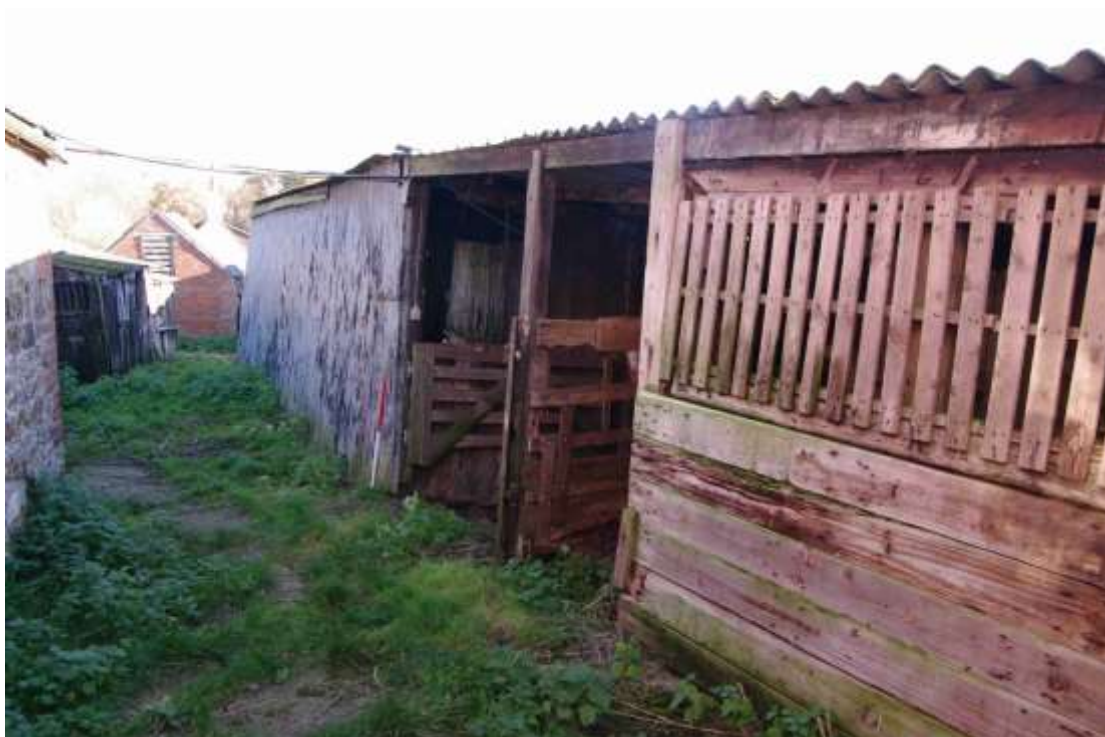
Figure 26: Shed 6 north-west corner  
Looking south-east. 1m scale

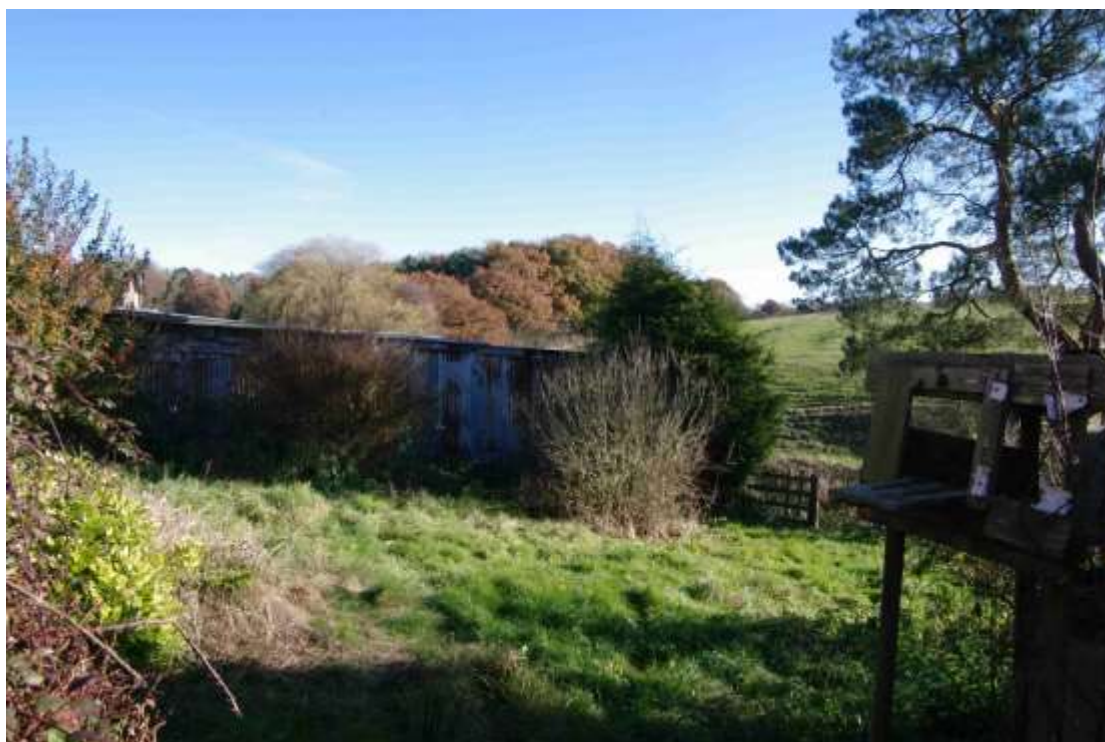
Figure 27: Shed 6 west facing elevation  
Looking south-east

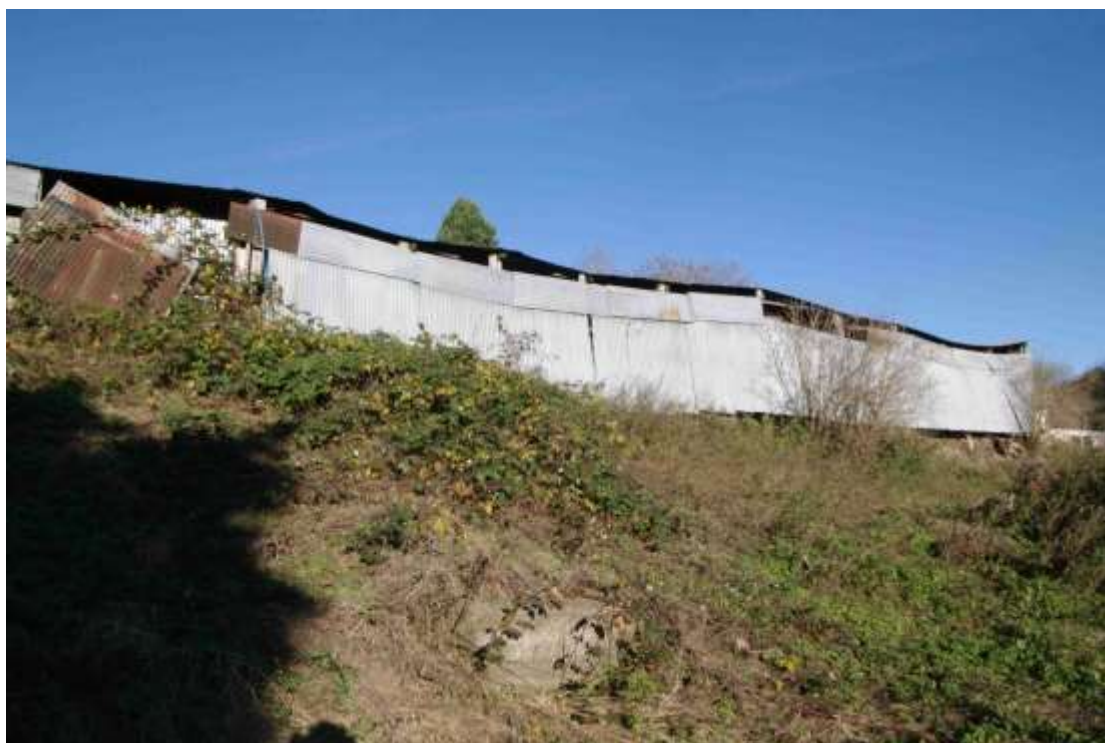
Figure 28: Shed 6 south facing elevation  
Looking north-east

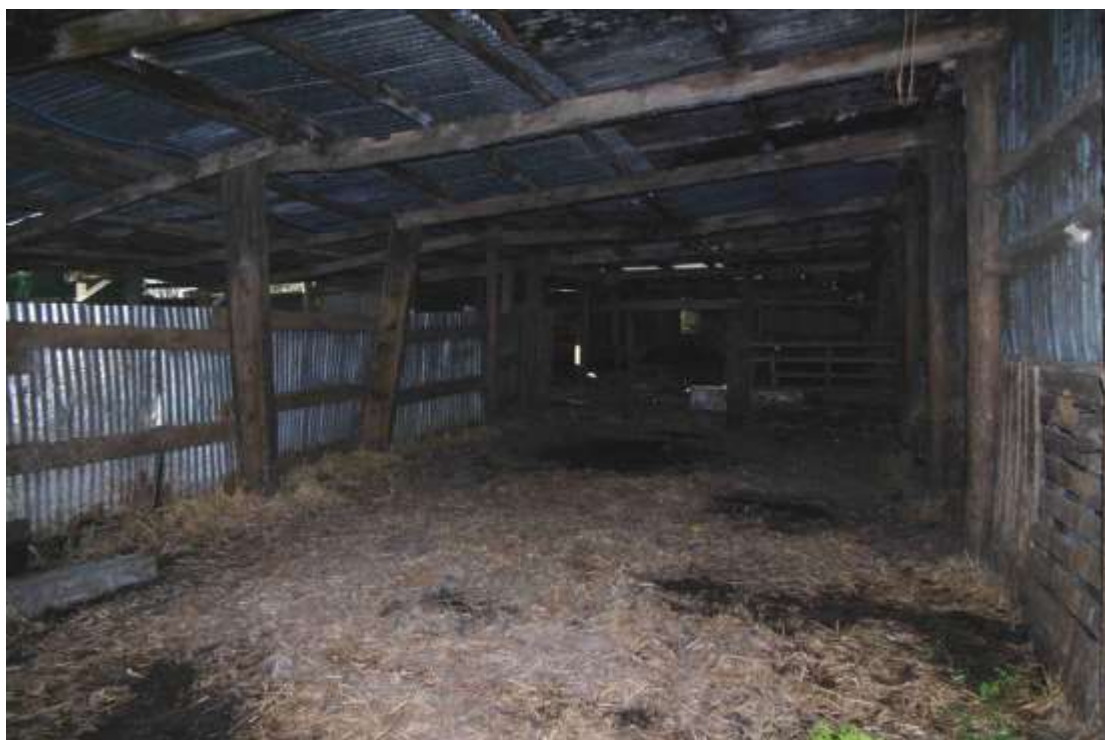
Figure 29: Shed 6, inside  
Looking west

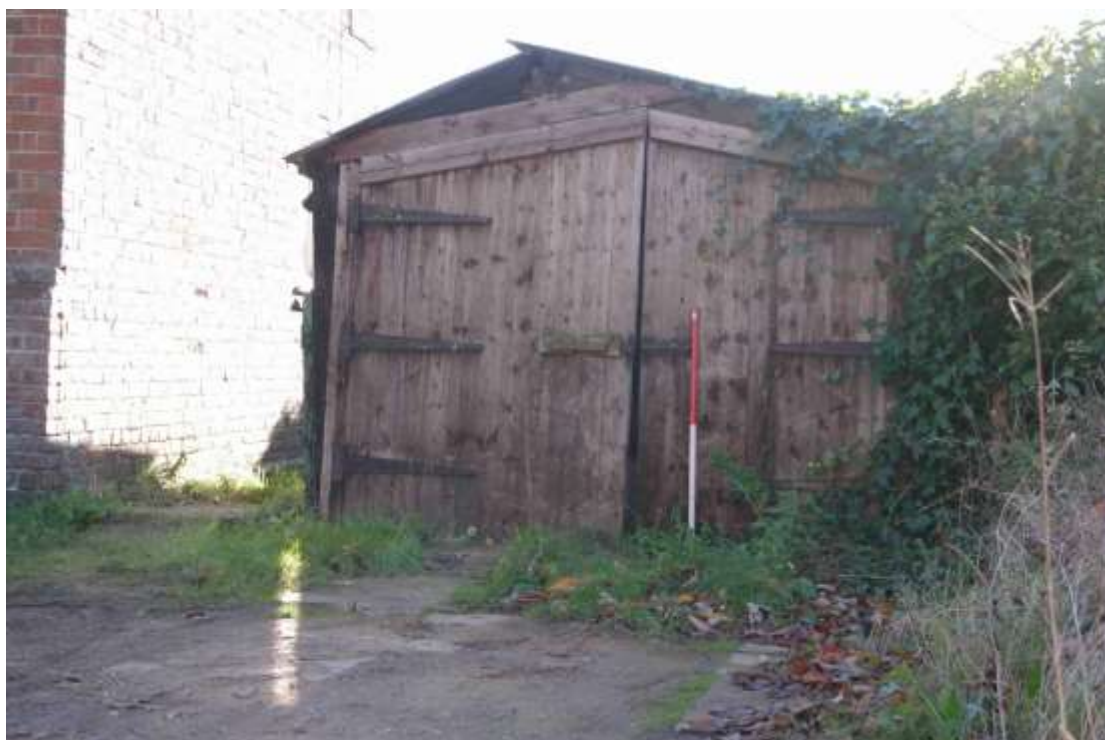
Shed 7 is a timber shed built on the western side of the farmhouse. It has most recently been used as a garage but access panels on the side suggest that it may have been designed as a chicken shed. It does not appear on the 1955 map. This building will be demolished.

Figure 30: Shed 7 north facing elevation  
Looking south. 1m scale. Farmhouse on left

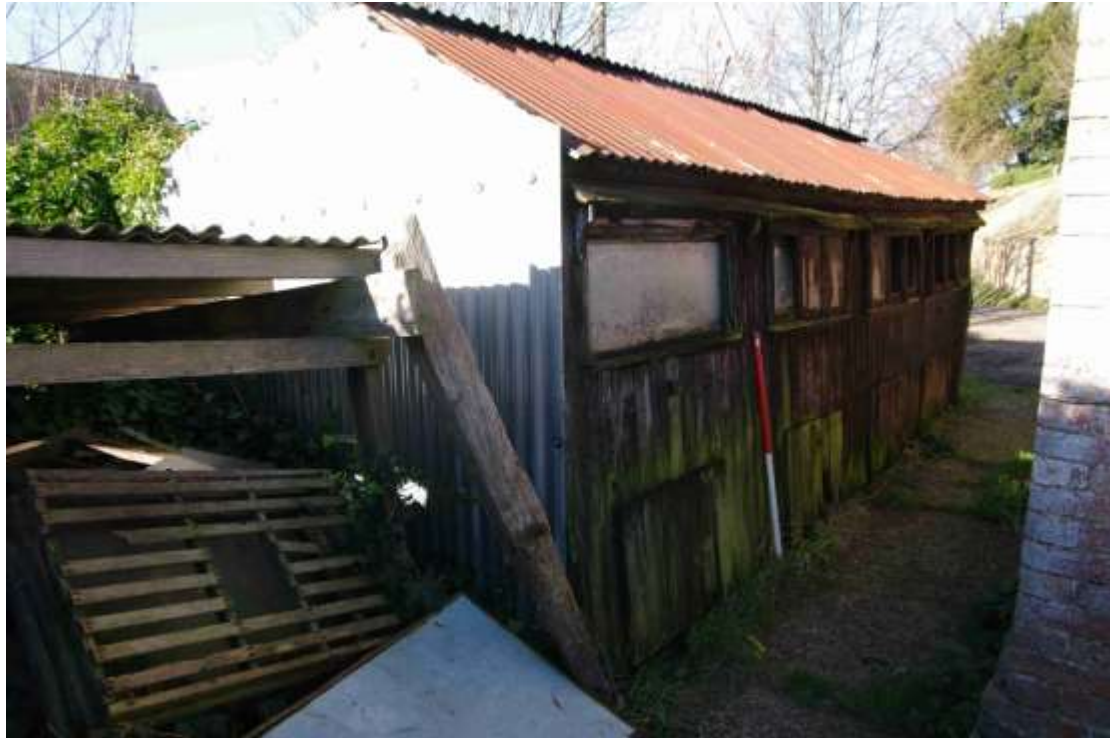
Figure 31: S34hed 7 south and east facing elevations  
Looking north-west. 1m scale

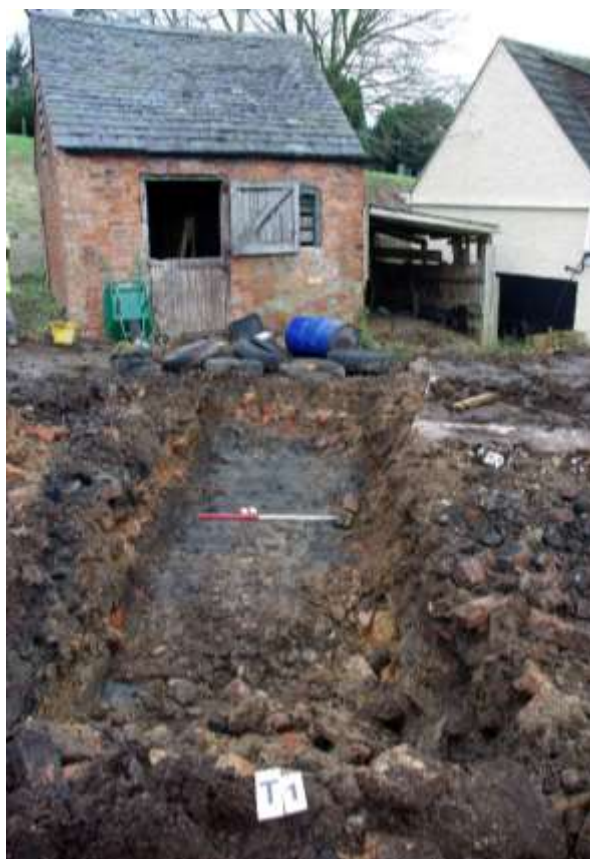
Figure 35: Trench 1  
Looking north. 1m scale.

Prior to full excavation a layer of concrete approximately 0.2m thick was removed along the length of Trench 1. This layer formed the hardstanding base of the now-demolished shed. Excavation of the northern end of the trench revealed nearly 0.9m of modern building rubble and disturbed subsoil presumably laid as a bedding for the concrete hardstanding. Removal of the rubble material exposed the dark grey/black natural substratum of sandy clay which had inclusions of small rounded stones (Fig. 35). The dark colour of the natural indicated that it had been stained and contaminated from the deep layer of cow manure up to 0.5m thick which had to be cleared from above the concrete layer. Despite being undisturbed natural there was a strong smell of diesel contamination from it.

At 3m from the northern end of the trench the natural substratum dropped away to reveal a trench base of modern made ground. At this point, and southwards, the natural substratum was inaccessible due to the depth of built up ground on the slope. The made ground was made up of bricks, rubble, tarmac, and concrete which was clearly modern material added when the barn was built around 40 years ago. Due to the steepness of the slope beyond the footprint of the old shed it was not possible for the machine to excavate any further south.

No archaeological features or deposits were present.

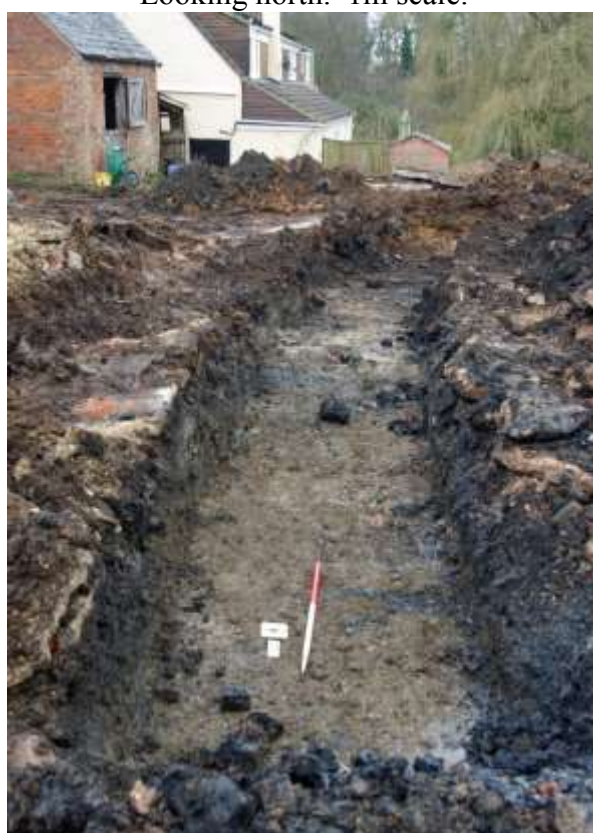
Figure 36: Trench 2 looking east.  
1m scale.

Trench 2 was placed on a south-east to north-west alignment through the centre of the development area and joined the southern end of Trench 1 (Fig. 34). As with Trench 1 the overburden consisted of modern building rubble beneath a surface of concrete. Removal of the overburden at the western half of the trench exposed an undisturbed natural substratum of sandy clay, dark greyish brown in appearance with inclusions of small rounded stones and gravel. The natural still appeared to be stained and contaminated in this trench. The south eastern half of the trench exposed the same thick layer of made ground as seen in Trench 1 (Fig. 36). At this point and beyond, the natural substratum was inaccessible due to the steep drop of the natural ground profile. This made ground consisted of modern bricks, rubble, tarmac, concrete and pieces of corrugated asbestos roofing material.

No archaeological features or deposits were present.

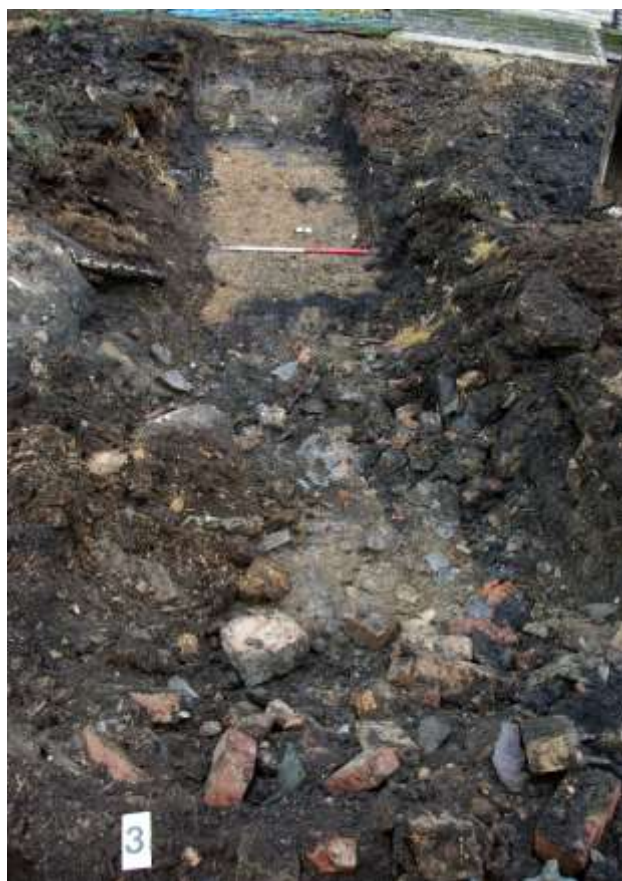
Figure 37: Trench 3 looking north.  
1m scale

Removal of the modern rubble overburden at the northern end of the trench exposed the natural substratum of orange sandy clay which had not been stained by the deep deposits of cow manure covering the floor of the shed. 5m from the northern end of the trench the natural substratum ended and band of made ground became visible (Fig. 37). At this point and beyond, the natural substratum was once again inaccessible due to the amount of built up ground on the steep slope.

No archaeological features or deposits were present.
